# A & A Environmental, Inc.

## Inspection

RE: 4018 Mineral Point Road, Madison, WI

On January 27, and February 1, 2014 an asbestos inspection for renovation was completed on the Mt. Olive Church facility located at 4018 Mineral Point Road in Madison. The facility was divided into three different buildings as delineated in the floor plan provided by the City of Madison.

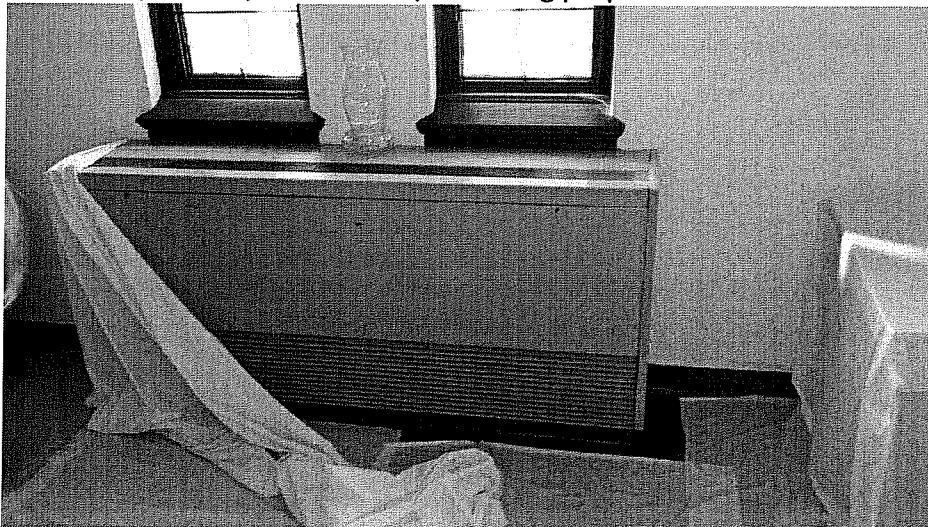
### Room 101 First floor:

The musty smell in this room could be attributed to the lack of air flow. There are plastic sheets hung on all walls and floors sealing in any moisture caused by condensation on the walls. The heating unit for the room also had the lower grates covered by a heavy linen sheet preventing proper air flow as seen in the picture below.

The plastic sheeting should be removed to allow the room to breathe and to allow for proper air circulation. The vent should not be covered.

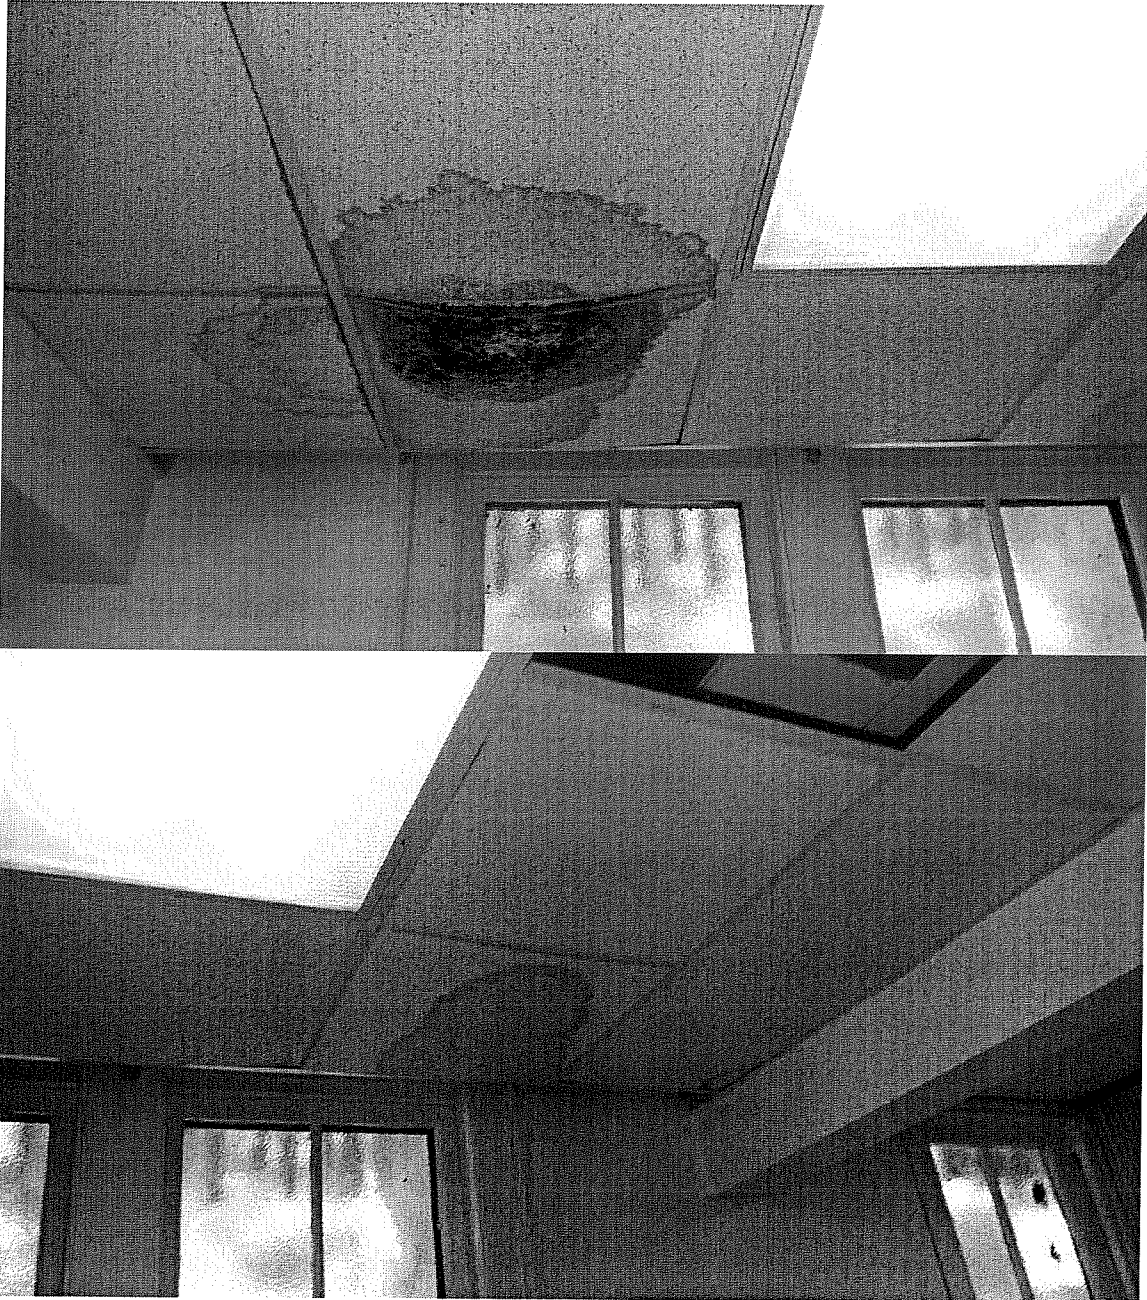
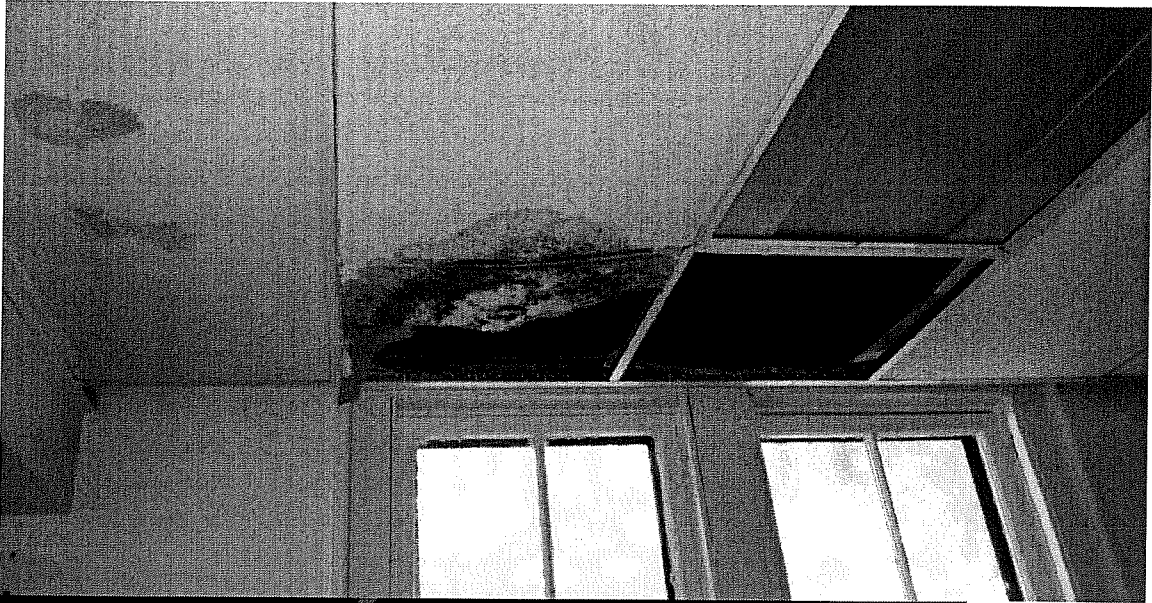
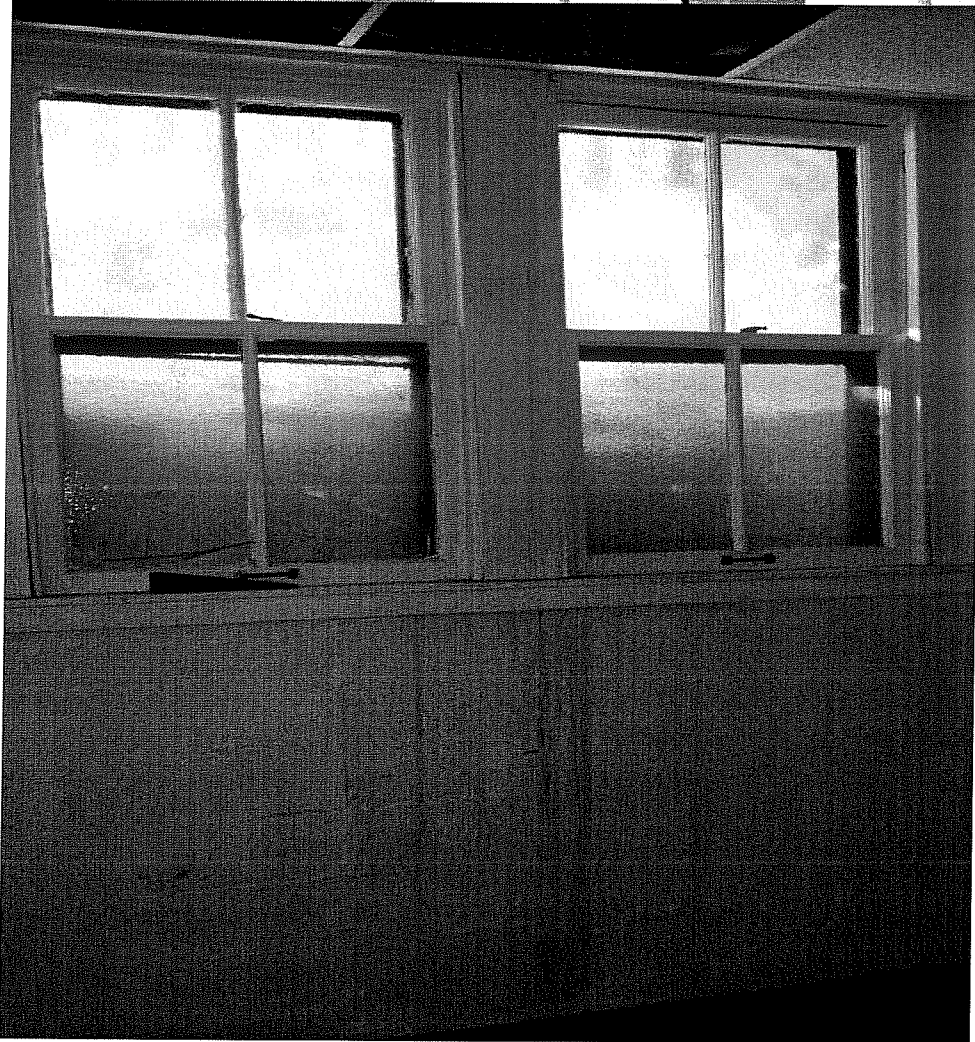
#### Room 1 (youth room)

This room is located directly below Room 101 and has had serious leaks from the rooms above as seen in the pictures below.

The leaks above seem to be coming from the unit heaters above. The water damaged areas should be cleaned and any water damaged material that is removable should be taken out and disposed of properly (carpet, ceiling tiles, pipe insulation). Also in this area there is evidence water was present for some time as there is apparent mold growth on the wall and near the heater vents as shown below.

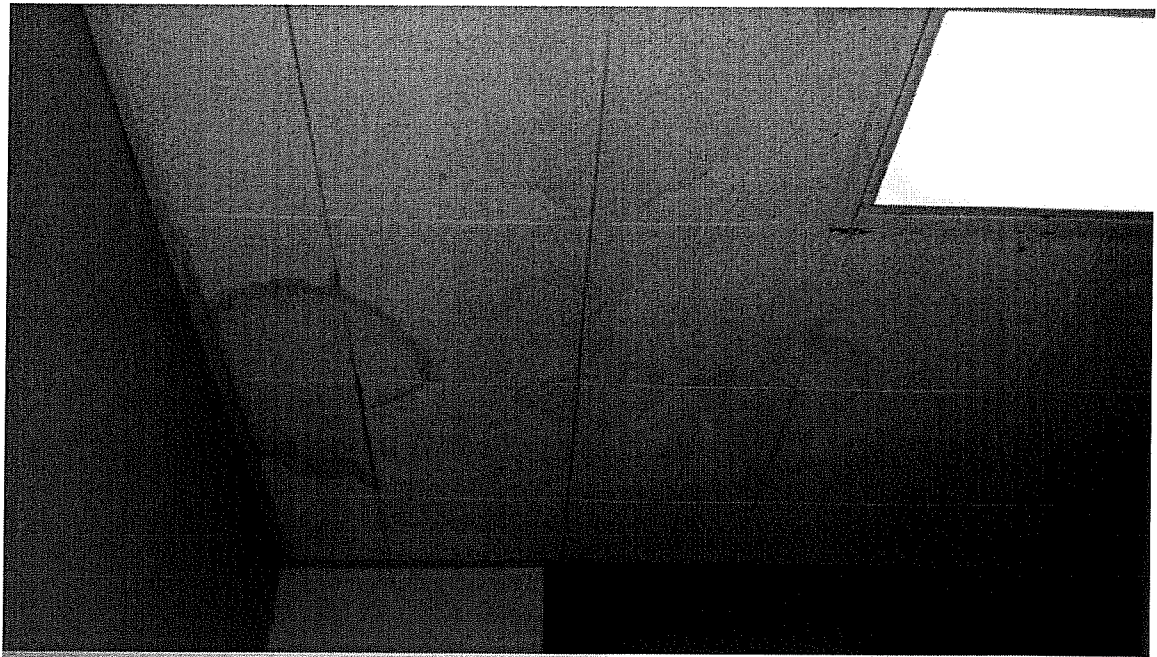
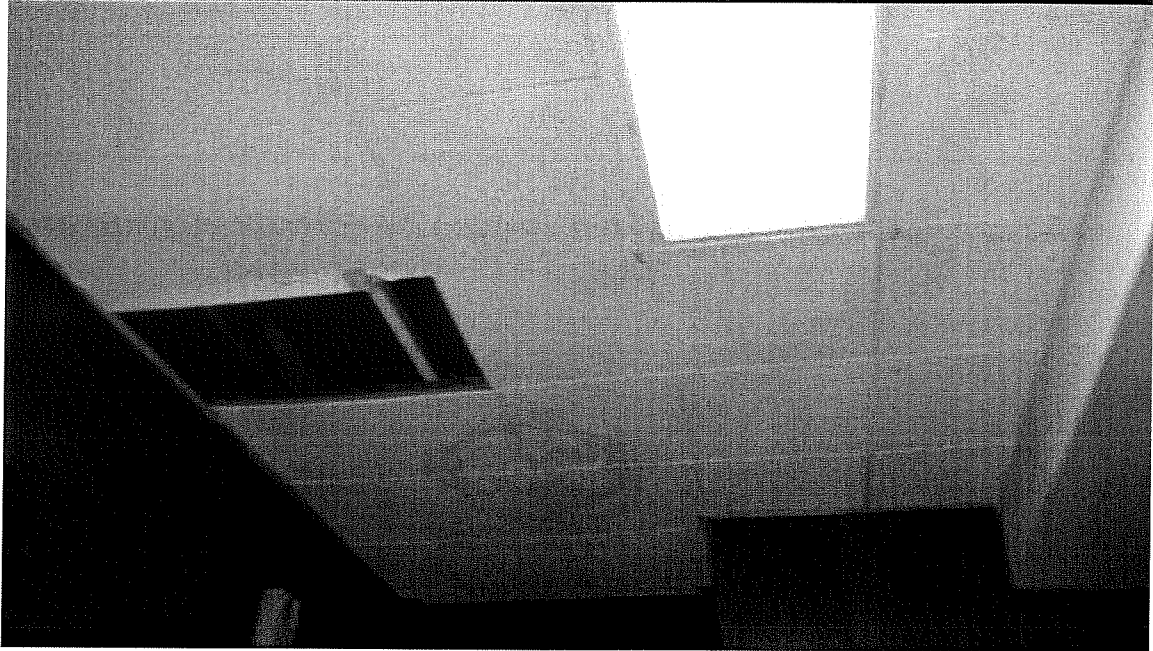
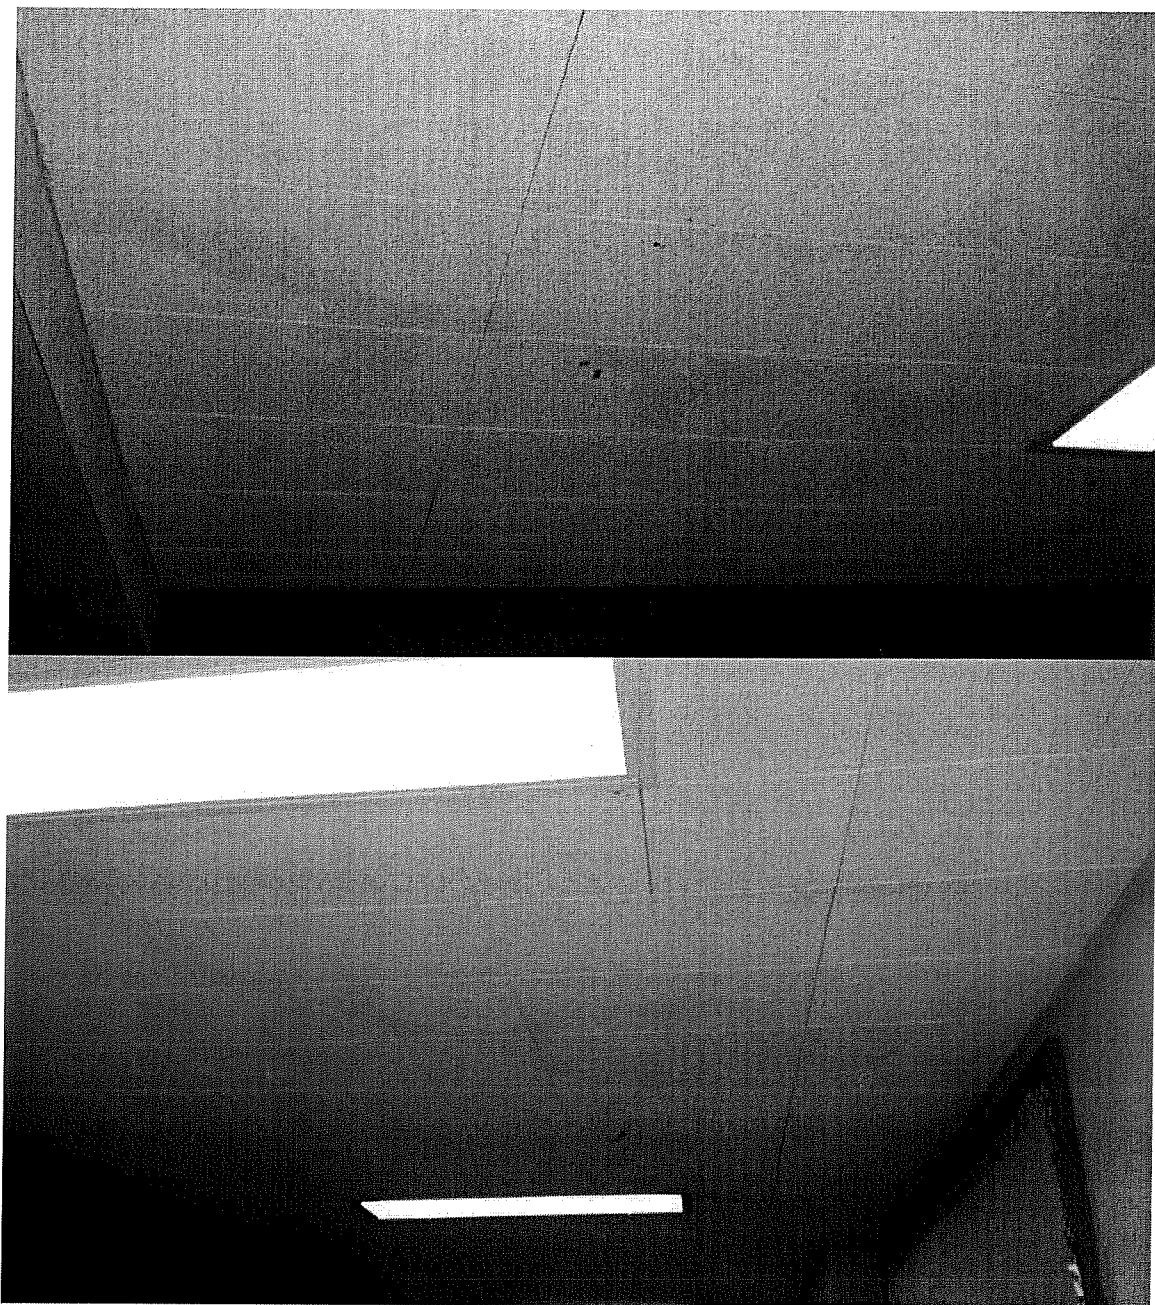
**Basement South Hallway**

The spline ceiling in the basement hallway has visible water damage. The ceiling is still intact so determining the cause was not possible. The pattern of the damage would lead me to suspect there is condensation coming from the pipes above leaking down on to the ceiling. The apparent lack of mold growth suggests the events are short duration and dry quickly before mold growth can occur. Removal of the ceiling to determine the cause and disposal of the damaged ceiling tiles would be the suggested method of remediation.

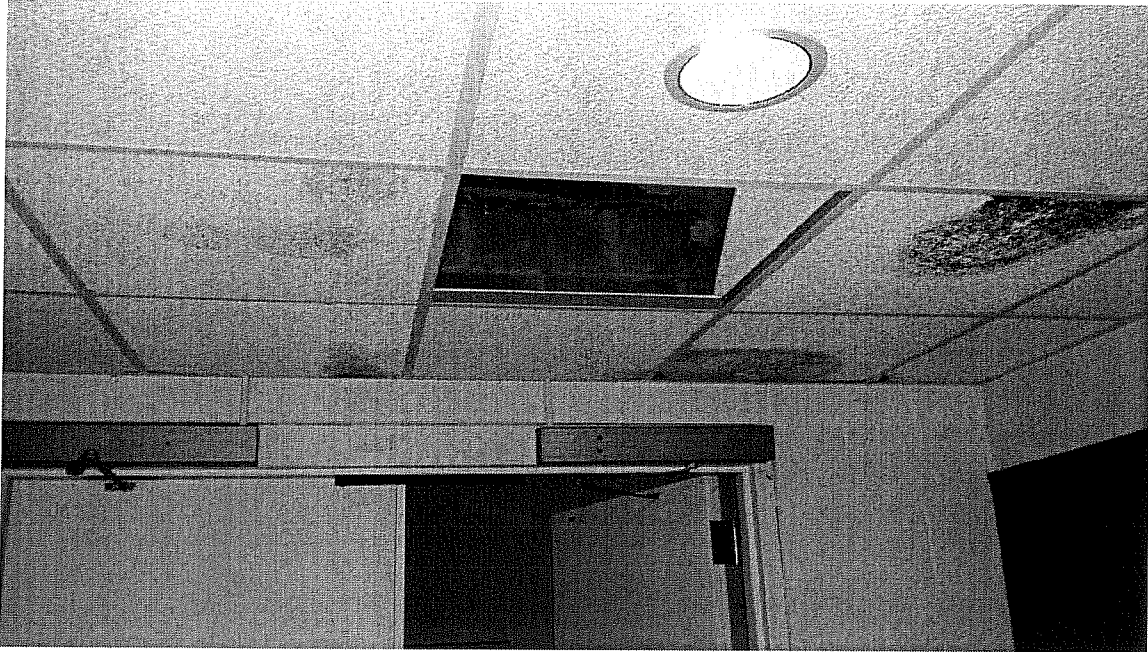
### **Basement Room 11**

The basement area labeled Room 11 has developed a leak above where the two buildings meet. This has caused damage to the ceiling tiles and an elevated mold spore count in the area. The elevated mold count means this leak has been going on for some time. Also the toilet shut off valve has developed a leak as well and needs to be repaired. Suggestions for this area would be to repair the roof leak and remove the water damaged materials. Also from the leaky toilet valve the carpet has been soaked and the adhesive is no longer performing its intended job. The carpet should be removed and the area thoroughly cleaned and treated for mold.

Air samples were taken in Room 101, Room 1, Room 11, and outside. The only sample that showed any elevated levels of mold growth was the sample from Room 11 where the floors were still wet from the leaky toilet valve, which was shut off on the initial walk through. The rest of the samples showed very few spores in the air.
