EXISTING BUILDING REVIEW

117-119 State Street

Name: Haswell Furniture Co.

117–119 State Street – Architectural Review

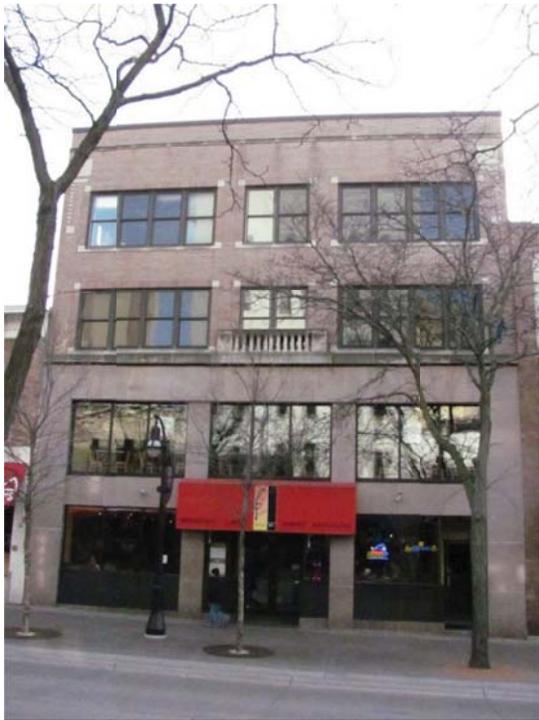
The State Street facade consists of manufactured polished stone panels and brick and cast stone masonry (Figure 1). Except for a limestone belt course and balustrade at the third floor (Figure 2), this facade was completely reconstructed in the 1990s. The only visible distress observed on this facade is localized water rundown staining below the stringcourse at the parapet wall (Figure 3).

Figure 1. The State Street facade.

Based on this limited survey, the State Street facade does not require any significant repairs at this time. The building roof should be surveyed and any maintenance needs addressed.

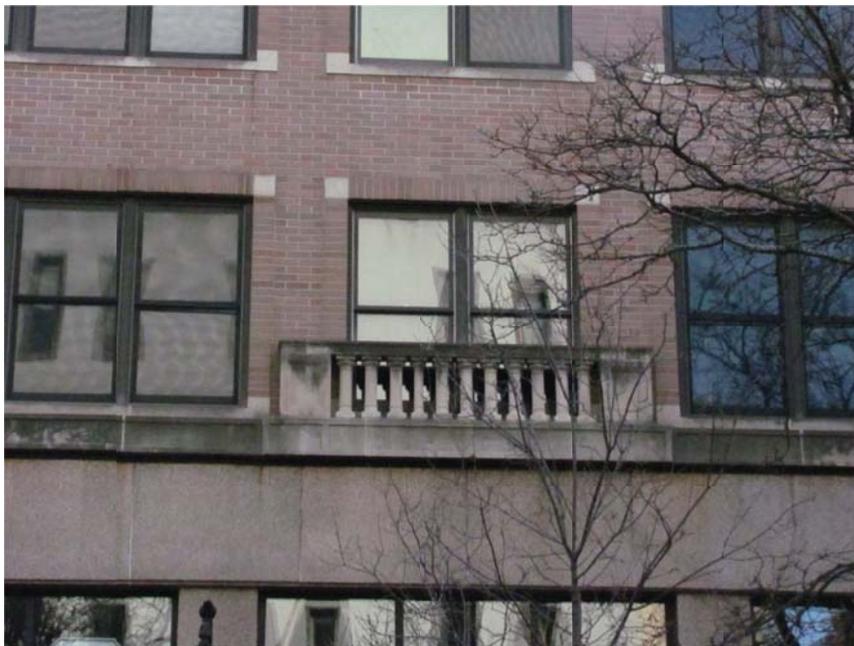
Figure 2. Only a limestone belt course and balustrade at the third floor remain from the original State Street facade.

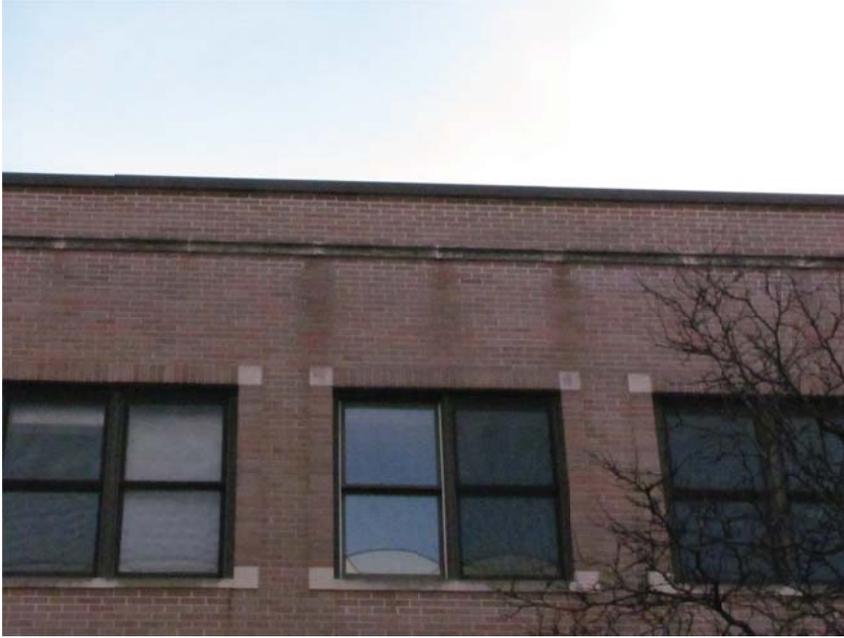
Figure 3. Water rundown staining below the stringcourse at the parapet wall.

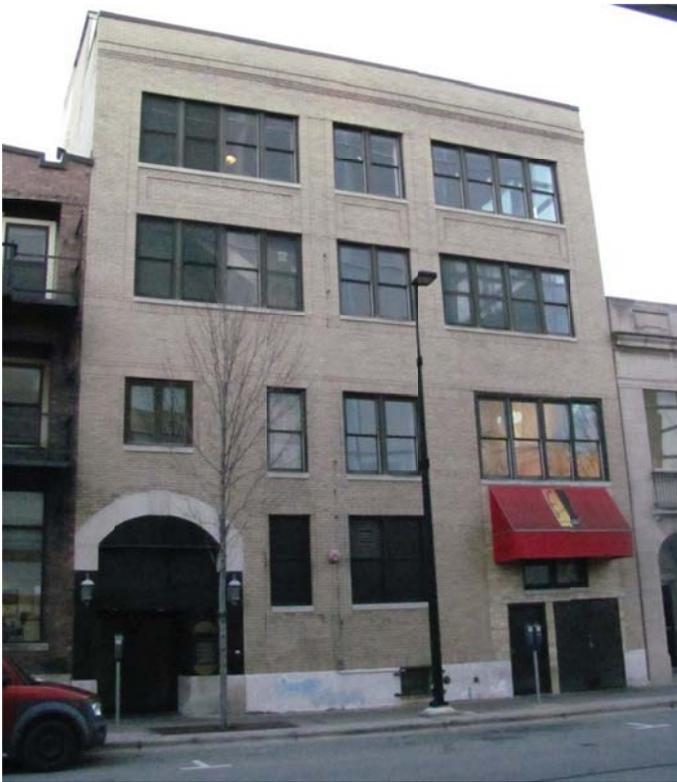
The Fairchild Street facade primarily consists of the original brick masonry facade, although the areas around the entrance doors were apparently altered as part of the 1990s renovation (Figure 4). Limestone is used for window sills at this facade. Cracking and displacement of brick masonry above window heads was observed, likely related to corrosion of embedded window lintels (Figure 5).

Figure 4. The Fairchild Street facade.

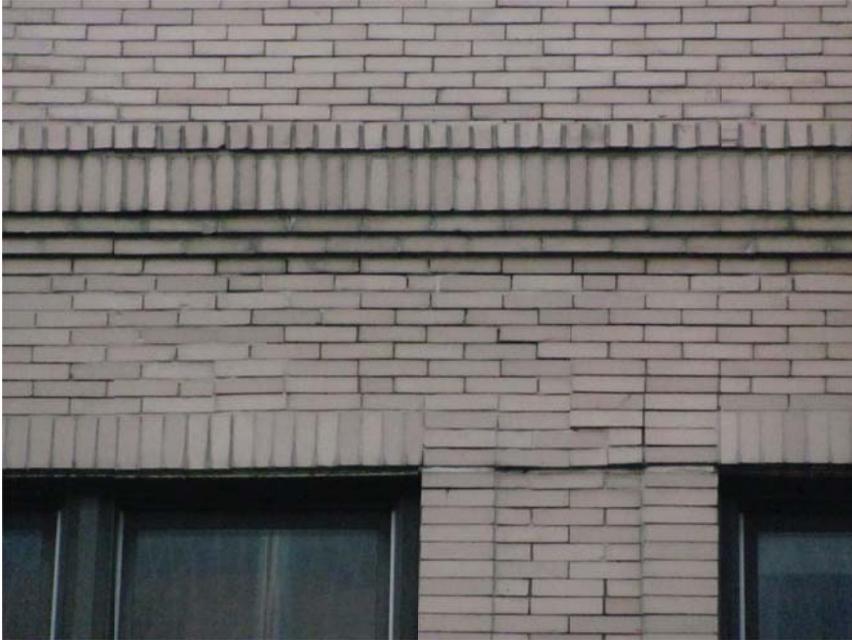
Figure 5. Cracking and displacement of brick masonry above window heads.

Masonry repairs are required at the party walls and the Fairchild Street facade. Areas of cracked masonry should be rebuilt, and areas of open or eroded mortar joints should be repointed. At the obtuse corners of the party walls, installation of backer rod and sealant in the continuous vertical crack may be appropriate to accommodate movement and provide a weather tight joint. Repairs are required at bearing locations of window lintels on the Fairchild Street facade; additional investigation is needed to evaluate the condition of the steel lintels and determine the scope and extent of the required repair.

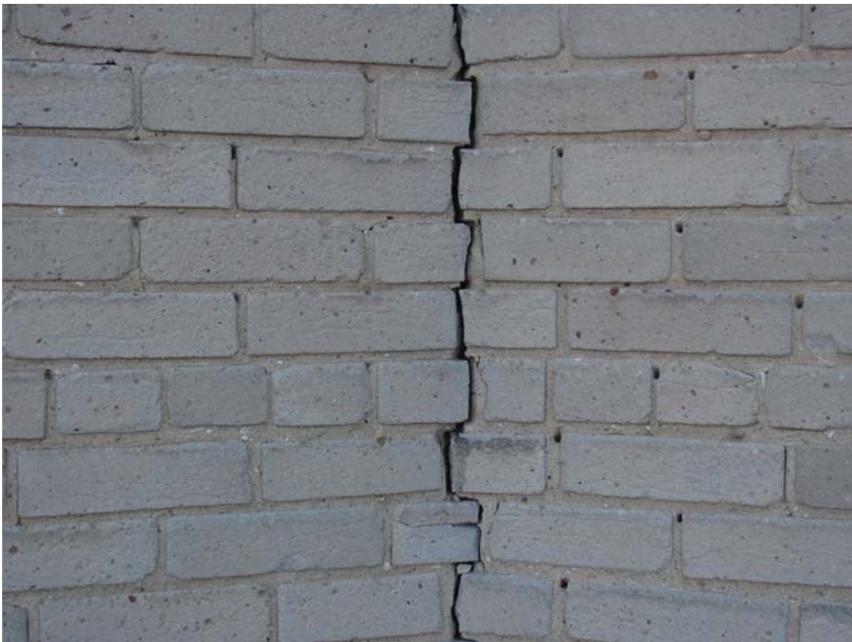
The brick masonry party walls at the sides of the building were reviewed from lower roofs of adjacent buildings, where these walls extend and are exposed above the adjacent roof levels. Vertical cracking was observed at multiple locations in both party walls, especially at obtuse angle changes in the plane of the wall (Figure 6 and Figure 7). Also, some areas of poorly matched repairs and areas overclad with an EPDM rubber roof membrane were observed (Figure 8). Erosion of mortar joints and water rundown staining was also observed at the party walls.

Figure 6. Vertical cracking at an obtuse corner in the brick party wall.

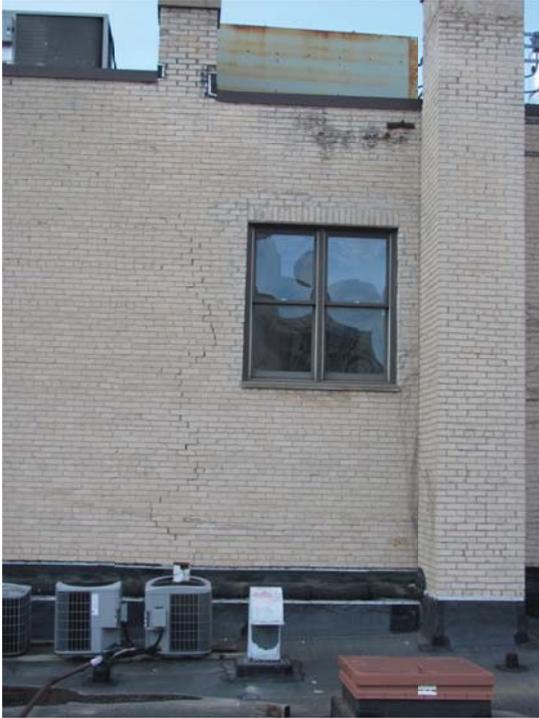
Figure 7. Left. Vertical cracking and localized damage in the brick masonry party wall, which is visible where it extends above the roofs of the adjacent buildings.

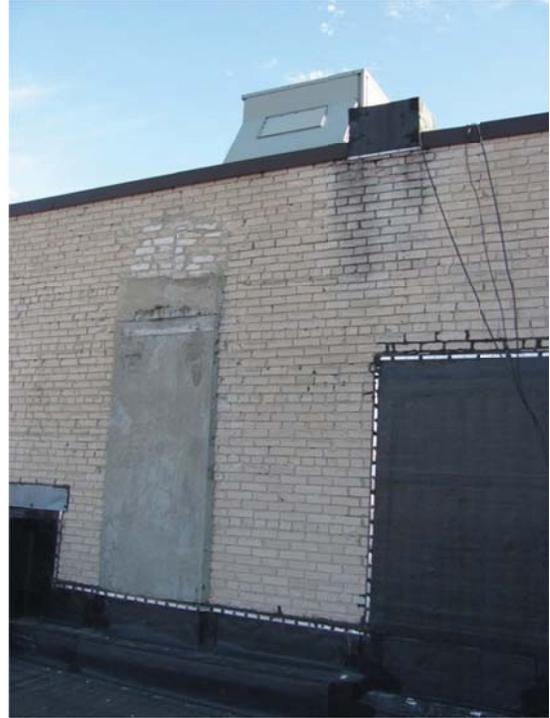
Figure 8. Right. Some areas of poorly matched repairs and areas overlaid with an EPDM rubber roof membrane were observed at the party walls. Also note rundown staining and open mortar joints.

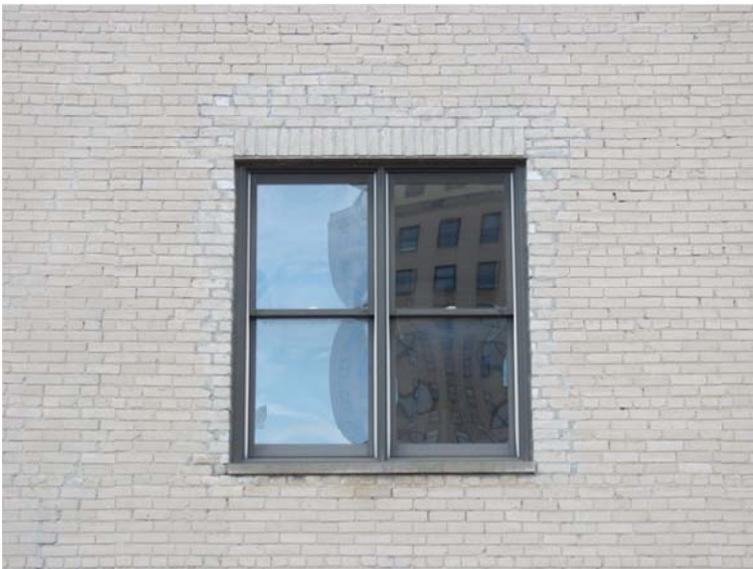
All of the windows in the building are aluminum-clad wood double-hung windows with insulating glazing apparently installed as part of the 1990s renovation (Figure 9). The first and second floor windows at the State Street facade are an aluminum-framed center-glazed storefront system with insulating glazing, also apparently installed as part of the 1990s renovation. The exterior aluminum-framed doors apparently date to the 1990s renovation. No distress was observed at the windows or doors.

Figure 9. Typical aluminum-clad wood windows.

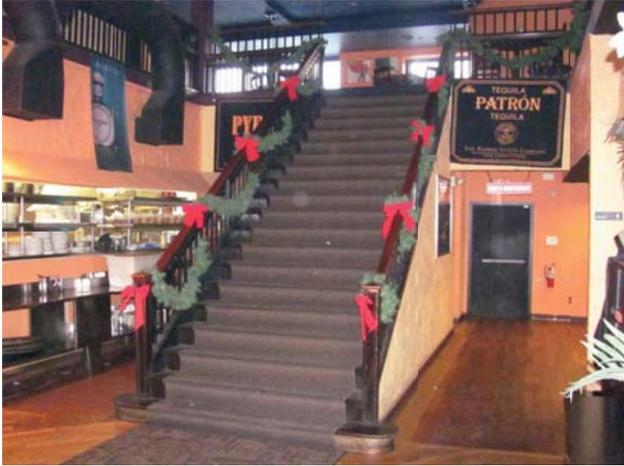
Figure 10. Original staircase from the first floor to the second floor.

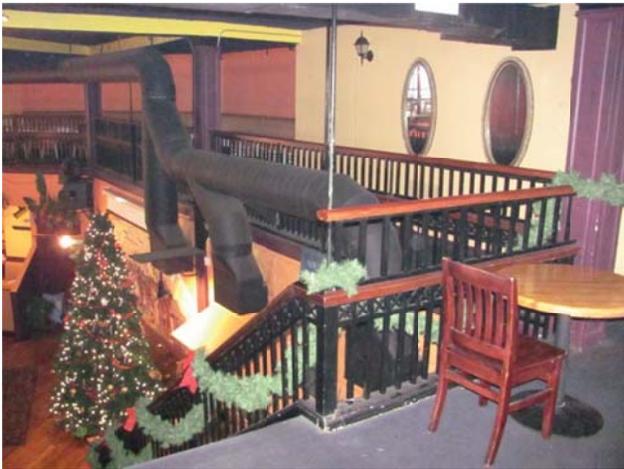
Figure 11. Second floor mezzanine with original balustrade.

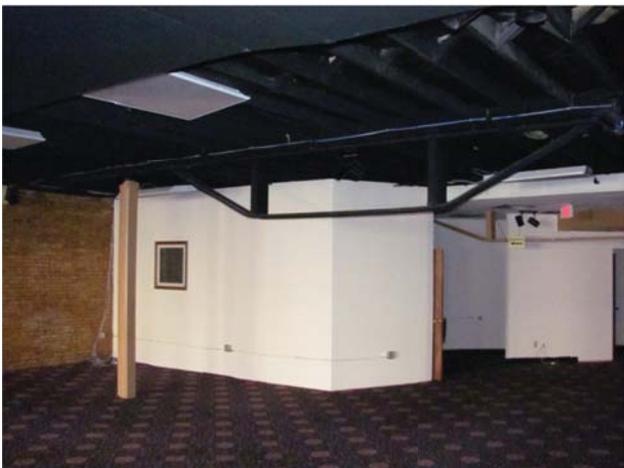
Figure 12. At the third and fourth floors of the building, unique original wood and iron trusses are exposed to view.

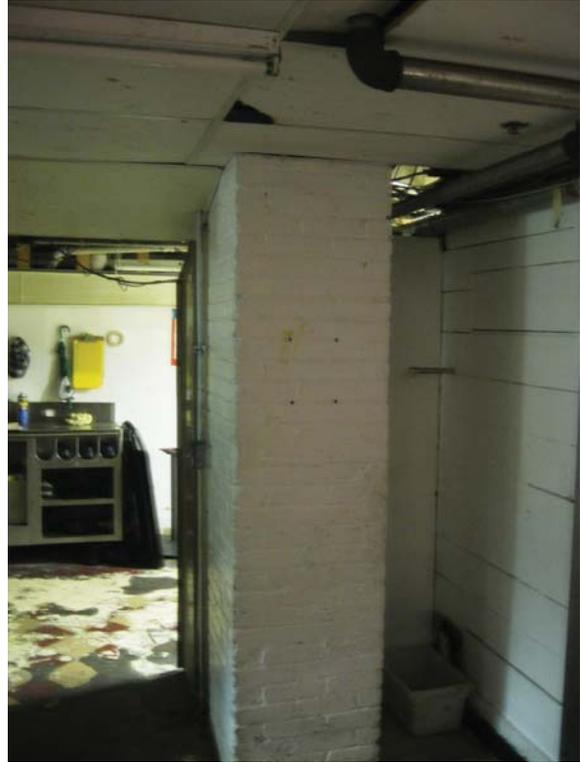
The floor is wood framed. The floor joists span perpendicular to State Street. They are supported on a wood beam of built up 2x members in turn being supported on 2' square brick piers. The floor live load capacity based on the joists is 85 psf. Floor load capacity based on the built up beams is less than 50 psf. The present day live load requirement is 100 psf for retail occupancy.

Photo 5 – Basement level brick pier

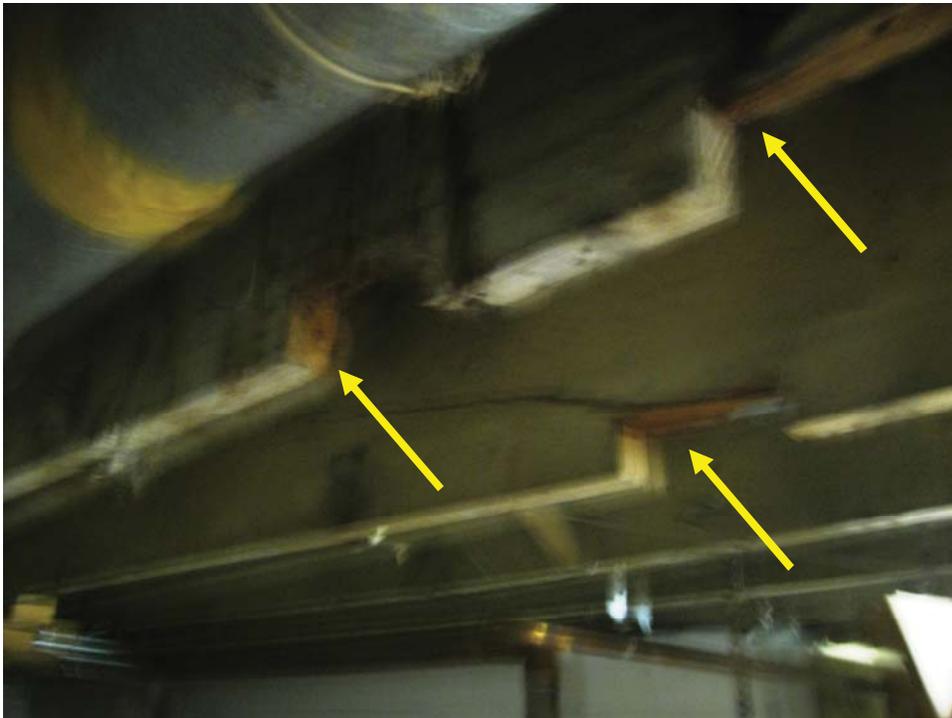
3. Areas of Compromised Structure
 - a. Numerous structural revisions have been made which are outlined in the body of the report.
 - b. Floor joists in the basement for the first floor framing have been cut and notched over the years for the passage of piping. Shores have been placed to prop some of these areas up. These areas are outlined in the body of the report.

Photo 6 – Notched 1st floor joists

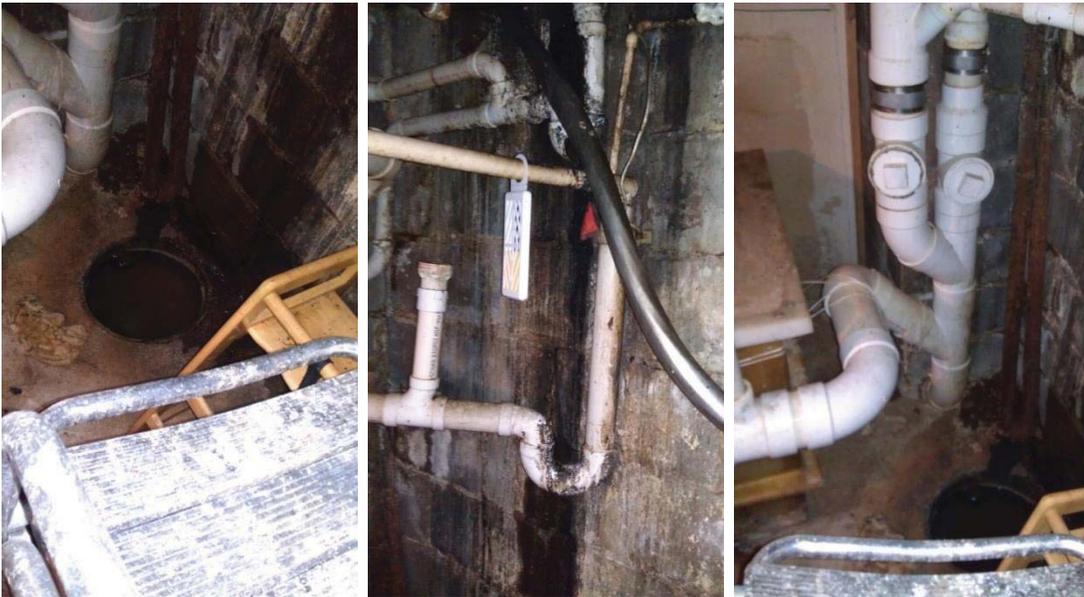
Poor condition of sanitary piping

The basement water heater appears less than 10 years old and is in good condition. Domestic hot and cold water piping is a mix of new and old in the basement due to renovations/remodeling over the years but it is expected that much of the piping on the upper floors is original or very old. Similarly, the sanitary piping from the kitchen in the basement is PVC due to recent modifications, but ties into original cast iron mains and under floor laterals. The domestic water heater on the upper floor appears to be fairly new, probably less than 5 years old.

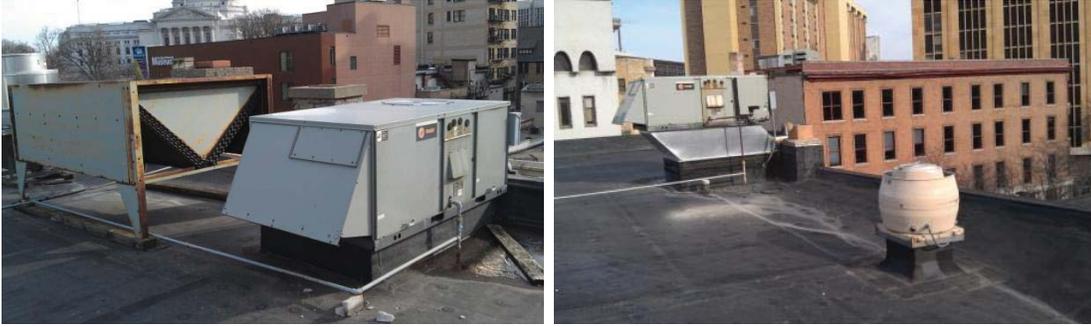
Existing rooftop equipment

The rooftop air handling units are estimated to be about 20-25 years old. That is past the typical average useful life for this type of equipment. The kitchen hood exhaust fan is newer, probably around 5 years old or less.

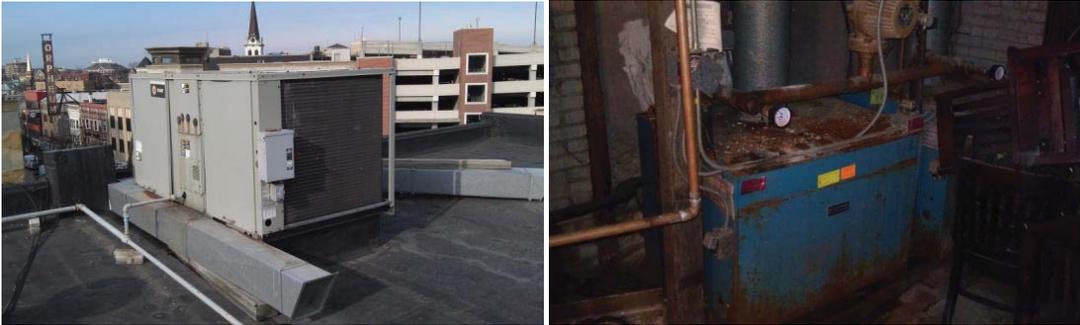
Basement Boilers

The boilers are estimated to be 25-30 years old and are in poor condition. Some of the hot water piping is new but it is expected that most is original. Some may contain asbestos insulation. It appears that piping that was replaced was due to repairs and/or equipment replacements.

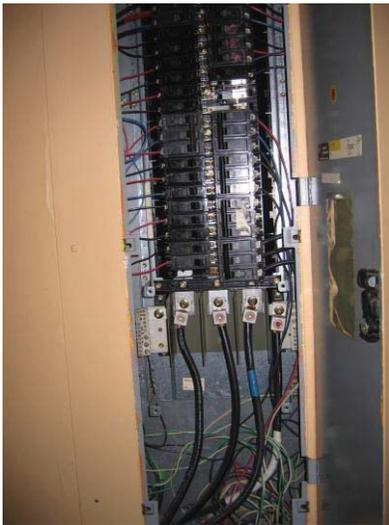
The branch panel on the 2nd floor was missing the interior trim cover, resulting in exposed wiring terminations when the panel front was opened. Since the current condition is a potential safety hazard the building manager brought this deficiency to the attention of the restaurant manager to replace the trim cover that was removed.

Electrical panel on 2nd floor restaurant missing interior trim cover.
