## Existing Building Assessment

### Photos

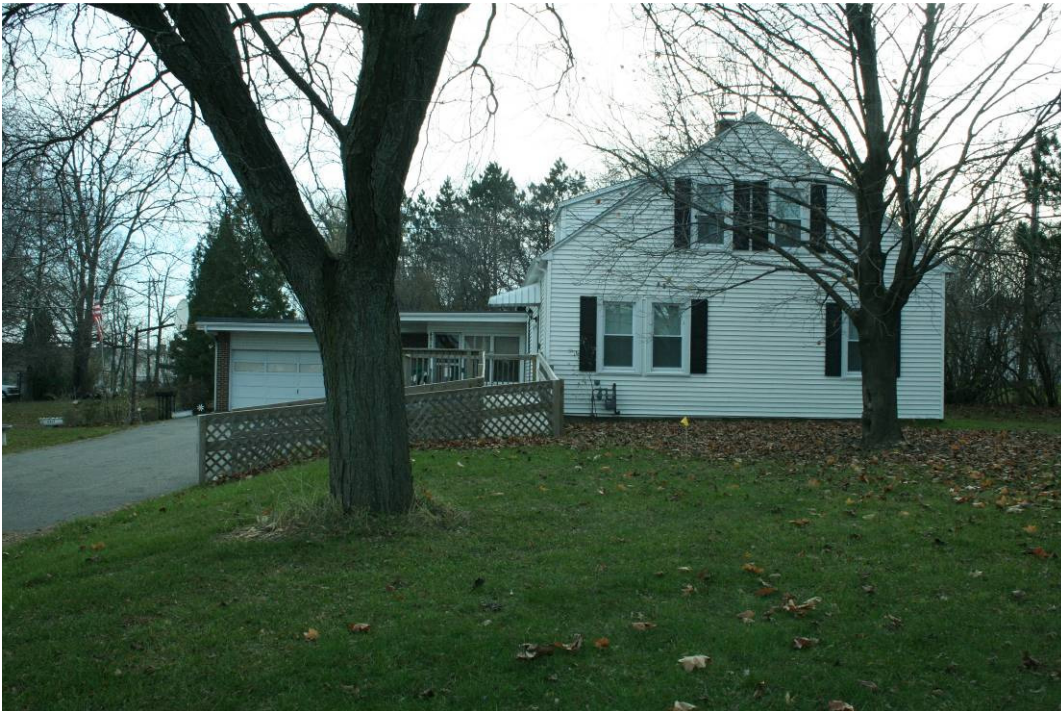
4817 Existing front elevation (north)

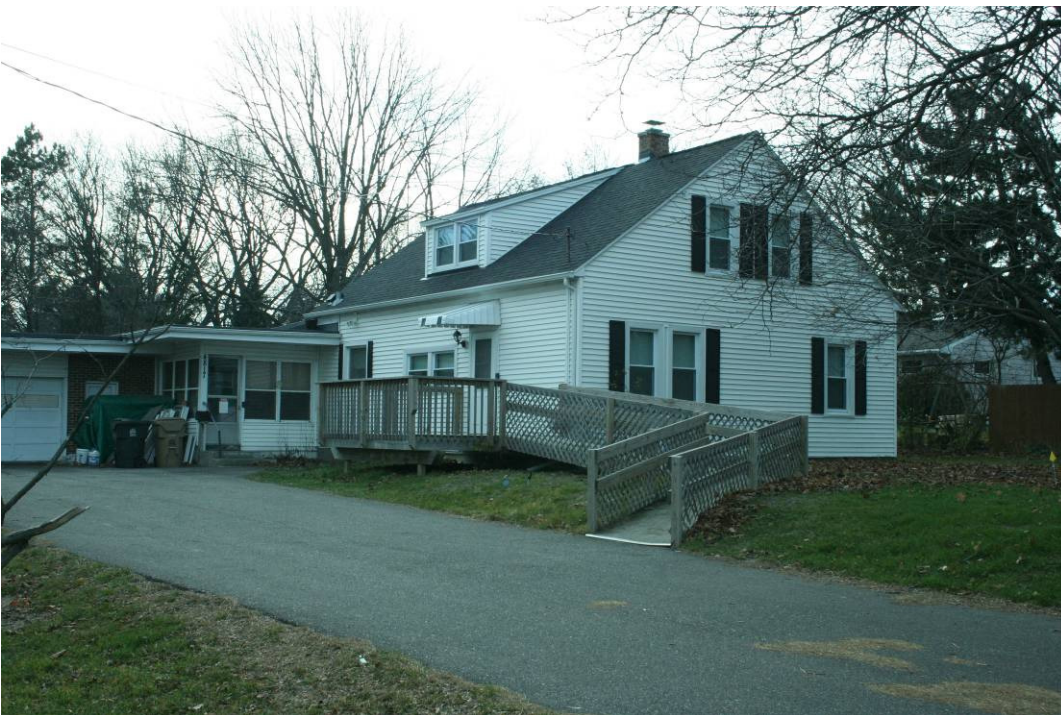
4817 Existing elevation (northeast corner) with HDCP ramp

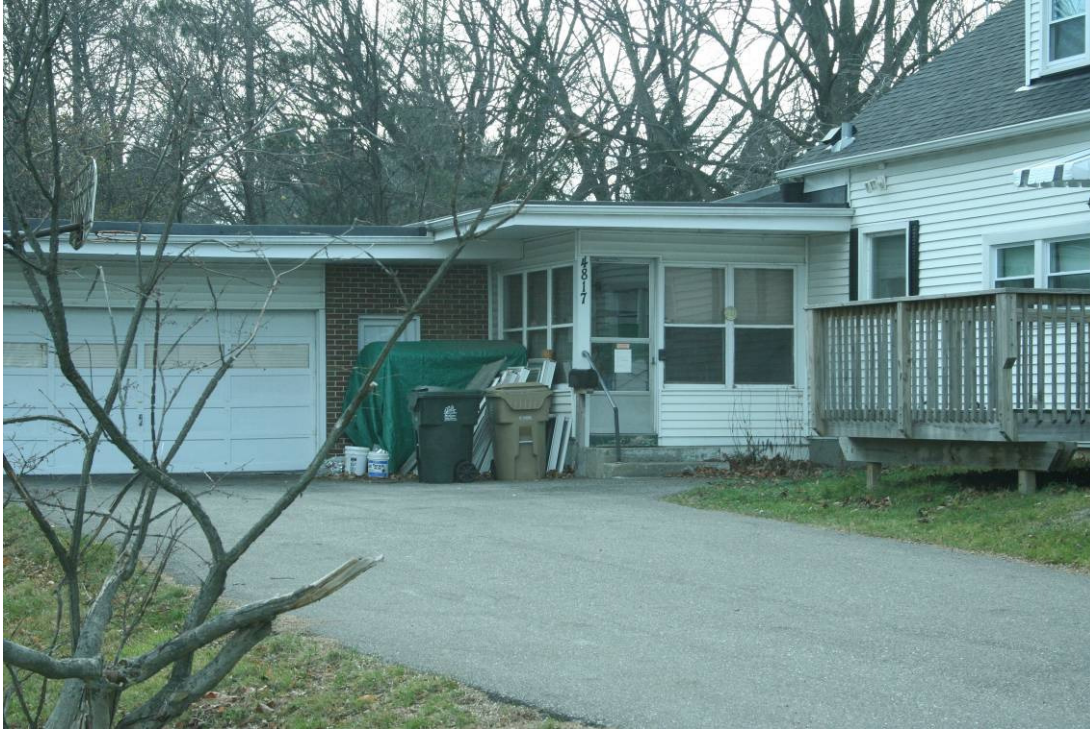
4817 Existing garage and three season porch

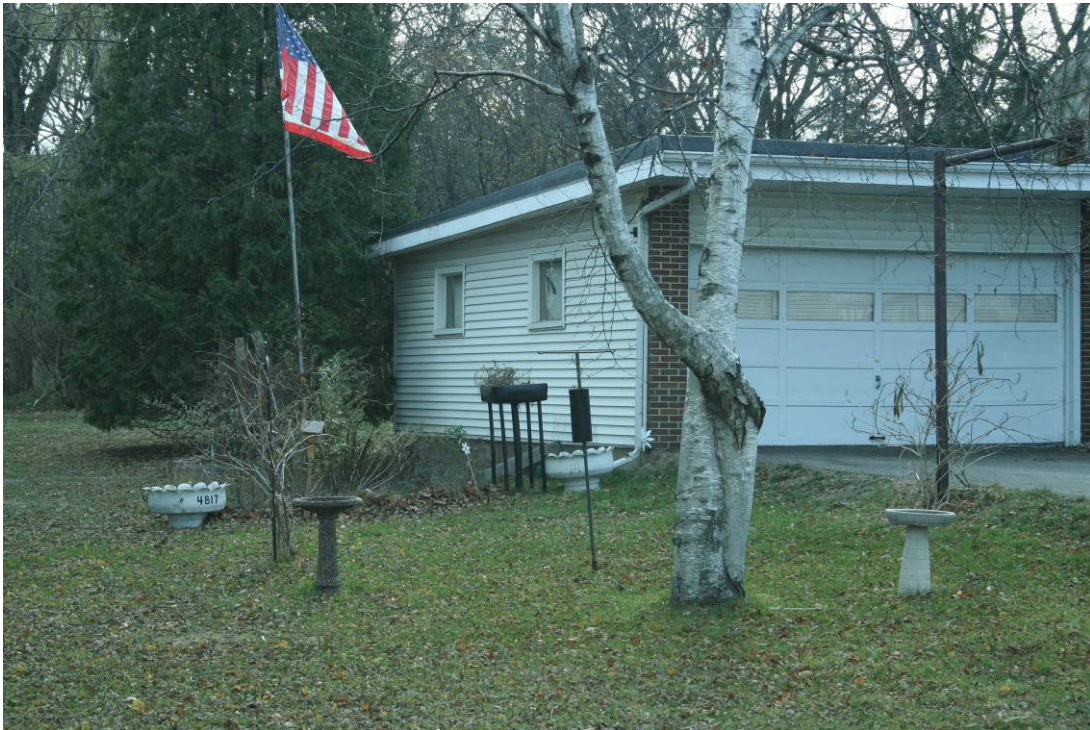
4817 Existing garage

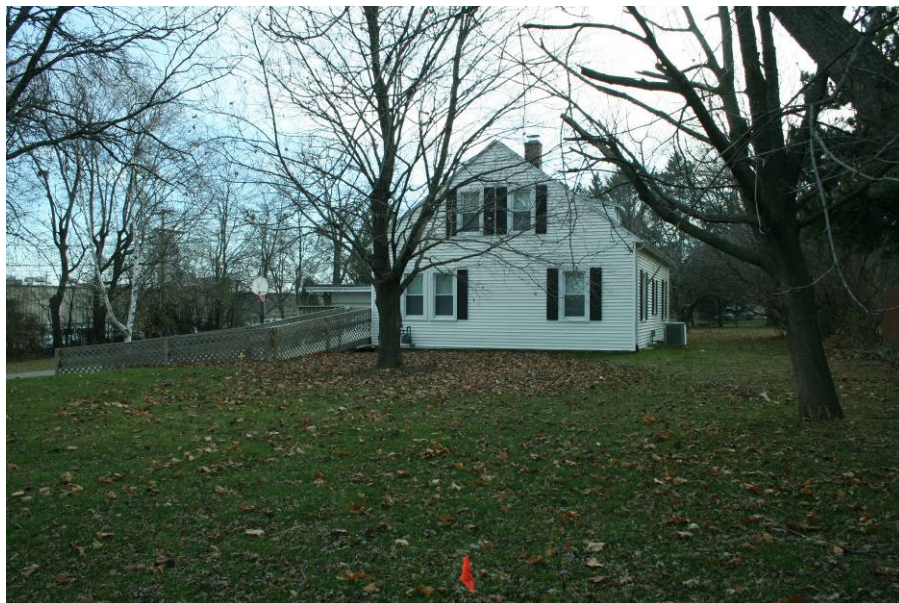
4817 Front elevation and yard

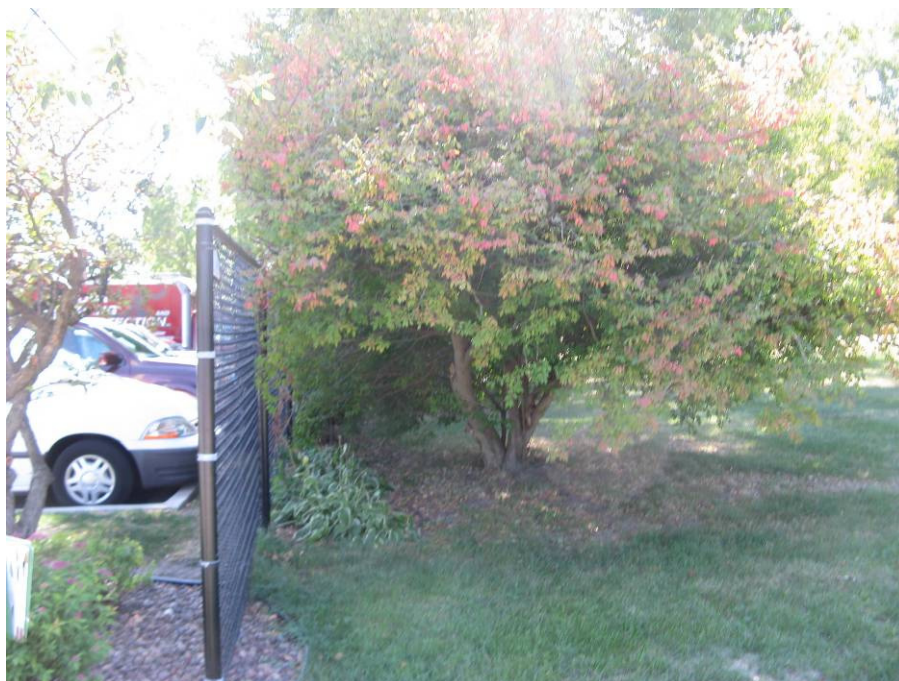
4817 Fence on east property line

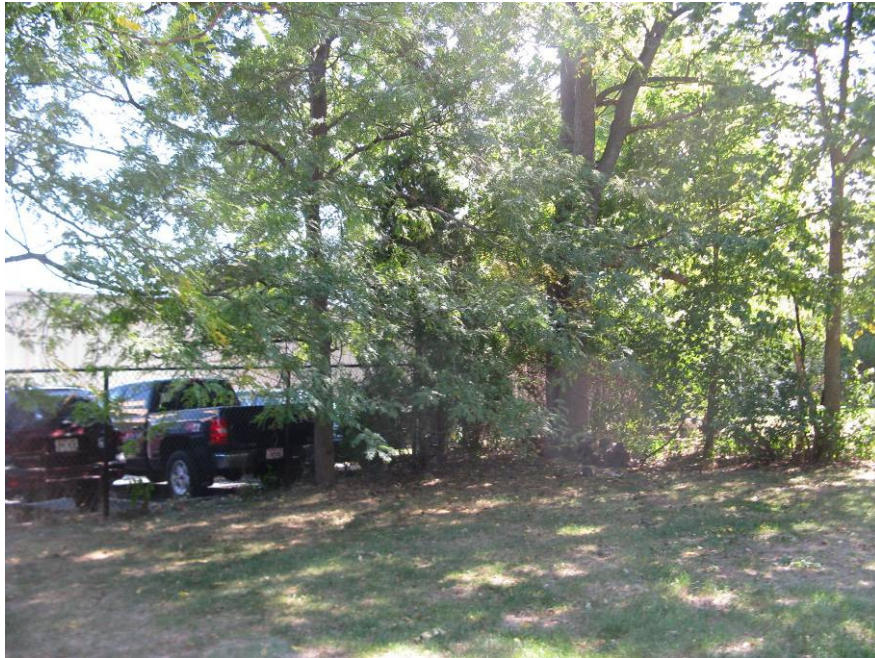
4817 East property line and view of Sub-zero parking lot

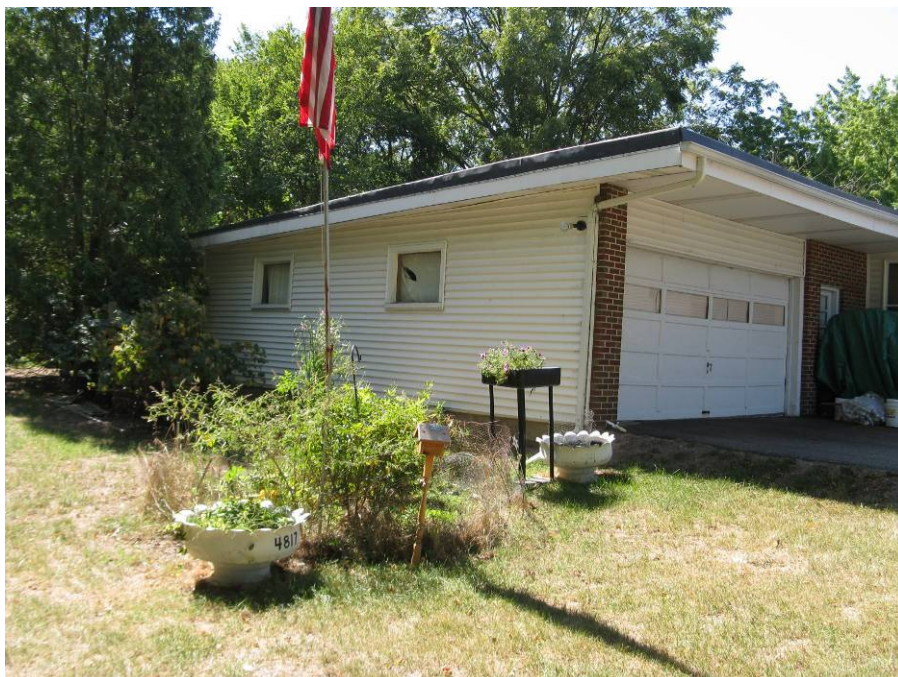
4817 Southeast elevation of garage

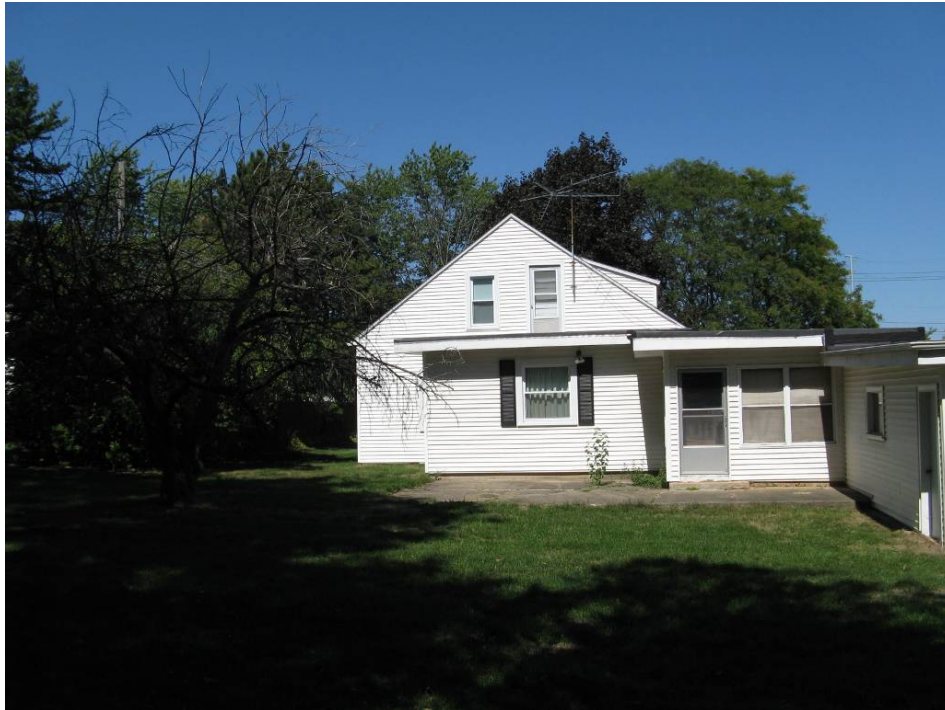
4817 North elevation of house

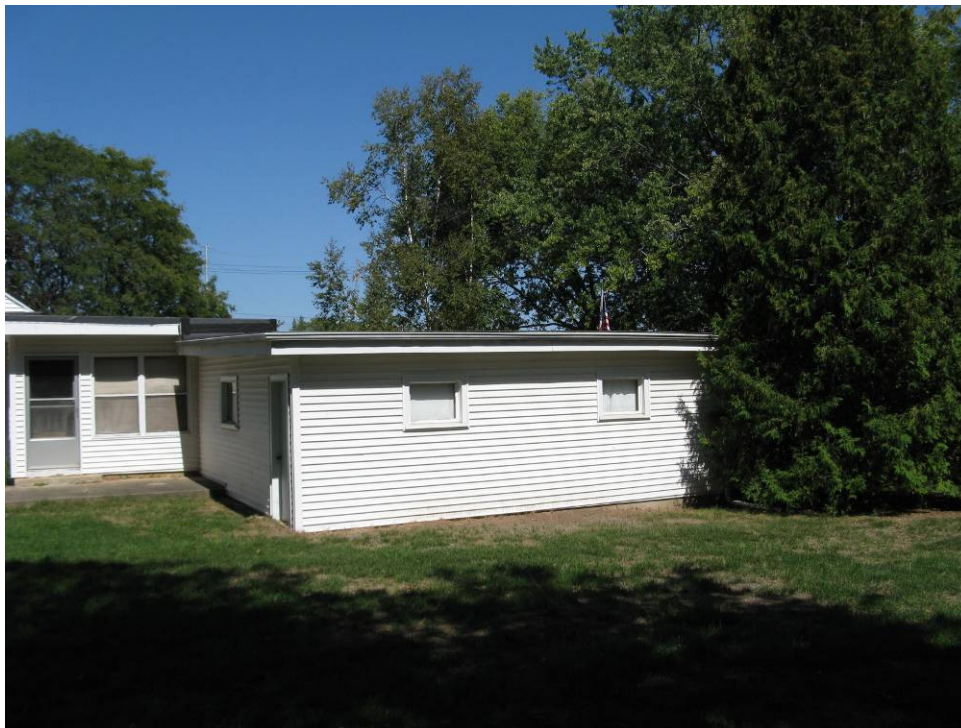
4817 North elevation of garage

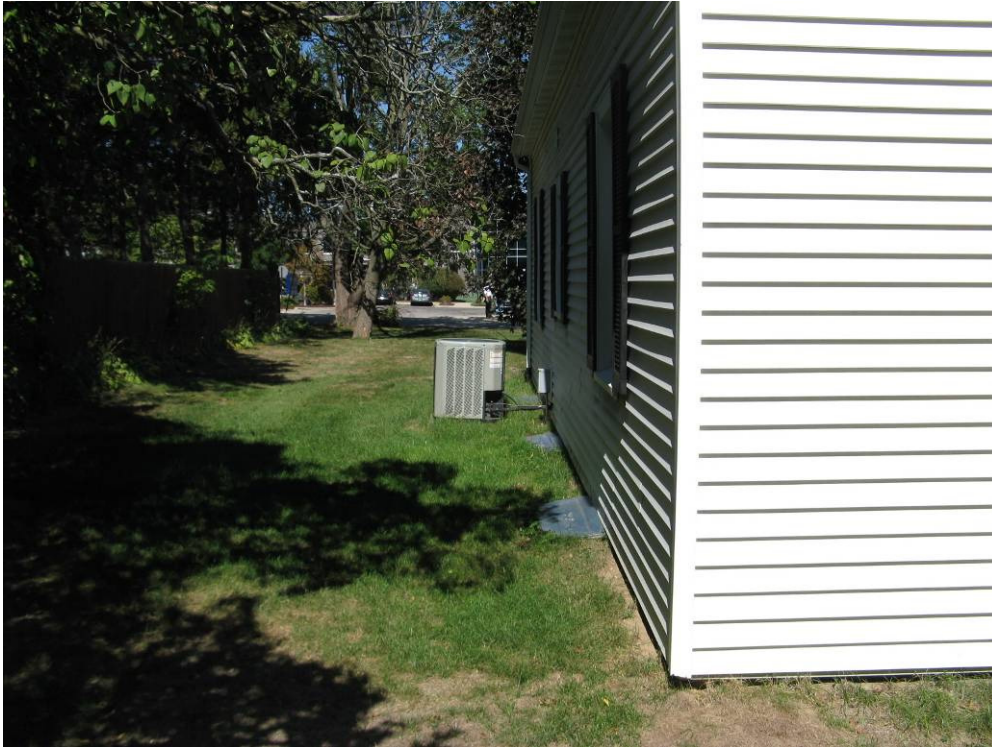
4817 Southwest corner of house. Evidence observed of wall structure bending

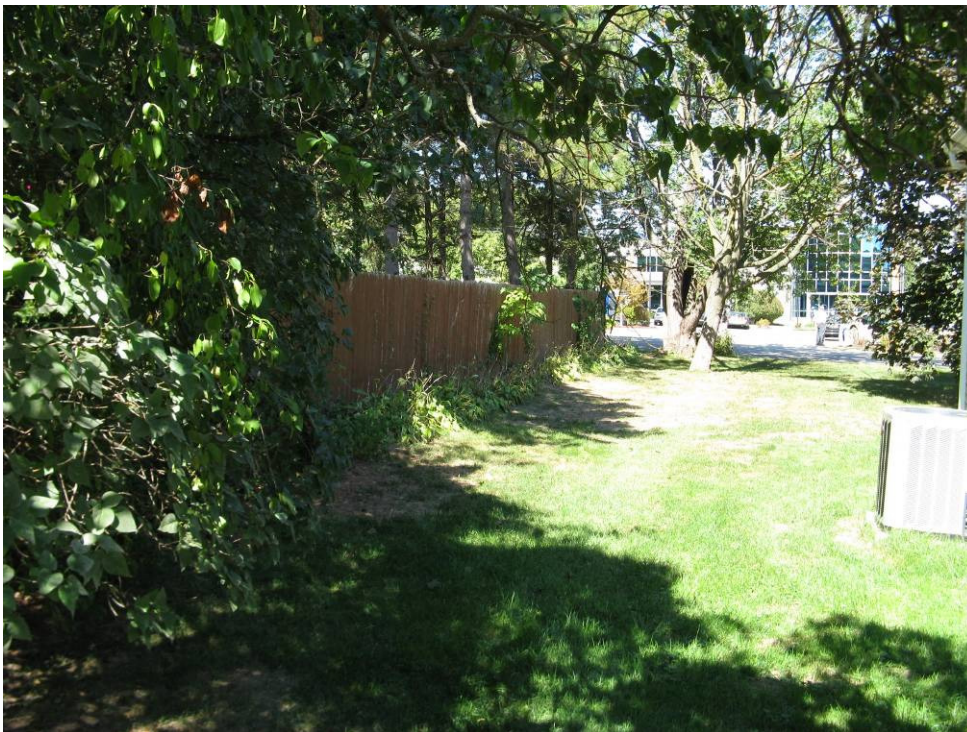
4817 West property line. Pacific Cycle is visible from backyard

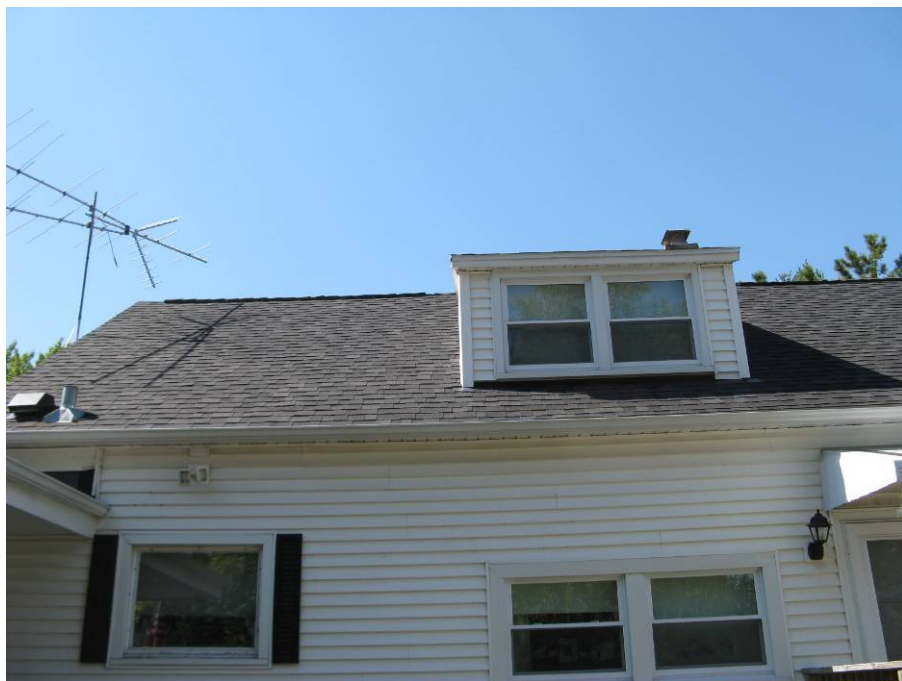
4817 Roof appears to be in good condition

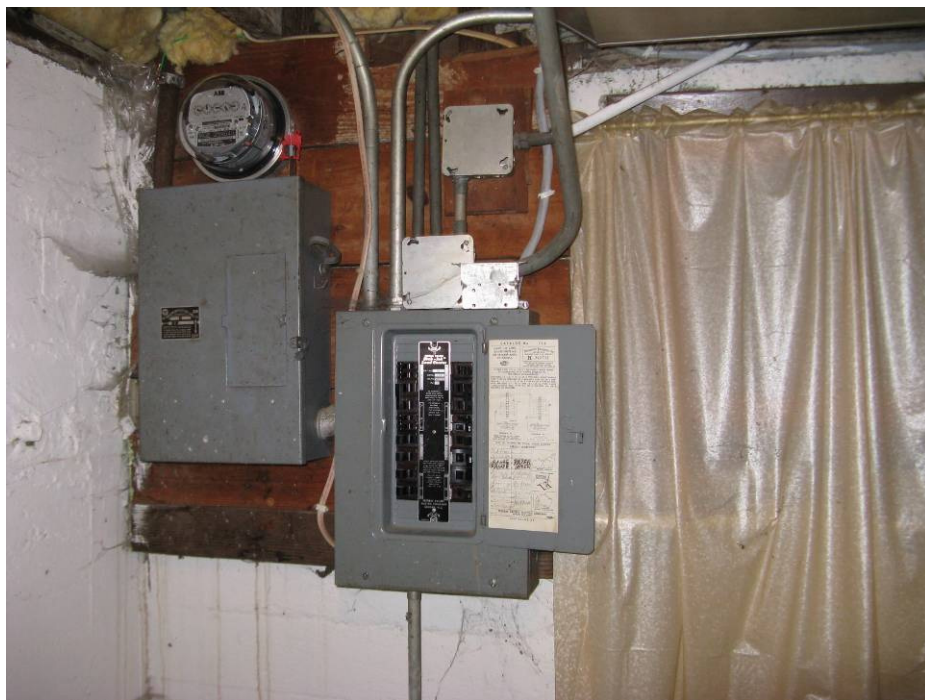
4817 Existing electrical service. Water damage observed on foundation wall

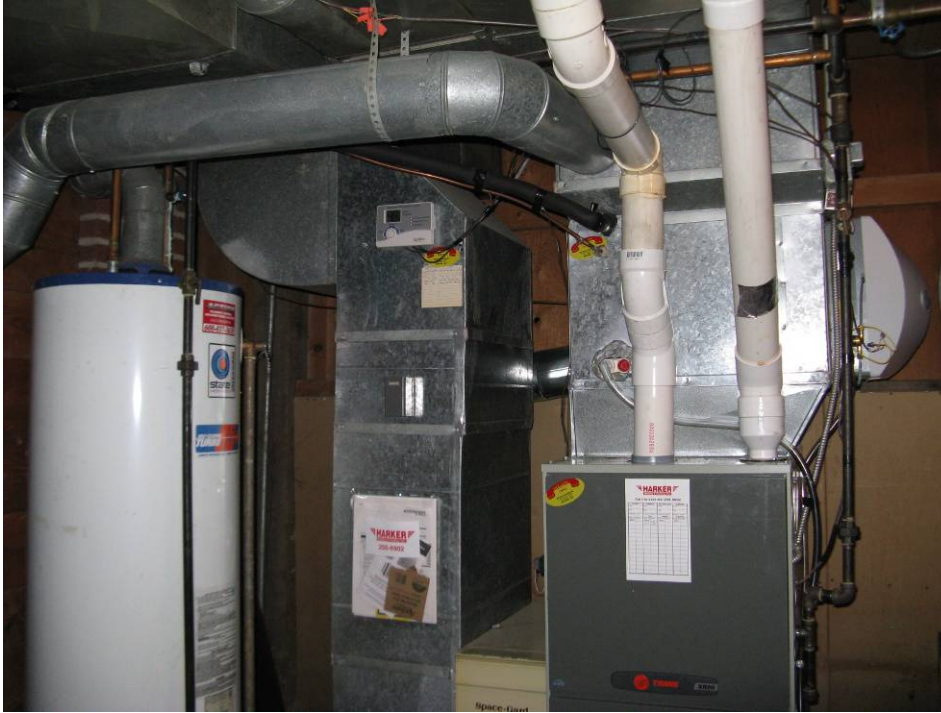
4817 Existing furnace and water heater

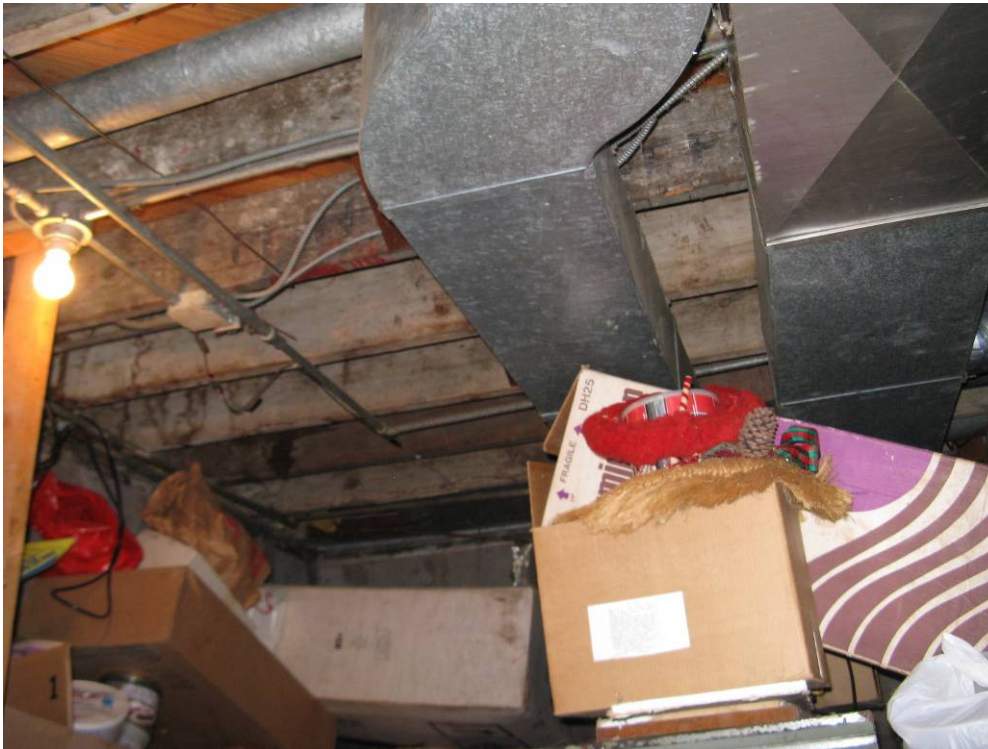
4817 Floor joist as visible from basement. Water damage was observed

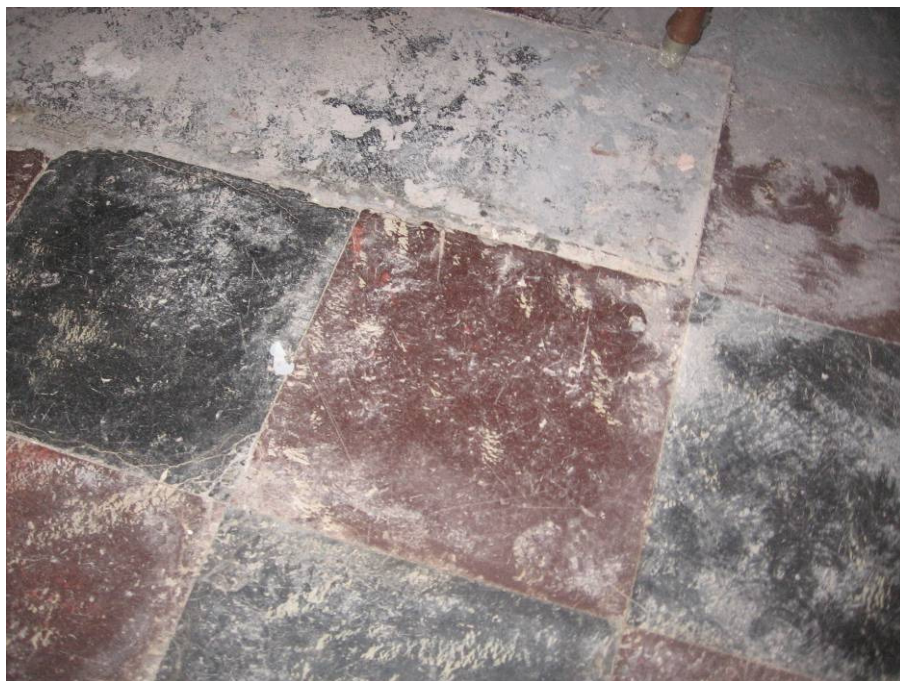
4817 Asbestos floor tile in basement
