621 Mendota Court
Existing Structure Photos
12/10/09

619 Mendota Court

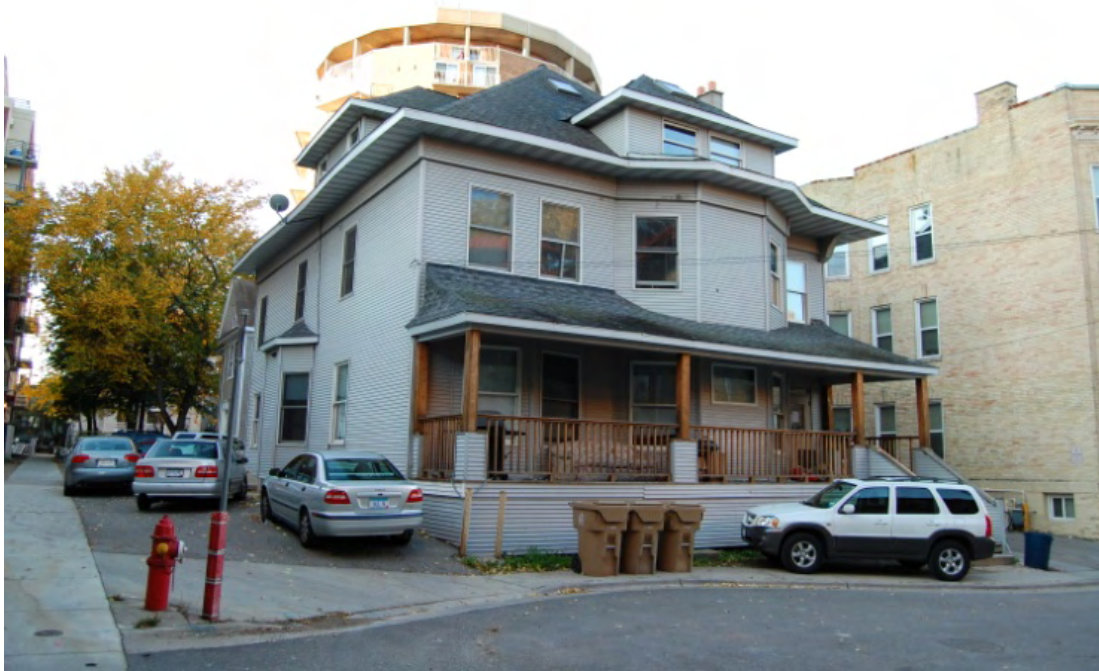
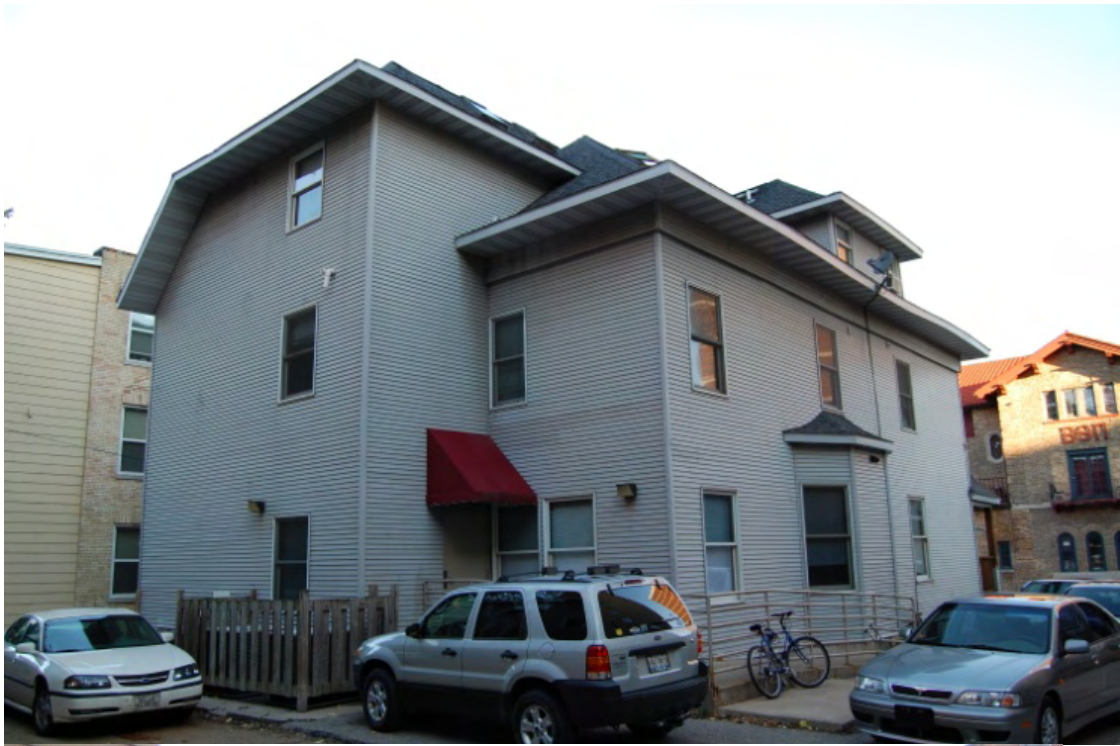
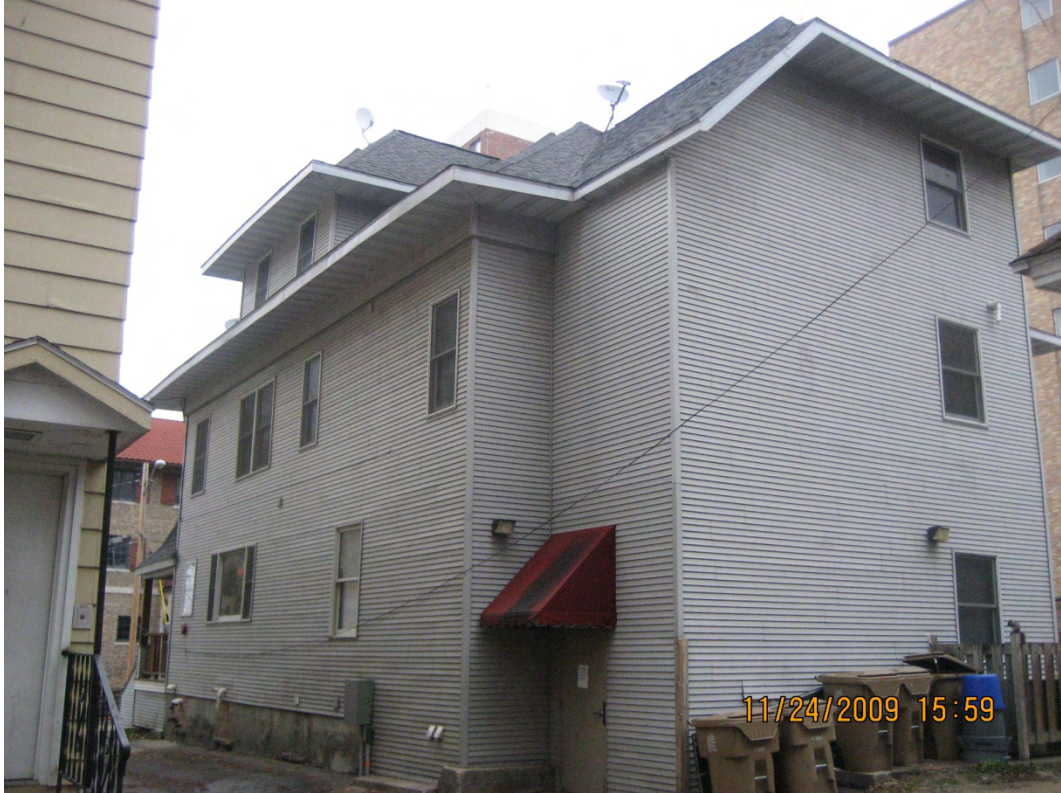
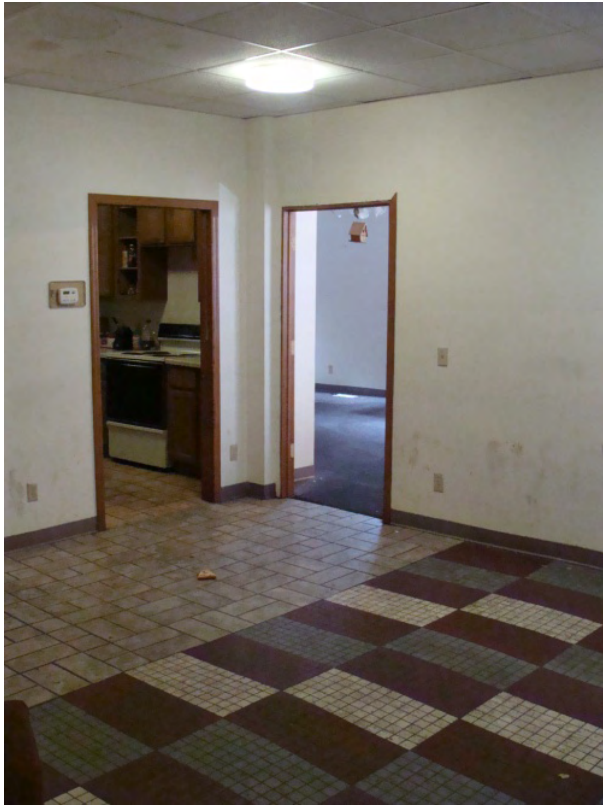
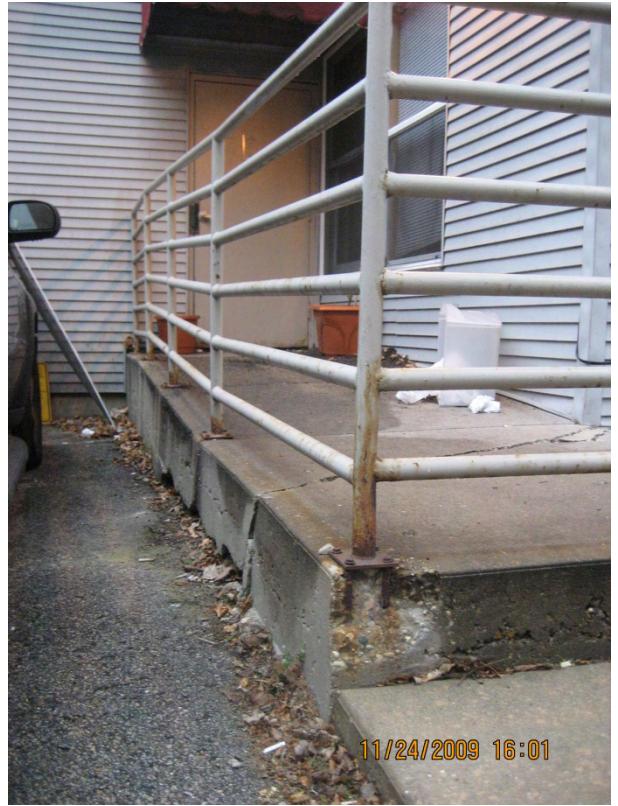
This two story wood framed multi-family structure was originally constructed in the 1890's. In the mid 1990's this building's interior was remodeled so it could house a fraternity. After 15 or so years of use as a fraternity/rooming house, the building is showing a great amount of wear. The exterior also has noticeable damage due to vehicles and mopeds nunning into the side, large numbers of people using the front porch and fraternity signage having been put up and taken down over the years. In summary, the building has reached its life expectancy and is in poor condition.

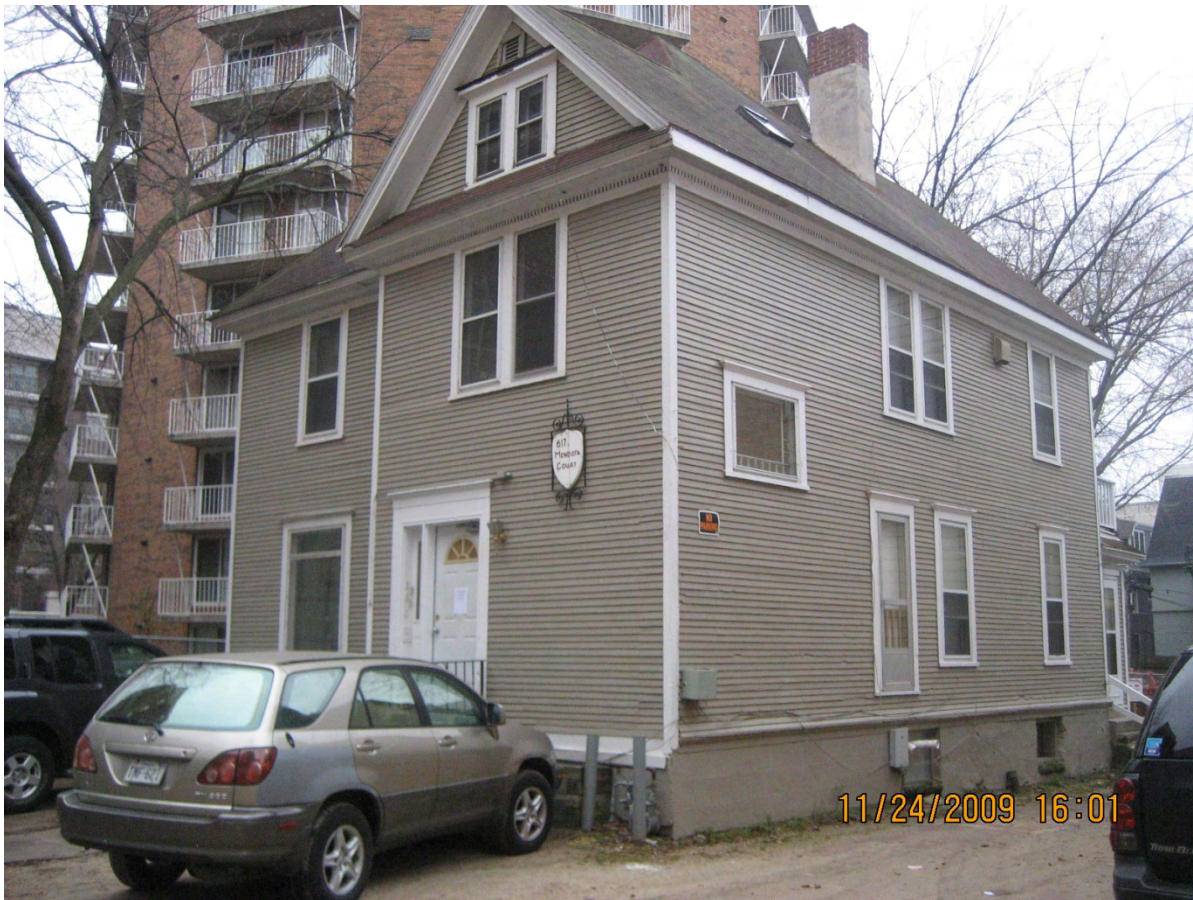
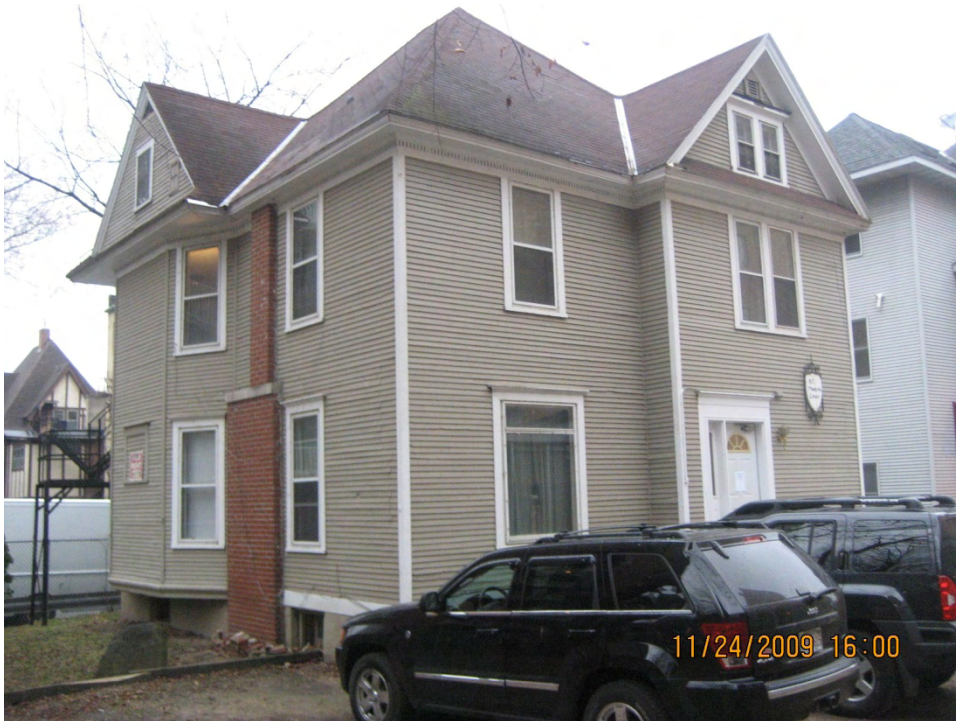
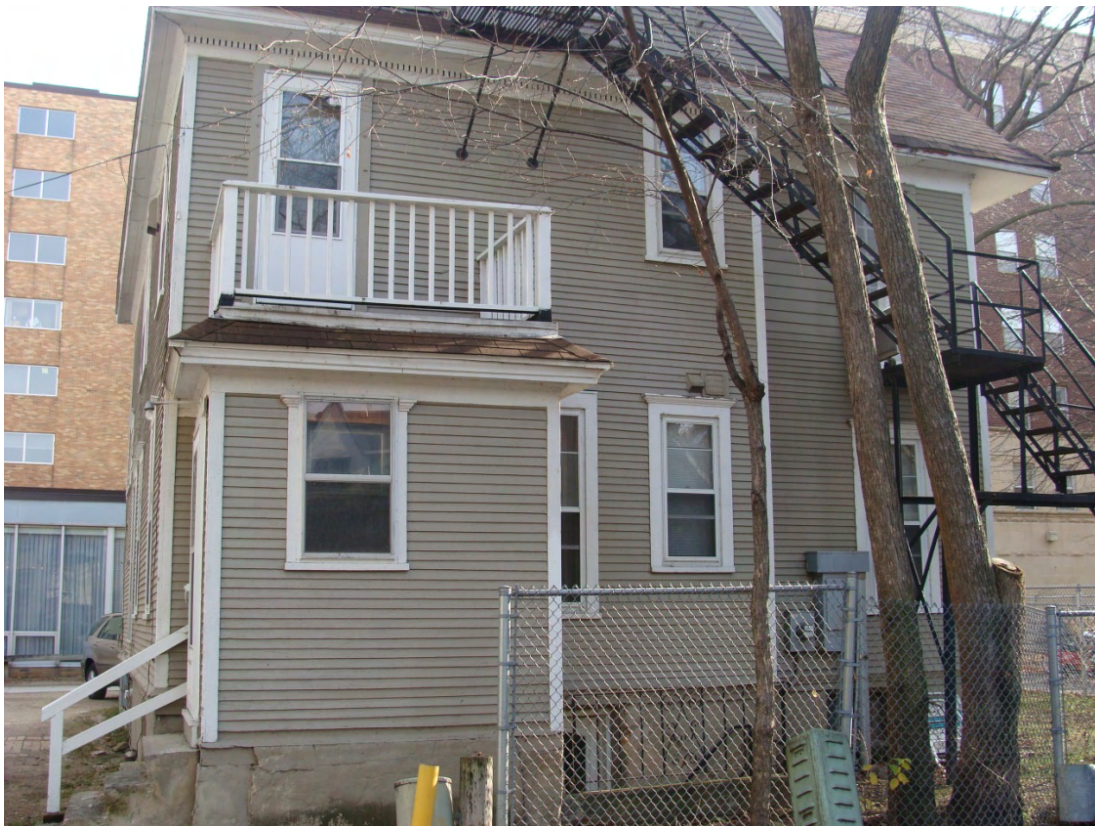
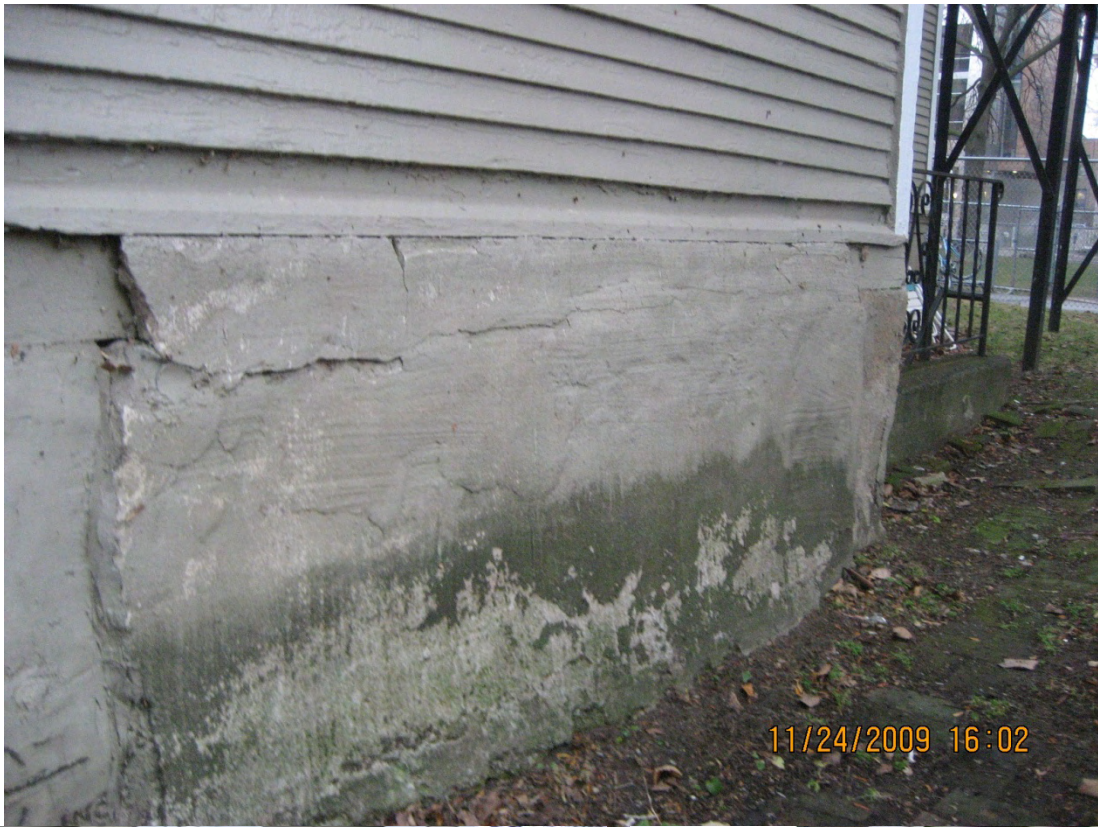
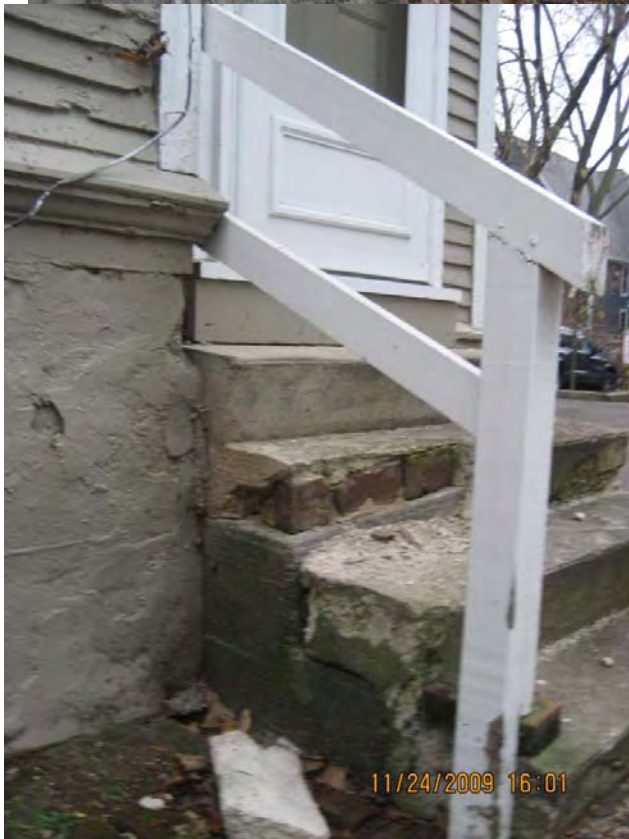
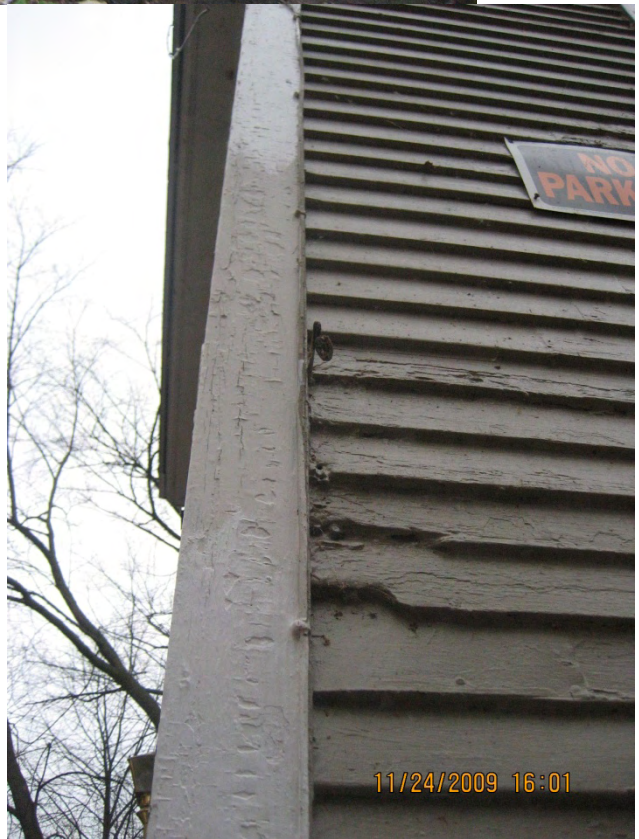
617 Mendota Court

This two story wood framed multi-family structure was originally constructed in the 1890's. Sometime in the 1960's or 70's it was converted to a five unit apartment building. It now is in poor condition with a cracked foundation, wood siding has deteriorated beyond repair, roof should be completely torn off and replaced. The interior walls were coated with stucco decades ago and is now failing and should be removed. Several of the baths do not comply with current building codes.
