**PRE-DEMOLITION INSPECTION REPORT****Job Site:**

**Storage Building
202-208 South Baldwin Street
Madison, Wisconsin**

KPH Project # 21-400-42.202

March 2021

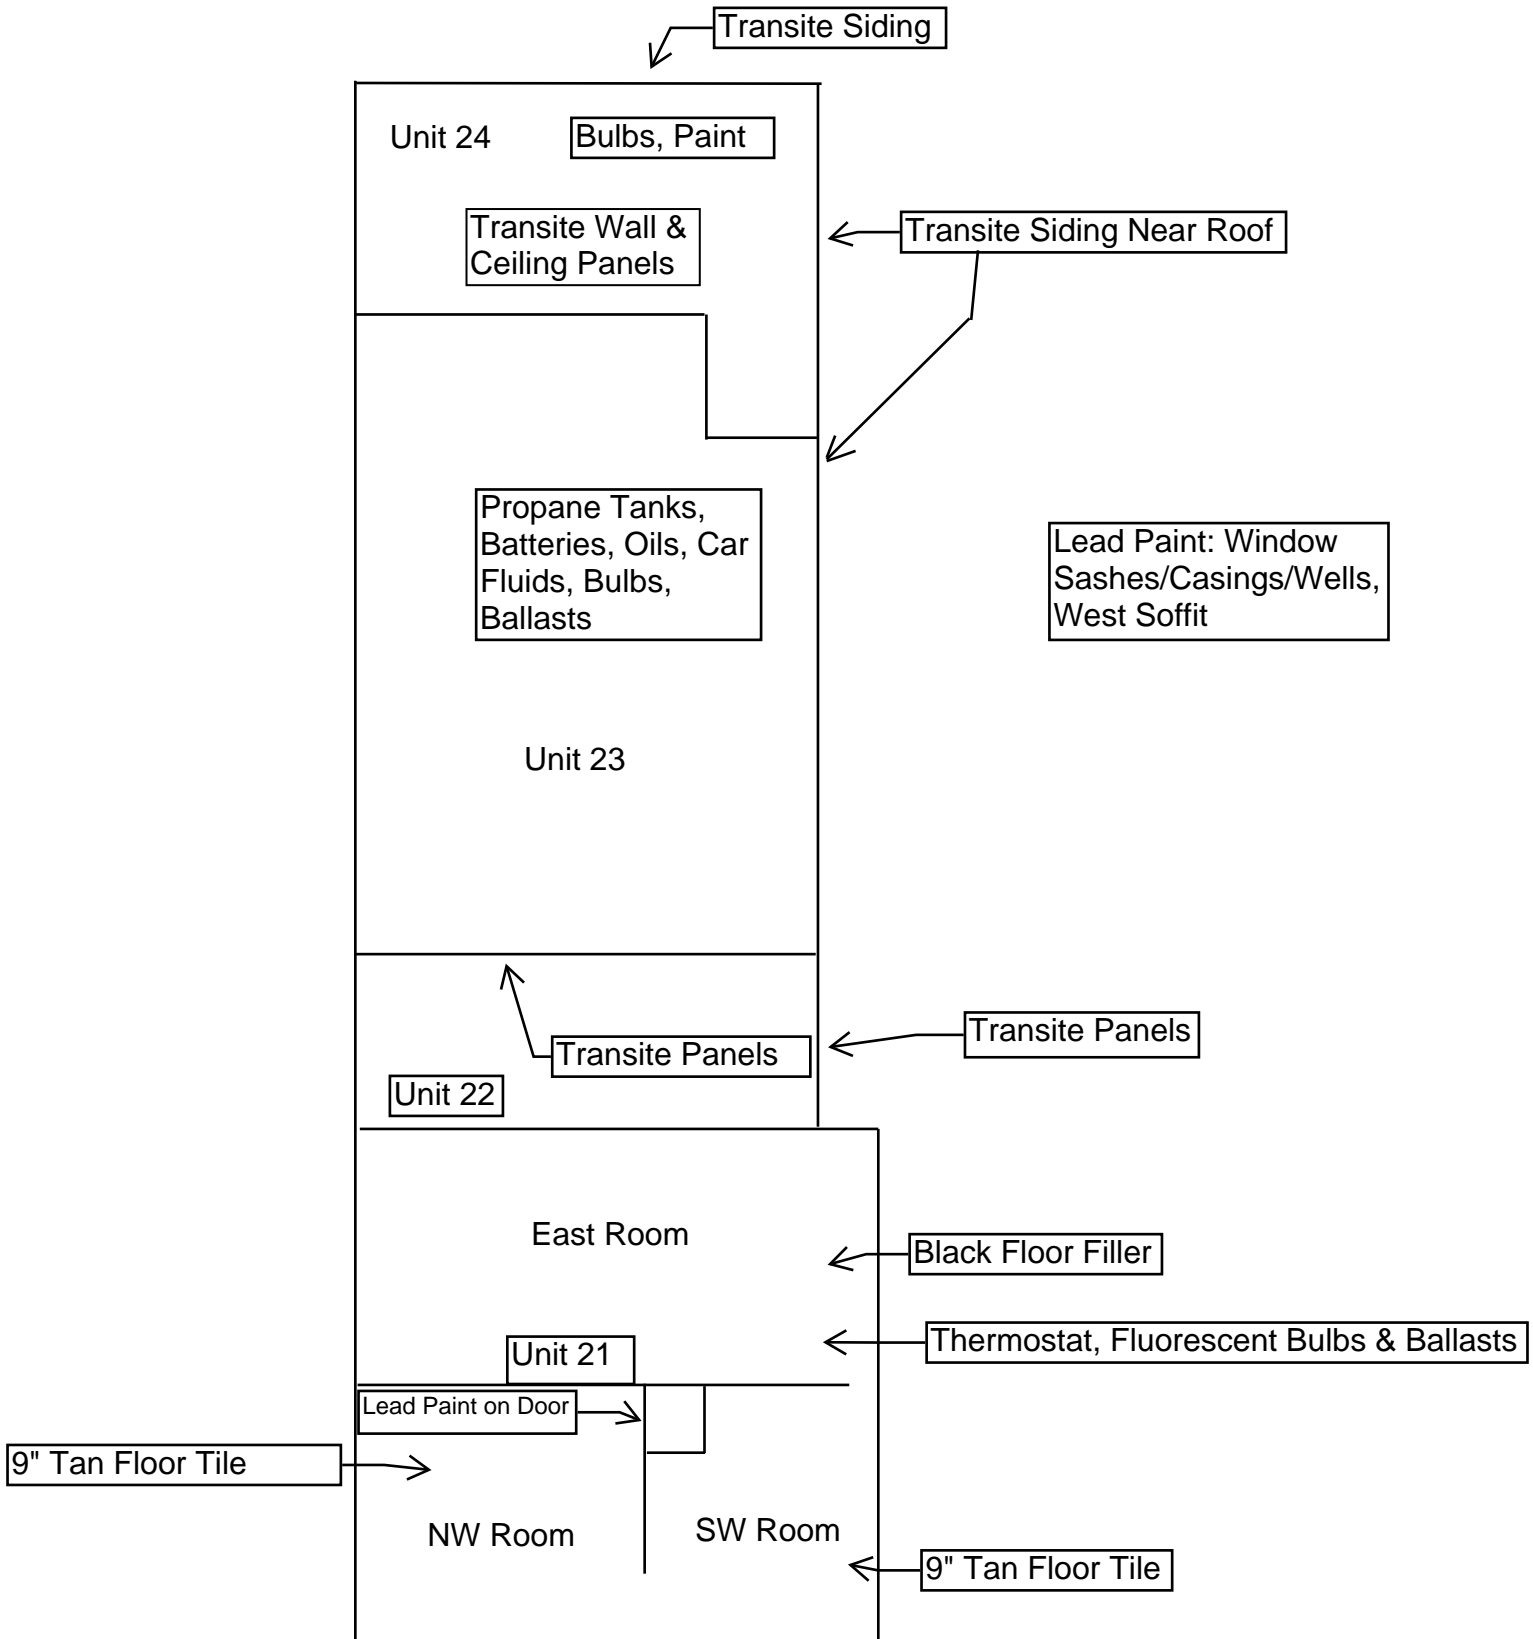
Storage & Office Building
210 South Baldwin Street
Madison, WI

The transite siding, transite panels, and black floor filler are category II non-friable asbestos containing materials. They were in non-friable condition at the time of the inspection. These materials have a probability of becoming crumbled, pulverized or reduced to powder by the forces expected to act on the material in the course of demolition or renovation operations and may become regulated asbestos containing material (RACM) as defined in NR 447.

The 9" tan floor tile is a category I non-friable asbestos containing material. It was in non-friable condition at the time of the inspection. If this material is subjected to sanding, grinding, cutting or abrading during demolition, it would then be defined as RACM under NR 447.

- Painted or coated drywall, wood, and transite walls and ceilings were observed on the interior, along with painted doors, windows, and casings. Lead based paint was detected on the Unit 21 utility room door. Other painted or coated interior surfaces sampled do not have lead based paint.

- Painted block, stucco, and transite walls were observed on the exterior, along with painted doors, windows, and casings. Lead based paint was detected on the exterior surfaces window casing and window wells, plus the west side gutter/downspout, west man door casing, and west soffit/fascia that were tested. Other exterior surfaces tested do not have lead based paint.

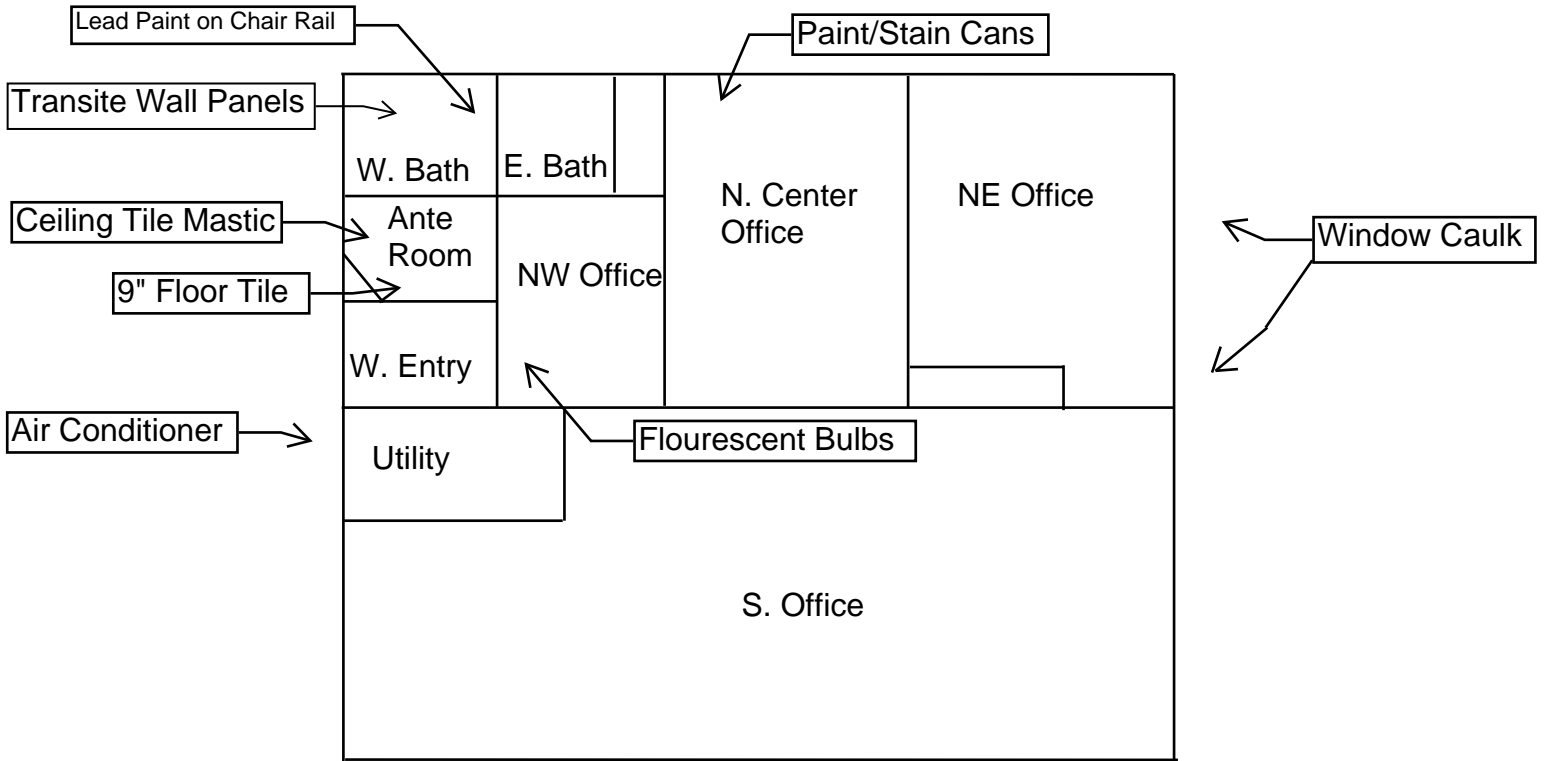
Office Building
212 South Baldwin Street
Madison, WI

The transite panels, beige caulk, and the brown dot mastic are category II non-friable ACM. The floor tile is a category I non-friable ACM. These materials were in non-friable condition at the time of the inspection. These materials have a probability of becoming crumbled, pulverized or reduced to powder by the forces expected to act on the material in the course of demolition or renovation operations and may become regulated asbestos containing material (RACM) as defined in NR 447.

- Painted and coated plaster, drywall, ceramic, and wood were observed on the interior surfaces. Lead based paint was only detected on the chair rail in the west restroom. Other painted and coated surfaces sampled did not have lead based paint.

- Painted block, stucco, and asphalt wall walls were observed on the exterior, along with painted doors, windows, and fascia. Lead based paint was detected on the east window

Lead Paint: Exterior
Window Casing/Wells,
East Window Sashes,
