PRE-RENOVATION INSPECTION: ASBESTOS & LEAD PAINT

City of Madison Engineering Division

200 N. First Street
Madison, WI 53704

NorthStar No. 190-340

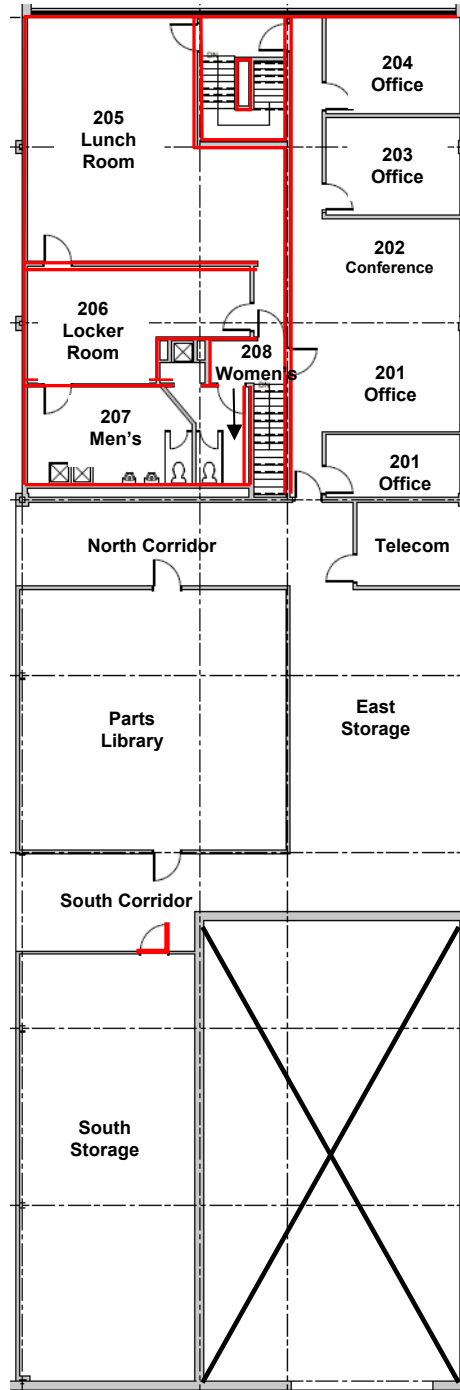
Lead Glazing on
Ceramic Block

Lead-Based Paint on
Wooden Door
(White Paint)
