Accompanied by Paul Jasenski of Common Wealth Development, I conducted two site reconnaissances of the Garver Feed Mill property, 109 and 115 S. Fair Oaks Avenue (historically: 3244 Atwood Avenue): one on September 26, 2008 and a revisit to the site on October 10, 2008. The site inspection on September 26th included the interior and exterior of the mill building and the exterior and boundaries of the land area within the study area (subject property). The revisit on October 10th was to re-inspect some of the observed features in and around the mill building. Following is a summary of the observations made at the Garver Feed Mill property.

Photo Location: Garver Feed Mill Property, 109 and 115 S. Fair Oaks Ave. (3244 Atwood Avenue), Madison, Wisconsin

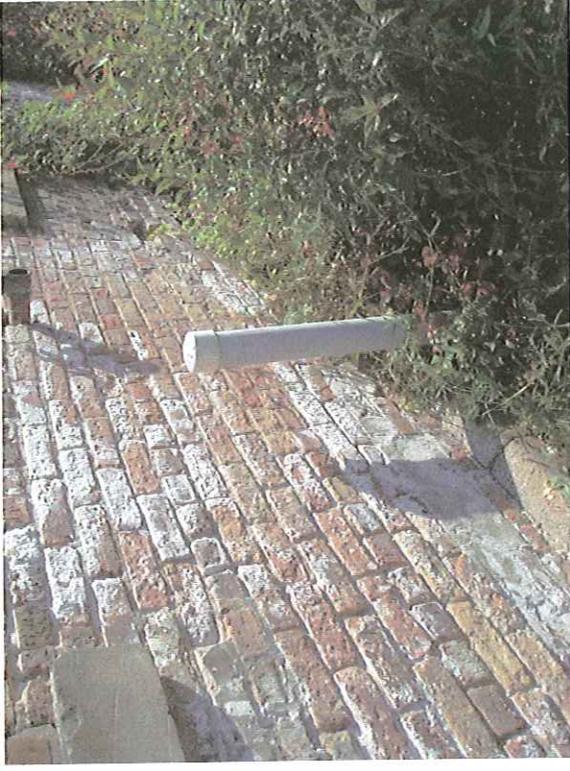
3. There is four-inch diameter PVC plastic pipe extending out of the ground on the west side of the building immediately across from Garver Cottage. While not of normal or expected configuration, this pipe was initially thought to be a groundwater monitoring well left over from the leaking underground storage tank remediation that occurred on the property in the early- to mid-1990s. Examination of the pipe, however, revealed that it is not a monitoring well and it's purposes could not be determined by observation.

Photo 14: 4-inch PVC pipe suspected of being a communication conduit extending out of ground next to mill building opposite Garver Cottage. Other pipe at top of photo is old molasses tank fill pipe.

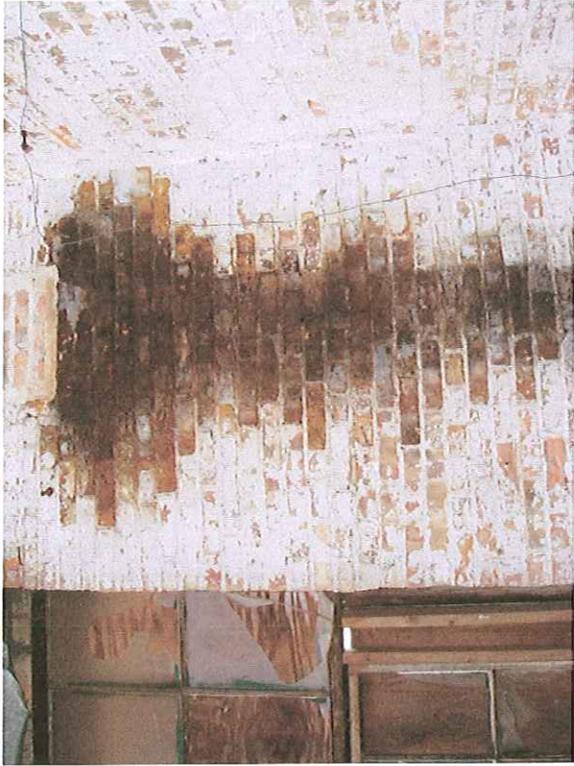
Photo 21: Oil staining on north wall of Room 4 near the northeast corner of the room.

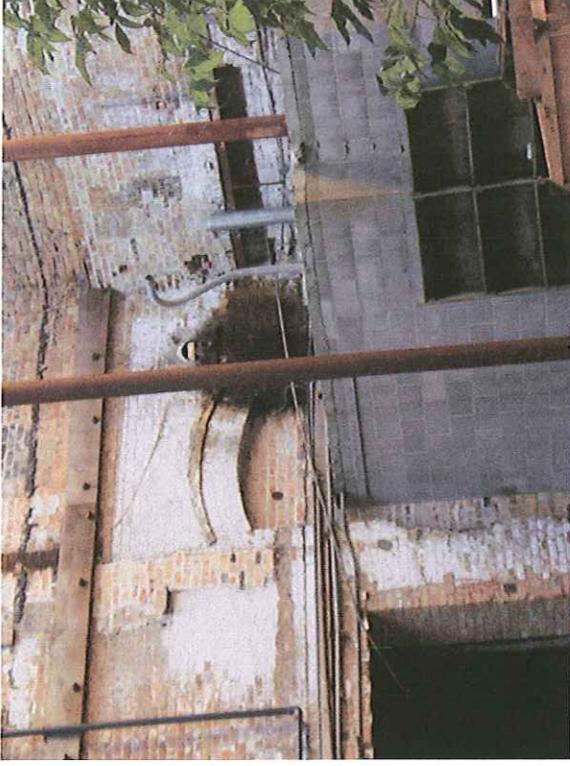
Photo 22: Oil staining on south wall of Room 4 near the southwest corner of the room above electrical room.

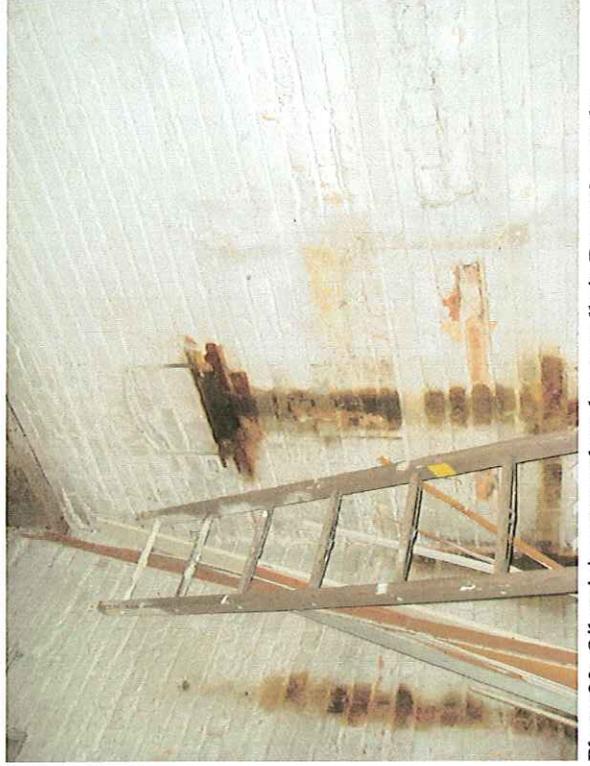
Photo 23: Oil staining on north and east walls in Room 2 near the northeast corner of the room.

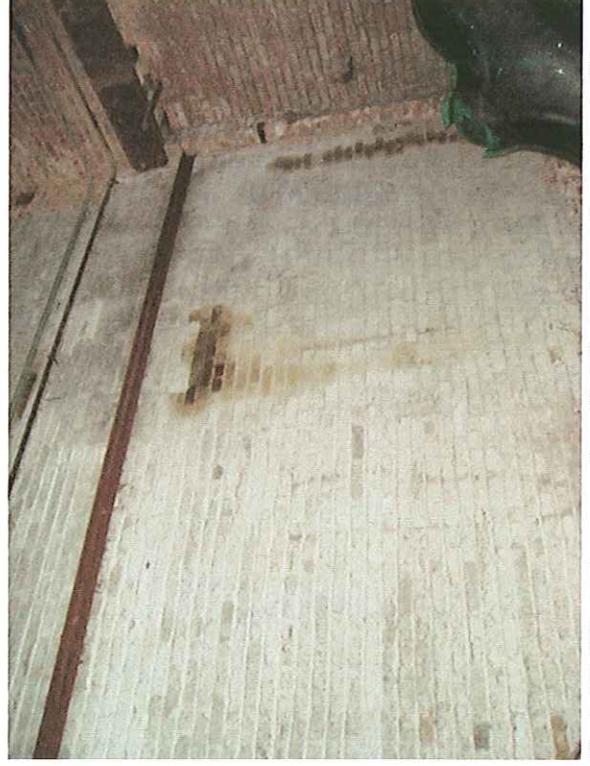
Photo 24: Oil staining on north wall of Room 1 near the east end of the room.

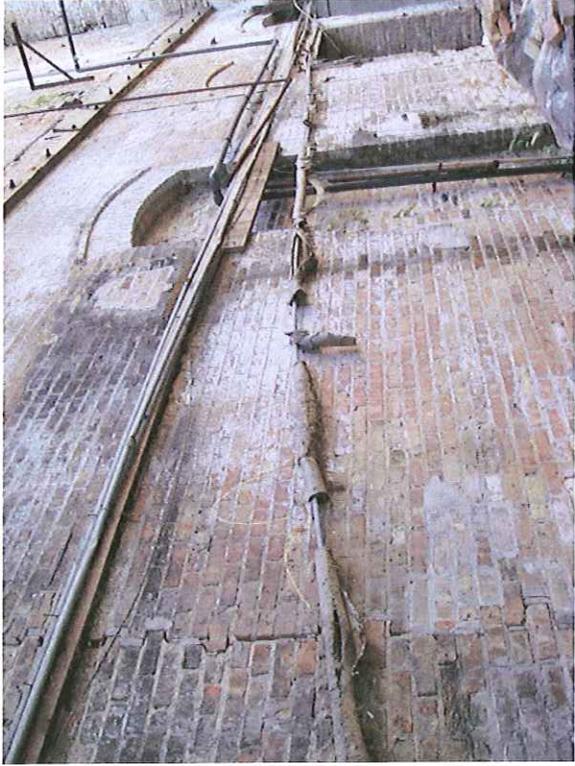
Because of exposure to the elements, much of the observed presumed asbestos materials are in damaged condition and are considered to be friable.

Photo 25: Air cell insulation (assumed asbestos) on steam pipe, east wall, Room 4.

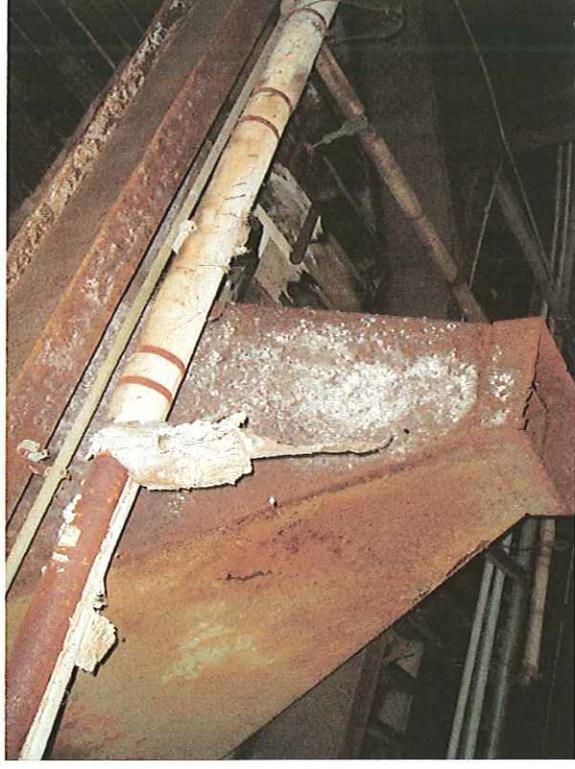
Photo 26: Air cell insulation (assumed asbestos) on steam pipe in Room 5.

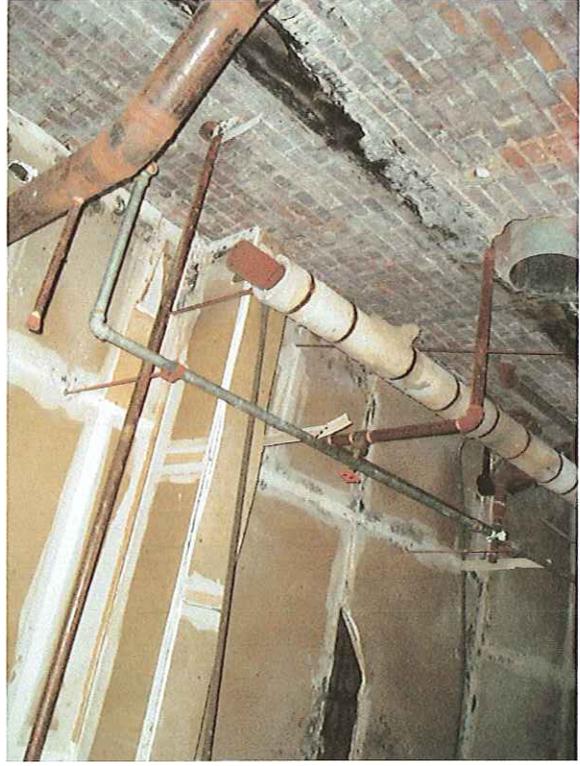
Photo 27: air cell insulation (assumed asbestos) on steam pipe in new boiler room in garage, east end of mill building.

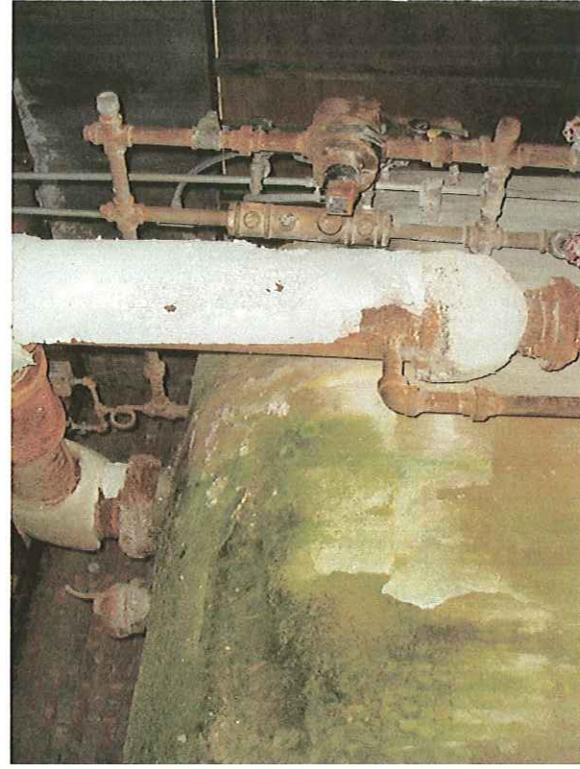
Photo 28: Plaster pipe and boiler jacket insulation (assumed asbestos) on old boiler in old boiler room.

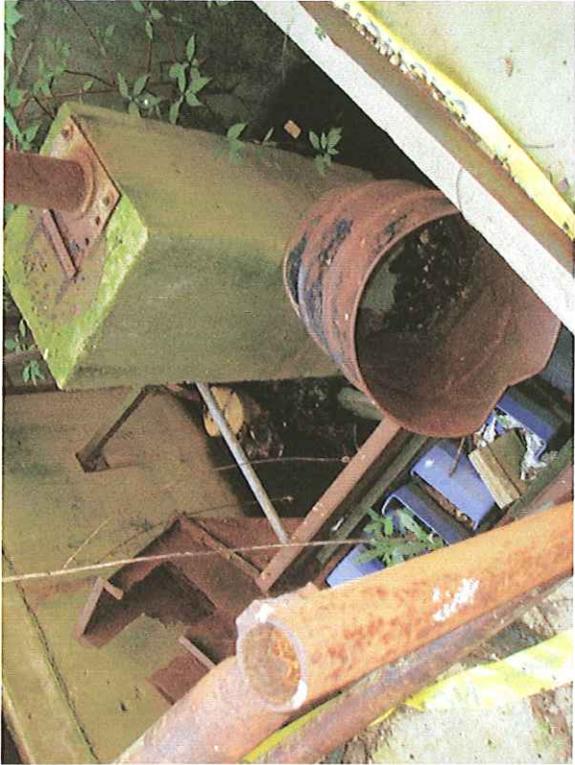
Photo 29: Open pit (south end of conveyor tunnel) in Room 4.

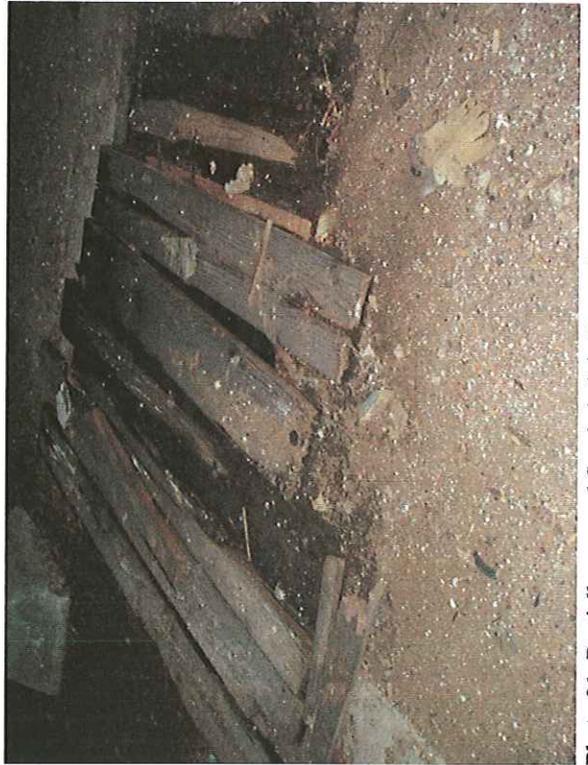
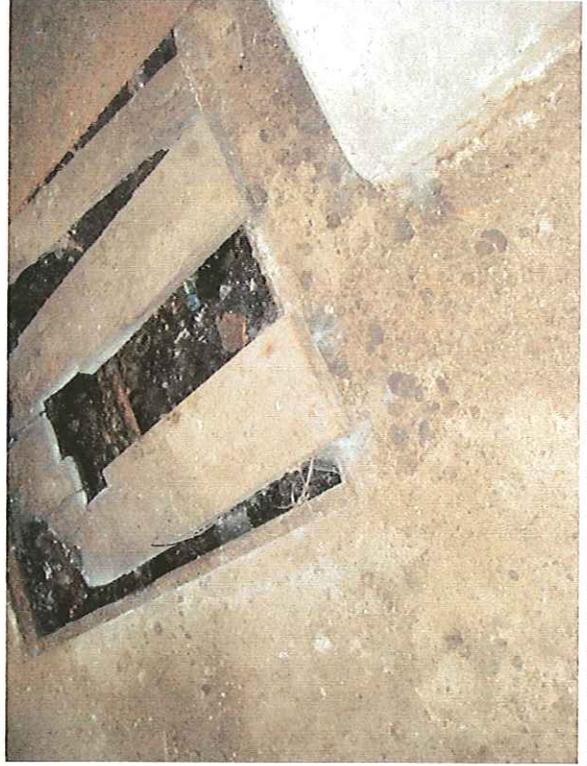
Photo 31: Partially covered flooded pit in Room 5.

Photo 32: Partially covered flooded pit in Room 5.

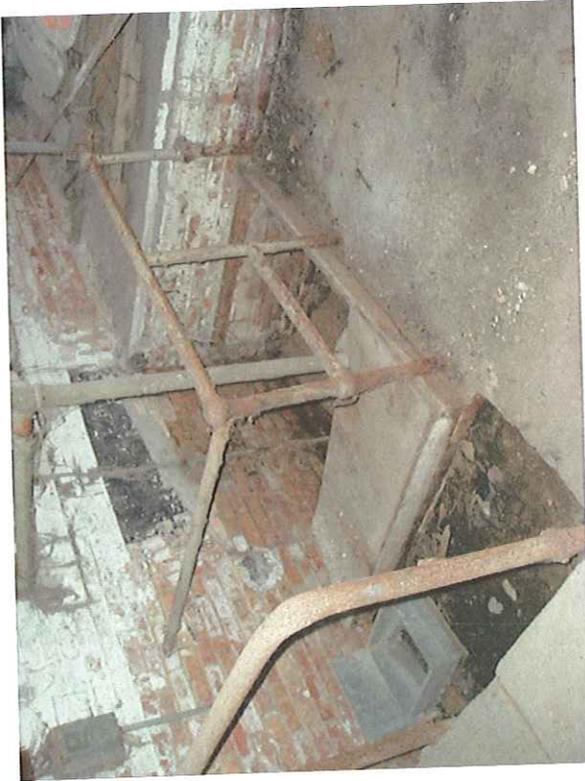
Photo 33: Open flooded pits south side of Room 8.

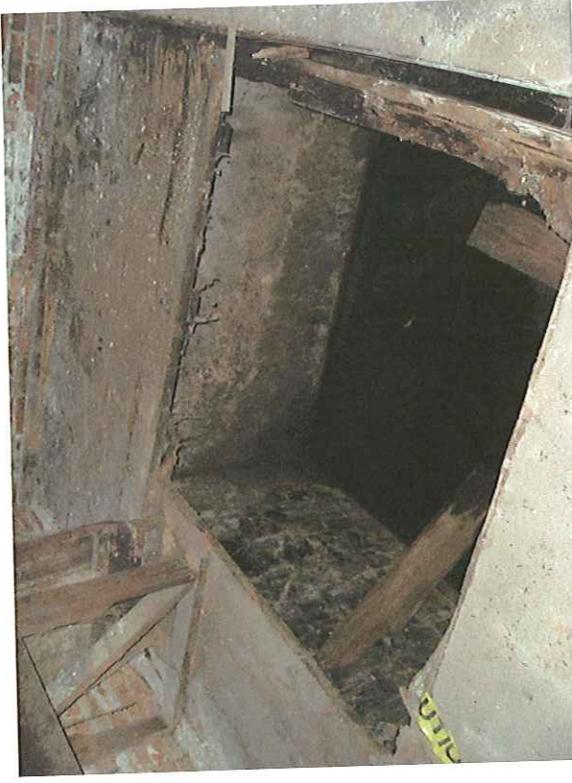
Photo 34: Open flooded pit near northeast corner of Room 9.

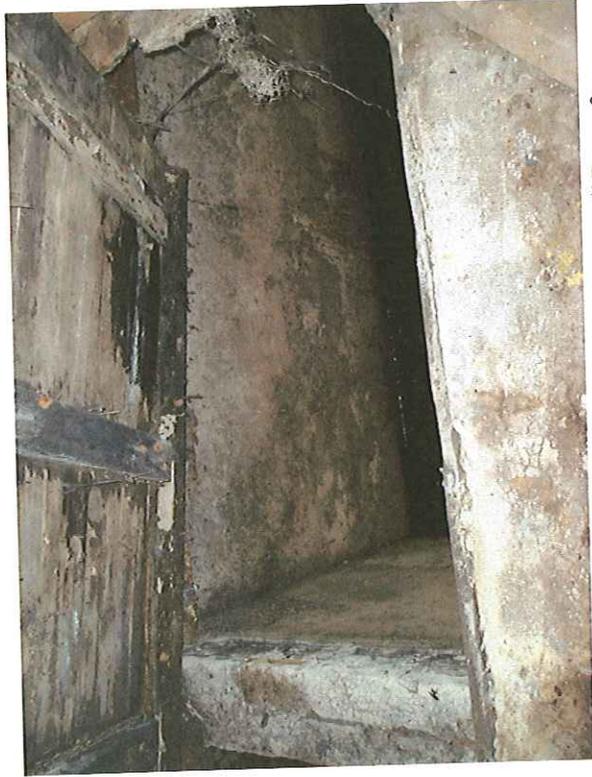
Photo 35: Flooded pit under trap door along west wall Room 9.

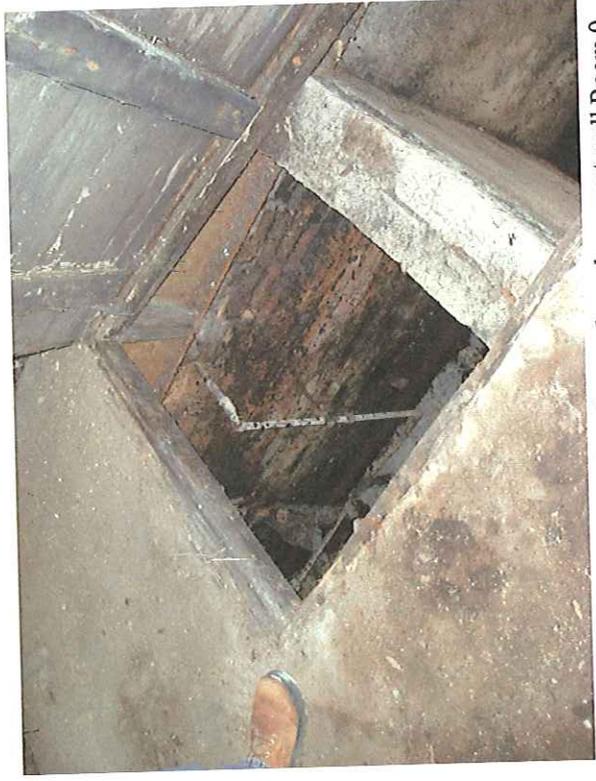
Photo 36: Second flooded pit under trapdoor along west wall Room 9.

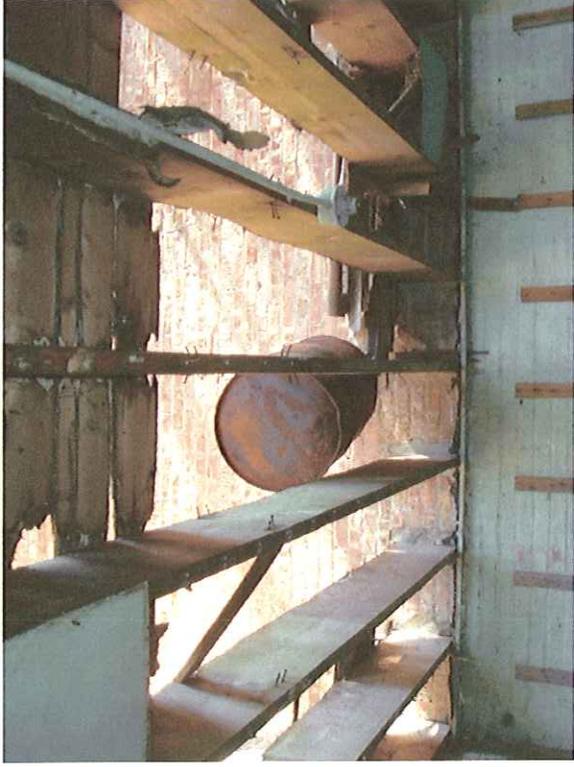
- A rusted 55-gallon drum hanging in the rafters in the locker room adjacent to Room 4;
 - A rusted 55-gallon drum in Room 5;
 - A 5-gallon container of tar roof patch in the partitioned office area in Room 1;

Photo 37: Drum (contents unknown) in rafters above rest room adjacent to Room 4.

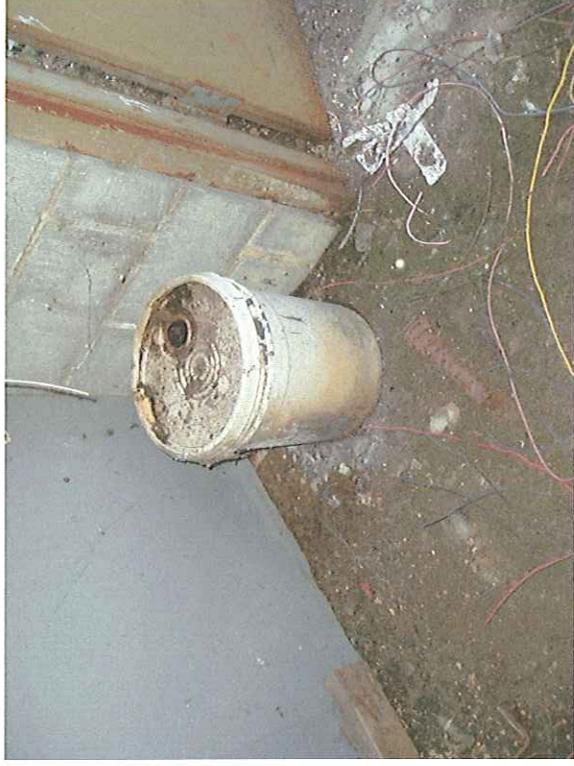
1. **Drums and Containers:** Drums and containers of unknown content were observed at the following locations in the Garver Mill building:
 - A 5-gallon container of presumed waste oil in the electrical room in Room 4;

Photo 38: Container of waste oil (presumed) in electrical room southwest corner Room 4.

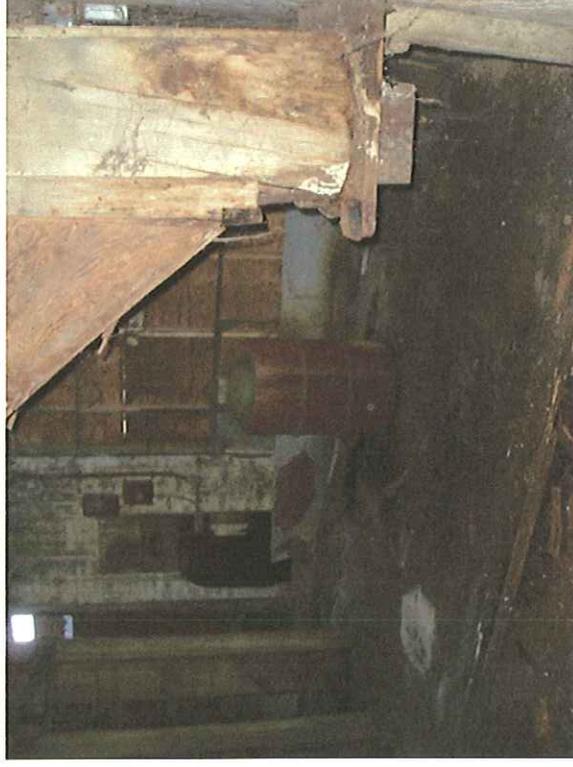
Photo 39: Drum of unknown contents in Room 6.

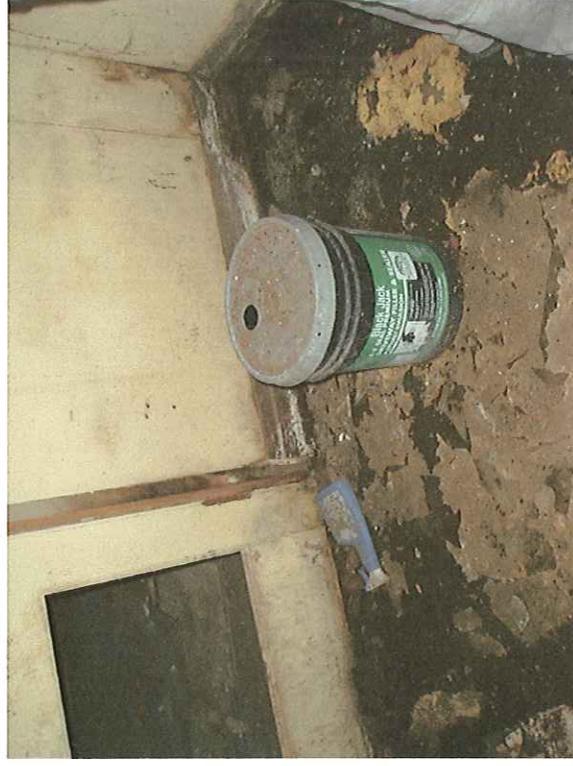
Photo 40: Container of tar roof patch in office area, Room 1.

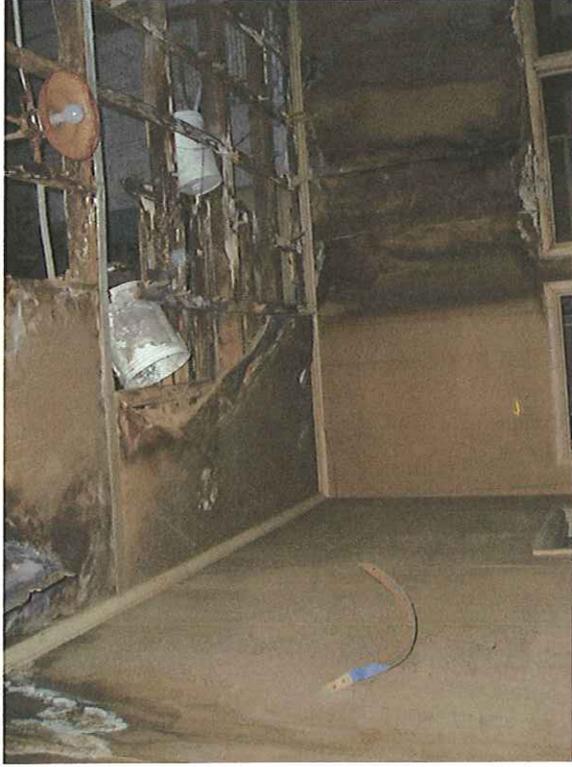
The south end of the room is partitioned into a single level office area. The ceiling of the office is falling in and several plastic 5-gallon containers were observed hanging in the rafters. While floors in the rest of the building are concrete, the floor area in the partitioned office space was covered with 9-inch tile. A 5-gallon container of Black Jack roofing compound was found in the office area.

Photo 41: Containers (presumed empty) in rafters above office space, Room 1.

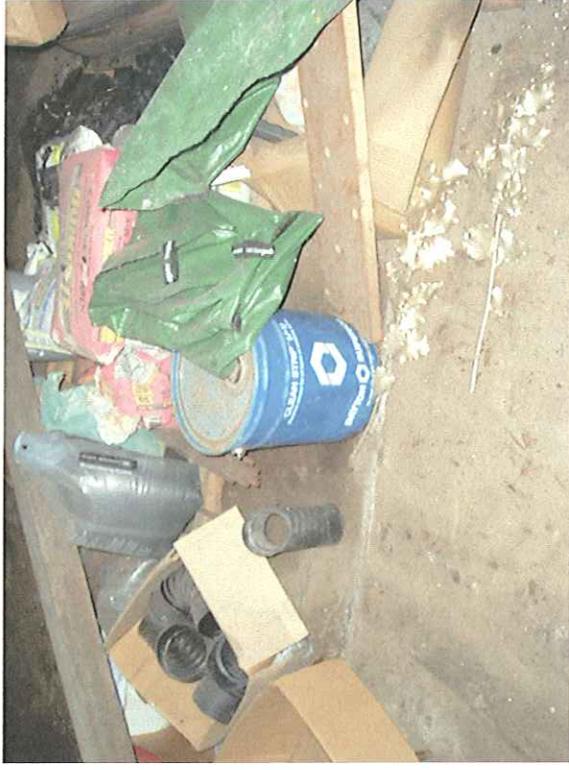
Photo 42: Container of petroleum-based concrete form release compound in Room 1.

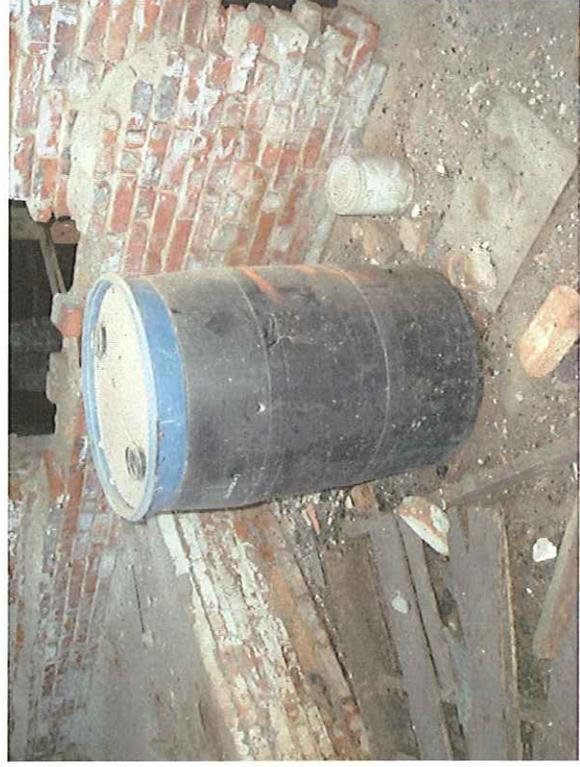
Photo 43: Drum and small container of unknown contents in Room 8.

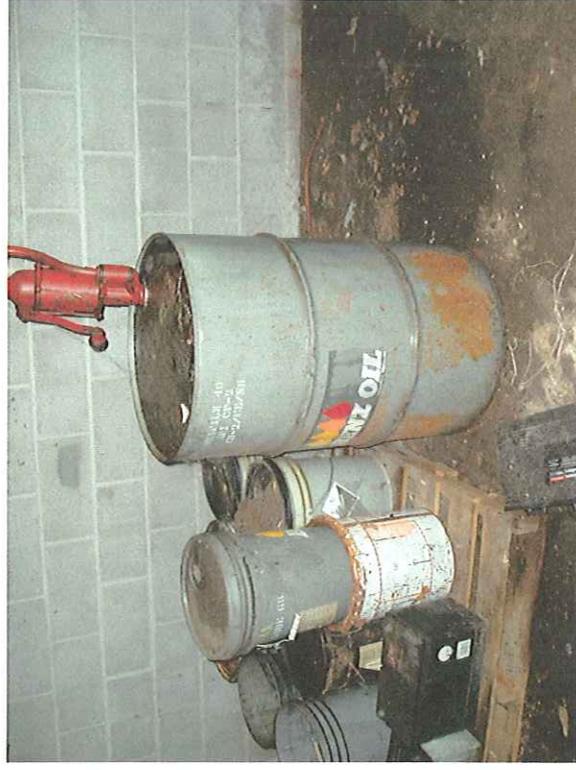
A small area of staining was observed on the garage floor in the area where the containers of waste oil are stored.

Photo 44: Oil of motor oil (product), containers of waste oil, lead-acid batteries in garage.

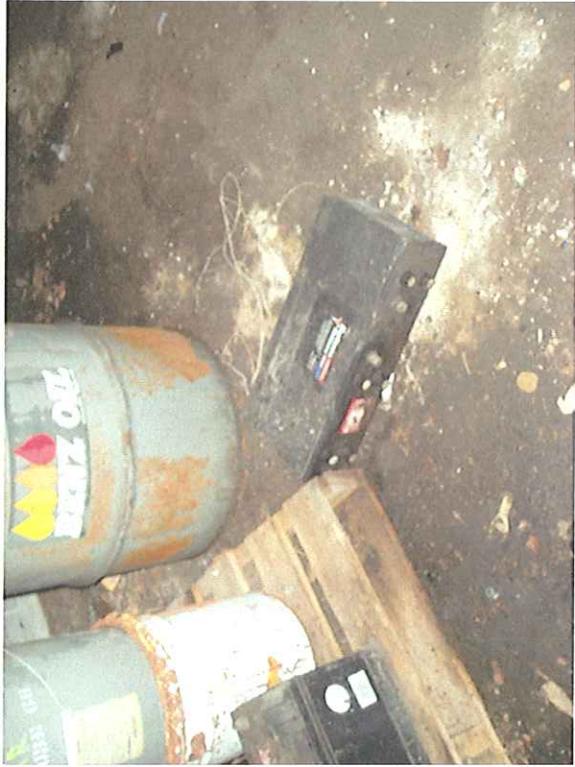
2. **Lead-Acid Batteries:** Four lead-acid batteries are stored next to the waste oil containers found in the garage. One of these appears to have leaked.

Photo 45: Leaking lead-acid battery on floor in garage.

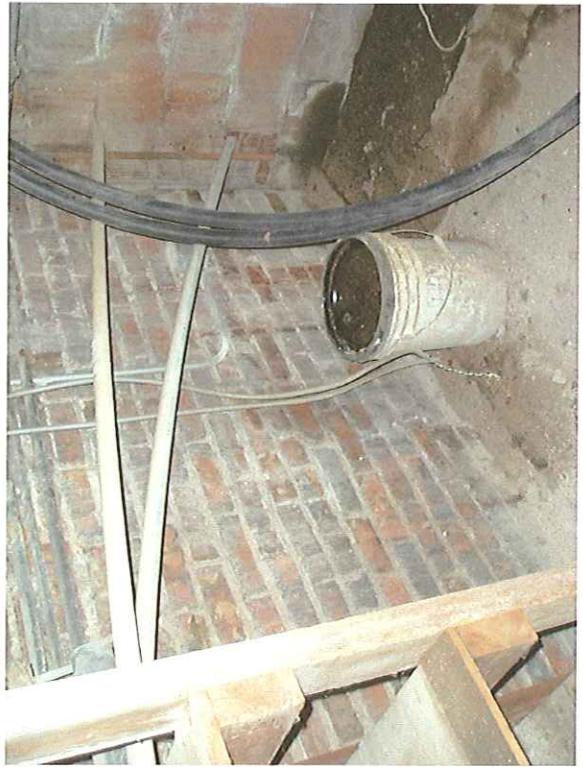
Photo 47: Container of waste oil (presumed) in maintenance storage area adjoining old boiler room (Room 3).

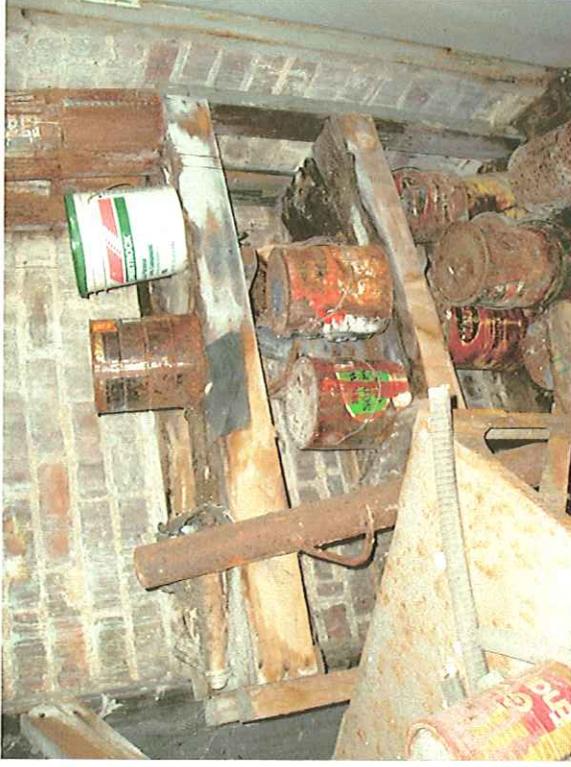
Photo 46: Old cans of paint in maintenance storage room adjoining old boiler room (Room 3).

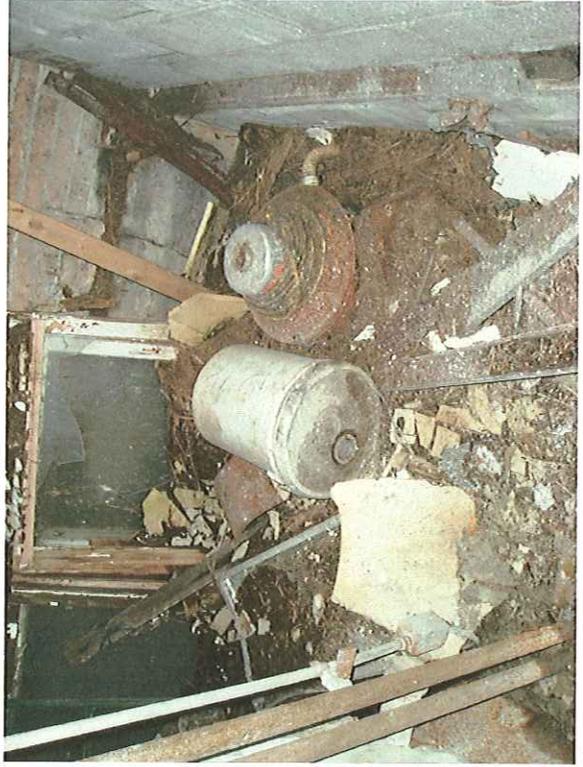
Photo 48: Container of unknown contents laying on floor of old boiler room.
