## ANNIE C. STEWART MEMORIAL FOUNTAIN ASSESSMENT REPORT AND RECOMMENDATIONS

<b>Date of Work:</b>	May 2022	<b>Project Name and Location:</b>	Annie C. Stewart Memorial Fountain Madison, WI
<b>Date of Report:</b>	June 22, 2023 (draft) Jamie Morris	<b>Owner/Client:</b>	City of Madison
<b>Reported by:</b>	Andrzej Dajnowski		
<b>Artist/Date:</b>	Frederick J. Clasgens, installed 1925		
<b>Dimensions:</b>	21' in diameter at perimeter wall		
<b>Project Goal:</b>	To perform conservation assessment and develop treatment options with estimated pricing.		
<b>Work Performed by:</b>	<b>Contact:</b> Karin Wolf, City of Madison William Fruhling, City of Madison		
	CSOS Neomek Incorporated Wiss, Janney, Elstner Associates

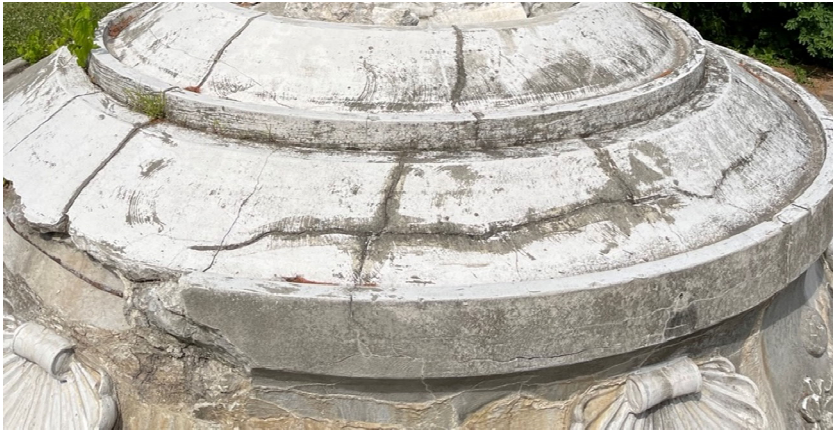
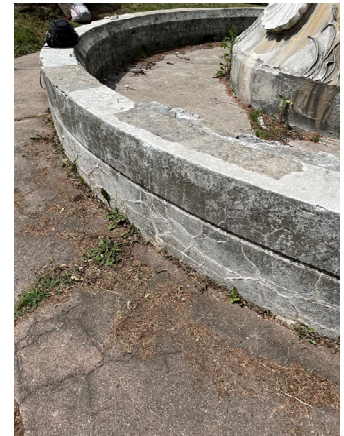
Extensive cracking was observed throughout the pedestal and the base. Many cracks appear to have secondary deposits (material filling the crack) either from minerals in the water the fountain previously held or from dissolved and redeposited mineral components of materials from various previous repair campaigns. The observed cracking ranged from hairline to greater than ¼ inch in width. The following photographs show typical cracks on the pedestal and outer ring.

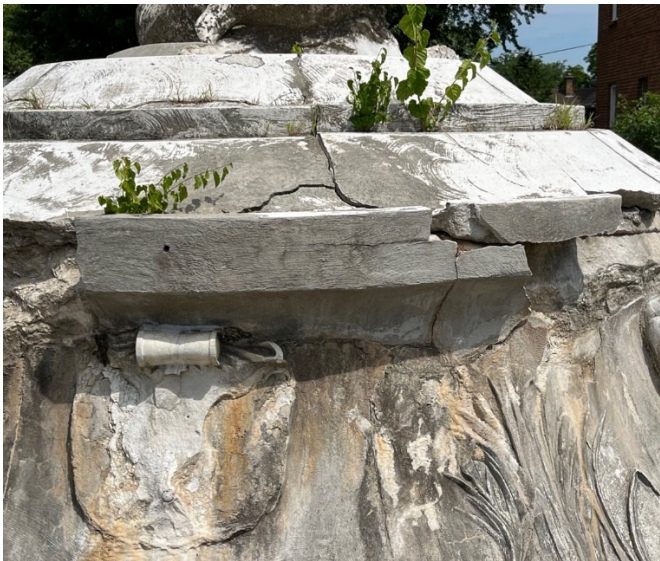
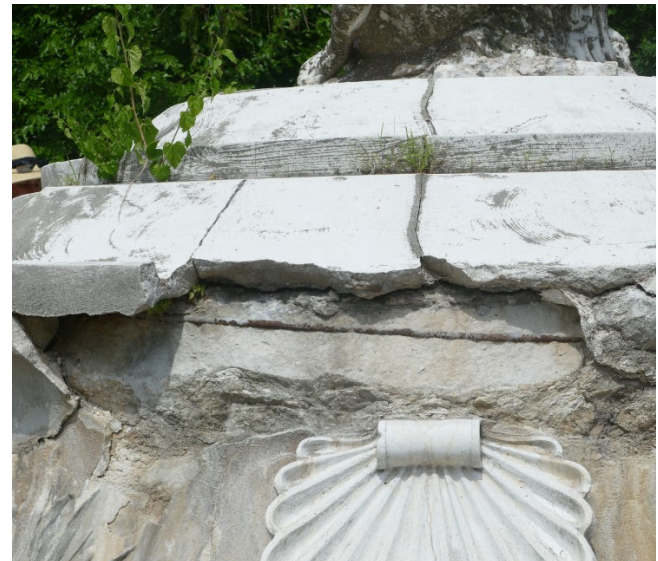
Spalls and areas of loss were observed on the pedestal especially at the lower ring. Some large pieces of material that had apparently previously fallen were sitting on the top of the pedestal. Other areas of incipient spalls (spalls that are about to become loose but are still weakly attached) were observed. The majority of the losses were observed to the left of the figures as viewed facing them. The photographs below show areas of spalls and loss on the pedestal.

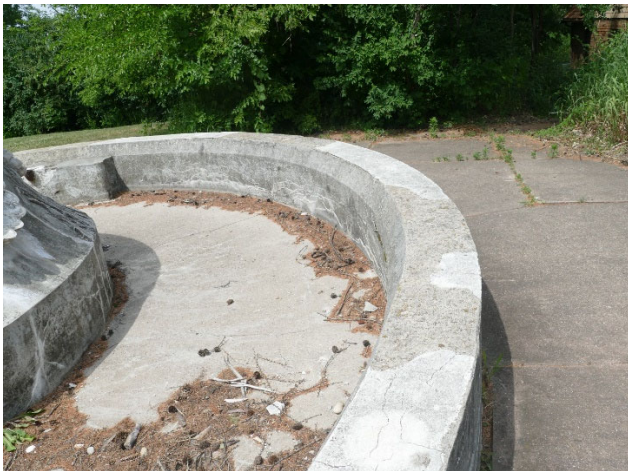
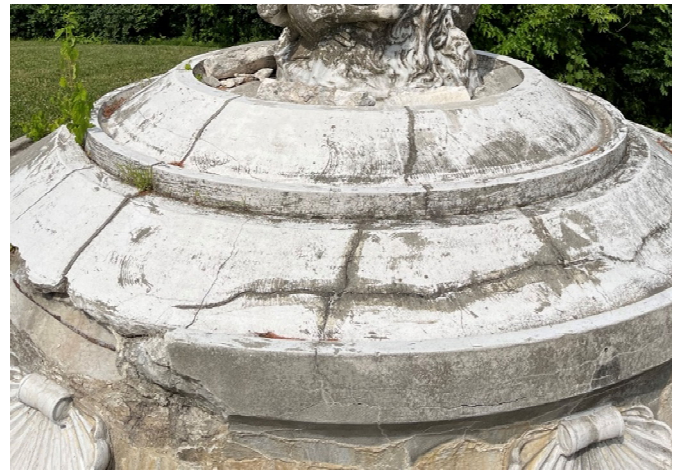
Patches, coatings, added materials. CSOS is unaware of any documented previous repair campaigns, however, many types of repair materials were observed in situ. Based on the number of previous repairs and the lack of documentation it is possible that repairs maybe have been implemented by well meaning activists without knowledge of how the two materials would interact. Mortar patches that are stronger than the masonry they are used to patch can contribute to degeneration of surrounding original materials. Many apparent mortar patches are present on the lower bowl. As shown in the photographs below, the pedestal includes apparent patch material as well as remnants of a coating applied to the top two tiers.

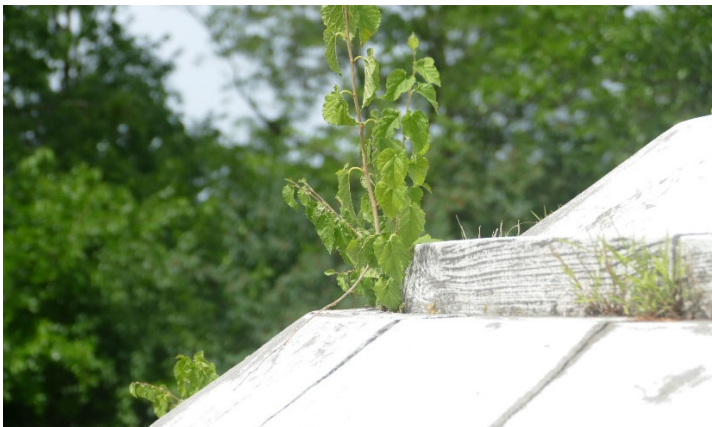
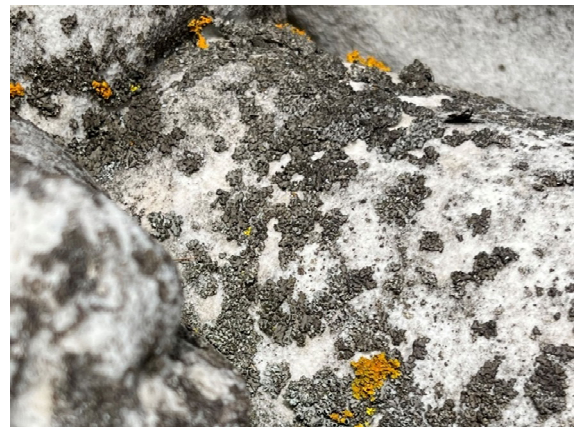
Vegetation and bio growth were observed in micro scale and macro scale with micro scale biological growth such as lichen primarily on the marble figures and large-scale vegetation (large weeds) growing out of crevices in the pedestal. The growth of large-scale vegetation exerts outward pressure that can exacerbate the formation of cracks while also holding on to moisture which contributes to freeze/thaw distress. Micro scale biological growth obstructs the ability to visually distinguish the features of the sculpture and some types of biological growth can secrete acids which can slowly chemically dissolve calcite-based stone. Additionally, biological growth absorbs and holds moisture to the stone surface potentially contributing to freeze/thaw distress. Examples of macro and micro scale biological growth are shown below.

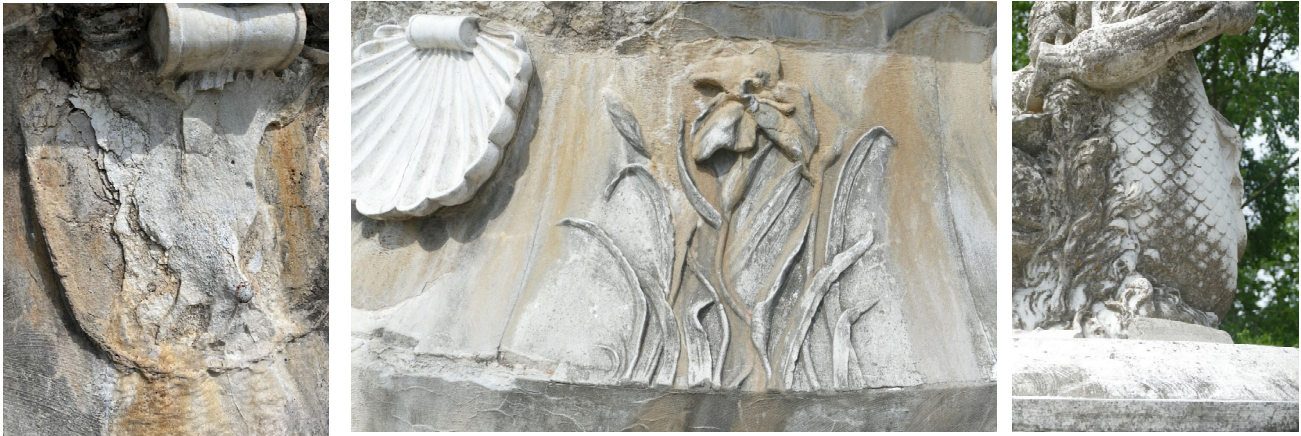
Discoloration and deposits. In addition to the discoloration imparted by the biological growth on the marble sculpture, streaks of white and yellow deposits were observed on the surface of the pedestal and a network of fine cracks with white deposits was observed on the surface of the lower bowl. Due to the general condition of the pedestal and concrete perimeter, samples were not taken for testing. It is likely that the deposits are due to both the water chemistry when the fountain was in use and migration of soluble minerals in construction and repair products. Various examples of discoloration and deposits are shown below.

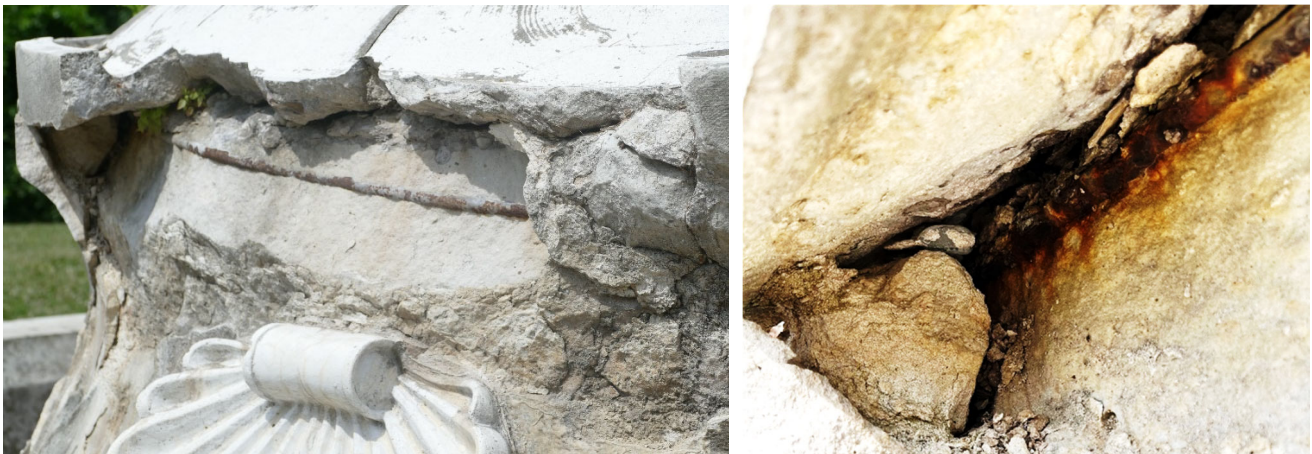
Corrosion of internal steel. A piece of corroded steel was observed at the location of lost material and extensive cracking at the second tier of the pedestal. Embedded steel elements that become exposed to moisture and corrode can expand to ten times their original surface area. This expansion exerts force on the surrounding materials that can lead to cracking. Distress can accelerate if cracking leads to increased moisture exposure. The photographs below show corroded steel remaining in the pedestal and an adjacent area of loss.

**Based on the amount of distress observed and the interrelationship of the distress conditions CSOS has concluded that the pedestal and the concrete lower bowl are beyond reasonable repair.**
