ANNIE C. STEWART MEMORIAL FOUNTAIN ASSESSMENT REPORT AND RECOMMENDATIONS

Date of Work:	May 2022	Project Name and Location:	Annie C. Stewart Memorial Fountain Madison, WI
Date of Report:	June 22, 2023 (draft) Jamie Morris	Owner/Client:	City of Madison
Reported by:	Andrzej Dajnowski		
Artist/Date:	Frederick J. Clasgens, installed 1925		
Dimensions:	21' in diameter at perimeter wall		
Project Goal:	To perform conservation assessment and develop treatment options with estimated pricing.		
Work Performed by:	CSOS Neomek Incorporated Wiss, Janney, Elstner Associates	Contact:	Karin Wolf, City of Madison William Fruhling, City of Madison

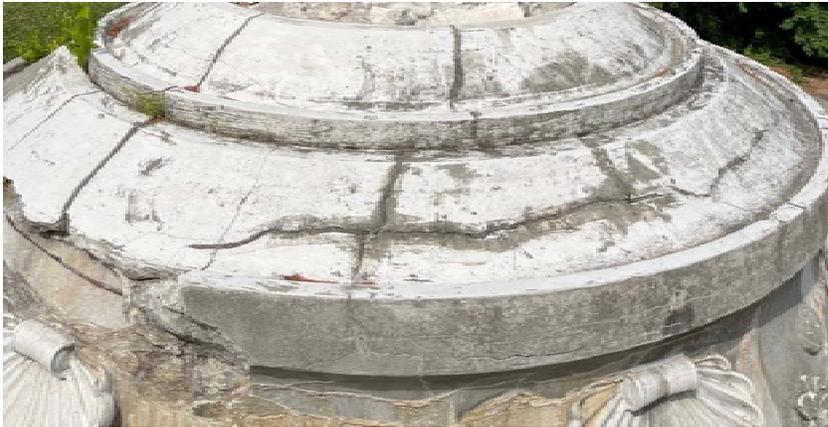
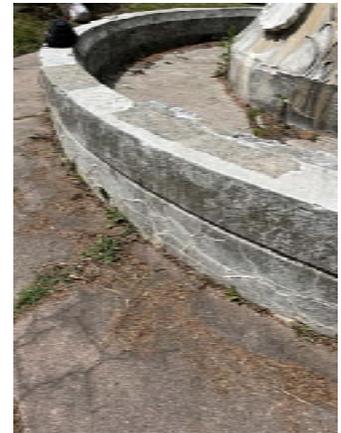
Extensive cracking was observed throughout the pedestal and the base. Many cracks appear to have secondary deposits (material filling the crack) either from minerals in the water the fountain previously held or from dissolved and redeposited mineral components of materials from various previous repair campaigns. The observed cracking ranged from hairline to greater than ¼ inch in width. The following photographs show typical cracks on the pedestal and outer ring.

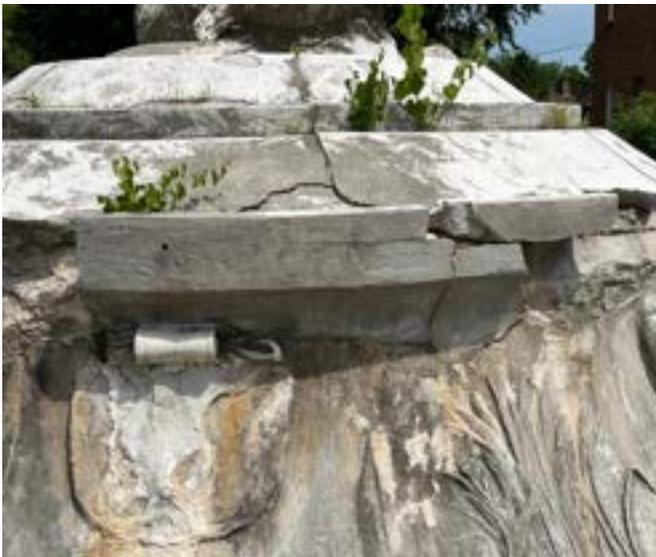
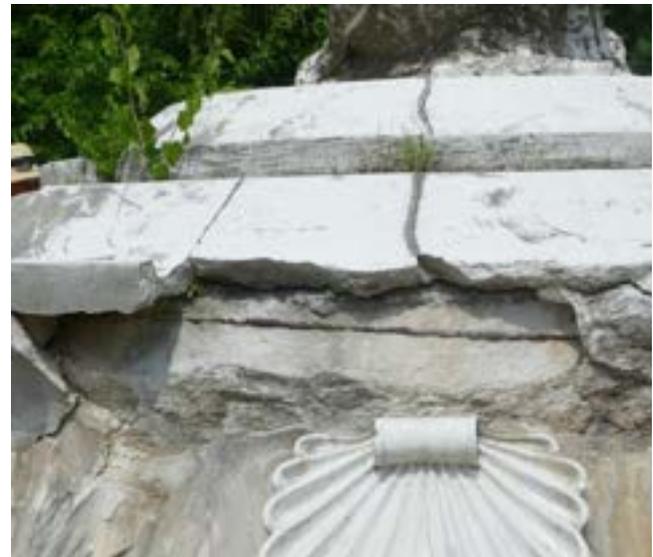
Spalls and areas of loss were observed on the pedestal especially at the lower ring. Some large pieces of material that had apparently previously fallen were sitting on the top of the pedestal. Other areas of incipient spalls (spalls that are about to become loose but are still weakly attached) were observed. The majority of the losses were observed to the left of the figures as viewed facing them. The photographs below show areas of spalls and loss on the pedestal.

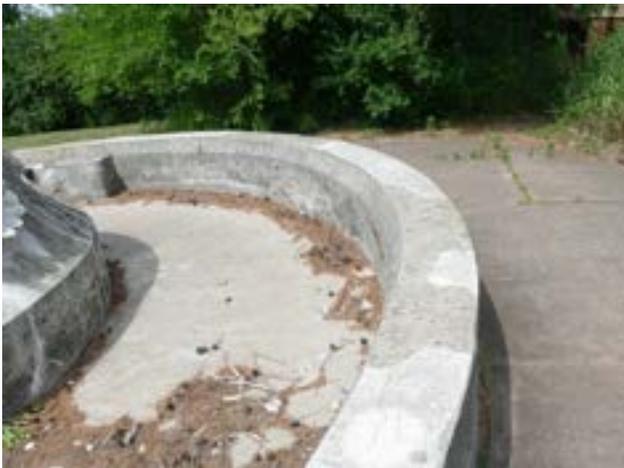
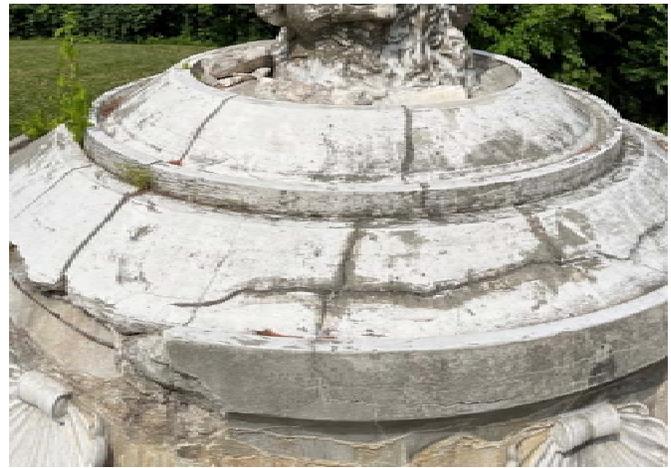
Patches, coatings, added materials. CSOS is unaware of any documented previous repair campaigns, however, many types of repair materials were observed in situ. Based on the number of previous repairs and the lack of documentation it is possible that repairs maybe have been implemented by well meaning activists without knowledge of how the two materials would interact. Mortar patches that are stronger than the masonry they are used to patch can contribute to degeneration of surrounding original materials. Many apparent mortar patches are present on the lower bowl. As shown in the photographs below, the pedestal includes apparent patch material as well as remnants of a coating applied to the top two tiers.

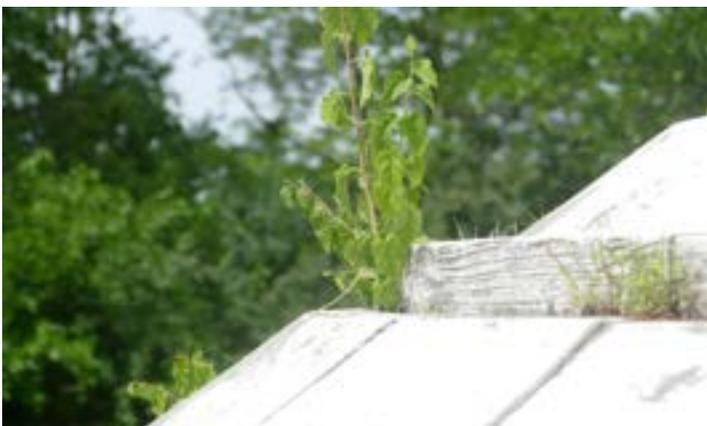
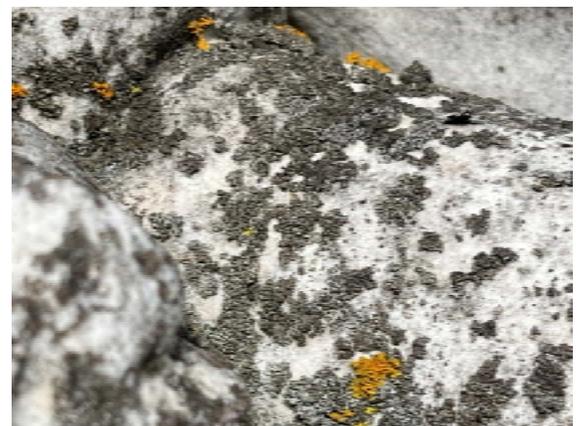
Vegetation and bio growth were observed in micro scale and macro scale with micro scale biological growth such as lichen primarily on the marble figures and large-scale vegetation (large weeds) growing out of crevices in the pedestal. The growth of large-scale vegetation exerts outward pressure that can exacerbate the formation of cracks while also holding on to moisture which contributes to freeze/thaw distress. Micro scale biological growth obstructs the ability to visually distinguish the features of the sculpture and some types of biological growth can secrete acids which can slowly chemically dissolve calcite-based stone. Additionally, biological growth absorbs and holds moisture to the stone surface potentially contributing to freeze/thaw distress. Examples of macro and micro scale biological growth are shown below.

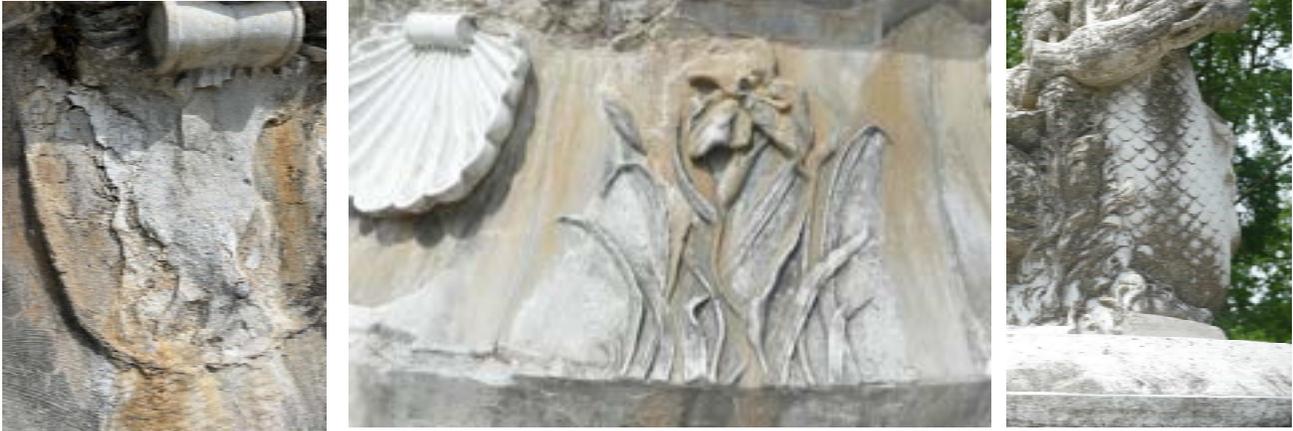
Discoloration and deposits. In addition to the discoloration imparted by the biological growth on the marble sculpture, streaks of white and yellow deposits were observed on the surface of the pedestal and a network of fine cracks with white deposits was observed on the surface of the lower bowl. Due to the general condition of the pedestal and concrete perimeter, samples were not taken for testing. It is likely that the deposits are due to both the water chemistry when the fountain was in use and migration of soluble minerals in construction and repair products. Various examples of discoloration and deposits are shown below.

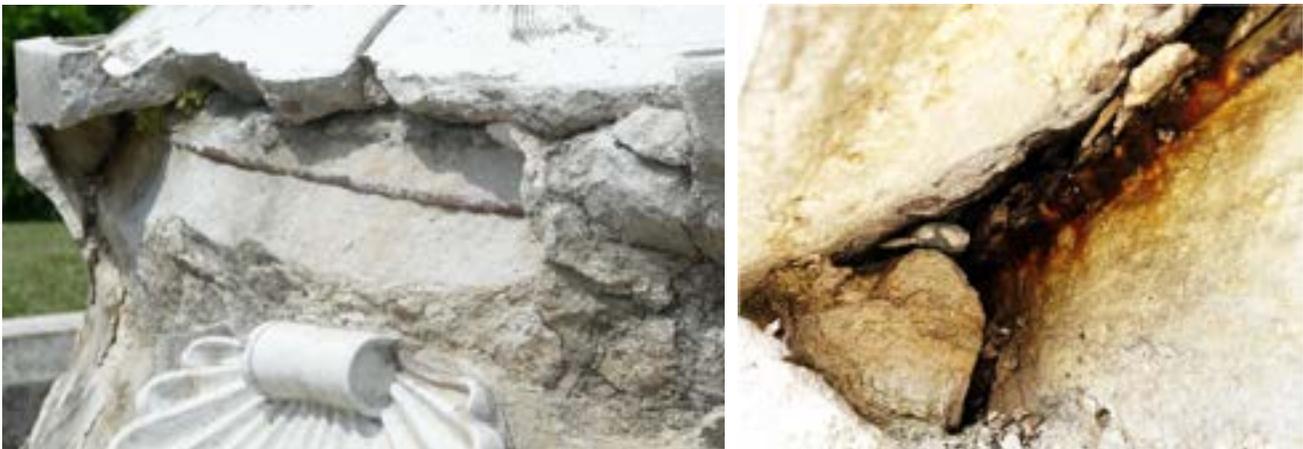
Corrosion of internal steel. A piece of corroded steel was observed at the location of lost material and extensive cracking at the second tier of the pedestal. Embedded steel elements that become exposed to moisture and corrode can expand to ten times their original surface area. This expansion exerts force on the surrounding materials that can lead to cracking. Distress can accelerate if cracking leads to increased moisture exposure. The photographs below show corroded steel remaining in the pedestal and an adjacent area of loss.

Based on the amount of distress observed and the interrelationship of the distress conditions CSOS has concluded that the pedestal and the concrete lower bowl are beyond reasonable repair.
