**ANNIE C. STEWART MEMORIAL FOUNTAIN
CONSERVATION/PRESERVATION PLAN
MADISON, WISCONSIN**

Annie C. Stewart Fountain Conservation/Preservation Plan

Prepared for the City of Madison
By InSite Consulting Architects

August 15, 2017

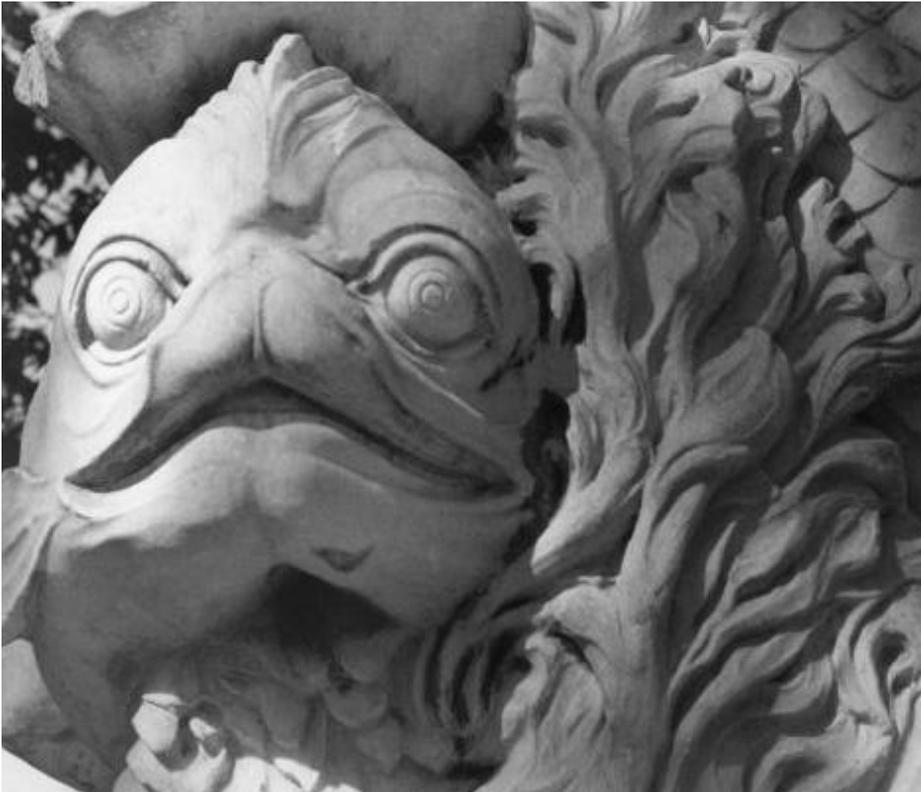
Dolphin in 1973 - The detail evident in this image is exceptional. While unconfirmed, it is apparent that the sculpture was either recently cleaned prior to this photograph or was benefited by a more proactive cleaning and maintenance program. When compared to a contemporary image of the same details it is evident that a significant amount of organic material obscures the detail. A proper conservation cleaning will help to ascertain what, if any, additional damage the piece has suffered.

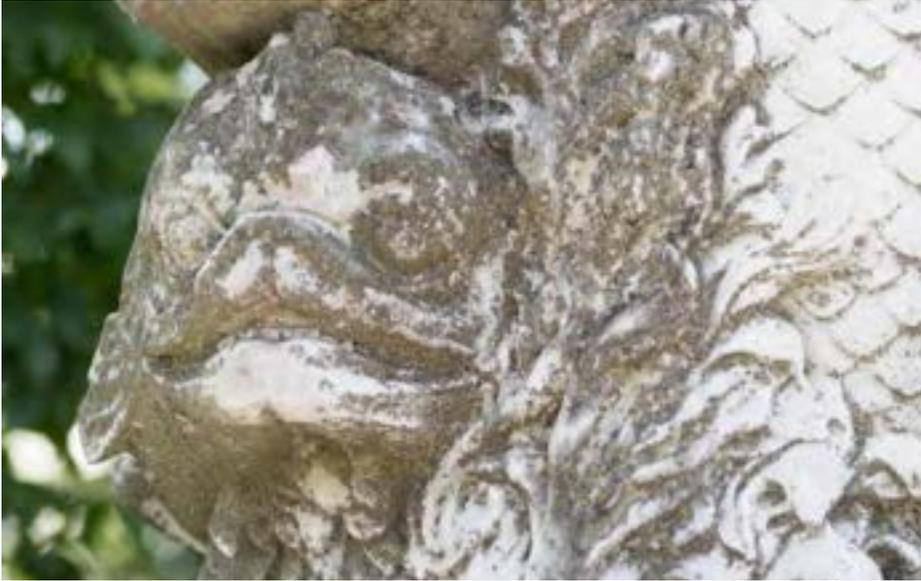
Dolphin in 2017- Much of the fine detail is obscured by organic growth. Cleaning using a benign biocide and appropriate (field tested/verified) techniques will reveal the true condition of the marble subjects. The nature of the piece's subjects, their delineation in stone, their orientation, neighboring vegetation and exposure to the elements will come to light after a proper conservation-based cleaning.

Similar to the dolphin figure of the overall piece, the other figures' features have been obscured by organic growth. In order to determine the best course of action for the piece, further study will be required as part of a conservation-based study/procedure. Clearly there has been some measure of degradation and material loss, the exact measure of this loss, its cause(s) and potential remedies should be the result of further study that are outside the scope of the report. A thorough cleaning using the gentlest means possible should be undertaken at which time a full conservation plan can be developed and implemented.

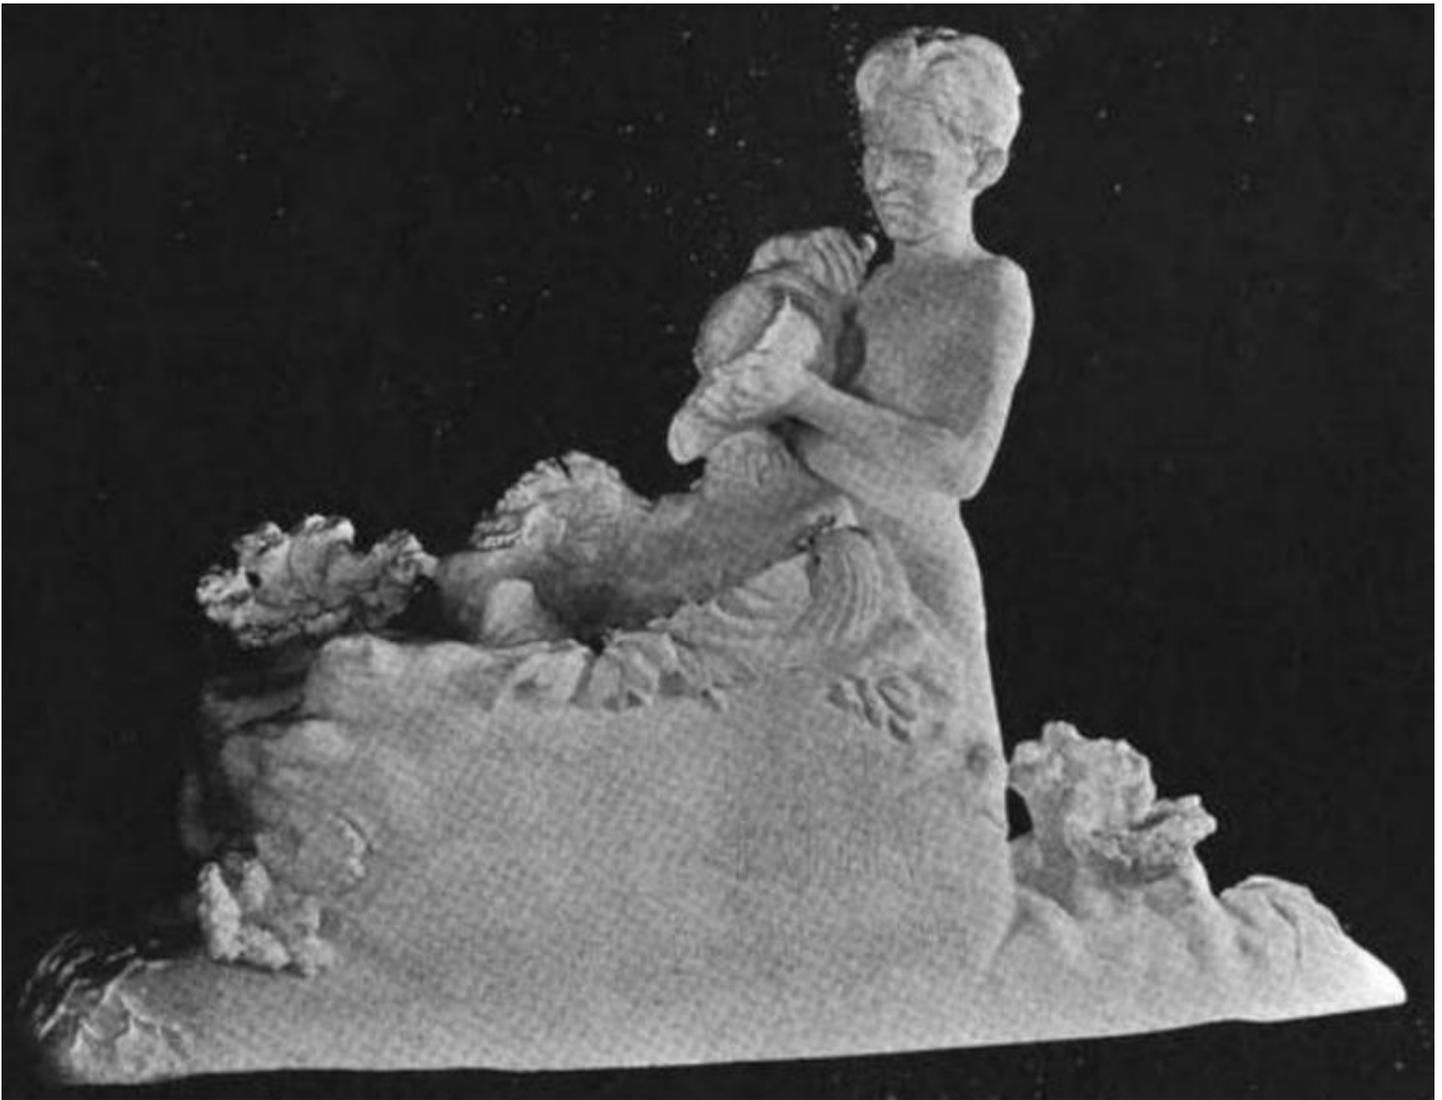
Trade Magazine image (1921) of one of the missing Tritons that were produced by Vermont Marble Company, Proctor, Vermont. Under the direction of the artist this portion of the work was completed several years before the final installation. The Triton and his context were executed with a very high level of detail and relief. These details were too tempting for vandals and did not last 20 years in situ.

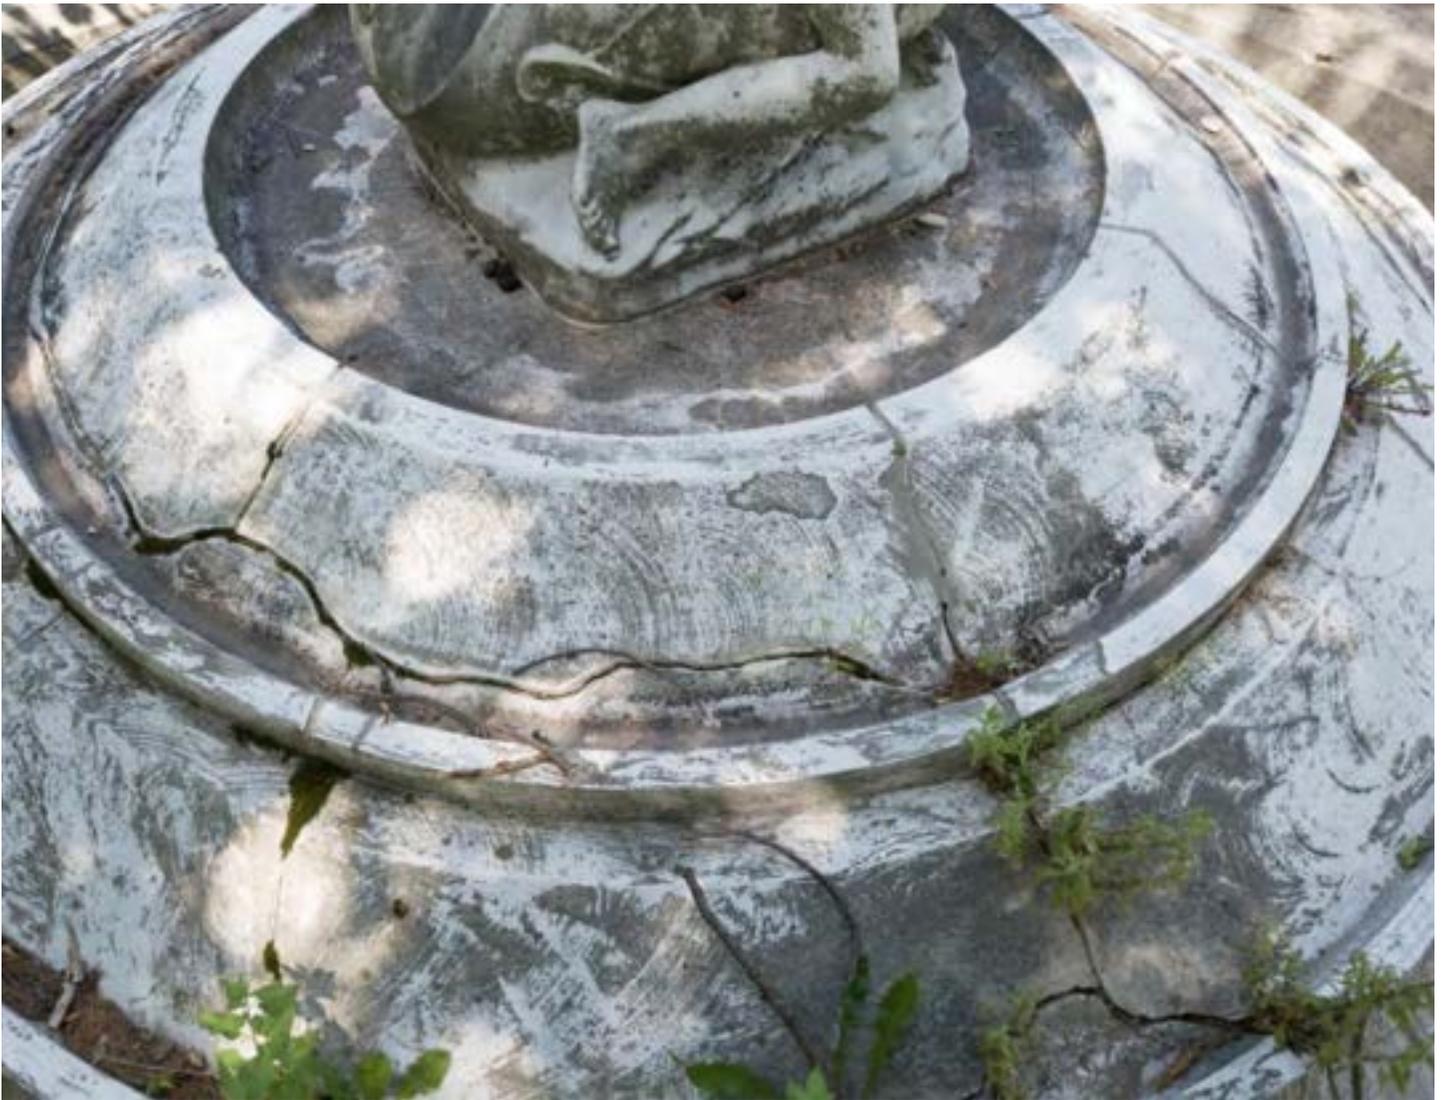
The transition from marble to limestone has fared poorly overall, but better than some of the “downslope” details. This is likely due to the fact that it was designed to handle significant amounts of water.

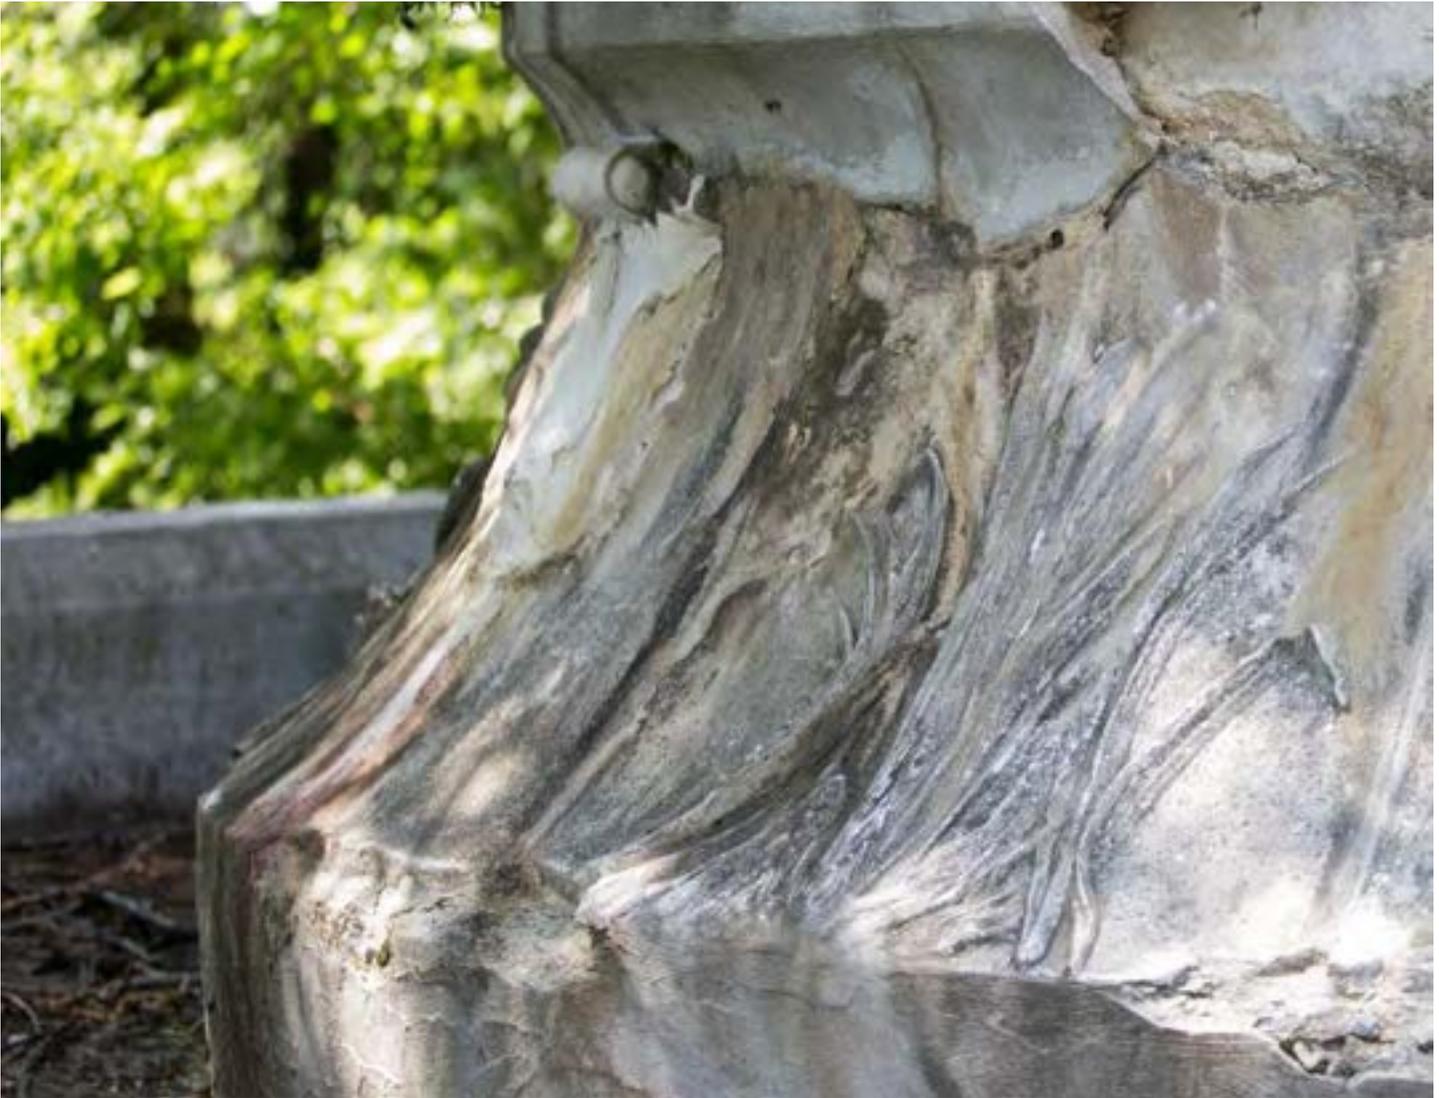
Egregious damage to the limestone base has come not only from the effects of the environment but also from repairs executed in the mid-1980's. The sealing of the surfaces of the stone eventually accelerated its deterioration and introduced long-term moisture exposure to the interior of the base's structure. Excessive corrosion of the stone's steel tension ring have contributed to significant deterioration from expansive metals.

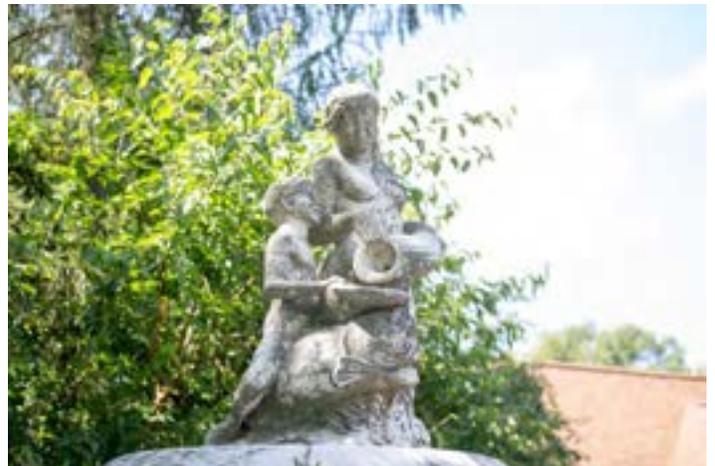
Figure 2: Overall view of condition of marble figures

CONDITION: The Basin and Base have been treated (1994) with an epoxy cement-type repair material typically used for concrete and occasionally employed to preserve and protect Indiana Limestone. Typically, these efforts fail as the material is aggressive in terms of strength, bond to the base material, water vapor transmission characteristics, color and texture. Evident damage can be seen in the following figures. Significant areas of water-borne damage throughout the limestone base and concrete basin are, simply, beyond repair. Preservation of the material, while perhaps possible, will not meet any acceptable preservation standard. It is recommended that the basin be rebuilt in-kind as a replica.

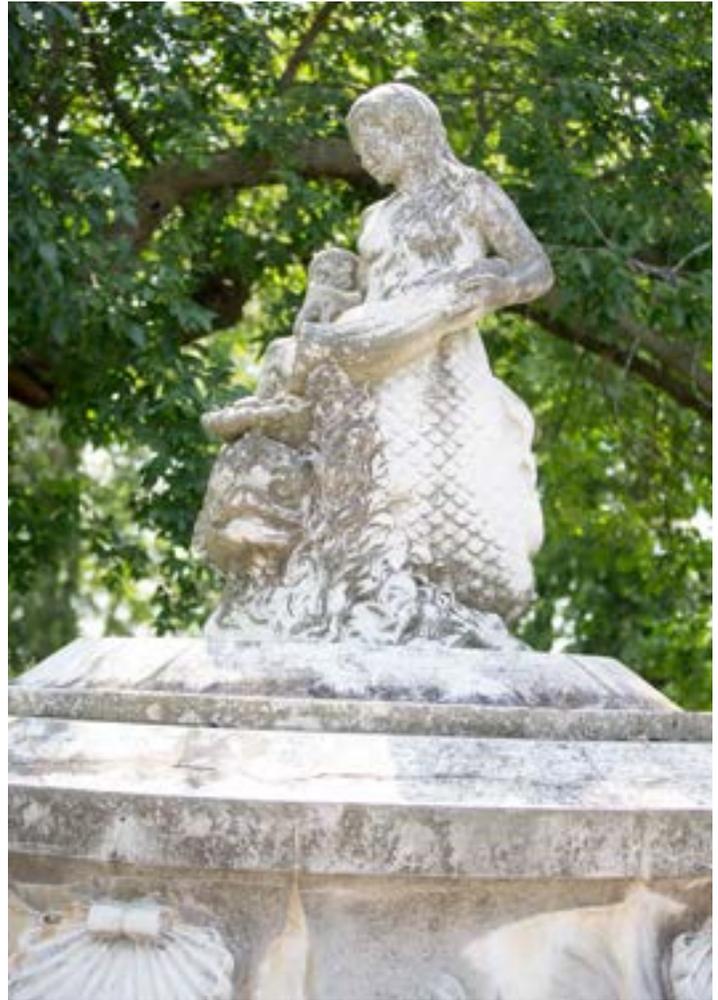
Figure 3: Overall view of condition of marble figures

The figures appear to have been cleaned and maintained as photographs from 1973 indicated the dolphin figure was in excellent condition. In the intervening 44 years organic growth has been allowed to establish a presence. The pieces should be removed for cleaning and further conservation and preservation treatments.

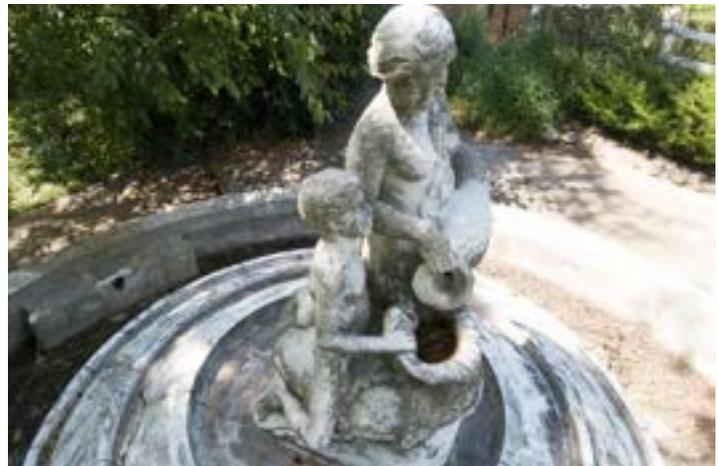
Water feature: We do not recommend the repair/resurrection of the water feature. However, several elements, such as the cornucopia may require some protection as they collect water. The collection points allow water and organic material damage to occur.

Figure 4: View of cornucopia water feature

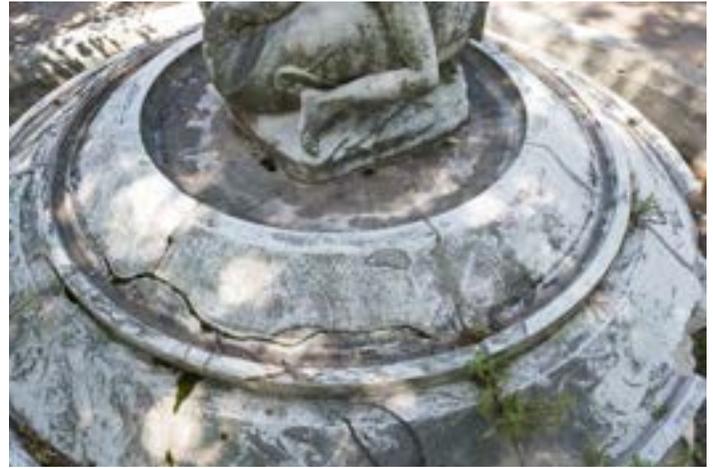
The previous treatment of the pedestal and base materials with the epoxy cement overcoat has altered and damaged the material beyond repair. Further, it is likely that this material will be damaged when the figures are removed for preservation/conservation based repairs. The area directly beneath the sculpture (pedestal) appears to be in the best overall condition of all the limestone that was treated in 1994. The cracks at the pedestal have been repaired and the surface treated. In this case, the configuration of the stone, the lack of fine detail, and its water shedding design helped the pedestal maintain its overall material and form.

Figure 5: Upper view of pedestal and base - note damage to pedestal has been repaired and appears to have stabilized

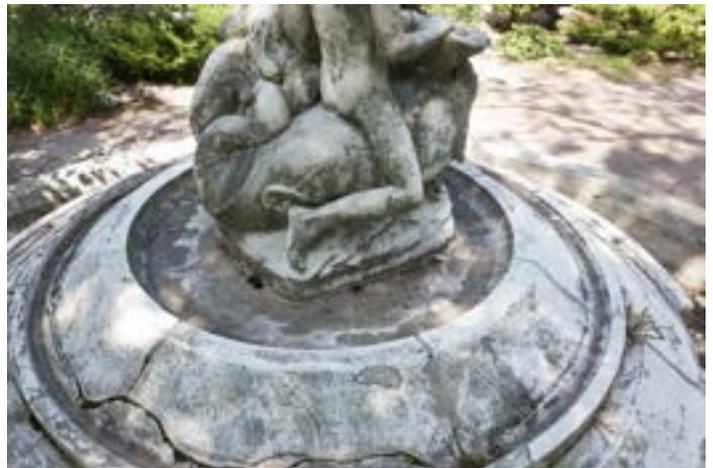
Cracks have formed at the base of the pedestal due to the differential movement of the pieces as produced and set. The interior “plumbing” of the fountain is likely to have an affect on this movement as it would act as a pinning point. Conservation of the piece would entail the careful deconstruction of the work to ascertain the interior configuration of the fountain, and its impact on the remainder of the piece.

Figure 6: View of marble figures and upper view of pedestal and base - note damage to pedestal has been repaired and appears to have stabilized

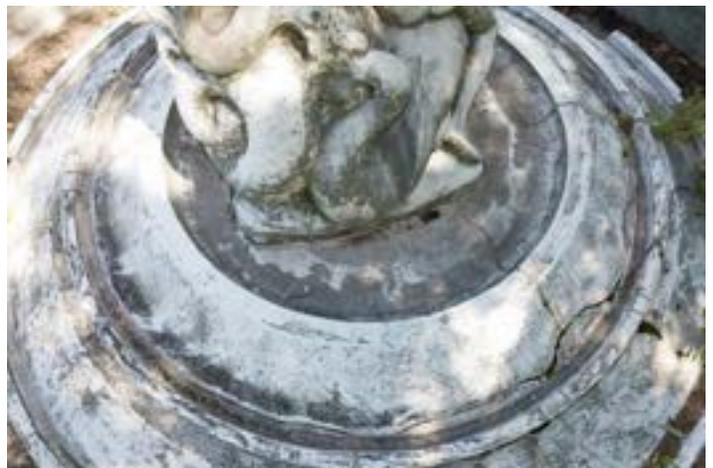
The shallow basin at the top of the pedestal collects water, promoting organic growth and the deterioration of the stone. This is a natural feature of the piece that must not be altered. It simply requires a regular maintenance regimen to keep it in optimal condition.

Figure 7: Upper view of pedestal and base - note damage to pedestal has been repaired and appears to have stabilized

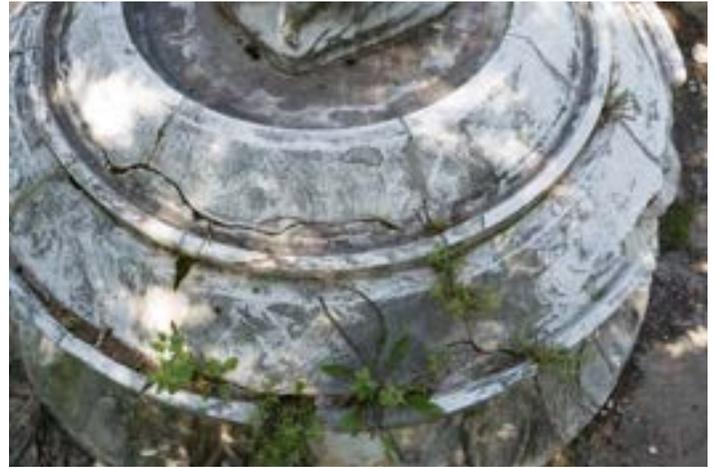
The organic growth has caused more damage to the limestone base as might be expected due to the relatively open nature of the stone as compared to marble. This part of the piece appears to be beyond repair and must be replaced. The long-term performance of any new work will also require a regular maintenance regimen to keep it in optimal condition.

Figure 8: Upper view of pedestal and base - note damage to pedestal has been repaired and appears to have stabilized

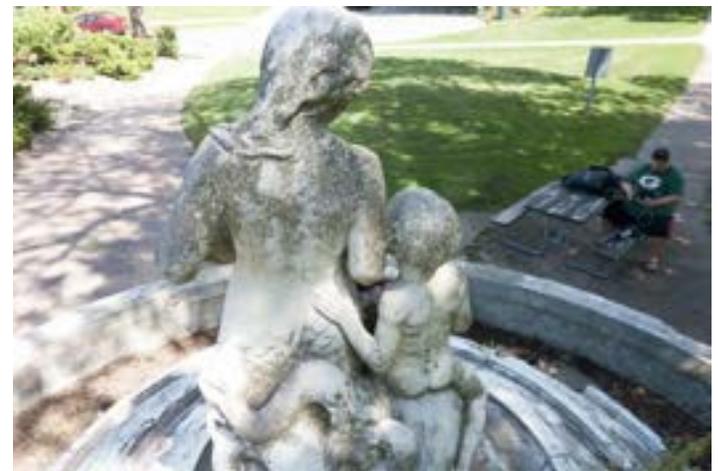
The organic growth at the marble portions of the piece appears to be mostly superficial. This must be confirmed through a thorough conservation-based cleaning and study. The long-term preservation of the marble artwork must be maintained regularly with a prescribed regimen, properly funded. A conservation plan must be developed and implemented if the piece is to remain available to the public.

Figure 9: View of marble figures and upper view of pedestal and base - note organic buildup

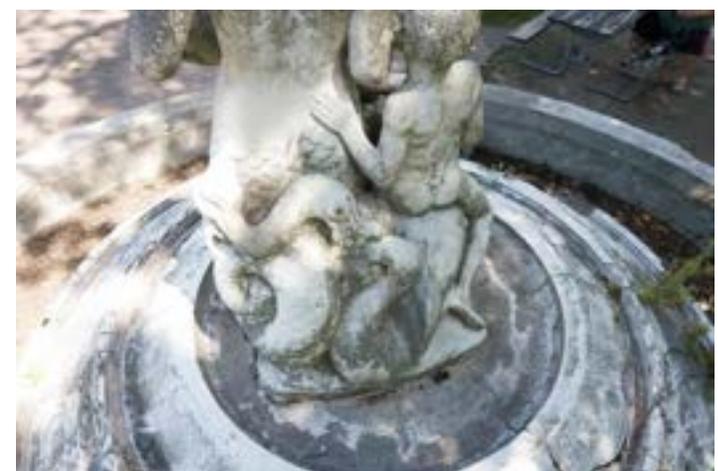
Figure 10: View of marble figures and upper view of pedestal and base - note mineral and organic buildup

Extraordinary care must be given during the preservation process to assure that the delicate details such as the Triton's arms are not damaged during the removal process.

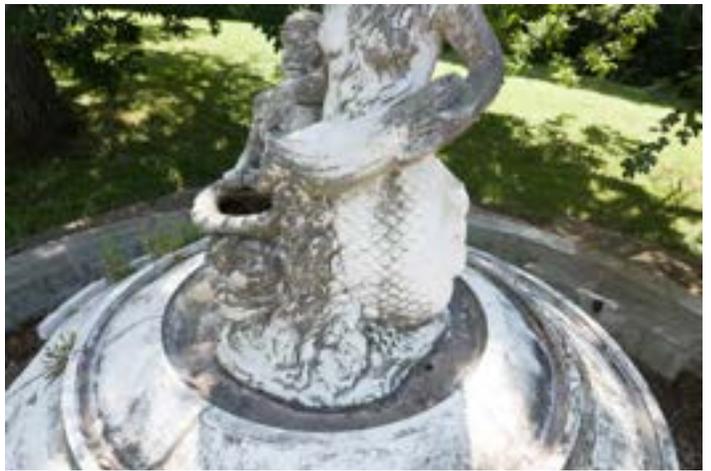
Figure 12: View of dolphin figure - note the apparent loss of detail from organic buildup

It is recommended that, once the piece has been restored to its best possible condition that it be laser-scanned to memorialize its condition digitally. From this scan a replica could be made and missing elements may be restored.

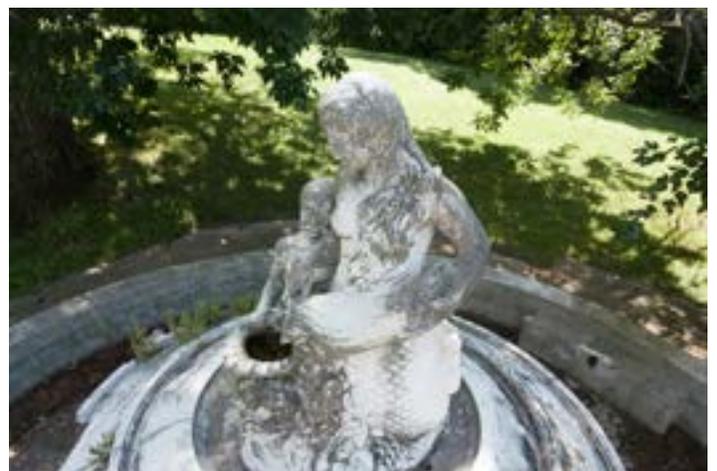
Depending on the conditions discovered one of the elements that may be restored in the future might be the sea-nymph's nose that was damaged by vandalism. The city and its conservator may develop plans for such work if budgets and the public's interest allow. Further, depending on the availability of documentation from the Vermont Marble Company and other sources, it is possible that the Tritons might also be reconstructed.

Figure 13: View of mermaid and cornucopia - note the apparent loss of detail from organic buildup

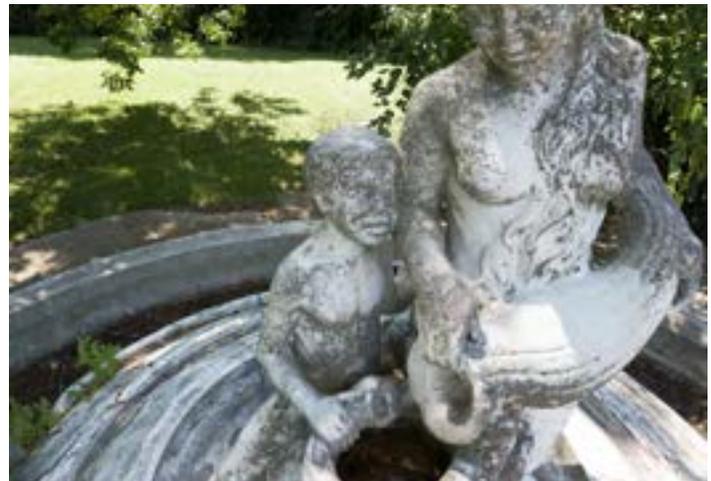
Figure 15: Close up view of Triton - note organic growth on surface of marble

The support of the removal will likely require the restraint and/or confinement of certain details within the sculpture, such as the negative space between the Triton and Mermaid. This must be executed with precision to avoid breakage.

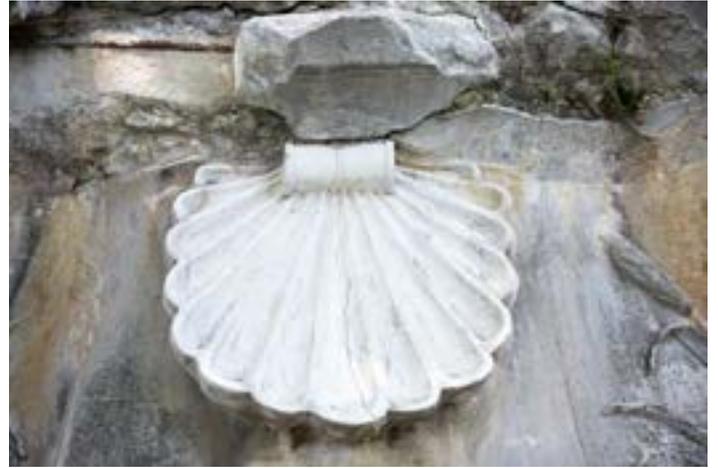
The limestone base was beautiful in its own right. The details of the shells and finely detailed bas-relief botanical motifs are unique and locally relevant through its depiction of plants indigenous to the area.

Figure 20: Shell motif condition amid limestone damage indicating restoration or replacement at some point in time

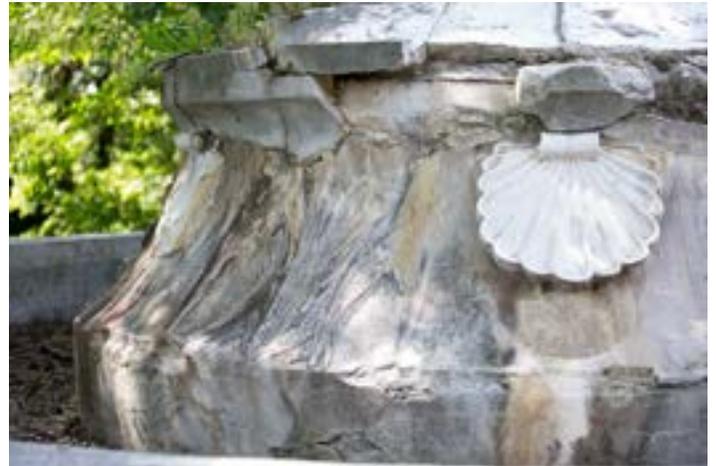
Deterioration at the limestone is, simply put, beyond repair. This is due to limestone's vulnerability to damage from moisture infiltration, freeze-thaw cycling, and organic growth.

Figure 21: Excessive limestone damage adjacent to steel tension ring - causing iron oxide (rust) staining

This piece, because of its structural loading (holding itself and the marble piece above), required a tension ring at the top of the limestone base. This tension ring was made using steel rod that was given a radius and resisted the spread of the base when the marble pieces were installed. This steel rod has corroded, expanded and caused irreparable harm to the limestone.

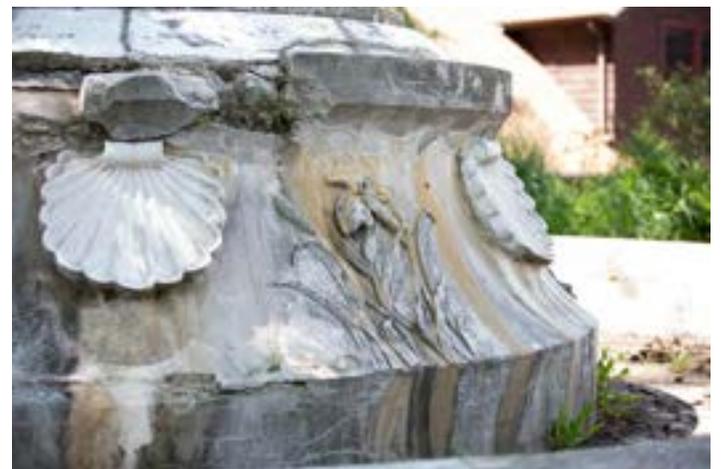
Figure 22: Overall condition of stone base - the damage is excessive and beyond repair

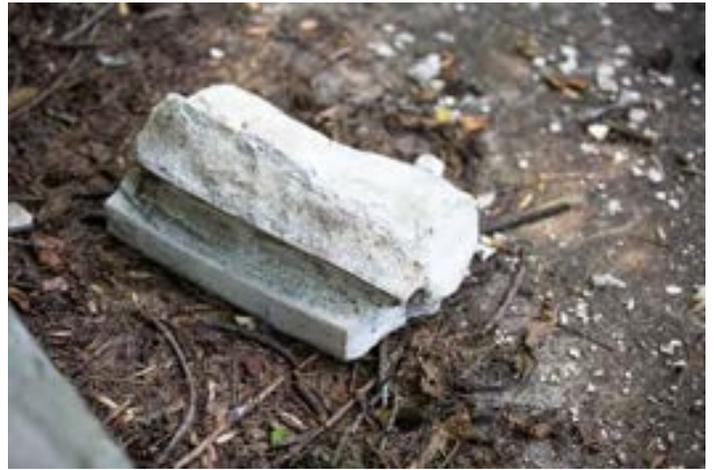
This piece of limestone came from the area shown in Figure 22 and is lying on the ground. It sheared off of the main base as the underlying steel corroded and expanded.

Figure 23: Broken piece on the site

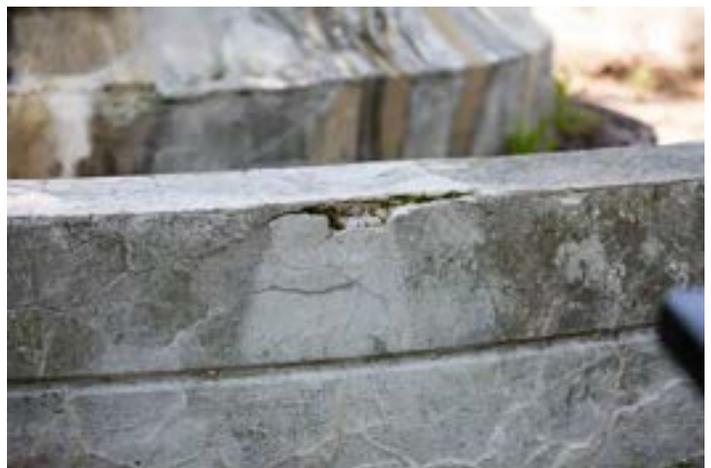
The term “emerging damage” could be used throughout this report. This is one of many examples of the deterioration at the fountain that will continue to worsen. In our experience, these issues manifest themselves at an increasing rate as time progresses and neglect continues.

Figure 25: View of emerging damage at concrete at lower perimeter ring

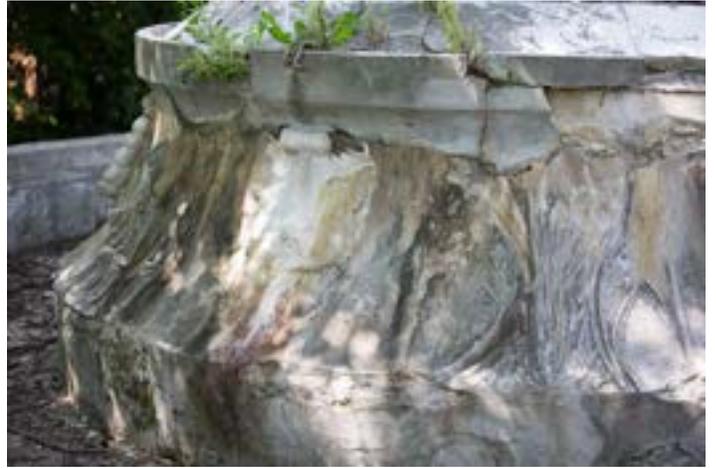
Figure 26: Excessive damage and improper repair with organic growth that is indicative of the level of disrepair

The fountain's base must be reconstructed.

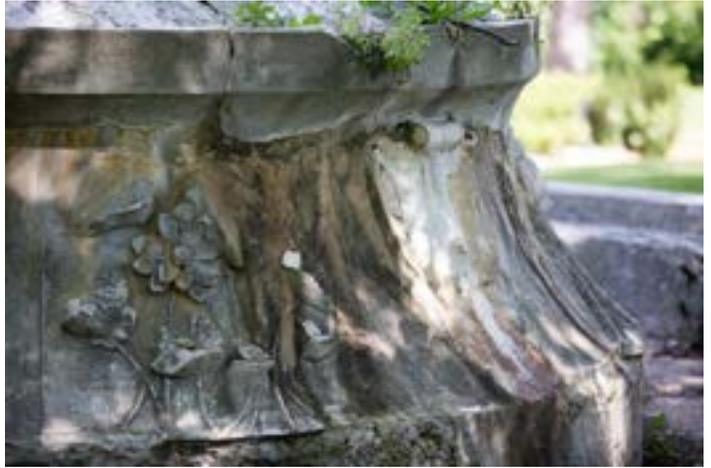
Figure 29: Excessive damage and improper repair with organic growth that is indicative of the level of disrepair

Then the fountain should be carefully deconstructed with as little loss to the original material as possible. Using an art conservator and a stone mason with experience in such work.

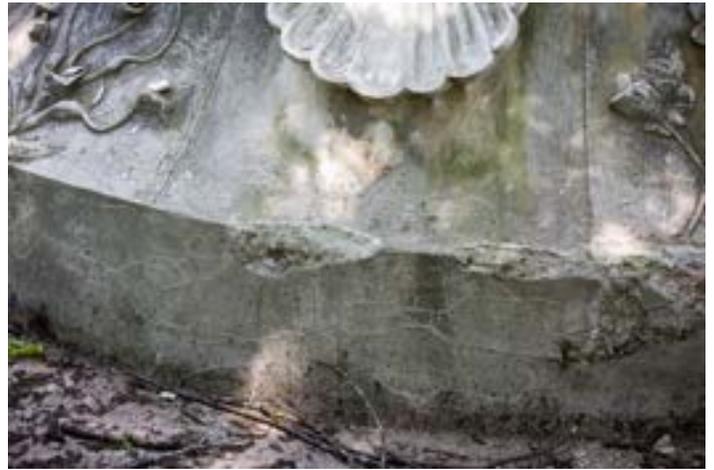
Figure 32: Degradation and mineral staining at trailing water

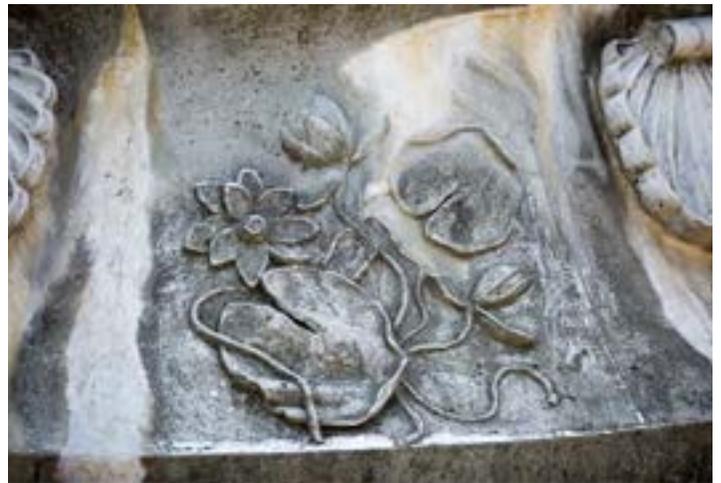
Figure 36: View of intricate detail at base, mineral deposits at trailing water

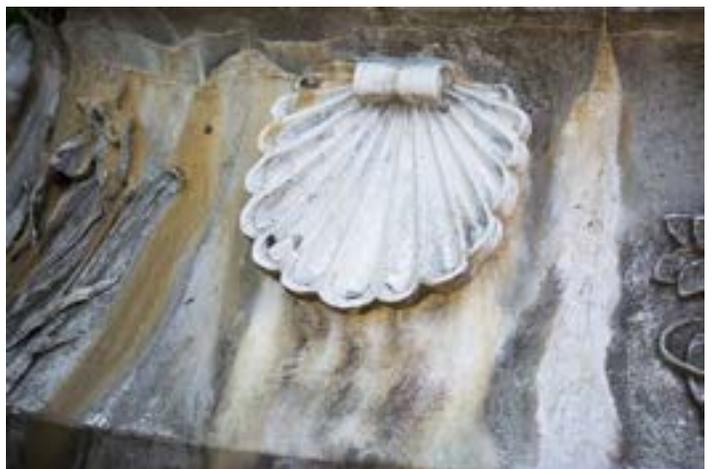
The shell motifs appear to have been part of a separate preservation effort, or, their shape and materials have led them to withstand the effects of the elements at the site better than the surrounding stone. Further study is required.

Figure 37: Shell motif condition amid mineral deposits at trailing water

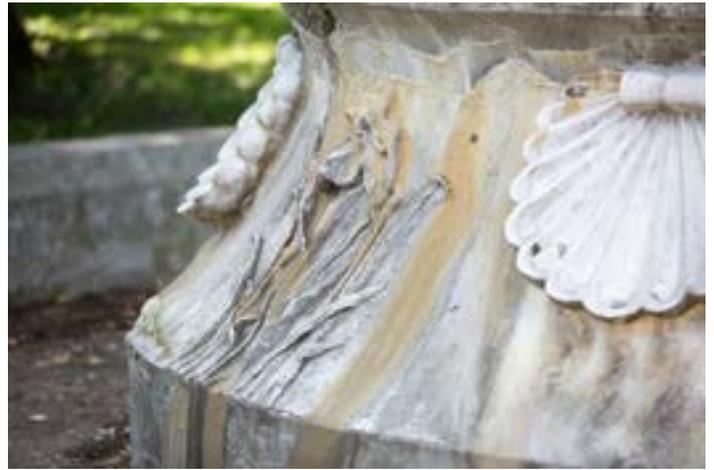
The mineral deposits appear to emanate from the sub-surface steel components of the base.

Figure 38: Shell motif condition amid mineral deposits at trailing water

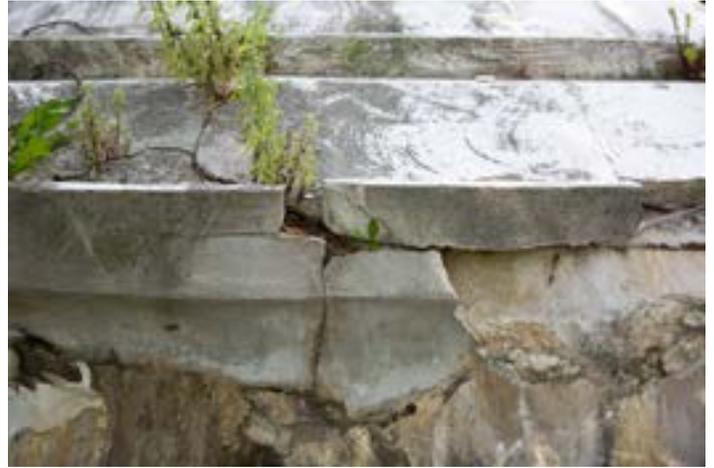
Figure 41: View of extreme damage to the limestone

The damage to the fountain's base of limestone and concrete is not reversible. Complete restoration is required.

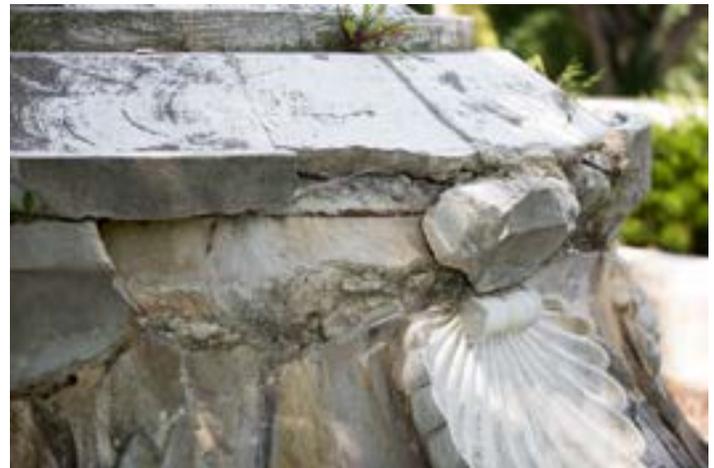
Figure 42: View of damage at tension ring

The damage to the fountain's base of limestone and concrete is not reversible. Complete restoration is required.

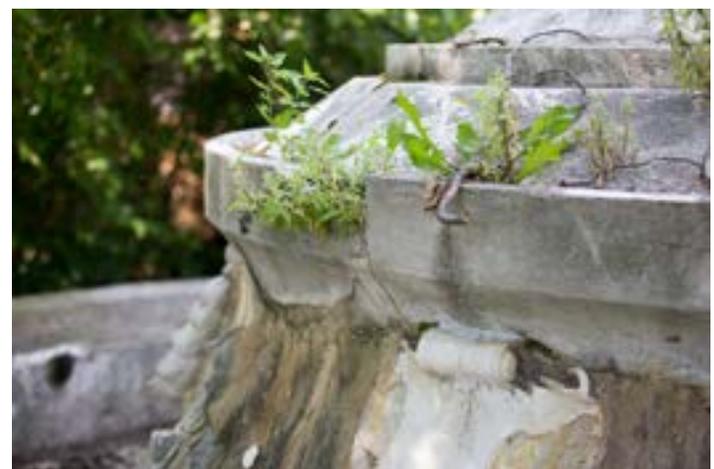
Figure 43: View of plant infestation and damage

The damage to the fountain's base of limestone and concrete is not reversible. Complete restoration is required.

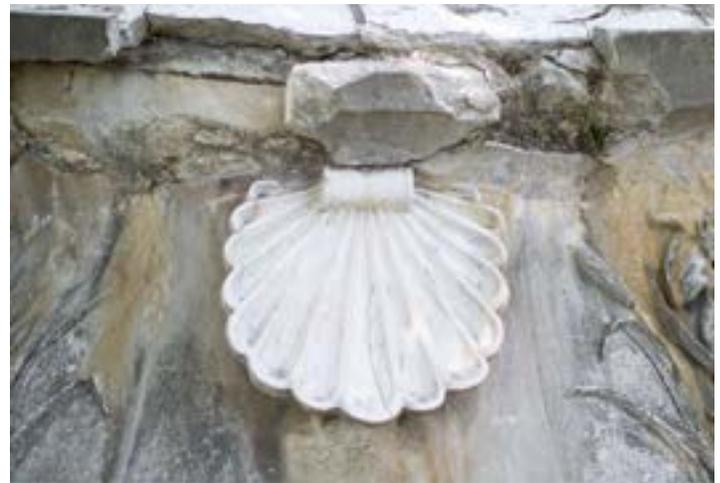
Figure 45: View of damage to limestone at base and relatively intact condition of shell motif

The damage to the fountain's base of limestone and concrete is not reversible. Complete restoration is required.

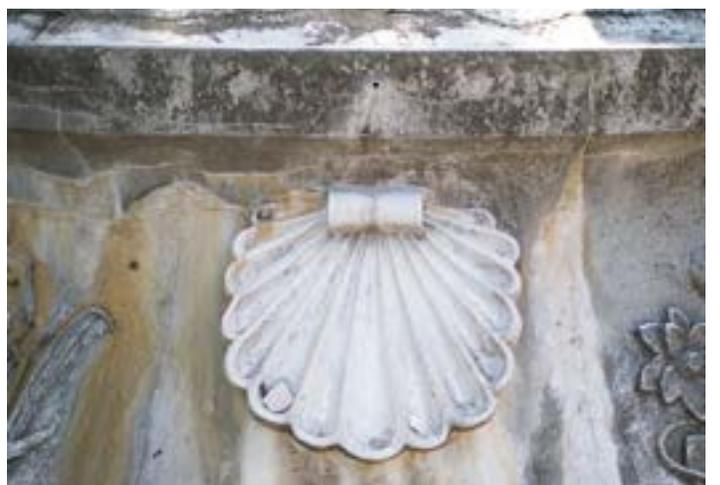
Figure 46: View of weep holes, cracked limestone mineral deposits and trailing water

The damage to the fountain's base of limestone and concrete is not reversible. Complete restoration is required.

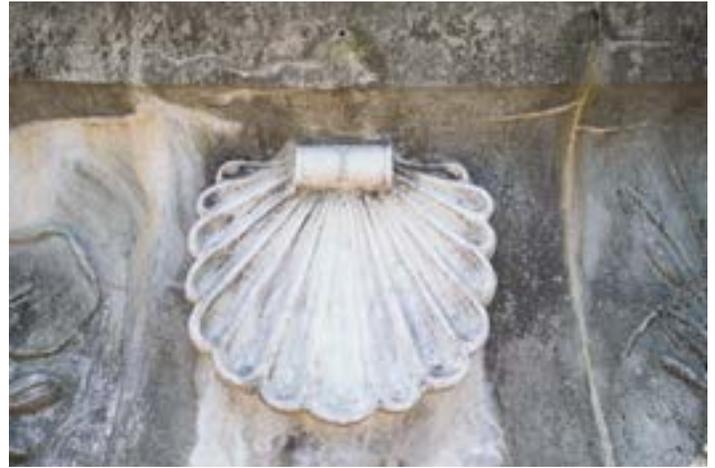
Figure 47: View of weep holes, cracked limestone mineral deposits and trailing water

The damage to the fountain's base of limestone and concrete is not reversible. Complete restoration is required.

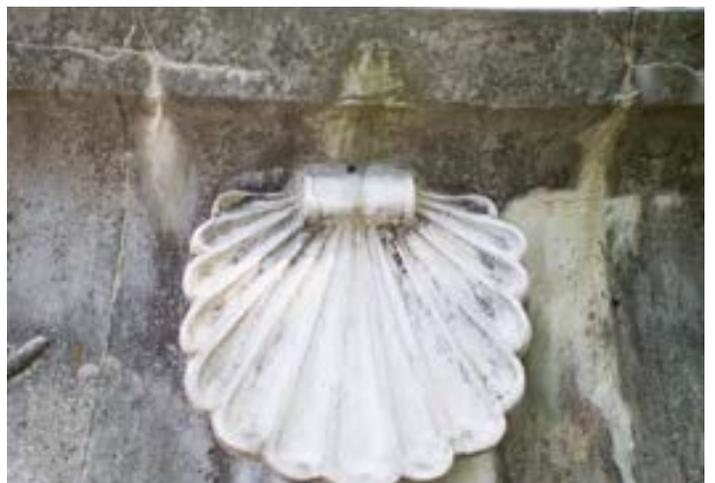
Figure 49: View of weep holes at shell, cracked limestone mineral deposits and trailing water

The damage to the fountain's base of limestone and concrete is not reversible. Complete restoration is required.

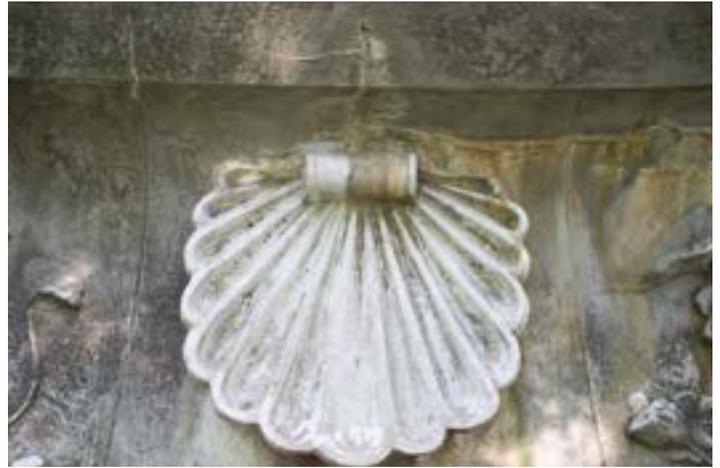
Figure 50: View of weep holes, cracked limestone mineral deposits and trailing water

The damage to the fountain's base of limestone and concrete is not reversible. Complete restoration is required.

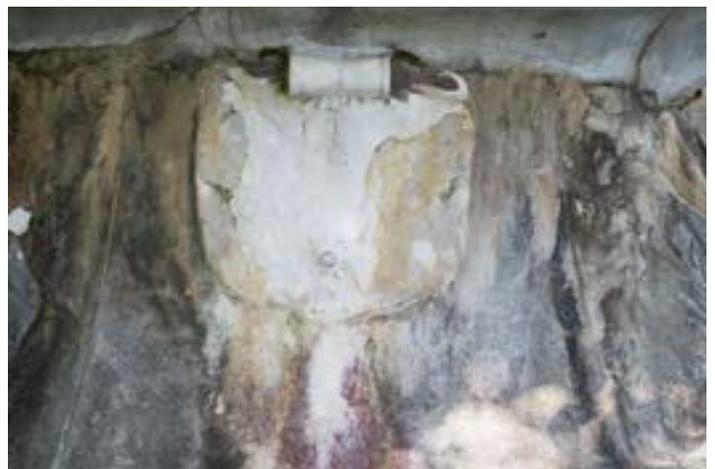
Figure 52: View of missing shell

The damage to the fountain's base of limestone and concrete is not reversible. Complete restoration is required.

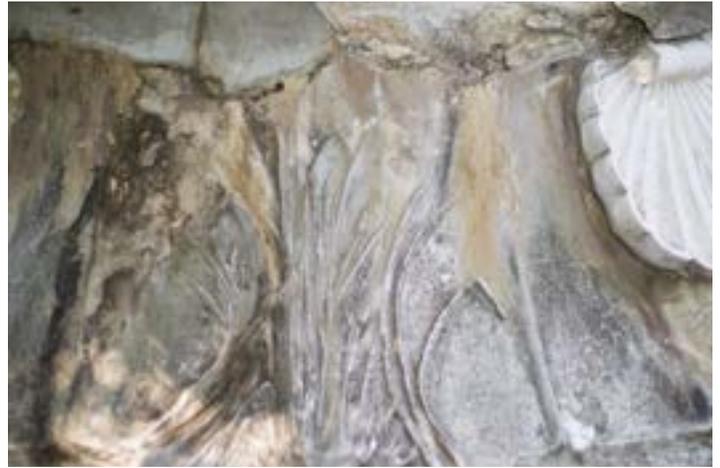
Figure 53: View of degraded material at cattail motif

The damage to the fountain's marble elements appears to be both treatable and reversible. Conservation is required.
