CSOS Review of Existing Conditions Annie C. Stewart Memorial Fountain

CSOS Review of Existing Conditions

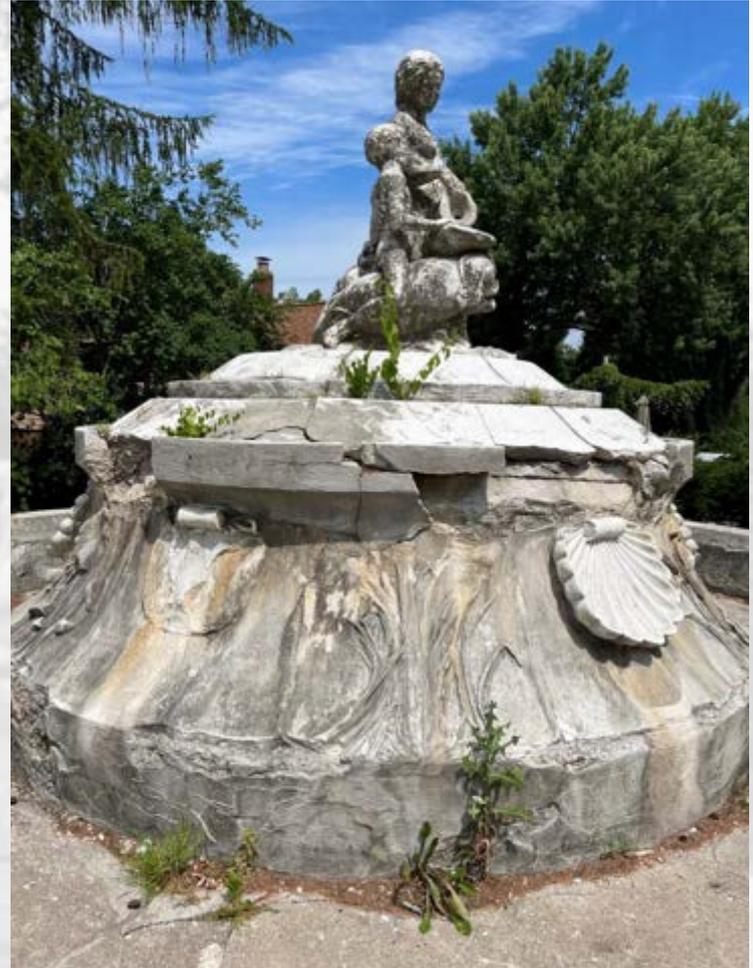
Overall Condition:

Fountain: very poor

Marble Sculpture: good

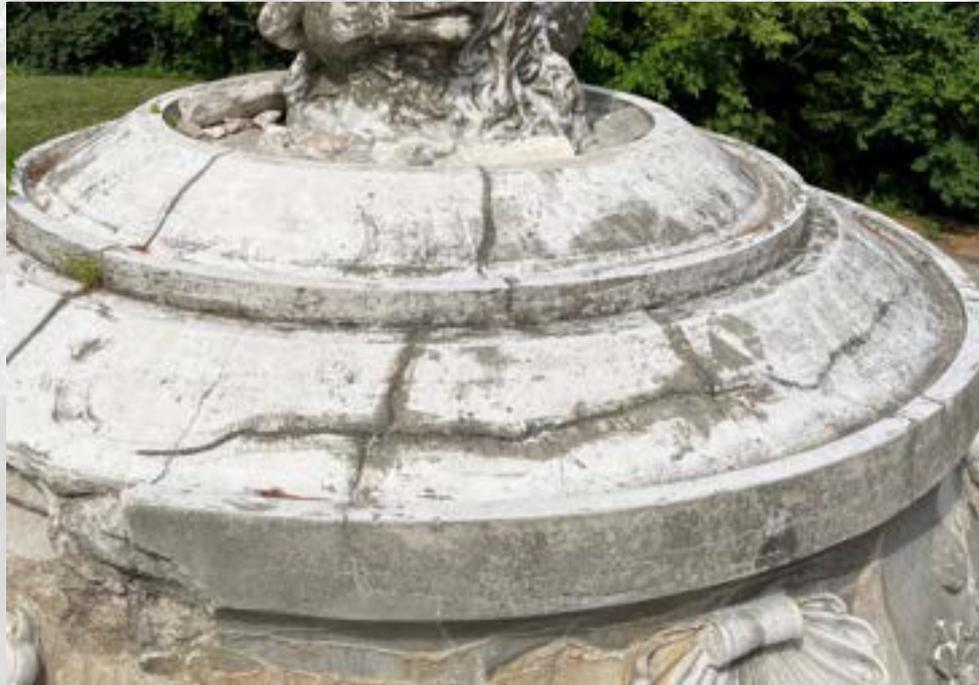
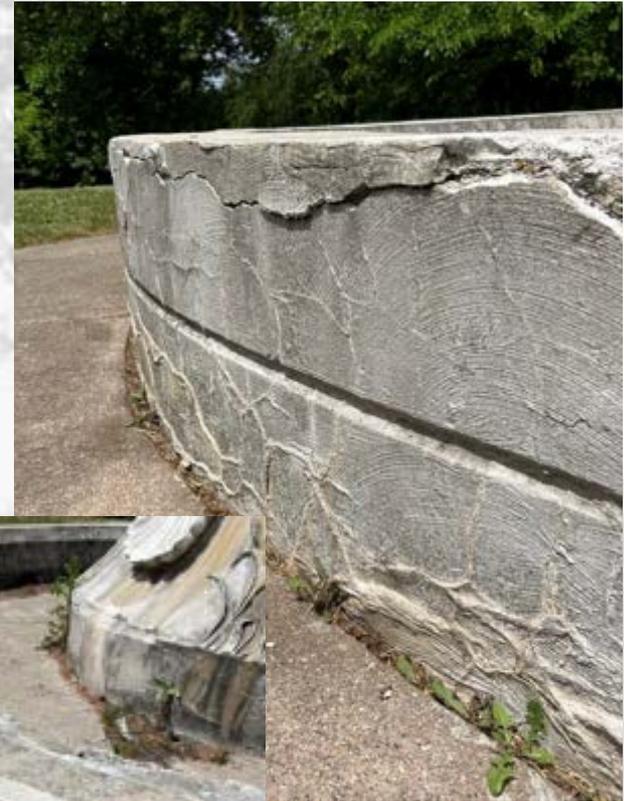
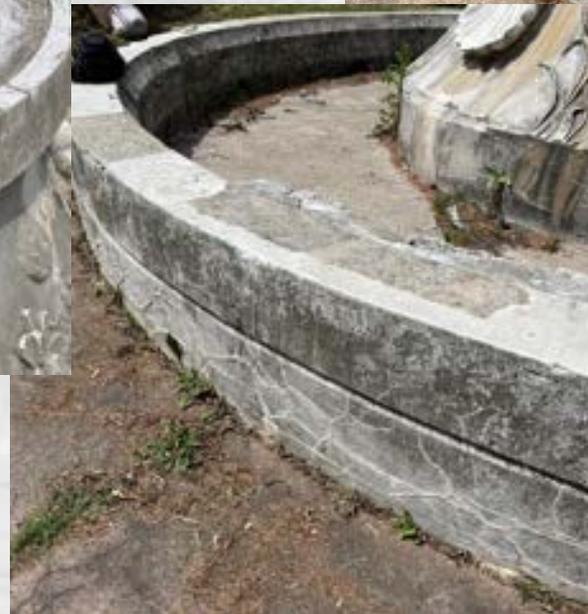
Extensive Cracking

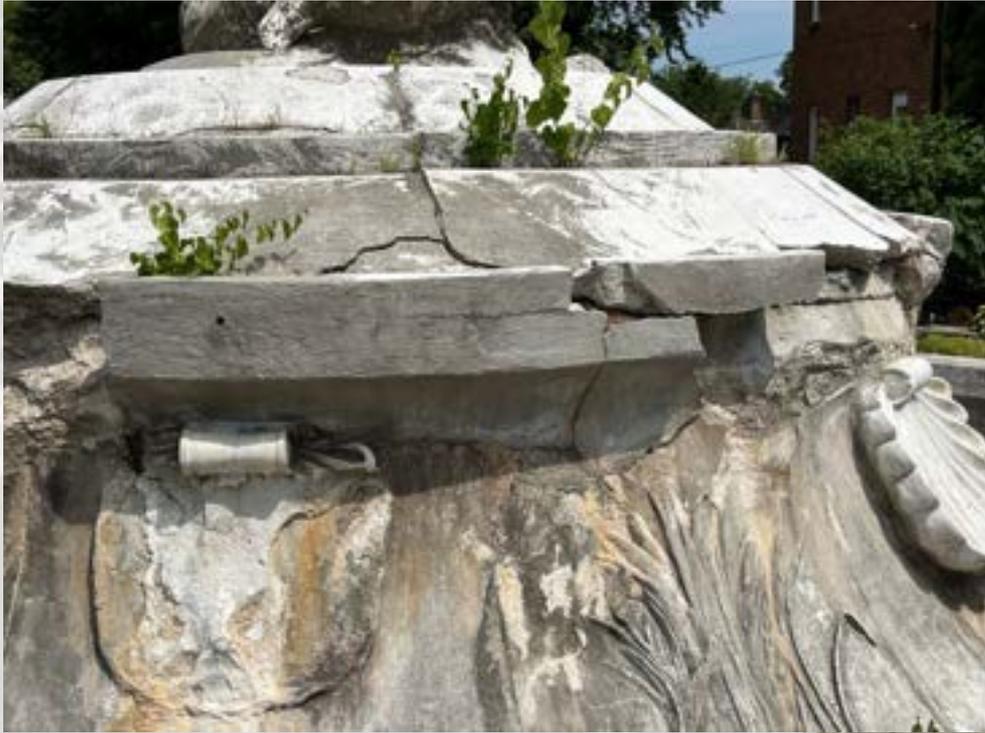
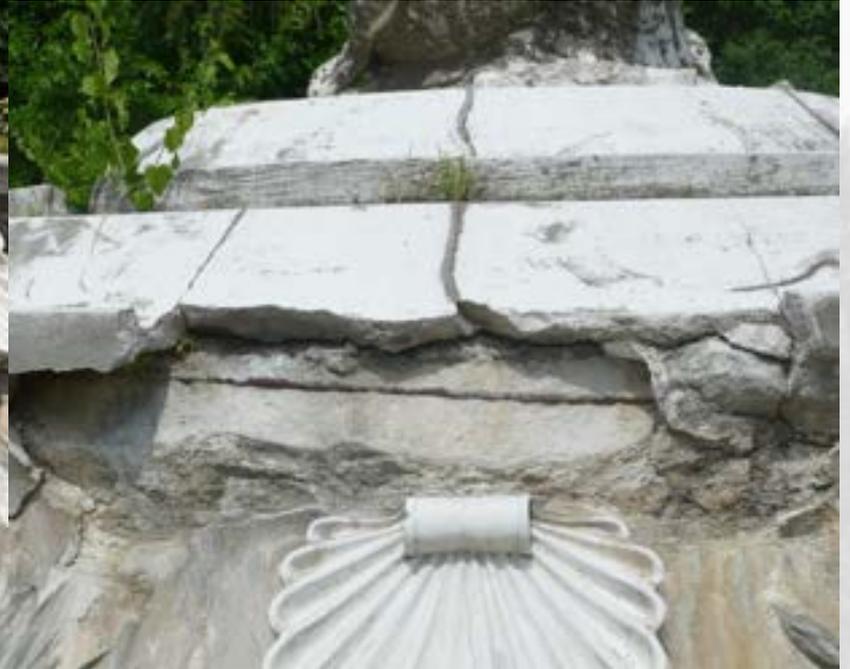
Spalls/Missing Material

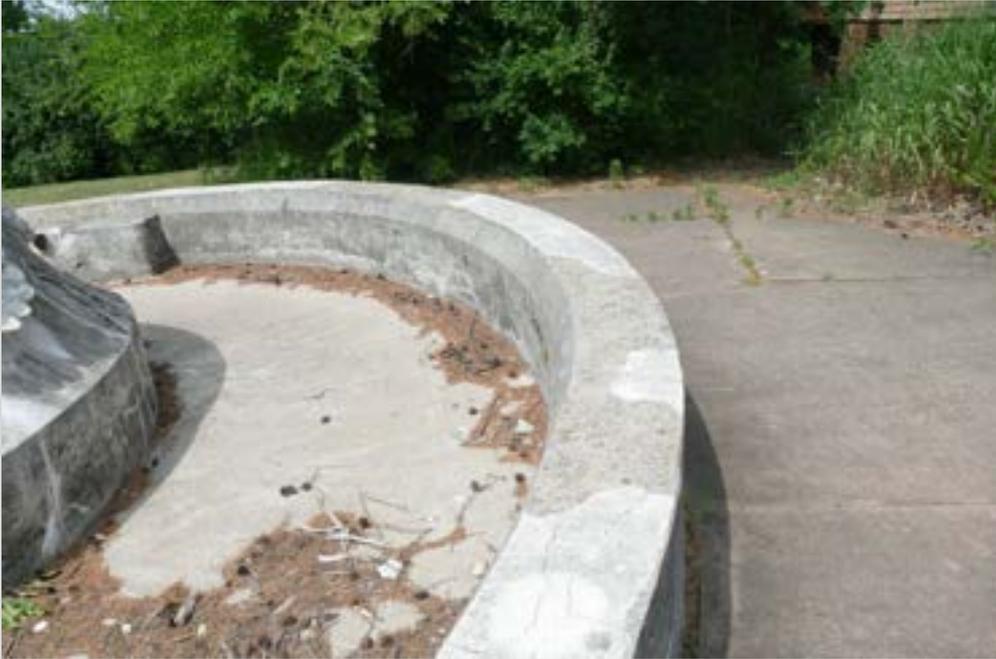
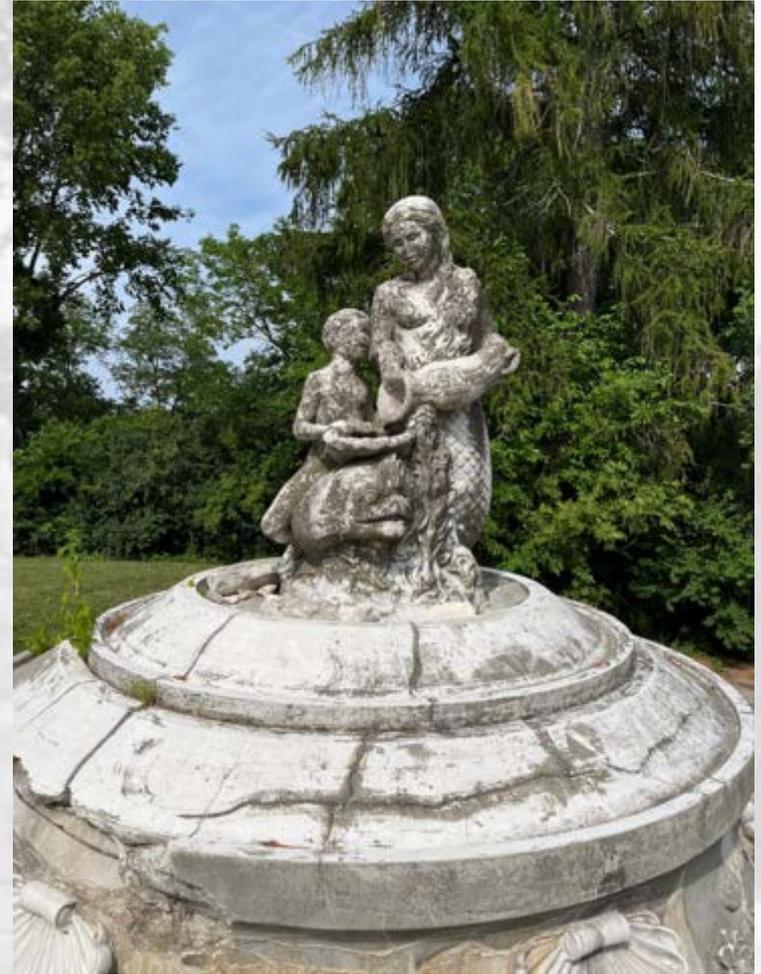
Patches/Coatings/Added Material

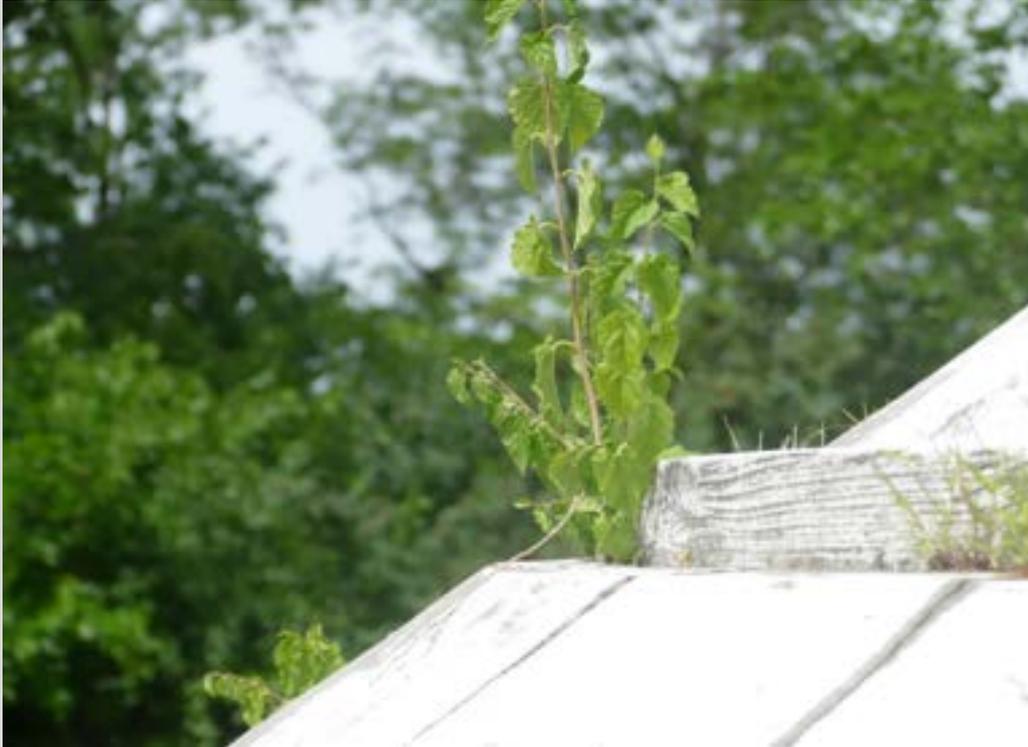
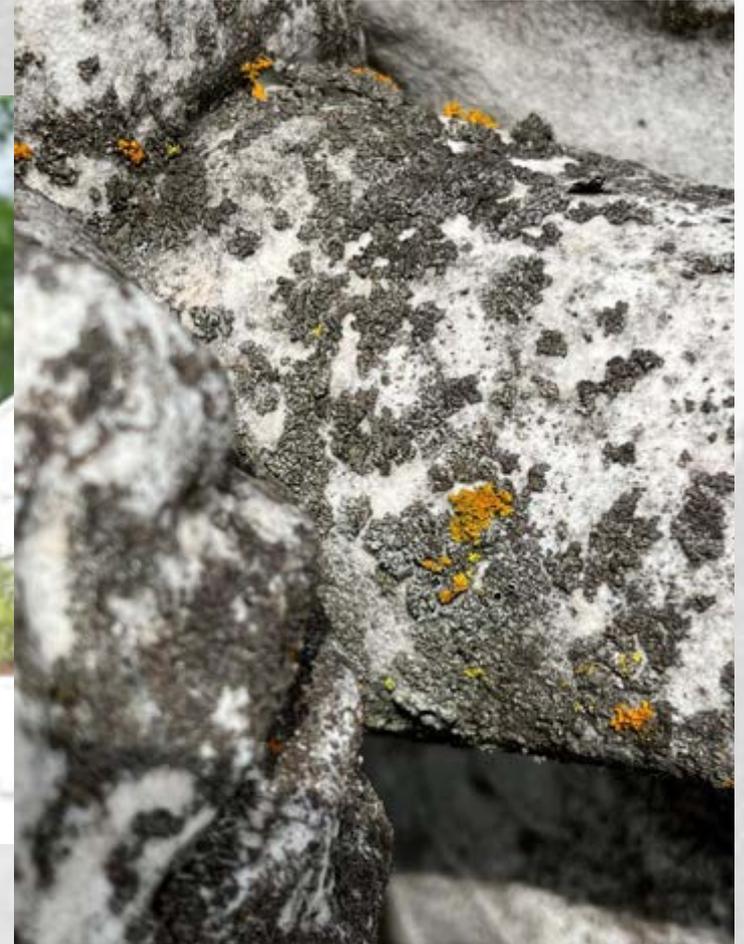
Vegetation/bio growth

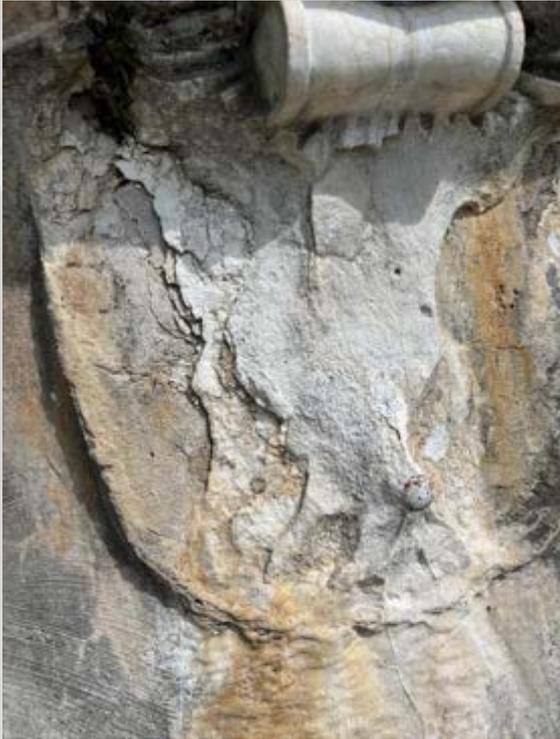
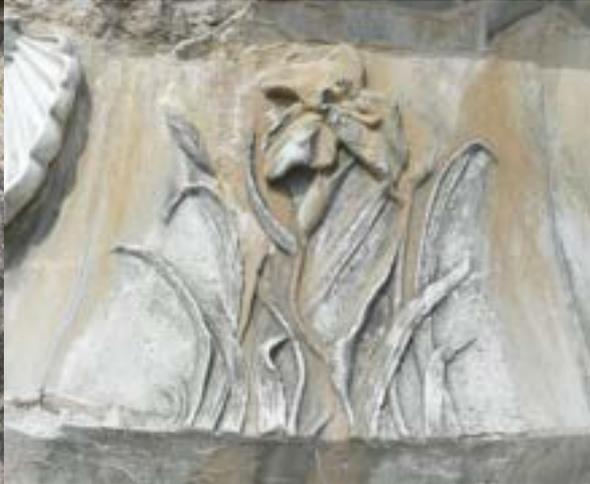
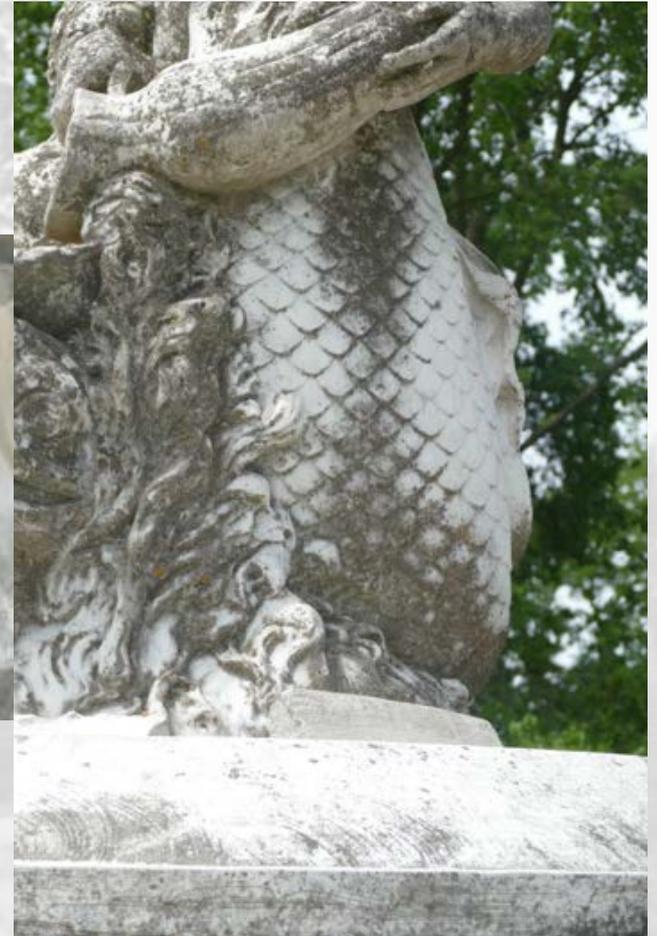
Discoloration/Deposits

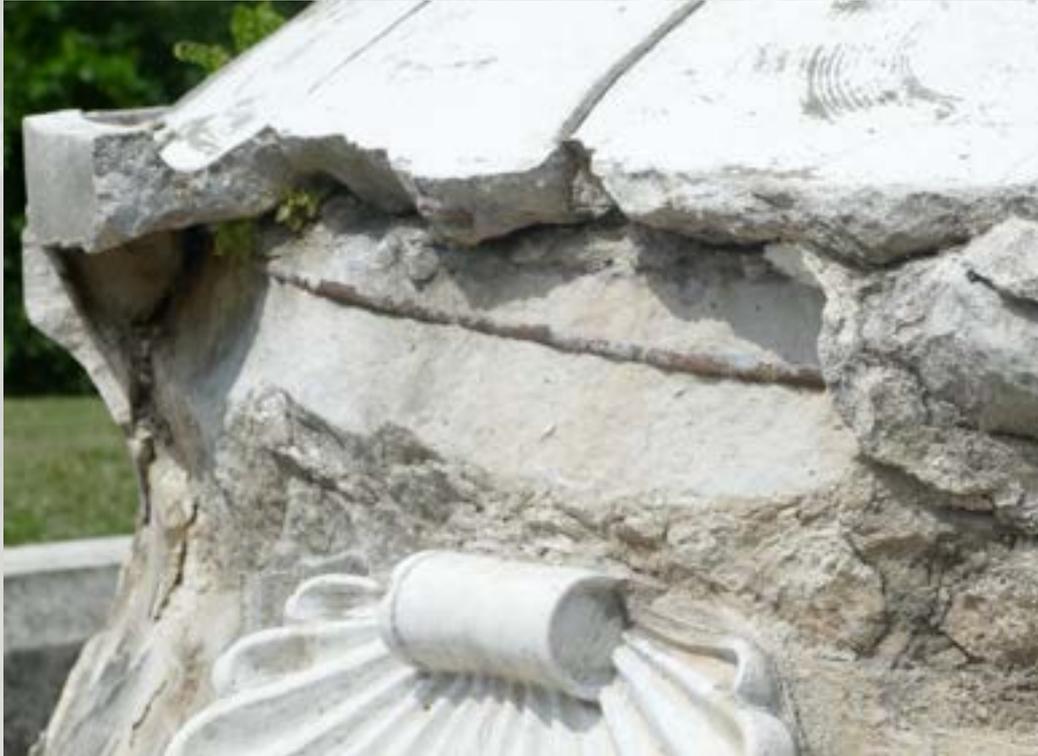
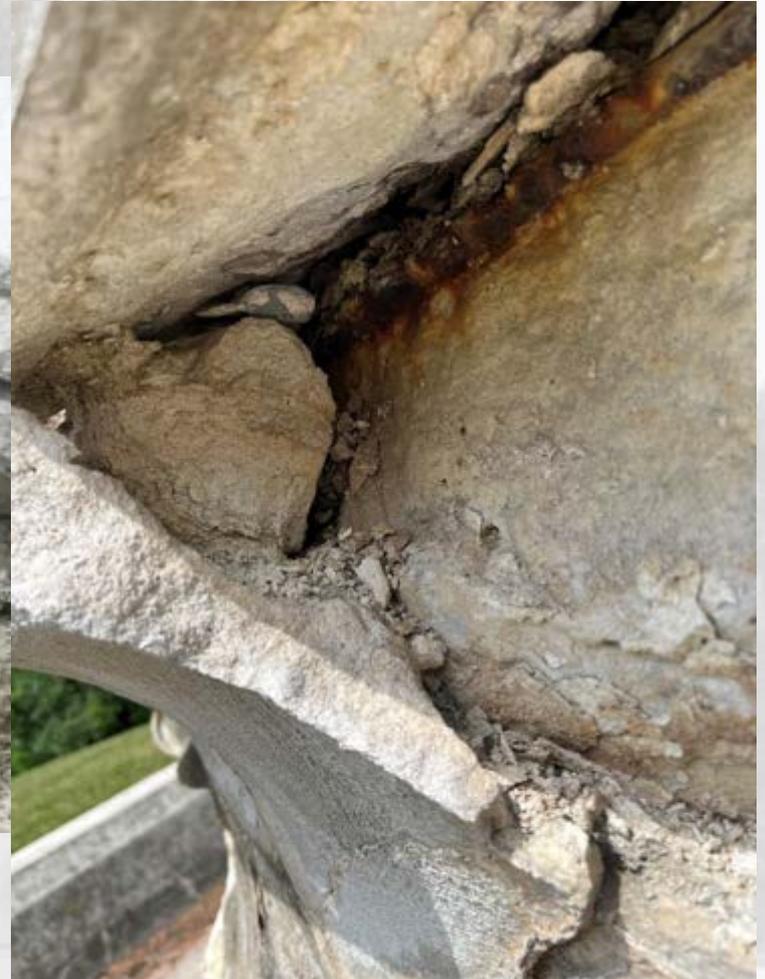
Corrosion of Internal Steel

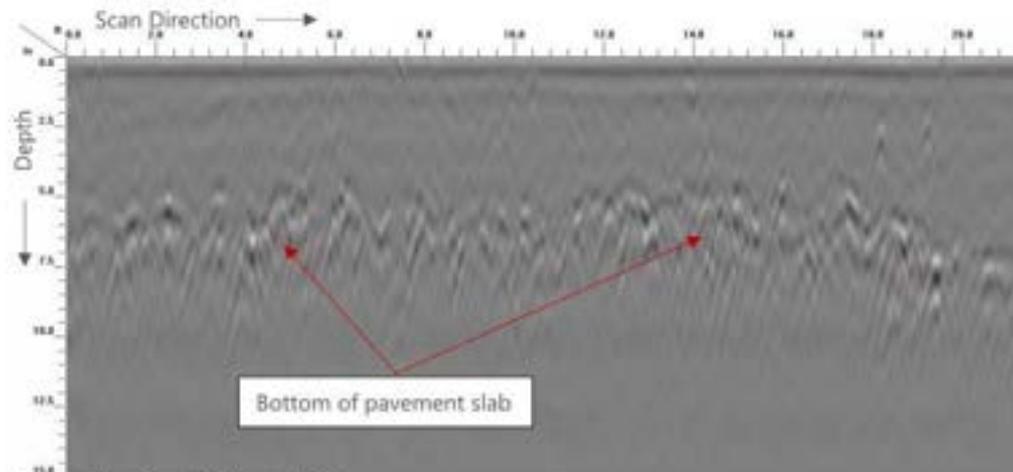
Figure 3. Portion of GPR scan #003

Ground Penetrating Radar of Perimeter
