SPRING HARBOR OUTFALL WALL REPAIR & HARBOR MAINTENANCE DREDGE

OUTFALL WALL REPAIR

HARBOR DREDGING

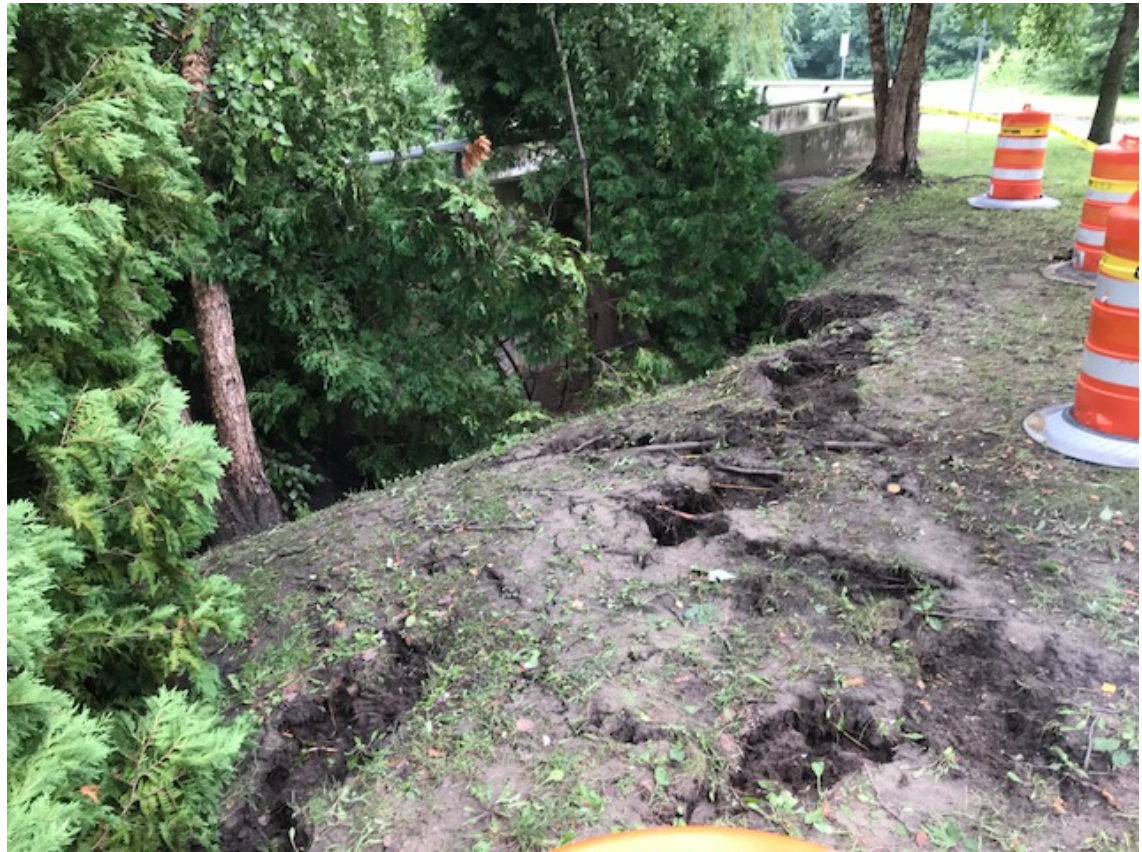
EXISTING CONDCTIONS: WALL

- August 20, 2018 rain damaged backfill and foundation of the existing retaining wall
- Scour beneath the footing resulted in rotational failure of the retaining wall

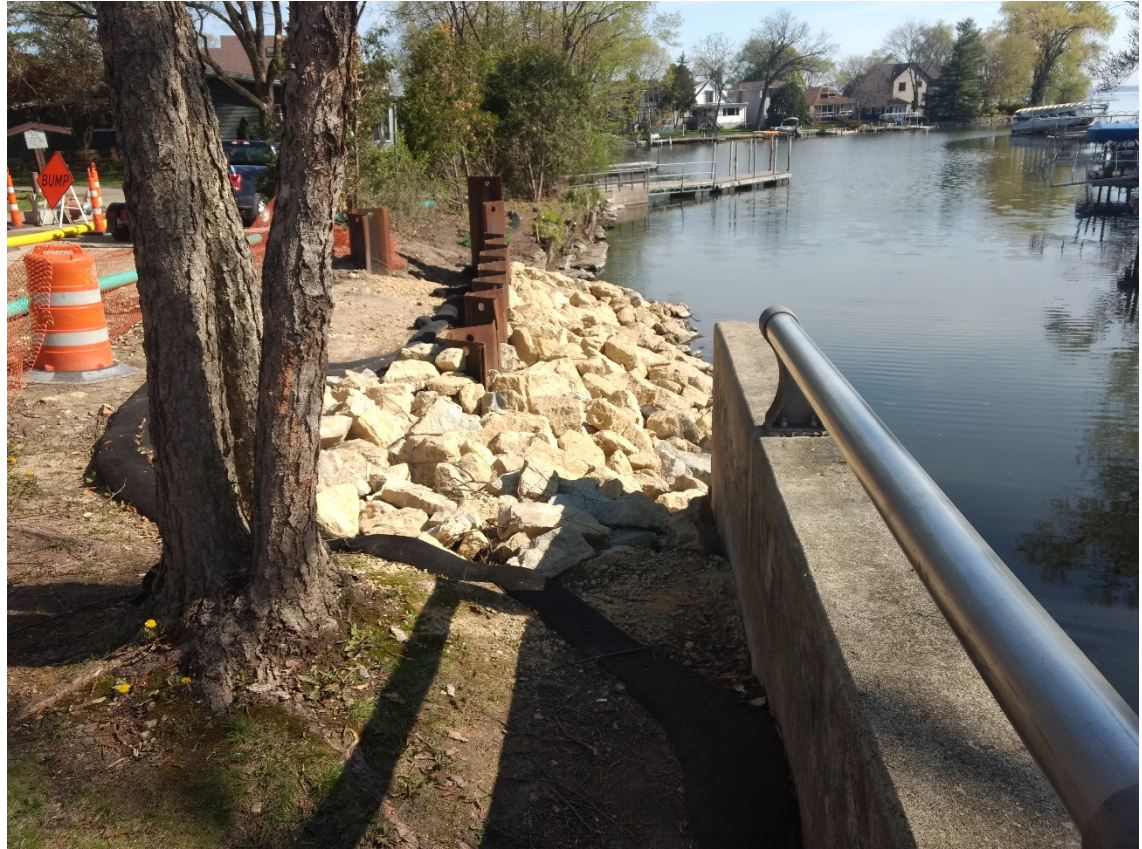
EXISTING CONDCTIONS: WALL

- Damaged wall was removed in fall 2018
- Temporary sheet piling and limestone riprap placed to stabilize the shoreline

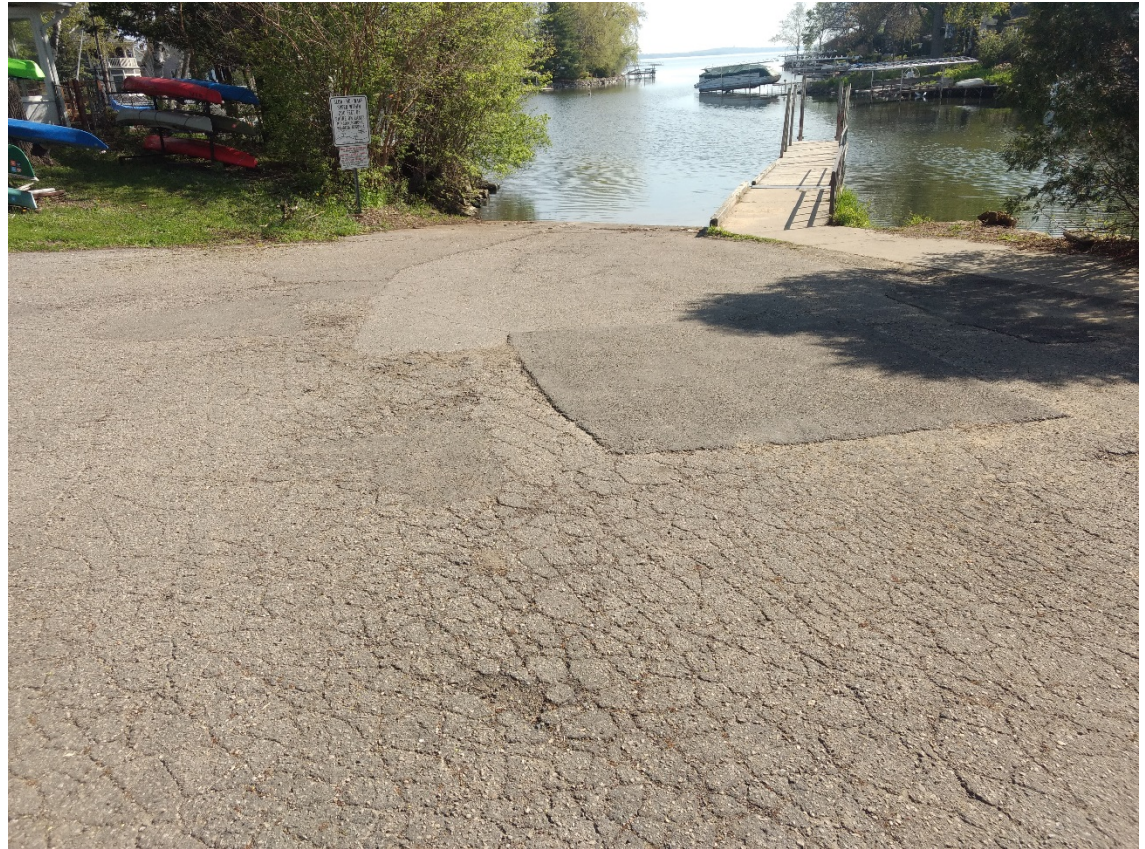
EXISTING CONDTIONS: BOAT LAUNCH

- Unknown age of existing pavement
- Multiple repairs and “alligatored” surface

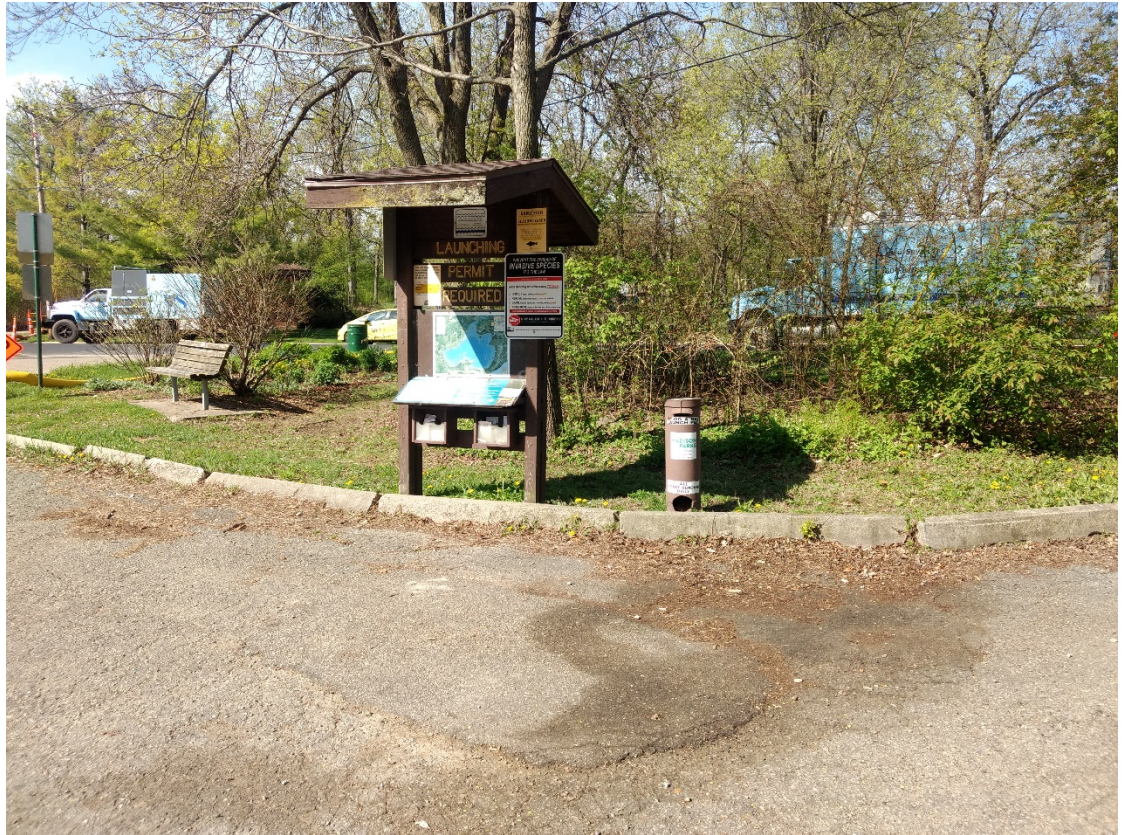
EXISTING CONDTIONS: BOAT LAUNCH

- Existing launch lacks curb and gutter

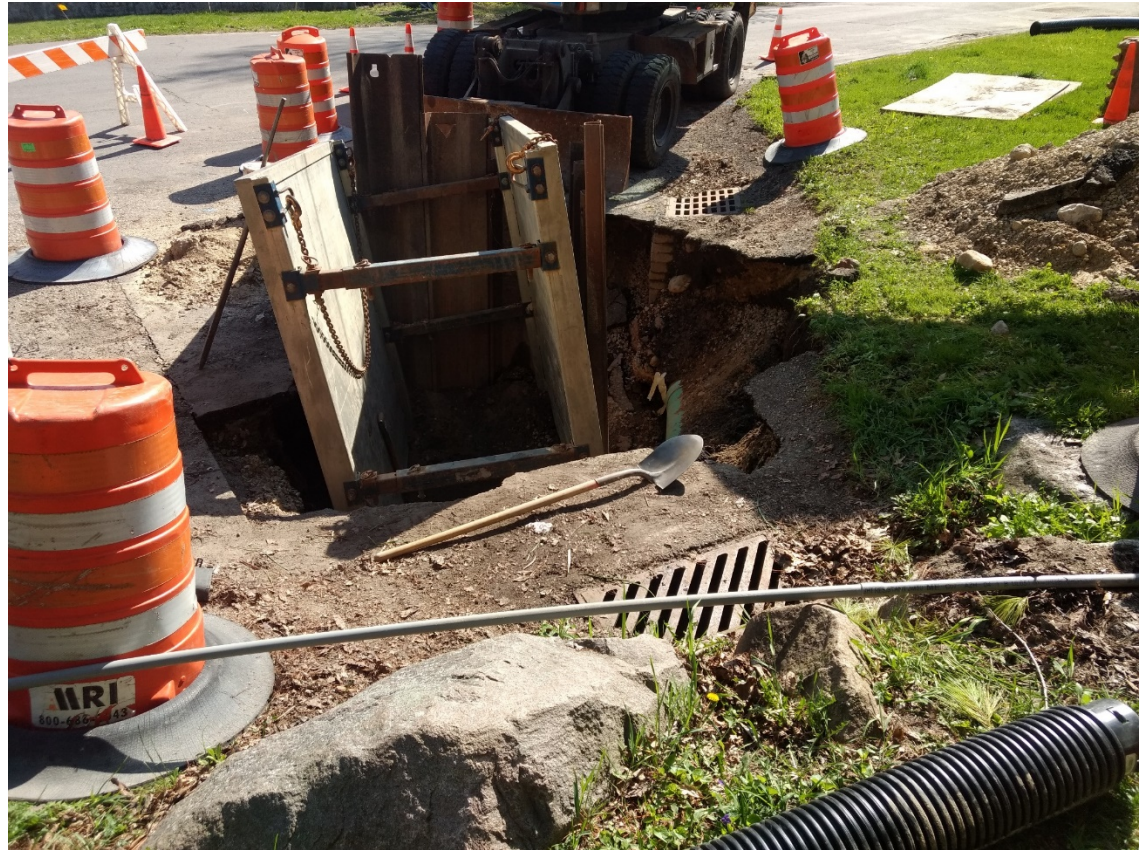
EXISTING CONDITONS: STORM SEWER

- Metal Pipe Installed in 1955 corroded and failed
- Sink hole opened in Lake Mendota Drive

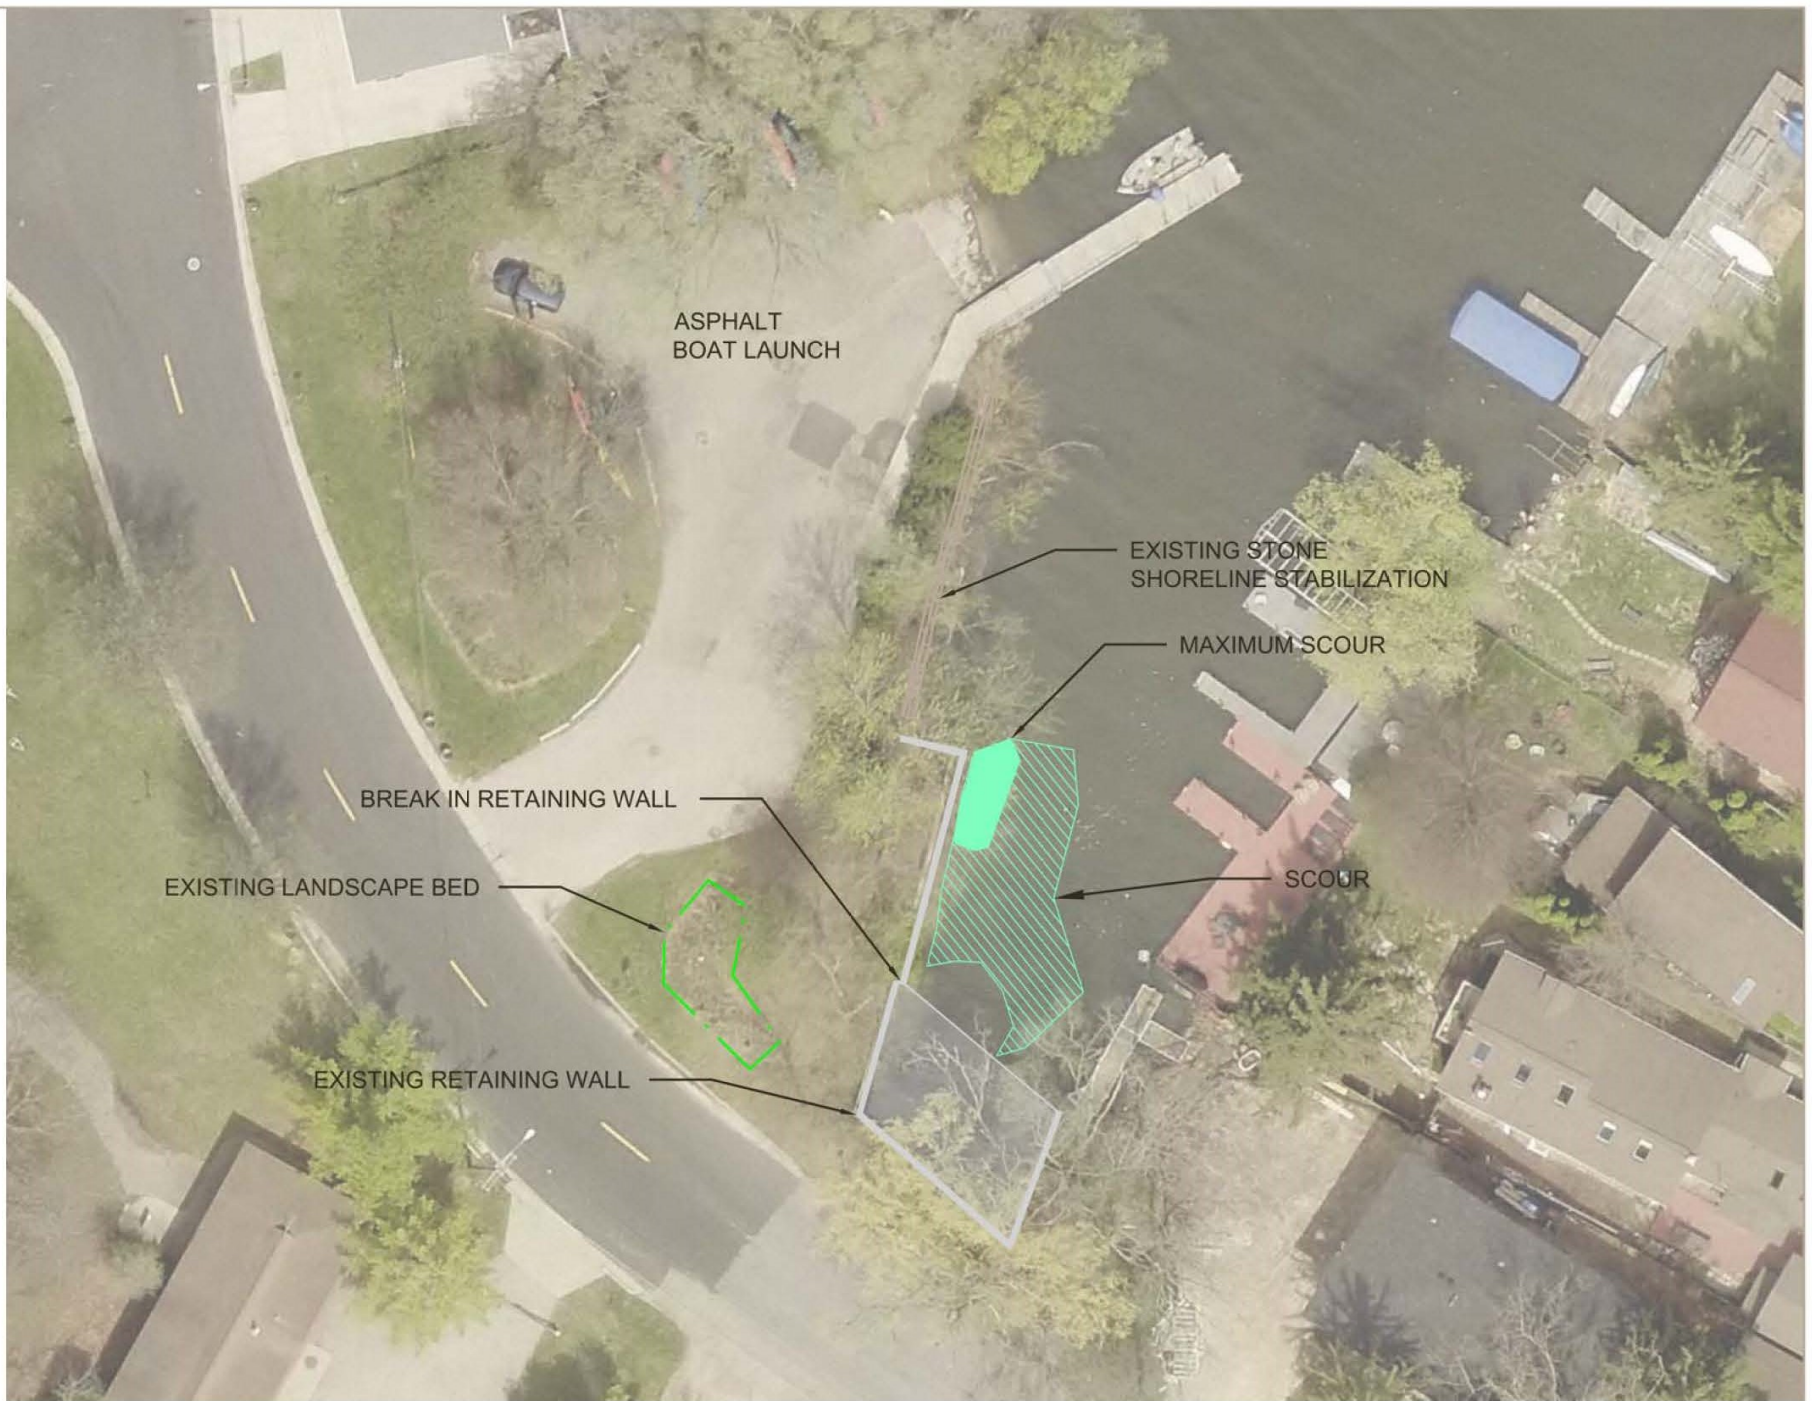
MAXIMUM SCOUR

SCOUR

BREAK IN RETAINING WALL

RETAINING WALL REPAIR

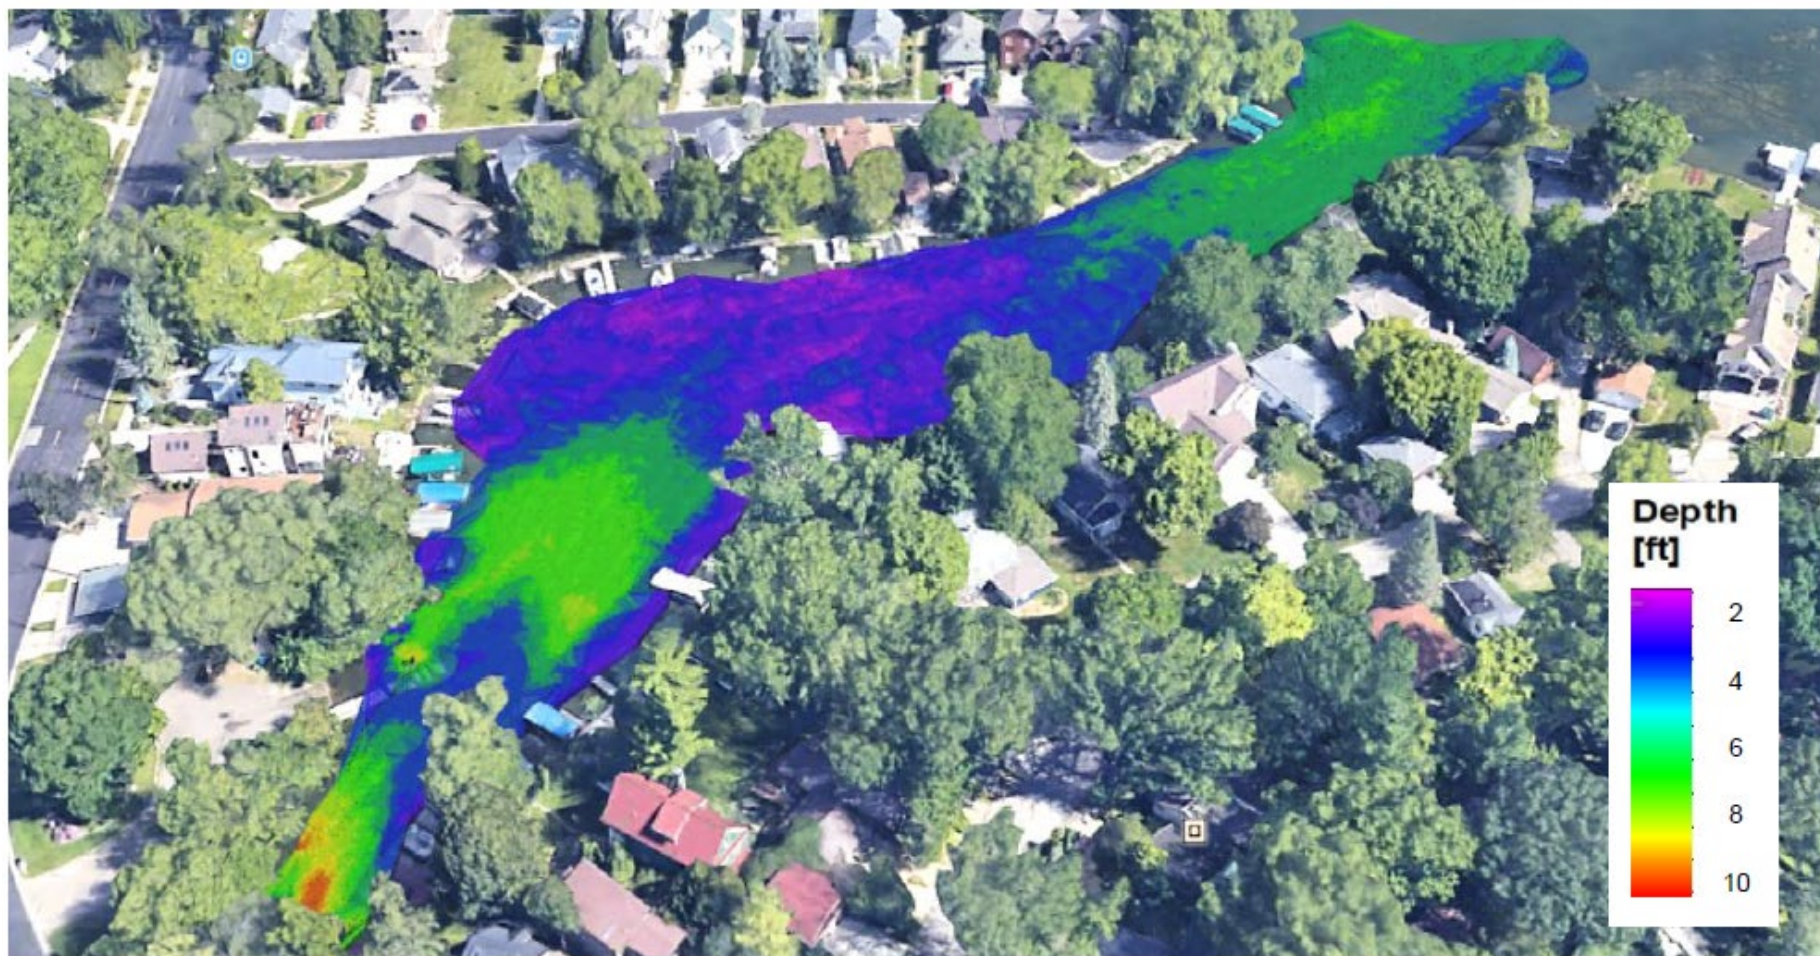
Figure 3. Visualization of the hydrographic survey data collected by FreshWater Engineering on 29 May 2020 in Spring Harbor.

Harbor depth is averaging only 2.5 feet due to accumulating sediment coming in from a major outfall located just east of the boat launch and directly discharges to Spring Harbor. Last dredge performed only near ramp in 2011.

This sediment is impacting recreational use of this boat launch and impacting the general use, water quality and aquatic habitat of the harbor.
