**Breese Stevens Field
Facility Plan**

April 2017

PART I- EXECUTIVE SUMMARY

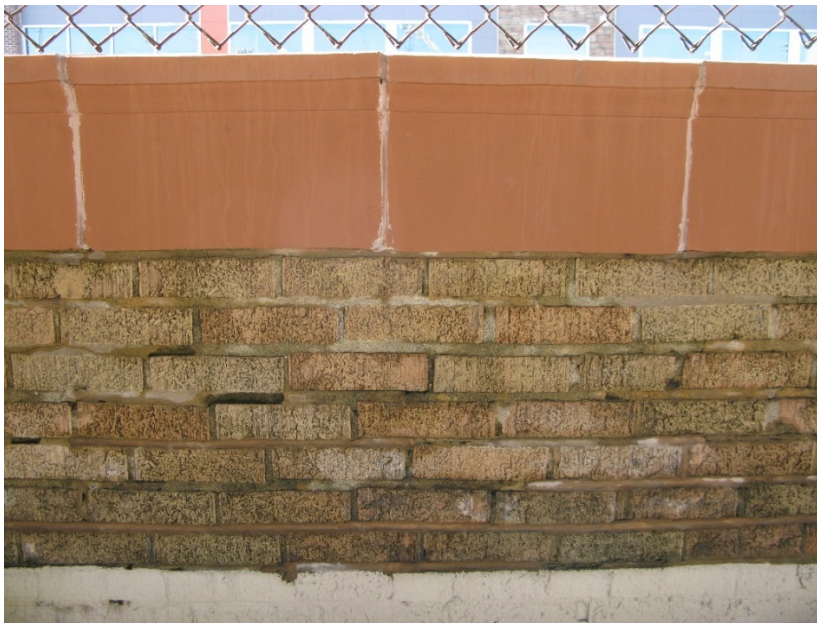
Exterior Wall of 1925 Grandstand

The exterior grandstand perimeter walls are made of brick and terra cotta constructed in 1925 are in fair to poor condition. Wind driven and poorly drained rainwater from the canopy has resulted in continual latent moisture within the masonry walls. Latent moisture has resulted in discoloration of the brick and mortar, crazing and spalling of terra cotta decorative elements. This condition is particularly evident along the top of the walls despite previous repair of joints at terra cotta caps with sealant. It is also evident at the pilasters where terra cotta elements protrude and take on moisture. Roof runoff infiltrates the outer wall due to its unfortunate alignment and lack of a roof gutter or downspouts. Many horizontal masonry components lack proper flashing and/or sealant joints required to adequately prevent water from entering the masonry wall.

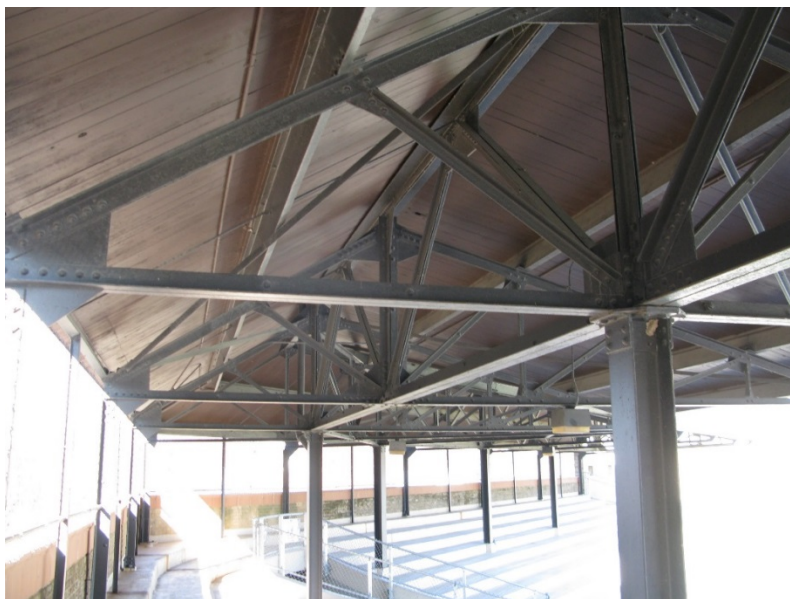
1925 Steel Truss Canopy

The steel truss canopy is in fair condition. The primary area of concern is prevention of further rusting of the steel members at the base connections to the seating deck. Rusting of these members has caused staining to the seating deck. The steel should be cleaned and coated to slow the oxidation and prevent future staining. The roof deck was observed to be in fair condition. A portion of the shingles at the eastern most end of the roof have been blown loose.

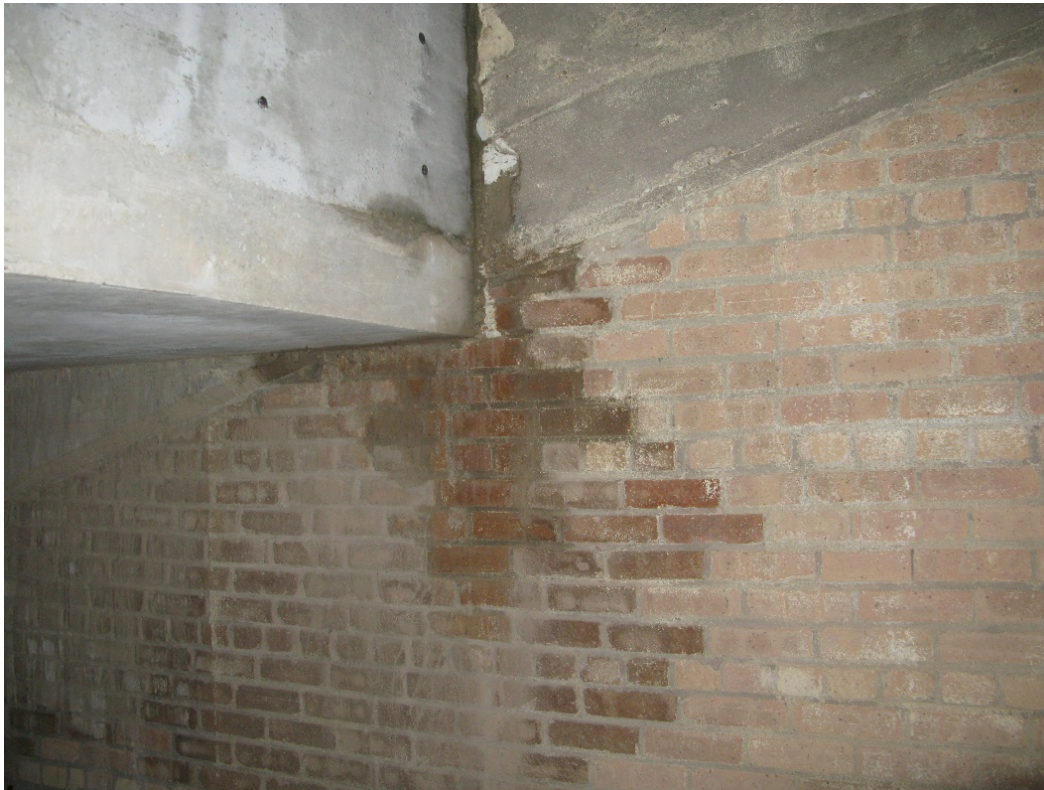
1934 Grandstand Walls

The exterior grandstand walls and all site walls constructed in 1934 were observed to be in fair condition requiring little immediate repairs. The walls facing Mifflin Street receive little to no direct sunlight due to the orientation and proximity to shaded tree cover. It appears that moisture properly drains and does not linger on or in the wall system. Significant area is in need of re-pointing as a matter of cyclical maintenance. Horizontal joints along the tops of site and parapet walls seem to be functional but could be improved through the use of sealant over mortar.

The areas of significant movement within the stone walls appear to have occurred in two locations. Both are large step cracks. One is located directly adjacent to the original light tower located near the northeast gate entrance to the field. The other is in the southwest corner near the large stone facing East Washington Avenue indicating the date of construction and its designation as a Civil Works Administration project.

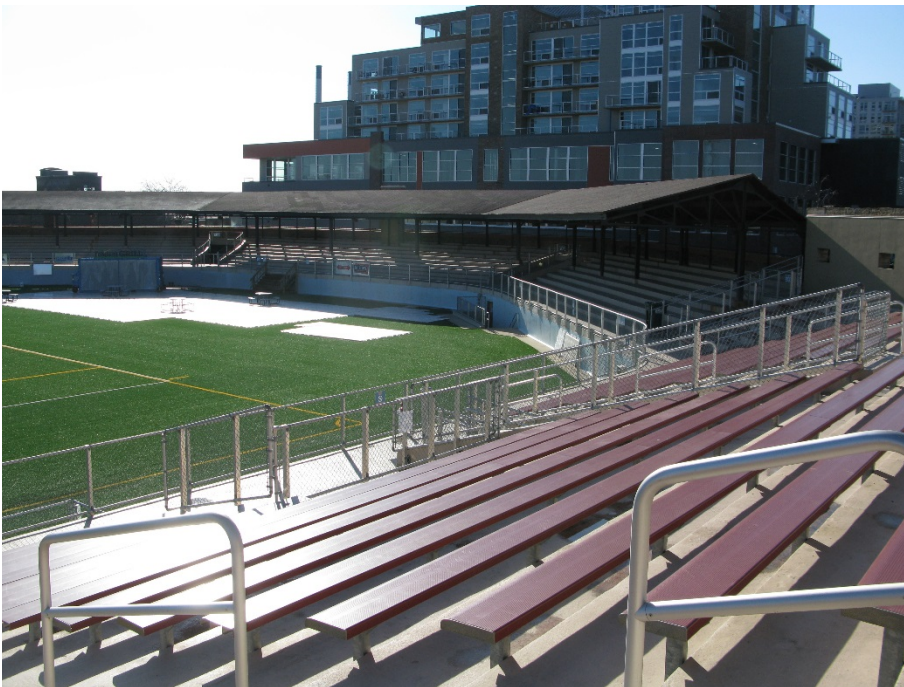
Bench Seating and Guard Rails

The seating deck of both the 1925 and 1934 grandstands is in fair condition. The absorption of moisture after rainfall on the topside of the deck contributes to deterioration of the concrete. The coating applied to the seating deck is failing, particularly at expansion joints, allowing moisture to enter the underside of the grandstands into occupied spaces. On the bottom side of the deck, concrete has spalled off at the edges and left exposed reinforcing bars in various locations.

In 2009, a liquid applied elastomeric waterproof membrane was applied to the deck and stands surface, and the face of the field wall. That installation did not provide for repair and improvement of the movement joints. Also, the detailing or installation of the membrane allowed for large portions of it to release itself from the concrete. Primarily along the 1925 stands and fieldwall, portions of the membrane have buckled and damaged upper levels of concrete that spalled off with the membrane. Further water penetration is noted on the underside regions. It is recommended that the seating deck be covered with an updated waterproof membrane and improvements to the expansion joints. Properly detailed movement joints are recommended for installation in conjunction with the membrane. Concrete repairs to the underside of the deck are recommended.

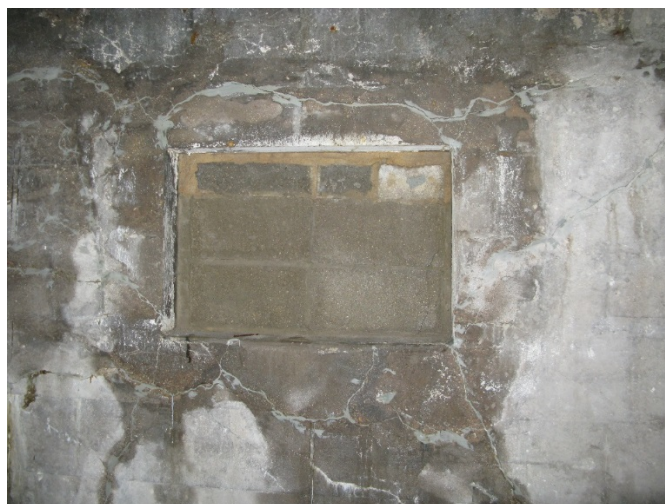
Field Wall at North Dugout

The north dugout, and the space directly inside that dugout, appear to have a couple conditions to make note of. Possibly, as a result of the 2009 report, this dugout has a drain in the bottom floor slab (west dugout does not). The slab appears to have cracked since that install and slopes steadily toward the drain. The field wall waterproof membrane applied in the 2009 repair now has stair step cracking in it, reflecting through from the block wall behind it. The interior wall, closed in window block, and floor in this area are all very damp showing signs of significant water penetration. Settlement of the raker beam for the stands has imposed load on a small wall section not intended for loading causing damage to that interior wall. The cracking and movement in this area would commonly result from a settlement of the foundation. The 2009 report recommended roofing and drainage to remove storm water from this area, so the issues seen here may have begun long ago, however, since the repairs and drain were added in 2009, the waterproof membrane has cracked, indicating that movement has occurred since 2009. Further investigation should try to determine the source of the water (leaking water or sewer lines, ground water, etc) before making any further repairs.

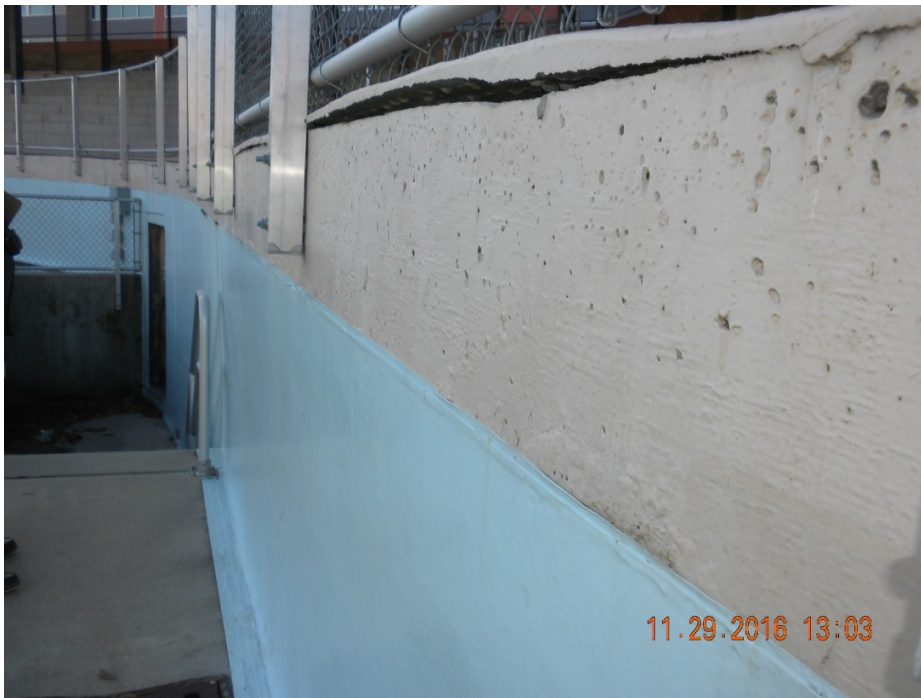
Repairs completed in 2009 included an overlay to provide positive drainage off the runners, and a membrane to prevent water penetration. Unfortunately, the materials and installation did not provide for movement of the joints and materials that this application would require. The deterioration of the membrane has also delaminated the overlay, primarily along the walkway/runner and field wall interface. We recommend that the repairs or replacement to the membrane includes corrections to the expansion joints. They should be cut wider to provide for more movement and the proper installation of an expansion joint designed for exterior uses.

Showing Delamination of the overlay from the 1929 base concrete

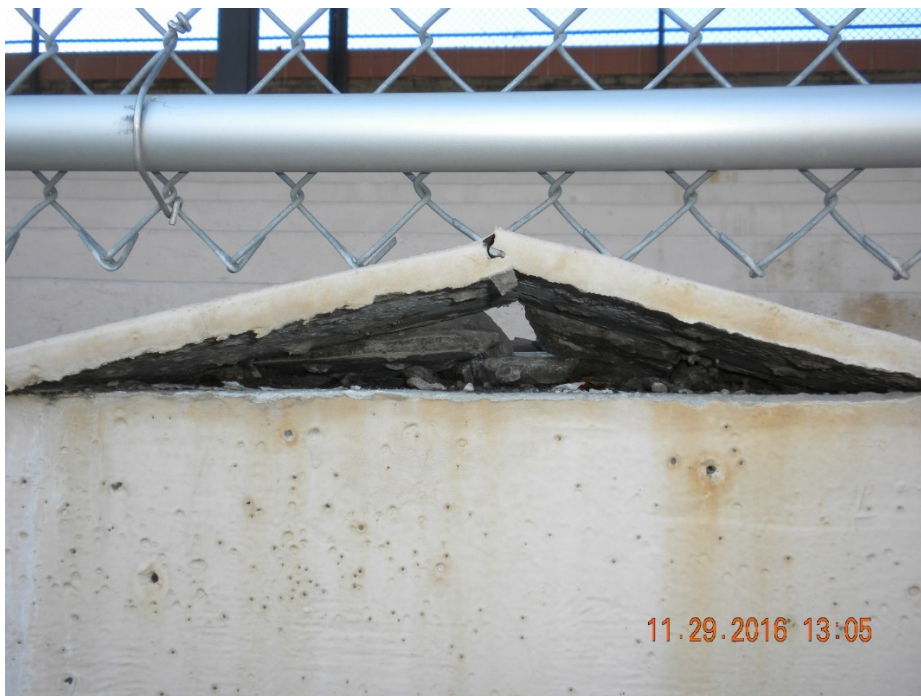
Delamination caused by moisture trapped under the walking surface membrane

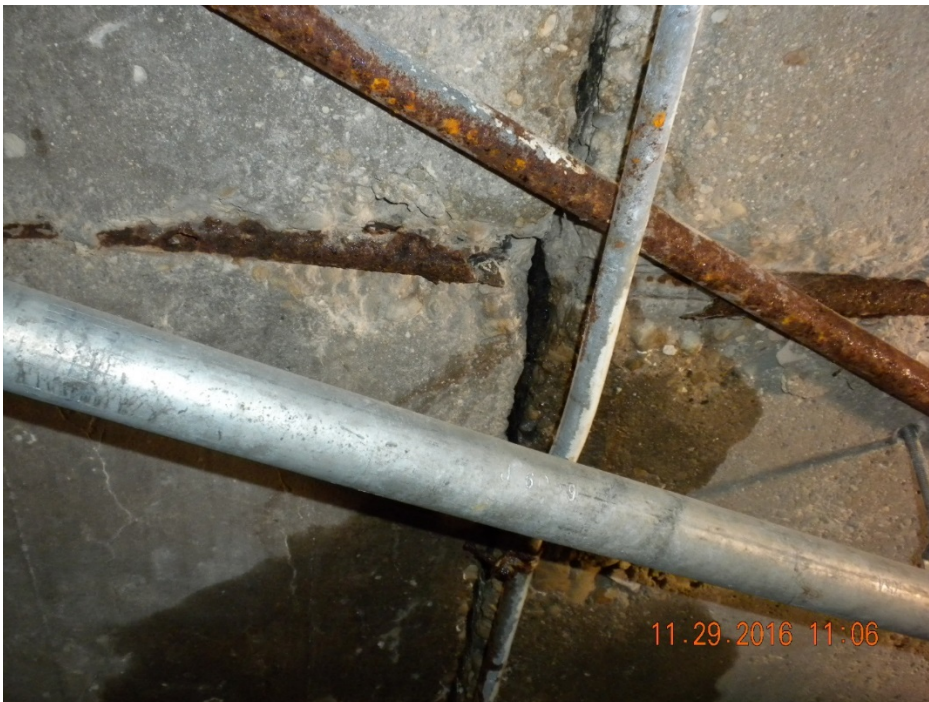
Water getting through the membrane at construction joint, causing damage to reinforcing steel and utility conduits.

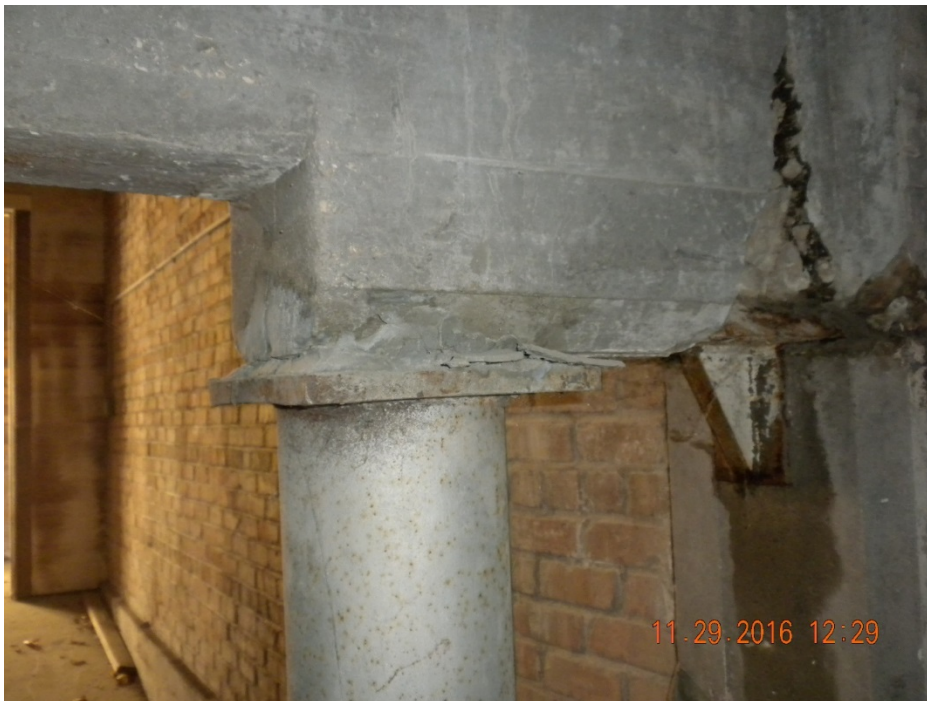
Previous damage to bearing end of concrete beam. Since supported.
Support is adequate and in good condition.

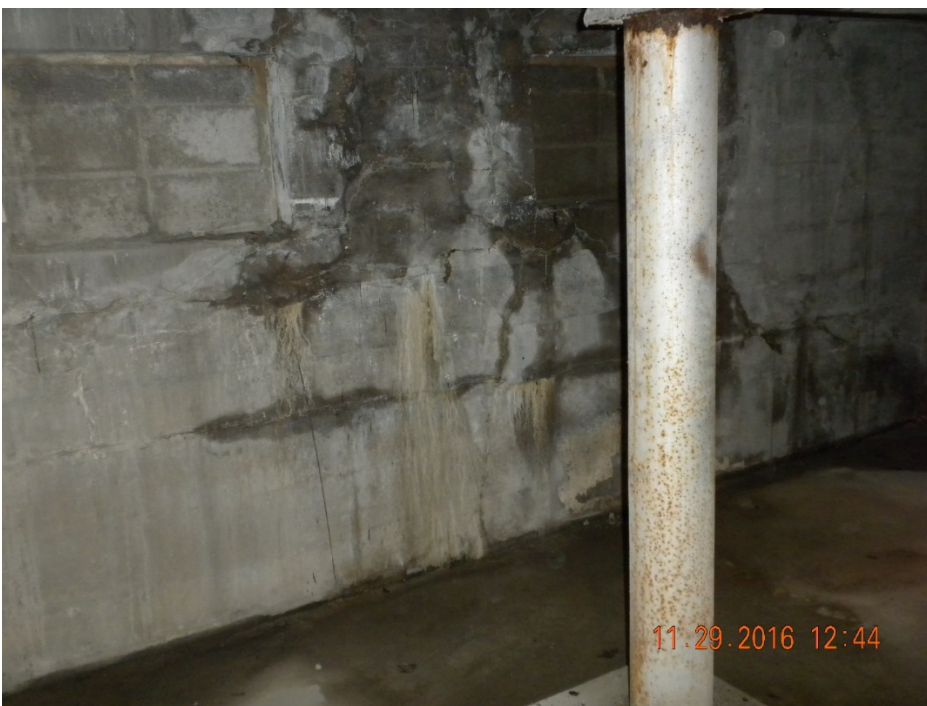
Moisture inside wall at North Dugout. Cracking in exterior wall membrane indicates
this area is moving and is required to be stabilized once settlement cause is determined.
