## Structural Conditions

## KJWW Draft Condition Assessment Report

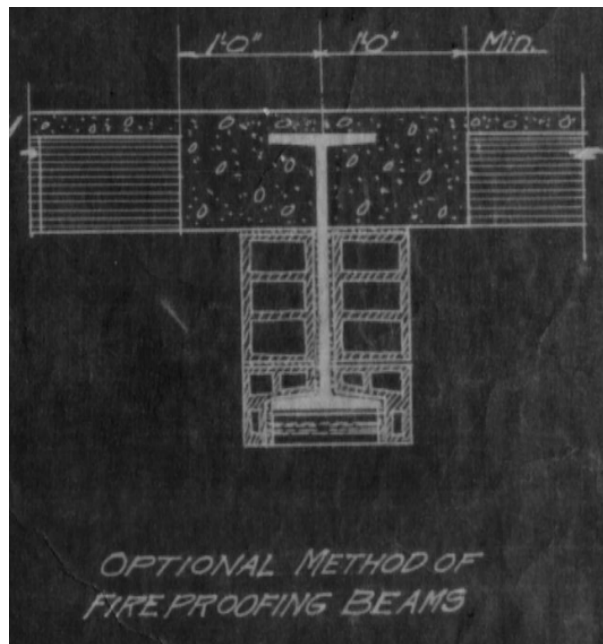
The existing drawings note that the concrete around the steel framing is for fireproofing. An alternate fireproofing detail is shown, using clay tile block, which indicates the steel and concrete were likely not designed to work together as a composite section.

Alternate Fire Proofing Detail from Existing Drawings

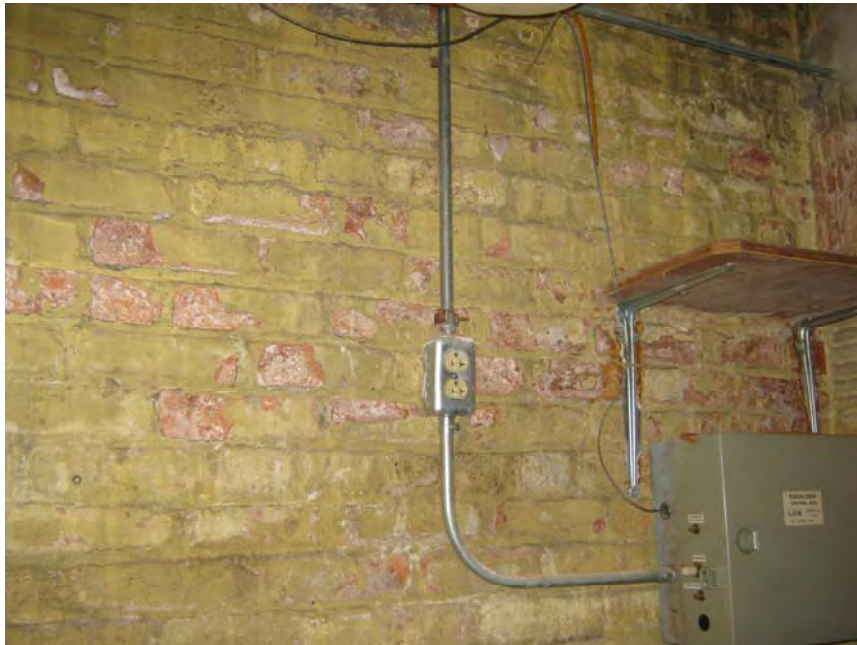
Where visible, the exterior basement walls appear to be multi-wythe brick walls. At the water service room in the west corner of the building, there is evidence of water damage to the existing brick. The paint is delaminating and portions of the brick faces have popped off.

**Existing Brick Basement Wall Water Damage**
