City of Madison

**Madison Municipal
Building
Conceptual
Schematic
Design Study**

November 2013

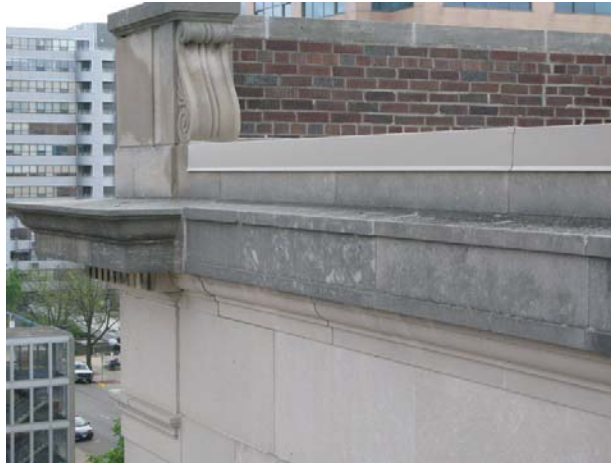
Brick is located on what is considered the rear of the building. Water infiltration at the parapet level within this “U” shape area is apparent. Moisture affecting the side walls is coming from deteriorated joints in the metal coping cap and/or flashing, not from the roof because these walls are on the high end of the roof slope located behind. The back wall parapet is showing signs of moisture infiltration that could be caused by deteriorated joints in the metal coping, flashing and from direct assault from the draining roof. The infiltration is at its worst where the metal coping meets the decorative stone scroll on both side walls.

Figure 21 – Darkening of the Stone below the Metal Coping indicates Water Saturation

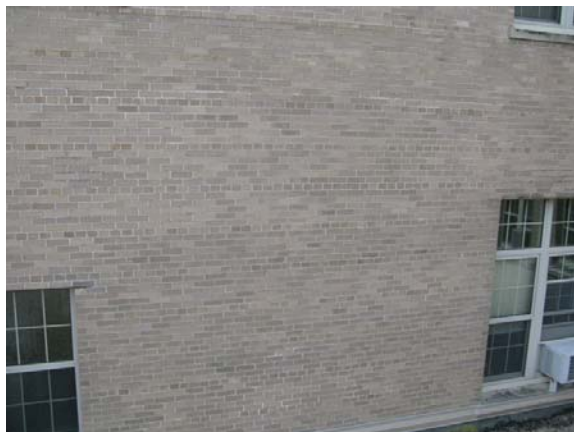
If steel in a masonry wall is not properly flashed, (water diverted away) overtime water will erode the protective surface and rust will start to occur. Left unchecked, the steel will expand in layers and surprisingly the separation of these layers has enough power to move the surrounding masonry. This phenomenon is called rust jacking. It appears that rust jacking is starting to occur at the steel relief angles used in the side walls. Deterioration of the brick faces, discoloration of the brick and slight bulging of the brick indicate movement is occurring. Rust jacking at the window opening steel lintels is more apparent because the supporting brick at the jambs are cracking and the sealant used to protect the steel at its bearing points is separating.

Figure 22 – Discoloration and Shifting of Brick indicates Rusting is occurring at the Hidden Relief Angles

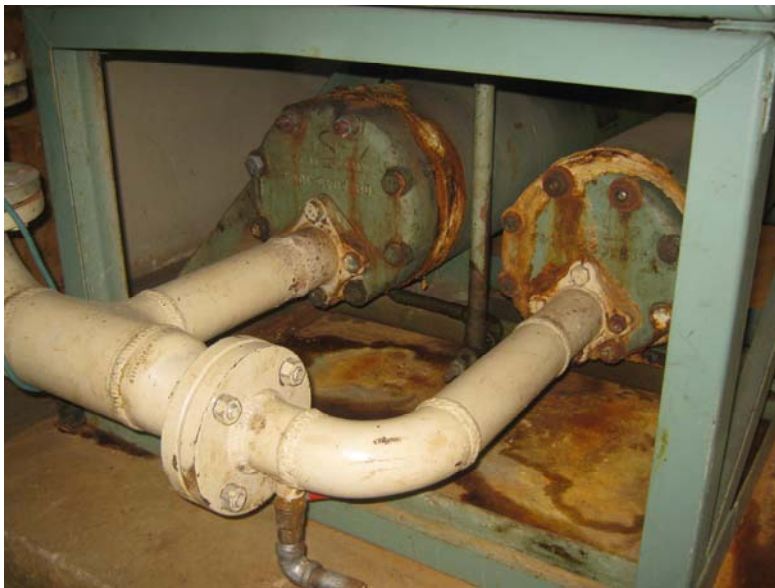
The chilled water system consist of one centrifugal water-cooled chiller (CH-1) located in the mechanical room. There is also a heat reclaim chiller (CH-2), which rejects heat from the chilled water system to a 10,000 gallon hot water storage tank located in the same lower level mechanical room. Both chillers were installed during the 1979 renovation, and are nearing the end of their usable life.

Figure 30 – Rust and Age Degradation on Heat Reclaim Chiller

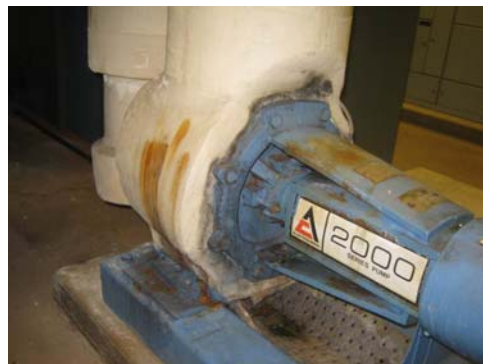
In the lower level mechanical room, there are a heating water primary and secondary pumps, chilled water primary and secondary pumps, and condenser water pumps. All pumps were installed during the 1979 renovation and are nearing the end of their usable life. Below is an example of the typical rust and water damage that is present on many of the pumps. The pumps require additional regular maintenance including seal replacement, bearing replacement, etc. due to their age.

Figure 33 – Rust on Pump Header

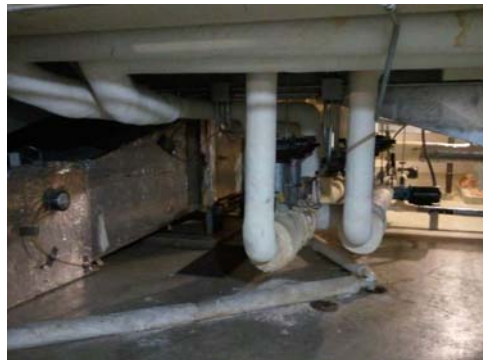
Ventilation air is provided to lower level and first floor through a 100% outside air unit located in a crawl space on first floor. The ventilation unit is currently very difficult to provide maintenance because of the limit dimensions of the crawl space.

Figure 38 – Ventilation Air Unit for Lower Level and First Floor

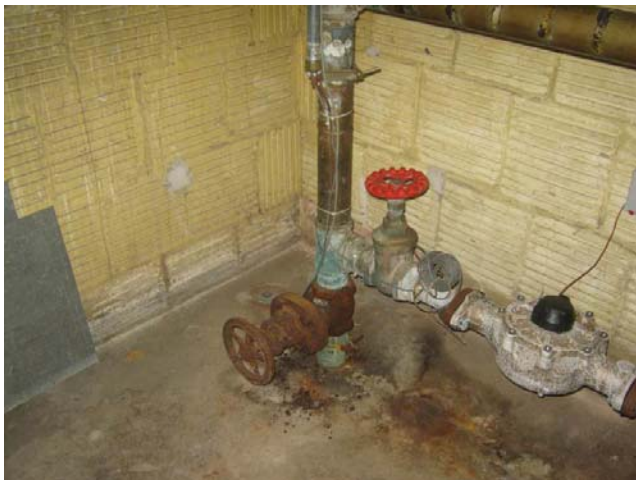
A 3” combination domestic water and fire protection service provides water to the building for the plumbing system. The 3” fire service splits off upstream of the water meter and feeds the remainder of the building; see fire protection system description below for details. Within the water entry room the domestic water system is metered and a building isolation valve is installed. The combined plumbing and fire protection service also shows significant rust and water damage within the water entry room.

Figure 39 – Incoming Combined Plumbing and Fire Protection Service

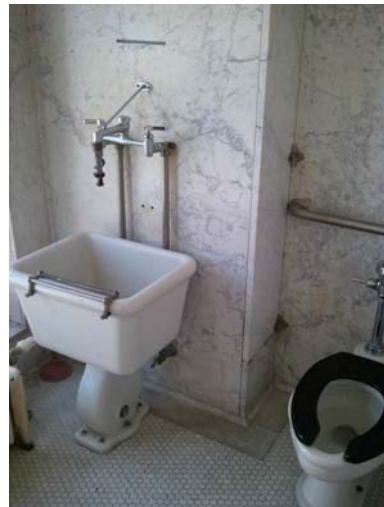
The existing plumbing distribution system consists of steel and copper piping for domestic water and cast iron and galvanized piping for sanitary and vent. Most of the piping is original to the building, and with the exception of some leaking shutoff valves, the system is reported to be in good working condition. There are various vintages of plumbing fixtures installed throughout the building. Many of the plumbing fixtures are antiquated, and some have been abandoned in place due to infrequent use. The current fixtures do not meet current EPA regulations for water flow requirements.

Figure 42 – Antiquated Plumbing Fixtures

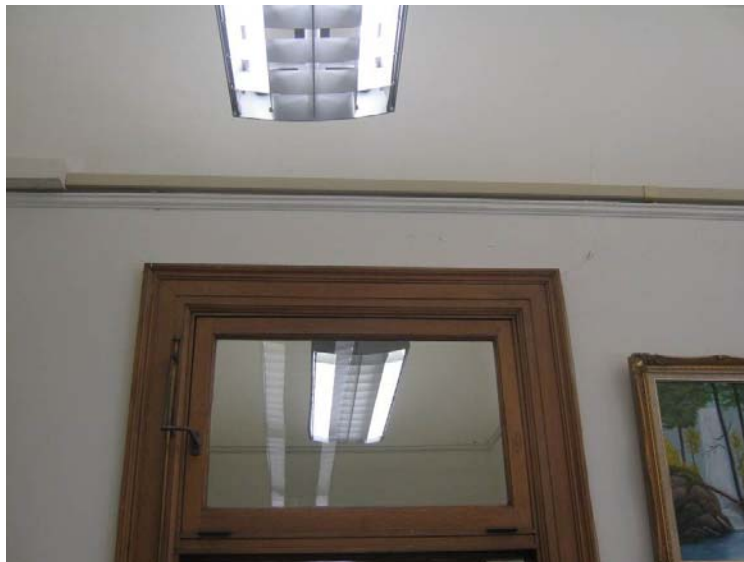
Figure 57 – Plaster Cracking at Corners of Third Floor Door

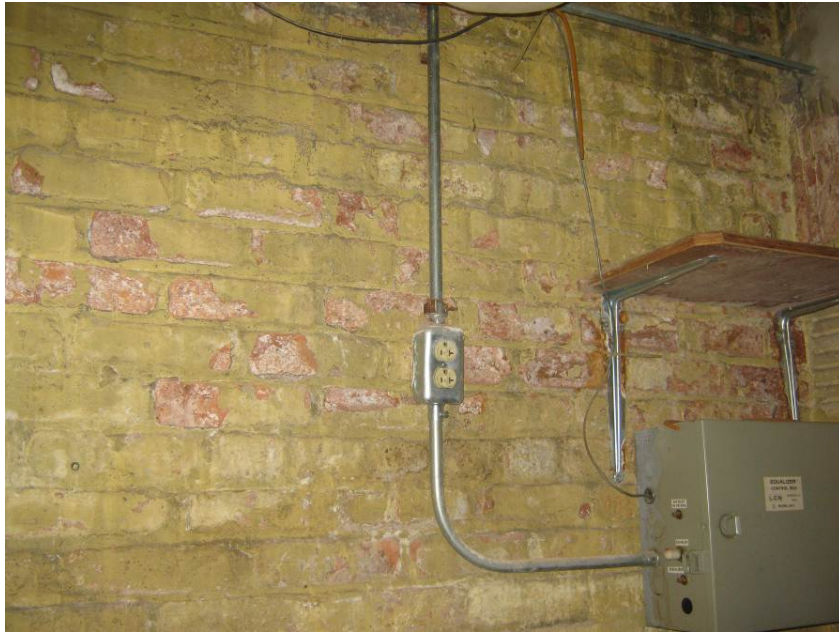
Figure 58 – Existing Brick Basement Wall Water Damage
