## Building Inspection Division

**DATE:** February 23, 2015  
**TO:** Plan Commission  
**FROM:** Matt Tucker, Zoning Administrator

**SUBJECT:** Request for PD Alteration, 520-524 E. Johnson Street

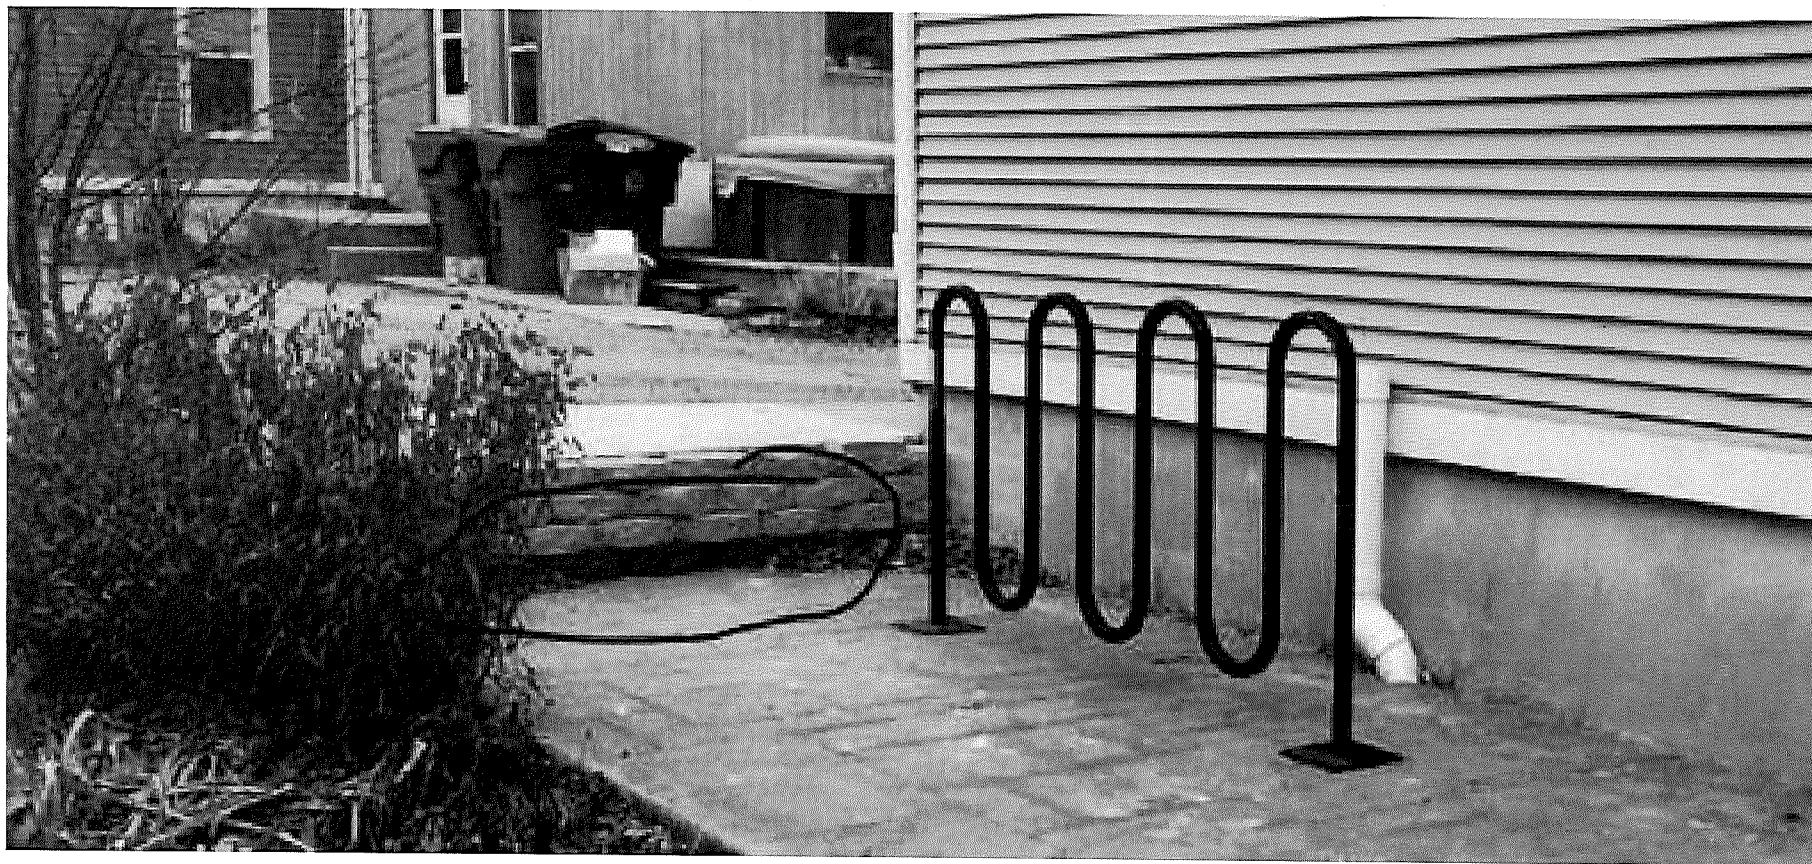
The bike parking access issue could be fixed if one added a step/steps in the retaining wall, so a person need not climb such a rise with a bike to get to the path leading to Blair Street.

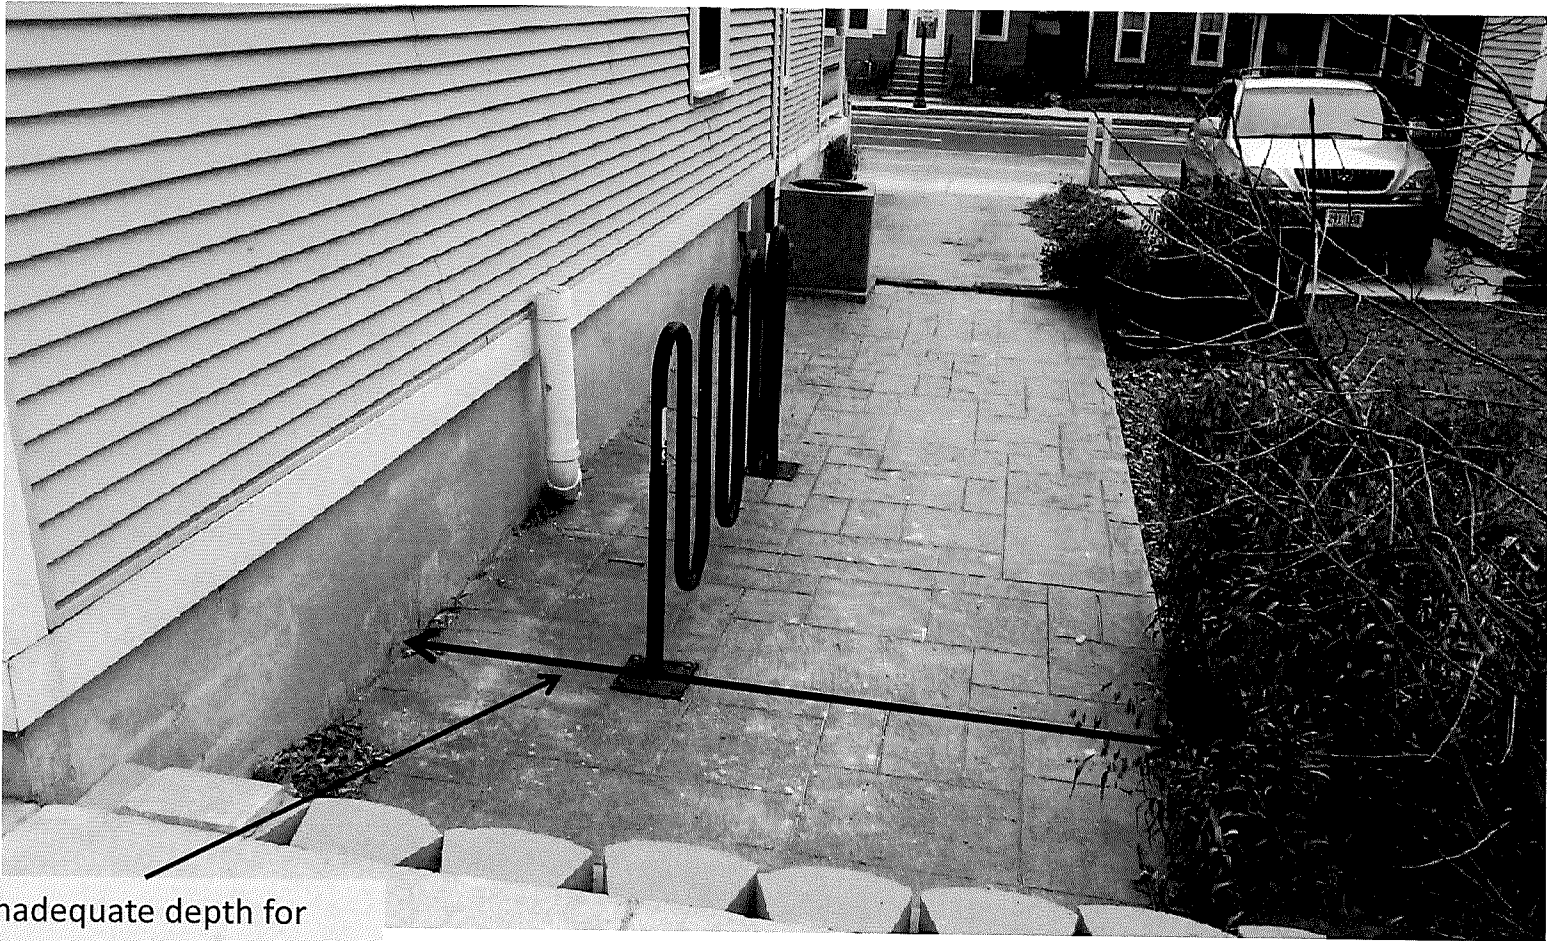
Inadequate depth for parking and access, need 11', provide about 6'-7'

We also need a detail of the rack, to be sure it meets code and a re-orientation of the rack/bike parking stall. This configuration does not appear to hold bicycles correctly in their spaces, and affords little or no access around parked bikes in the rack. Rotating a rack and/or having a different rack design would accommodate the required bike parking

- Re-orient bike parking in this area to a compliant configuration that maintains the required access.
- Install a course of block at the front of the retaining wall to create a “step” that one may use to carry their bicycle between the driveway and the bike parking area.
- Provide a detail of the bike rack, showing the rack in compliance with Zoning Ordinance requirements.

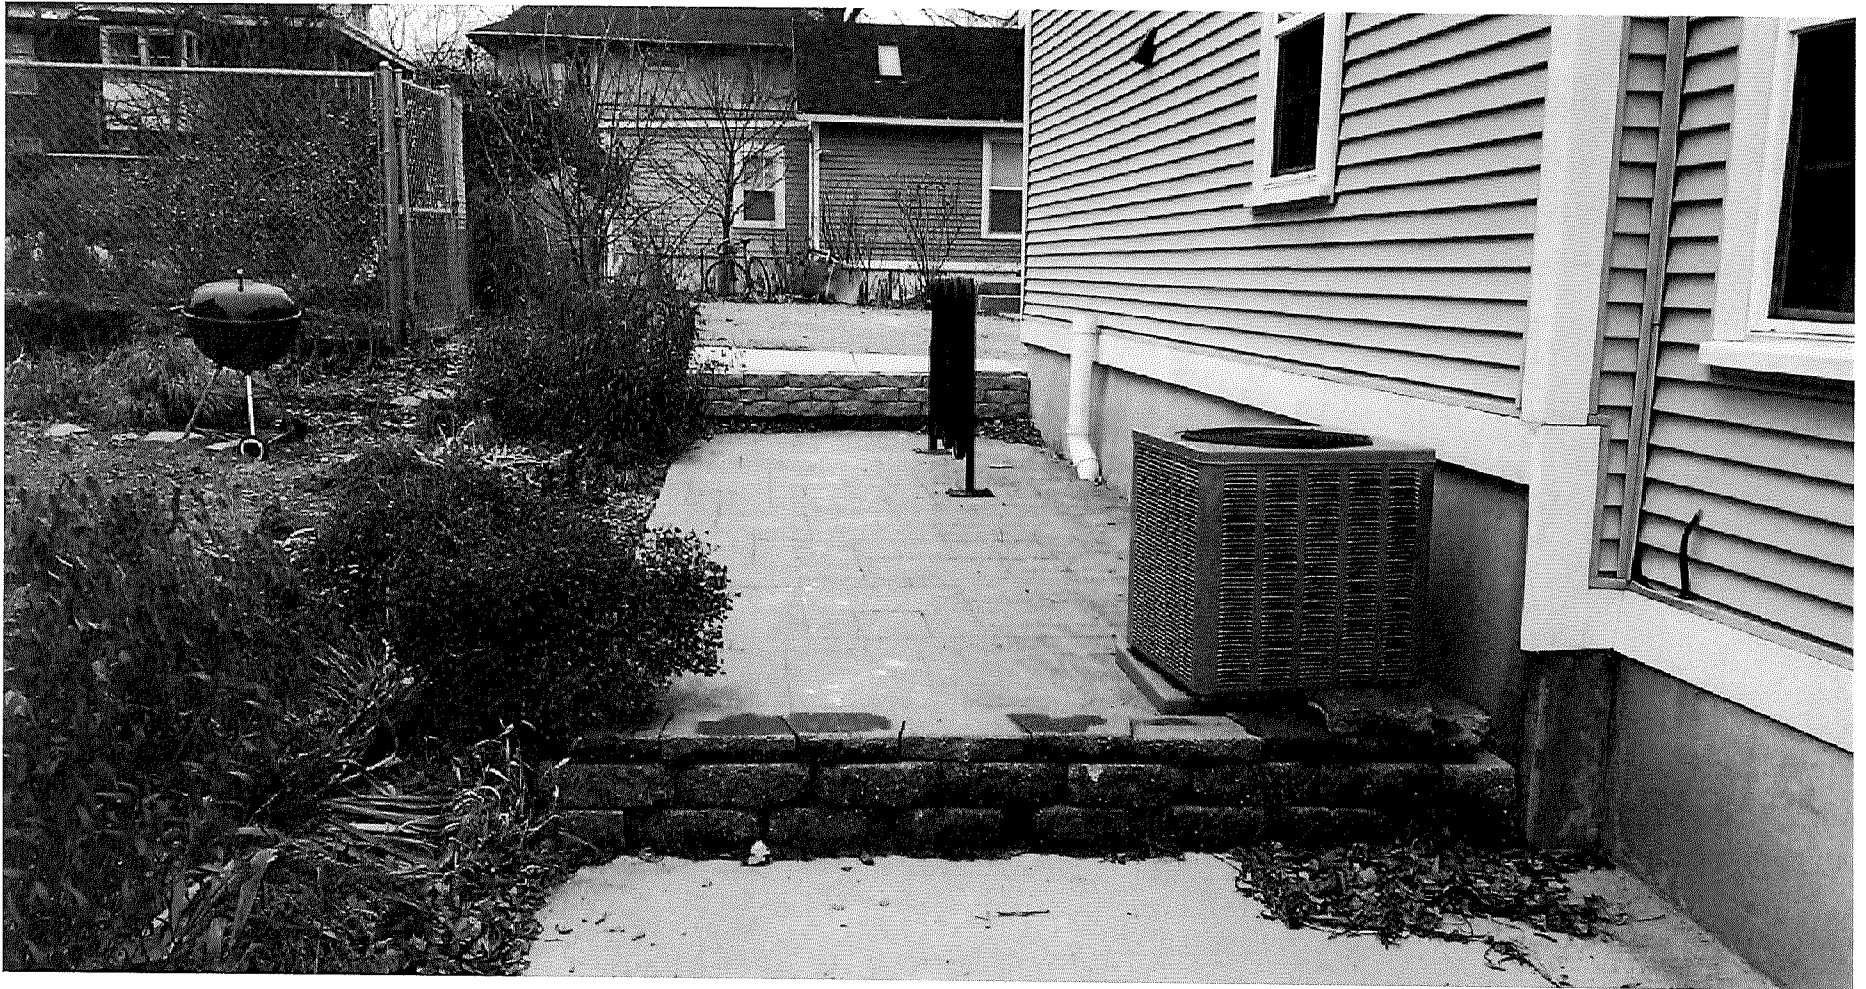
View from parked car space off E.  
Johnson Street looking toward driveway

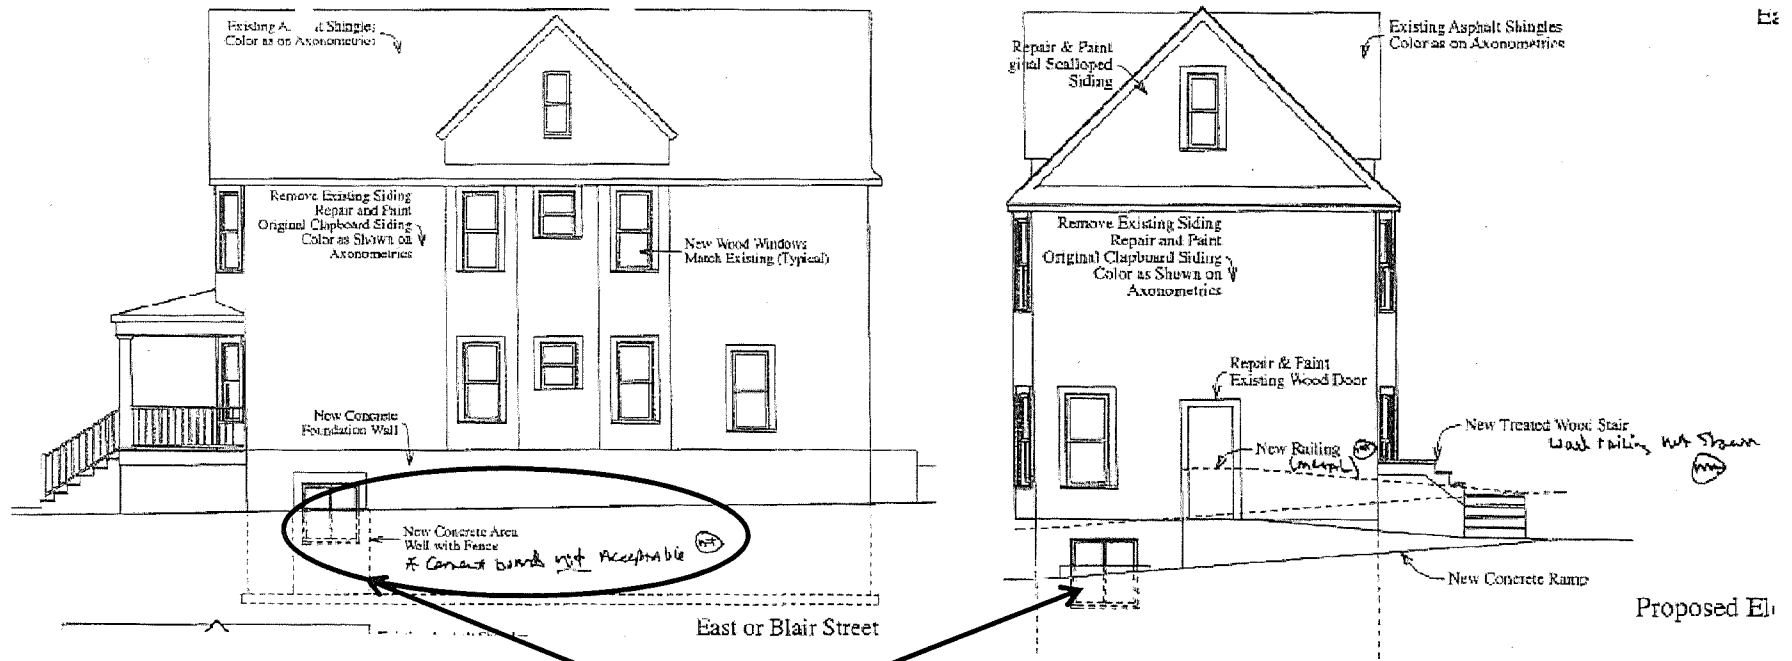
# Approved plans for window well installation

Unacceptable window wells installed here

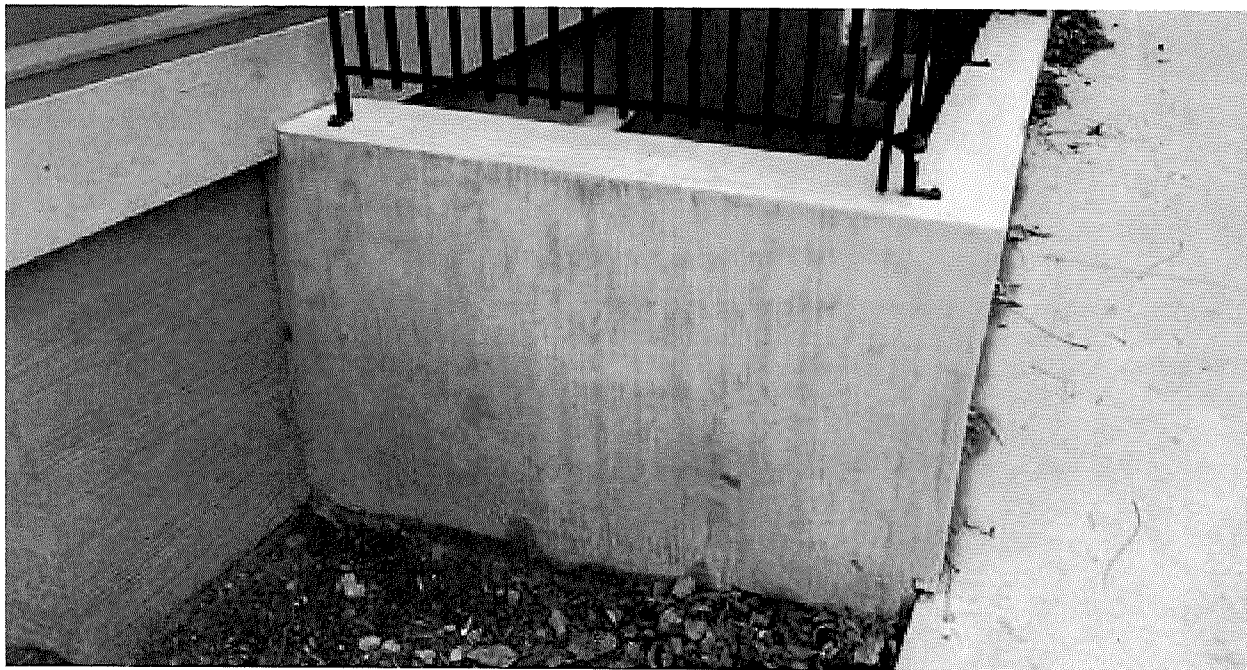
Here is the window well at the rear (driveway):

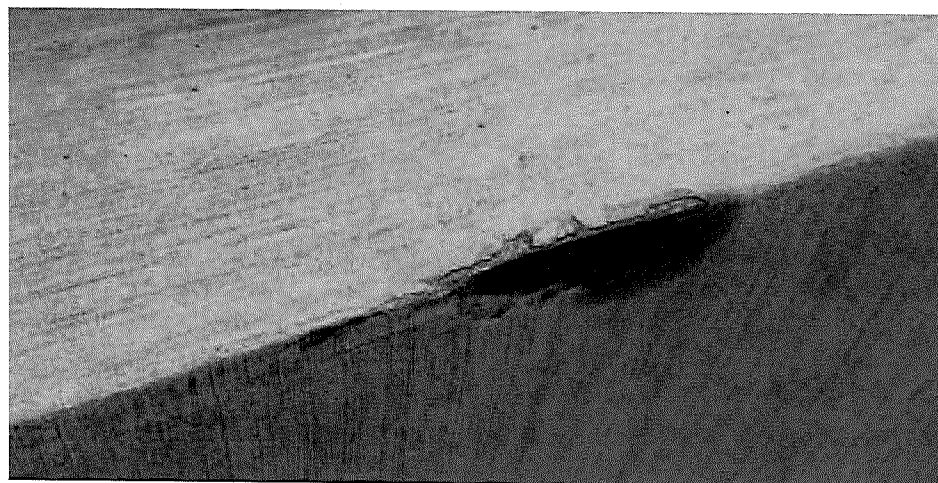
Here is a close-up of some existing damage, appear to be oxidizing/rusting and showing early sign of failure:

- Reconstruct the window wells of masonry/concrete or another acceptable durable material.

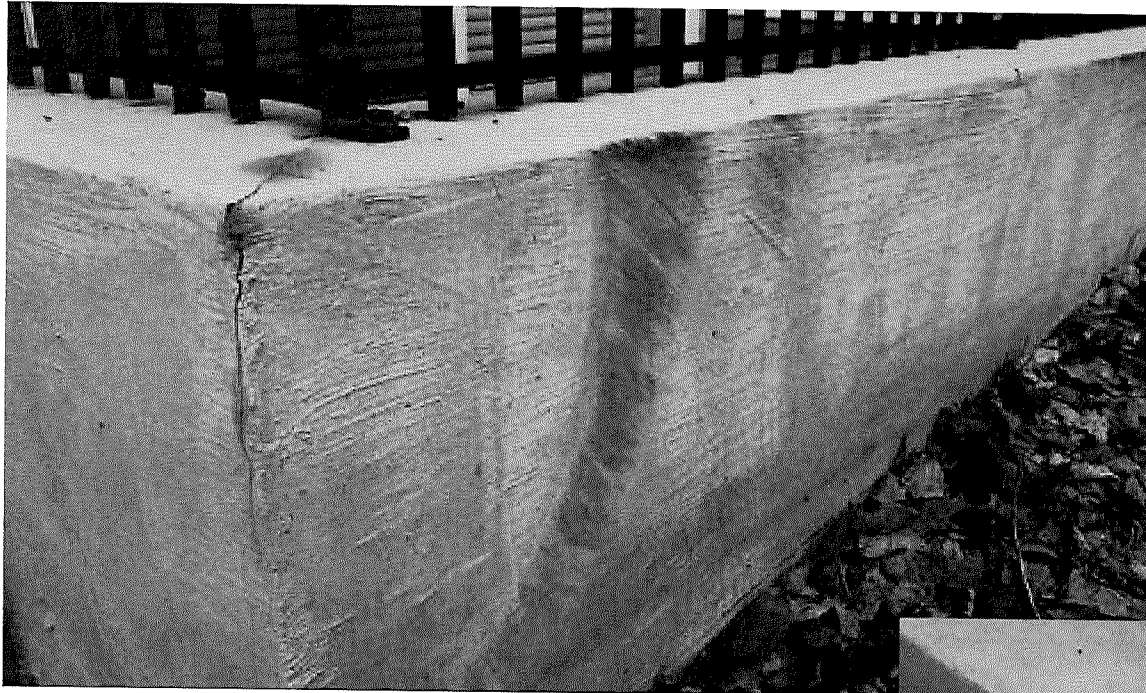
Here is the well by the sidewalk of N. Blair St., it already has a few marks where something hit it.

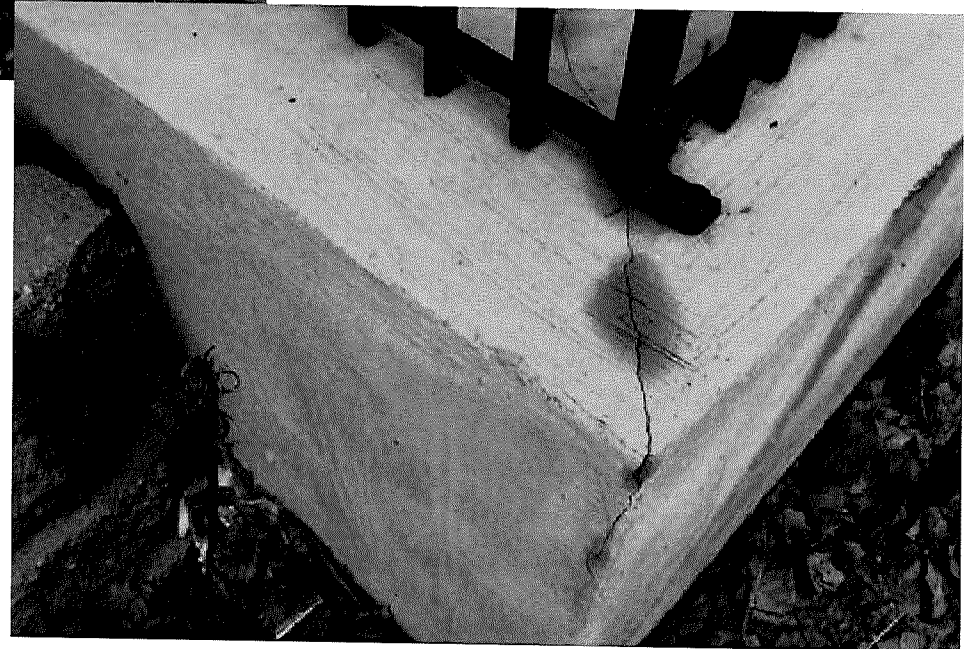
Here is a close-up of a crack that has developed on top, runs from front-to-rear, dark spots show moisture penetrating the structure. This shows failure, which is why we did not allow these installed in this location, this way. Concrete or masonry would have been acceptable.
