EXISTING BUILDING REVIEW

125 State Street

Name: Madison Fire Engine House No. 2/ Castle & Doyle Building

125 State Street – Architectural Review

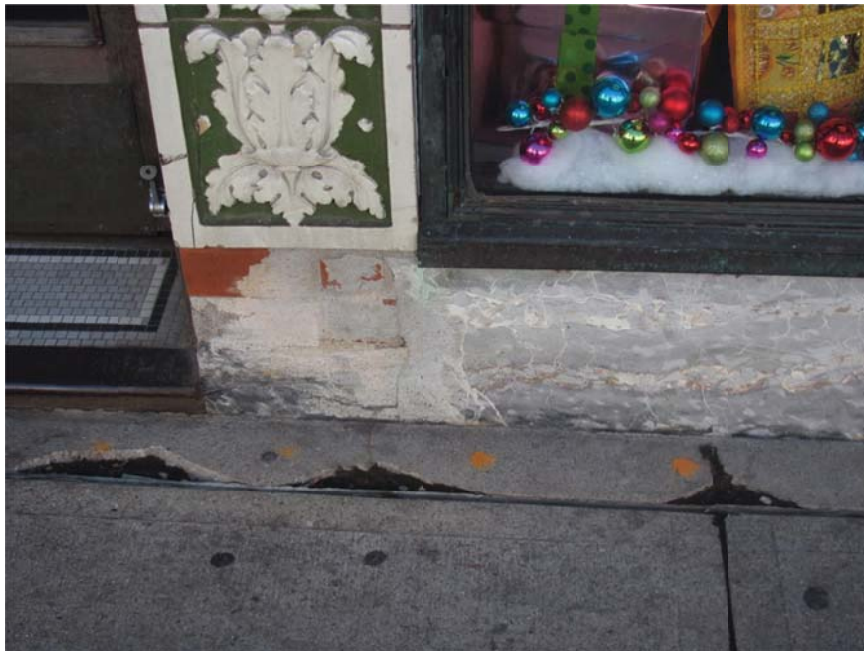
Figure 2. Marbleized cast stone and brick masonry at the base of the State Street facade.

Appropriate repairs to the terra cotta State Street facade may include repair of individual damaged units; re-setting of coping units, perhaps to include a through-wall flashing integrated with the roof membrane and counterflashing; and repointing of mortar joints. At grade, a new masonry veneer may be desirable to

replace the existing mixture of common brick and faux marble cladding with a material more compatible with the historic 1921 design of the facade.

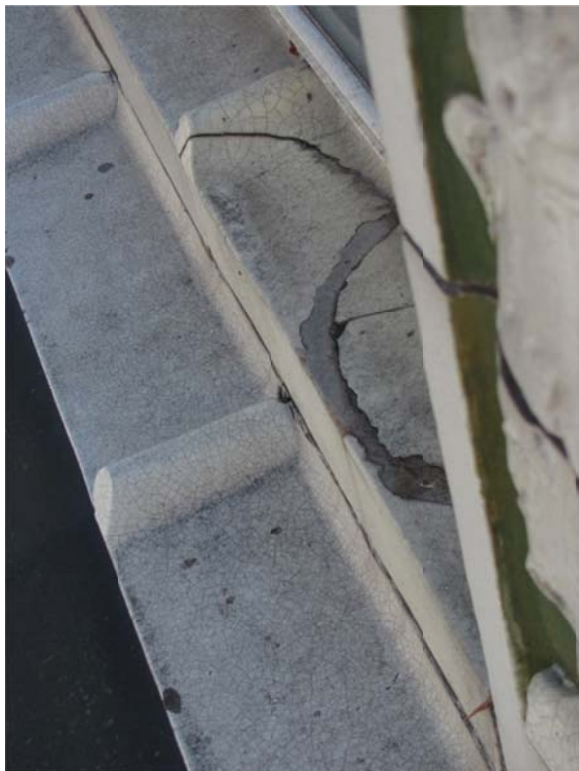
Figure 3. One cracked terra cotta window sill.

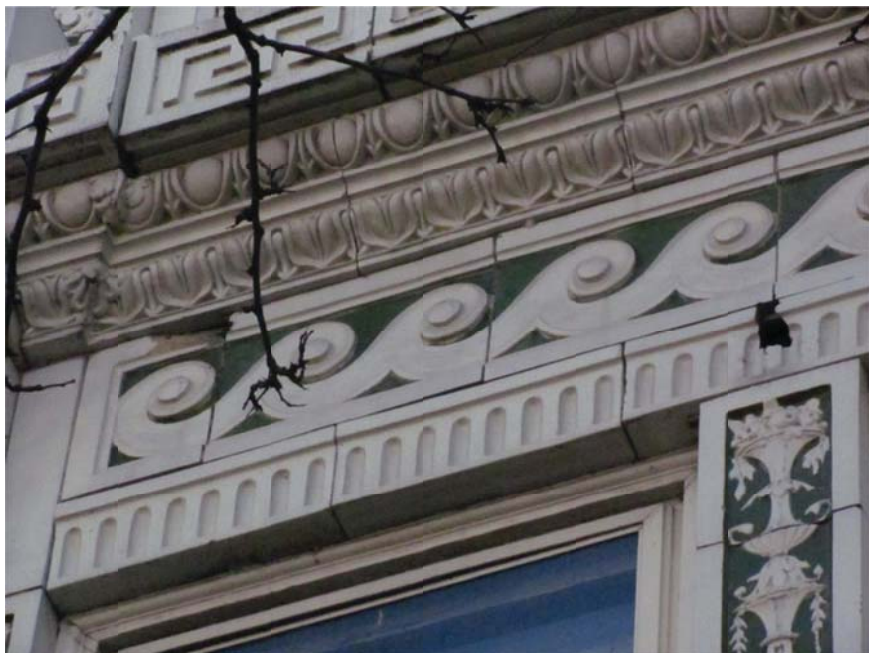
Figure 4. One unit with a hole and one spalled unit.

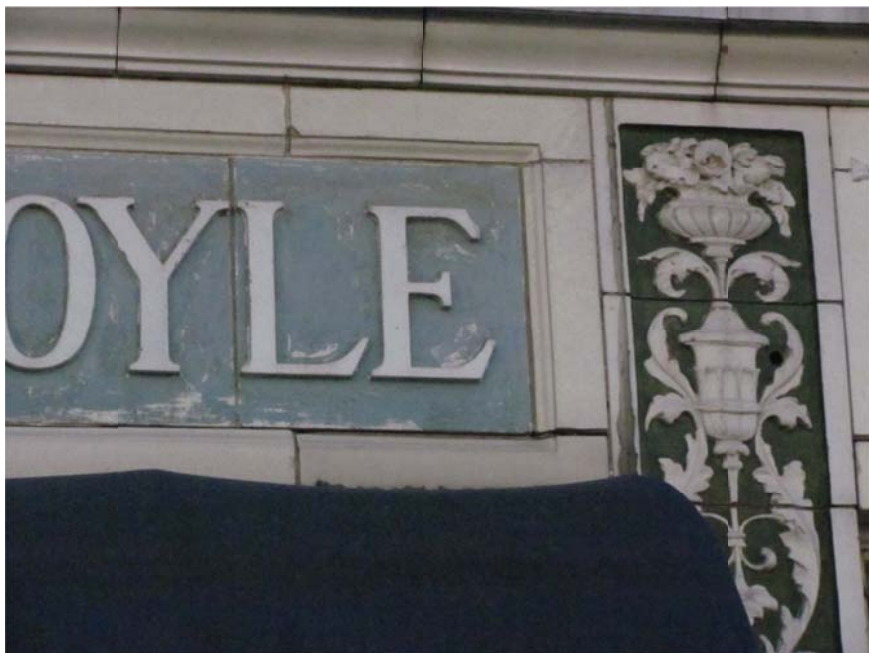
Figure 5. One displaced unit above the first floor storefront.

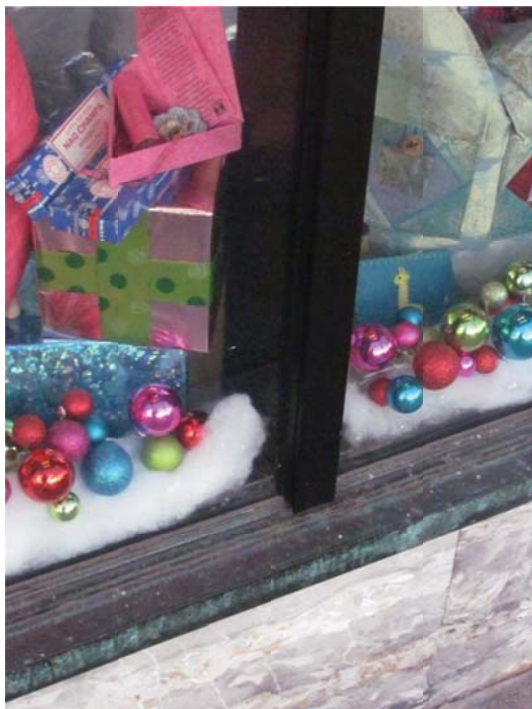
The central storefront at the first floor is a bronze-framed window. Previously, the storefront appears to have been a single large glass unit; an aluminum mullion has been added at the center of the opening, dividing it into two panes (Figure 6). Above the storefront and entrance doors are prism glass transoms incorporating operable sash. The first floor exterior entrance doors are stained and varnished wood stile-and-rail doors with brass hardware and ceramic tile thresholds. The doors are intact, although the finish is worn.

Figure 6. An aluminum mullion has been added at the center of the storefront at the first floor of the State Street facade.

At the first floor storefront on State Street, consideration could be given to removing the added center mullion and installing a single pane of glass to match the 1921 design. The exterior entrance doors should be refinished to match the historic appearance. At the second floor, the center window on the State Street facade should be replaced with a new window system matching the 1921 design.

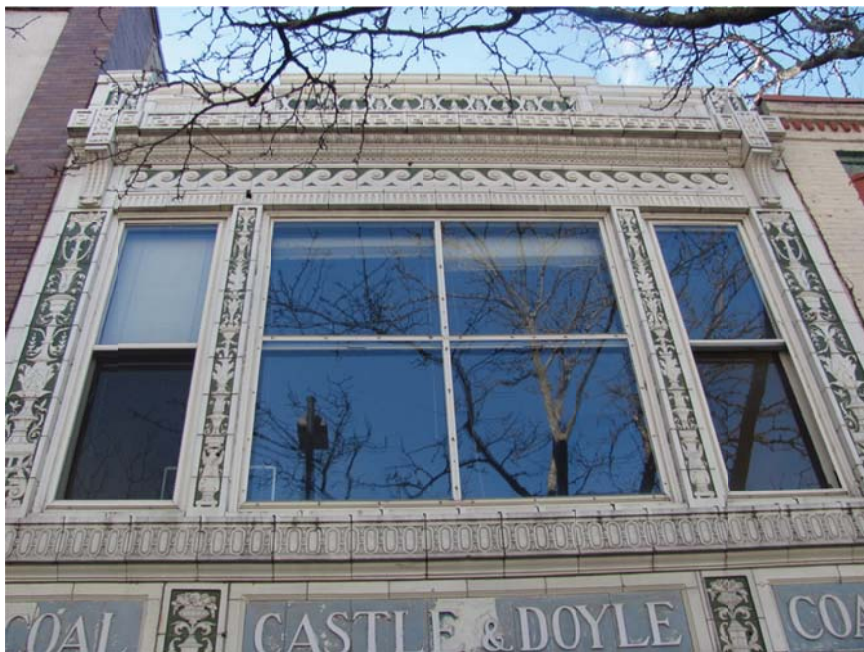
The central second floor window is a non-original assembly consisting of painted 2x wood framing supporting four panes of glass and a separate, similarly divided storm window (Figure 7). The smaller windows at either side are one-over-one wood double hung windows dating to the 1921 renovation. These windows are covered by exterior aluminum triple track storm windows, although some of the storm

Figure 7. The central second floor window is a non-original assembly consisting of painted 2x wood framing supporting four panes of glass and a separate, similarly divided storm window.

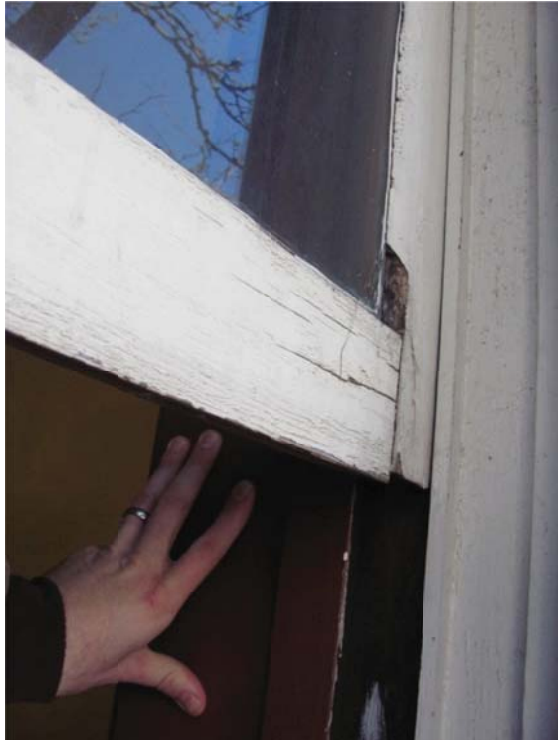
window sash have been removed. The wood windows are in fair condition, with missing components such as the parting stop, loss of paint and glazing putty, and some wood decay and displacement of window sash joinery (Figure 8).

Figure 8. The wood windows are in fair condition, with some wood decay and displacement of window sash joinery.

The double hung wood windows throughout the building should be restored, including stripping and repainting, repairing the wood frame and sash as needed, reglazing, and repairing the pulley and counterweight balance system. If desired, new interior or exterior storm windows can be provided to improve the thermal efficiency of the windows.

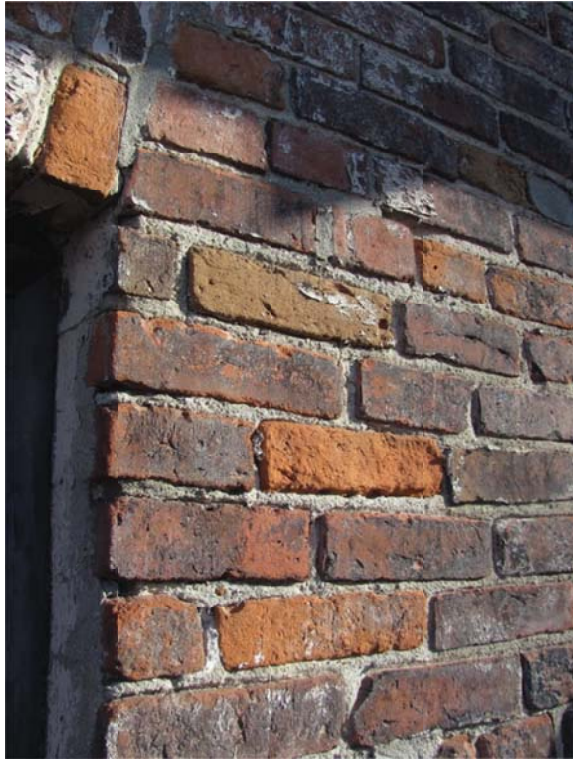
Figure 10. Left: Individual brick units were observed to have erosion or spalling of the face.

The brick masonry on the Fairchild Street facade requires more extensive repairs, likely including replacement of individual spalled brick units, repointing, removal of remnant coatings, and pinning of previously rebuilt areas to connect the face wythe to the backup masonry. Further investigation is needed to quantify the extent of these repairs. The fire escape platform should be removed and repaired or replaced as necessary.

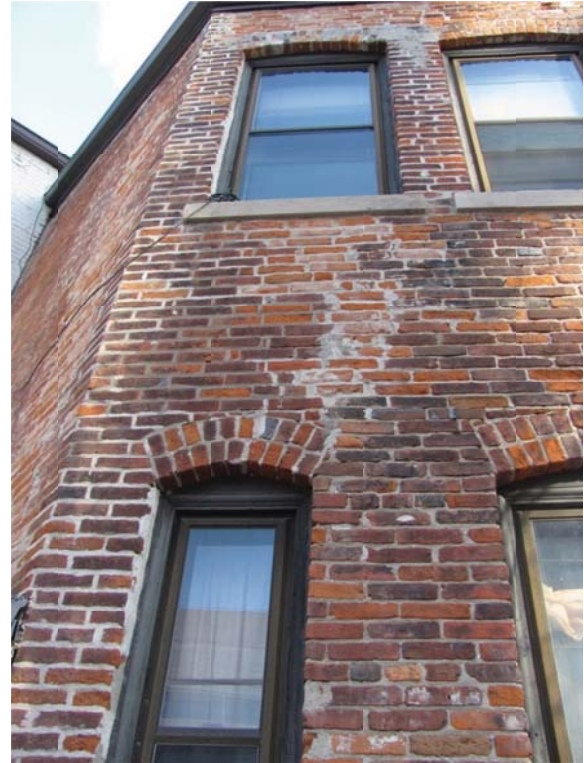
Figure 11. Right: Cracks and spalls that have been previously filled with mortar were observed.

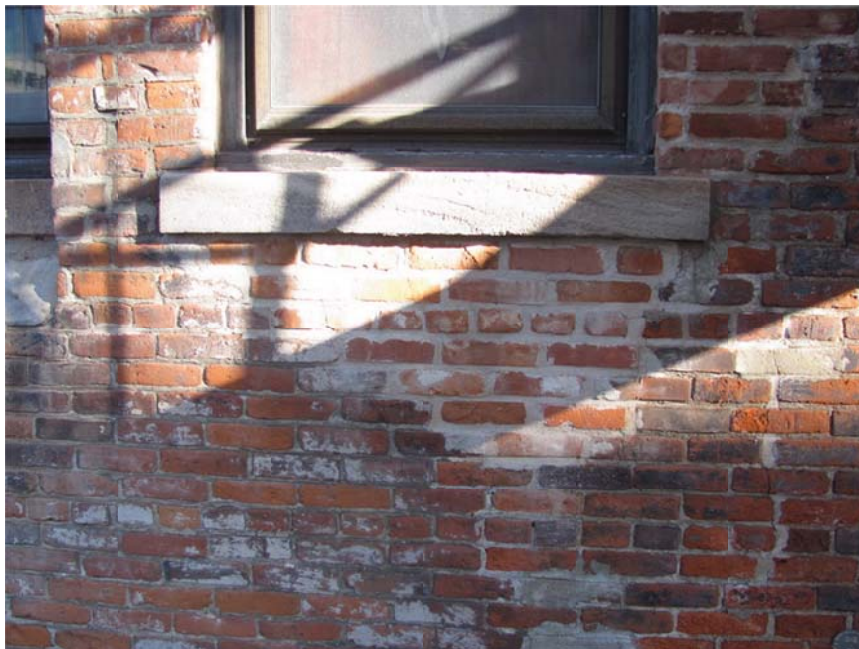
Figure 12. Localized areas of brick masonry appear to have been rebuilt previously.

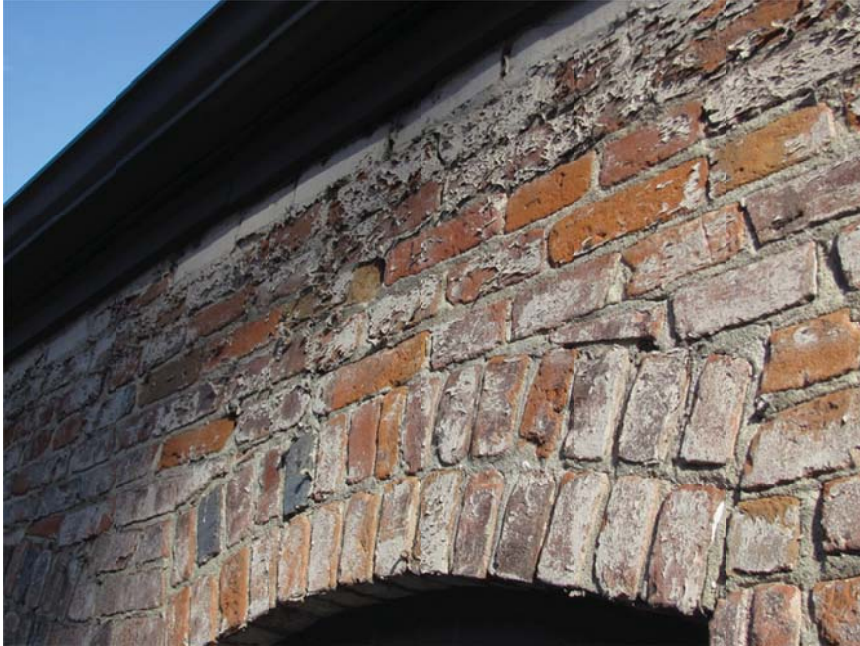
Remnants of a previous coating on the masonry were observed at more sheltered areas near the top of the facade (Figure 13). Depending upon its vapor permeability, the previous presence of this coating may have exacerbated the spalling and deterioration of the brick units observed throughout this facade.

Figure 13. Remnants of a previous coating on the masonry were observed.

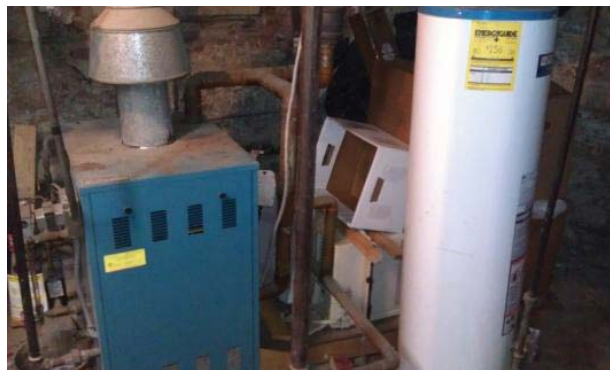
Hot water boiler and water heater

The boiler is estimated to be 10-15 years old and appears to be in good condition. The hot water piping in the basement is newer, possibly installed when the boiler was installed but could not see piping outside of the basement. None of the piping is insulated.

The water heater appears to be no more than 5 years old and is in good condition. Domestic hot water piping is copper (uninsulated) in the basement but it is unknown what the material is on the upper floors. Sanitary piping is a mix of PVC (newer) and cast iron (original). The kitchen and bathroom fixtures within the building are not historic. The second floor apartment fixtures appear to have been added when the second floor was adapted to an apartment.

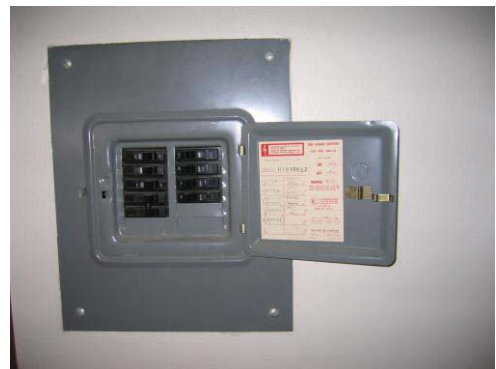
Electrical equipment age varies from the 1970's to 1990's. While one of the basement panels is from the 1990's (which powers the retail store on first floor), the second floor electrical panel is nearing the end of its useful life. There were no noted obvious failures of electrical equipment, such as evidenced by heat or smoke discoloration. The MG&E electrical service equipment appeared to be in good condition.

Electrical panel 125 ½ State Street (2nd floor apartment).
