EXISTING BUILDING REVIEW

127-129 State Street

Name: Frances Vallender Building

127–129 State Street – Architectural Review

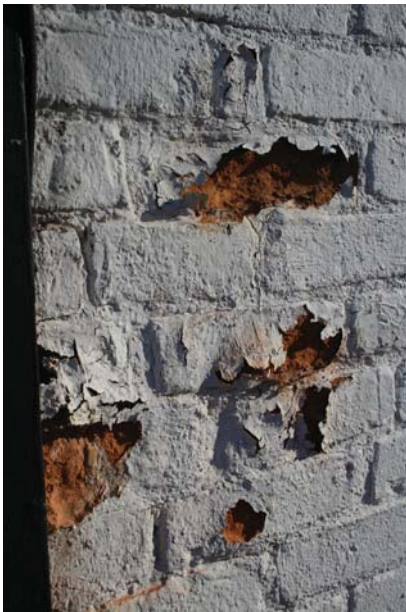
Exterior: View of damaged brick veneer

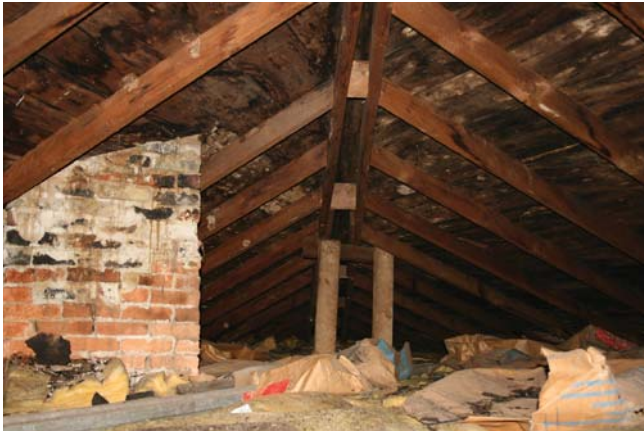
Attic: View toward flat iron corner showing damage to chimney

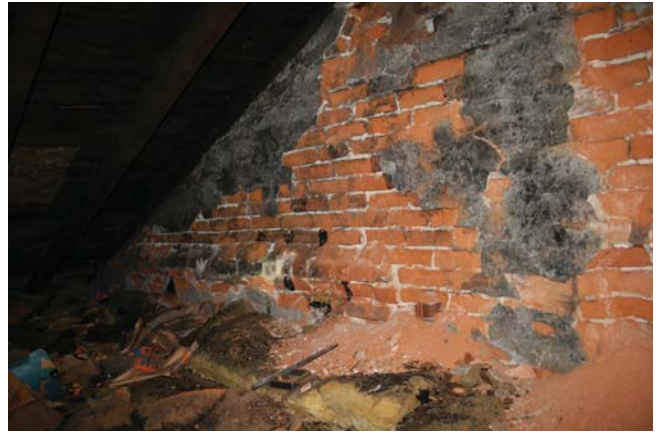
Attic: View toward wall between 127-129 state street and the castle and doyle building showing significant damage to existing brick

3. Areas of Compromised Structure
 - a. Water infiltration was noted in the basement. Brick damage due to moisture infiltration is noted at the attic at the east gable wall.

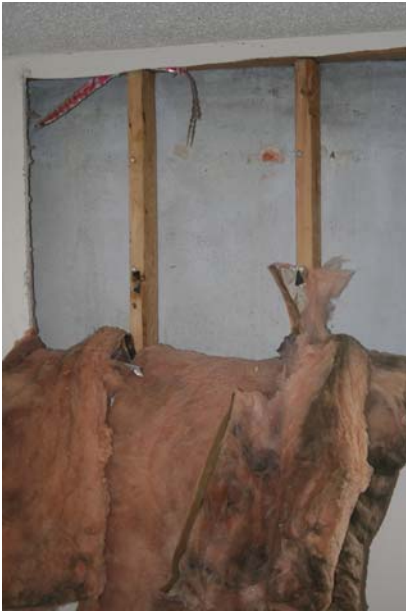
Third Floor: Section of exterior wall exposed showing back of brick and moisture within the insulation space

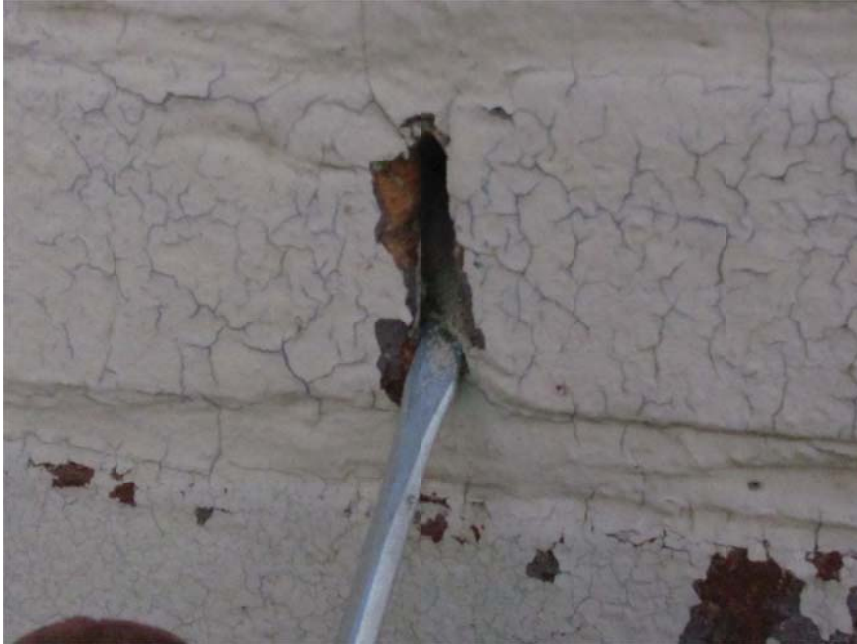
Figure 5. Mortar behind the coating layers is friable and has disintegrated.

The brick masonry has deteriorated over time, and coatings and cementitious parging have been applied to the surface of the wall rather than addressing the underlying masonry distress. The build-up of coating layers has exacerbated and accelerated the deterioration of the brick masonry. Deterioration of the brick and mortar appears to be so widespread that extensive reconstruction of the exterior walls is now required. The quality and condition of the masonry materials appears to be relatively consistent across the facades; therefore, 100 percent replacement of the outer wythe of brick masonry of the facades should be assumed. Since the majority of the exterior walls are only 8 inches thick, reconstruction of the outer wythe only may not be feasible, especially considering the deterioration of the back-up wythe of brick in the portions near grade. Rather, reconstruction of the full thickness of substantial portions or all portions of the wall will likely be necessary. Development of an appropriate approach requires further investigation and coordination with the results of the structural survey recently undertaken by others. Inspection openings should be made to confirm the exact thickness of the wall in various locations and to review the condition of concealed portions of the wall.

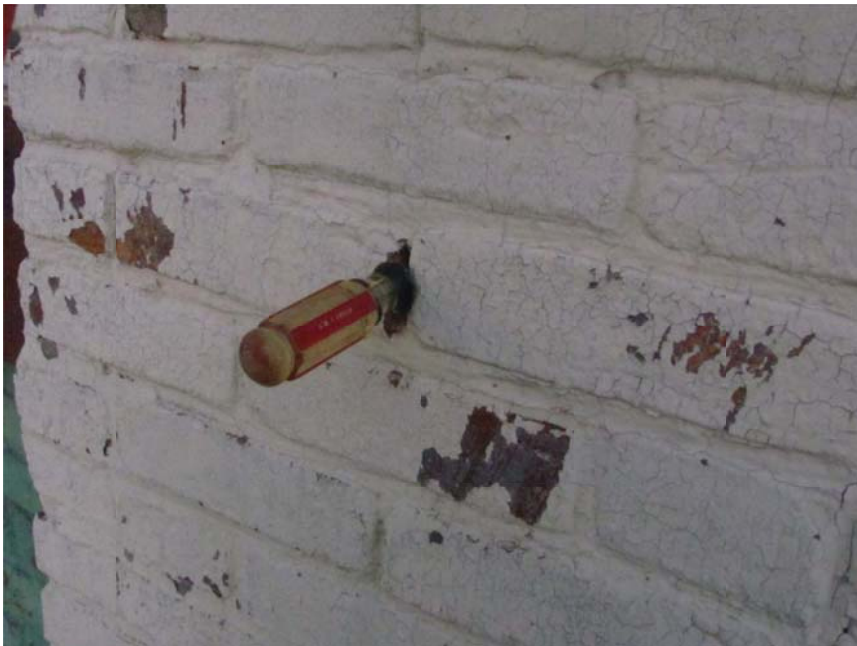
Figure 6. Mortar behind the coating layers has disintegrated, resulting in voids within the masonry construction.

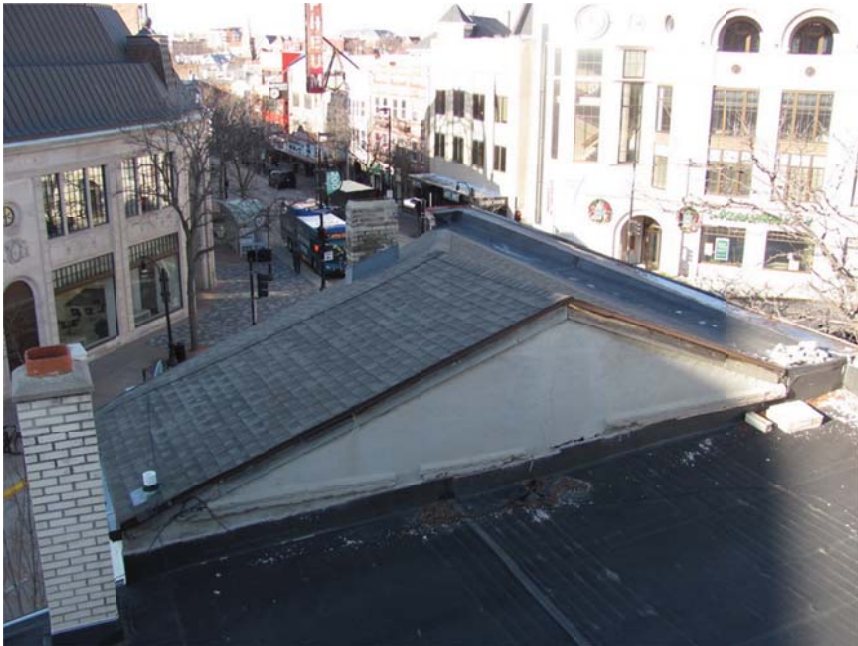
The building roof was not accessible for close-up inspection but was viewed from a nearby higher building (Figure 8). The existing roof covering is asphalt shingle that appears relatively new and intact. Along State Street, there is a low parapet wall and built-in gutter lined with EPDM rubber membrane. Along Fairchild Street, there is a hanging galvanized metal gutter. When viewed from below in the building attic, widespread water staining was apparent on the wood framing (Figure 9). Also, debris and remnants of roofing material were scattered over the insulation in the attic. It appears likely that much of the existing staining is from old water leakage that is not currently active, given the apparently good condition of the existing roofing.

Figure 8. Overview of the roof.

The existing roof system is likely relatively new and intact, based on its appearance as viewed from adjacent buildings, although the perimeter detailing and provisions for drainage should be reviewed in greater detail.

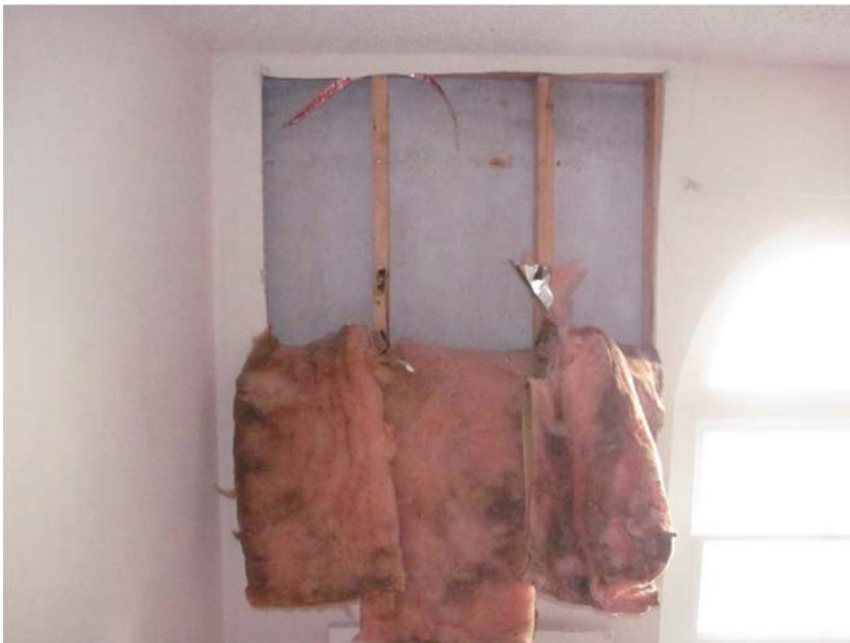
The second and third floors together constitute one three-bedroom rental apartment. The apartment is accessed via a separate entrance vestibule and stair from the south corner of the building on Fairchild Street. The apartment interior finishes include carpeting, sheet vinyl flooring, wood paneling, and gypsum board walls and ceilings (Figure 11). Several inspection openings were made during the site inspection at the exterior walls of the third floor. From interior to exterior, the exterior construction consists of gypsum board supported on 2x4 studs with batt insulation between the studs, installed inside the original brick masonry wall. Previous plaster finishes were observed directly applied to the inside face of the brick masonry. Staining and evidence of moisture penetration was observed on the batt insulation and plaster (Figure 12).

Figure 12. Staining and evidence of moisture penetration was observed on the batt insulation and plaster at an inspection opening created at the third floor during the site visit.

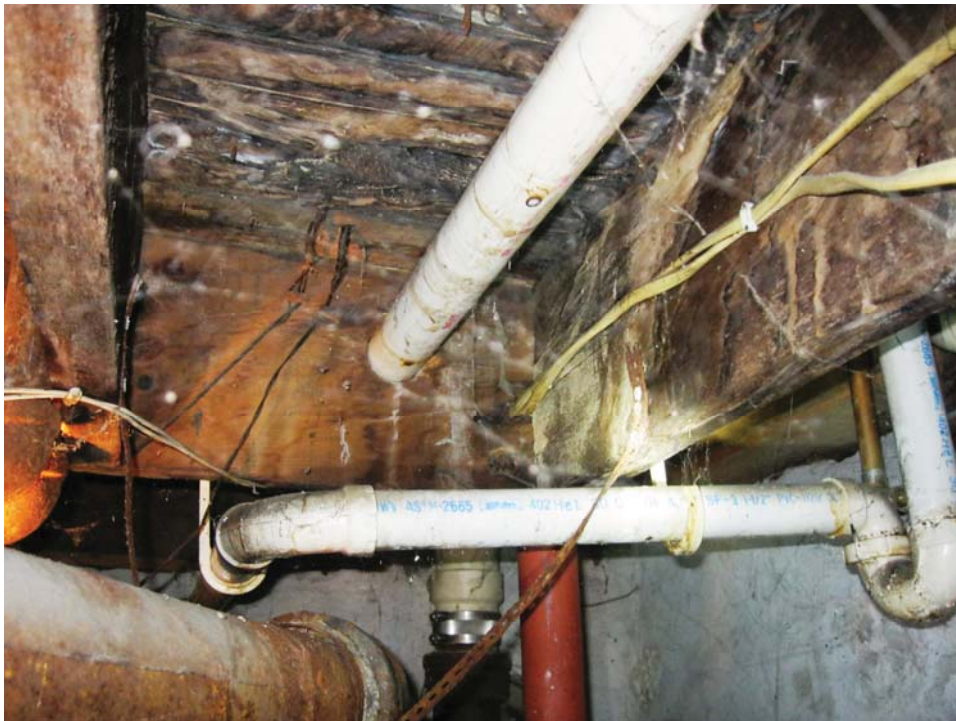
- b. Piping revisions over the years have damaged the first floor structure rendering the floor unusable.
4. Floor. Roof Loading
 - a. Existing Structure Capacity. First floor live load capacity-none specified, replacement needed. Second floor live load capacity 35 psf. Third floor live load capacity of 45 psf. Roof live load capacity 21 psf.

Photo 7 – 1st floor framing with water damage

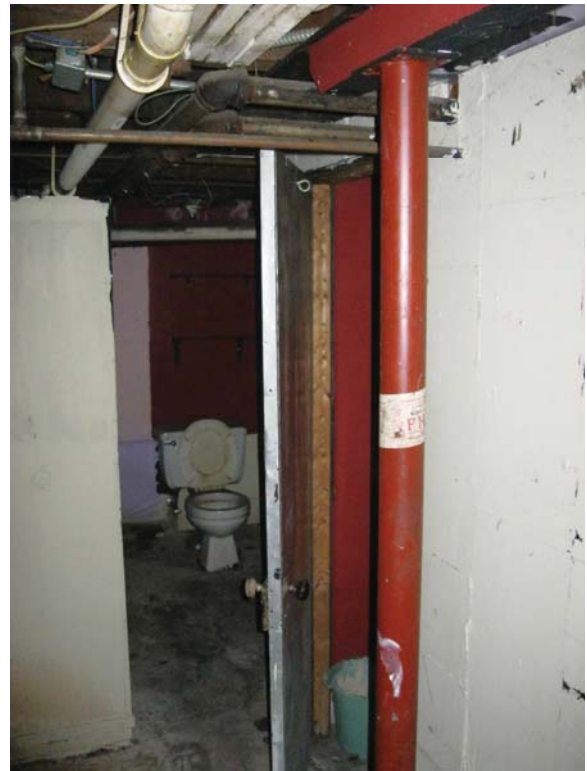
The floor is wood framed. There are two locations where shoring has been added to re-support the floor. The shores bear on wooden boards on the floor with no added footing present and as such should be considered temporary. The floor framing has been modified over the years to accommodate revised plumbing runs. The 2x framing has been cut as needed to allow the piping to pass. There are rotted 2x 's noted near the piping indicating unresolved leaks. No load capacity is assigned to this floor as it has excessive defects and needs to be replaced.

Photo 10 – 1st floor shoring beam and post

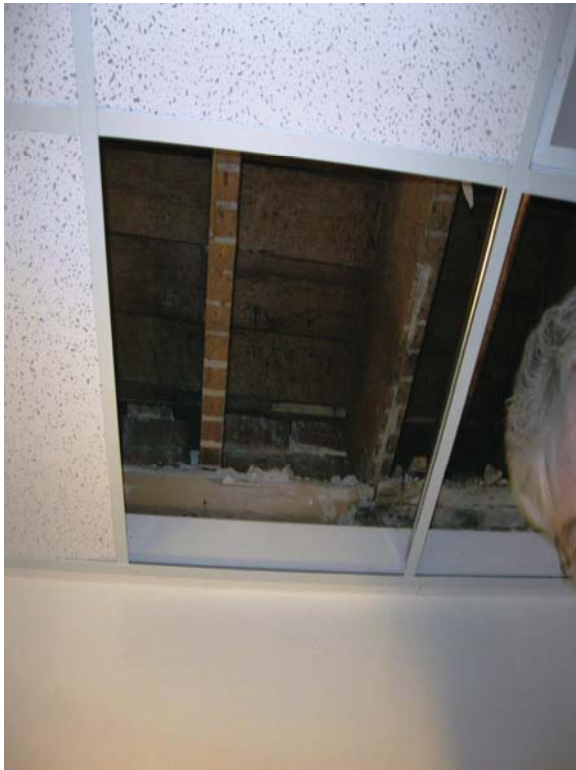
The framing for the second floor was observed from the 129 space. The second floor framing is full size 2x8 @16" oc spanning 17' and paralleling State Street. The calculated live load capacity of the second floor for the noted joists would be 35 psf. Present day code would require 40 psf for apartment occupancy.

Photo 12 – 2nd floor joist framing observed from 1st floor retail space

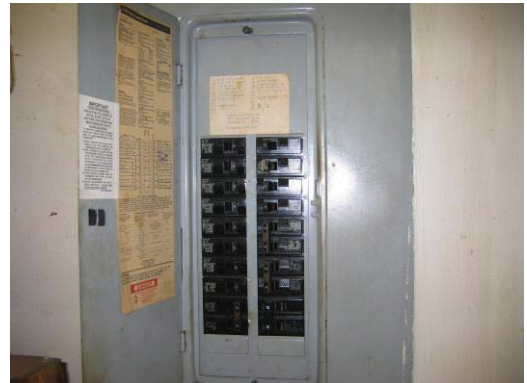
Electrical equipment age varies from about the 1970's to 1980's. The electrical panels are either at or are nearing the end of their useful life. There were no noted obvious failures of electrical equipment, such as evidenced by heat or smoke discoloration. The MG&E electrical service equipment appeared to be in good condition.

Electrical panel in 127 State Street (First Floor).
