Letter of Intent – 1026 Sherman Ave

As-Purchased Condition

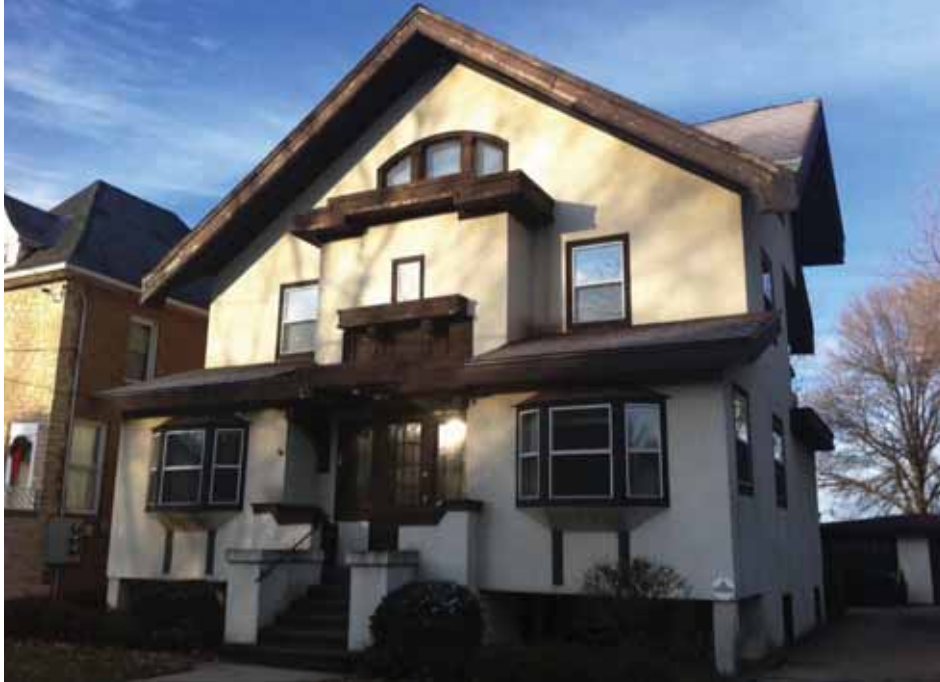
Figure 1 Primary view of house facing Sherman Ave. Significant degradation of soffits, gutters, stucco. The squirrels and raccoons enjoy the friendly confines of the roof thanks to all the holes. The stucco is not properly installed with rope and vee-groove. There is water damage behind the stucco as a result. The front bump-outs and rear additions were built without expansion joints and the stucco is cracking in these places also.

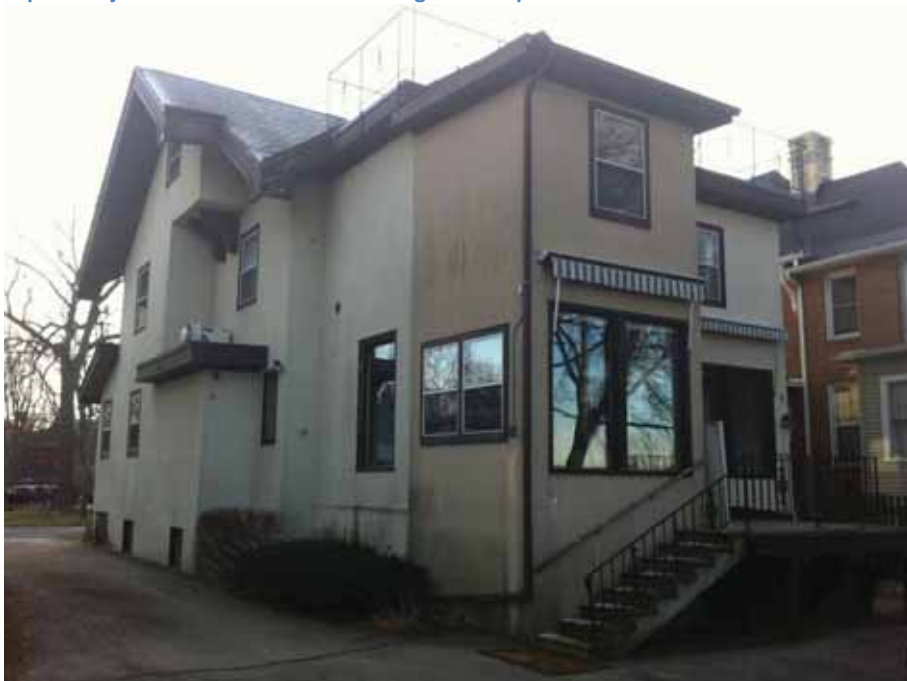
Figure 2 Rear view facing Lake Mendota. Back porch and additions from the 1980's visible. Nothing matches or lines up properly. There are at least three clearly defined generations of construction. We are very excited to build a house which matches the generally high quality properties of the area.

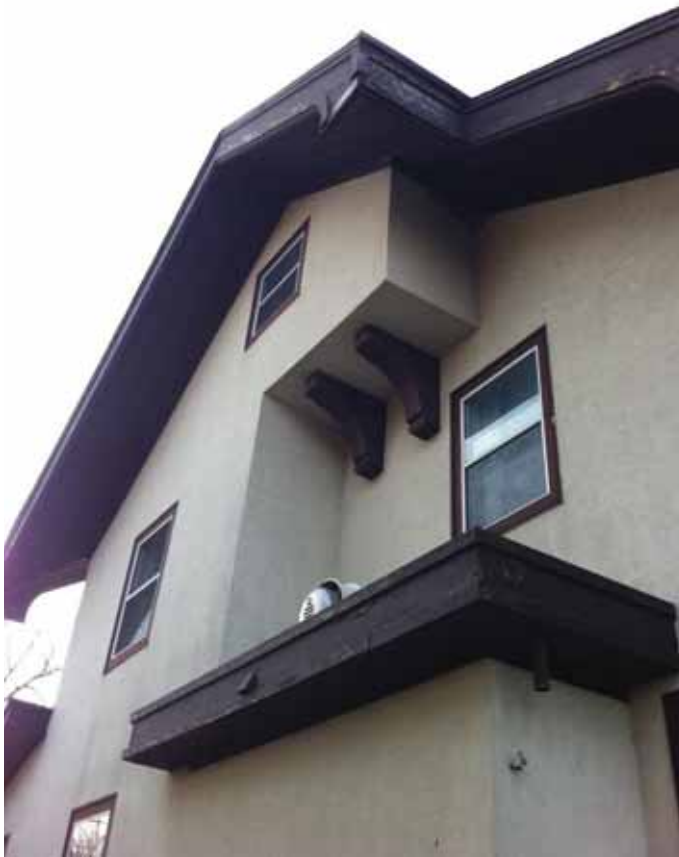
Figure 3 All exterior soffits are damaged beyond repair and the City of Madison correction order has not been acted upon. A dead squirrel fell out of the attic access hatch when we opened it because the damaged soffits act as squirrel entry points. It is difficult to see in photos, but the stucco is damaged here also.

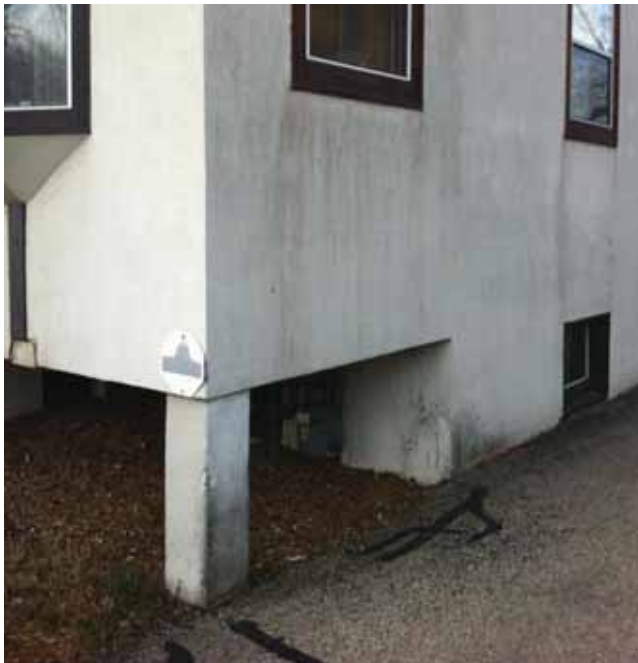
Figure 4 The added "bump outs" are sinking and cracking the existing stucco. Water damage resulting from the improperly hung stucco/drainage is visible on most windows (the dark "waterfalls" stemming from the bottom corners).

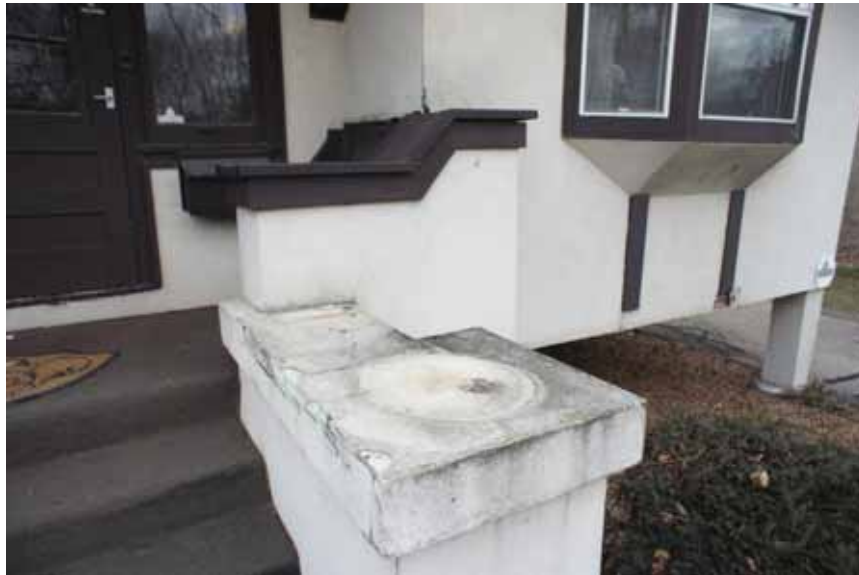
Figure 5 Stucco, wood and roofing are generally damaged beyond repair. Our new home will contribute to the general feel of the neighborhood and will not be an eyesore. The carpet, wood and stucco here are very moldy after years of water damage and neglect.

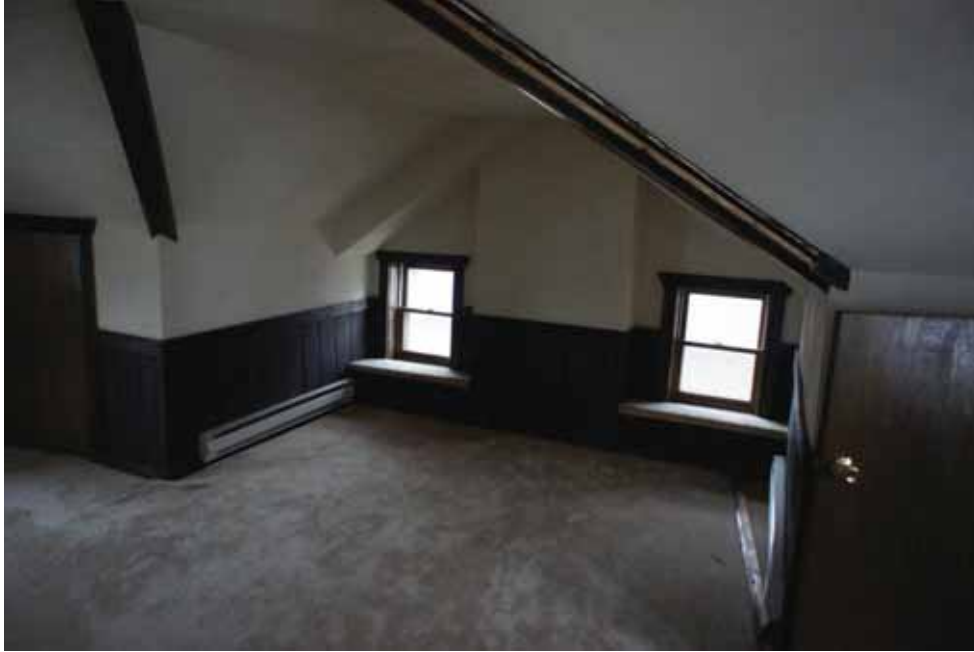
Figure 6 The third floor attic was finished without a permit and has knob and tube wiring.

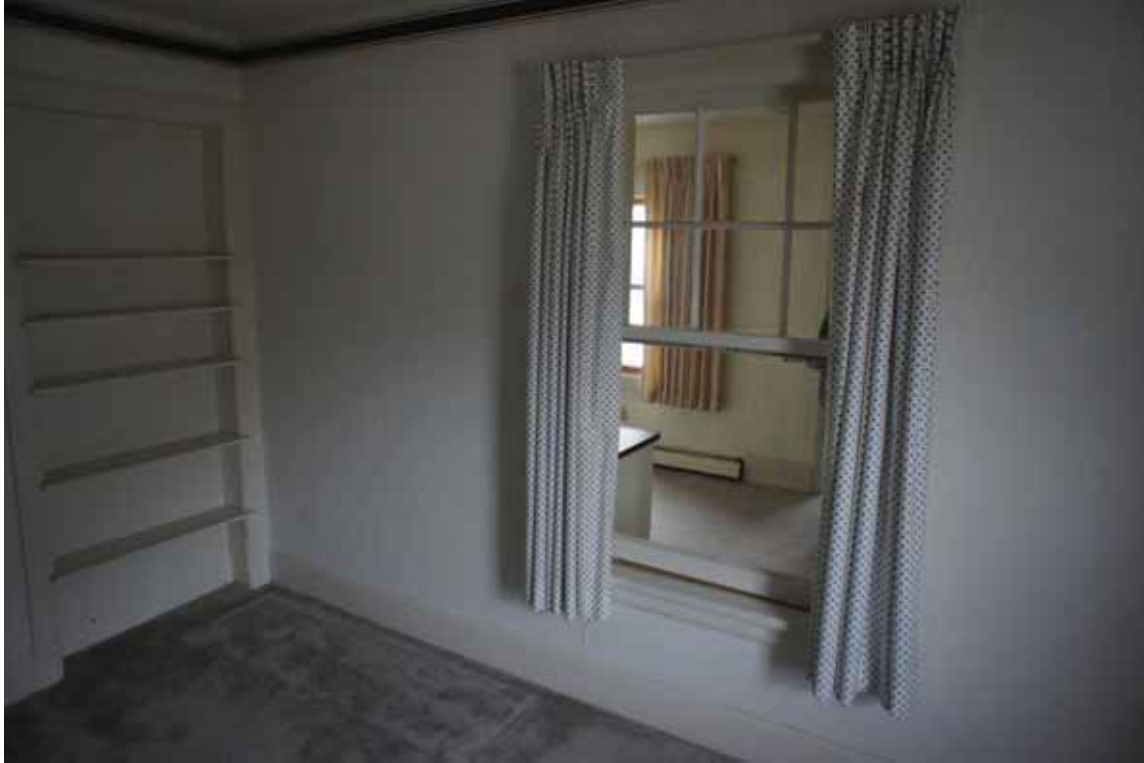
Figure 7 The three seasons porch was built in as an addition in the 1980's. Unfortunately, there are now disjoint spaces inside the house separated by formerly exterior walls and sliding windows. The entire second floor is also partially serviced by a live knob and tube circuit. The replacement electric panel is double tapped with loose connections throughout. This is a significant fire danger.

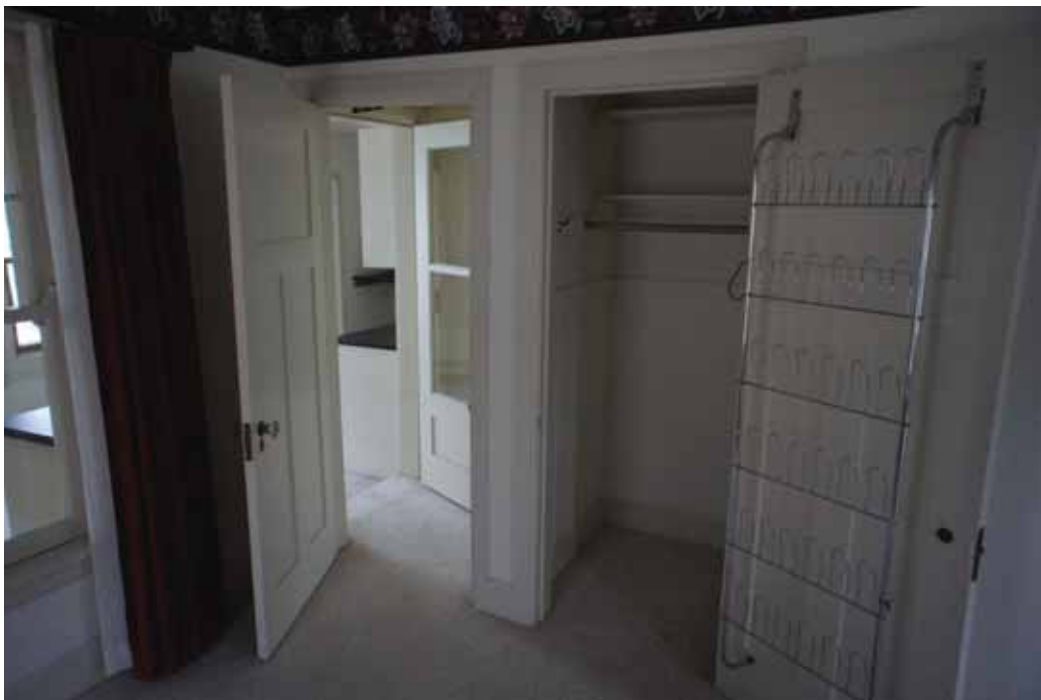
Figure 8 Another view of the strange space resulting from the improper addition viewed from the master bedroom (which also features an asbestos containing false roof covering the original cracked plaster ceiling).

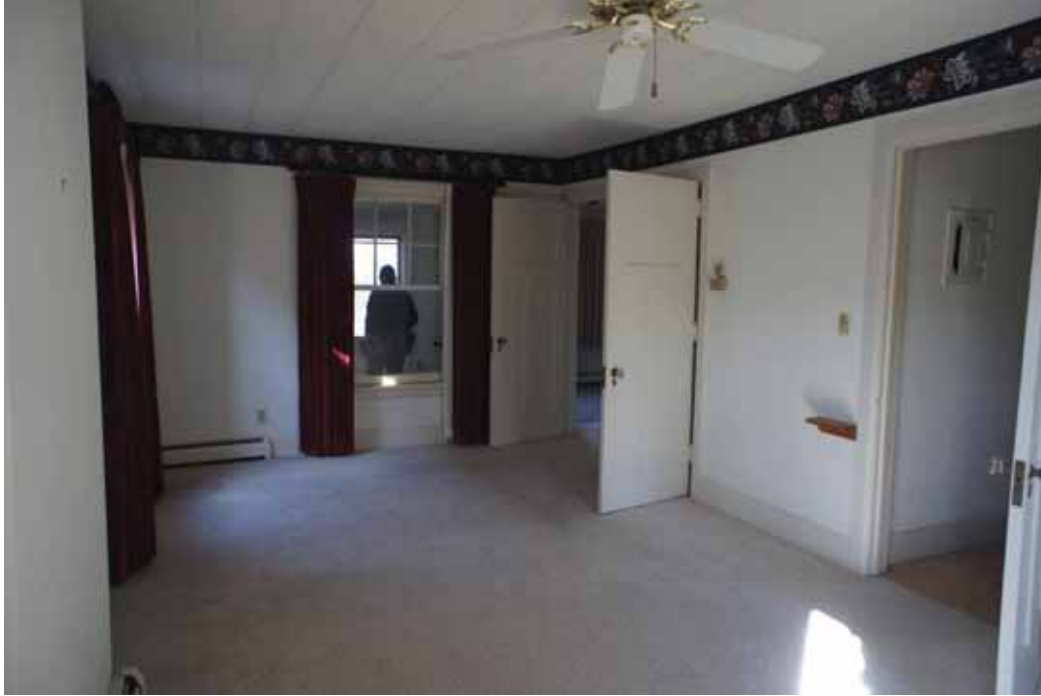
Figure 9 Dropped asbestos tile ceiling covering up original, water damaged, cracked plaster ceiling.

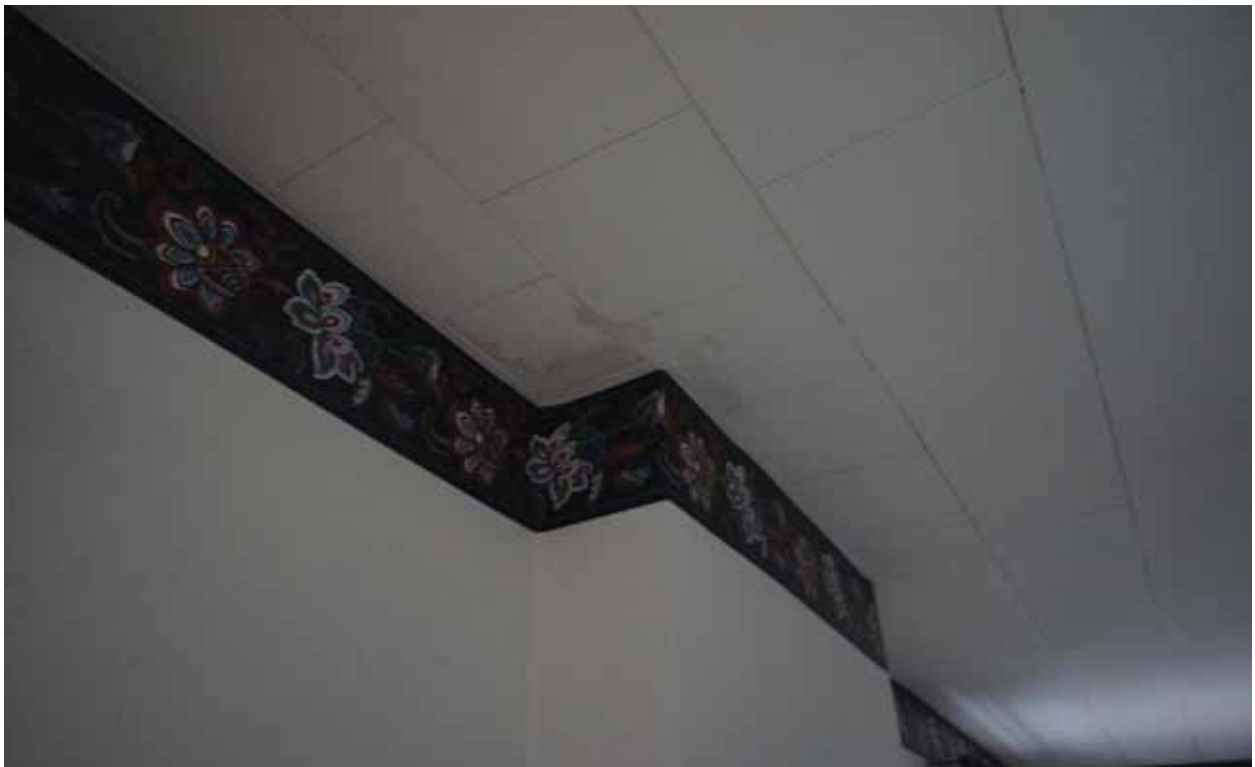
Figure 10 Water damage permeates through the original plaster and on to the asbestos faux ceiling.

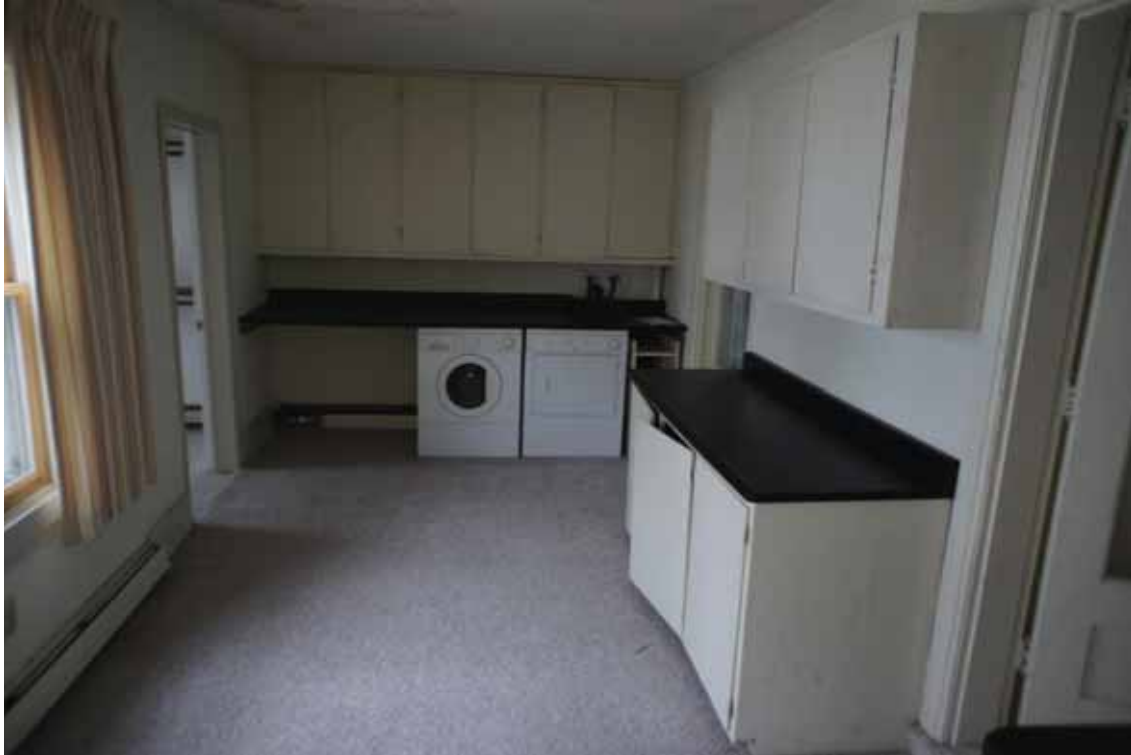
Figure 11 This is the addition, please note that roof leaks and water damage is evident throughout.

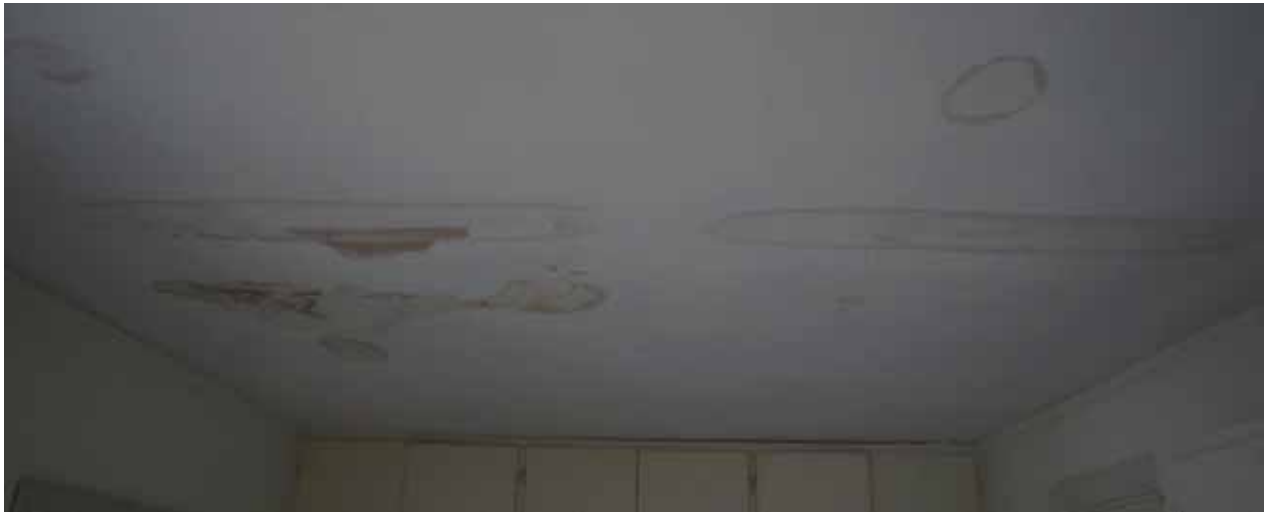
Figure 12 The roof over the addition is improperly drained and has been leaking through to the drywall below. Mold and water damage throughout.

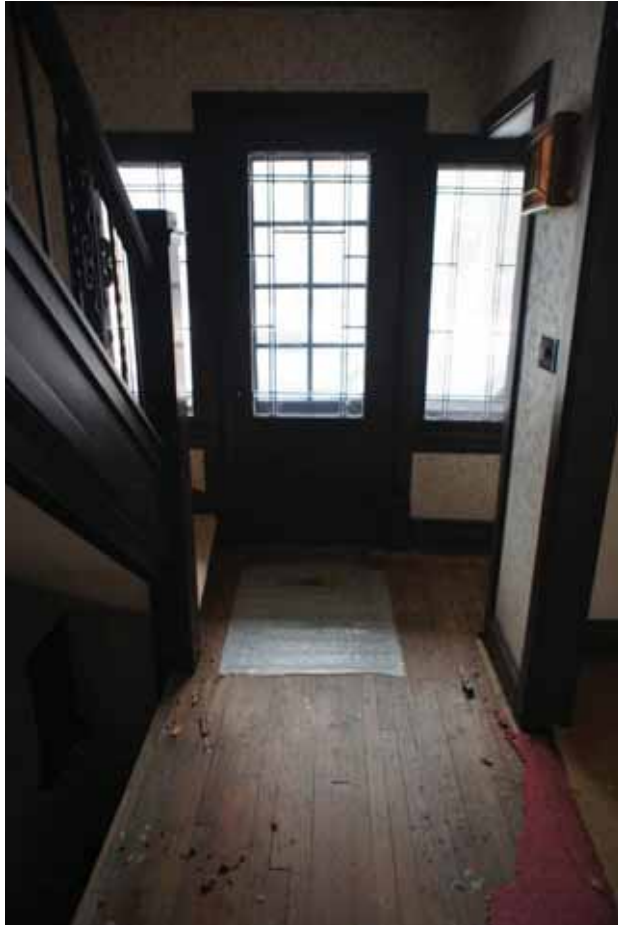
Figure 13 First Floor entry. Stairwell (and handrails) not as originally built. Existing wood floor was covered by carpet since last remodel, but is very damaged and has many missing pieces.

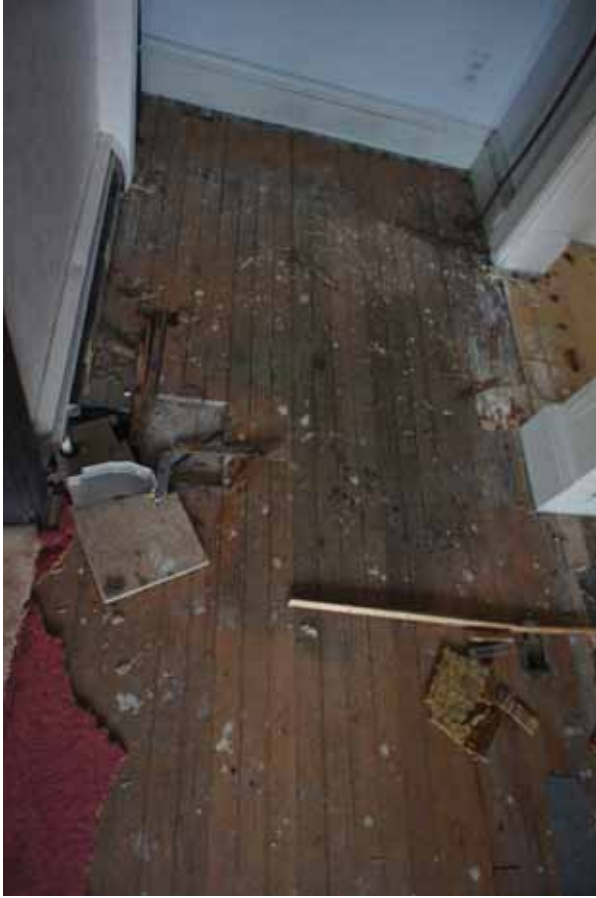
Figure 134 Damaged flooring in entry and through the house.

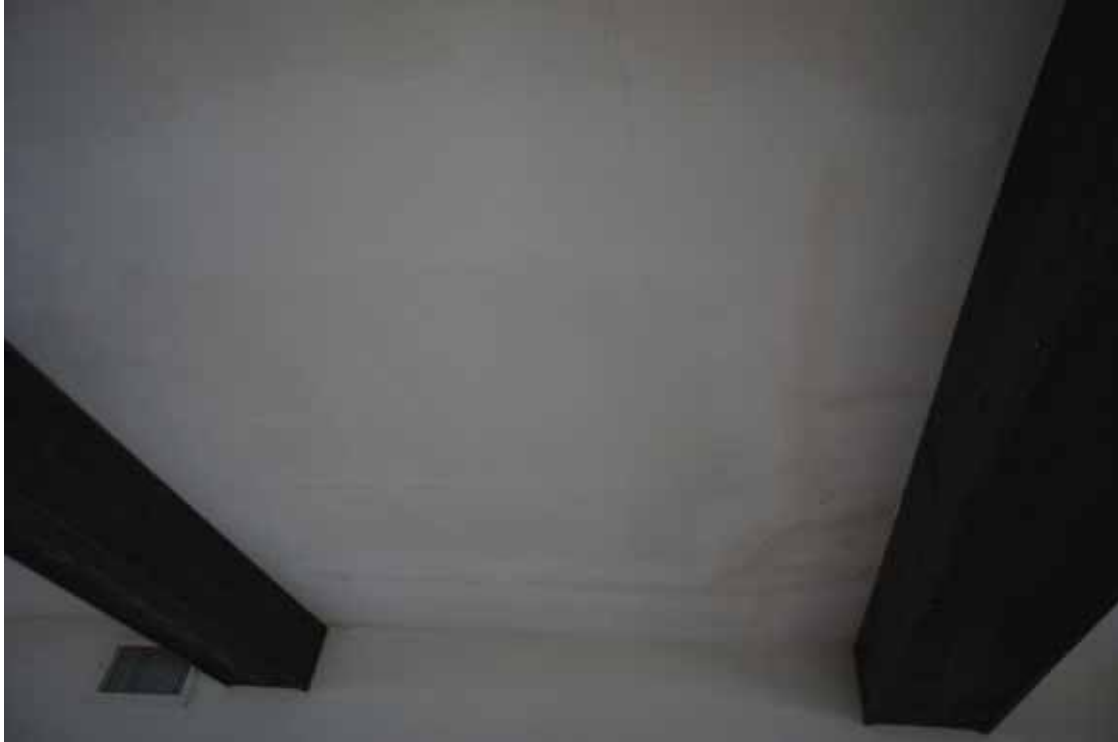
Figure 17 The living room plaster ceiling exhibits significant cracking and water damage

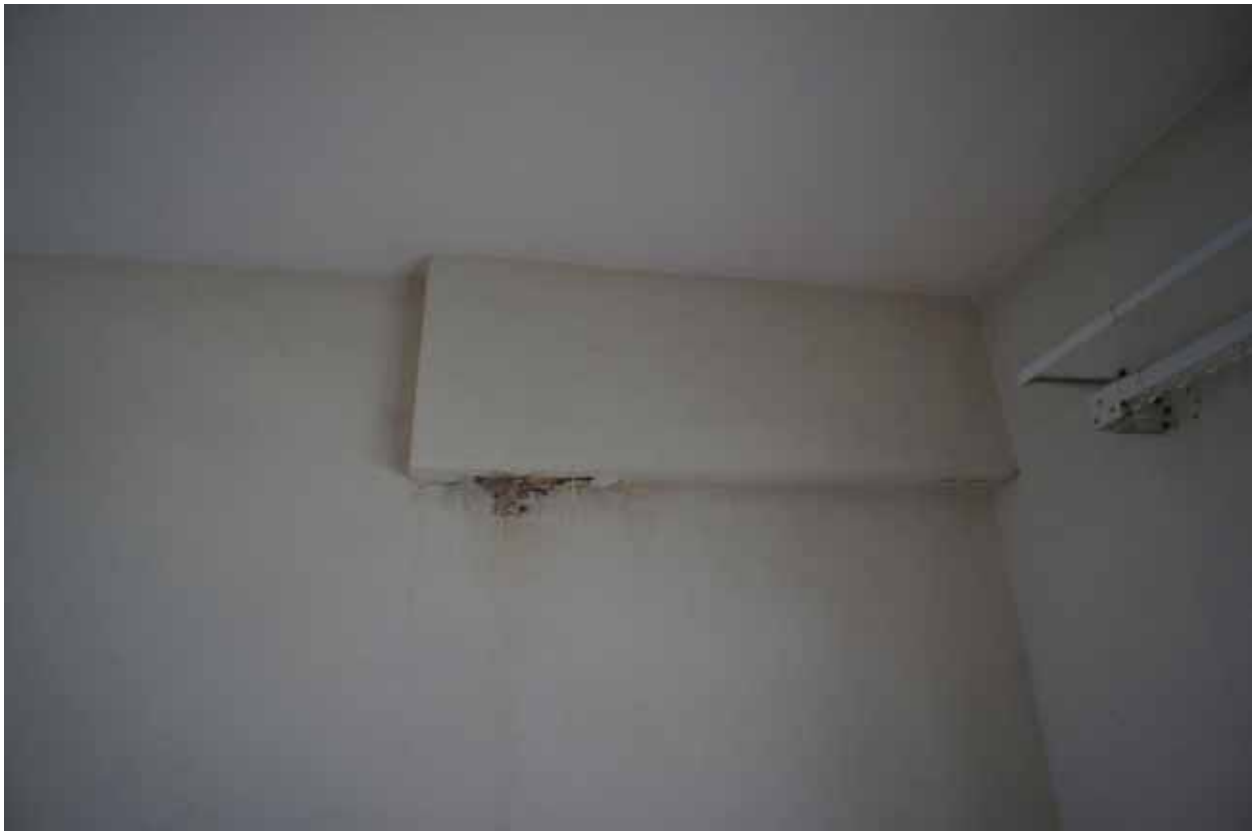
Figure 158 Water damage prevalent throughout (this is in the living room)

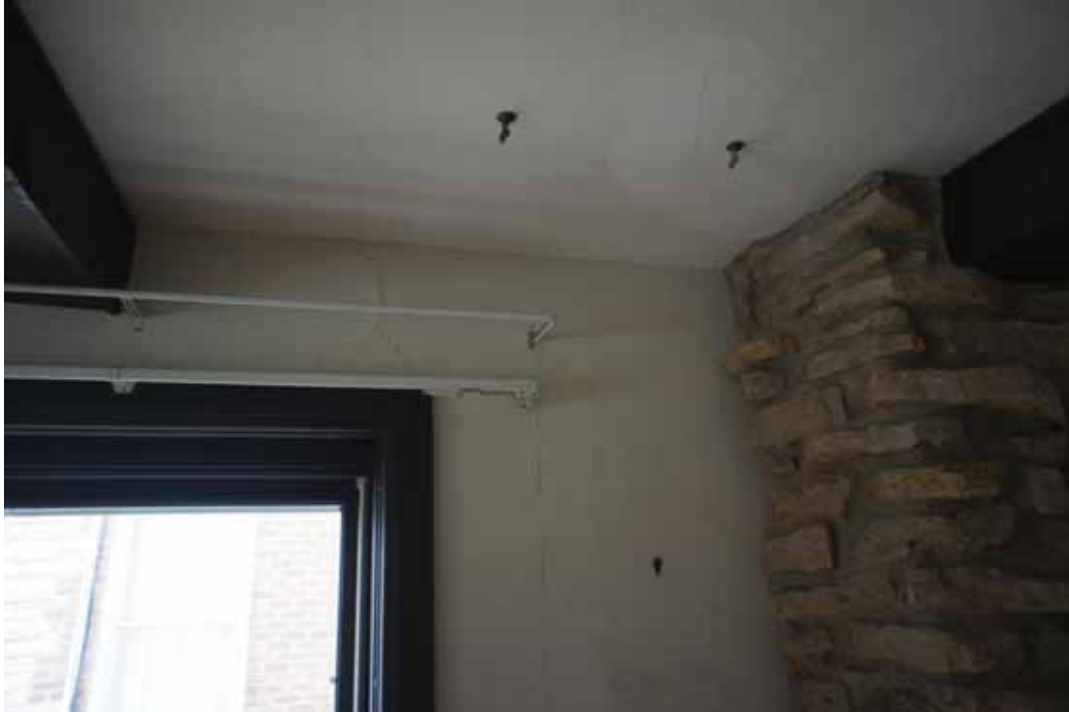
Figure 19 Water damage and plaster cracking around unoriginal ceiling beams and fireplace.

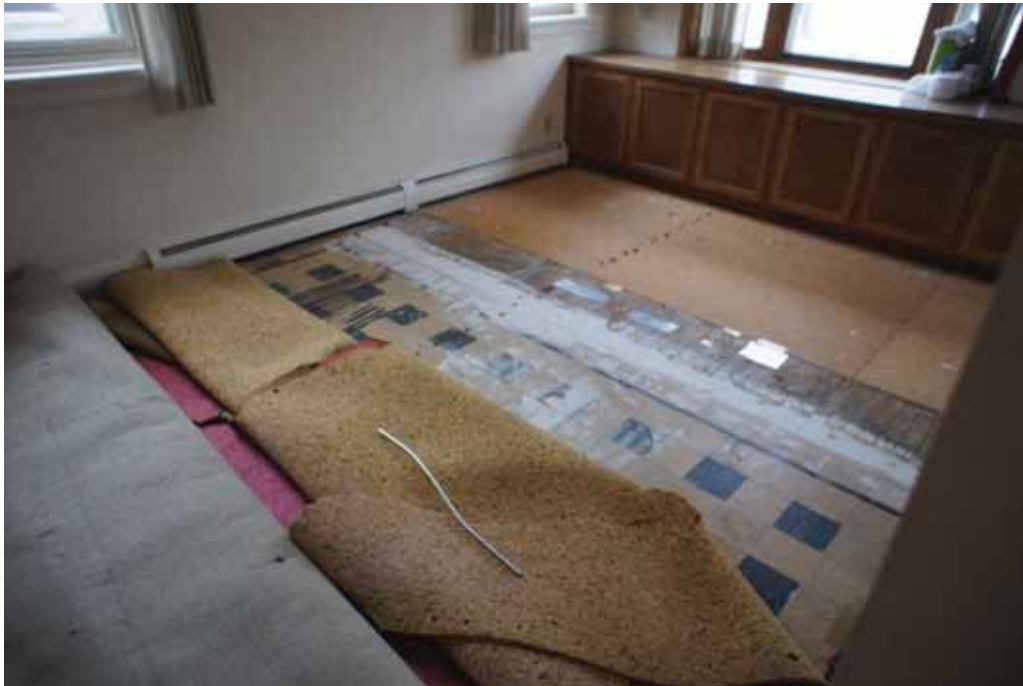
Figure 16 Dining room and living room extend into "bump outs" from 1980's remodeling. Walls are partially drywall and partially plaster. All trim and built in cabinets not original to house. Flooring is a mixture of asbestos containing tile, damaged wood and raw subfloor.

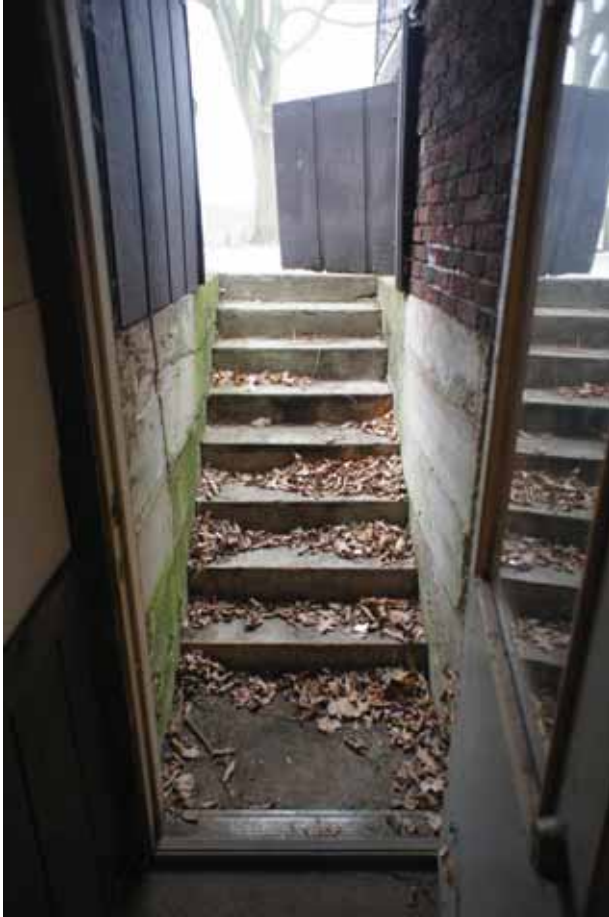
Figure 17 The 1980's remodel extended to the basement. While many thoughtful touches were added, they introduced new risks. For example, this sunk entry does not have any drainage (and has flooded into the basement repeatedly). Also, the foundation is cracked in this stairwell.

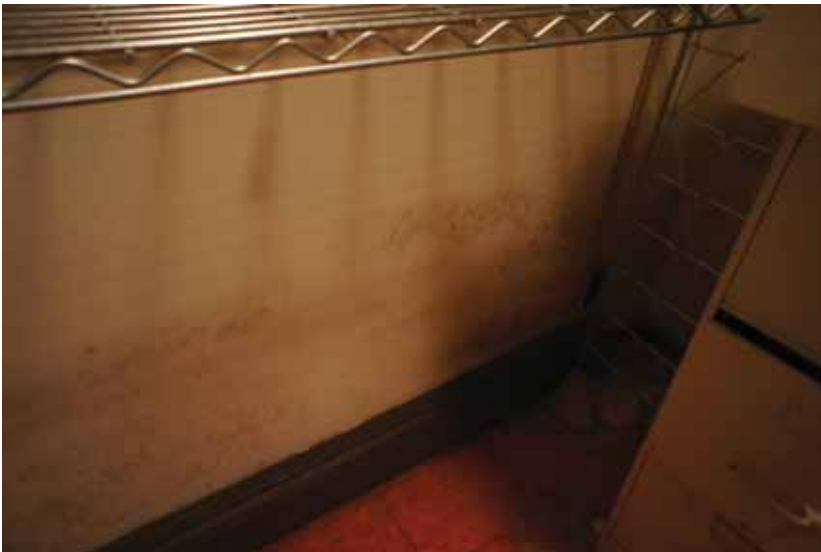
Figure 22 Mold has spread along the basement walls.
