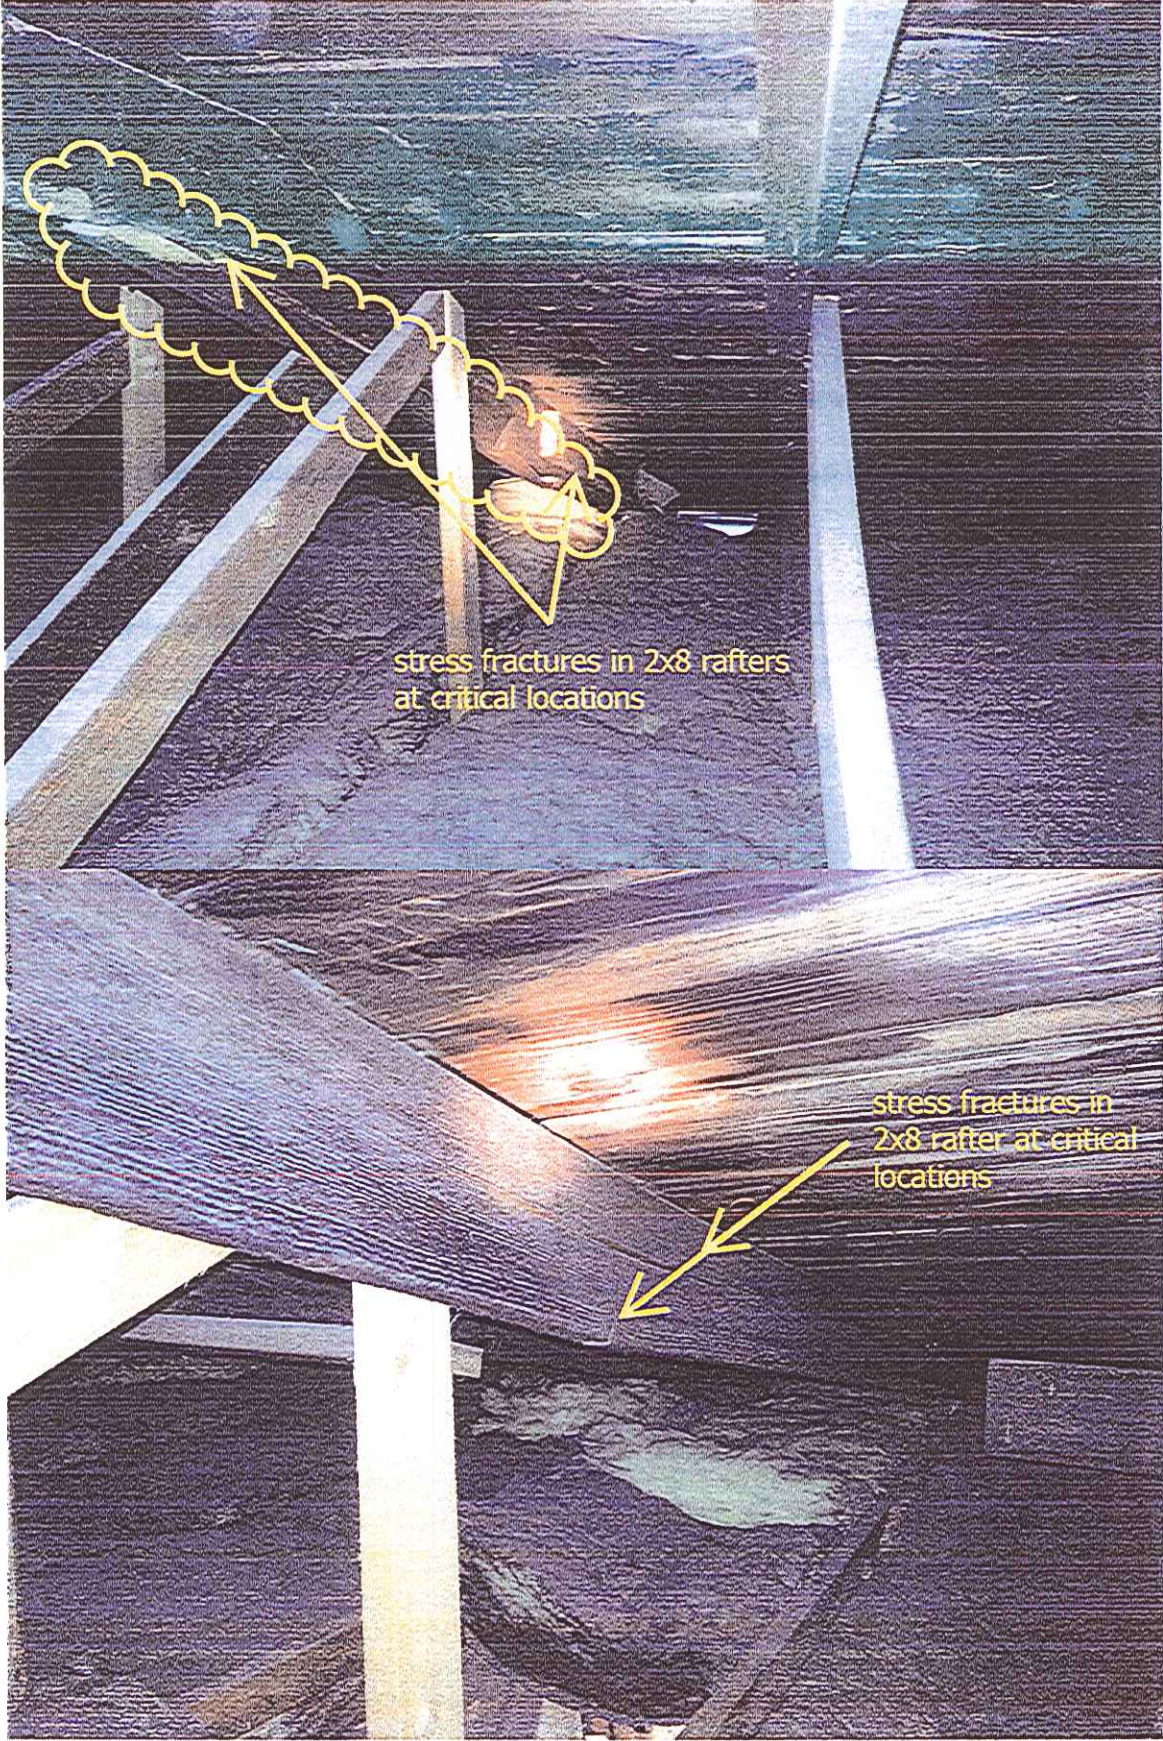
stress fractures in 2x8 rafters at critical locations

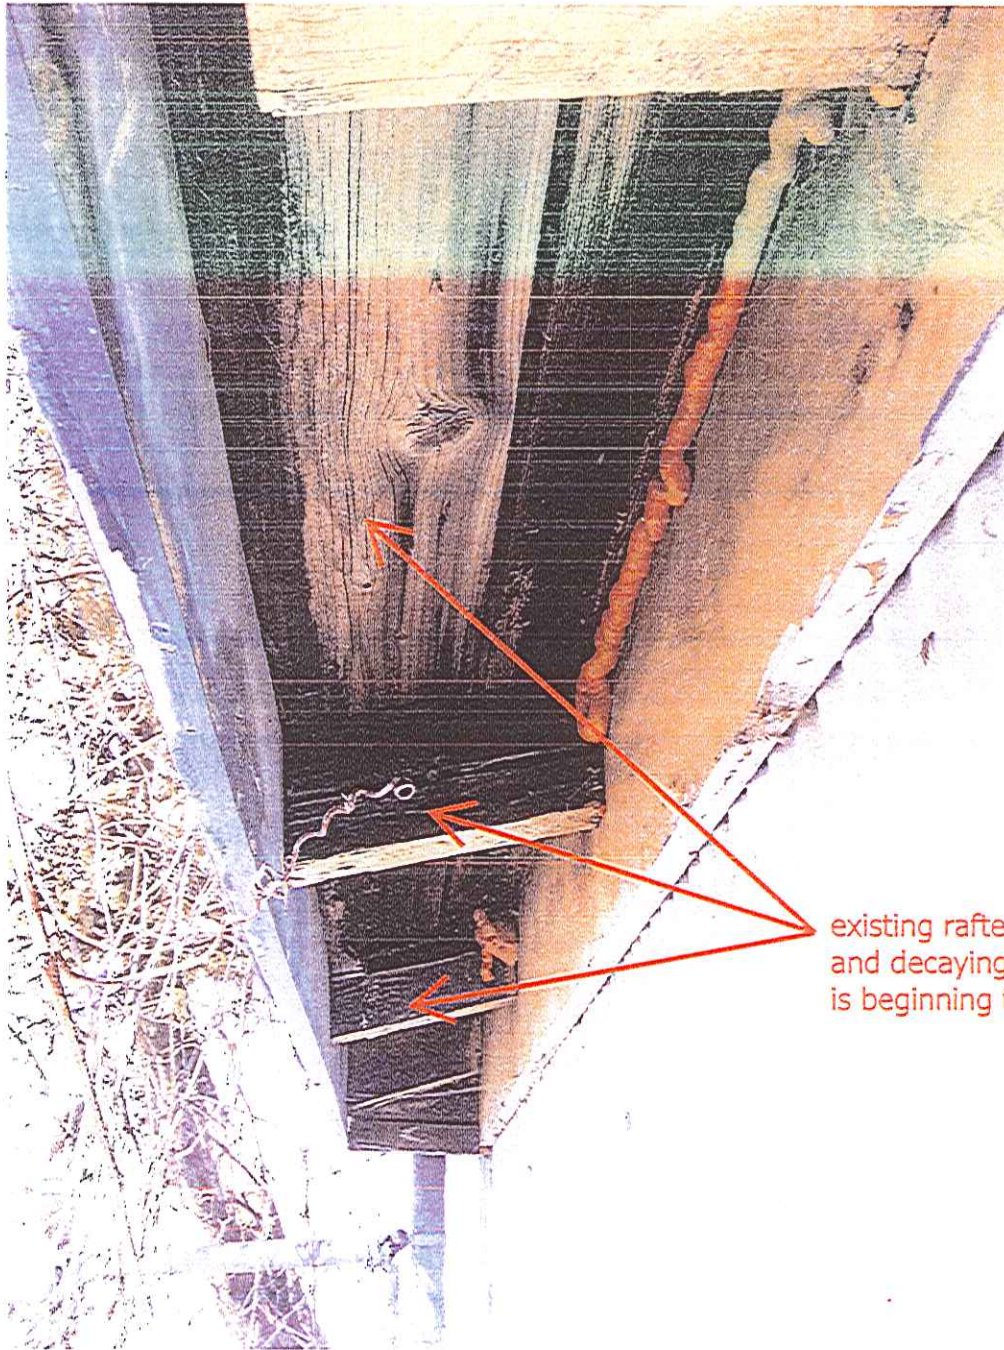
existing rafter tails are splitting and decaying. exposed sheathing is beginning to show signs of decay

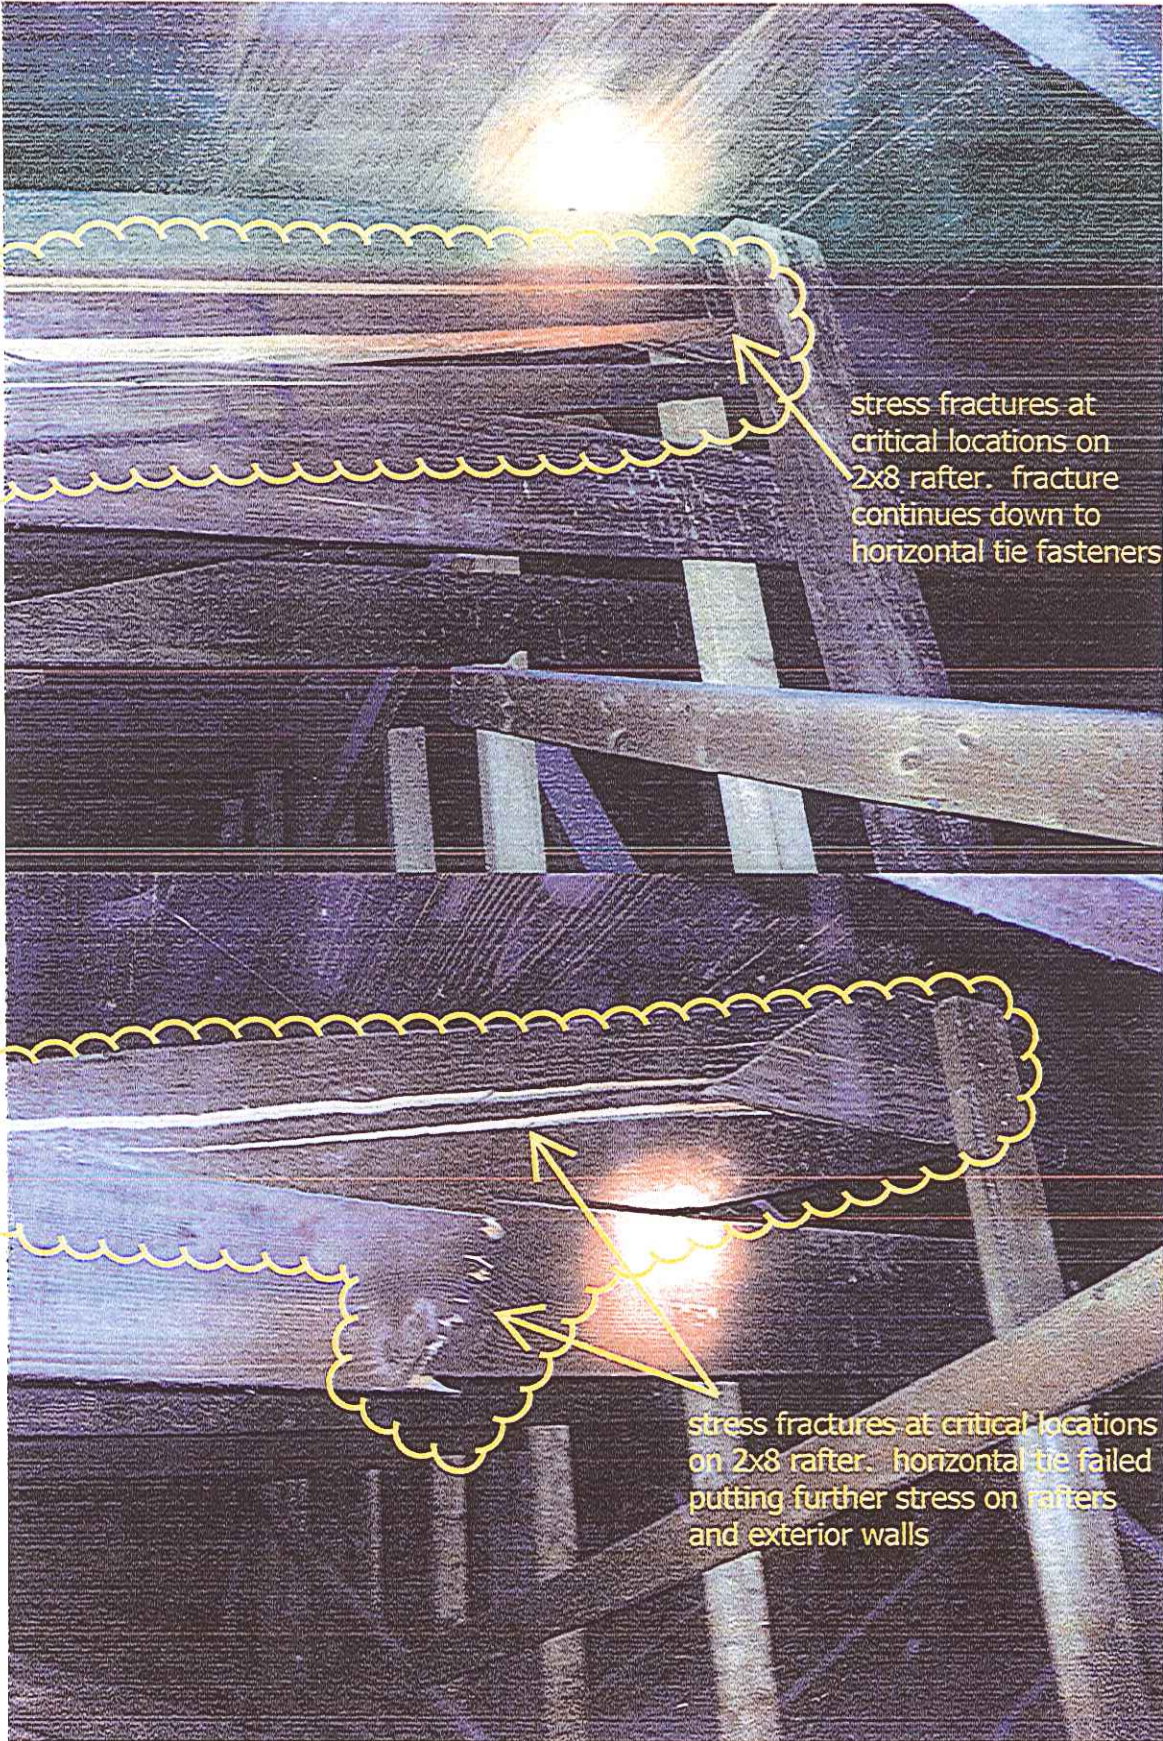
stress fractures at critical locations on 2x8 rafter. fracture continues down to horizontal tie fasteners
