DEMO  
PHOTOS

SUBJECT PROPERTY

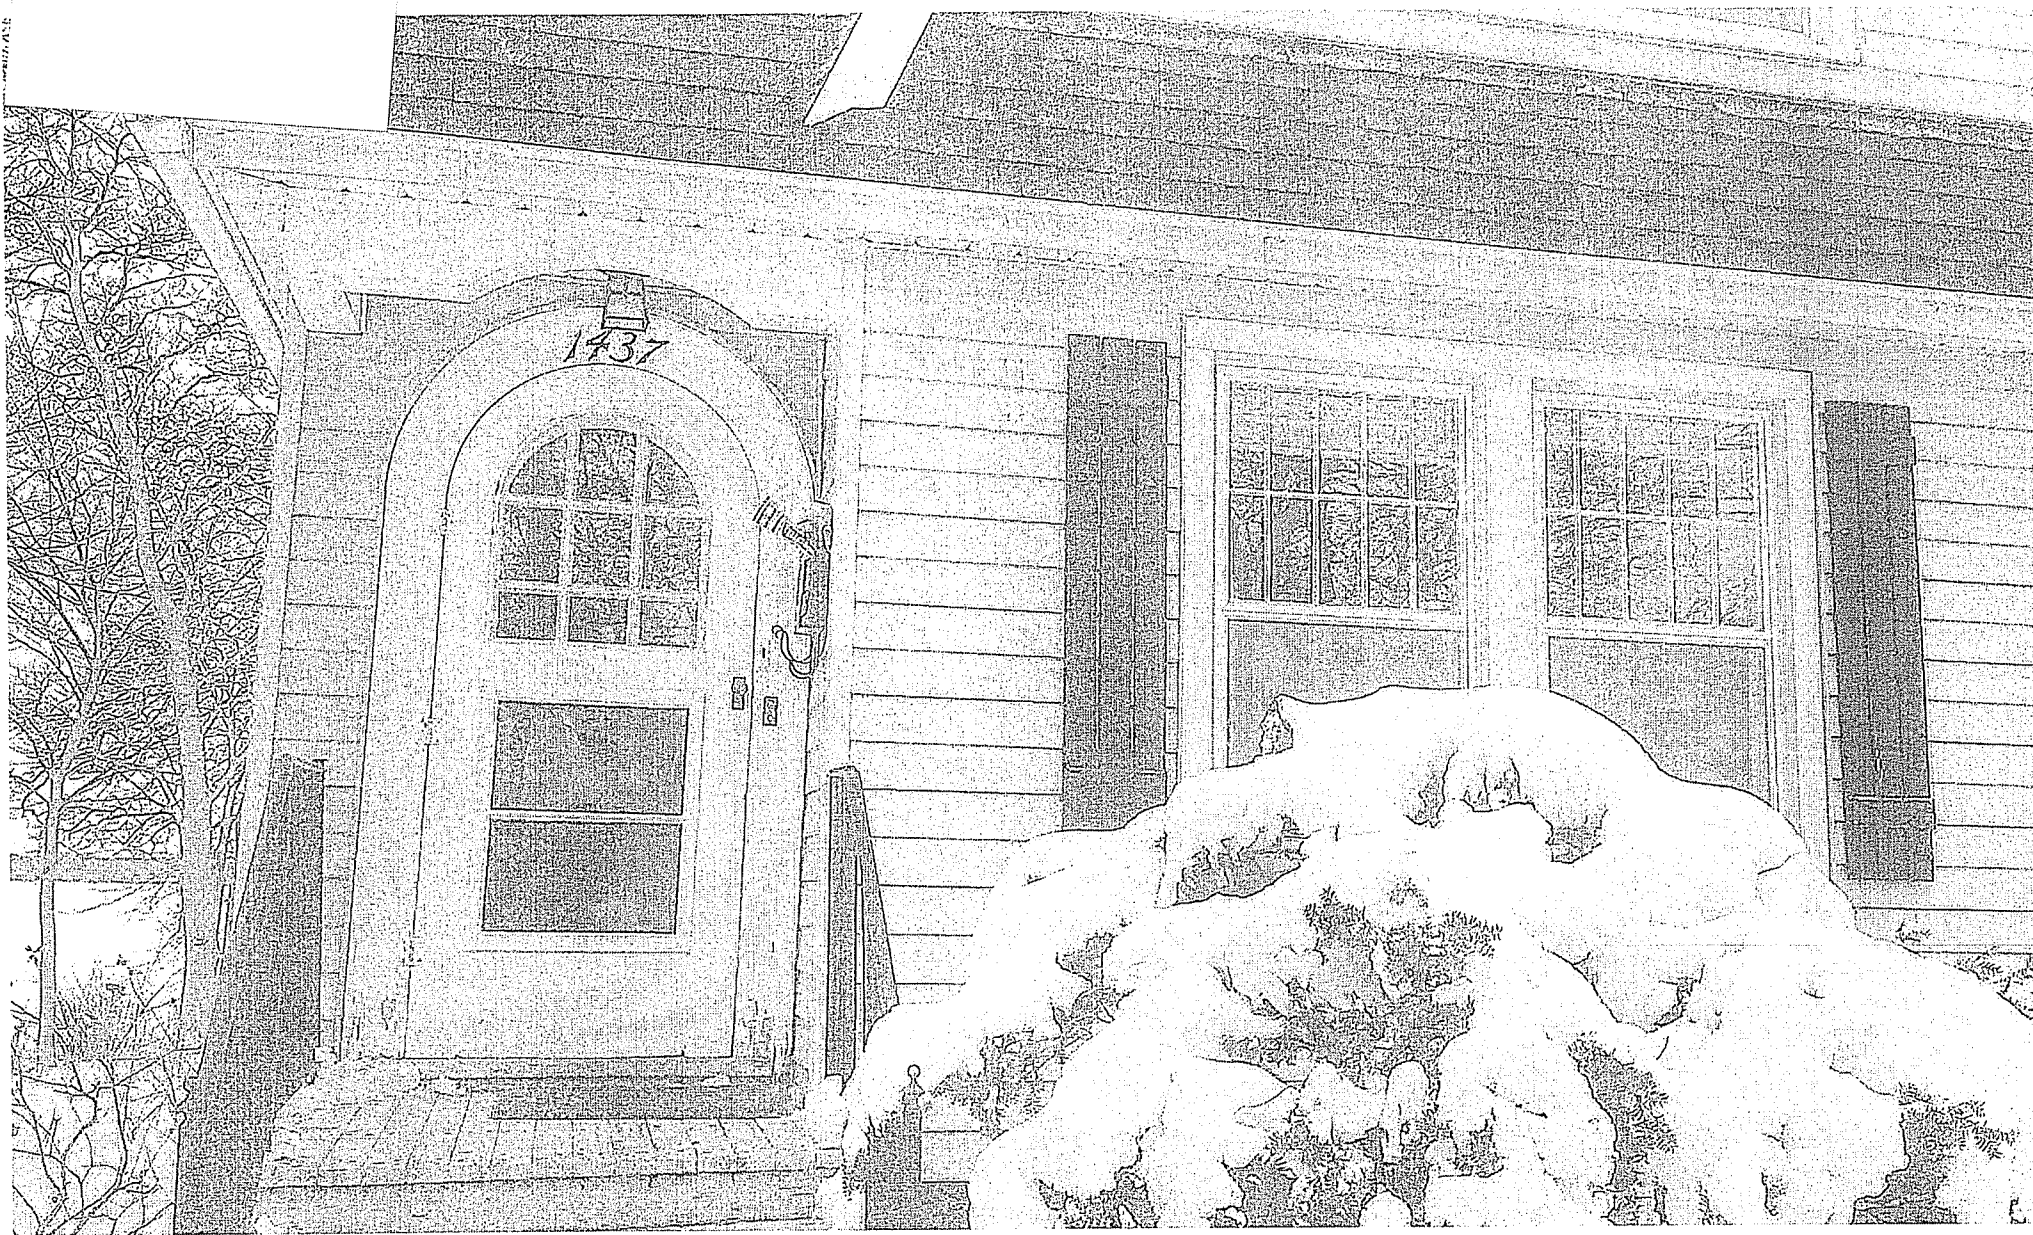
D-10FC

NOTE SETTLING FRONT PORCH, ROTTING TRIM.

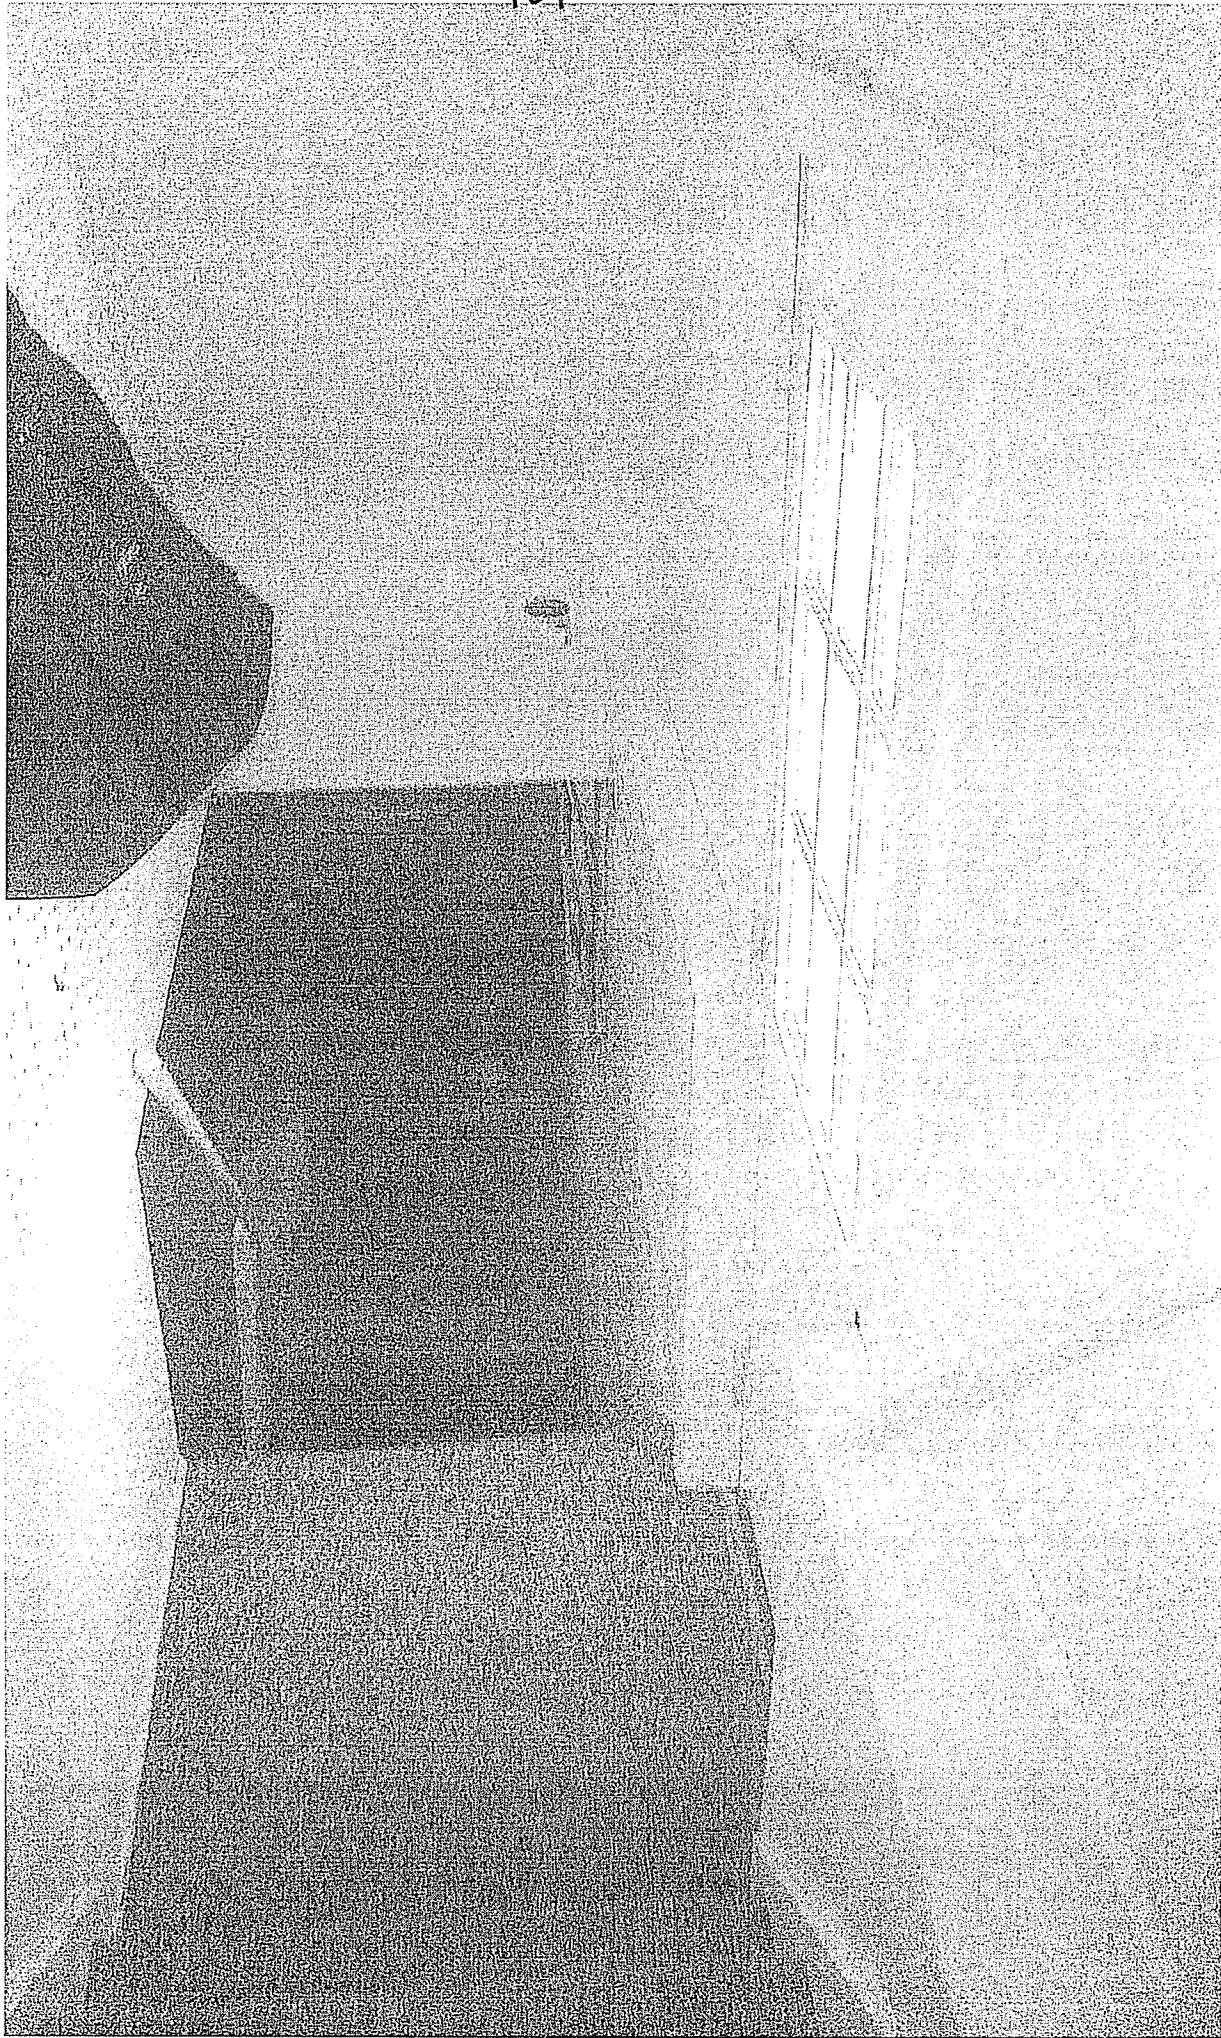
D- 20F6

NARROW, DANGEROUS STAIRWAY AND LANDING,

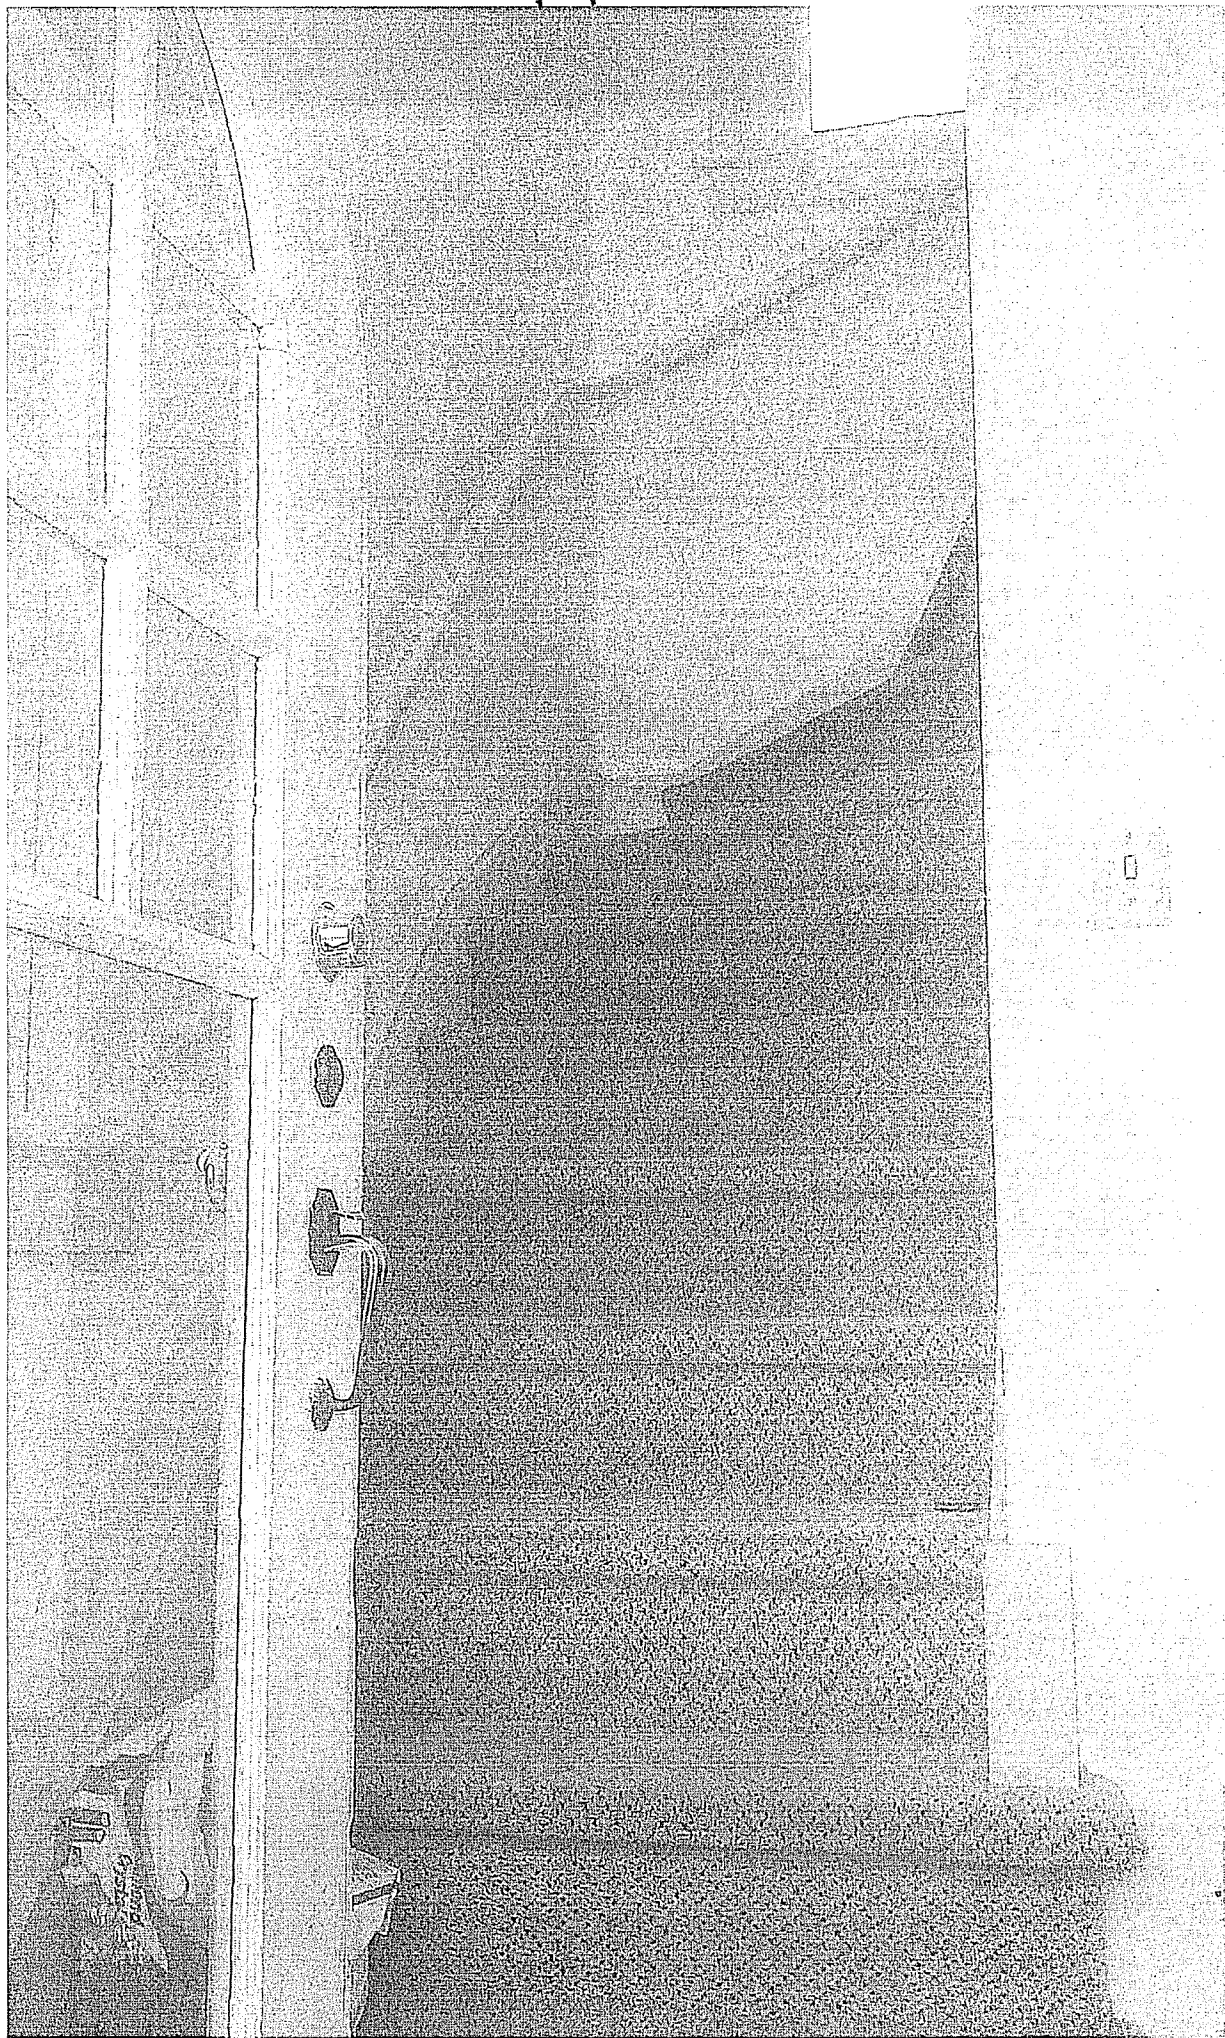
D-30F6

NARROW DANGEROUS WINDING STAIRS.

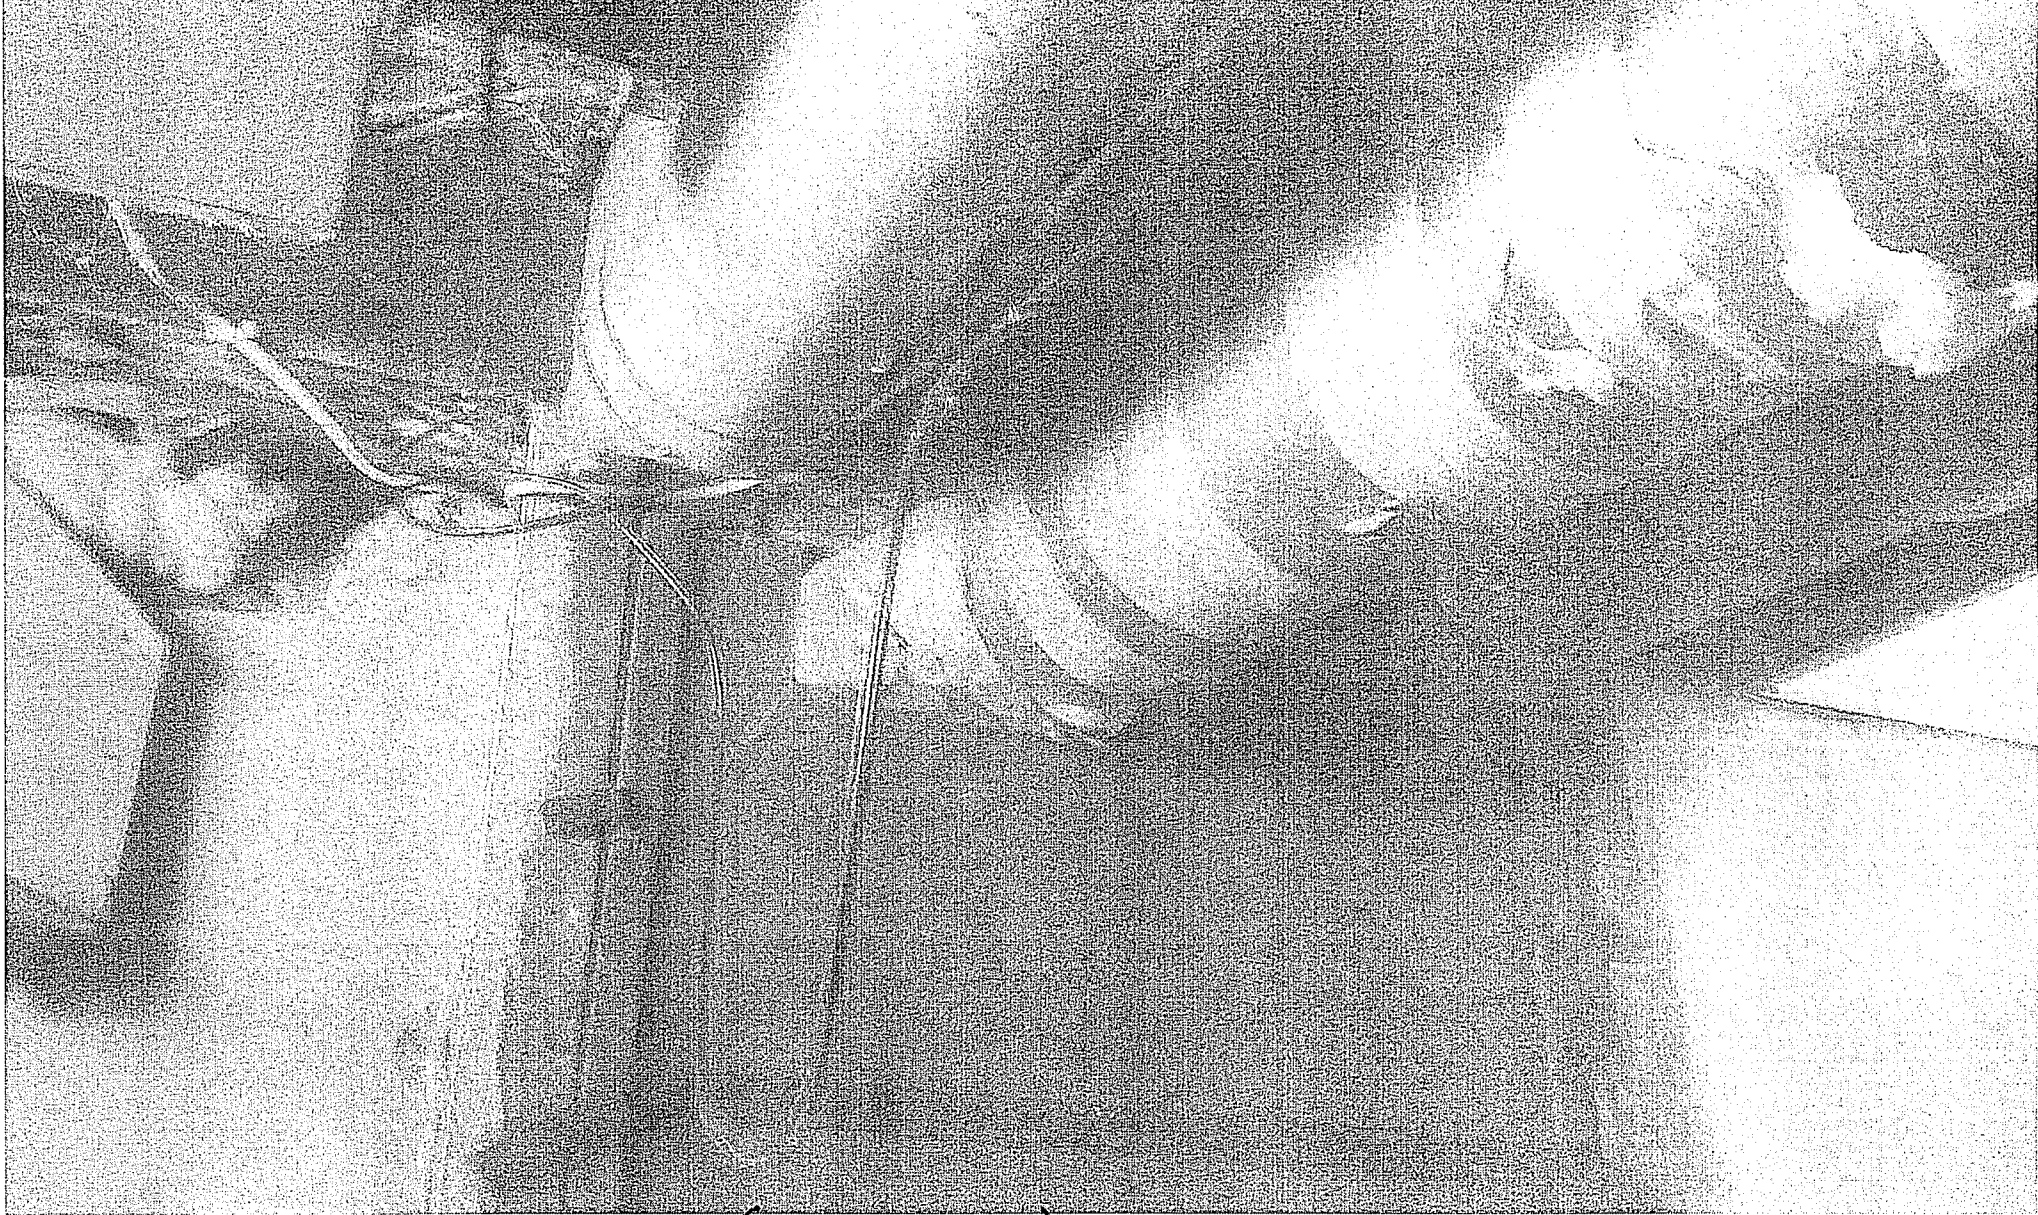
ANCIENT HEAT DUCTS. (ASBESTOS?)

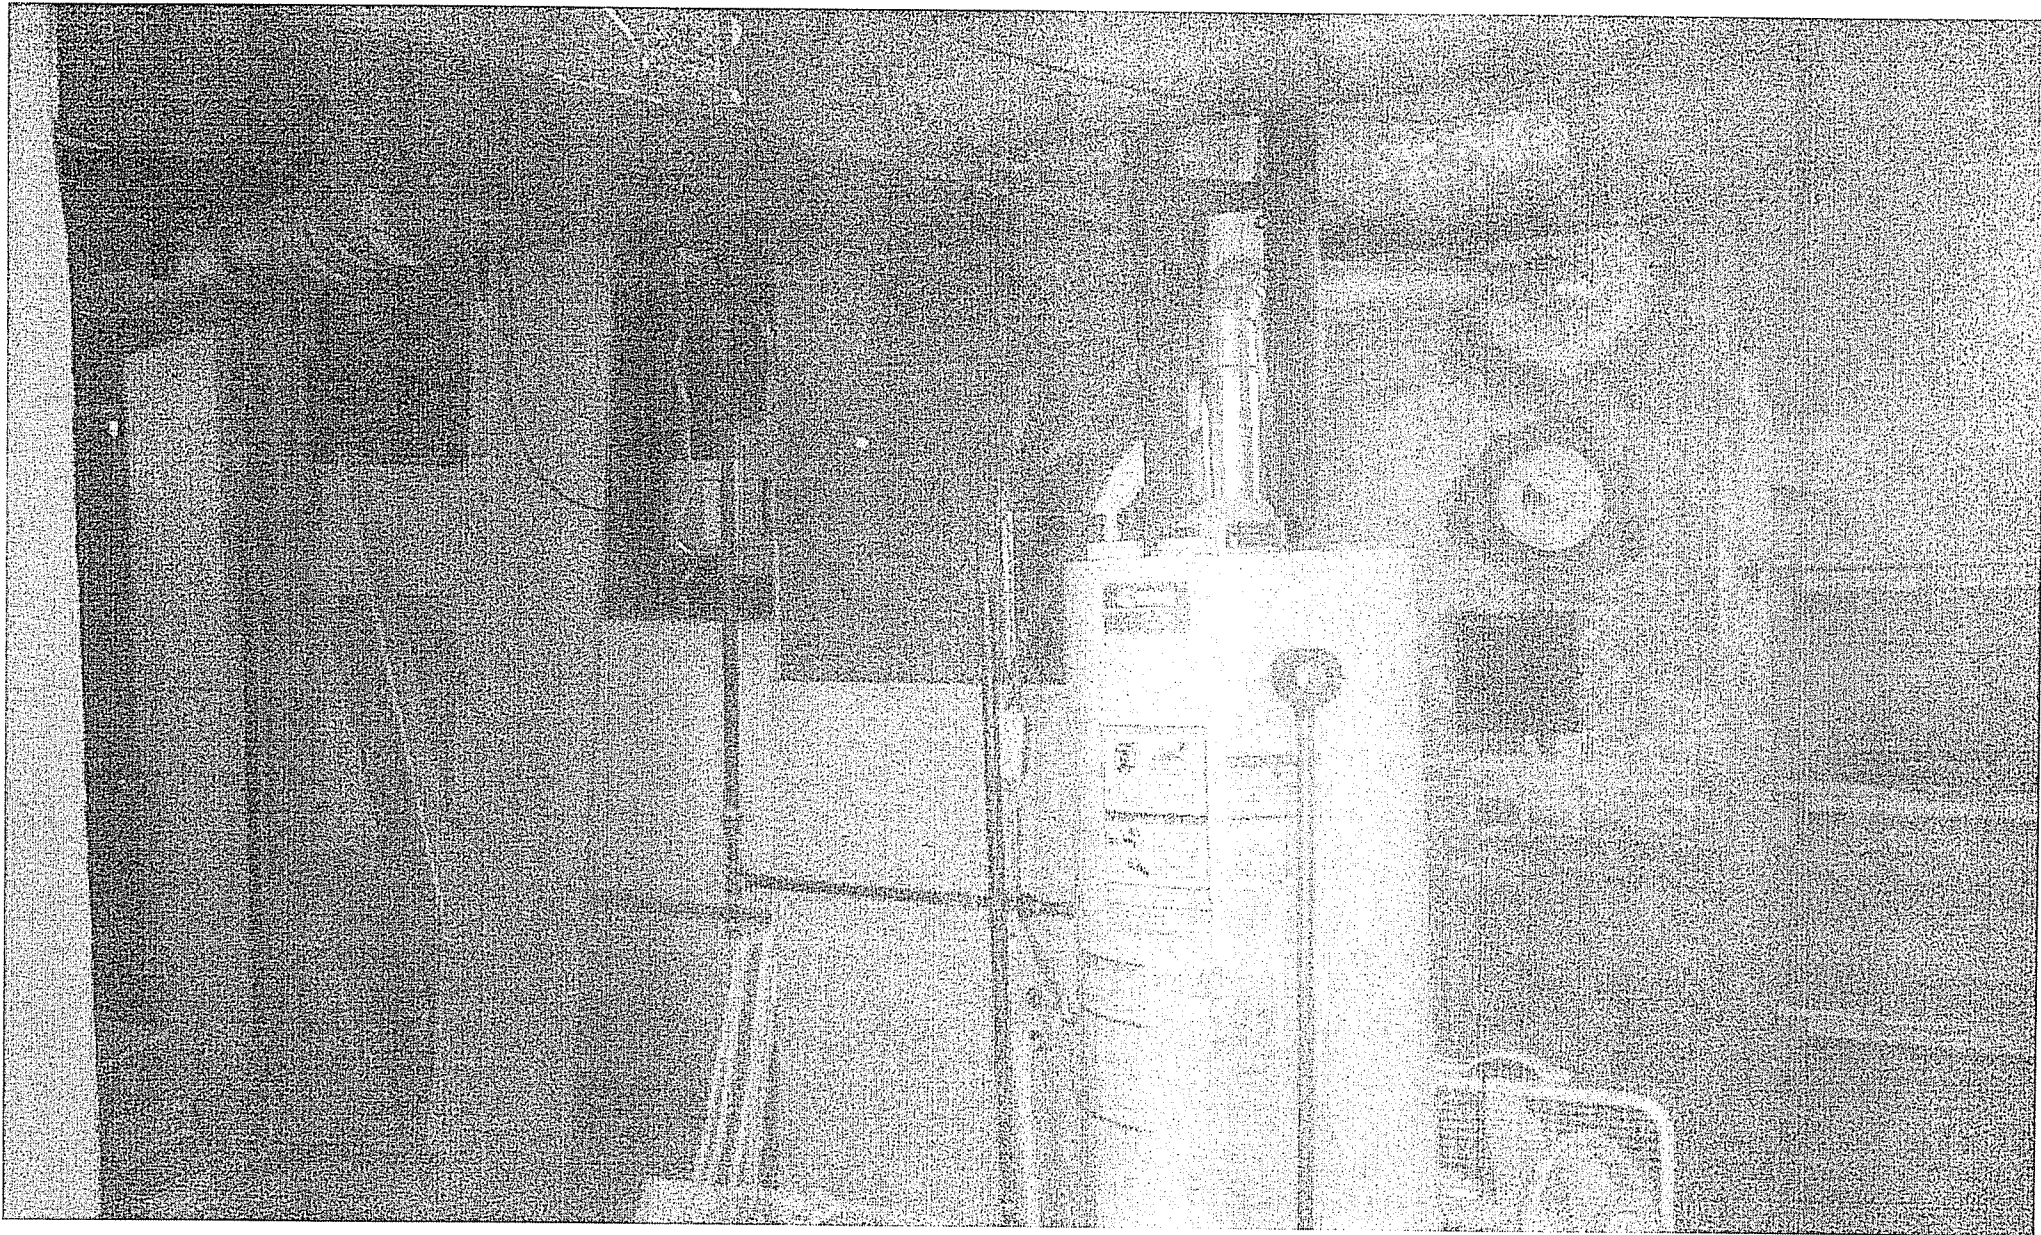
D-50F6

COBBLED BASEMENT MECHANICAL SYSTEMS,

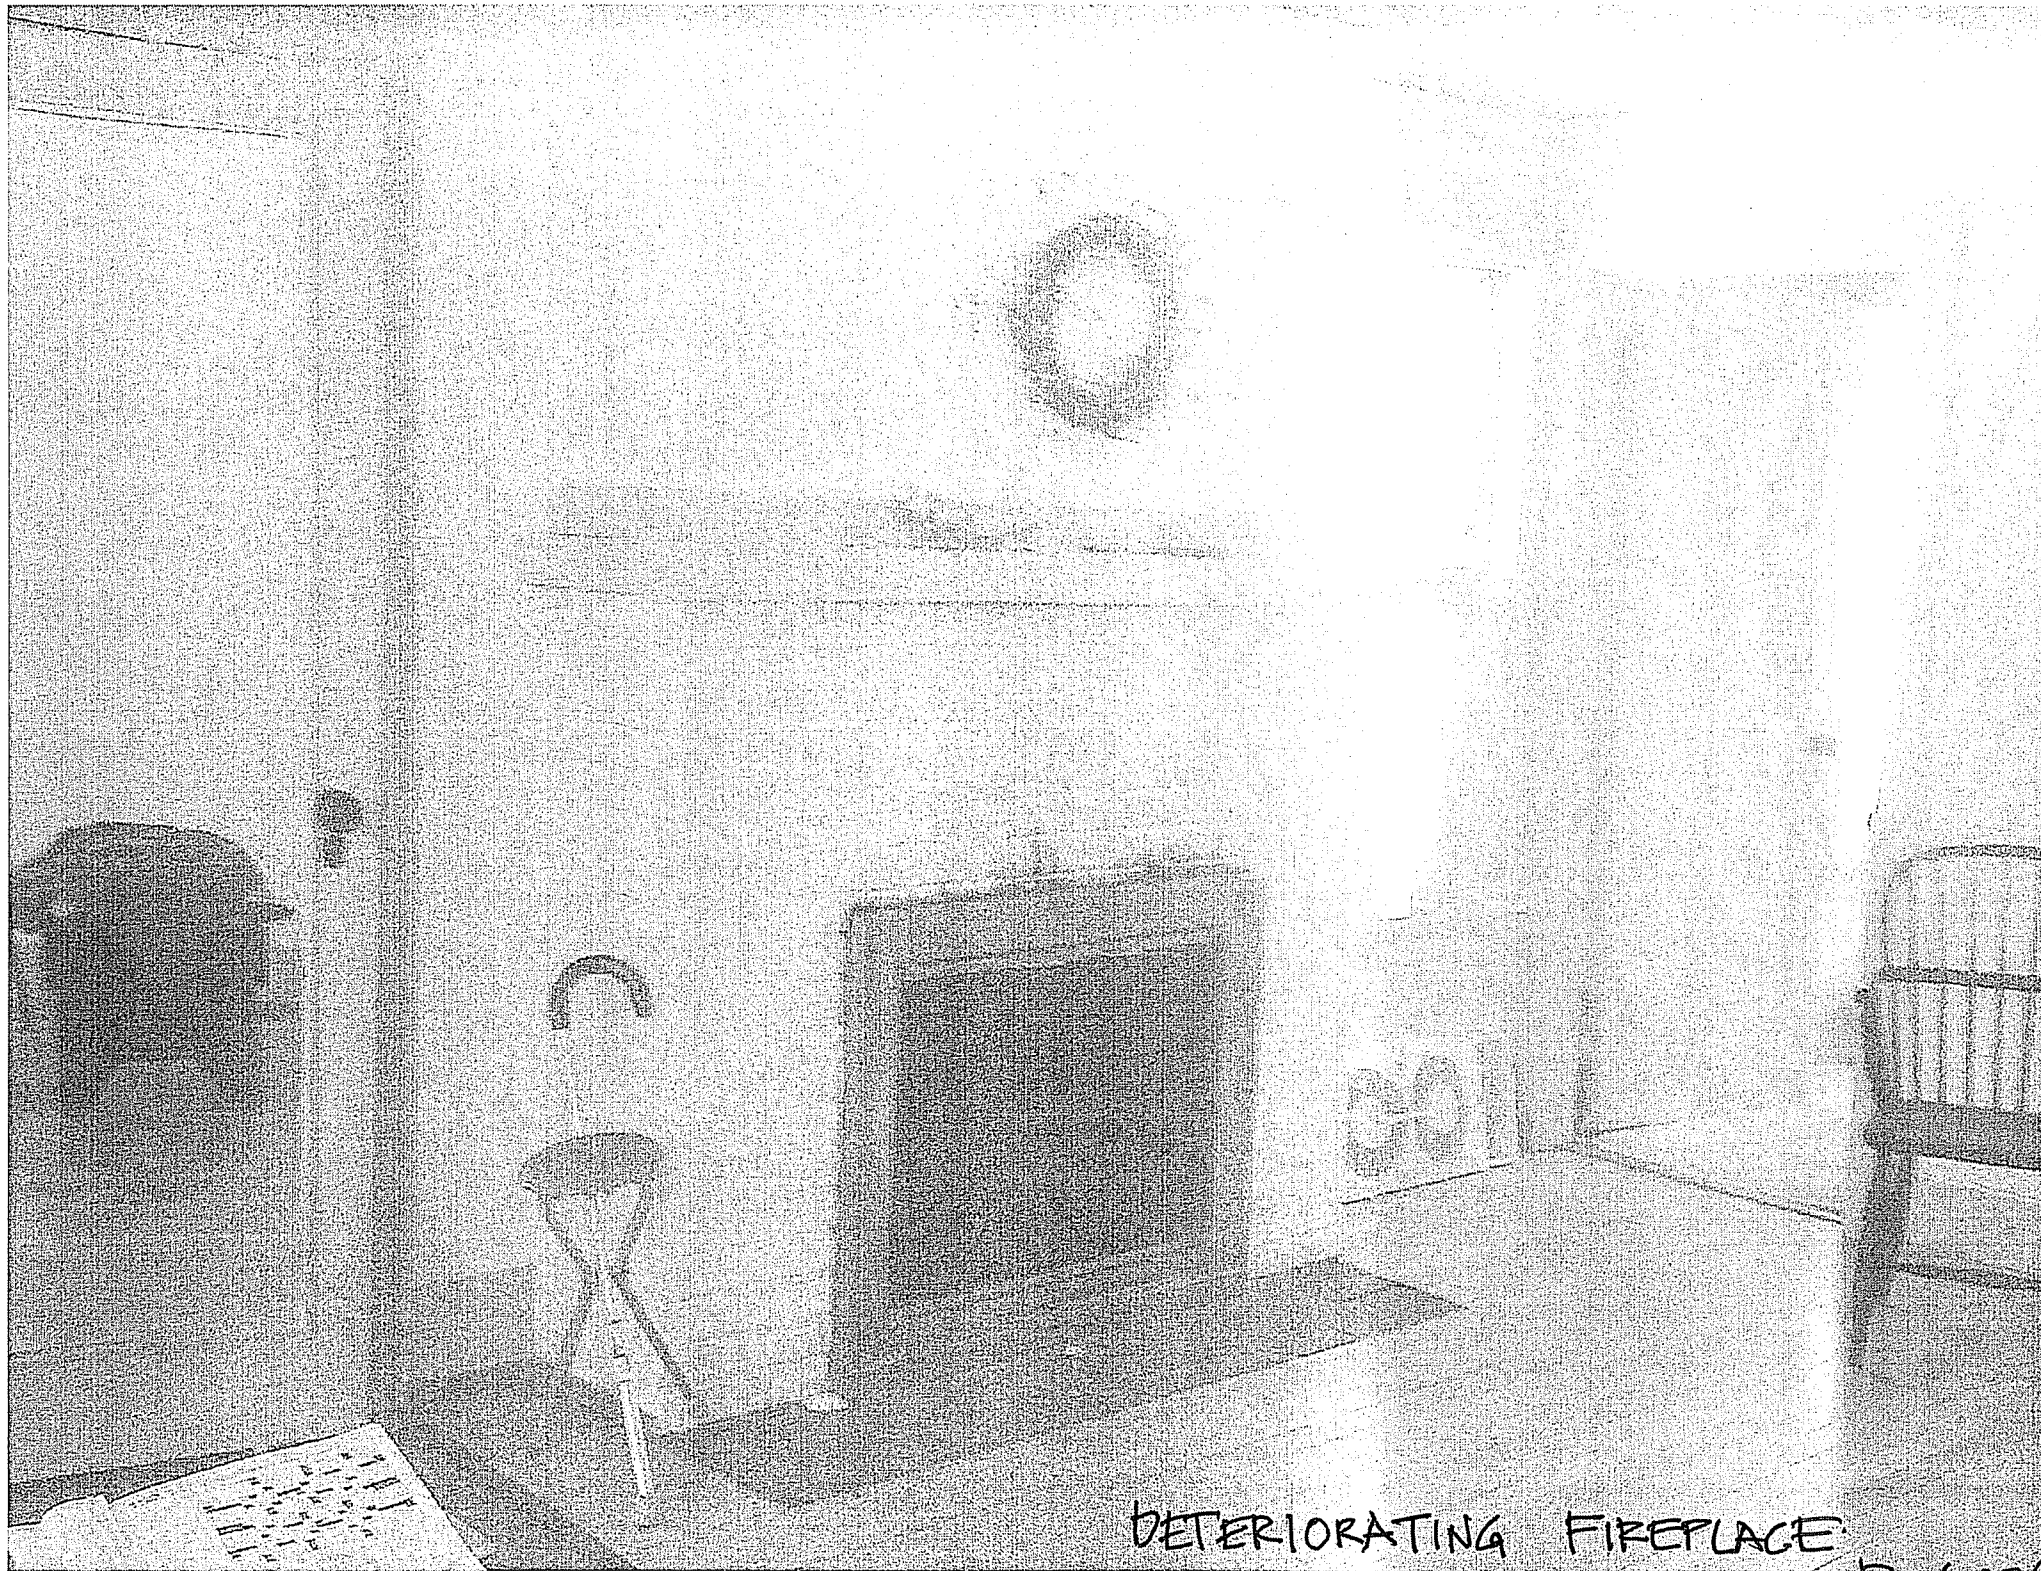
D-60F6

DETERIORATING FIREPLACE

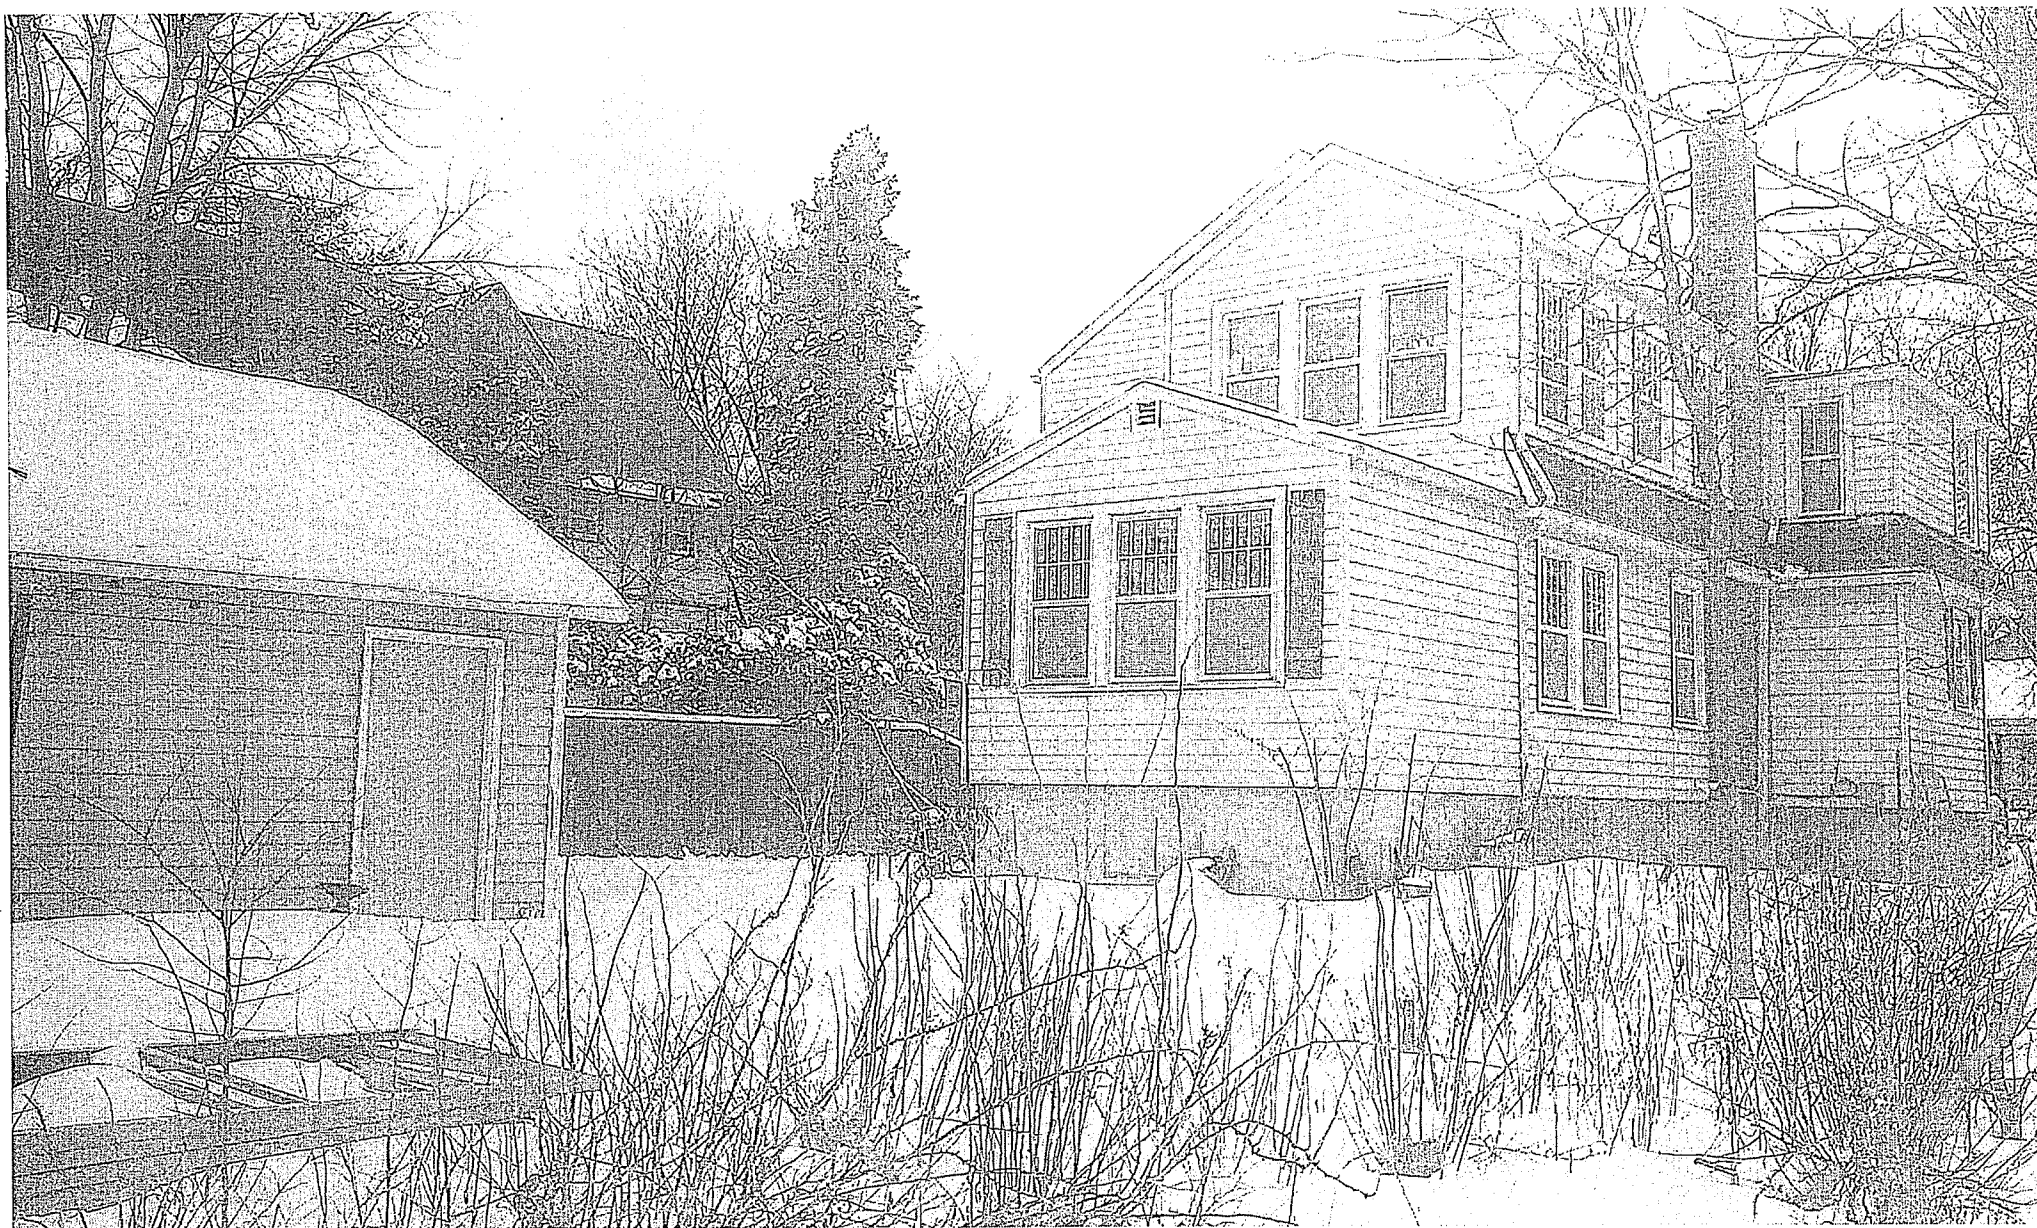
NOTE HOW FAR HOUSE IS RAISED  
ABOVE GRADE.

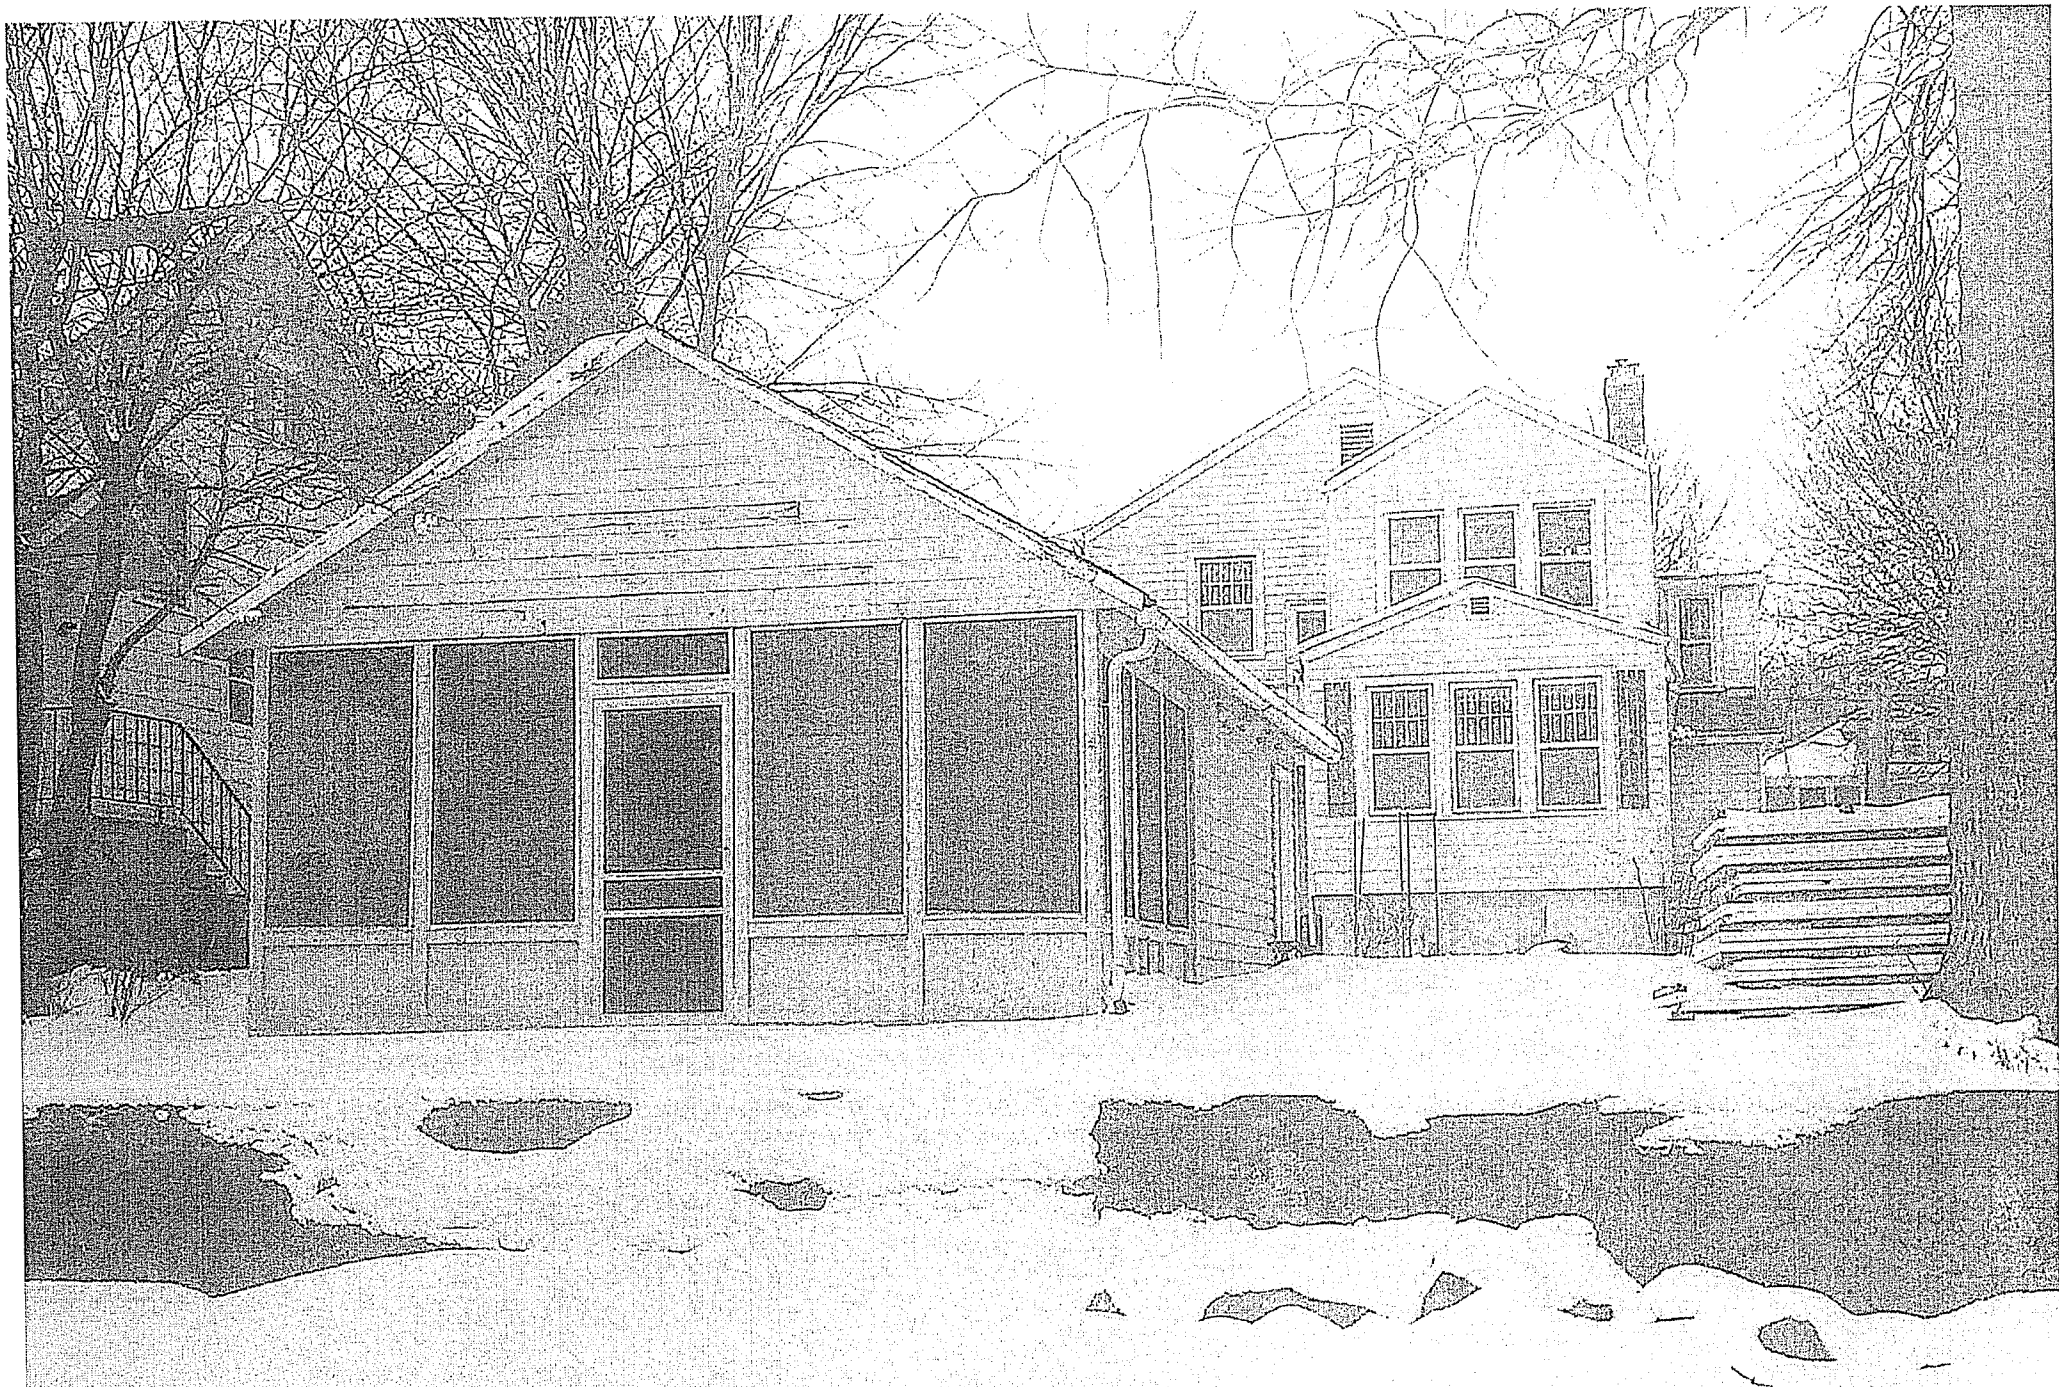
SOUTH (LAKE) ELEVATION.  
SUBJECT PROPERTY

NOTE DETERIORATING SIDING / FASCIA. 7 OF 13
