DEMO  
PHOTOS

SUBJECT PROPERTY

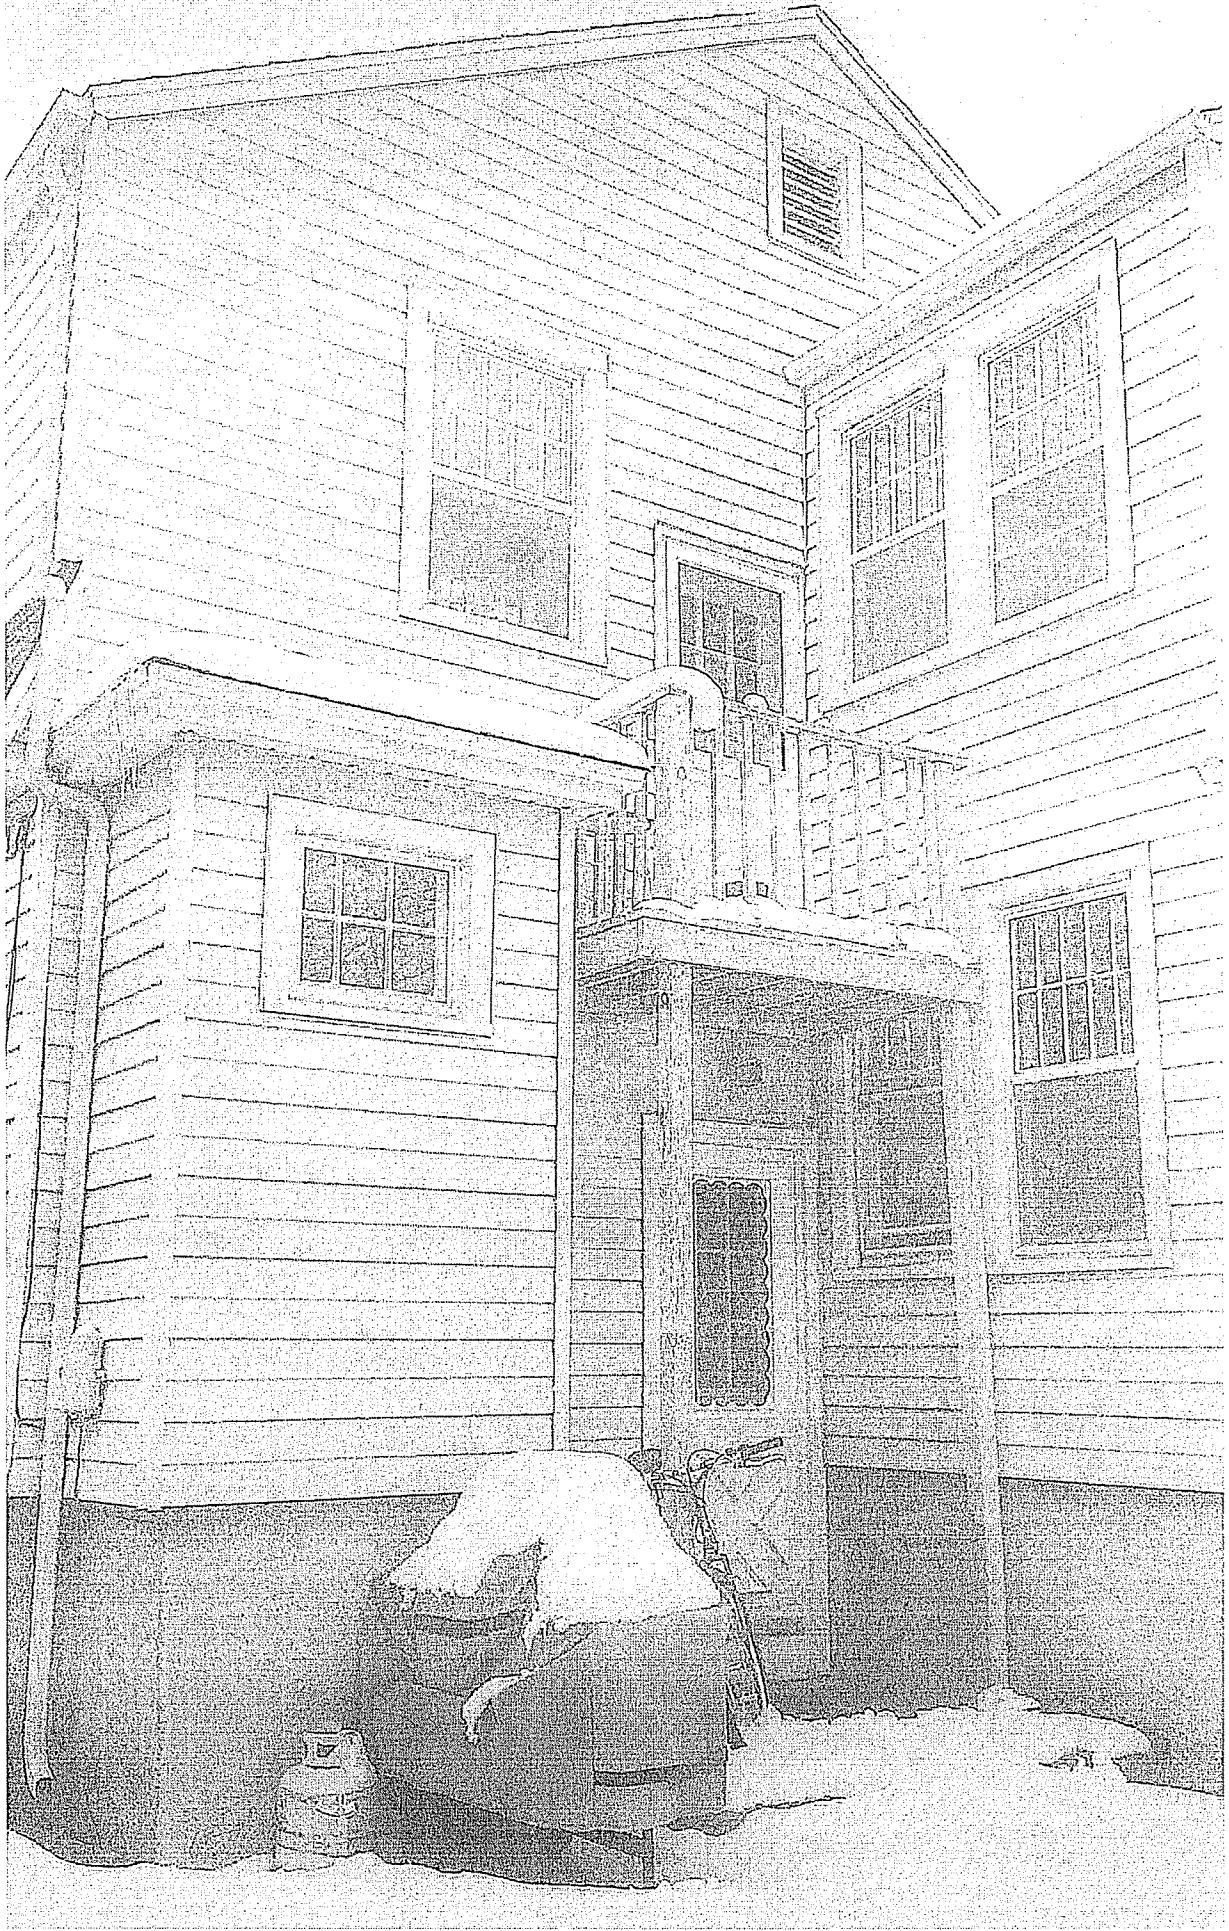
SUBJECT PROPERTY

NOTE FLAT ROOFED ADDITION AND JUMP  
BALCONY
