## Memorandum

July 16, 2008

Re: Structural/Architectural Assessment of Homes for Proposed Demolition  
Findorff Yards Office Lofts  
Urban Land Interests  
Engberg Anderson Project No. 081780.00

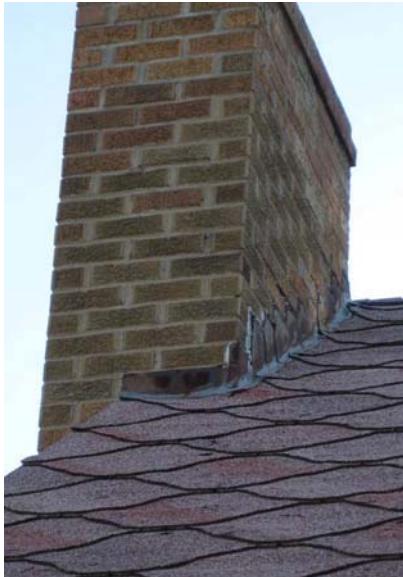
There is noticeable damage to the asphalt shingles as well as flashing or lack of flashing at the chimney and front porch/entry. The deterioration of flashing, or lack of flashing, has led to water infiltration and staining at the chimney in the attic, wall of the back porch and within the ceiling of the back bedroom. A complete removal and replacement of the roofing system would be required to eliminate water infiltration issues. See the following photos that highlight the issues discussed related the water infiltration:

Caulk failing between flashing and masonry and flashing and asphalt shingles

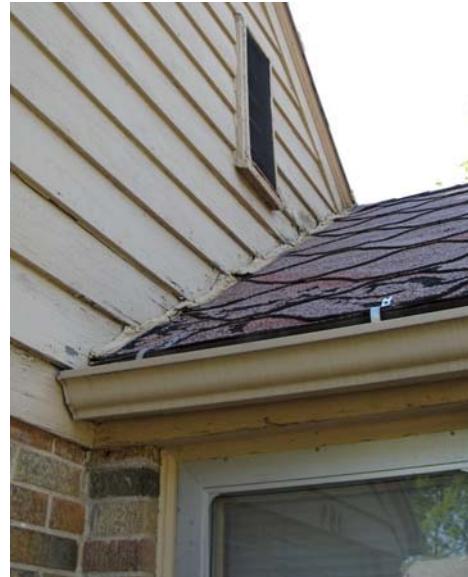
Deterioration of caulking and missing flashing at front porch roof interface with exterior wall

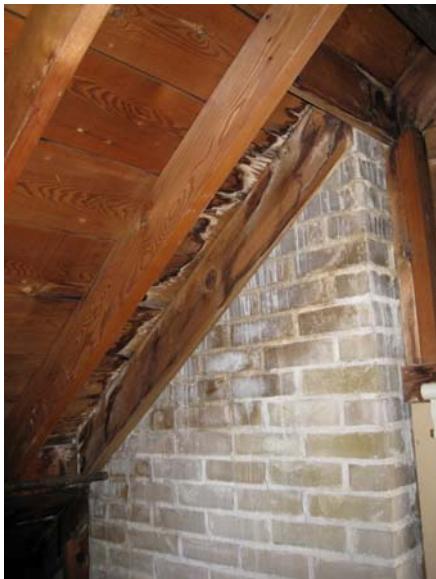
Water staining on roof sheathing and masonry at chimney

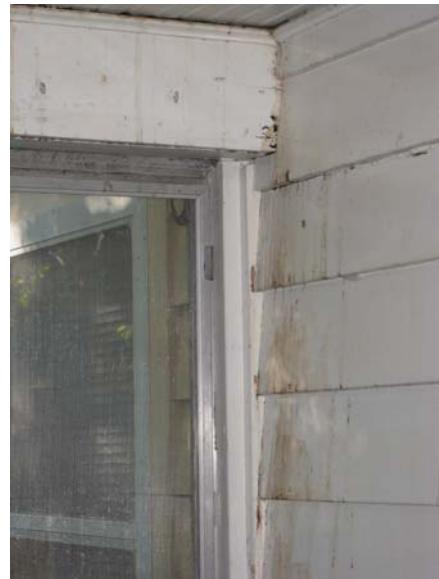
Water staining at back porch

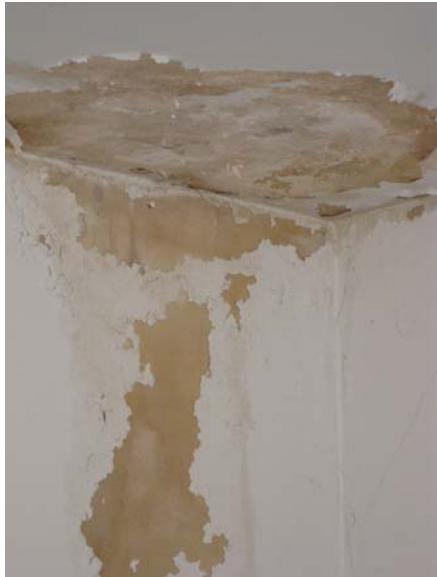
Water staining and deteriorated ceiling and wall plaster in back bedroom

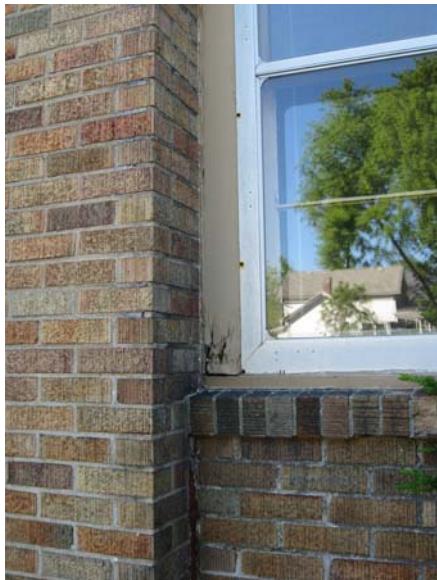
The wood siding and masonry appeared to be in generally good condition. The issues appear where either interface with each other, the roof, or opening conditions. At these conditions there is noticeable rot of wood trim.

Rot of window trim and deterioration of masonry/masonry interface

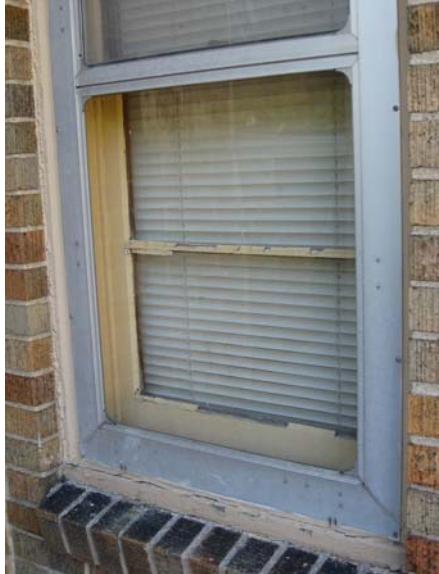
Deterioration of wood trim and caulking at masonry interface

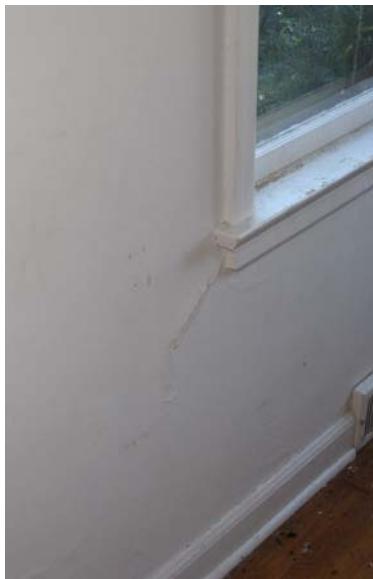
The single pane windows and storms are in poor condition. Most windows were difficult to open, or non-operable, in their current condition. Within the interior of the home there is noticeable cracking and blistering in the plaster; this would suggest water issues in some cases as mentioned earlier. The remainder of the plaster cracking is from typical settling, but would need to be cleaned and recoated. Issues of moisture in the kitchen and bathroom were noticed with the flaking and peeling of finishes on the ceiling and walls.

Blistering and cracking of plaster at window in living room

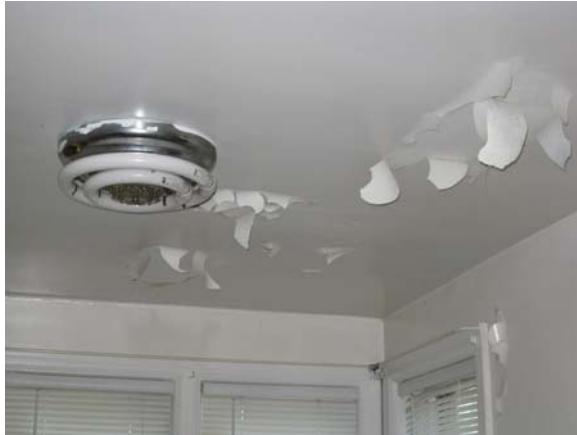
Peeling paint on ceiling and wall in kitchen

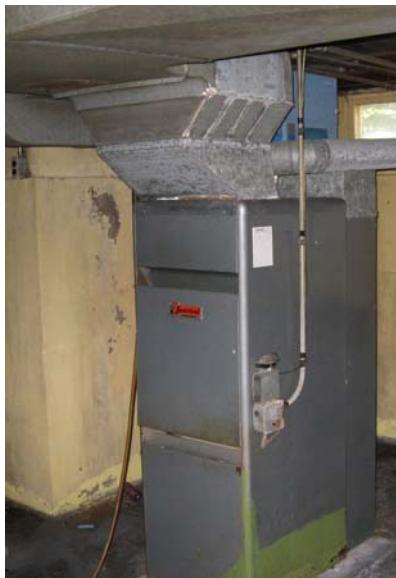
Electrical and mechanical systems are outdated and will need to be removed and replaced with up to date systems.

Outdated furnace

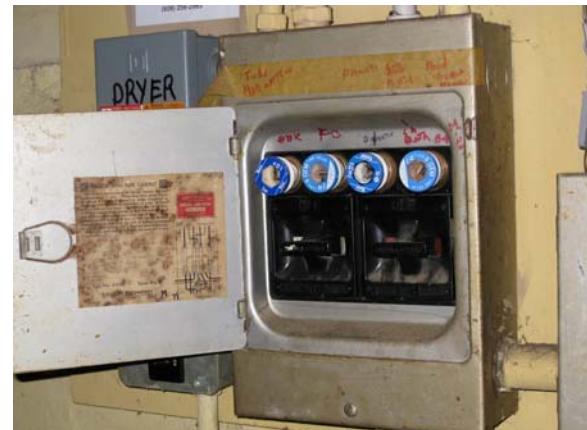
Outdated electrical system (no ground at the outlets)

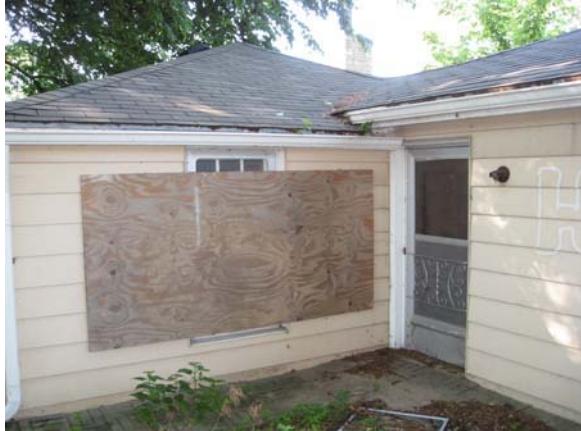
The aluminum cladding of the home extend below grade level; this is not a typical condition for aluminum siding due to the fact that moisture has no place to escape if it moves behind the siding itself. There is noticeable damage to the siding as well as some of the openings on the home. The interface of the masonry chimney and the metal siding has deteriorated over time. It is noticeable that attempts have been made to fix water issues by the numerous sealant joints at the interface.

Damage to metal siding and detail of siding continuing below grade

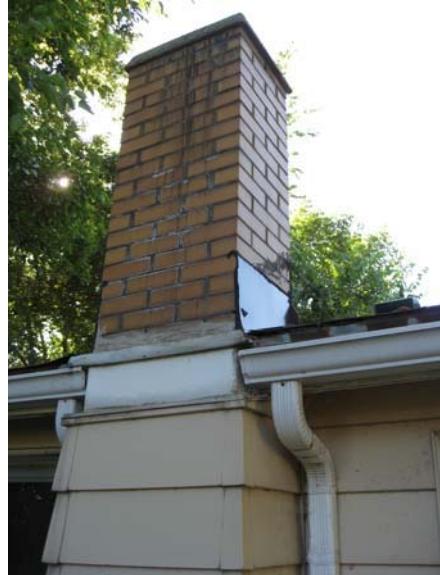
Water staining and attempts to correct at masonry chimney and metal siding interface

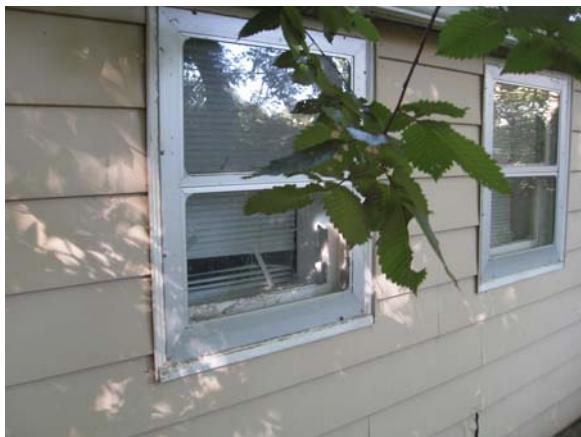
Broken/non-operable single pane window and storm

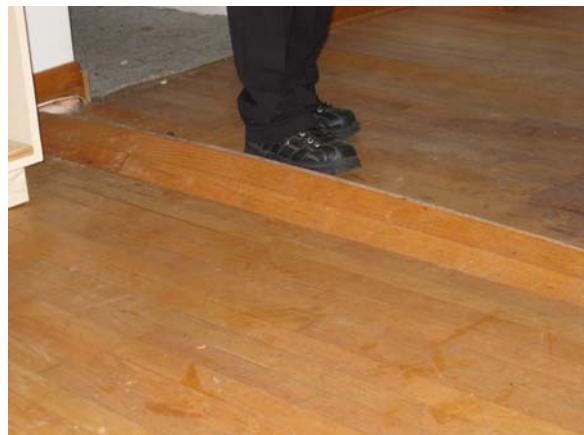
Within the interior of the home the main room is hardwood floors that have buckled due to excessive moisture. Peeling paint in the bathroom continued to suggest moisture issues. Upon attempting to enter the basement we encountered mold growing on the walls and door leading to the basement. We did not proceed further in to the basement do to the fact that the basement was filled with what we observed as 2-3 feet of water. Although the mold is not visibly growing on other walls in the home, it is assumed that the mold is far beyond the single wall of the basement and the door. See the following support photos for this documentation:

Swollen hardwood floors in main room

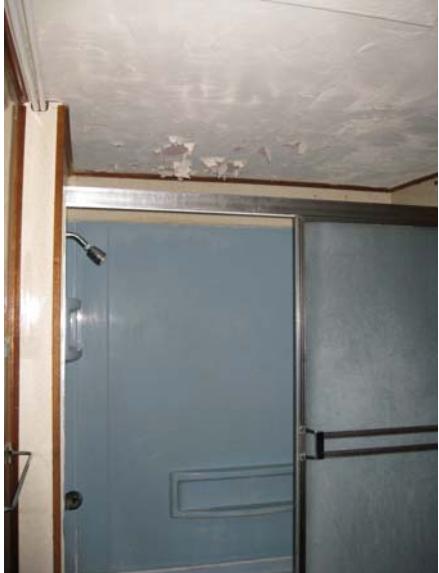
Peeling paint on bathroom ceiling

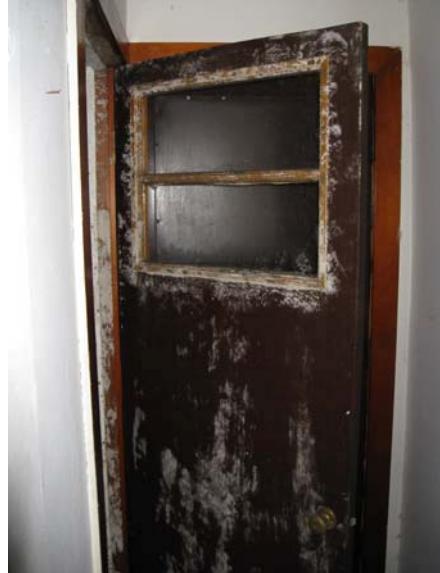
Mold on door leading to basement

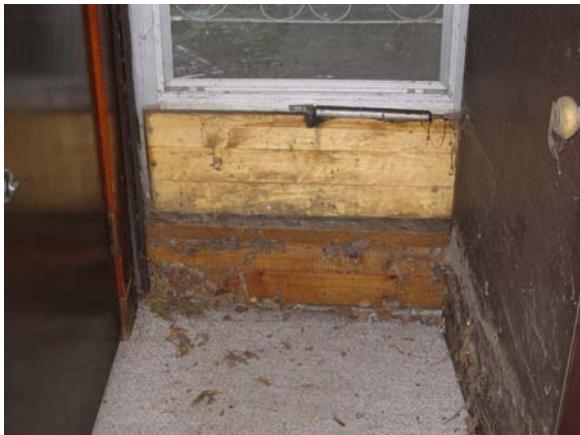
Floor elevation in home is 10" below outside grade

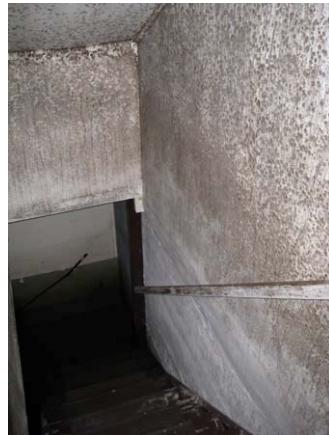
Mold throughout walls leading down to basement/water filled basement

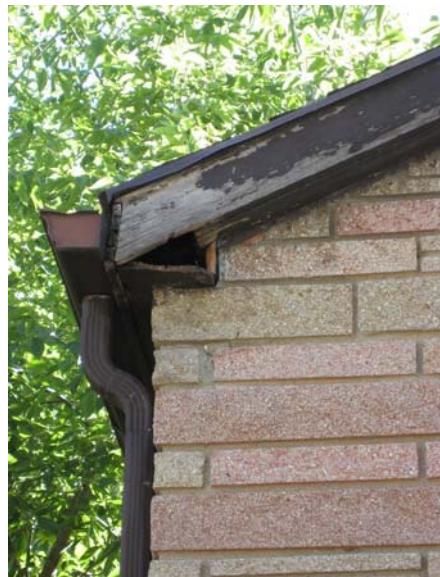
Rot and noticeable openings in eaves

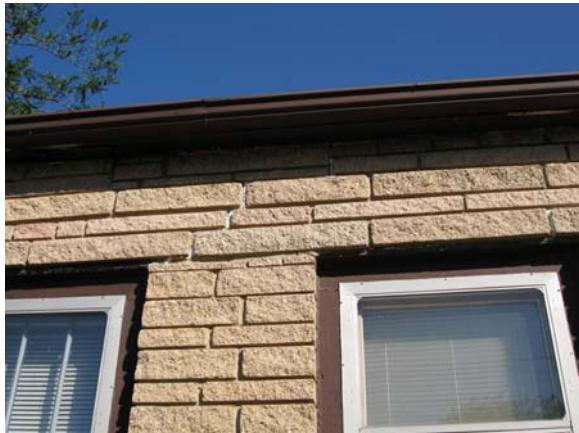
Caulking within mortar joints to attempt to repair cracking

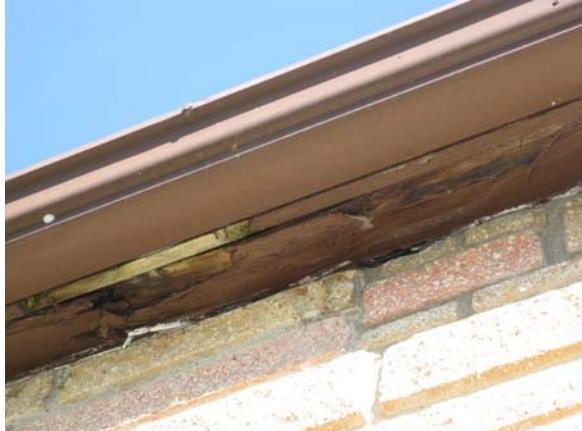
Rot at wood eave/masonry interface

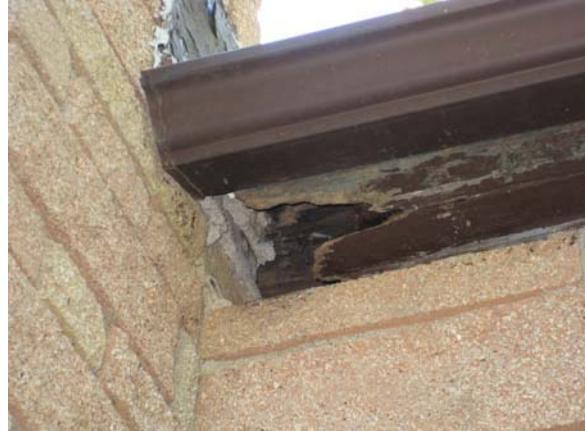
Rot at wood eave/masonry interface

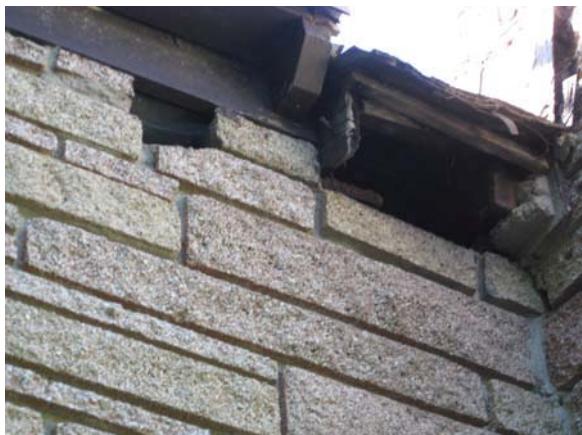
Rot and noticeable openings in eaves

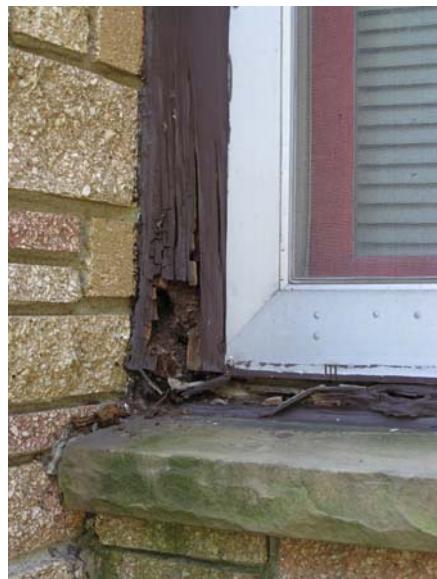
Rot and insect damage at wood window trim

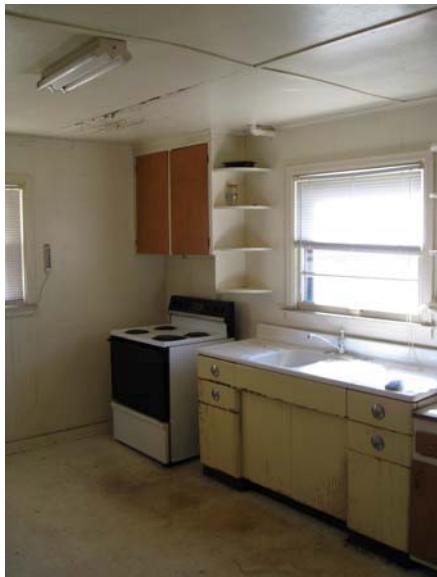
The rotting and deterioration of the roof and eave system has led to noticeable water damage within the home. The kitchen had a standing puddle of water on the floor and the painted wood panel ceiling was sagging from water damage. Other areas throughout the bedrooms have noticeable sagging in the wood panel ceiling as well as staining on the walls.

Sagging ceiling and water damage in kitchen  
ceiling/water on the floor

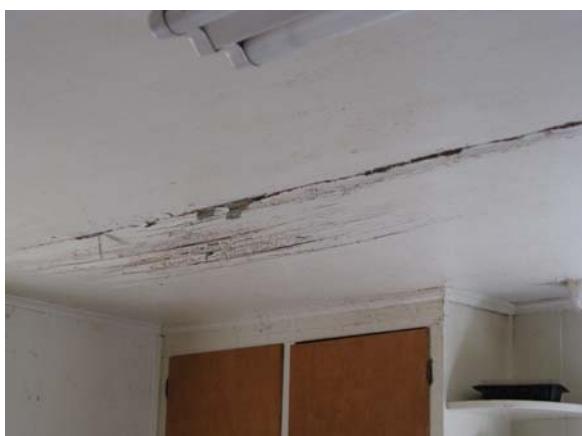
Water damage in kitchen ceiling

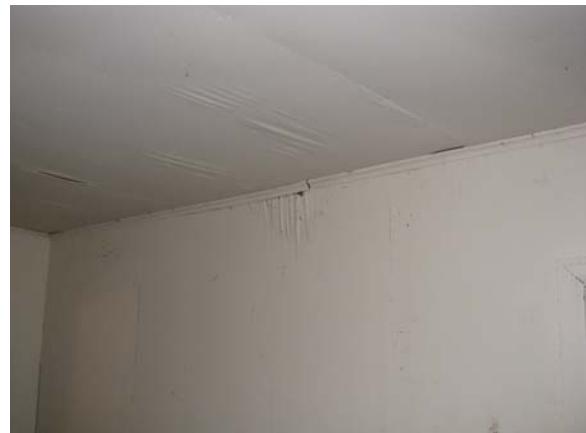
Water damage on ceiling and wall within  
bedroom

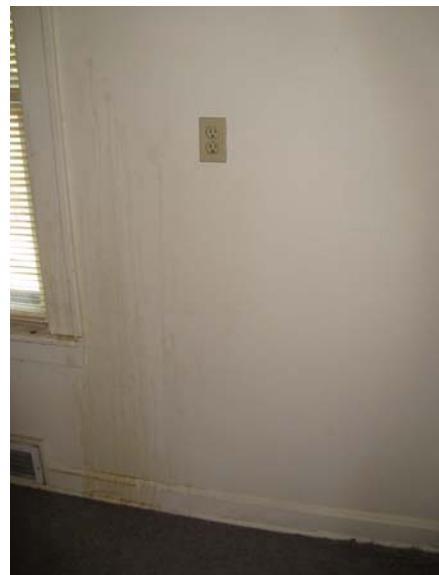
Water staining on wall around window

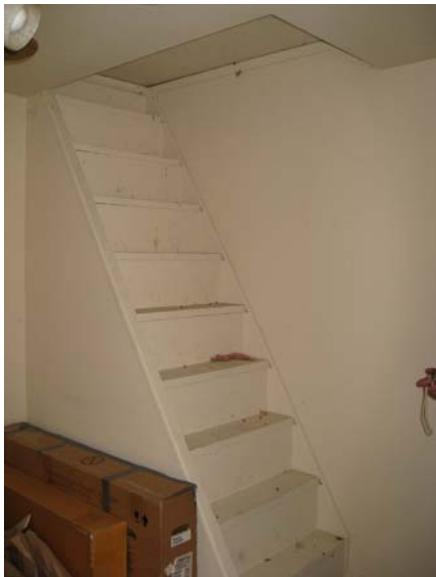
Non-code compliant stair to attic; would have to be removed or renovated

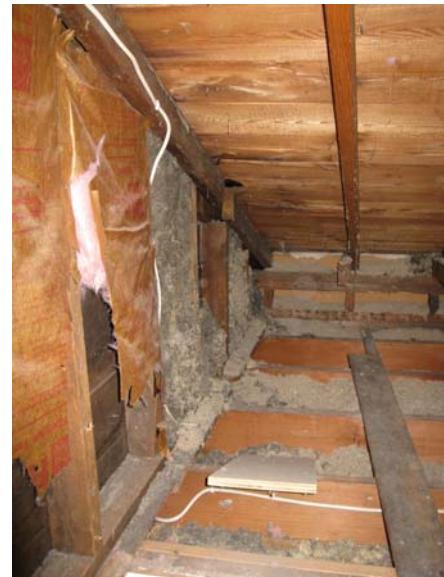
Throughout the house cracking and chipping has occurred in the plaster from typical settling of the house. A non-code compliant stair was located in the center of the home that led to unfinished attic space. Limited insulation was found in the attic, and the smell of feces was very noticeable. Areas of the limited insulation appeared to have been chewed; expected with the number of holes in the eaves on the exterior.

Limited insulation/chewed insulation within the attic

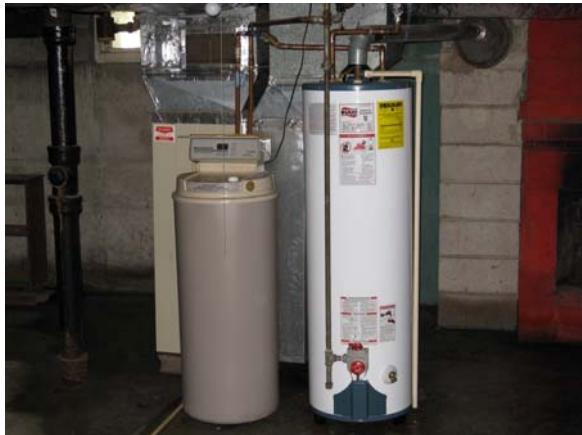
The basement had noticeable signs of water entering the building from the concrete foundation walls and running directly in to the floor drain; staining was prevalent. The mechanicals were not running, but appeared to be in good condition.

Mechanicals in basement
