DEMOLITION STANDARDS & PHOTOS

17,19 25 N. Webster
201 E. Mifflin
Rezoning from DR1 to UMX
Madison, WI 53703

Re: Properties located at 201 East Mifflin Street and 17, 19 and 23/25 North Webster Street
Madison, Wisconsin

Purpose

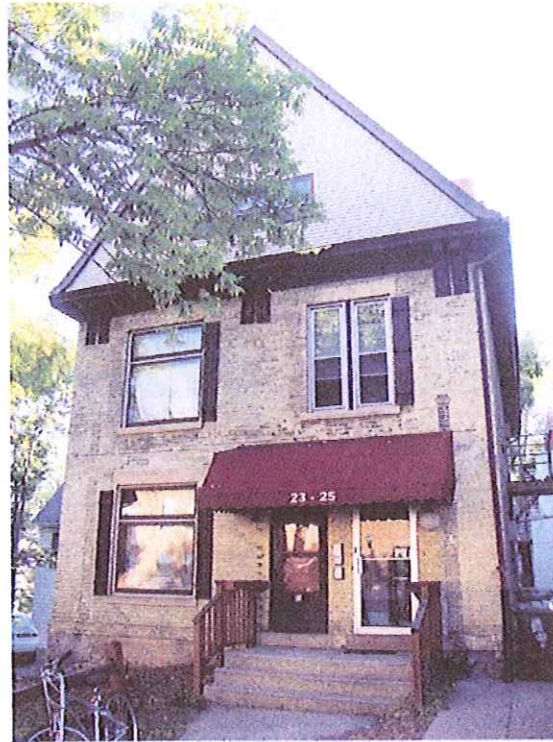
*Front view 23/25 N. Webster Street.
Original front porch and related details removed.*

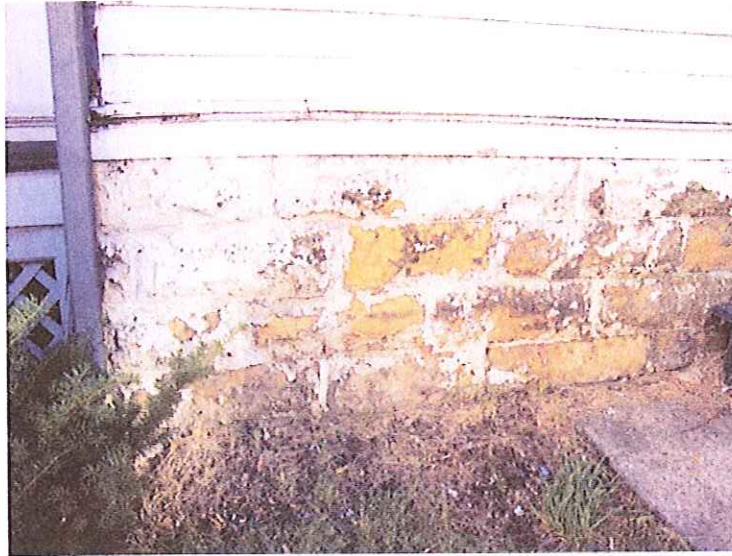
The stone exterior basement walls of the buildings have areas of delamination and deterioration especially right above ground level. Retained moisture freezes and spalls off layers of the stone.

Image of 201 E. Mifflin St. showing the deterioration of the stone masonry foundations walls

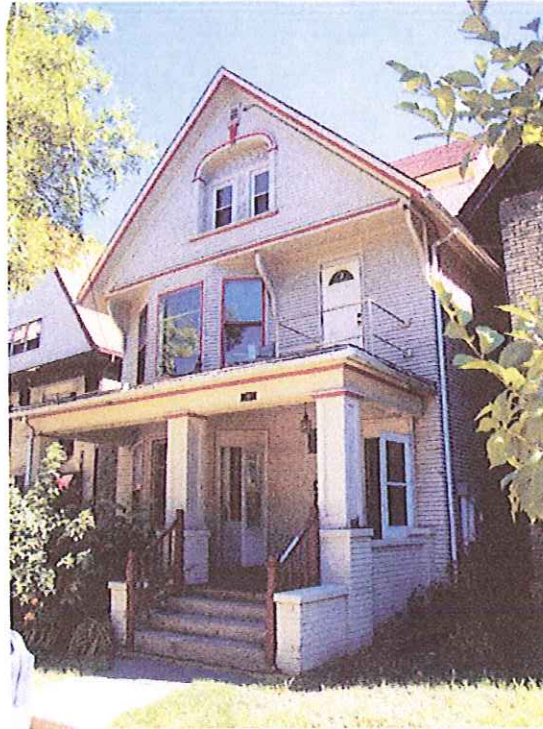
*View of the front 19 N. Webster.
The porch has several deterioration issues.*

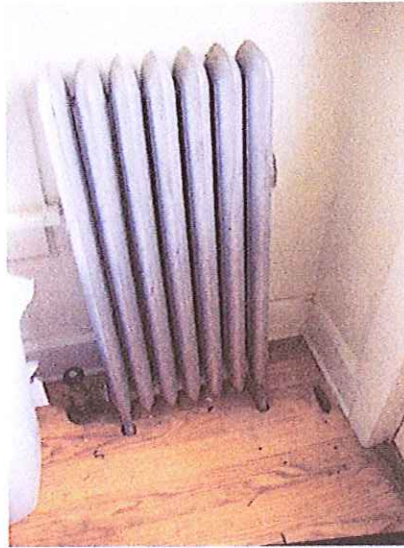
*Typical hot water radiator.
17 N. Webster St first floor apartment.*

In all four buildings the existing mechanical, electrical and plumbing systems are functional and apparently generally code compliant. However, the age and state of maintenance of the equipment indicates upgrades and replacement that are not too far in the future. The buildings are heated by boilers supplying hot water to perimeter radiators or fin tube enclosures. These are controlled by thermostats. Electrical systems are a combination of knob and tube and contemporary Romex wiring. Evidence of original gas lighting remains in 201 E. Mifflin and 17 N. Webster.

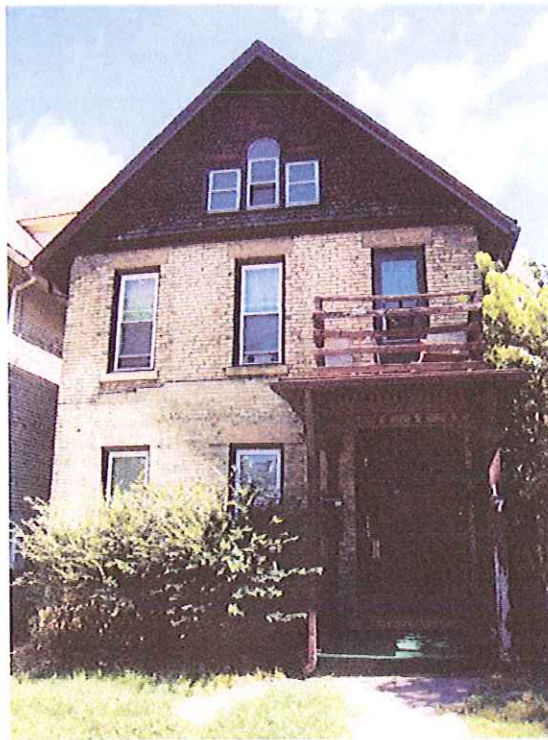
*Front of 17 N. Webster Street.
The rear portion of this house is the original section.
The front addition was constructed sometime later.*

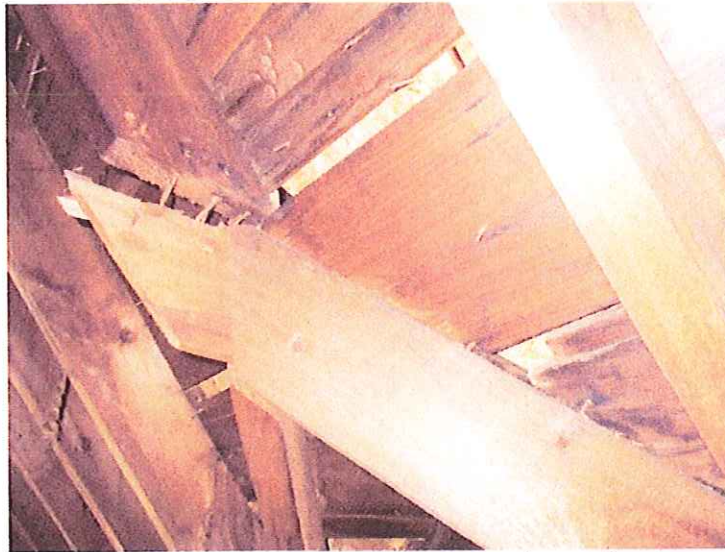
Other portions of the basement are an inaccessible crawlspace. The roof lines in the front of the building were generally poor. Significant deformations were observed in the regions of the dormers. On the exterior, large areas of masonry on the north and south elevations have spalled faces, likely due to the presence of water and freeze thaw cycling.

*Image showing damaged roof framing at dormer framing.
17 N. Webster St.*

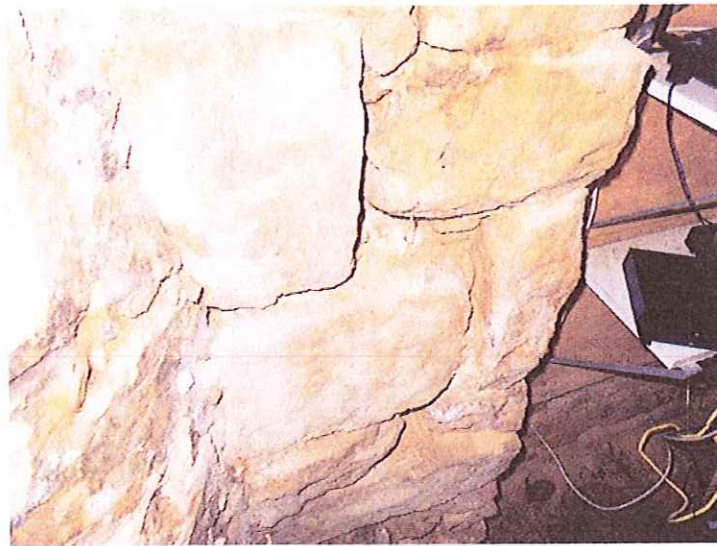
Structural issues at 17 North Webster Street were noted in the basement. The basement is divided into three spaces; two were accessible. Most of the basement has a dirt floor. The presence of fuel oil smell was noted in the west section. The interior surfaces of the foundation walls were in poor condition. Significant deterioration was noted in the mortar. Several holes were observed that were crudely punched in the walls in various locations for access to services and other areas.

*Image showing significant deterioration
of mortar in foundation walls 17 N. Webster St.*

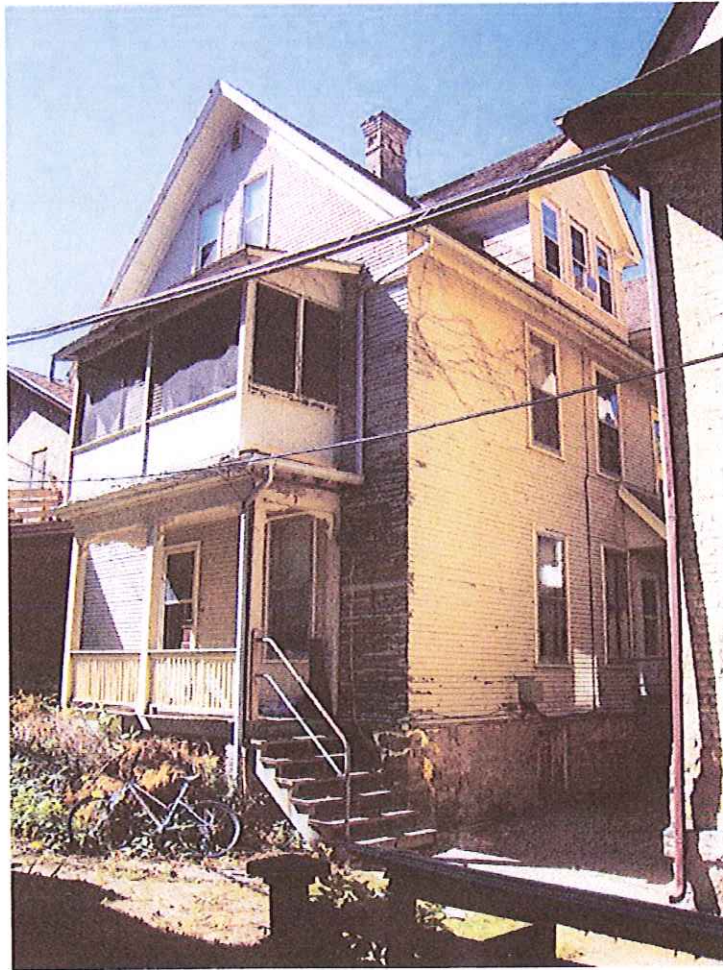
At 19 North Webster Street the most significant issues is the poor condition of the rear porch. This porch is leaning and floors and roof are deteriorated. Some recent repairs to deteriorated floor framing have been carried out. More similar repairs will be likely, soon. At the front porch there is deterioration within at least one of the wooden roof support columns and at the interface where the brick pier of the porch abuts the house framing at the north side.

*Image showing dilapidated rear porch.
19 N. Webster St.*

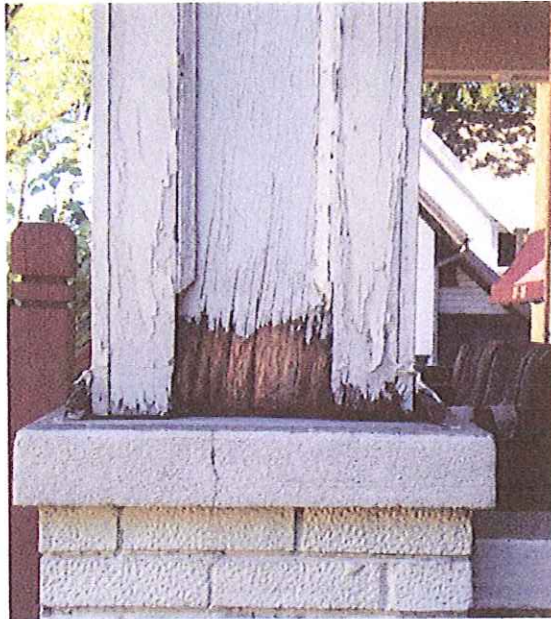
*Deteriorated porch column.
19 North Webster St.*

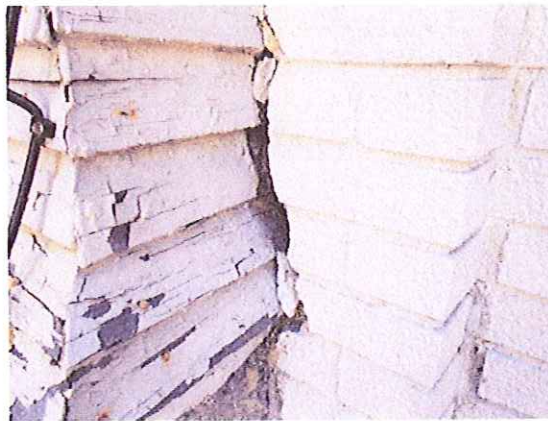
*Image showing the path of water infiltration
into framing areas at the porch and house intersection.
19 N. Webster St.*

Water has gotten behind the siding and likely caused damage to some wood framing behind. The extent of the damage is unknown due to the presence of finishes. On the interior many cracks were observed in the ceilings of the upper floor. The roof and ceiling framing is likely lightly built allowing the cracking to result over time. The basement foundation wall at the northeast corner is significantly deteriorated. Spray foam has been used to fill gaps in the foundation wall to prevent water intrusion.

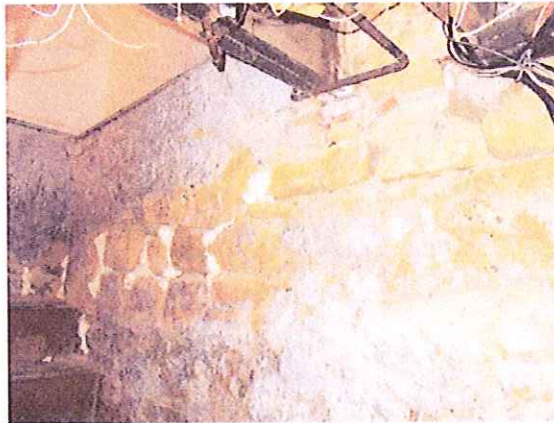
Image showing deteriorated stone foundations and spray insulation filler at 19 N. Webster St.

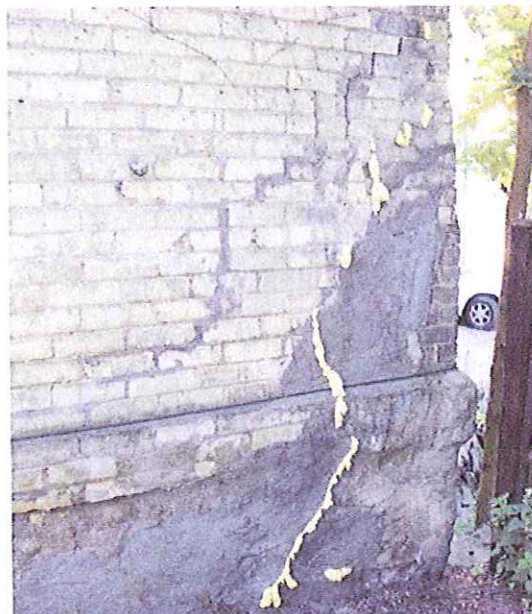
Northeast corner of 23/25 N. Webster St.

23/25 North Webster has some significant structural issues. The exterior walls are constructed of brick. Although most areas are in fair condition, some portions of the exterior brick wall at first floor and foundation wall along the north wall and most significantly at the northeast corner are in poor condition. Significant damage was noted due to the lack of adequate support offered by a retaining wall at a lower parking lot.

Movement in the lower retaining wall or soil erosion (or both) at this wall has likely led to foundation settlement and rotation in the wall present today. The outward movement (bulge) in the foundation wall at the northeast corner is approximately two to four inches. A heavily patched section of the masonry brick is present on the back of the building (east). The condition currently appears somewhat precarious and eventually may become unstable and lead to a partial collapse of the wall, floors, and roof.

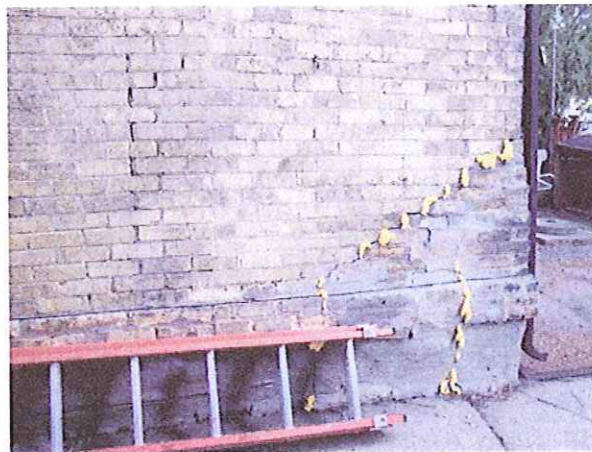
Southeast corner of 23/25 N. Webster St.

Cracking was observed in many of the masonry stone lintels. The brick mortar lines of the walls appeared to sag near corners suggesting that there have been some ongoing settlements at the corners likely the result of long term washing of fine soil particles with in the bearing regions of the soils below the masonry foundations. An interior survey confirmed issues with the north wall, especially at the northeast corner of the building. Large cracks were present near the corner at the east wall. There were also large cracks and gaps between the exterior north wall and several interior walls that had originally been integrated into it. Some roof framing deformations were noted in the area of the dormers possibly attributable to undersized headers and collecting rafters at the dormer edges.

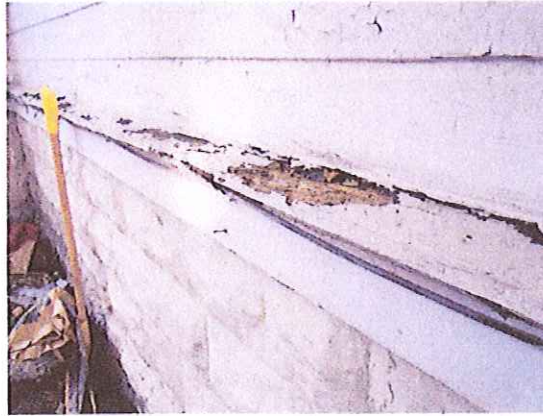
Some deterioration of the trim along the water table located at the height of the first floor rim joist was observed at 201 East Mifflin Street. The trim has been channeling water into the interior of the wall in some locations. It is likely that some framing deterioration exists behind the deteriorated water table.

*Image showing water infiltration and location of possible damage to framing at the water table trim.
East side of 201 E. Mifflin St.*
