1838 CAMELOT DRIVE

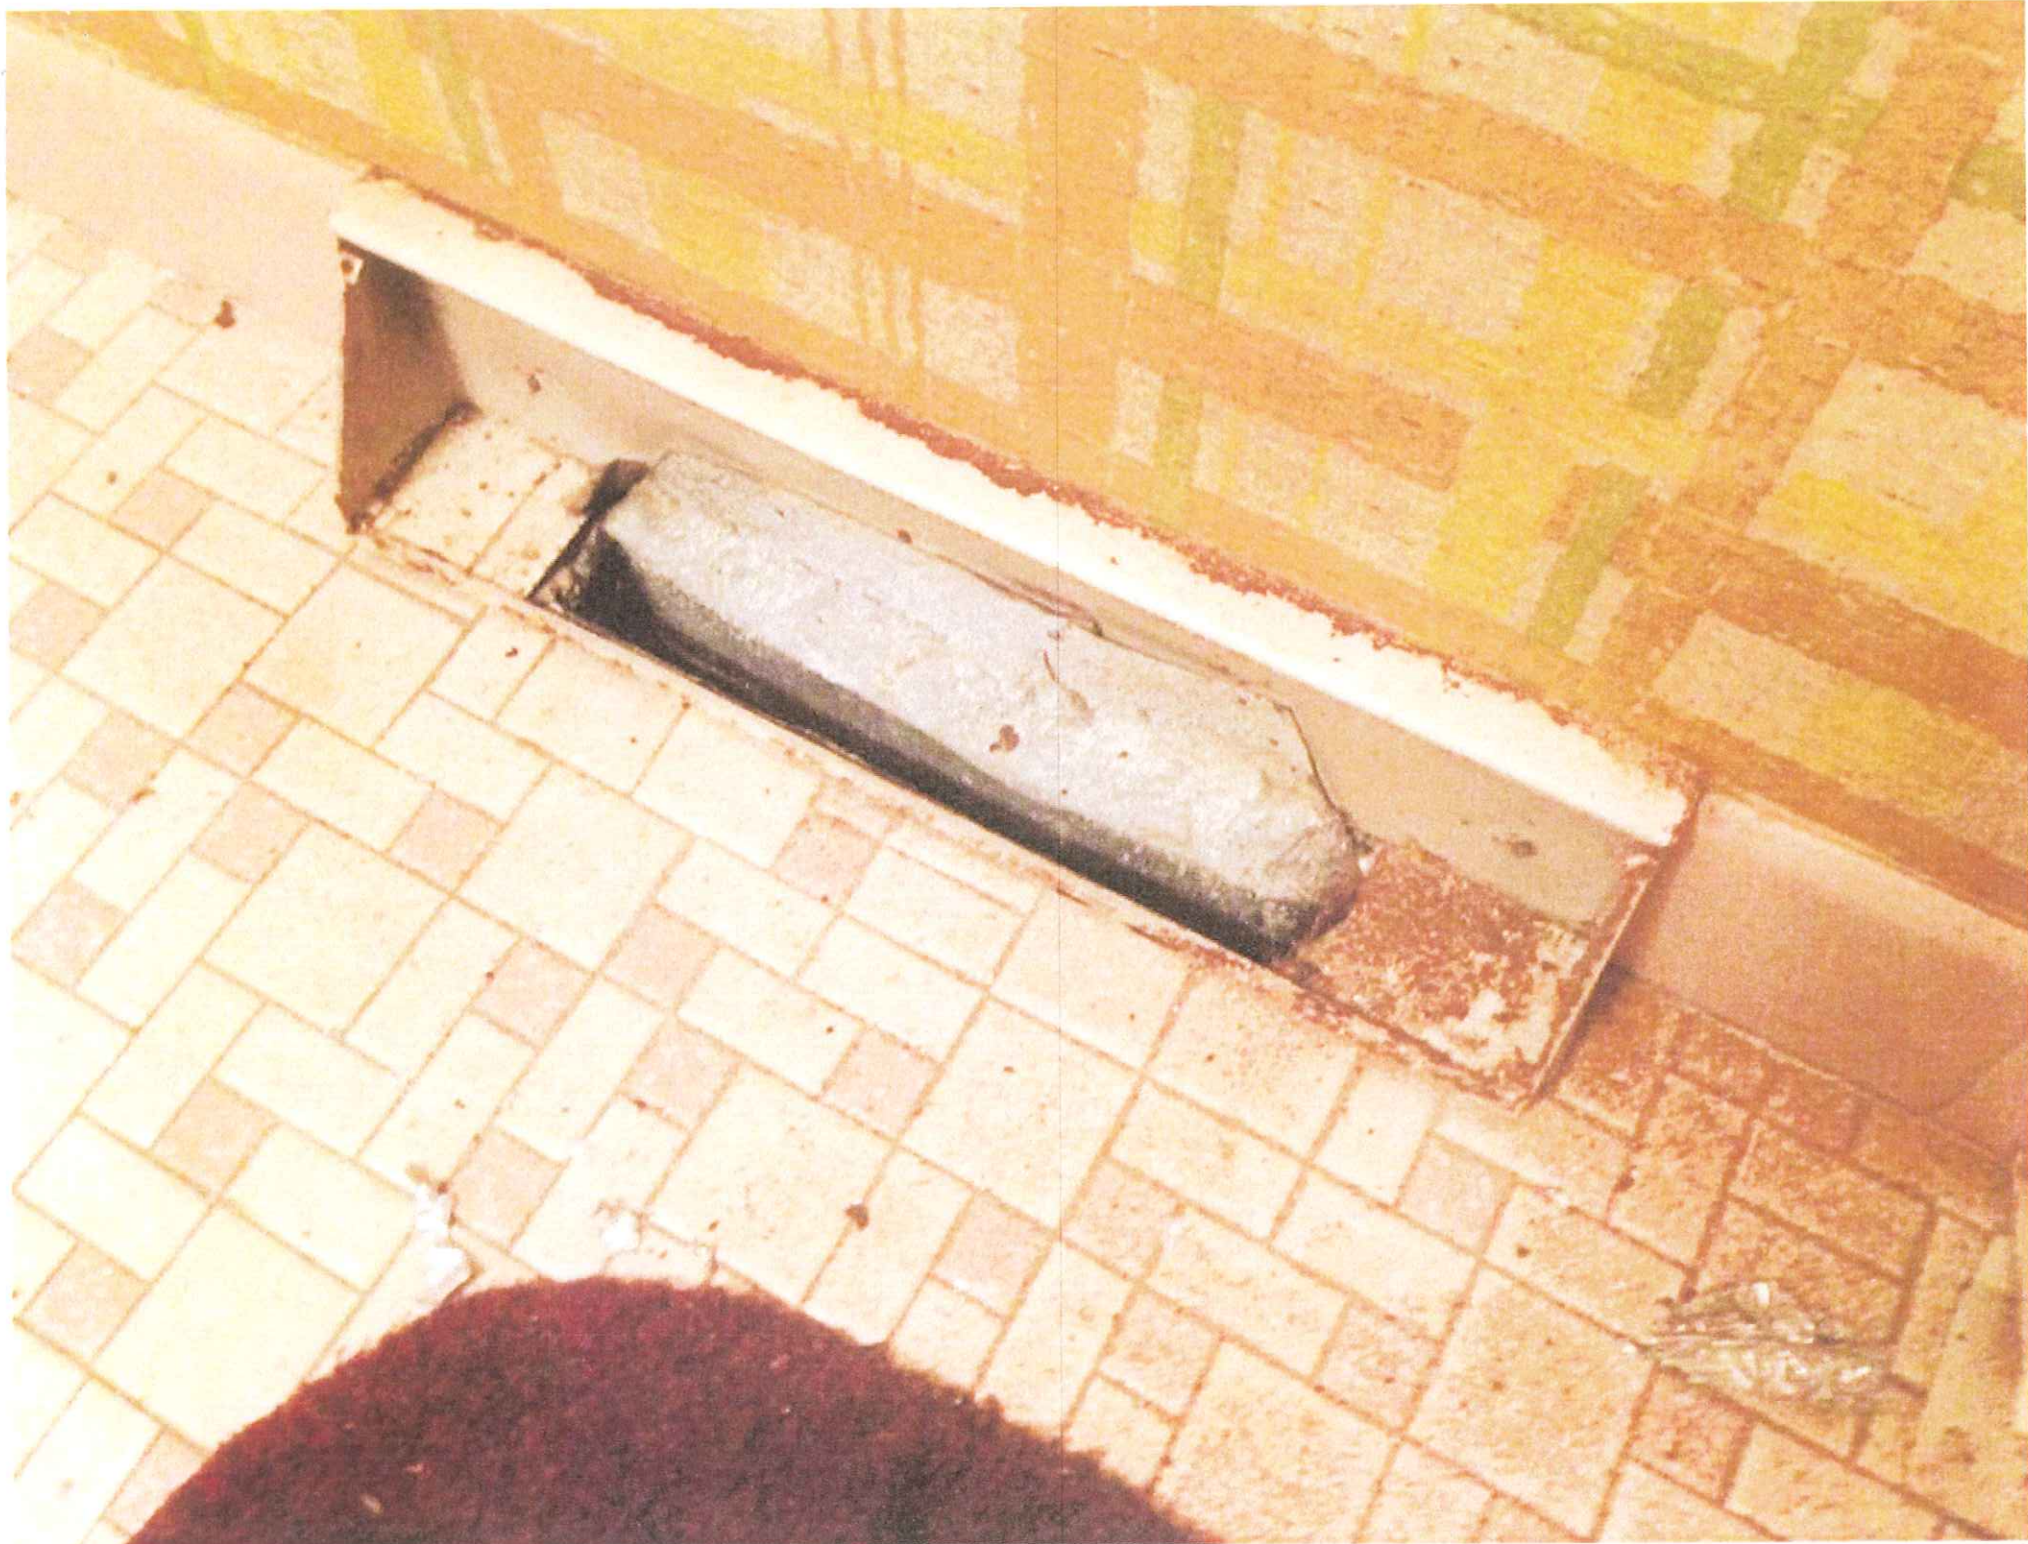
L.L. DUCT COMING OUT OF FLOOR - RUST-MOLD CAUSED BY WATER UNDER SLAB

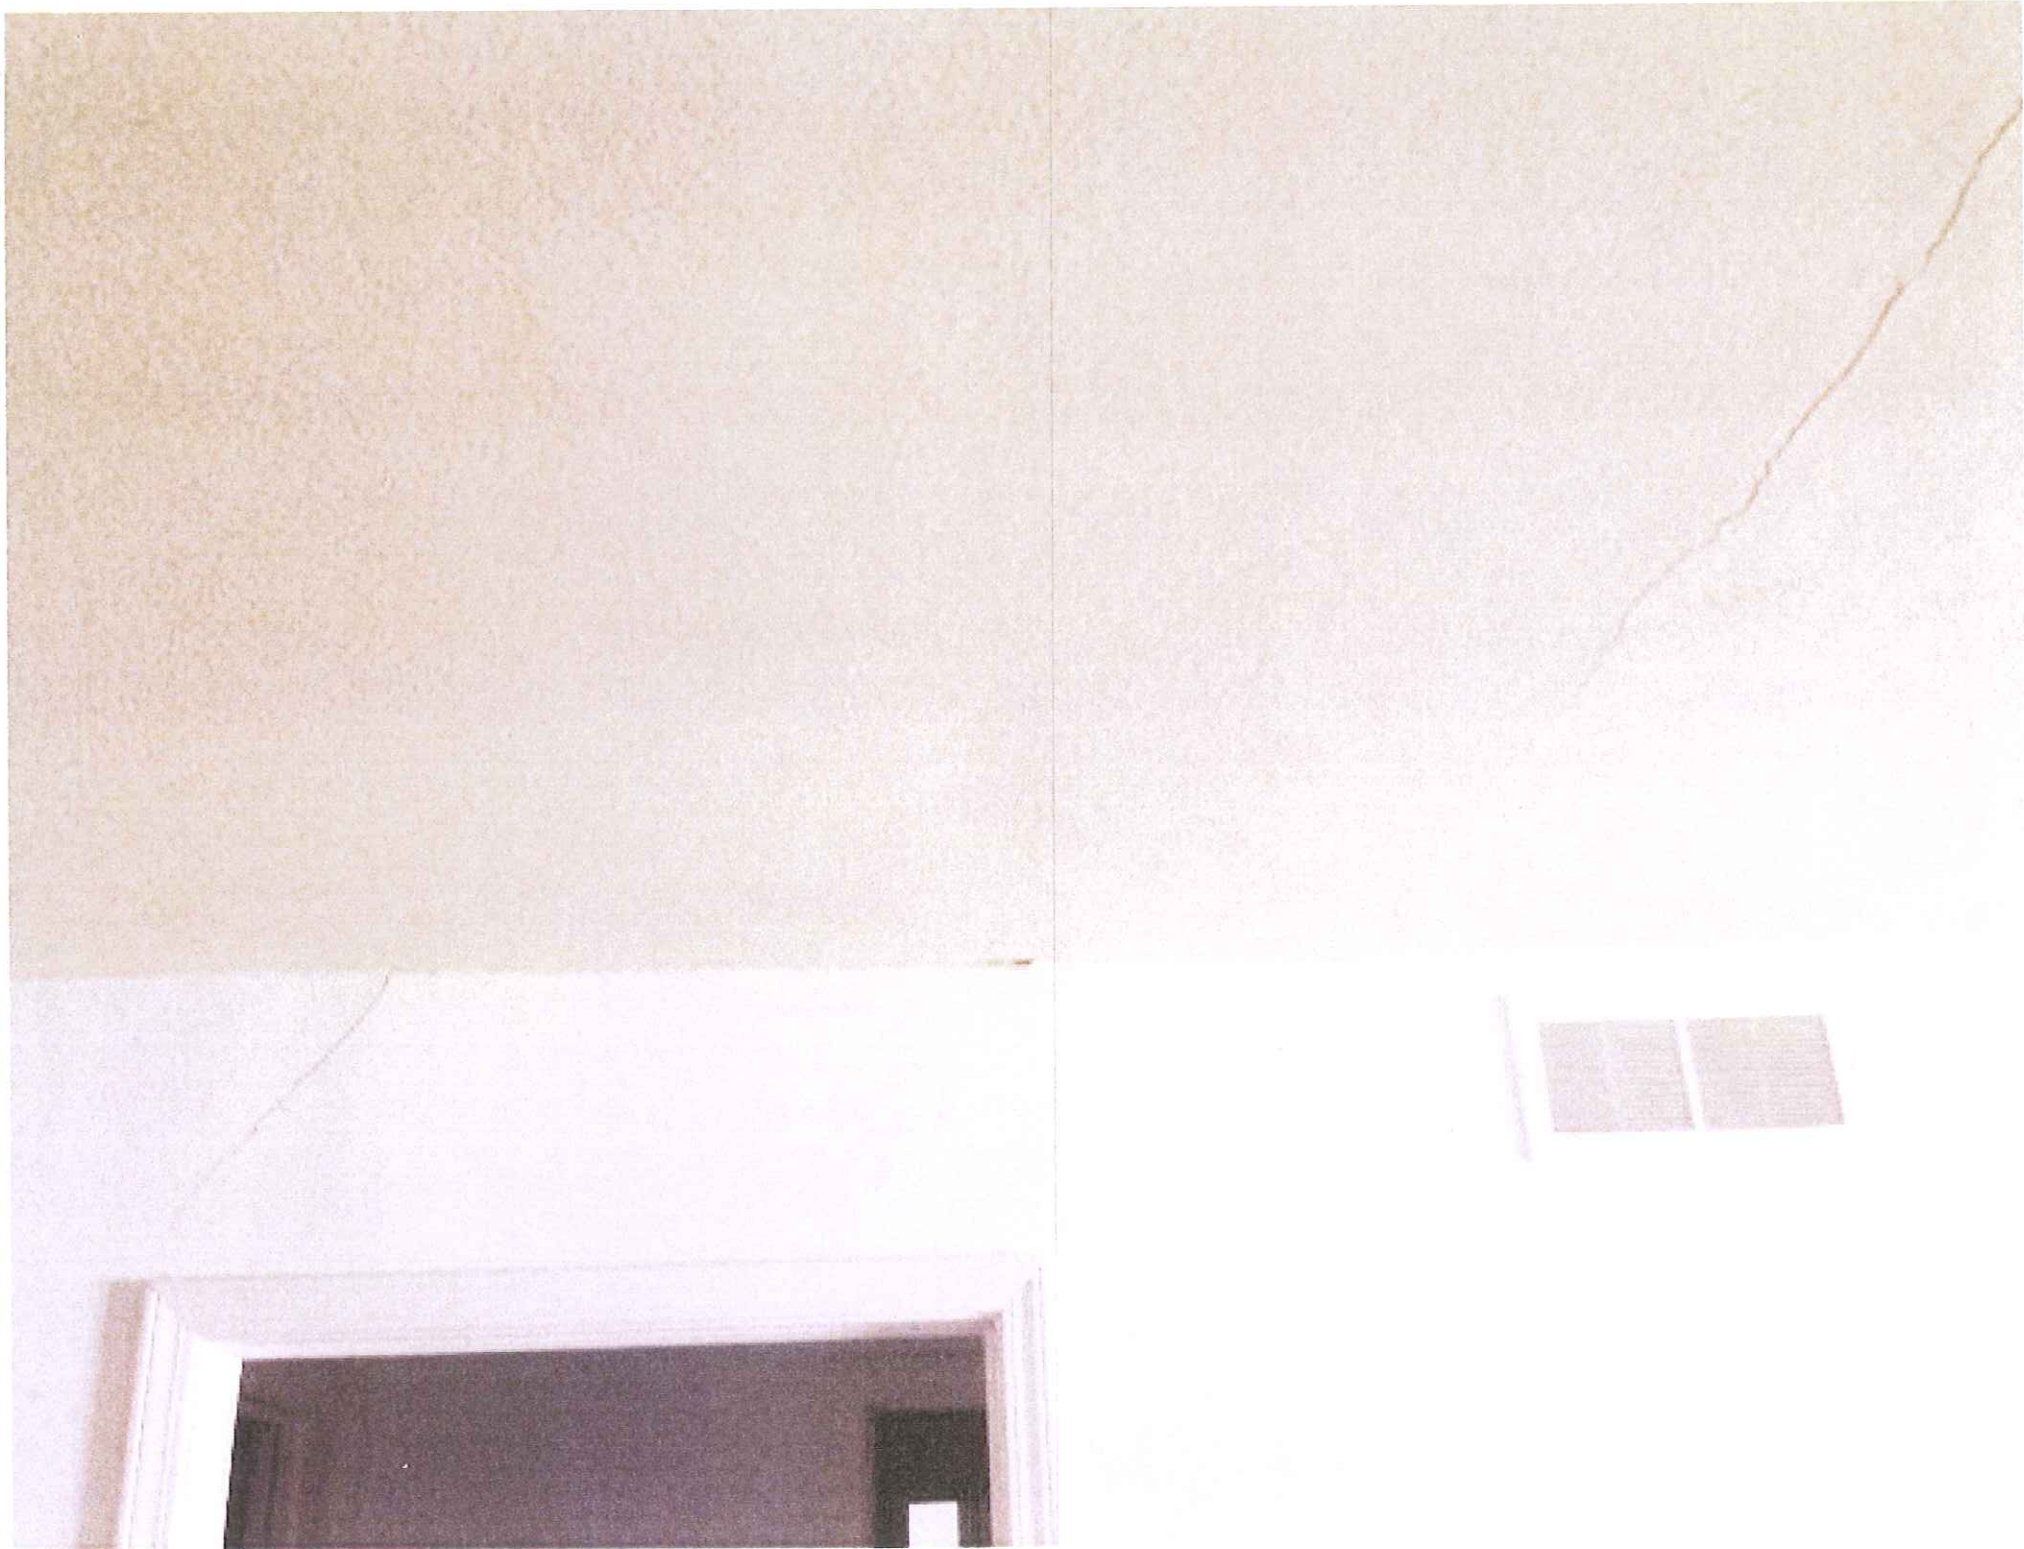
MANY CRACKS - FROM ABNORMAL SETTLING AND SHRINKING
