## Photo Group 1

Photo Group 1 focuses on the mechanicals in the basement. The photos show the original plumbing without any updates. Floor joists have been cut and patched in the bathroom floor area. In another area, a major support beam has been bored through.

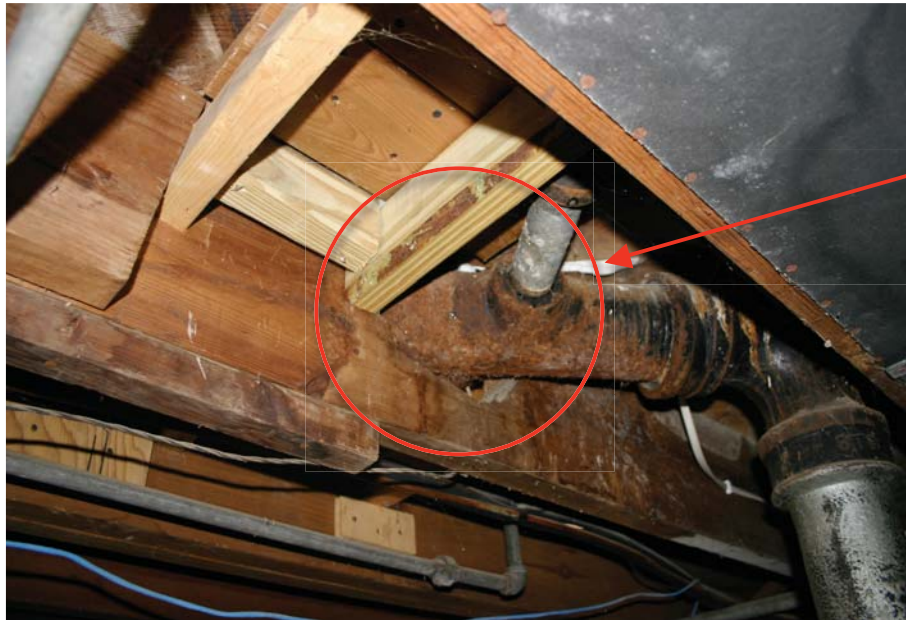
Cutting  
of joists

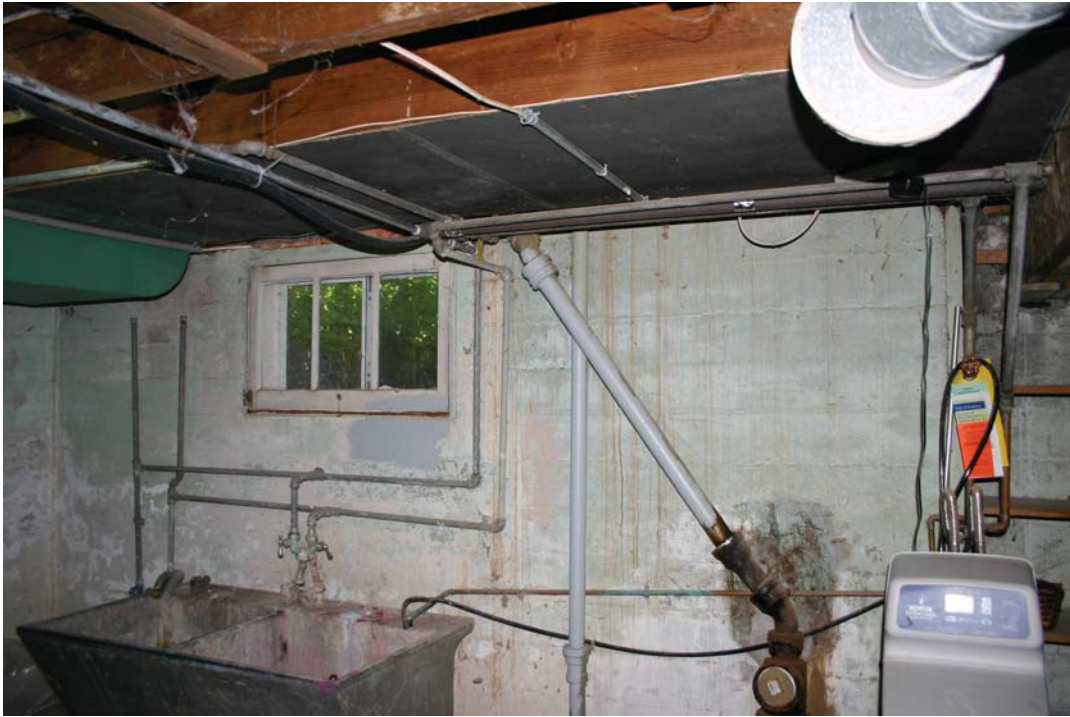
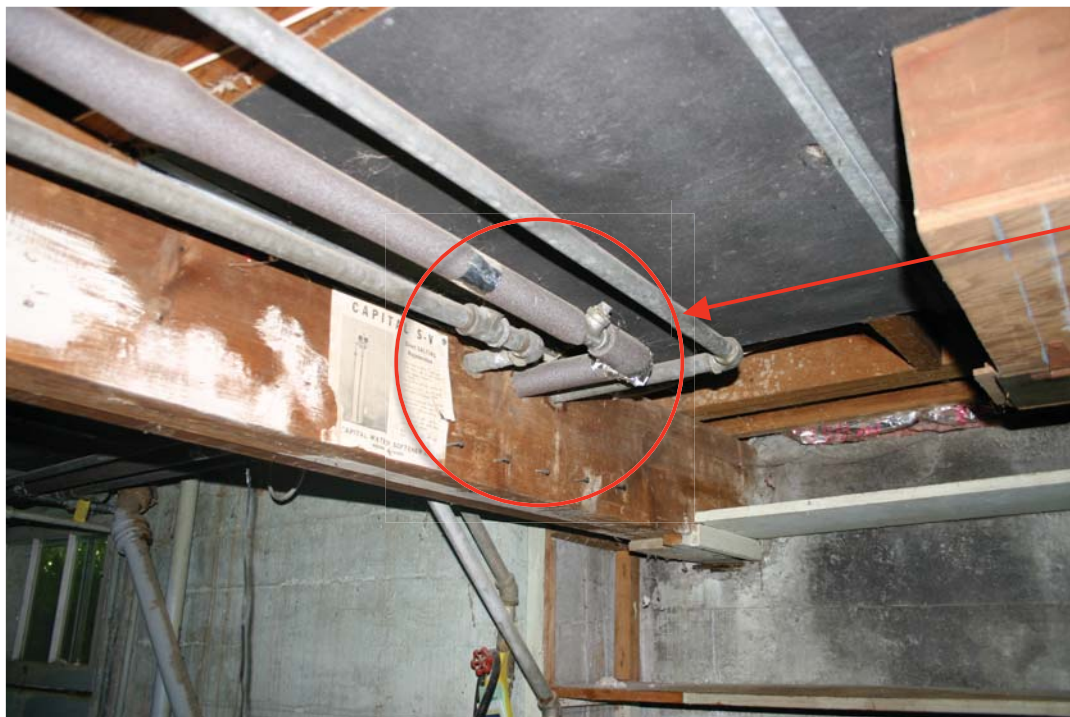
**Boring through a support beam**

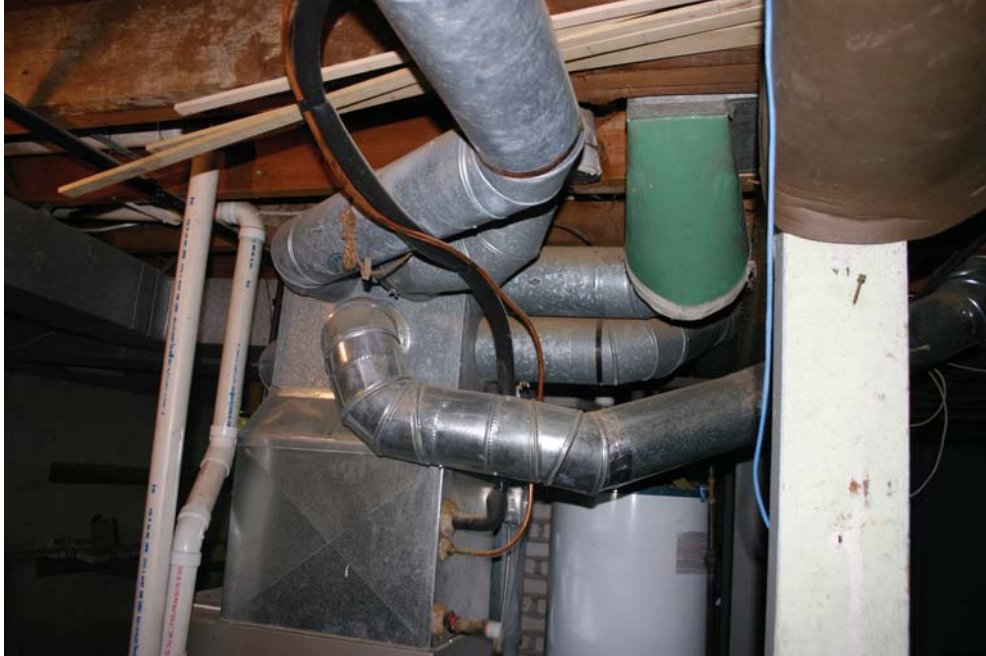
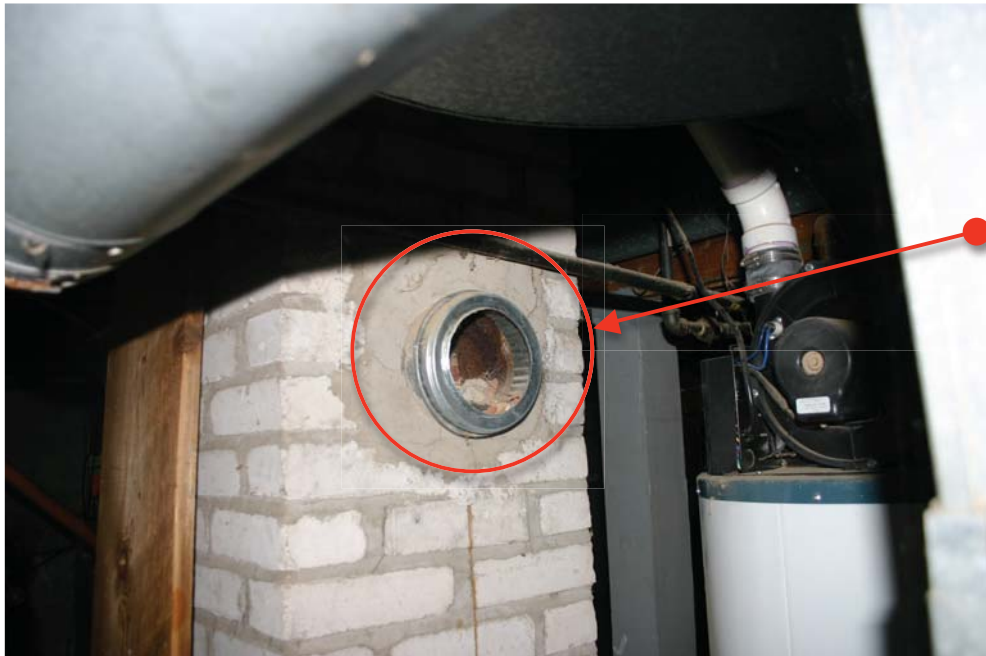
**Inactive  
chimney  
is not  
capped**

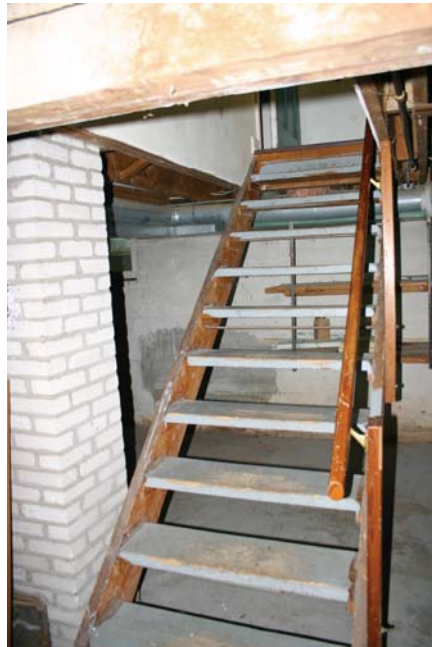
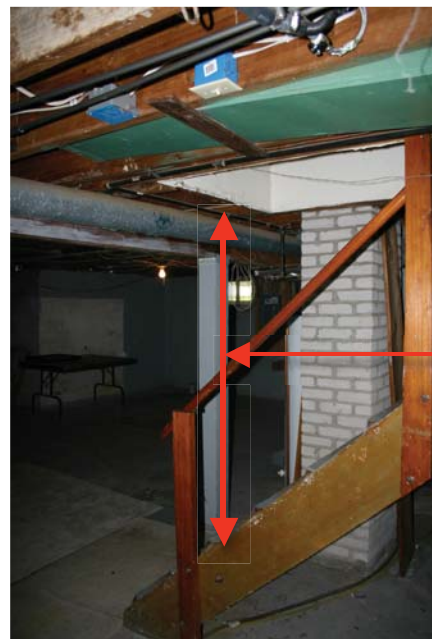
Photo Group 3 depicts the stair area, revealing it to be unsafe with no railing. I measured the current head clearance area vertically, and from the top of the stair tread to the ceiling it measured 5 ft. 9 in. – a space that falls far short of current code.

**5 ft. 9 in. head clearance does not comply with current code**

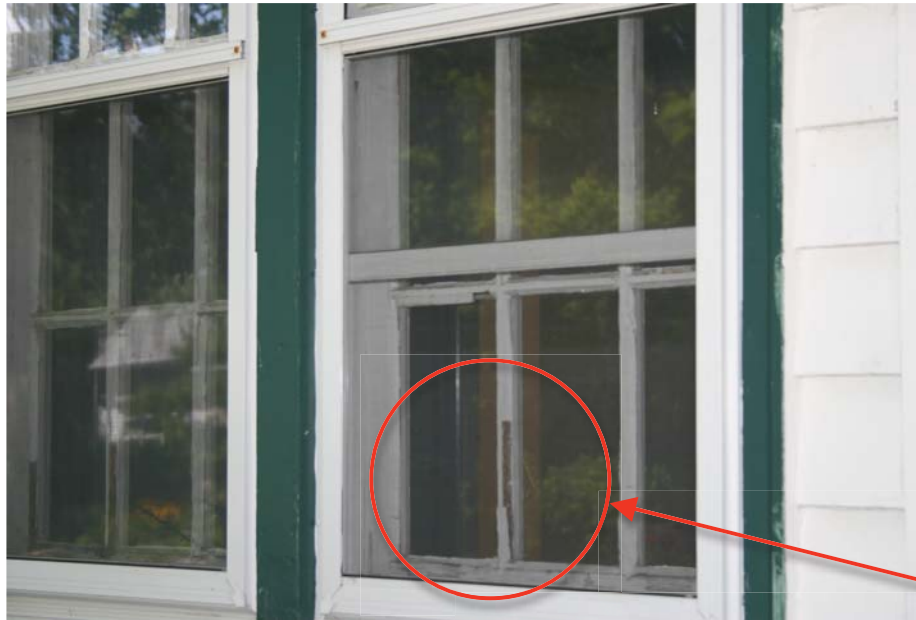
**Poor  
glazing**

Photo Group 4 captures several issues on the main floor. Sixteen of the 20 windows in the house are original and should definitely be upgraded for energy efficiency. The photos show the glazing falling off, loose panes of glass and the poor condition of the windows and doors.

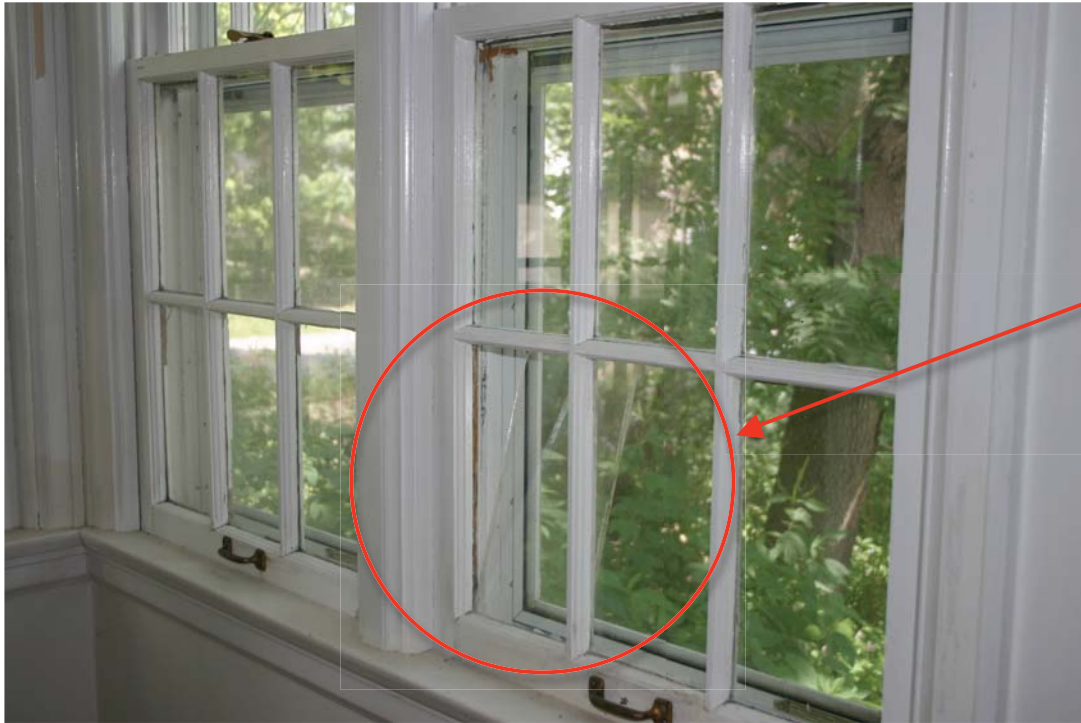
**Loose  
pane of  
glass**

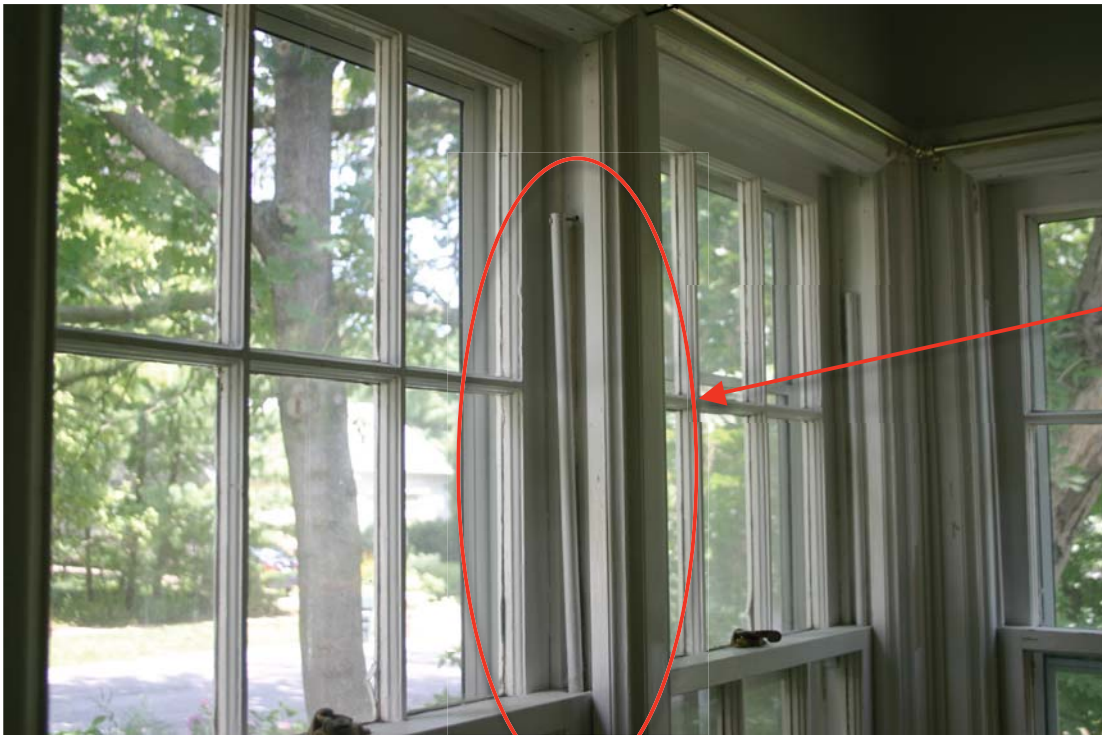
**Poor  
balance  
spring  
system**

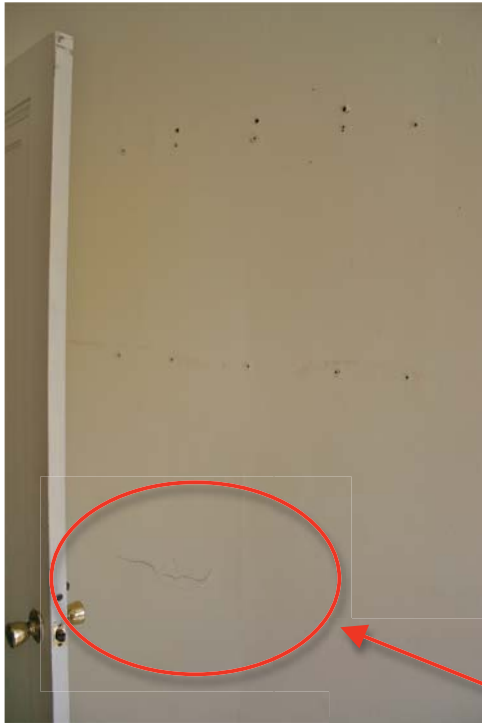
Photo Group 5 shows the current condition of the plaster in the house and is just a sampling of many similar areas of concern throughout the house. I came across two areas of bulge in the walls that indicate water leakage behind the plaster or that the plaster is at the point of falling off the wall. Although it is difficult to capture with a camera, the plaster issues indicate some serious problems associated with the age of the house.

**Sampling of cracked plaster**

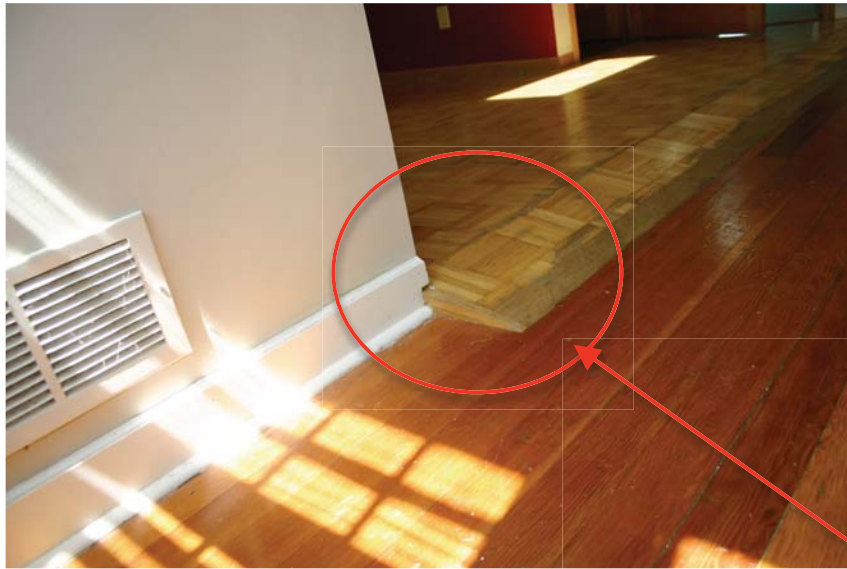
Photo Group 6 shows an existing front porch that was converted into living area many years ago. The photo reveals a difference in floor height of 1 5/8 inches between the converted porch and the original floor. While this addition may have been sufficient for a rental property, it is not appropriate for our homeowners who are in their early 70's. The difference in floor height as well as issues with roof sag indicate a greater concern about how the converted space was added on and why some structural integrity was lost in the process of converting this addition.

**1 5/8" rise  
where porch  
was  
remodeled  
and  
converted  
into  
additional  
living space**

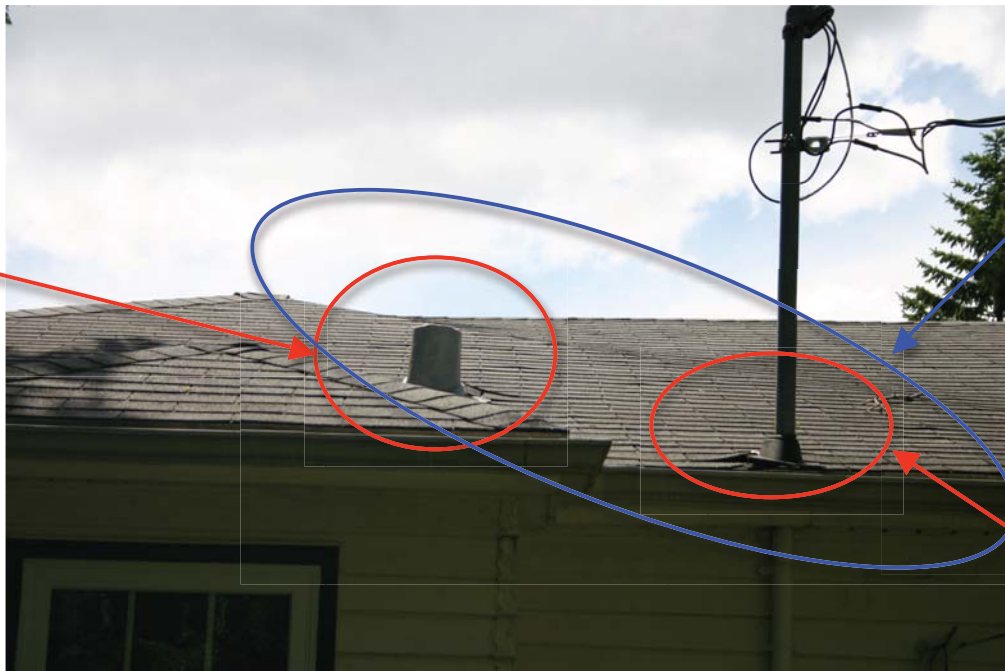
**Shifting or poor blending of converted porch area to original house**

**Water leakage**
