Pacific Cycle – Existing Residence 4908 Hammersley Rd

Iconica Project Number: 20120410

Date of Inspection: November 6, 2012
Report: Capital Needs Assessment
Report By: Robert G. Feller, AIA

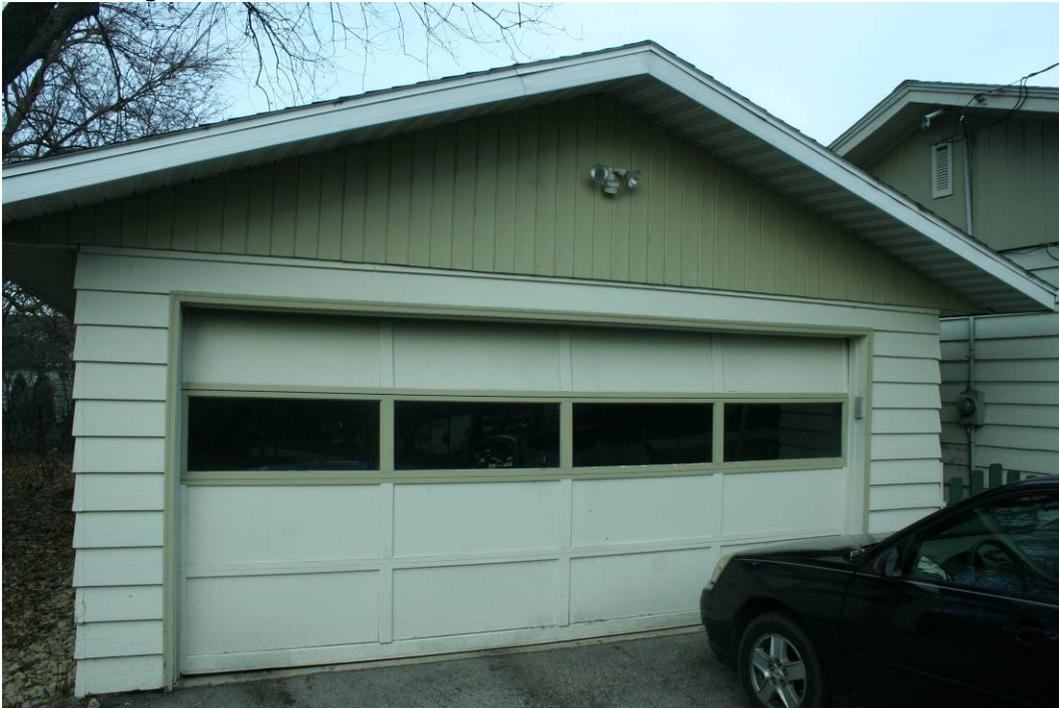
4908 Garage

The existing semi-attached garage is located on the west side of the house. The garage is in need of maintenance and repair required for the overhead door.

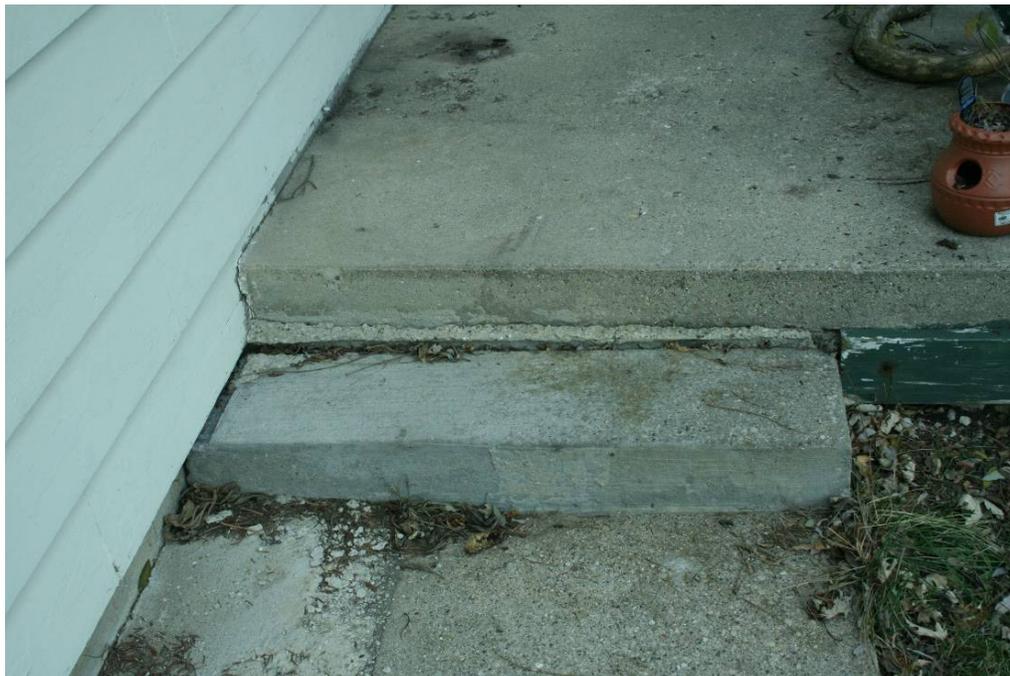
Building sidewalks are concrete and in poor condition. There are damaged sections that have cracks and major spalling. Accessibility to the building is impeded with stairs that are in poor condition. There is heaving occurring and consideration should be made for replacing all walks. There are no public sidewalks on the property. The existing Asphalt drive has out lived its useful life and is in need of replacement.

4908 Entrance steps and sidewalk – replacement is recommended

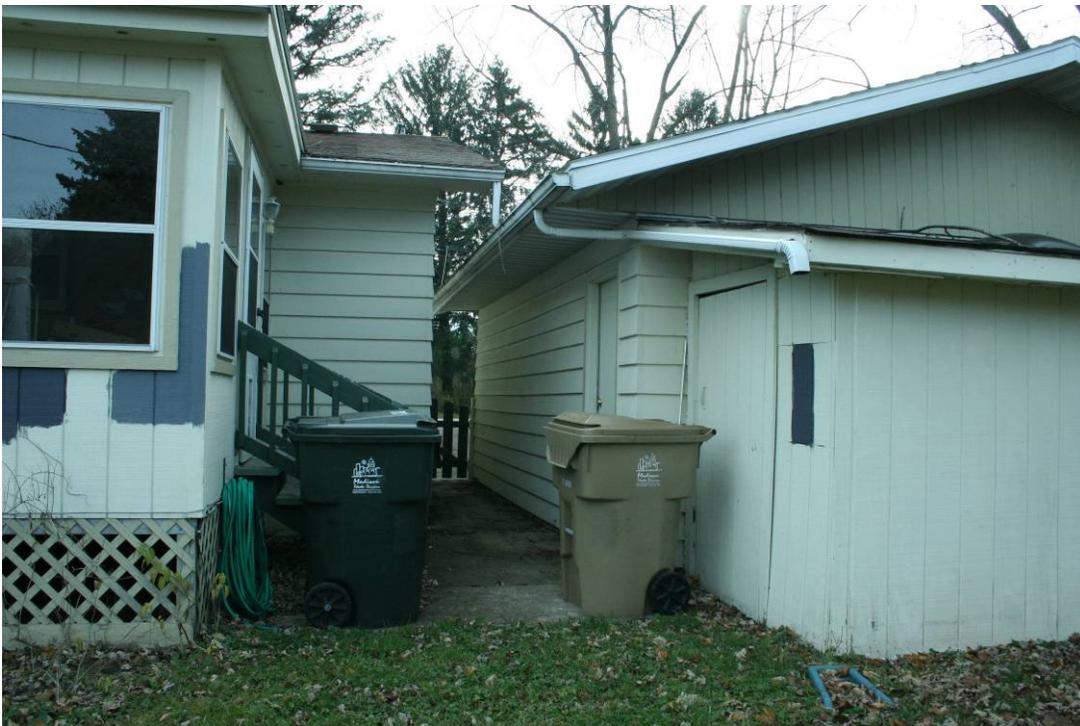
The building exterior siding appears to be original and is in fair condition. The exterior soffits appear to be in good shape. The garage requires repair work and the existing lean-to shed should be removed or completely rebuilt.

4908 Three season porch and garage (rear of building) Lean-to shed is in need of re-building

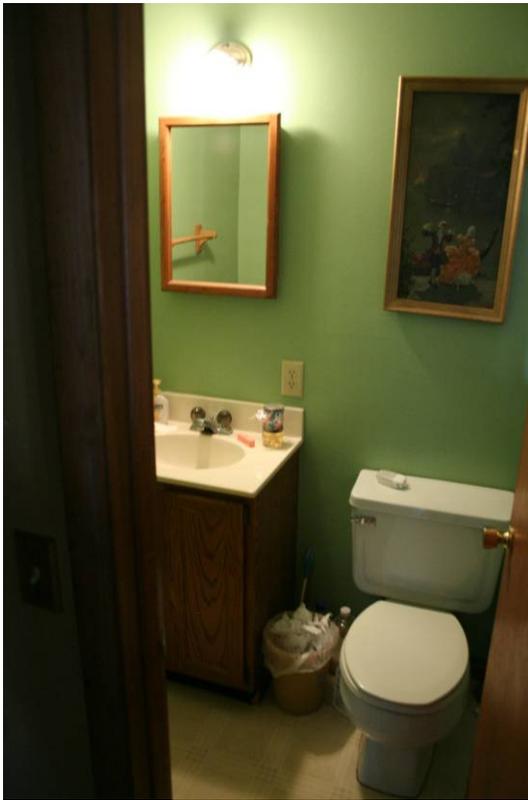
4908 First floor bathroom Interior

The house is heated by forced air furnace heat. Cooling is provided by way of on grade condenser. The bathroom is not exhausted to the exterior which will eventually lead to moisture issues. The kitchen also is not exhausted to the exterior. Exhaust should be provided to the exterior to prevent moisture build and interior damage including mold build-up.

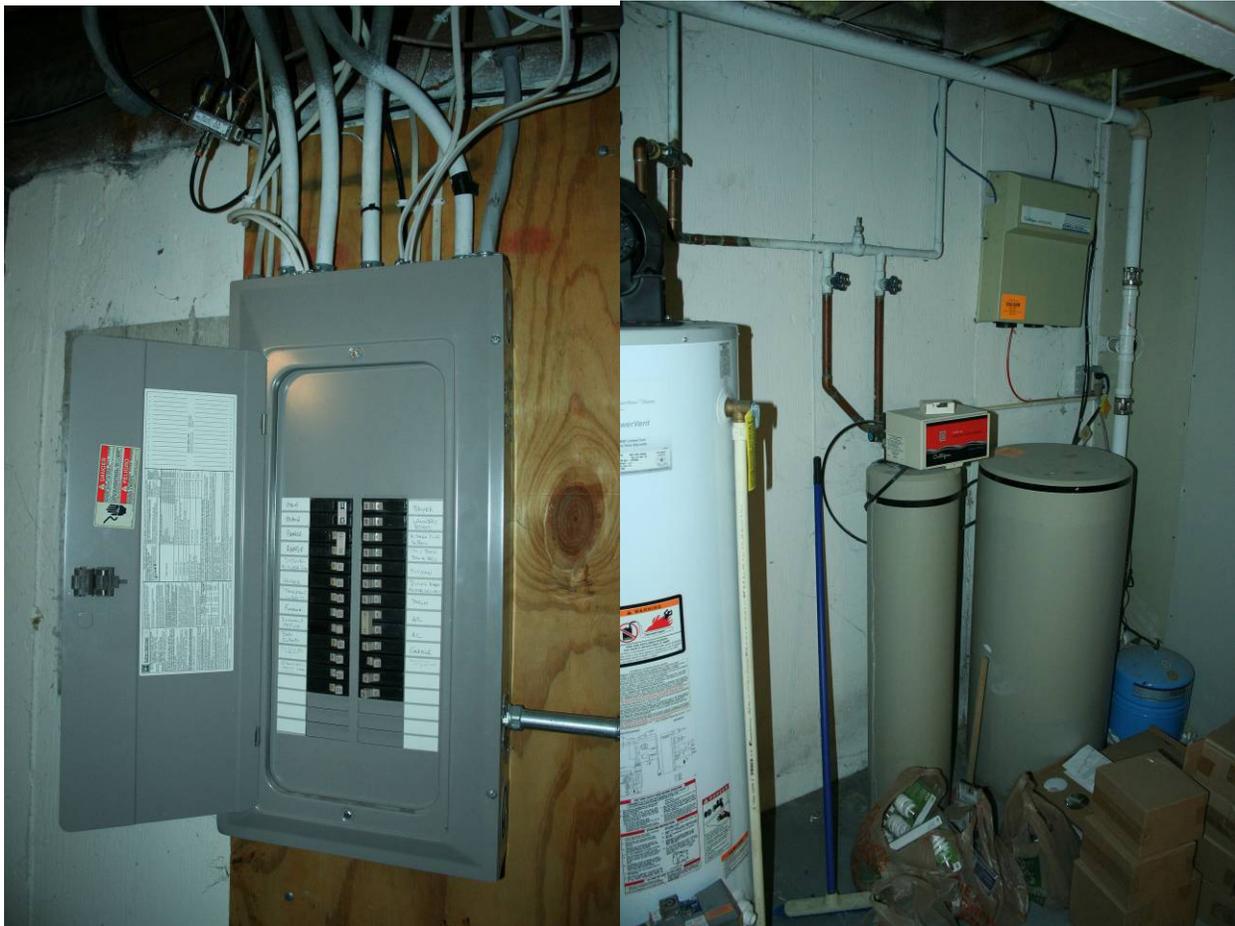
4908 Electrical service and water heater/softener

The existing water heater appears in fair condition but is reaching the end of its life. Water softener is in good condition.

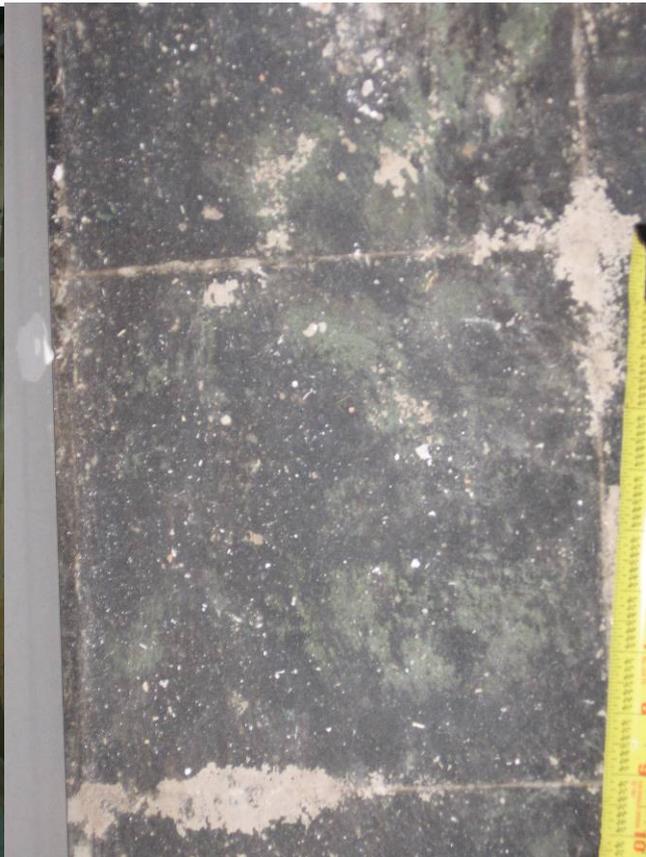
4908 Asbestos tile floor

The subject property was built before the 1978 ban on asbestos containing construction materials. It is fair to assume asbestos exists in the original building. Upon cursory review, there appears to be exposed materials containing asbestos in the basement in the form of floor tiles. These will need to be abated and disposed of properly. Caution should be taken in future demolition and remodeling projects to test existing materials for asbestos.
