April 16, 2014

**SUBJECT:** 827 E. Gorham Street  
Structural Assessment  
MP-Squared Project No: 1411046W1

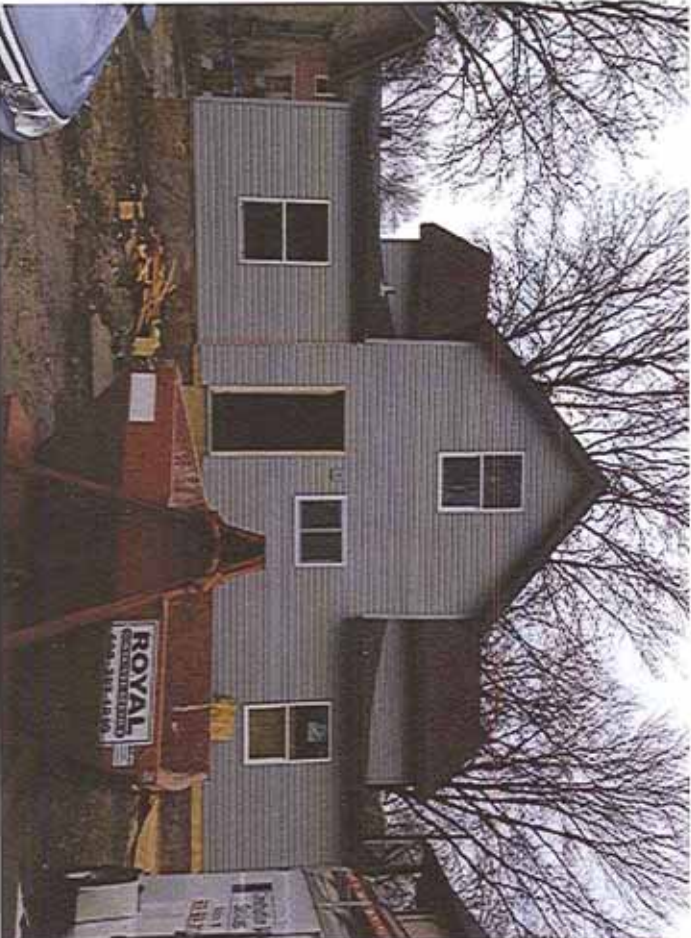
There is a lower roof over a portion of the first floor that frames a hip; the hip beam is a 2x4 and spans 18'-0" (see Images 1, 32, & 33). We analyzed the capacity of the 2x4 by applying roof dead load and uniform snow load; we found the member to be 192.3% overstressed.

Image 1: Exterior view showing two lower hip roofs.

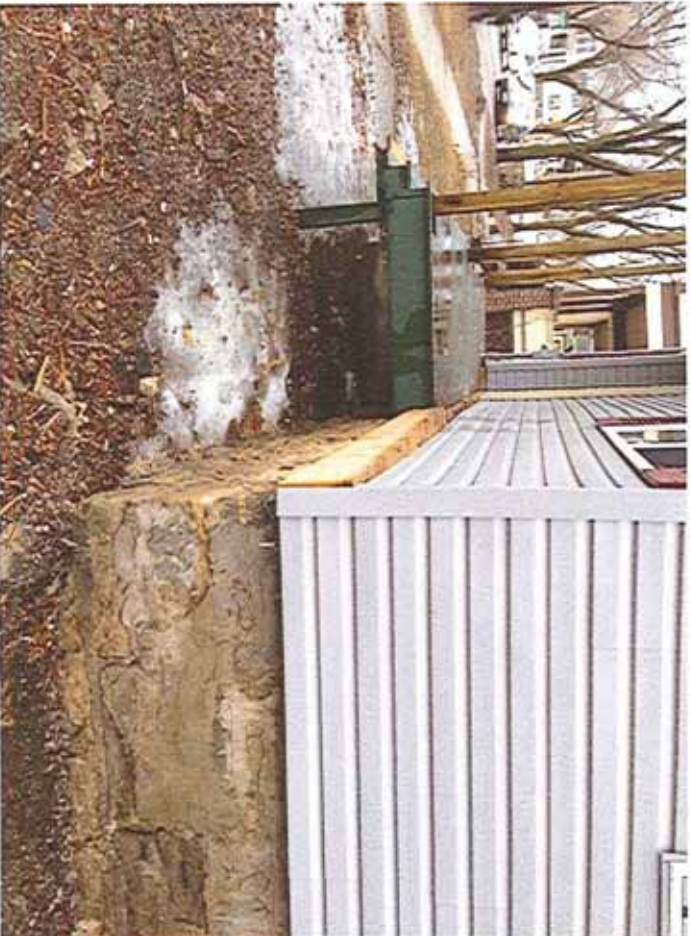
Image 6: First floor framing extending beyond the face of the foundation wall & exterior wall framing.

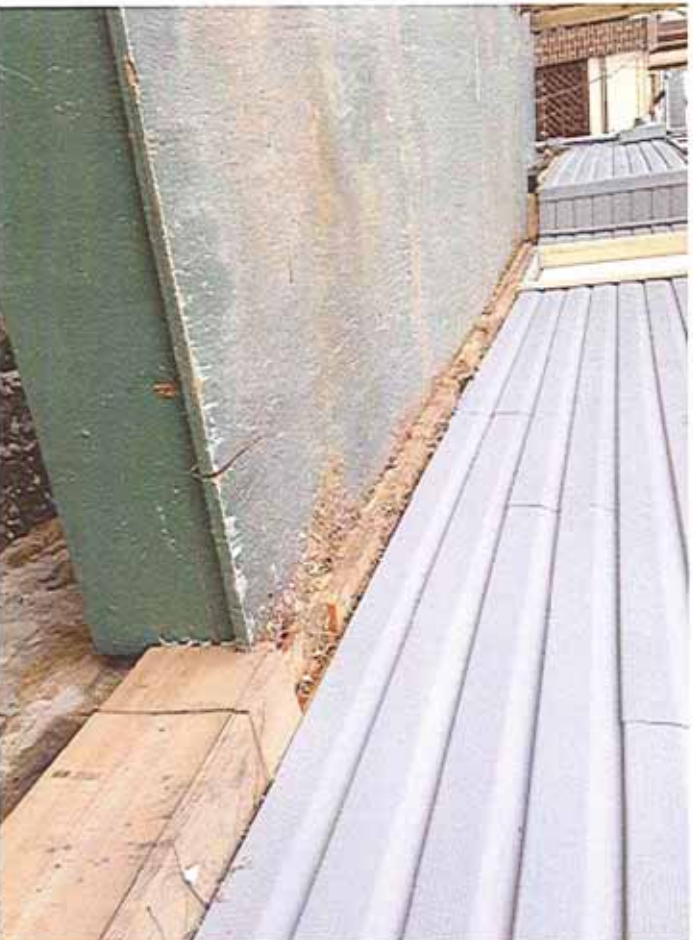
Image 7: First floor framing extending beyond the face of the foundation wall & exterior wall framing.

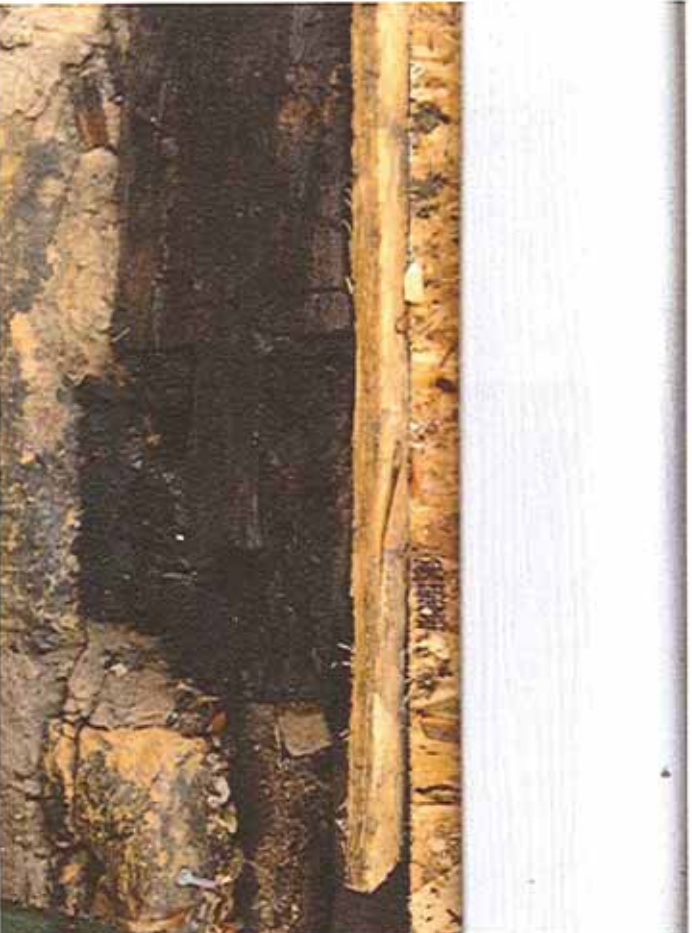
Image 8: Rotting wood bearing on the foundation wall.

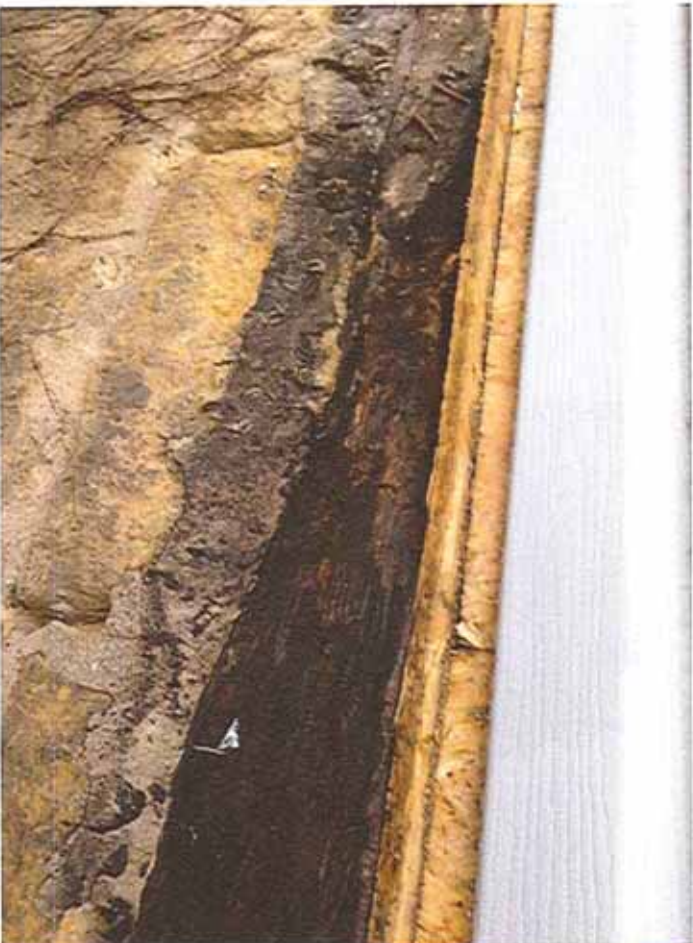
Image 9: Rolling wood bearing on the foundation wall.

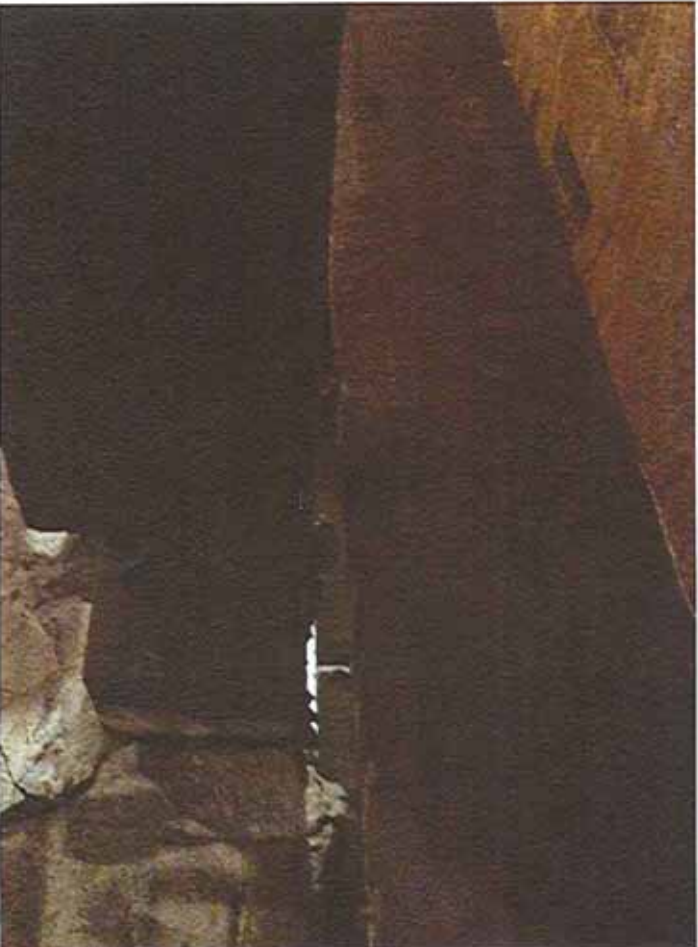
Image 10: Floor joist not bearing on support beam.

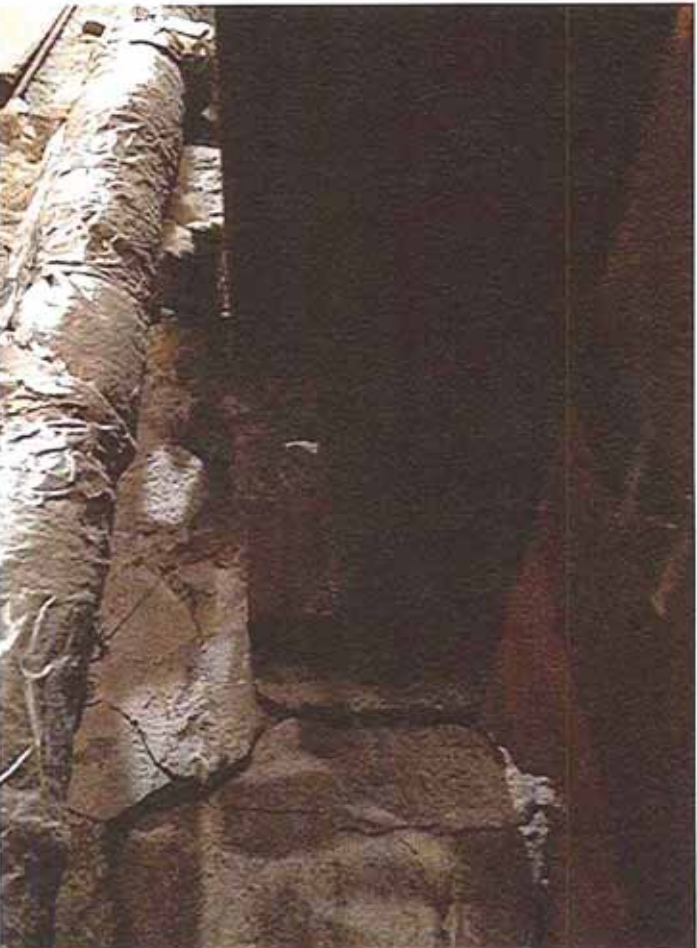
The perimeter floor framing that bears on the foundation wall does not appear to be anchored to the foundation. In some areas, the floor joists do not even bear on the foundation wall, they are simply nailed to the rim joist. In other cases, the floor joists, likely untreated, bear directly on the concrete wall (see Images 11, 14, 15, 19, 25)

Image 11: Wood beam bearing directly on concrete with notch.

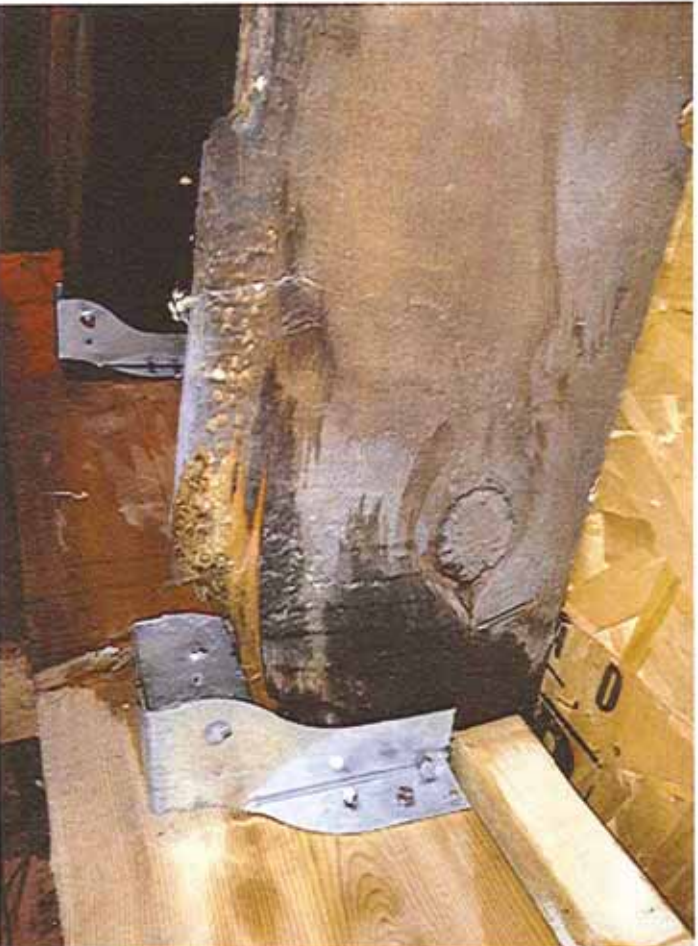
Hurricane ties connecting the roof joists to the sill plate are not used. In general, the only clips observed were installed recently, likely during this most recent renovation, in an attempt to bring the framing up to current standards (see Images 12, 21, 23, 24, & 34).

Image 12: Deteriorated joist with new clip.

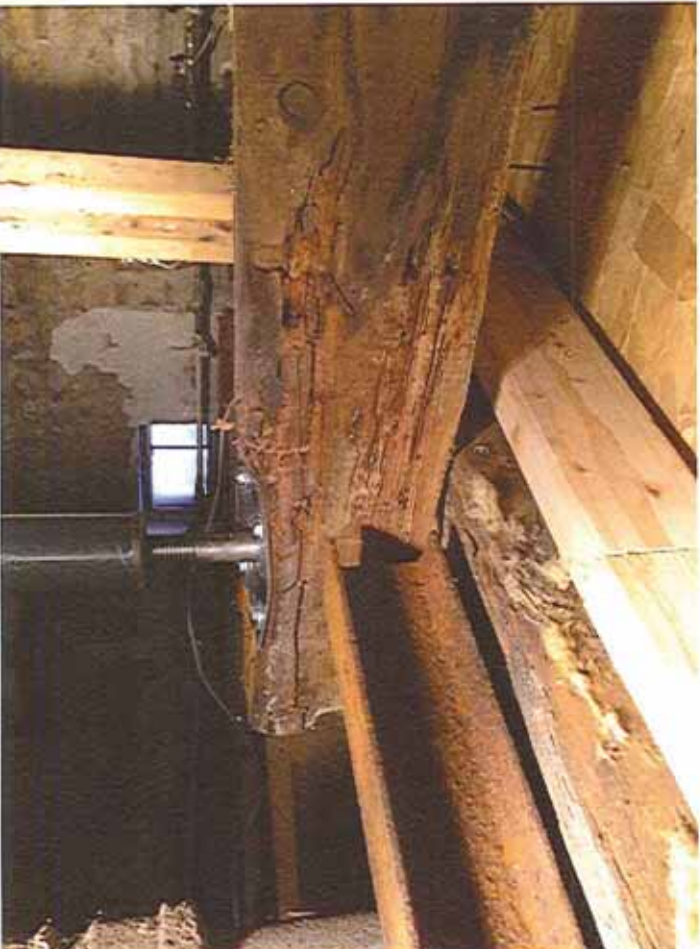
Image 13: Severely deteriorated support beam.

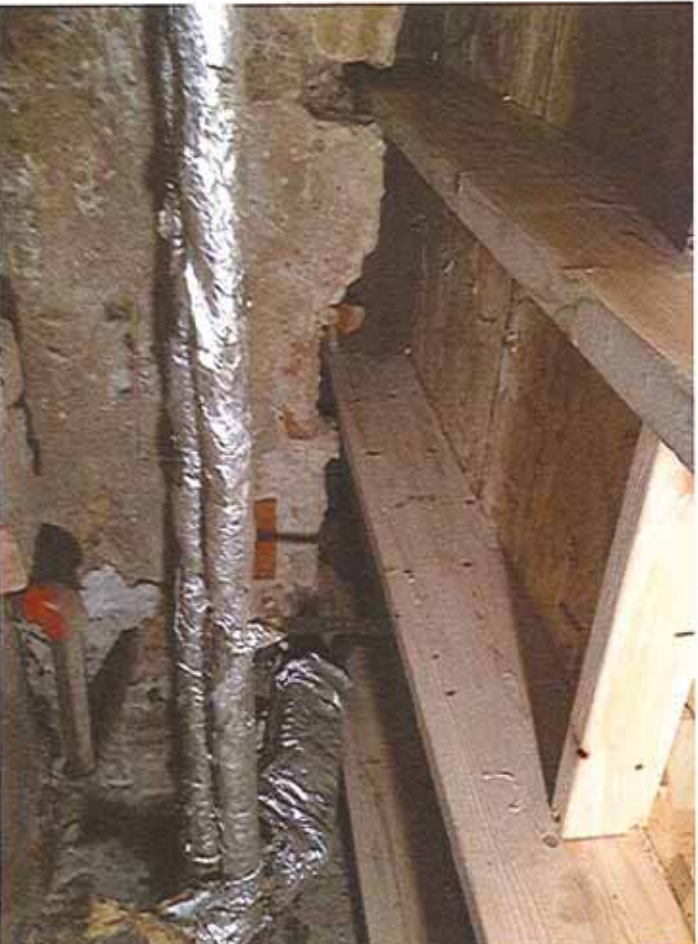
Image 14: New floor joists not bearing on foundation wall, supported by rim joist.

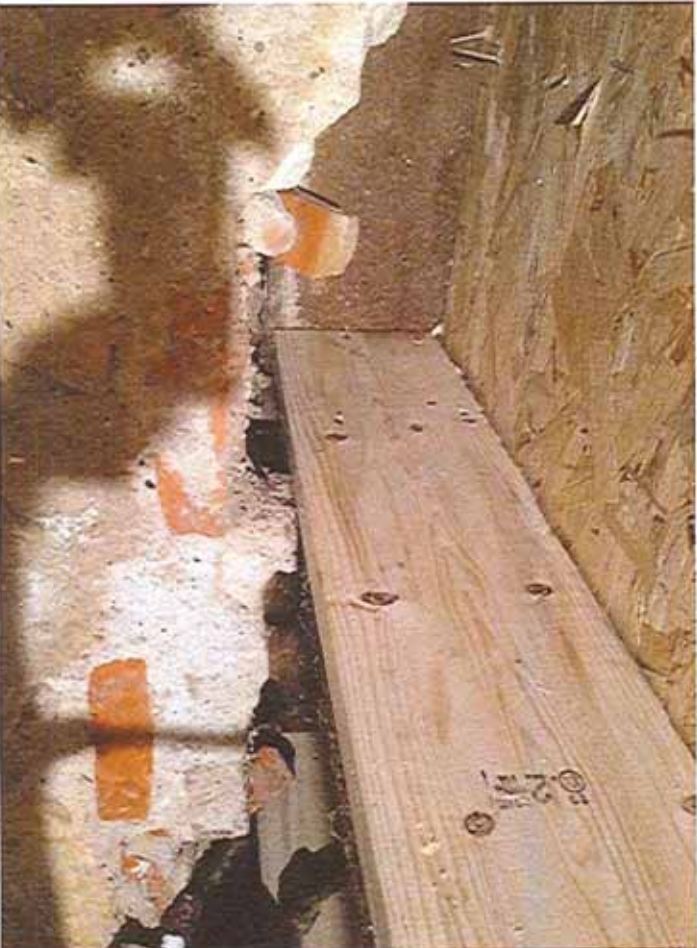
Image 15: New floor joists not bearing on foundation wall, supported by rim joist.

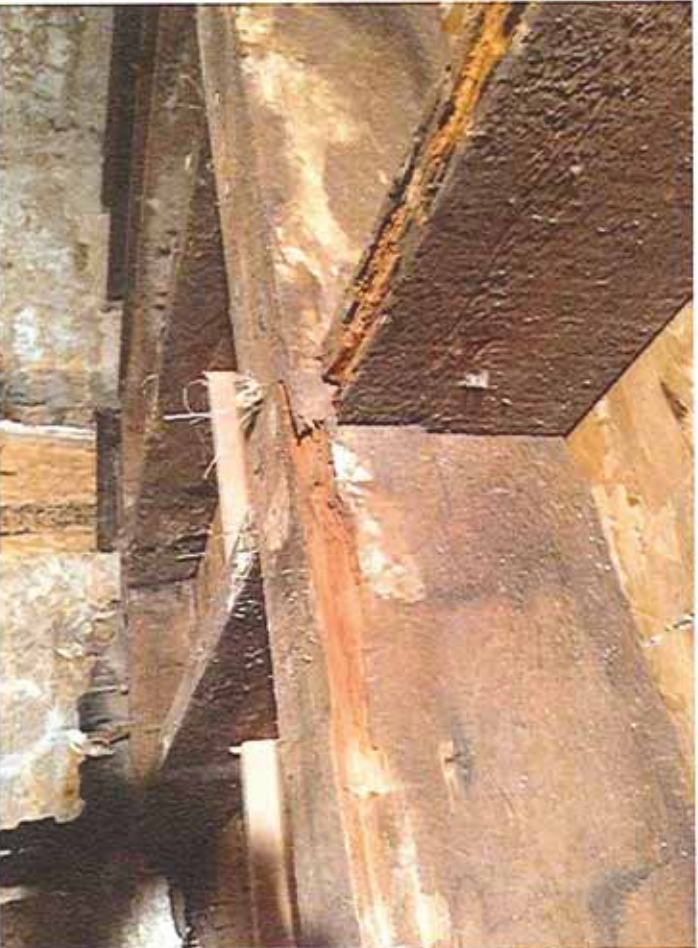
We observed wood deterioration likely caused by insects, fungi, and fire. Insect damage was found on the first floor framing and second floor framing (see Images 16, 21, 22, 27, 42 & 43). Fungi deterioration, likely a combination of dry, white, and wet rot, was noted on the first floor, wall framing, and roof framing (see Images 8, 9, 12, 13, 23, 24, 27, 30, 38, & 41). Fire damage was noted throughout the roof framing on the second floor (see Image 37).

Image 16: Floor joist with apparent insect deterioration.

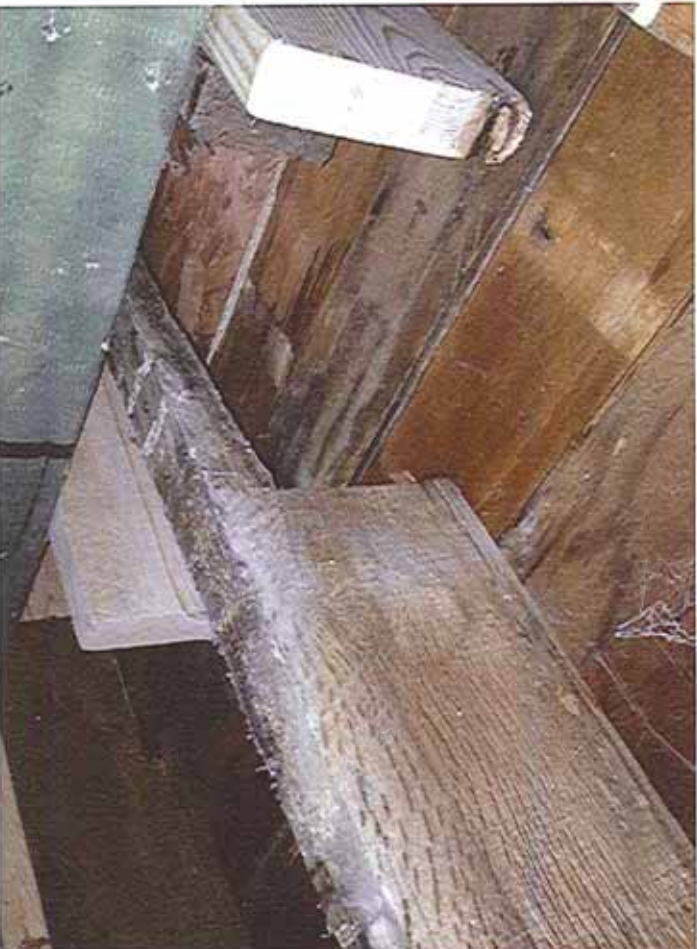
We observed notches at the ends of floor joists that exceed the NDS limit that a notch not exceed one-fourth the depth of the member (see Images 17 & 31).

Image 17: Floor joist with notch bearing on support beam.

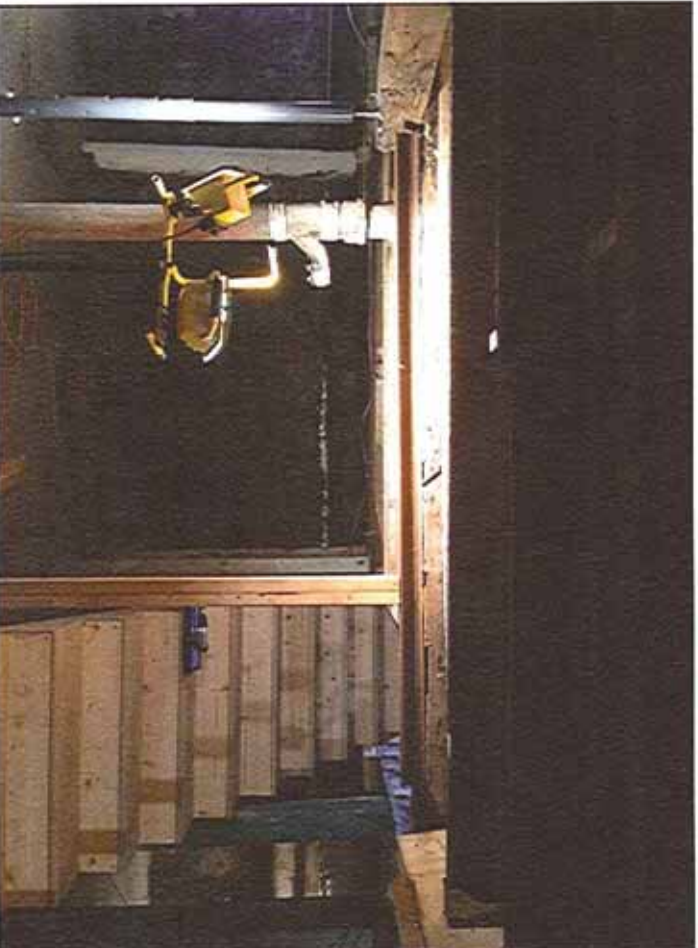
Image 18: Steel W-beam possibly shoring existing support beam; shoring unstable as installed.

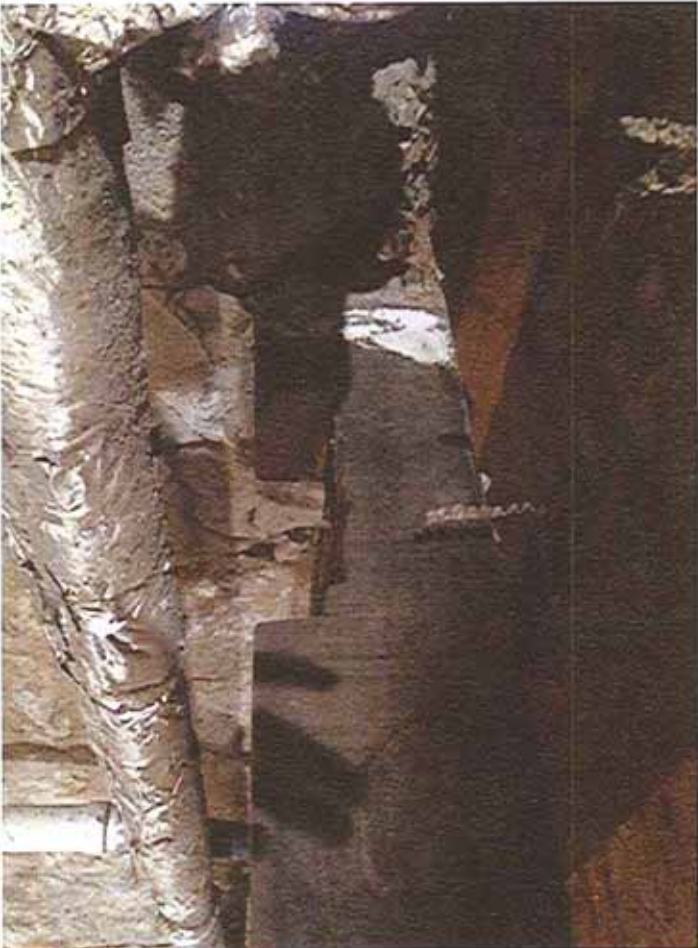
Image 19: Deteriorated support beam with notch.

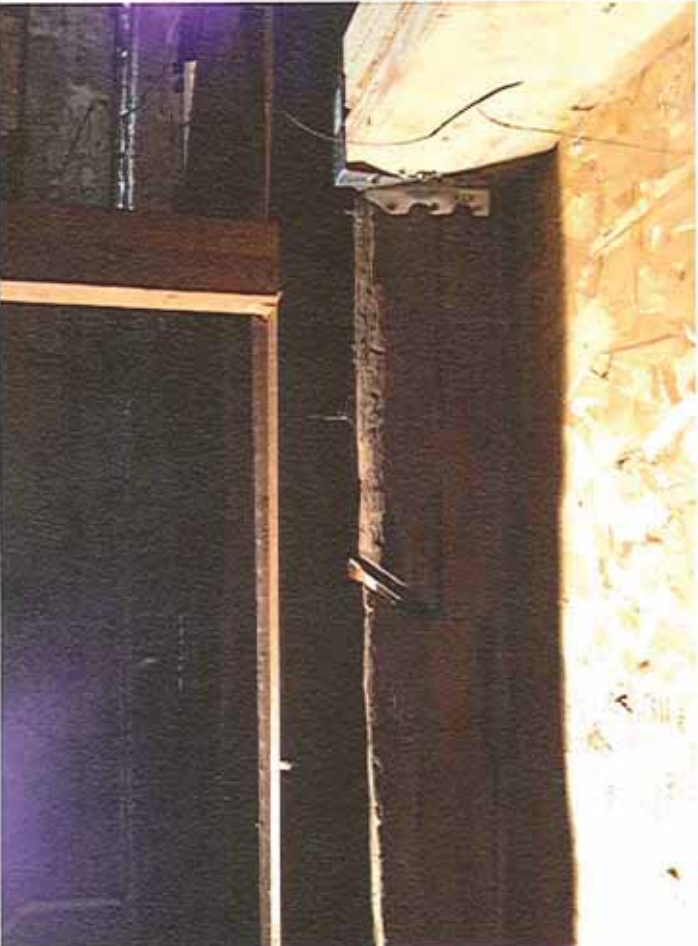
Image 20: Support beam with apparent shear failure.

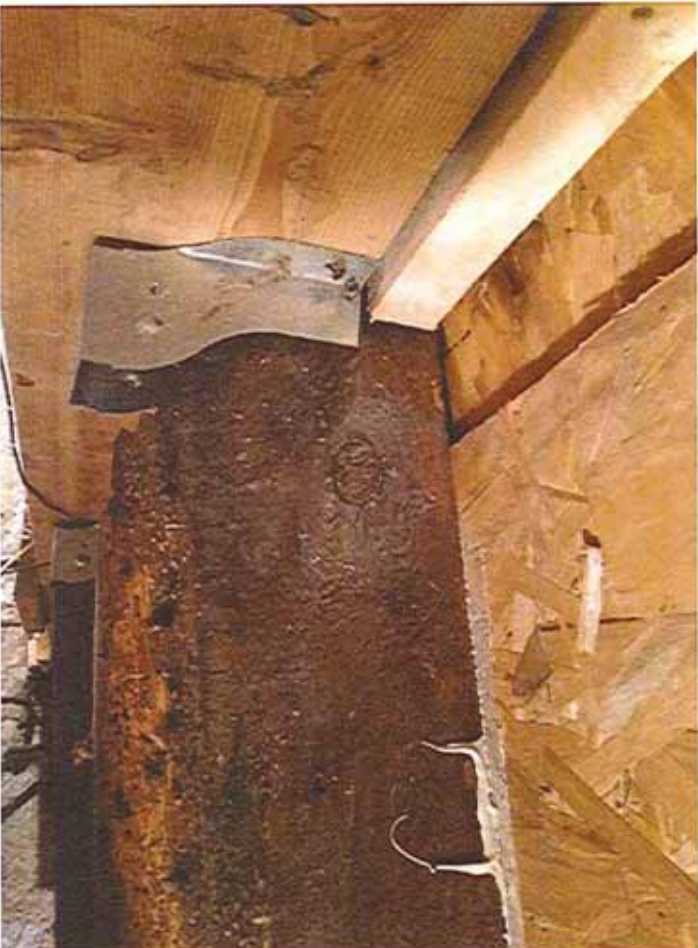
Image 21: Joist with apparent insect deterioration.

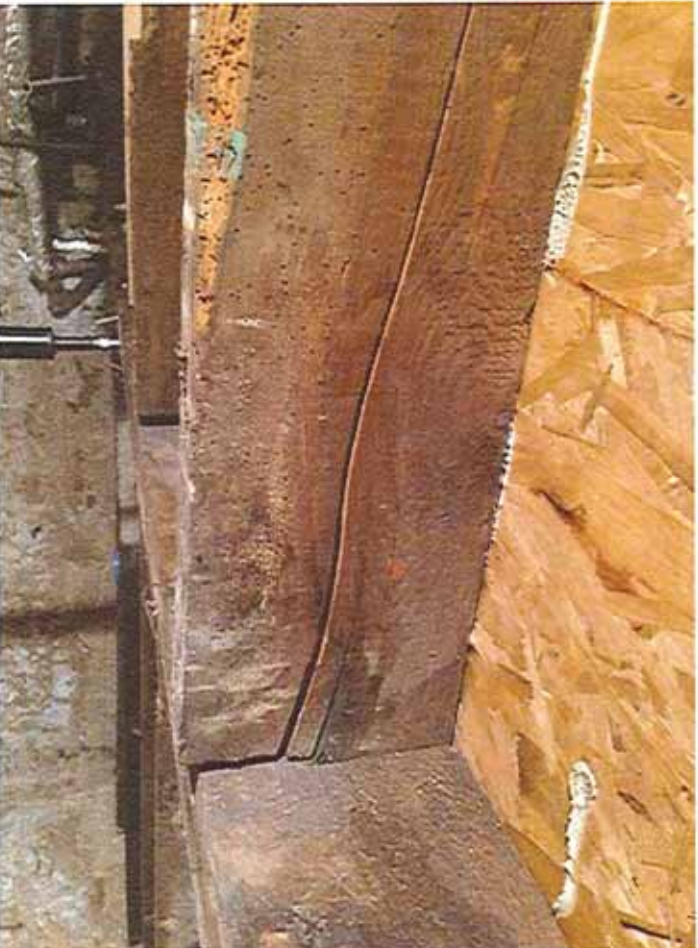
Image 22: Joist with apparent insect deterioration and shear failure.

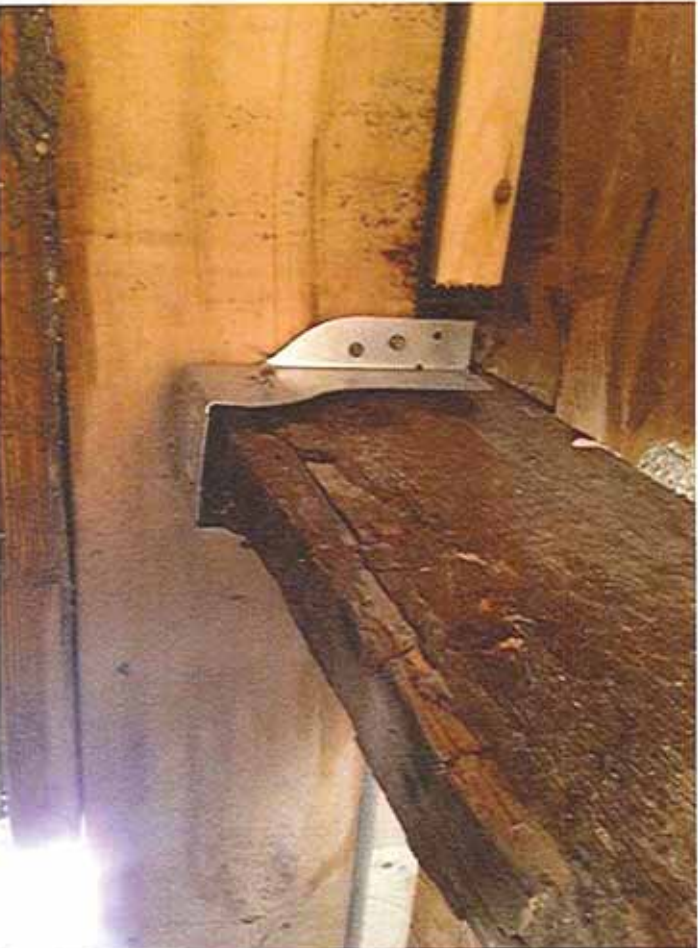
Image 23: Joist with deterioration and new hanger.

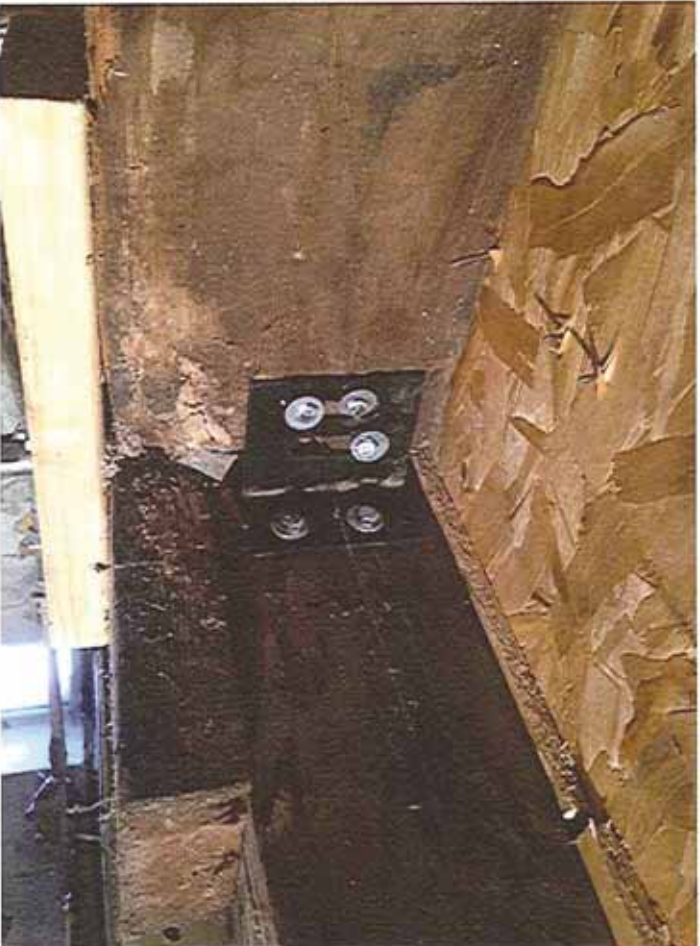
Image 24: Beam to beam connection. Note deterioration.

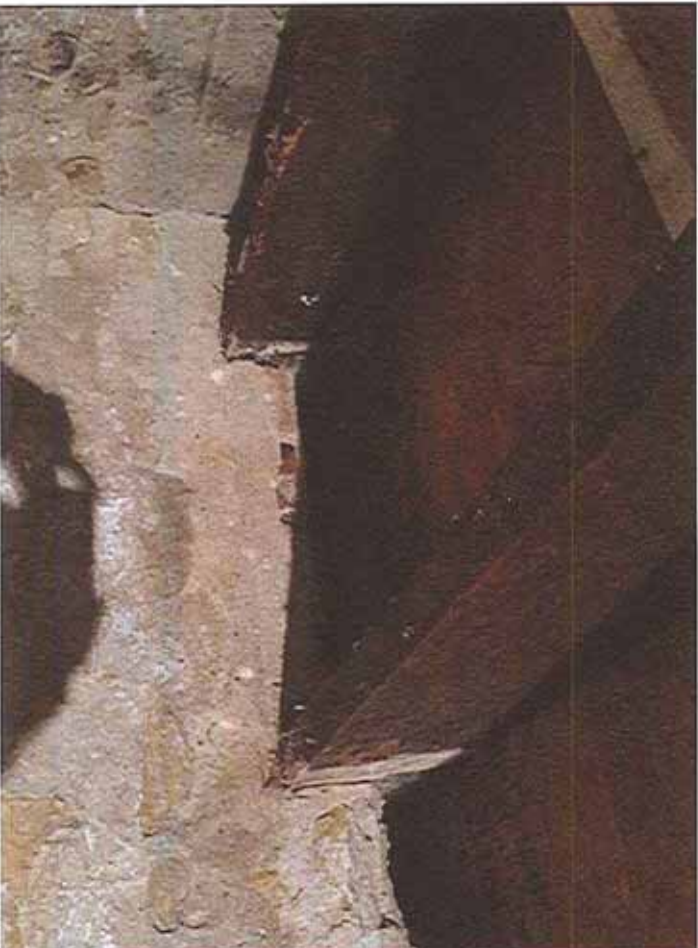
Image 25: Joists bearing directly on concrete foundation wall.

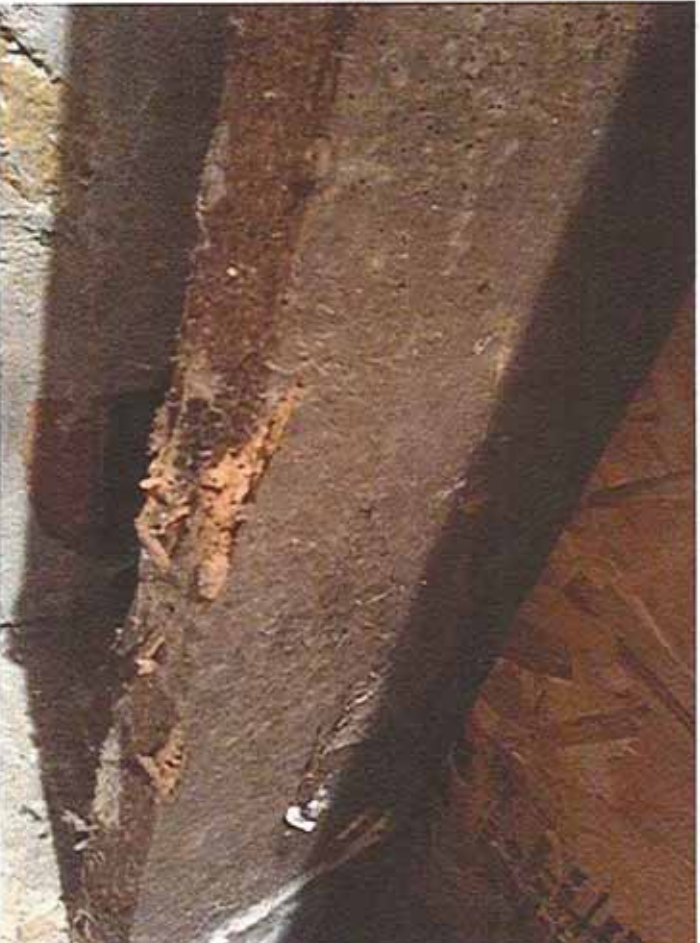
Image 26: Floor joist with apparent insect deterioration.

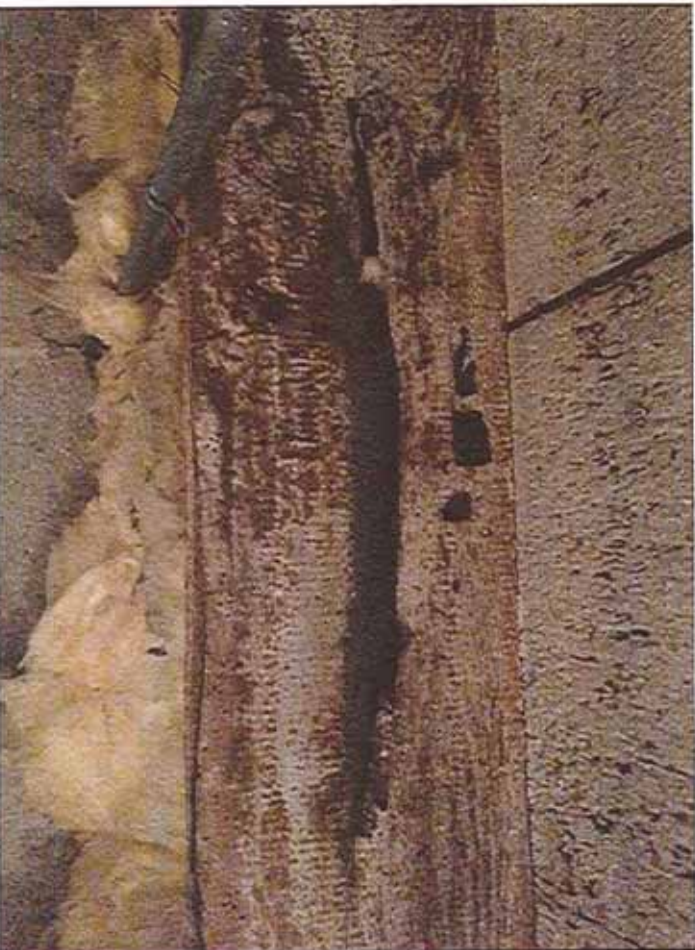
Image 27: Floor joist with damage/deterioration.

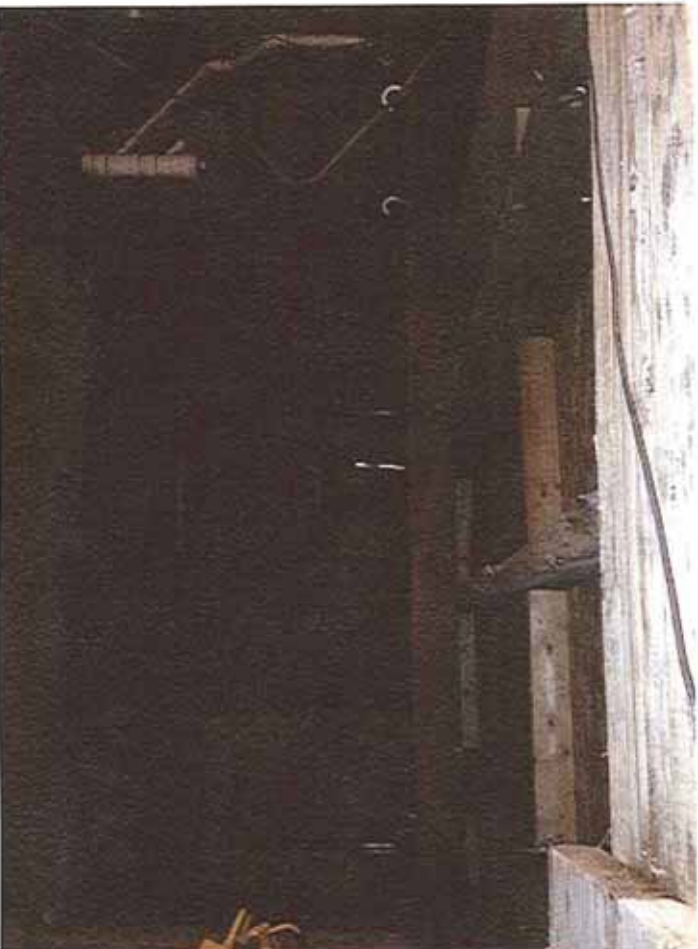
A 3.75" x 6" beam supports the first floor framing (see Images 28 & 29). We analyzed the beam to support the floor dead and live loads and found the beam to be 1,097.7% overstressed.

Image 28: View of undersized support beam.

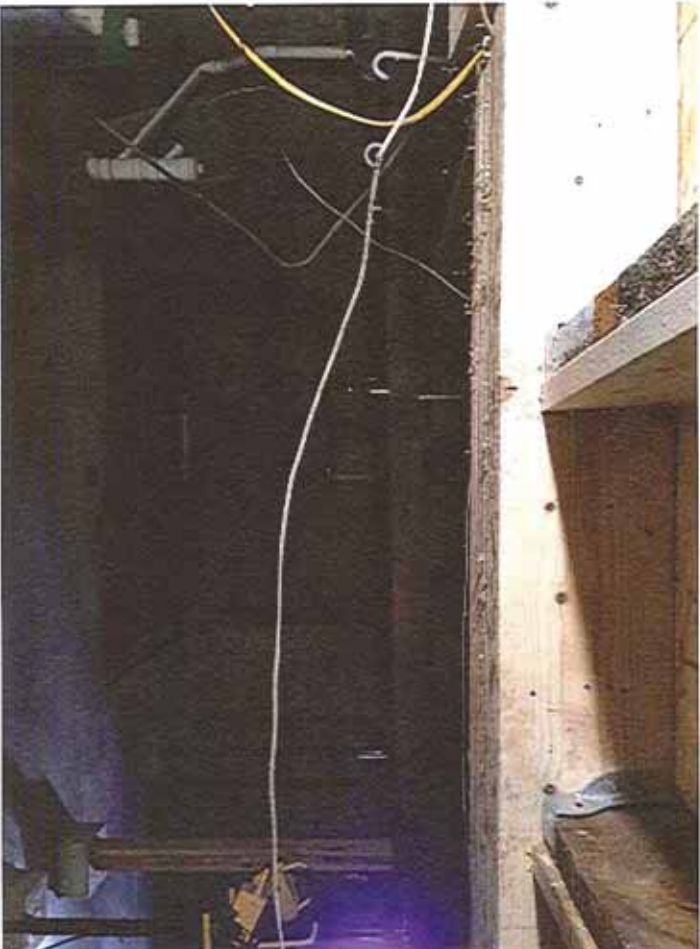
Image 29: View of undersized support beam.

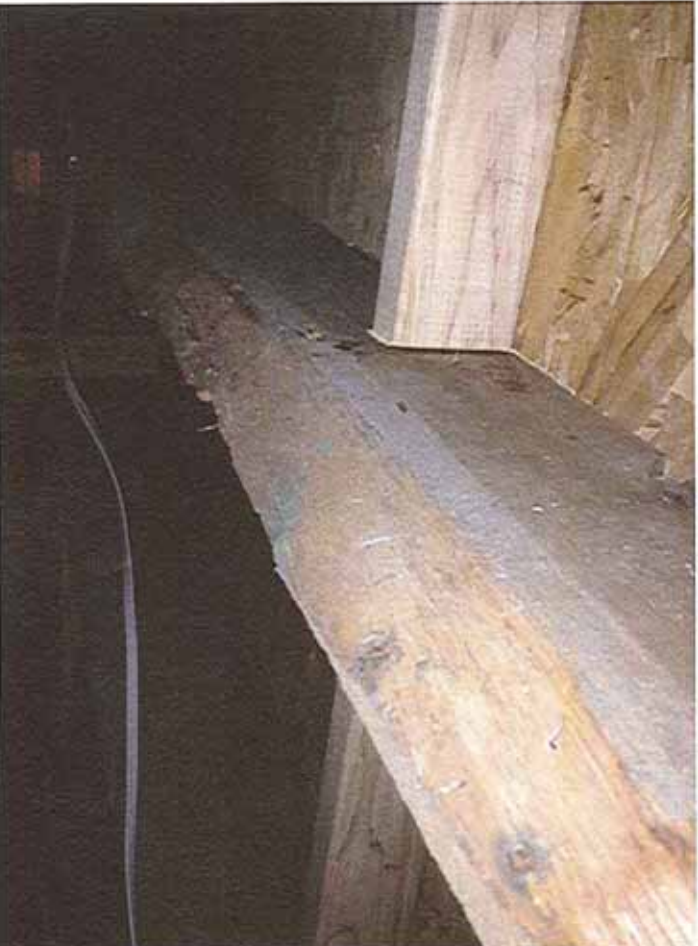
Image 30: View of damaged joist.

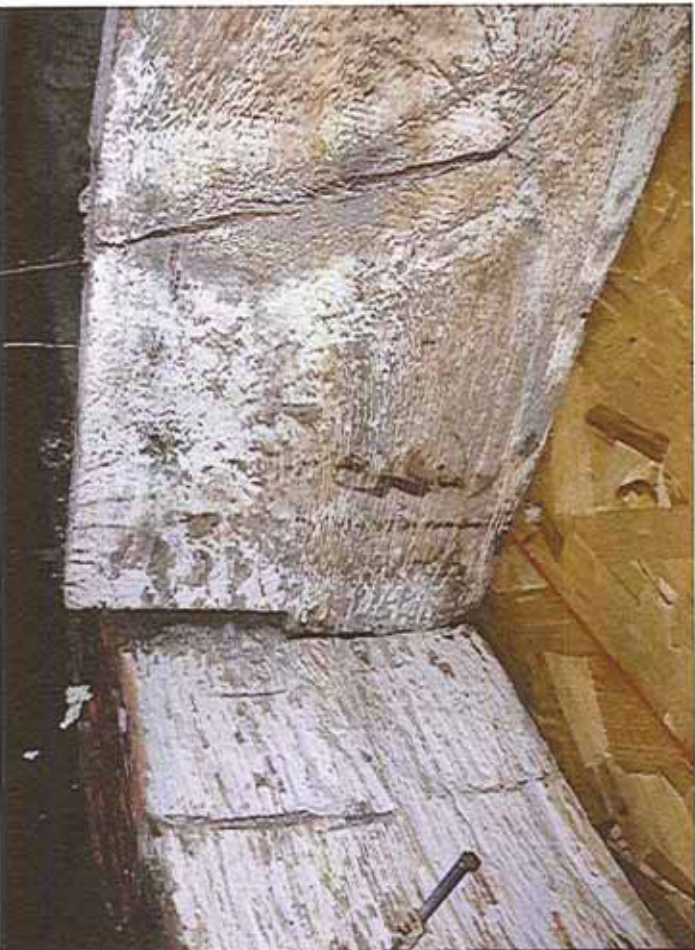
Image 31: Floor joist with notch exceeding NDS limitations.

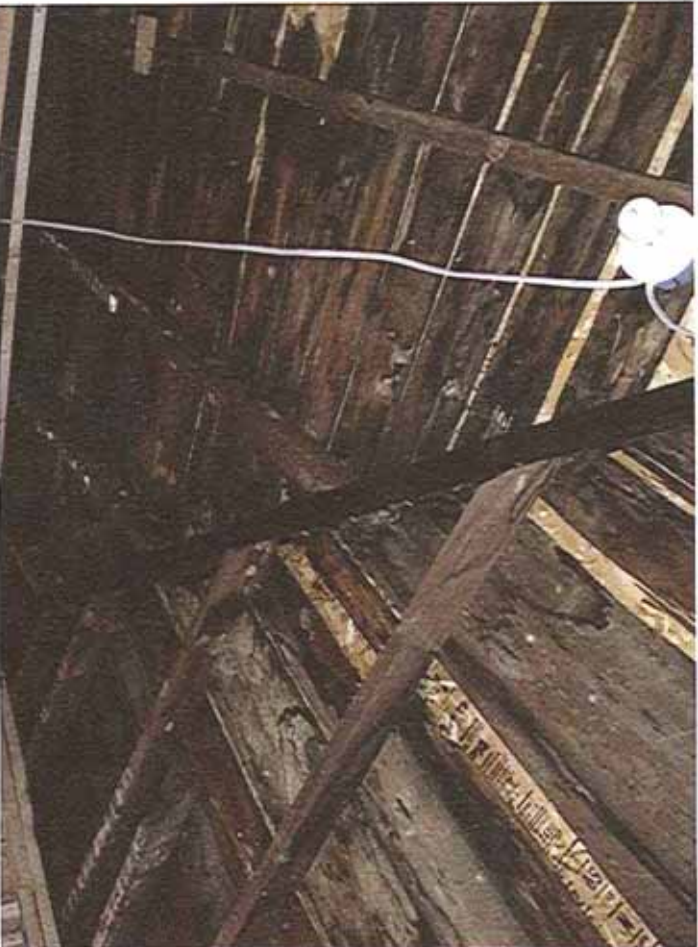
Image 32: Undersized hip beam.

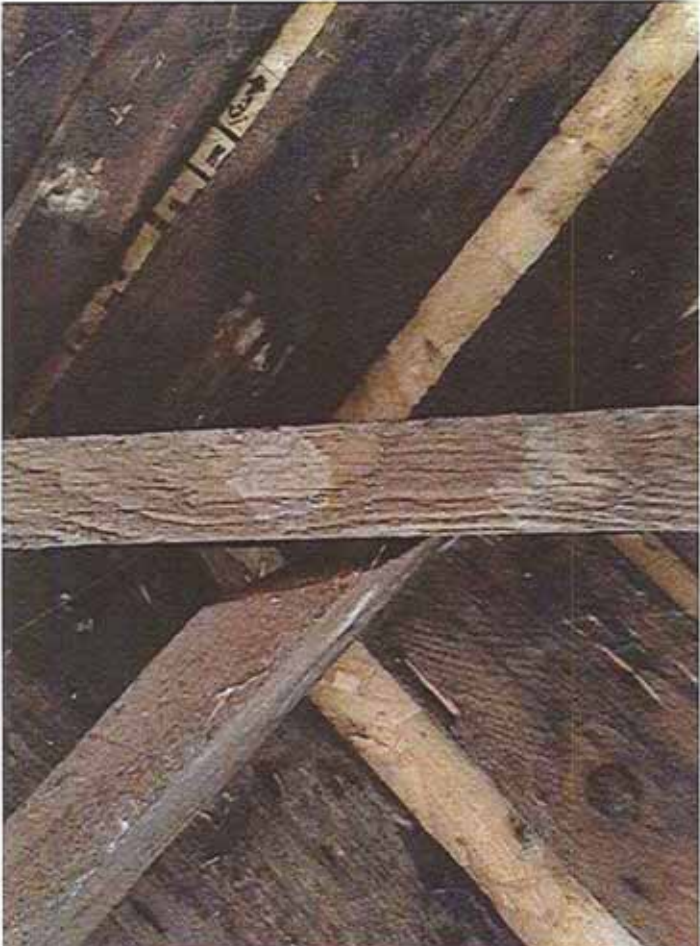
Image 33: Hip joist to hip beam connection.

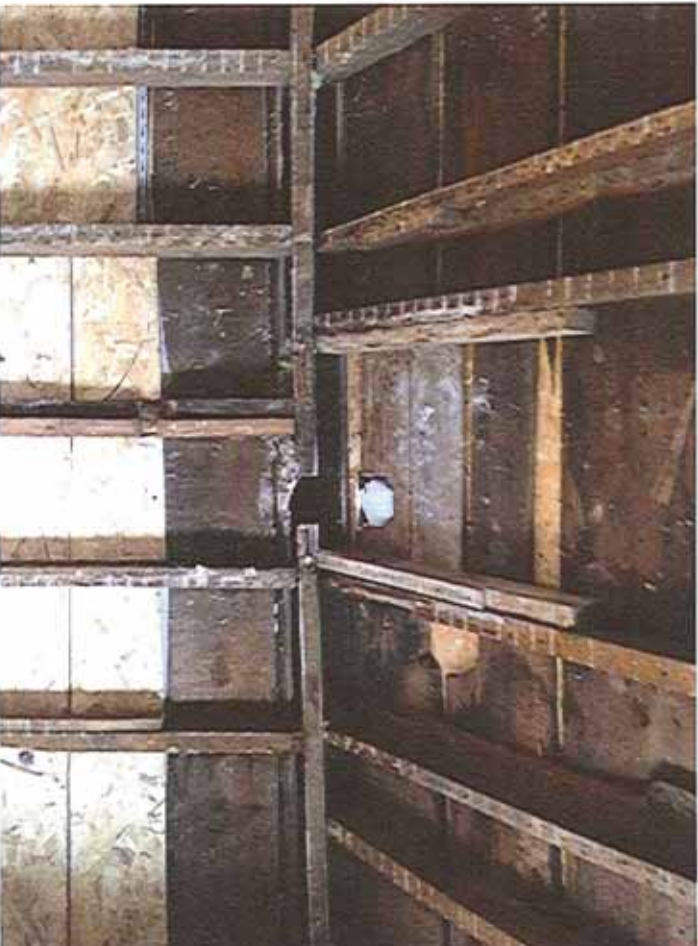
There is only a single sill plate for the roof joists to bear on and the joists do not line up with the wall studs (see Images 34 & 35).

Image 34: Single sill plate supporting roof joists.

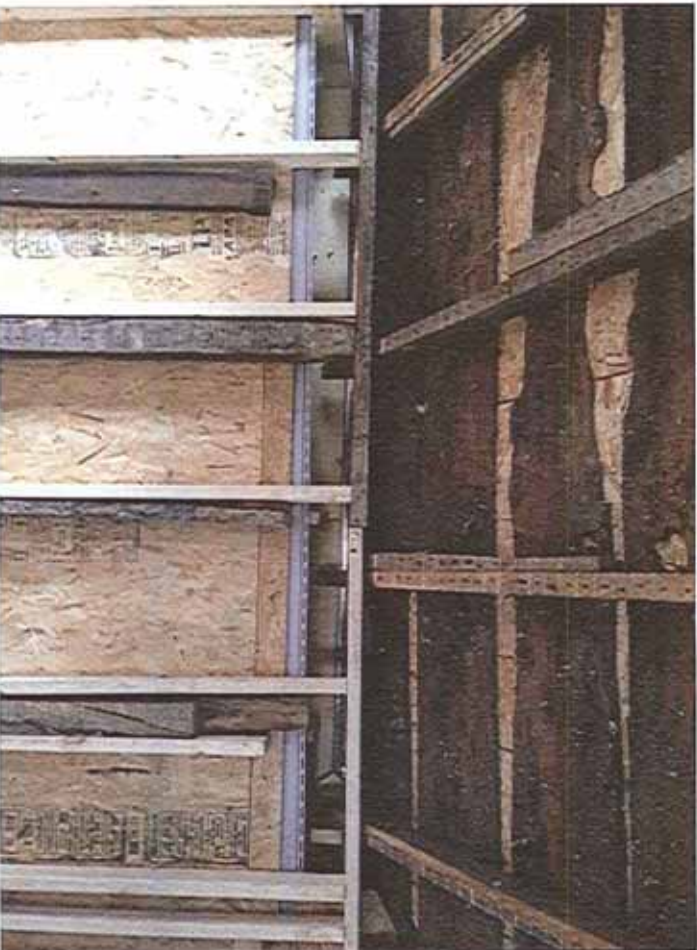
Image 35: Single sill plate supporting roof joists.

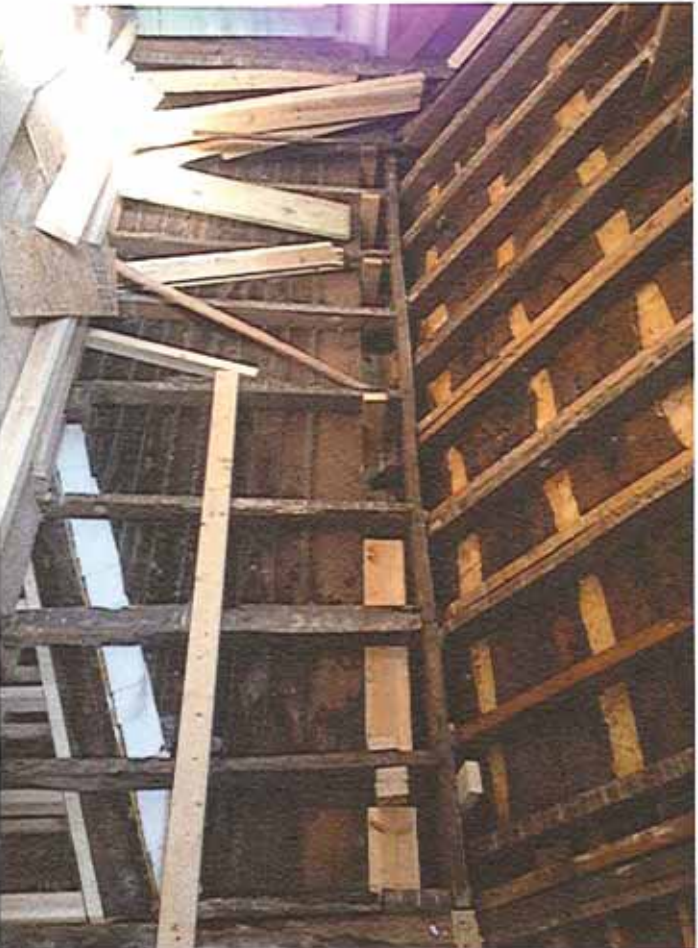
Image 36: Single sill plate supporting roof joists.

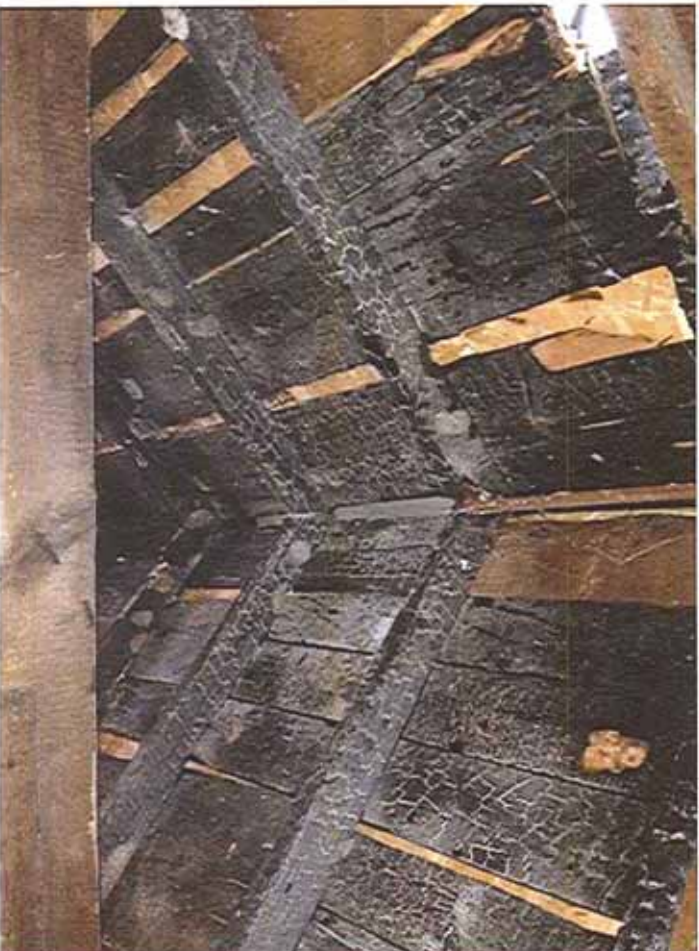
Image 37: Fire damage.
