April 16, 2014

**SUBJECT:** 827 E. Gorham Street  
Structural Assessment  
MP-Squared Project No: 1411046W1

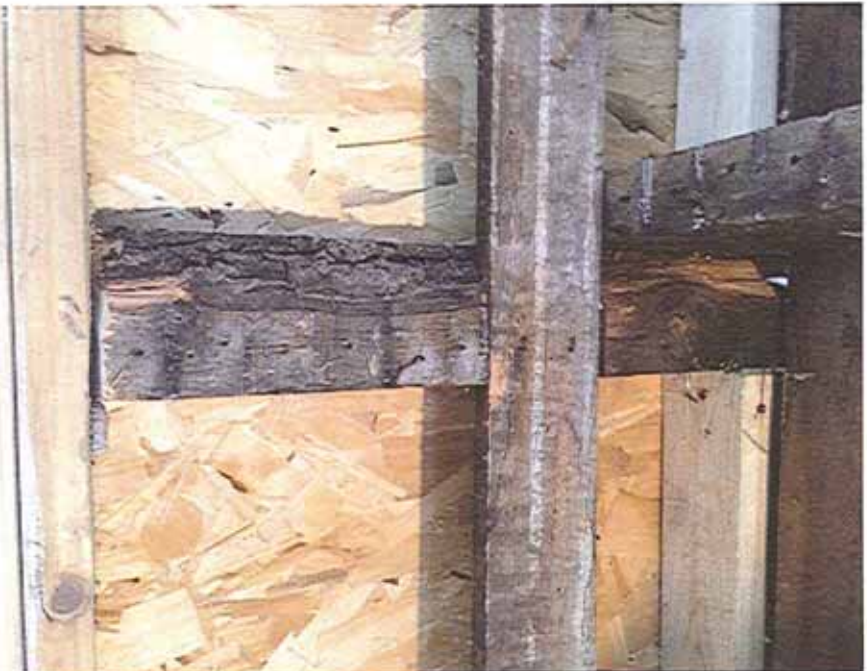
We observed wood deterioration likely caused by insects, fungi, and fire. Insect damage was found on the first floor framing and second floor framing (see Images 16, 21, 22, 27, 42 & 43). Fungi deterioration, likely a combination of dry, white, and wet rot, was noted on the first floor, wall framing, and roof framing (see Images 8, 9, 12, 13, 23, 24, 27, 30, 38, & 41). Fire damage was noted throughout the roof framing on the second floor (see Image 37).

Image 38: Deteriorated wall stud.

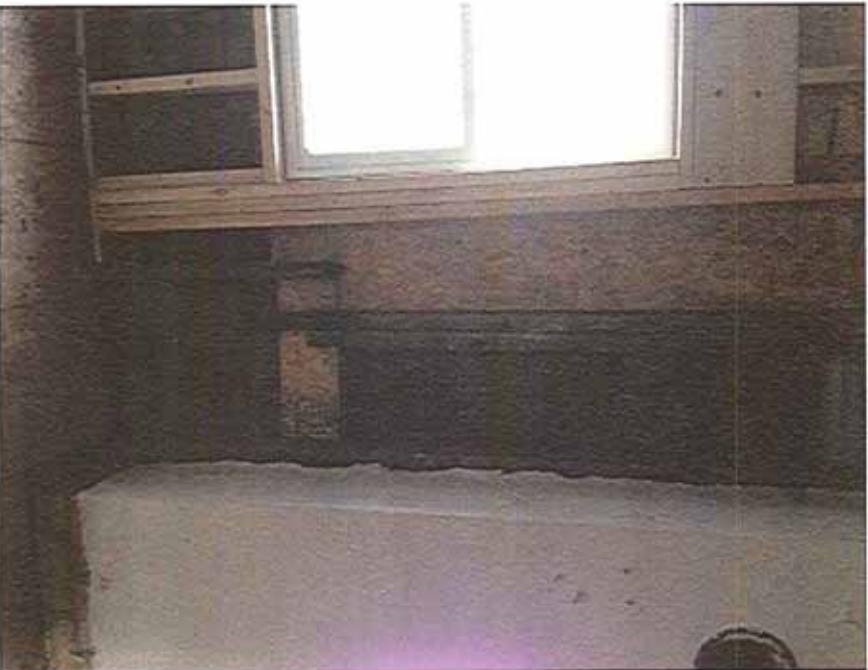
Image 39: Discontinuous wall stud.

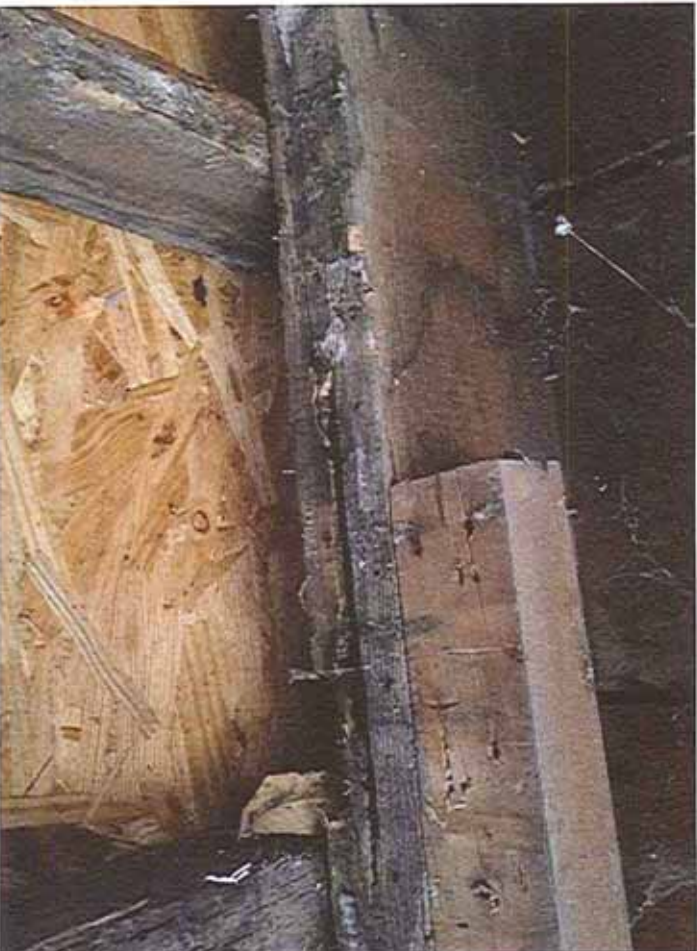
Image 41: Deteriorated framing at exterior wall.

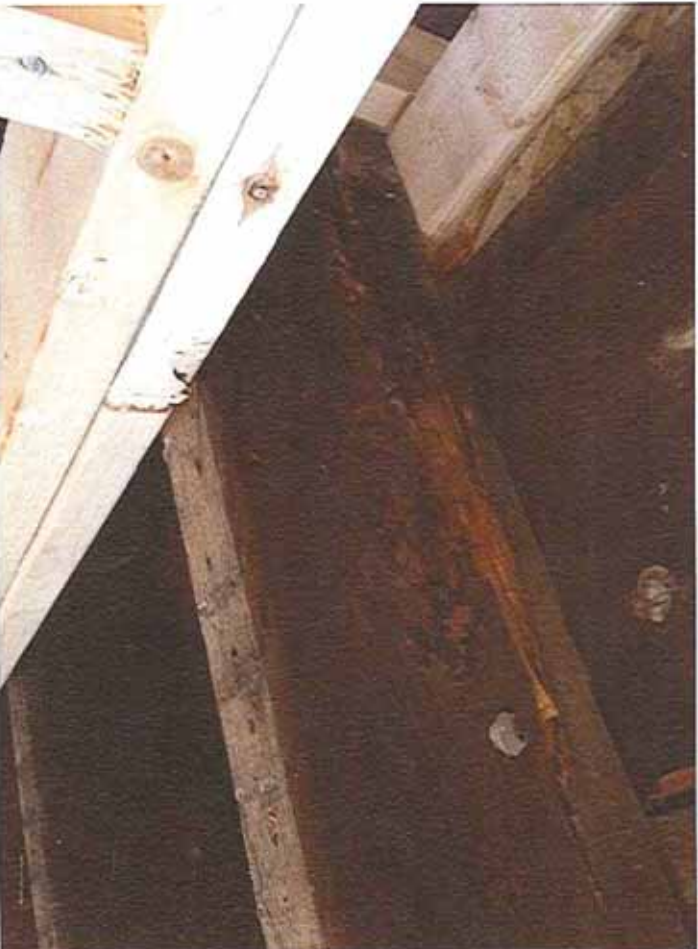
Image 42: Deteriorated second floor joist.

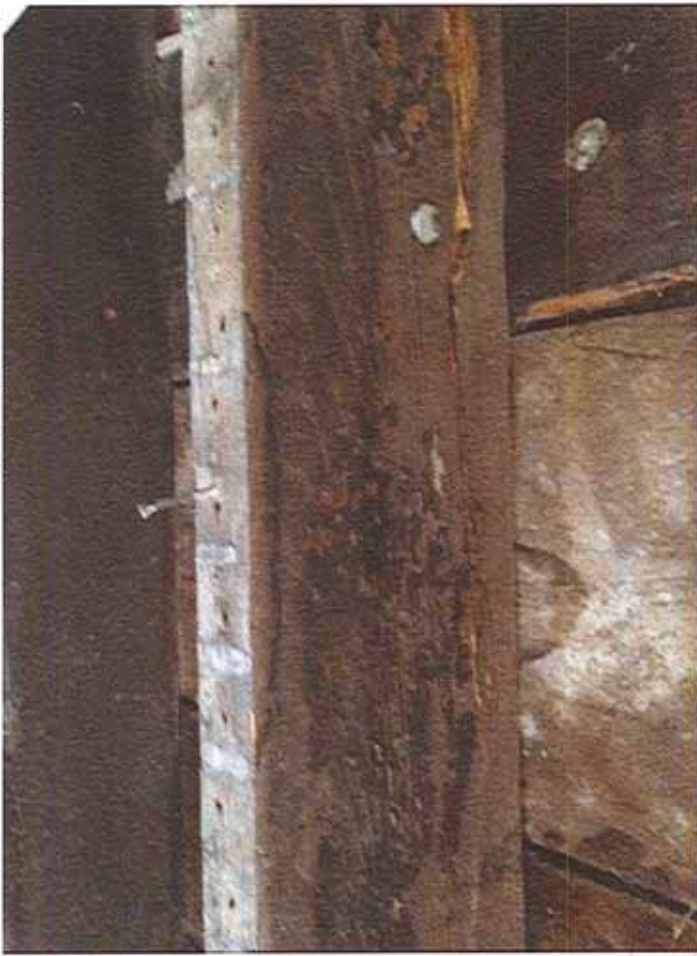
Image 4.3: Deteriorated second floor joist.
