**ANNIE C. STEWART MEMORIAL FOUNTAIN
CONSERVATION/PRESERVATION PLAN
MADISON, WISCONSIN**

Annie C. Stewart Fountain Conservation/Preservation Plan

Prepared for the City of Madison
By InSite Consulting Architects

PHOTO REPORT

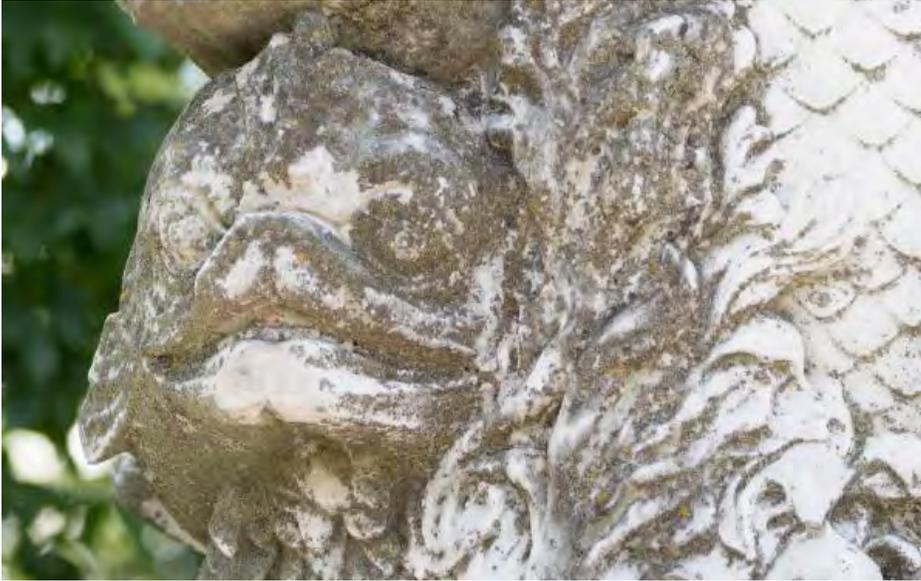
Dolphin in 2017- Much of the fine detail is obscured by organic growth. Cleaning using a benign biocide and appropriate (field tested/verified) techniques will reveal the true condition of the marble subjects. The nature of the piece's subjects, their delineation in stone, their orientation, neighboring vegetation and exposure to the elements will come to light after a proper conservation-based cleaning.

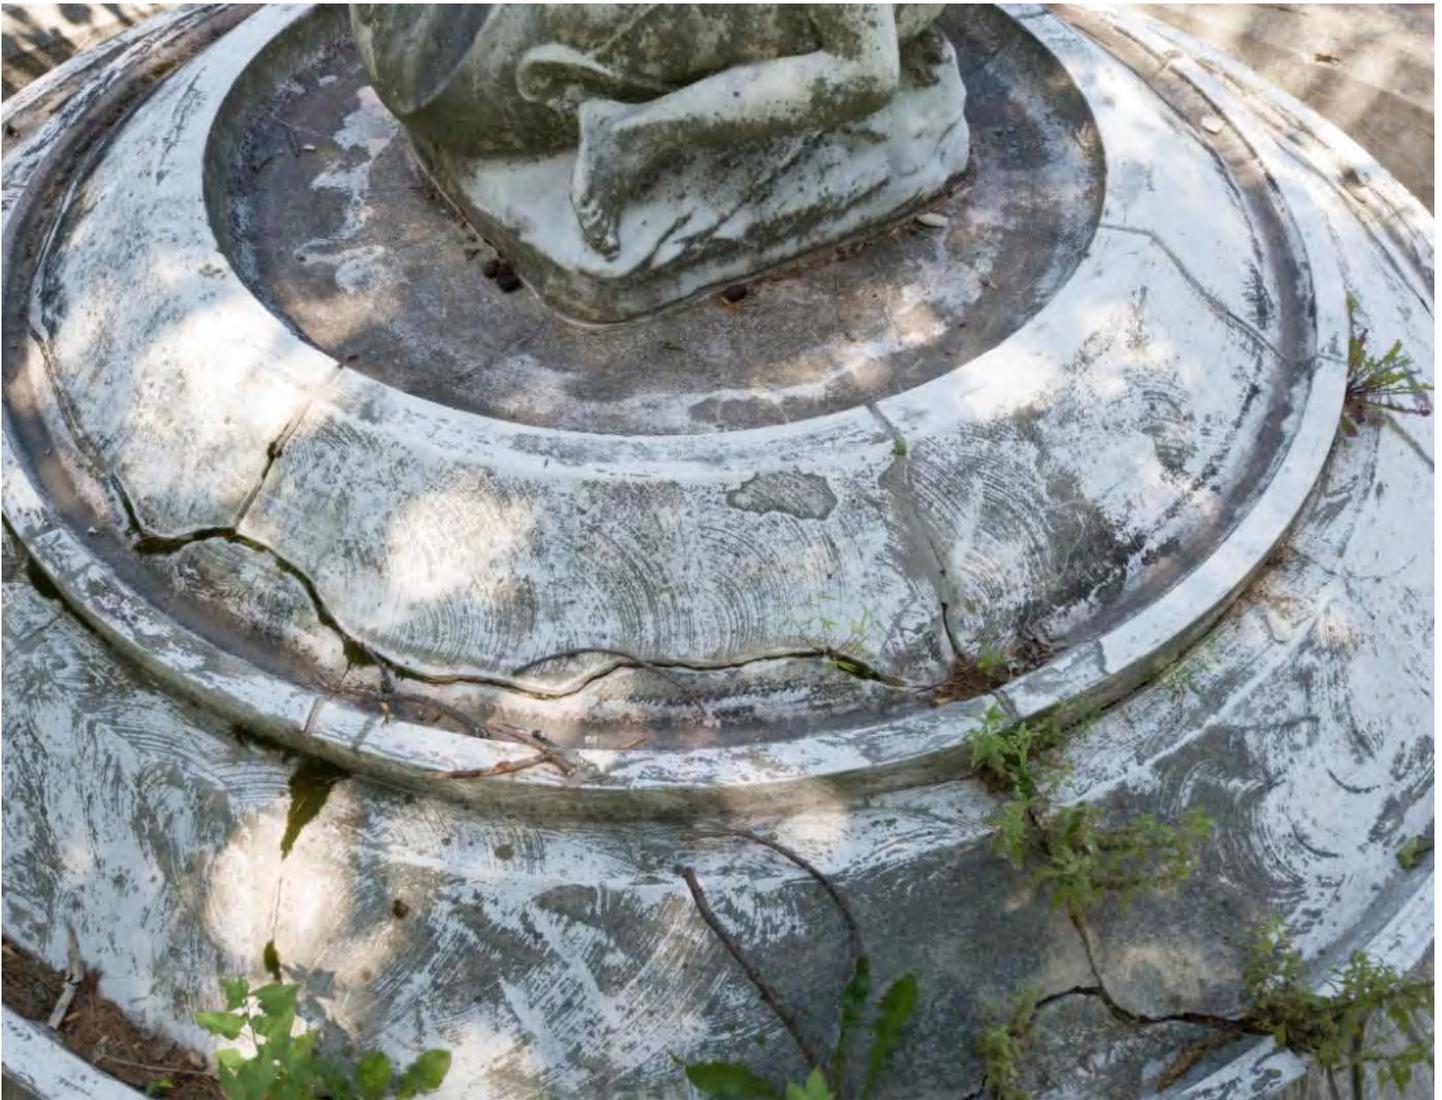
The transition from marble to limestone has fared poorly overall, but better than some of the “downslope” details. This is likely due to the fact that it was designed to handle significant amounts of water.

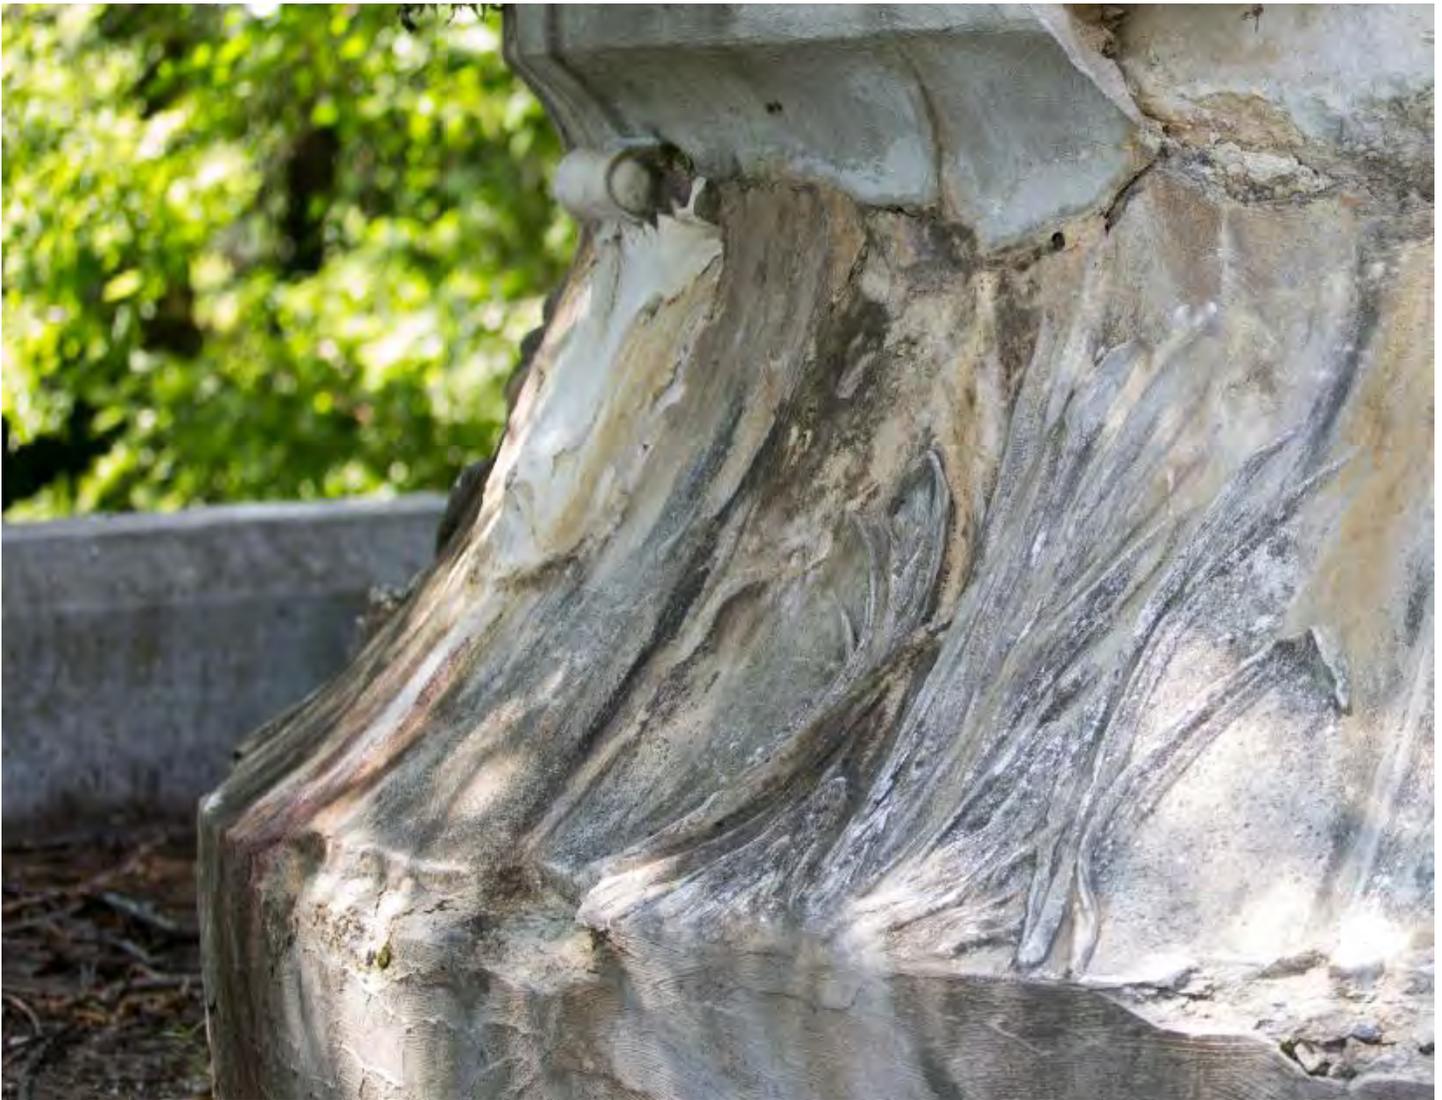
Egregious damage to the limestone base has come not only from the effects of the environment but also from repairs executed in the mid-1980's. The sealing of the surfaces of the stone eventually accelerated its deterioration and introduced long-term moisture exposure to the interior of the base's structure. Excessive corrosion of the stone's steel tension ring have contributed to significant deterioration from expansive metals.

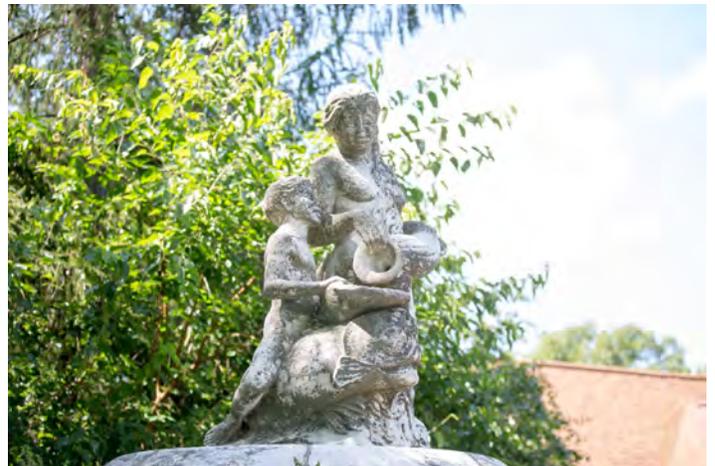
Figure 2: Overall view of condition of marble figures

CONDITION: The Basin and Base have been treated (1994) with an epoxy cement-type repair material typically used for concrete and occasionally employed to preserve and protect Indiana Limestone. Typically, these efforts fail as the material is aggressive in terms of strength, bond to the base material, water vapor transmission characteristics, color and texture. Evident damage can be seen in the following figures. Significant areas of water-borne damage throughout the limestone base and concrete basin are, simply, beyond repair. Preservation of the material, while perhaps possible, will not meet any acceptable preservation standard. It is recommended that the basin be rebuilt in-kind as a replica.

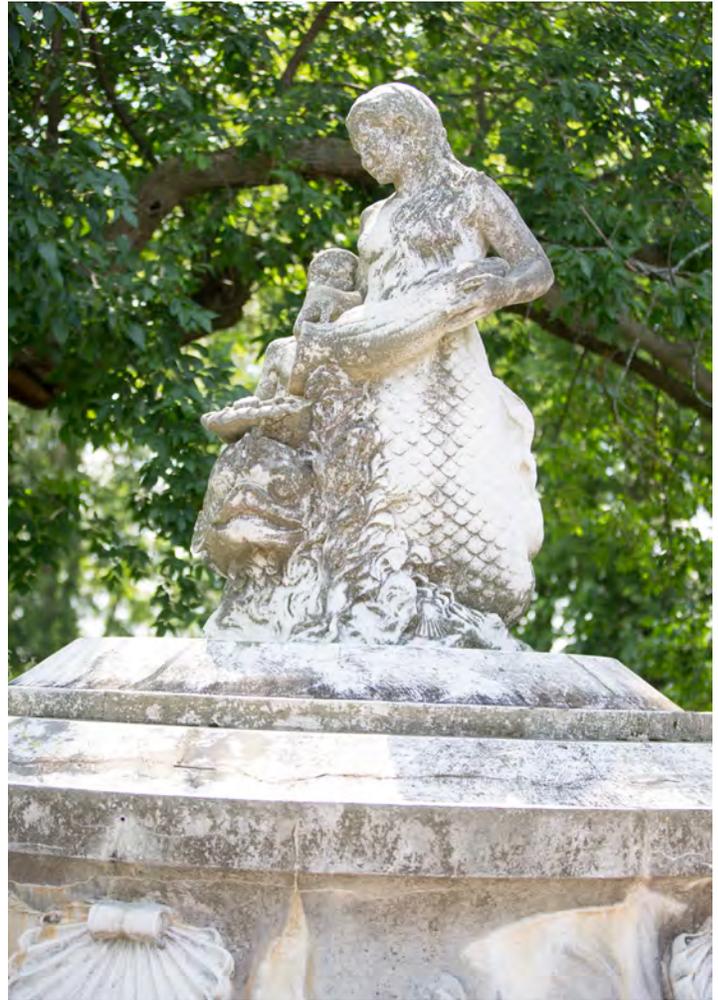
Figure 3: Overall view of condition of marble figures

The figures appear to have been cleaned and maintained as photographs from 1973 indicated the dolphin figure was in excellent condition. In the intervening 44 years organic growth has been allowed to establish a presence. The pieces should be removed for cleaning and further conservation and preservation treatments.

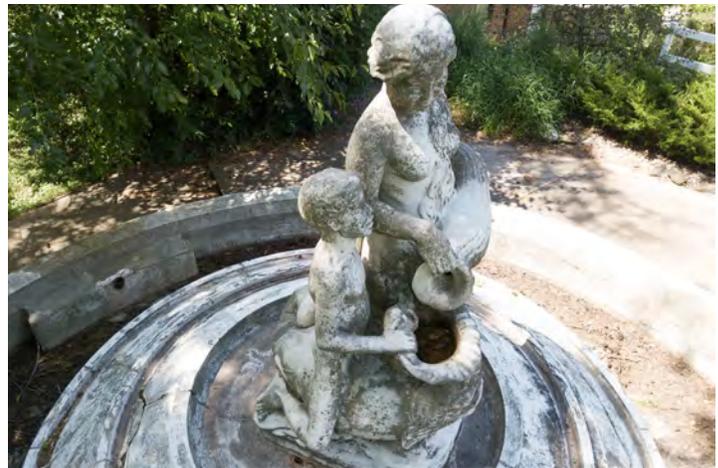
Water feature: We do not recommend the repair/resurrection of the water feature. However, several elements, such as the cornucopia may require some protection as they collect water. The collection points allow water and organic material damage to occur.

Figure 4: View of cornucopia water feature

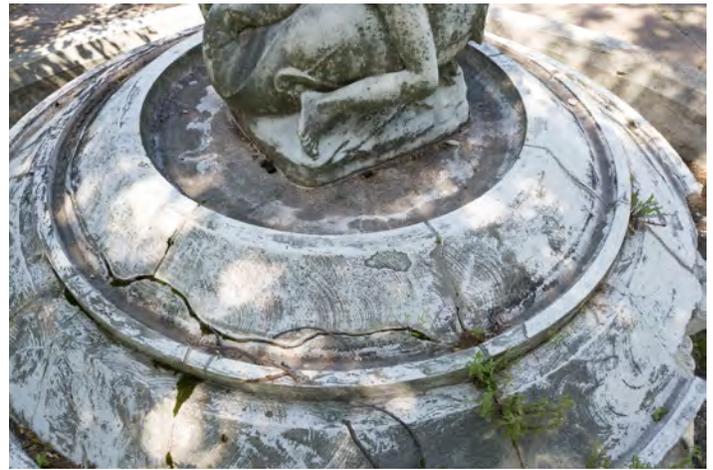
The previous treatment of the pedestal and base materials with the epoxy cement overcoat has altered and damaged the material beyond repair. Further, it is likely that this material will be damaged when the figures are removed for preservation/conservation based repairs. The area directly beneath the sculpture (pedestal) appears to be in the best overall condition of all the limestone that was treated in 1994. The cracks at the pedestal have been repaired and the surface treated. In this case, the configuration of the stone, the lack of fine detail, and its water shedding design helped the pedestal maintain its overall material and form.

Figure 5: Upper view of pedestal and base - note damage to pedestal has been repaired and appears to have stabilized

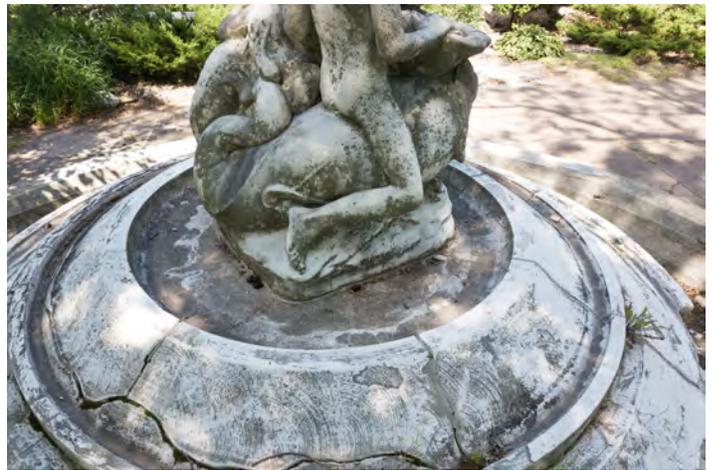
Cracks have formed at the base of the pedestal due to the differential movement of the pieces as produced and set. The interior “plumbing” of the fountain is likely to have an affect on this movement as it would act as a pinning point. Conservation of the piece would entail the careful deconstruction of the work to ascertain the interior configuration of the fountain, and its impact on the remainder of the piece.

Figure 6: View of marble figures and upper view of pedestal and base - note damage to pedestal has been repaired and appears to have stabilized

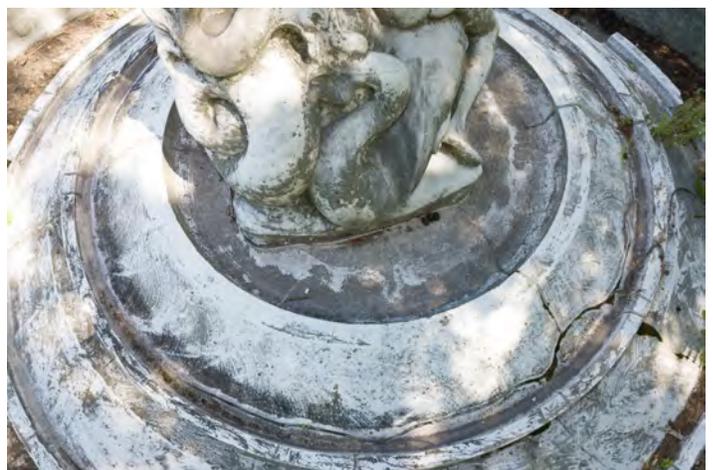
The shallow basin at the top of the pedestal collects water, promoting organic growth and the deterioration of the stone. This is a natural feature of the piece that must not be altered. It simply requires a regular maintenance regimen to keep it in optimal condition.

Figure 7: Upper view of pedestal and base - note damage to pedestal has been repaired and appears to have stabilized

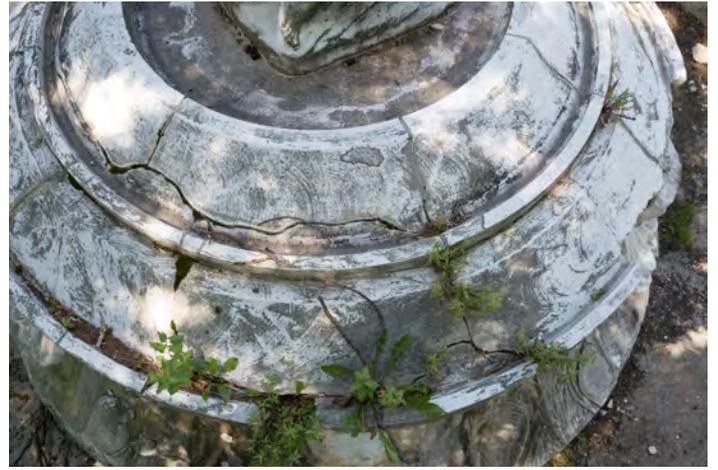
The organic growth has caused more damage to the limestone base as might be expected due to the relatively open nature of the stone as compared to marble. This part of the piece appears to be beyond repair and must be replaced. The long-term performance of any new work will also require a regular maintenance regimen to keep it in optimal condition.

Figure 8: Upper view of pedestal and base - note damage to pedestal has been repaired and appears to have stabilized

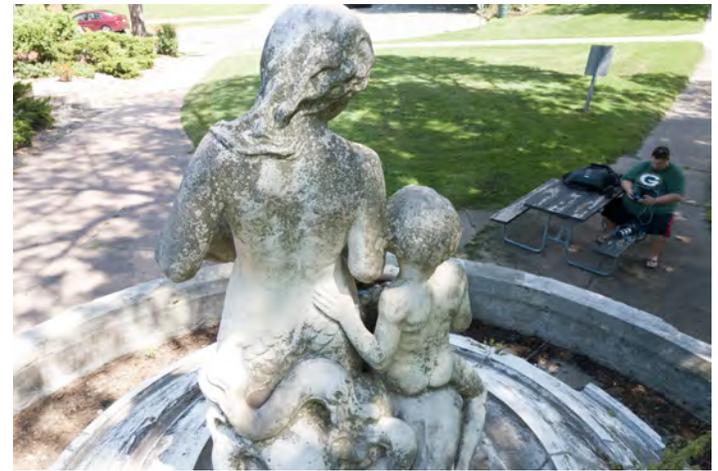
The organic growth at the marble portions of the piece appears to be mostly superficial. This must be confirmed through a thorough conservation-based cleaning and study. The long-term preservation of the marble artwork must be maintained regularly with a prescribed regimen, properly funded. A conservation plan must be developed and implemented if the piece is to remain available to the public.

Figure 9: View of marble figures and upper view of pedestal and base - note organic buildup

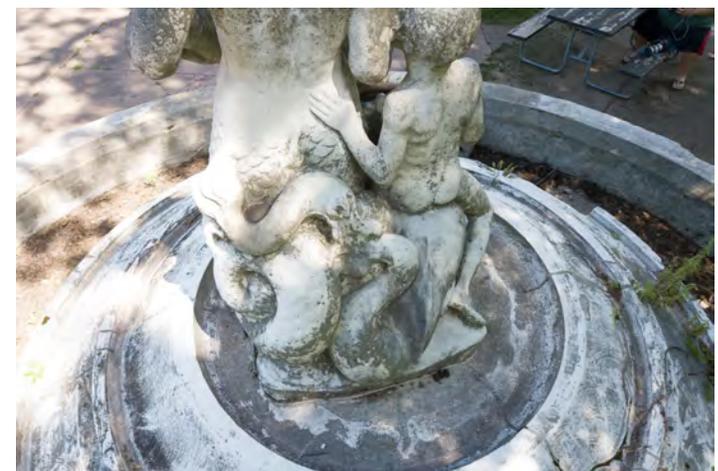
Figure 10: View of marble figures and upper view of pedestal and base - note mineral and organic buildup

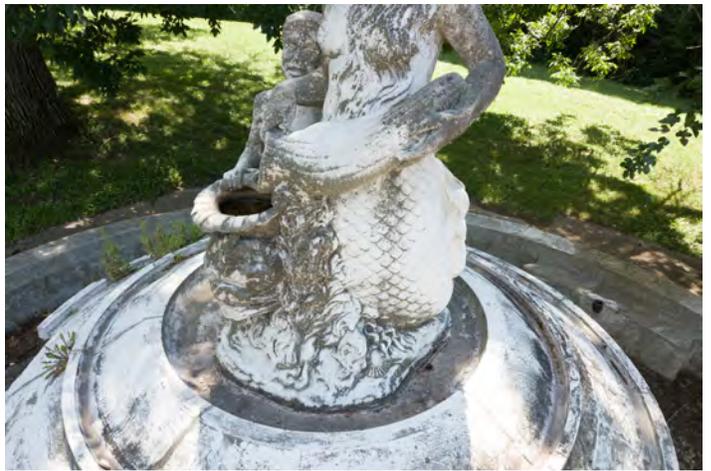
Figure 12: View of dolphin figure - note the apparent loss of detail from organic buildup

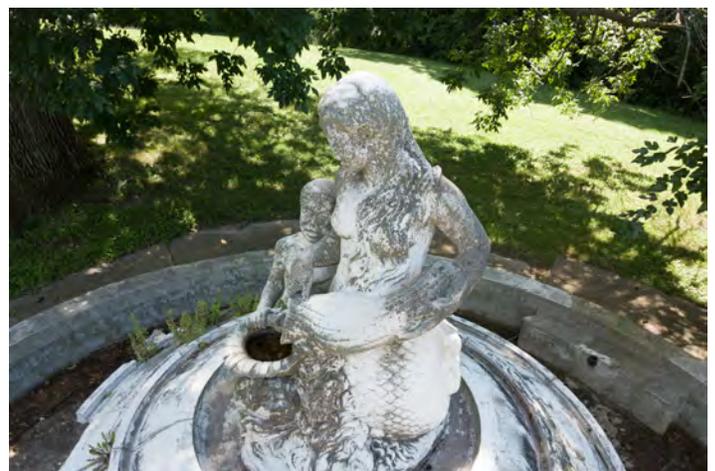
Figure 13: View of mermaid and cornucopia - note the apparent loss of detail from organic buildup

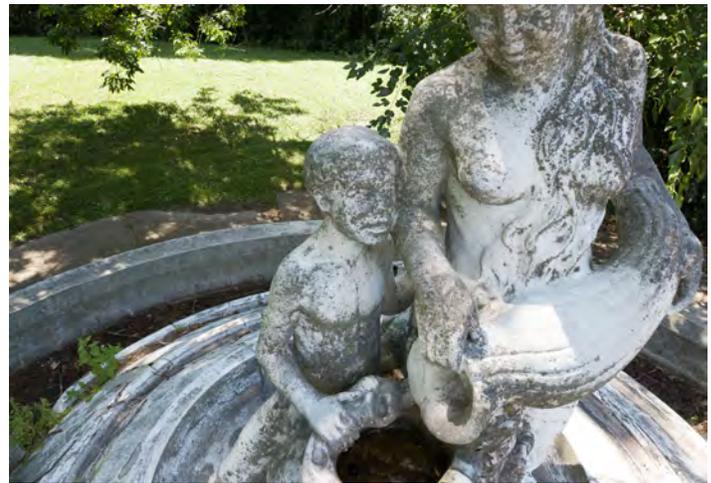
Figure 15: Close up view of Triton - note organic growth on surface of marble

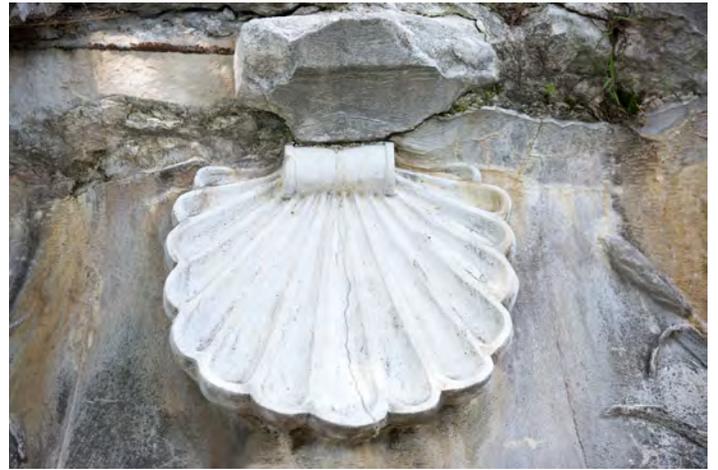
Figure 20: Shell motif condition amid limestone damage indicating restoration or replacement at some point in time

Deterioration at the limestone is, simply put, beyond repair. This is due to limestone's vulnerability to damage from moisture infiltration, freeze-thaw cycling, and organic growth.

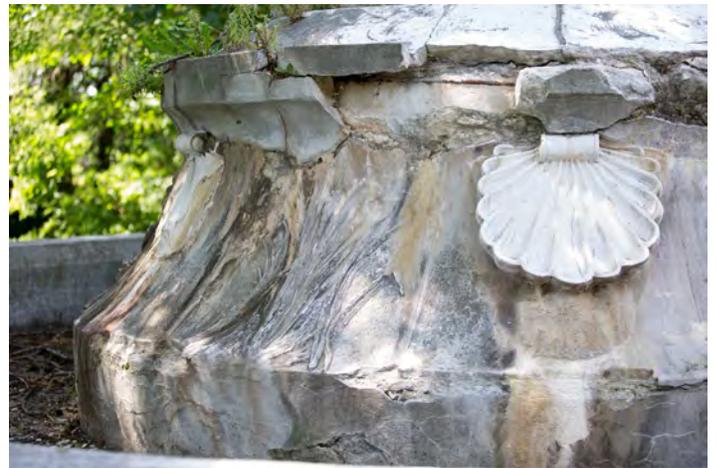
Figure 21: Excessive limestone damage adjacent to steel tension ring - causing iron oxide (rust) staining

This piece, because of its structural loading (holding itself and the marble piece above), required a tension ring at the top of the limestone base. This tension ring was made using steel rod that was given a radius and resisted the spread of the base when the marble pieces were installed. This steel rod has corroded, expanded and caused irreparable harm to the limestone.

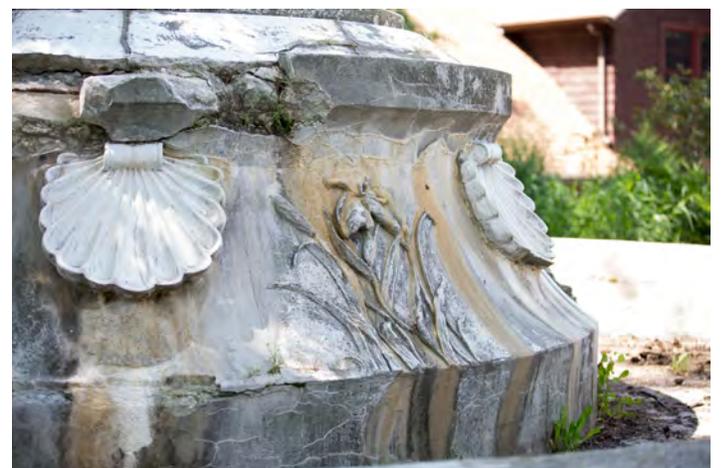
Figure 22: Overall condition of stone base - the damage is excessive and beyond repair

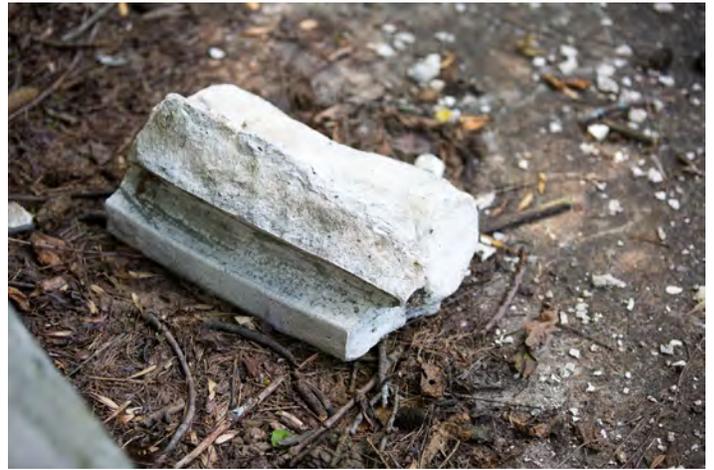
This piece of limestone came from the area shown in Figure 22 and is lying on the ground. It sheared off of the main base as the underlying steel corroded and expanded.

Figure 23: Broken piece on the site

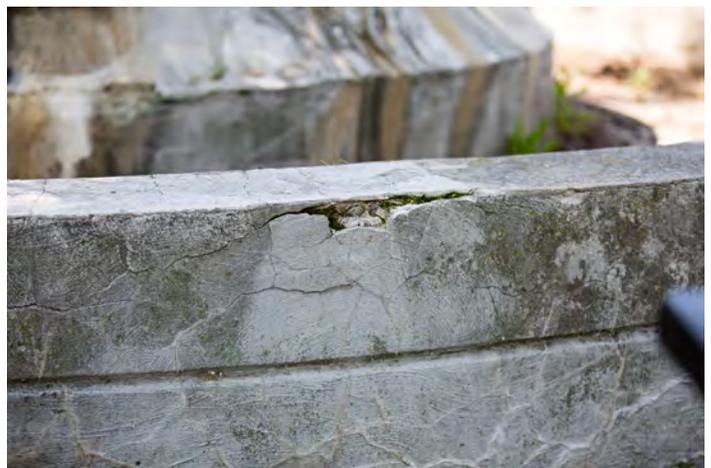
The term “emerging damage” could be used throughout this report. This is one of many examples of the deterioration at the fountain that will continue to worsen. In our experience, these issues manifest themselves at an increasing rate as time progresses and neglect continues.

Figure 25: View of emerging damage at concrete at lower perimeter ring

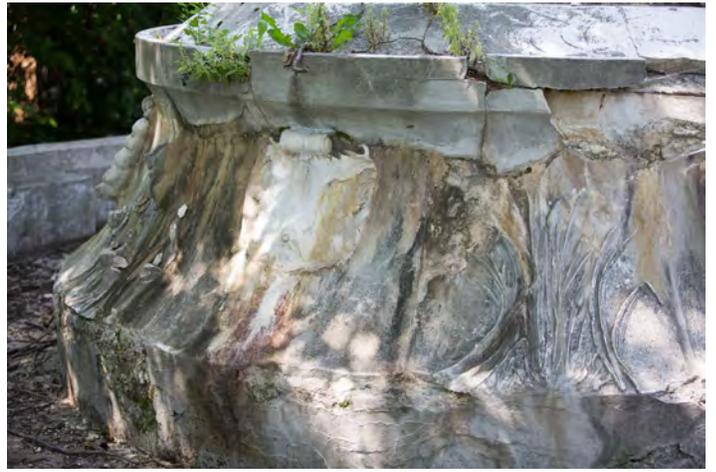
Figure 26: Excessive damage and improper repair with organic growth that is indicative of the level of disrepair

The fountain's base must be reconstructed.

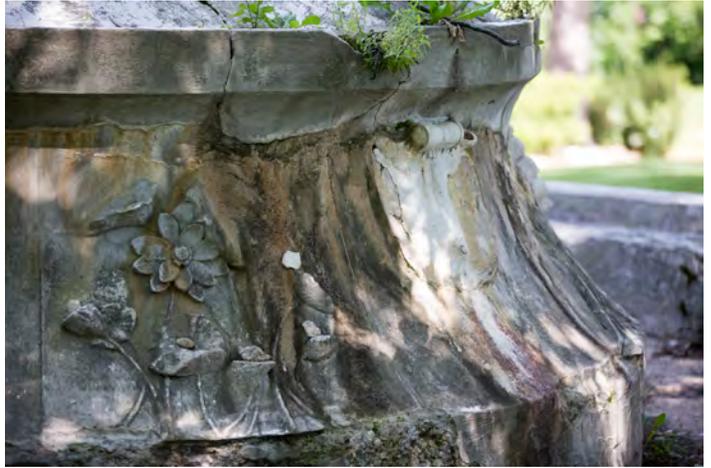
Figure 29: Excessive damage and improper repair with organic growth that is indicative of the level of disrepair

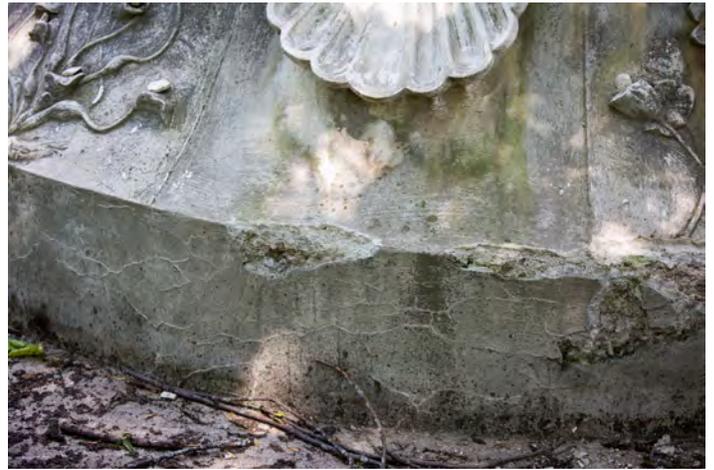
Figure 32: Degradation and mineral staining at trailing water

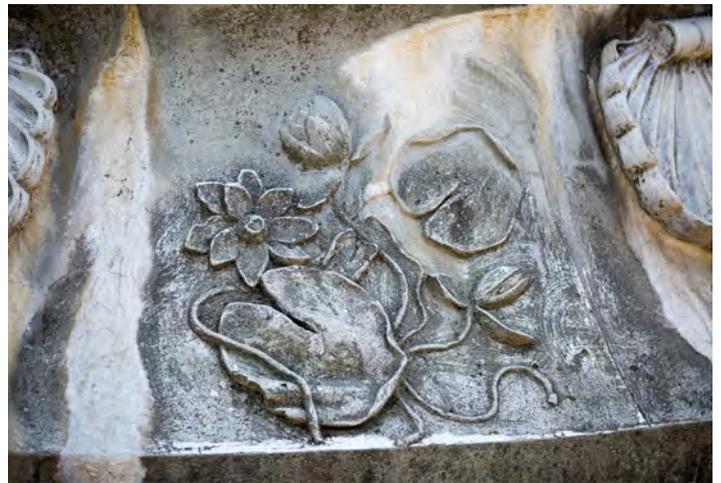
Figure 36: View of intricate detail at base, mineral deposits at trailing water

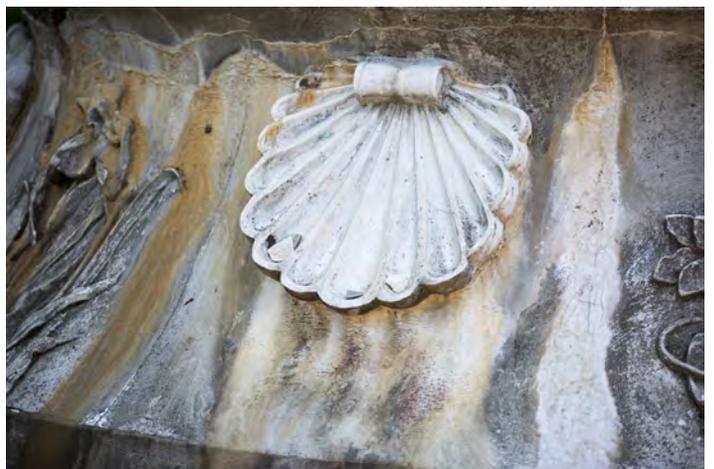
The shell motifs appear to have been part of a separate preservation effort, or, their shape and materials have led them to withstand the effects of the elements at the site better than the surrounding stone. Further study is required.

Figure 37: Shell motif condition amid mineral deposits at trailing water

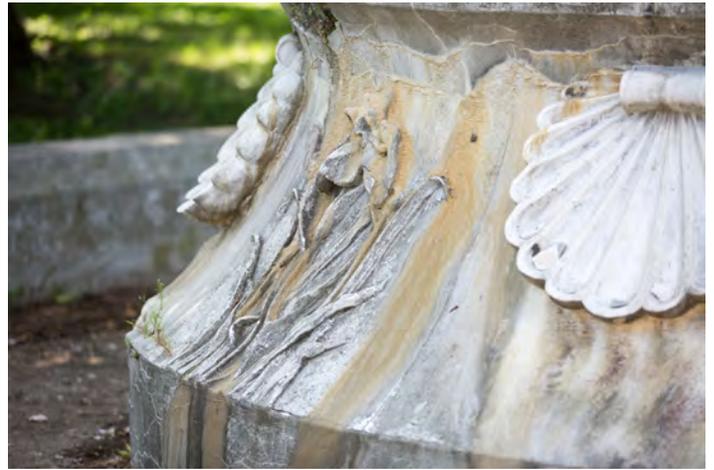
The mineral deposits appear to emanate from the sub-surface steel components of the base.

Figure 38: Shell motif condition amid mineral deposits at trailing water

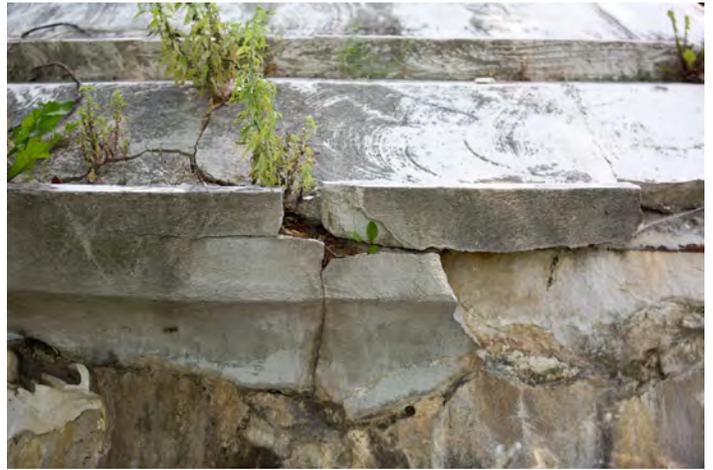
The damage to the fountain's base of limestone and concrete is not reversible. Complete restoration is required.

Figure 41: View of extreme damage to the limestone

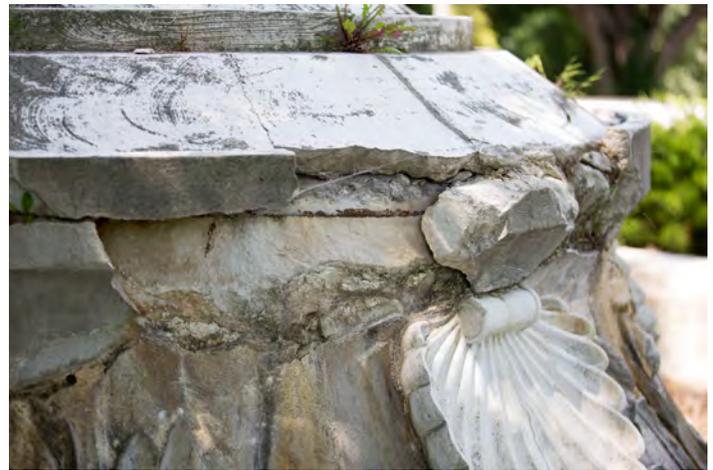
The damage to the fountain's base of limestone and concrete is not reversible. Complete restoration is required.

Figure 42: View of damage at tension ring

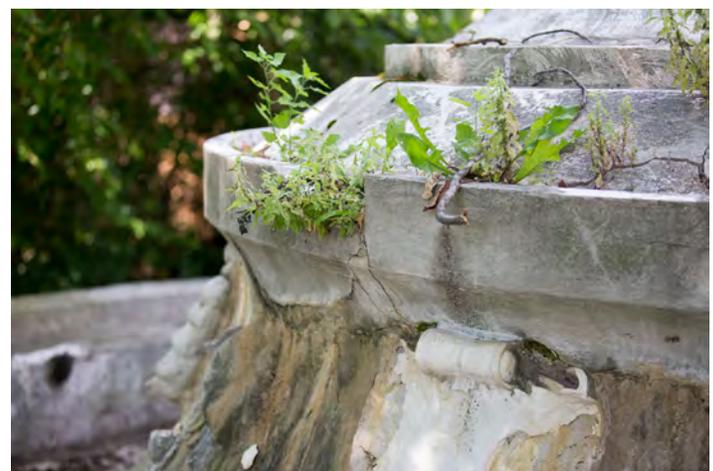
The damage to the fountain's base of limestone and concrete is not reversible. Complete restoration is required.

Figure 43: View of plant infestation and damage

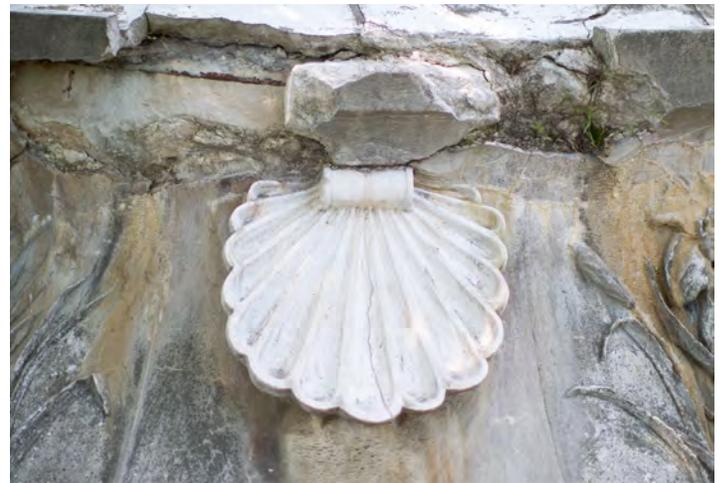
The damage to the fountain's base of limestone and concrete is not reversible. Complete restoration is required.

Figure 45: View of damage to limestone at base and relatively intact condition of shell motif

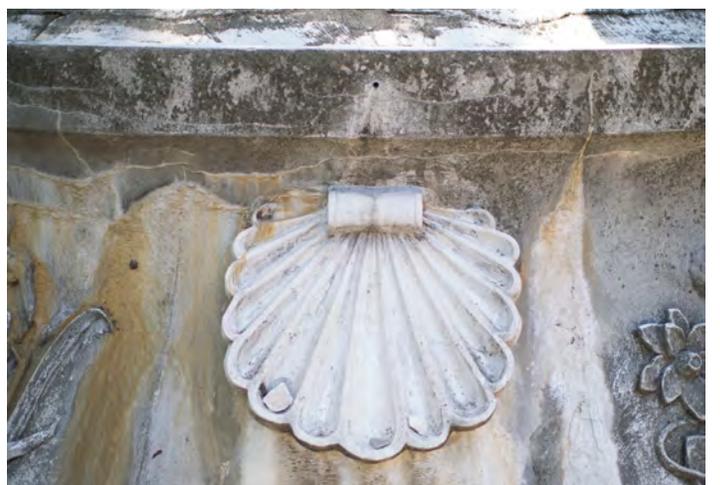
The damage to the fountain's base of limestone and concrete is not reversible. Complete restoration is required.

Figure 46: View of weep holes, cracked limestone mineral deposits and trailing water

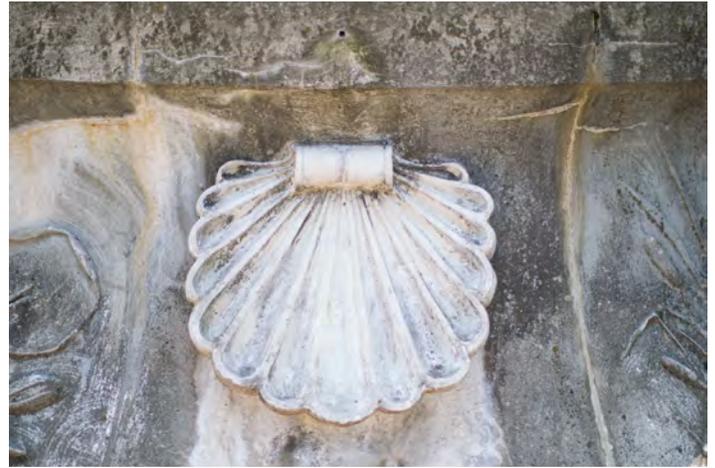
The damage to the fountain's base of limestone and concrete is not reversible. Complete restoration is required.

Figure 47: View of weep holes, cracked limestone mineral deposits and trailing water

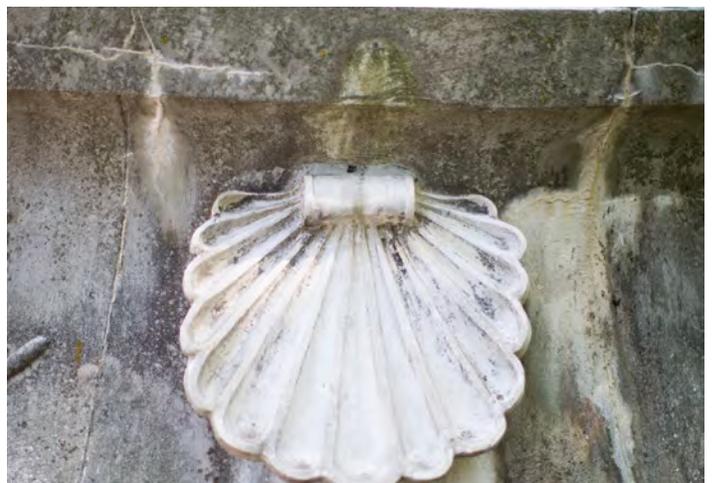
The damage to the fountain's base of limestone and concrete is not reversible. Complete restoration is required.

Figure 49: View of weep holes at shell, cracked limestone mineral deposits and trailing water

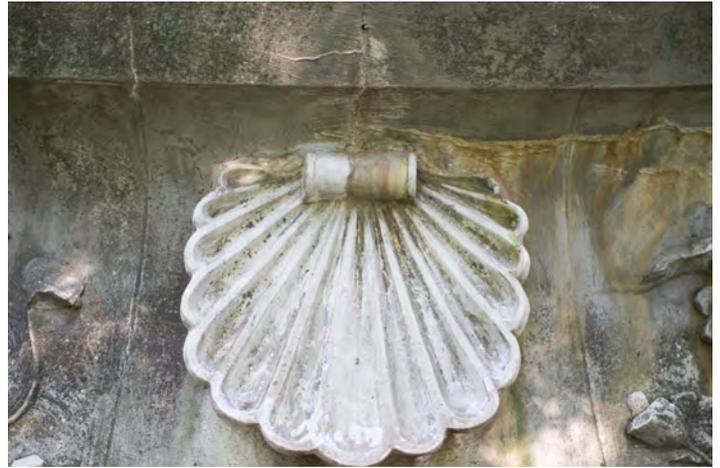
The damage to the fountain's base of limestone and concrete is not reversible. Complete restoration is required.

Figure 50: View of weep holes, cracked limestone mineral deposits and trailing water

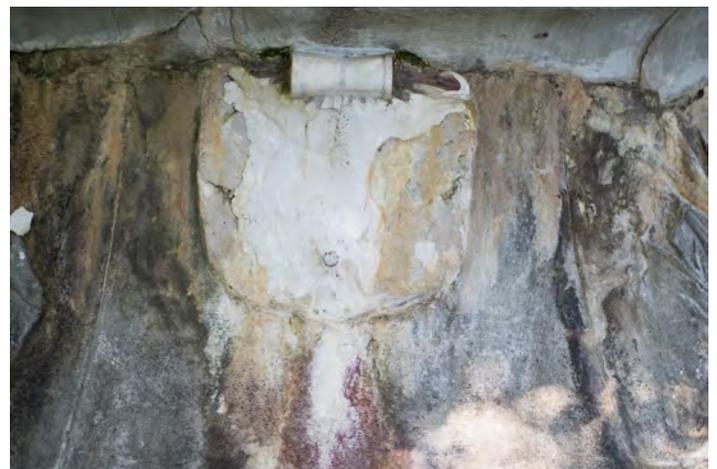
The damage to the fountain's base of limestone and concrete is not reversible. Complete restoration is required.

Figure 52: View of missing shell

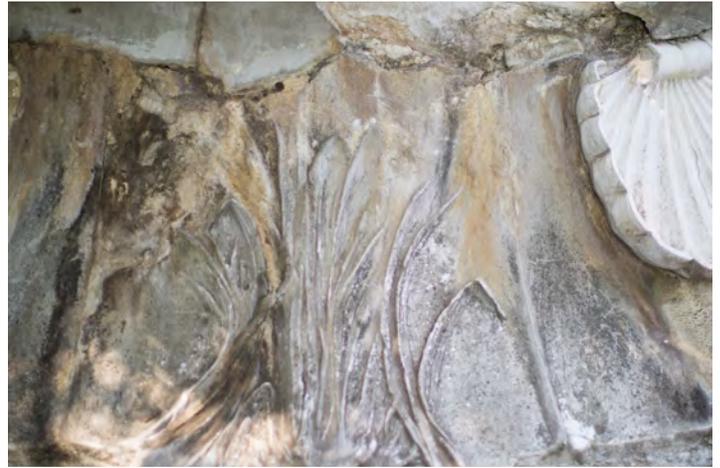
The damage to the fountain's base of limestone and concrete is not reversible. Complete restoration is required.

Figure 53: View of degraded material at cattail motif

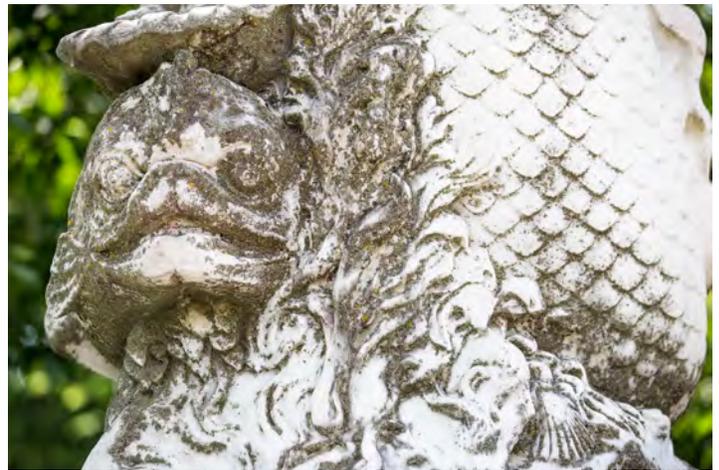
The damage to the fountain's marble elements appears to be both treatable and reversible. Conservation is required.

Figure 54: View of dolphin in 2017
