### **EXISTING BUILDING REVIEW**

# 120 W. Mifflin Street

Name: Andrew Schubert Building Built: 1908 Designated City landmark

# 120 West Mifflin Street – Architectural Review

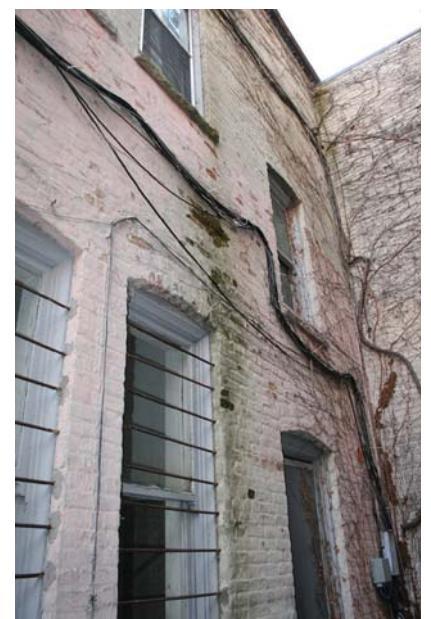
Exterior: View of the back of building showing eroding brick veneer

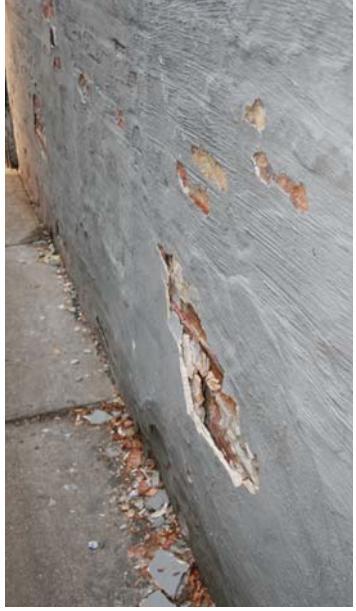
Exterior: View in the alley showing a section of delaminated parging

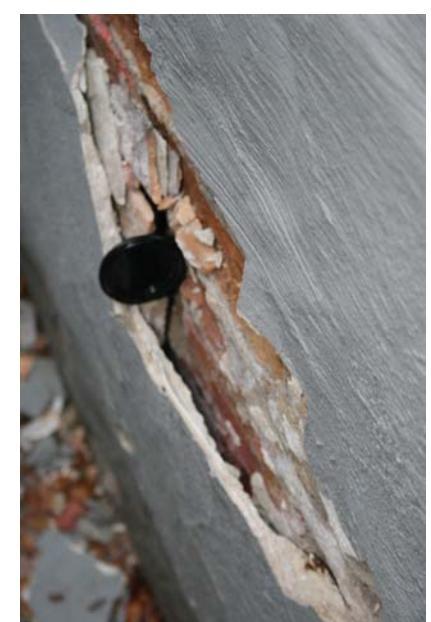
Exterior: View in the alley showing the delamination of the parging system from the brick veneer

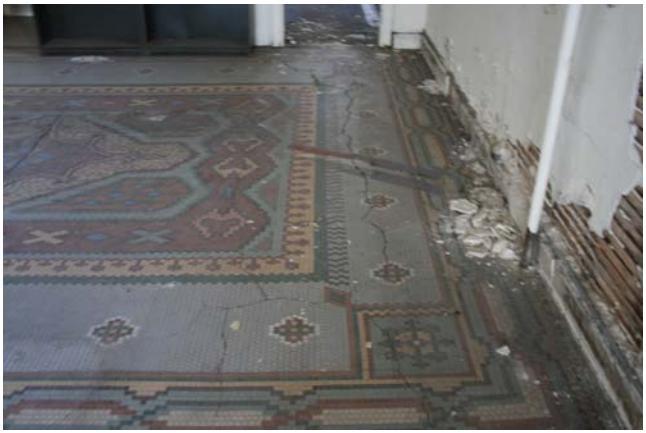
First Floor: View toward back exit showing multiple cracks in floor tile

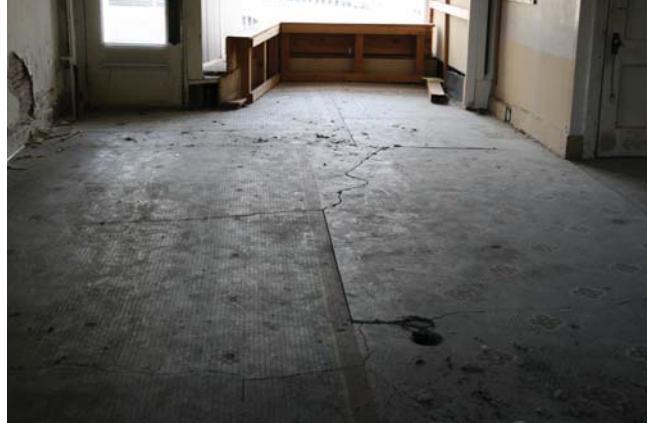
First Floor: View toward Mifflin Street entry showing multiple cracks in floor tiles

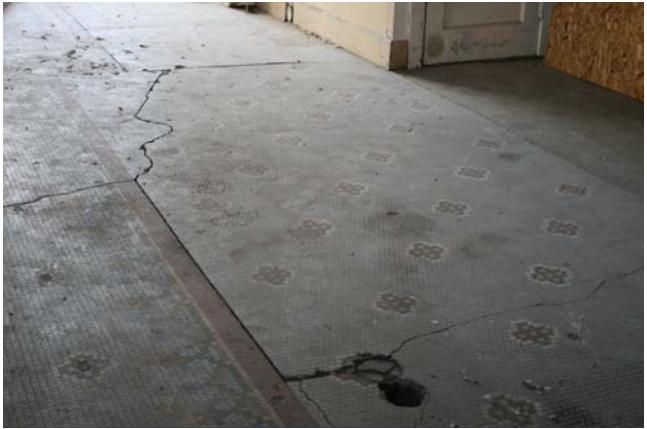
First Floor: View toward basement stair showing multiple cracks in tile floor

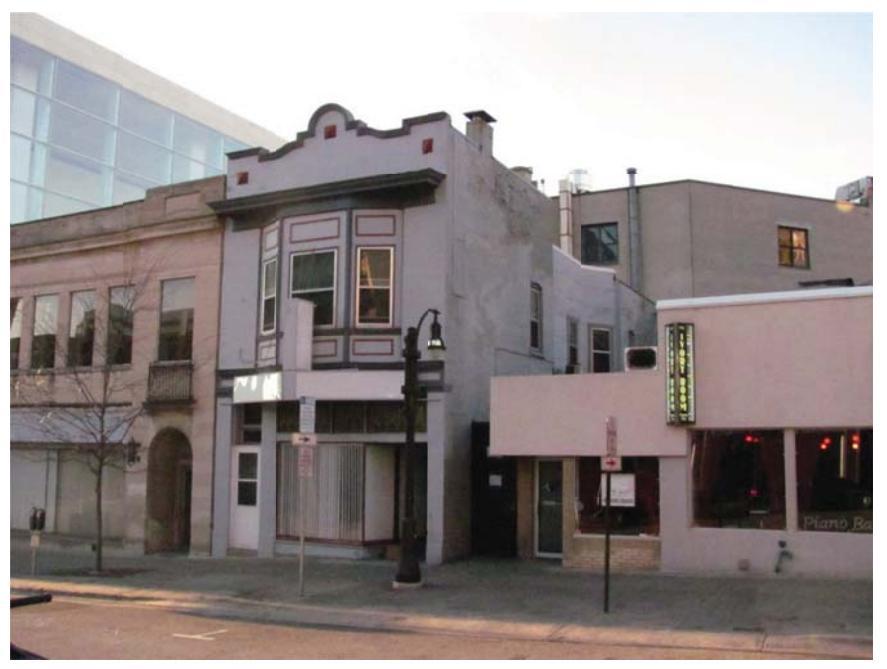
The front facade consists of limestone at the first floor and face brick at the second floor and parapet (Figure 1). All of the masonry has been painted. There is a projecting bay window and cornice at the second floor that is clad with painted sheet metal. The sheet metal appeared intact and well anchored to the underlying framing. Some areas of the sheet metal exhibit surface corrosion.

*Figure 1. Overview of the building from the south. The Mifflin Street facade is at left.*

The Mifflin Street facade is generally in good condition. Appropriate repair would begin with removal of the existing coating from all masonry using chemical strippers, followed by a more detailed assessment of repair needs. The extent of repointing of the brick and limestone masonry can be determined following removal of the coating. At the west (left hand) top of the parapet wall at the street facade, an approximately three foot by three foot area of displaced brick masonry will likely require dismantling and reconstruction.

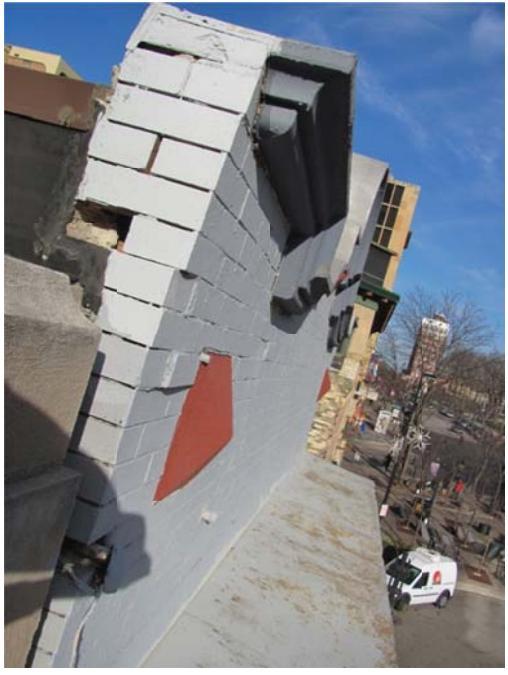
The top west (left hand, as viewed from the street) corner of the parapet wall is displaced outward, with dislodged brick units and open mortar joints at this location (Figure 2). At the limestone masonry of the first floor, some areas of coating have debonded, revealing the stone below (Figure 3). Open mortar joints were observed in the limestone portion of the facade. Although coated, the limestone and face brick masonry at the street facade appears to be in fair to good condition.

*Figure 2. Left. View of displaced masonry at the top corner of the parapet wall. Figure 3. Right. At the limestone masonry of the first floor, some areas of coating have debonded.*

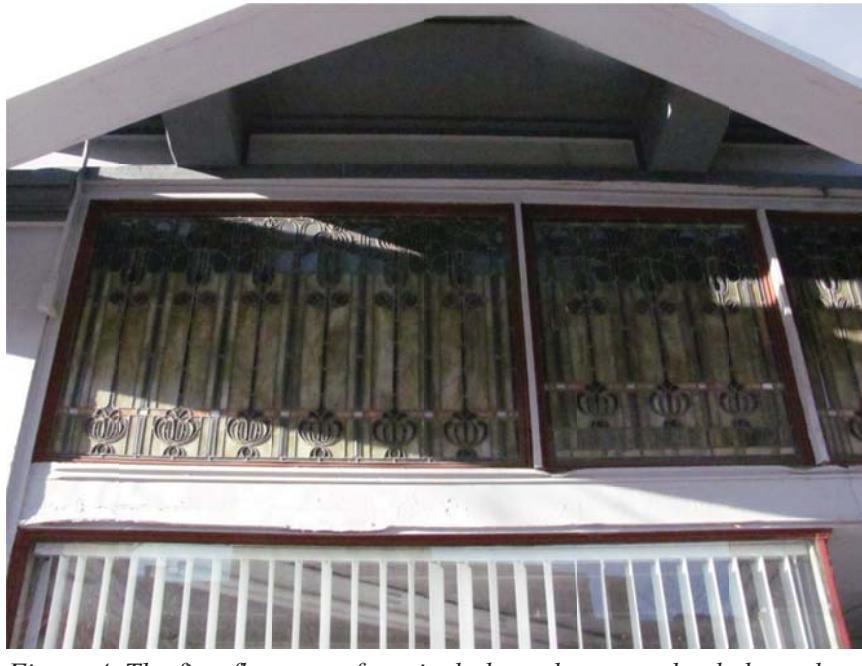
The first floor storefront includes a three-part leaded art glass transom in good condition (Figure 4). The area of the storefront below the transom appears to have been altered following original construction, based on comparison with historic photographs included in the city landmark nomination.

Figure 4. The first floor storefront includes a three-part leaded art glass transom.

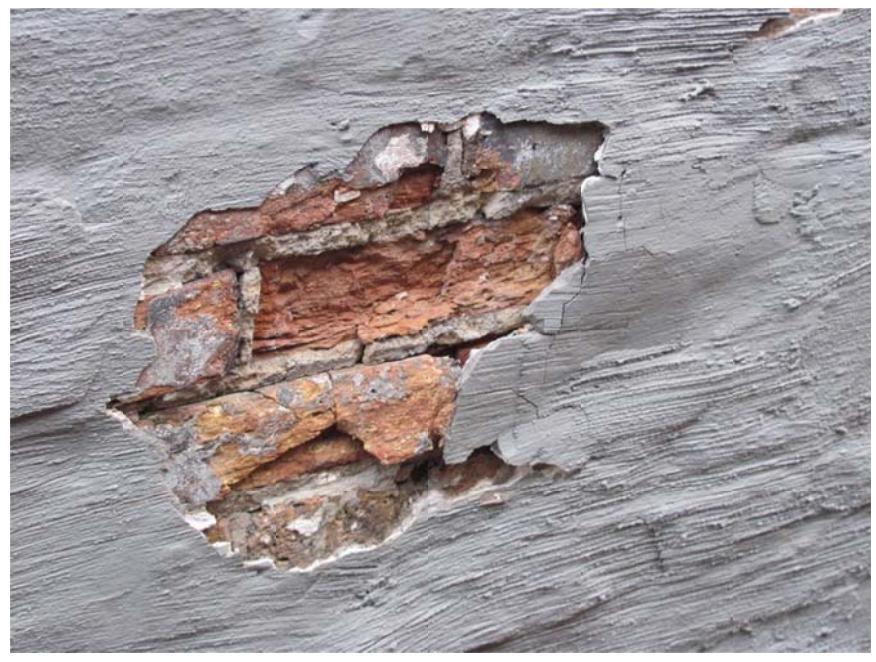
The northeast-facing side wall and northwest-facing rear wall are common brick masonry that has been variously parged and coated. Portions within 6 feet of grade have a build-up of multiple layers of cementitious parging and coating. These layers are now debonding, exposing the original brick masonry. The common brick masonry is in poor condition, with open joints and deep face spalling of the brick units. Examples of this distress are shown in Figure 5 through Figure 8. The deterioration is most severe near grade and below the coping at the top of the wall. The ongoing deterioration of this masonry wall has resulted in detached fragments of brick, mortar, or parging.

*Figure 5. Failure of cementitious parge coat, revealing deteriorated brick masonry.*

In contrast to the street facade, the side and rear walls are in very poor condition. Appropriate repair would include removal of existing coatings and parge materials, followed by selective replacement of the outer wythe of brick with new masonry. Replacement required is likely extensive, based on conditions observed. Based on this limited survey, the majority of the outer wythe of brick on the alley side and rear walls may require replacement, including extensive areas at grade and at the top of the walls. The condition of the backup wythes of brick masonry is not known at this time. Further investigation of the brick backup masonry, especially at grade and the parapet walls, is needed to determine if the existing deterioration extends beyond the exposed face wythe of brick and whether repair or replacement of backup masonry is required.

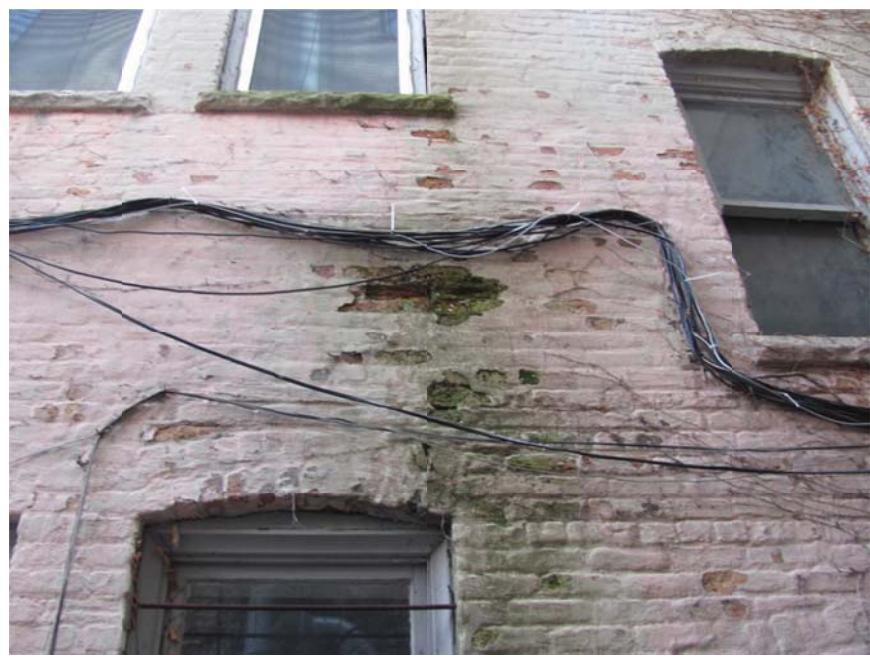
Figure 6. Deterioration of brick masonry at the rear facade.

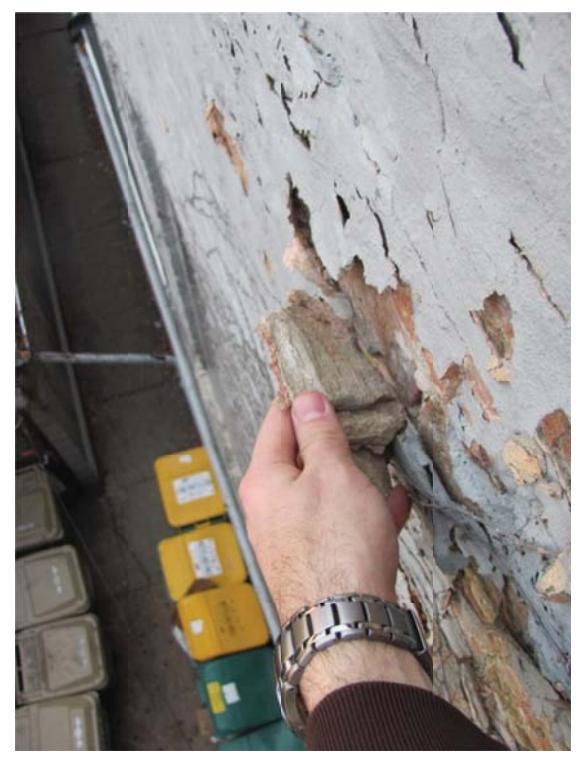
*Figure 7. Left. Loose fragments of brick/mortar/parging were removed by hand from the side wall. Figure 8. Right. Deterioration of brick and parging near the top of the side wall.*

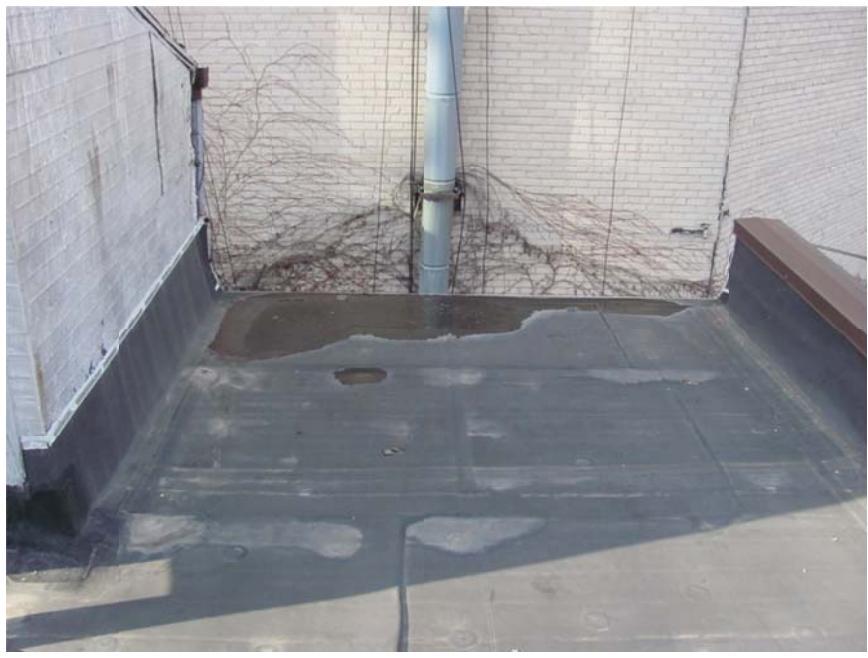
The roof is covered with a relatively new EPDM rubber membrane (Figure 10). The membrane is extended up the rear face of the parapet walls. The membrane intersects a sheet metal coping. Five circular attic vents are located near the south end of the roof. The roof slopes from south to north and is drained to a continuous galvanized metal gutter along the north wall. Ponded water was observed on the roof surface near the gutter (Figure 11). The gutter itself is in poor condition, with open seams, accumulated debris, and broken support brackets.

Figure 11. Ponding on the roof near the gutter.

The penthouse roof and wall cladding requires repair or replacement to create a watertight building envelope. The main roof appears generally watertight, but further investigation is needed to ensure that perimeter flashing details are appropriately integrated with the coping and that appropriate slope for drainage is provided. The existing gutters and downspouts along the rear wall should be replaced.

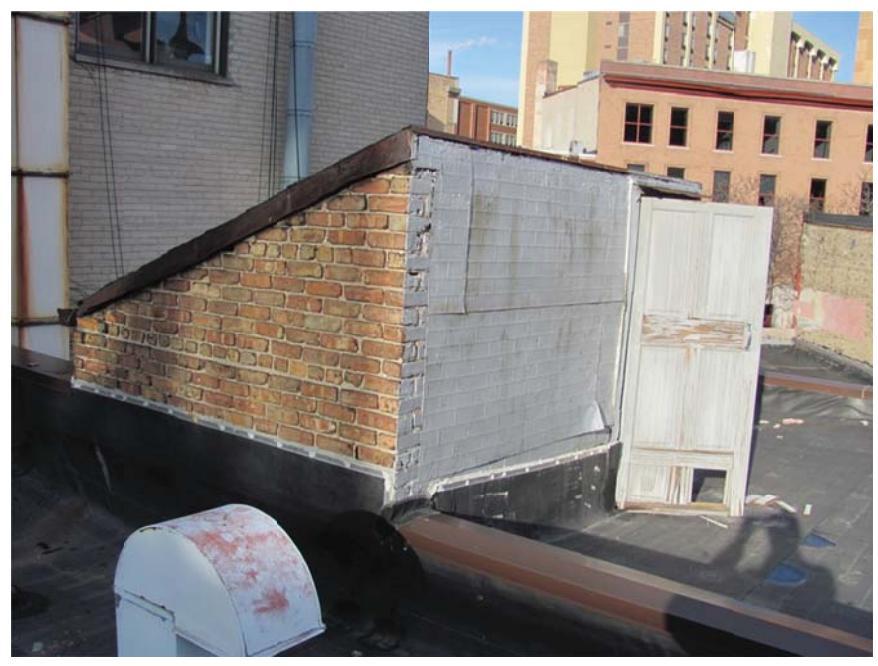
The roof is accessed through a small penthouse over the rear stairwell (Figure 12). The roof of the penthouse is covered with asphalt shingles that are in extremely poor condition (Figure 13). The walls of the stairwell are brick masonry and wood framing covered with painted sheet metal. Water infiltration through the walls and roof of the penthouse has occurred in the past, as the interior plaster in the stairwell is severely deteriorated.

Figure 12. View of the penthouse walls constructed of brick masonry and painted sheet metal.

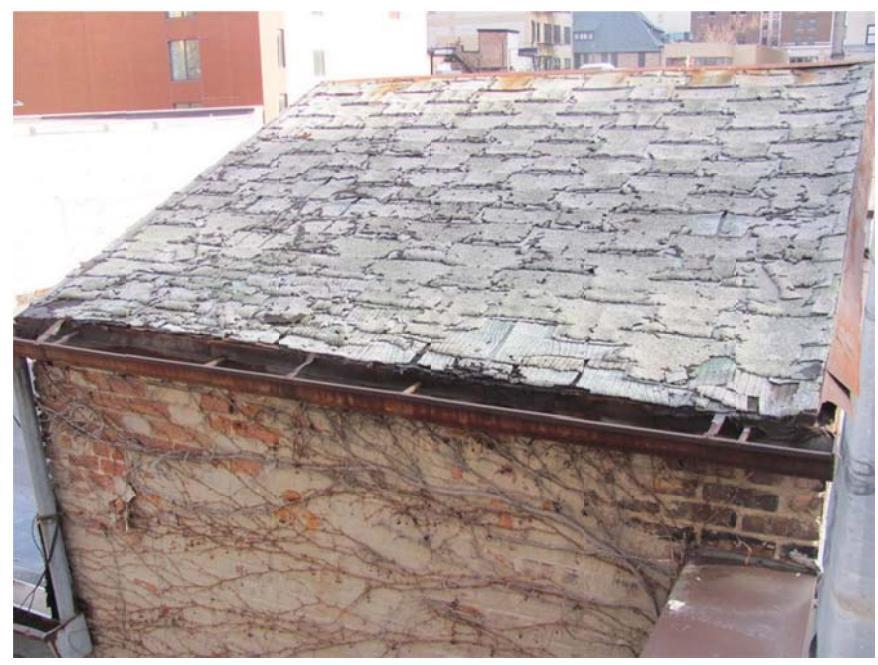
Figure 13. The penthouse roof is covered with asphalt shingles in deteriorated condition.

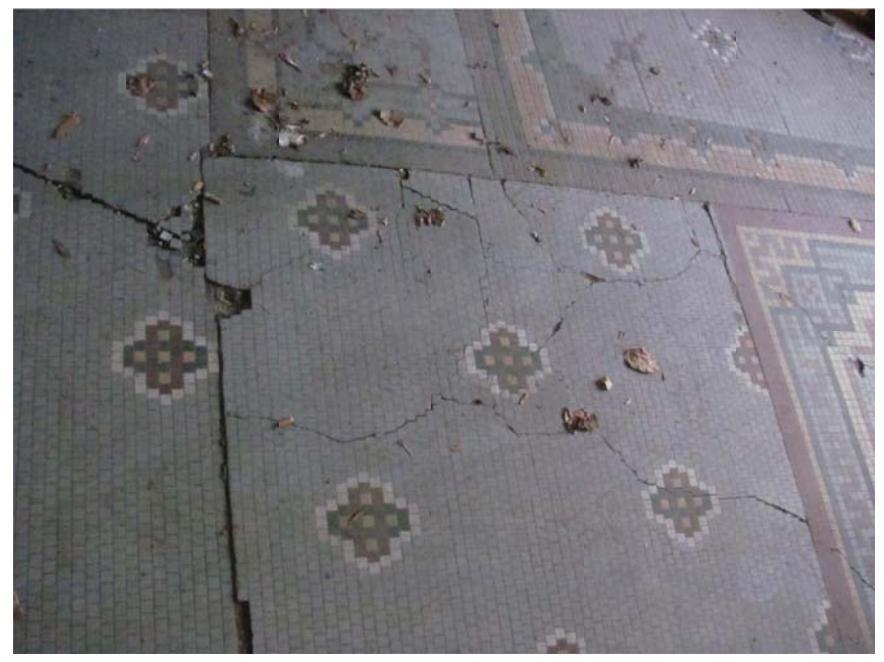
The first floor main interior room has four different areas of flooring consisting of elaborate decorative mosaic tile floor composed of various colors of 3/4 inch square tiles in a running bond. A portion of the ceramic tile flooring near the front door has been replaced with 1 inch square tiles with rounded edges. A second area of non-original flooring is located adjacent to the storefront at the southeast end of the space. Localized individual ceramic tiles throughout the flooring are missing and have been replaced with concrete patching. Extensive cracking, displacement, and settlement have occurred at this flooring (Figure 14). The distress in the flooring is apparently the result of significant and widespread deterioration of the basement-level wood columns, wood beams, and wood joists that support the floor. A detailed assessment of the first floor framing was beyond the scope of this study, but obvious signs of decay as well as previously installed temporary shoring were observed in the basement.

Figure 14. There is elaborate mosaic tile flooring at the first floor; the flooring has suffered extensive cracking and displacement.

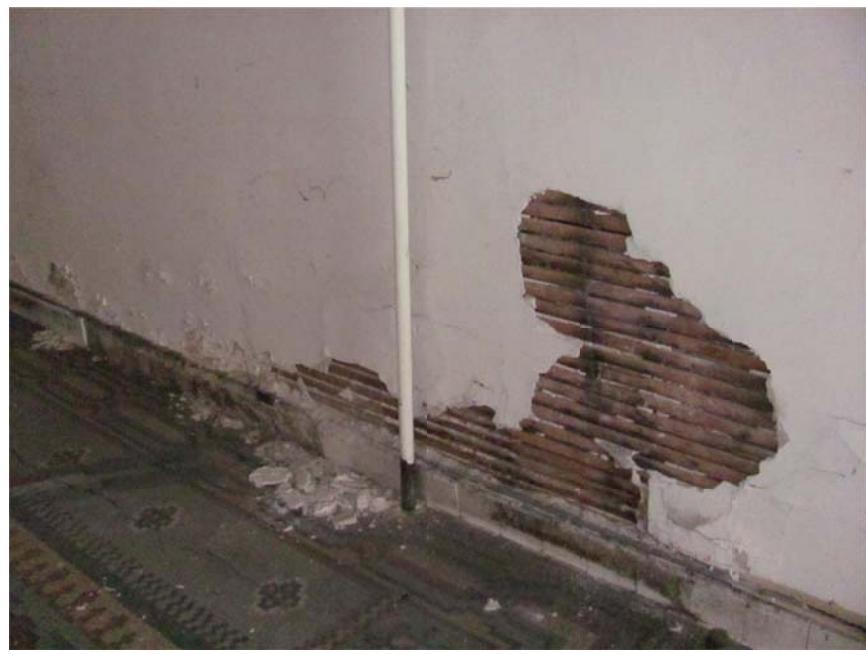
The first floor walls and ceiling are painted plaster on wood lath. Portions of the plaster have detached from the lath, likely due to water infiltration (Figure 15). Water staining and bubbling of the plaster were also observed (Figure 16).

Figure 15. Damage to interior plaster wall finish.

Interior plaster finishes have suffered deterioration apparently related to water infiltration through roofing and the side and rear brick masonry walls and may require replacement.

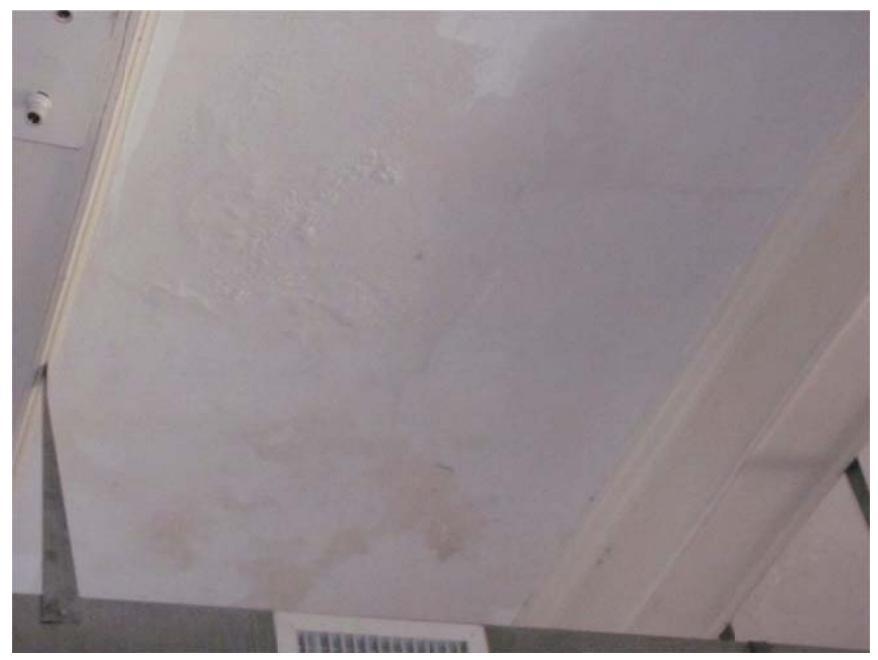
Figure 16. Water staining and bubbling of interior plaster ceiling.

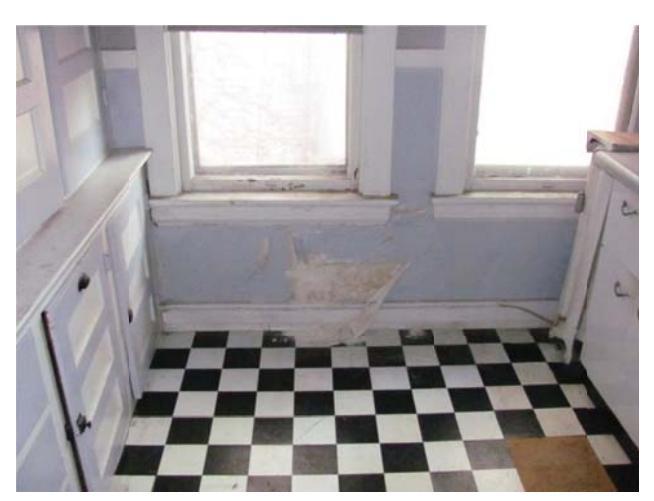
Figure 18. Plaster damage at the rear wall at the second floor of the building.

The second floor interior is in poor condition overall. Much of the interior plaster at or adjacent to the exterior walls has evidence of water infiltration damage and may require replacement. Consideration should be given to salvaging intact original elements such as interior doors and trim.

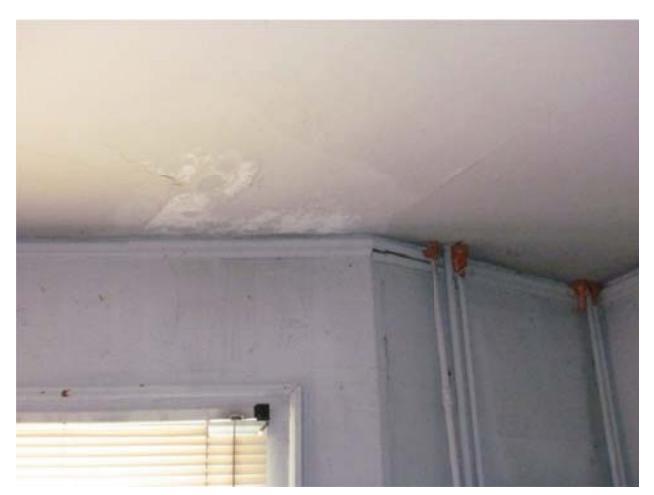
*Figure 19. Moisture damage to plaster finishes at the second floor.*

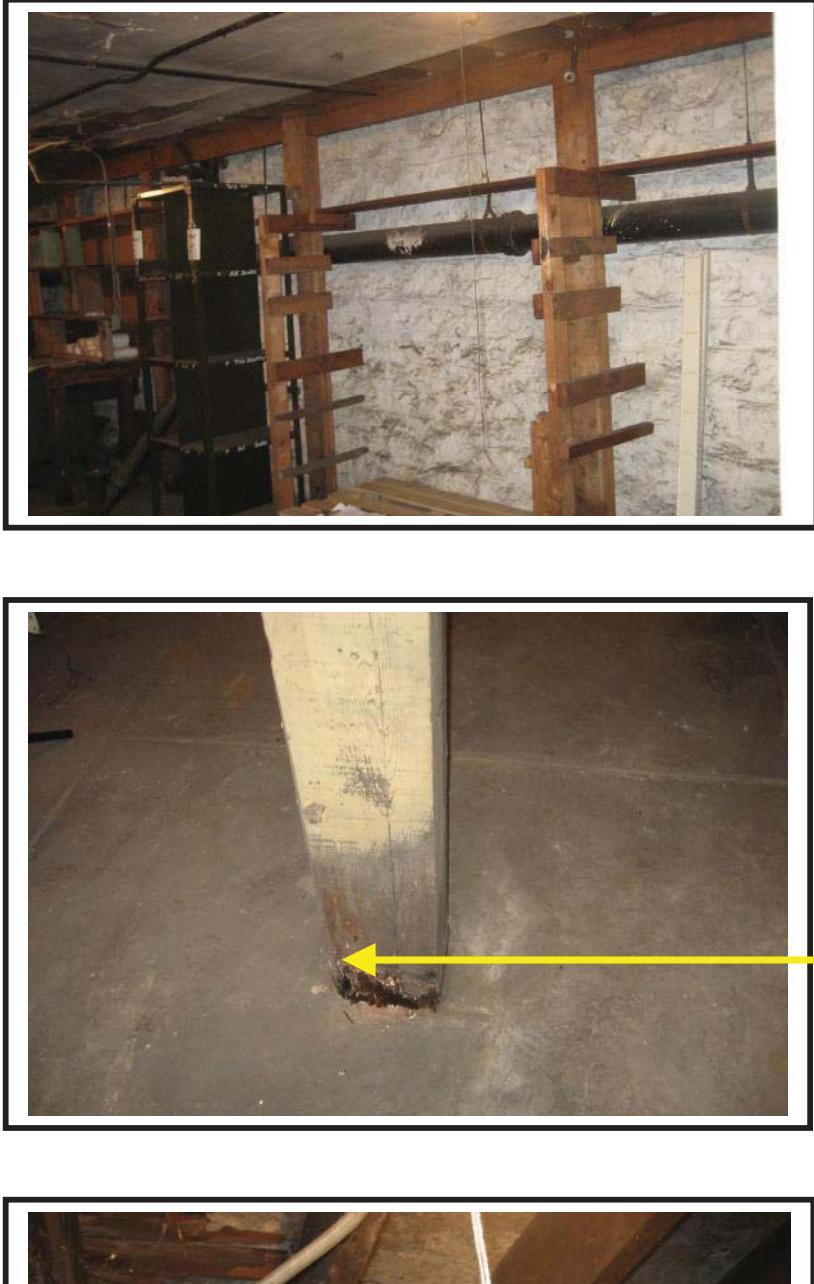
Floor is cast in place concrete on grade. Stains on bottom of wood columns indicate water entry over a period of time. Column bases to the north are rotting at the bottom. The rubble foundation walls appear in good condition. Basement access thru the sidewalk vault has been covered over with a concrete slab. The electrical and water service are in this room. The vault slab is shored up with wood cribbing on east /west faces. Repair to the bearing of this slab is thus recommended which would necessitate removal of a sidewalk panel or two.

Figure 1 – Shoring along basement wall –also used a s shelving.

Figure 2 – Rooted column base in basement.

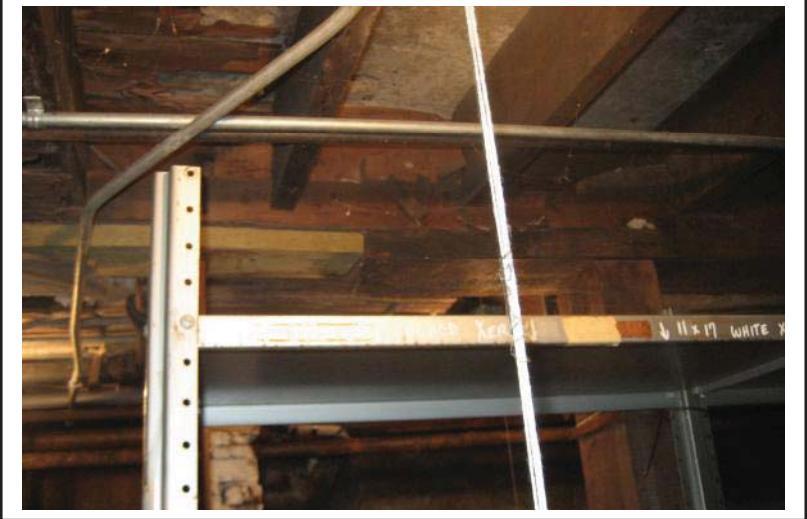
The first floor is roughly 3" concrete/tile topping on wood decking on 2x10 wood joists at 16" o/c. Floor joists span east/ west to a center support line. The floor shows significant deflection. Wood shoring has been placed along both east and west basement walls to re-support floor joists where they have rotted at their bearing in the rubble wall. The center beam line has been re-supported by metal posts to deal with rotted original wood columns. In certain areas of the center beam line the joists are pulling away from the support ledger. There have been wood materials added to deal with the ledger condition but they are not, in the writer's opinion, a permanent solution. The floor appears to sag toward the southwest stair. The support of both the first and second floor appears marginal in this area.

Figure 3 – Wood materials added to aid in support of the joists and the center beam line.

The quantity of defects and the defection in the first floor result in the suggestion to replace of the entire floor system as the most logical course of action. A new floor might be constructed of concrete fill on metal form deck on sheet metal joists. It remains a possibility to re-establish support for the existing floor, but the deflection would largely remain.

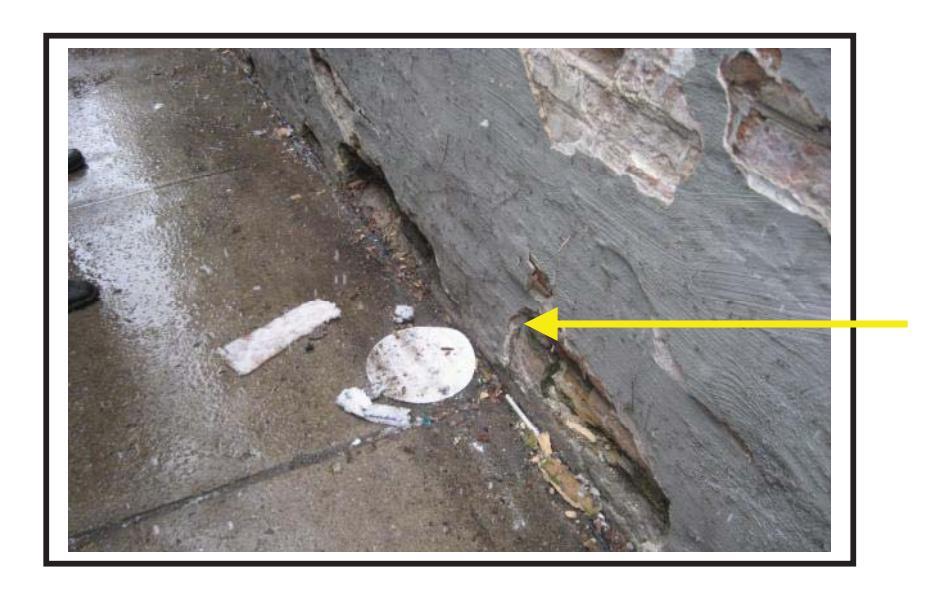
The walls on the east and west sides were observed from the alleyway running along the east side. The grade level walls appear to be a porous brick with a painted parging at the surface. The pargings are usually placed to cover defects in the brick- which appears to be the case here. Areas where the faces of the brick have fallen off were observed. The east wall steps back at the second level. At this location sheet metal siding is used. The west wall was not observed but is probably a party wall with the adjacent property.

Figure 4 – Spalling brick faceeast exterior wall.

The observed walls were judged to be structurally stable but in need of repair to maintain water tightness. One option might be to cover the existing brick with an exterior insulation and finish system to economically reestablish the water barrier. Any repair system chosen should be investigated for its own tendency to trap moisture in the wall. Any projection beyond the existing wall line would have to be verified with property rights.

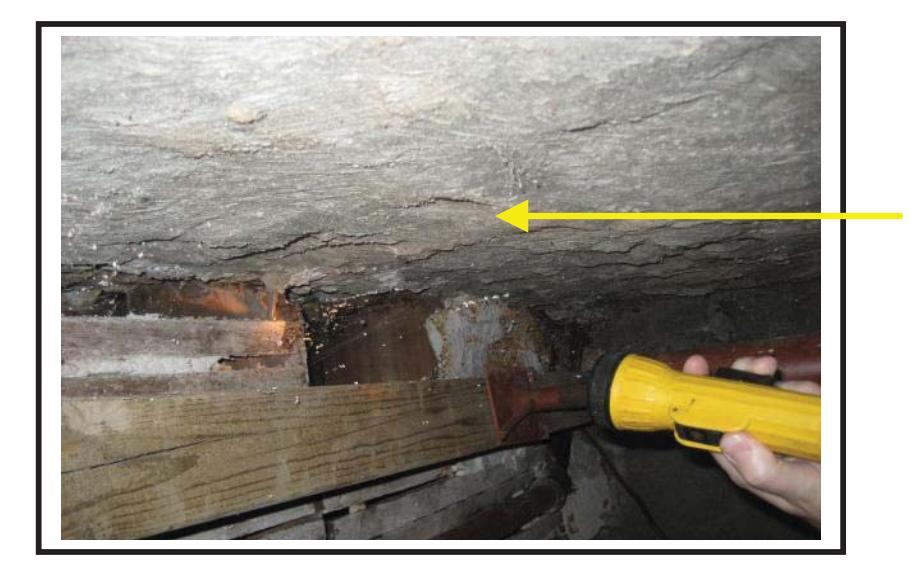
Figure 5 – Picture of rotted end of wood floor joist at first floor.

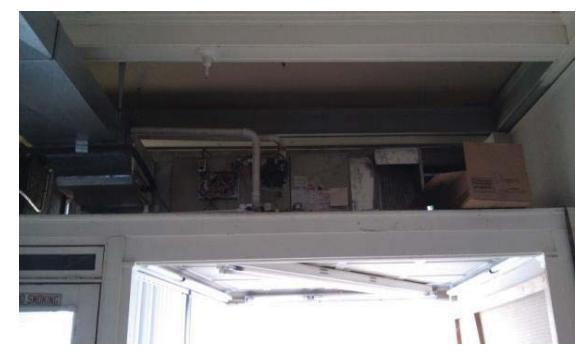
Furnace above entrance

The furnace appears to be operational but has signs of incomplete repairs from many years ago. Exact functionality is unknown. The support of the storm main is weak and the last several feet pitches upward, indicating a deteriorating system. The lead piping is an obvious health issue. A portion of the gas piping is badly deteriorated and has the potential to fail. Several sections of sanitary piping has either completely failed or is leaking. The storm main through the building is inappropriate since it doesn't directly serve the building.

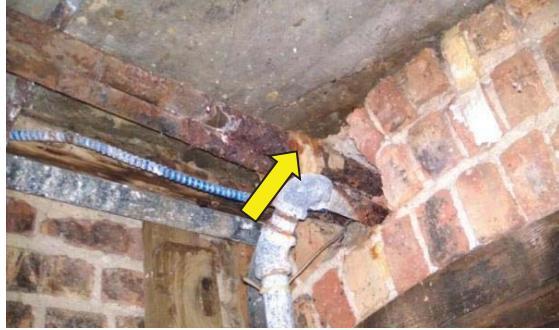
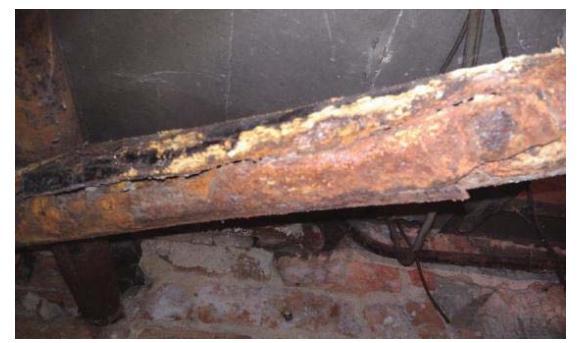
Deteriorated sanitary pipe

Deteriorated gas pipe

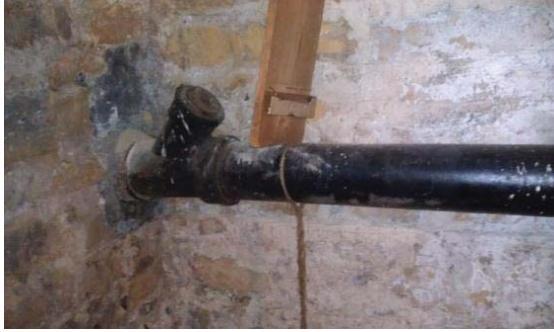
Storm main support/pitch

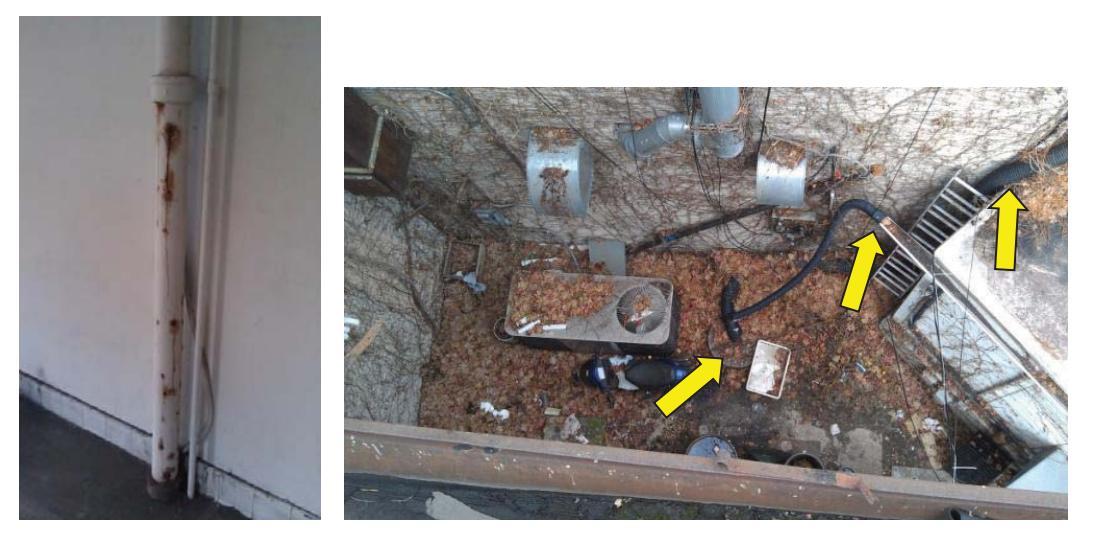
Leaking sanitary pipe Roof drains into cistern that discharges through basement

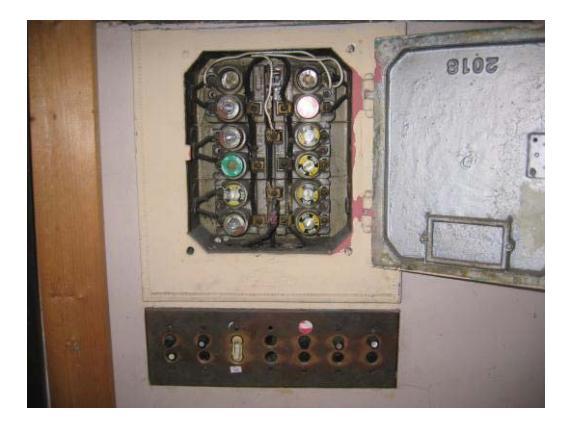
The fuse panel on the 1<sup>st</sup> floor is past its reliable life, and the panel on the 2<sup>nd</sup> floor is at the end of its useable life. The fusible panel on the 1<sup>st</sup> does not meet current code requirements. The current wiring device locations in the apartment do not comply with accessibility requirements. Receptacle quantity and locations in the apartment do not comply with current NEC requirements. Compliance with current codes for these items would require branch circuit, receptacle and fuse panel replacement.

Electrical fuse panel on 1<sup>st</sup> floor.

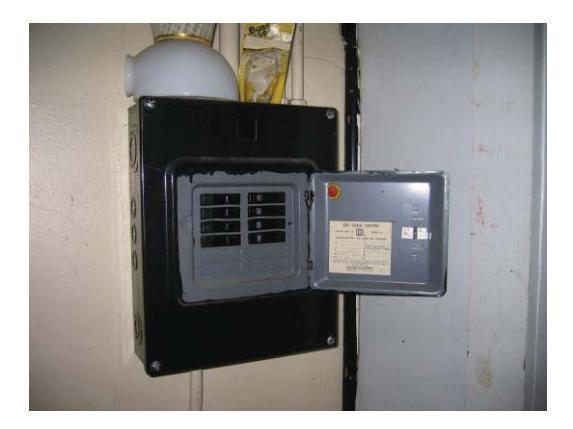
Electrical panel on 2<sup>nd</sup> floor.
