#### **EXISTING BUILDING REVIEW**

# 122-124 W. Mifflin Street

Name: Fairchild Building Corporation Built: 1925

# 122–124 West Mifflin Street – Architectural Review

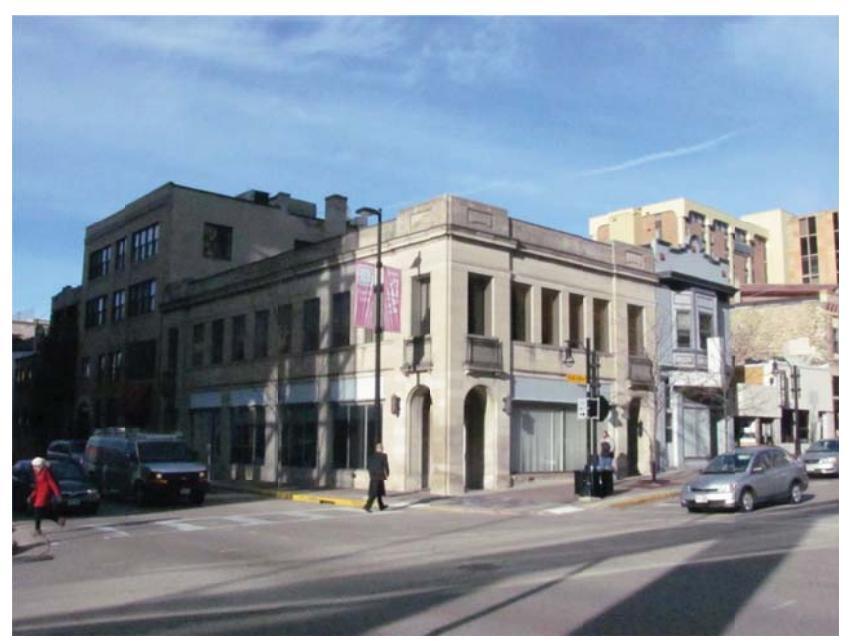
The masonry exterior of the building is constructed of limestone, likely Indiana limestone (Figure 1). Ornamental features of the facade include decorative brass and glass exterior wall-mounted light fixtures and decorative iron balustrades below the second story windows above the entrances (Figure 2 and Figure 3).

Figure 1. Overall view of 124 West Mifflin. The Mifflin Street facade is at right, while the Fairchild Street facade is at left.

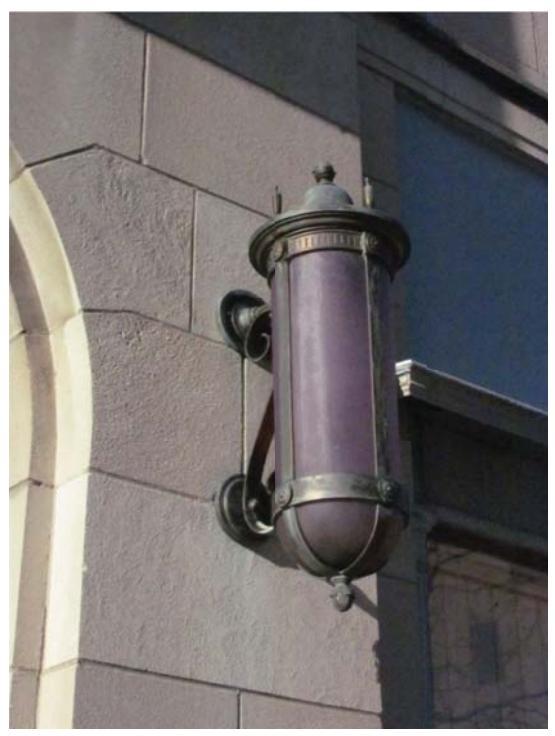
*Figure 2. Left. Decorative brass and glass exterior light fixture. Figure 3. Right. Decorative iron balustrade.*

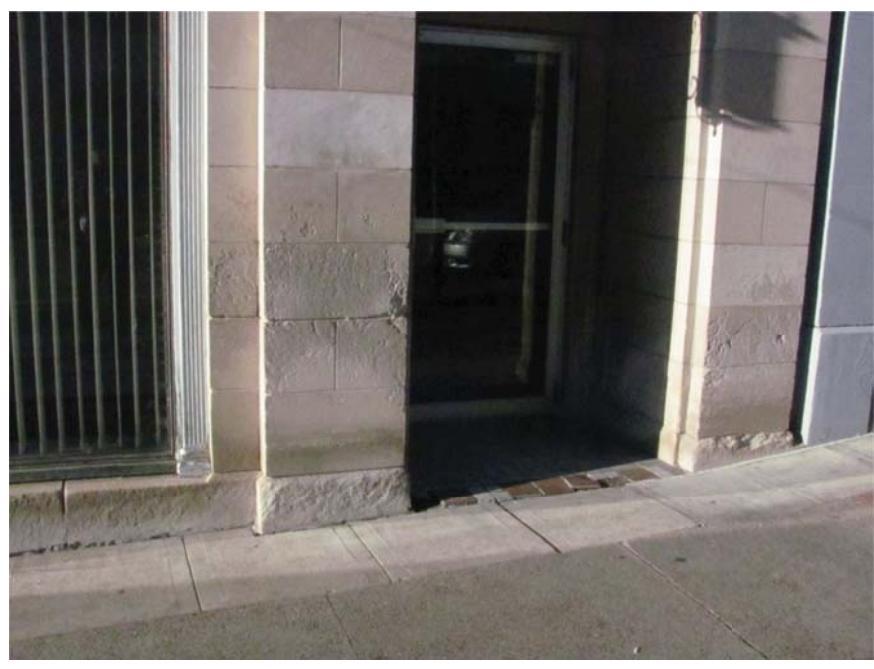
Localized distress was observed in the limestone masonry. Portions of the stone near grade exhibit erosion and pitting of the face (Figure 4). Erosion of this type is often related to water splash-back from sidewalk paving, snow accumulation, and the use of de-icing salts. Dark staining was observed at the recessed entrances and at the parapet walls. Occasional cracked or open mortar joints are present throughout the facade. Cracking and spalling were observed at the head of many of the first floor window openings; this type of distress is likely related to corrosion of embedded steel lintels (Figure 5).

*Figure 4. Portions of the limestone masonry near grade exhibit erosion and pitting of the face.*

Based on this limited survey, the limestone masonry of the street facades would require localized repairs to address spalling, cracking, loss of mortar, and staining. The condition of the embedded steel window lintels requires further study to evaluate existing conditions and determine an appropriate repair. The integration of the roof assembly with the cornice, parapet, and coping requires further study to provide a watertight envelope. If required by code, provision for overflow roof drainage will need to be created.

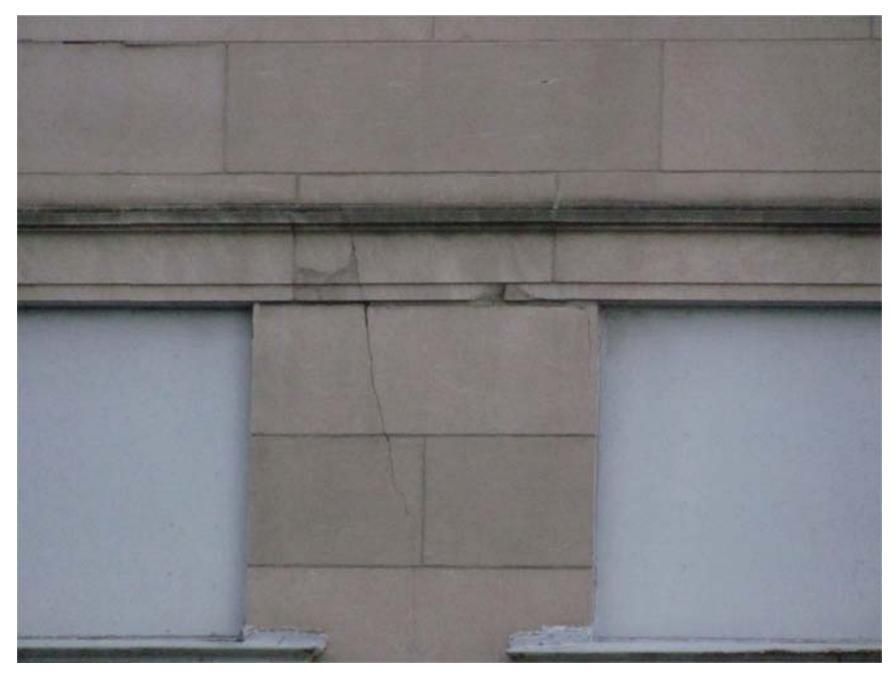
*Figure 5. Cracking and spalling of limestone masonry at the head of a first floor window opening.*

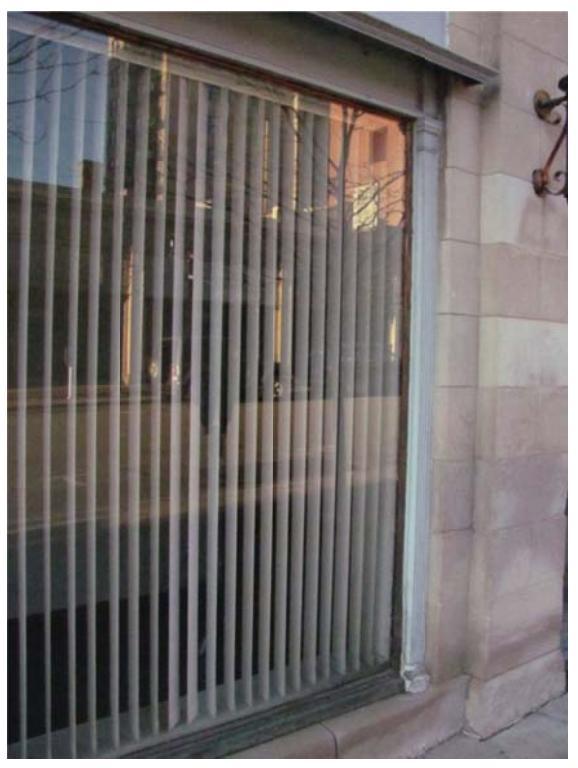
*Figure 6. The storefront facing Mifflin Street has a bronze frame and fluted bronze pilasters as window jambs.*

The window and door system at most areas dates to the late 1960s. It is likely not cost effective to retrofit the system for improved performance. Therefore, consideration could be given to replacing the windows and doors with new thermally improved aluminum-framed assemblies. The existing first floor transom windows and the one bay of bronze storefront at Mifflin Street appear intact and could be rehabilitated and reused.

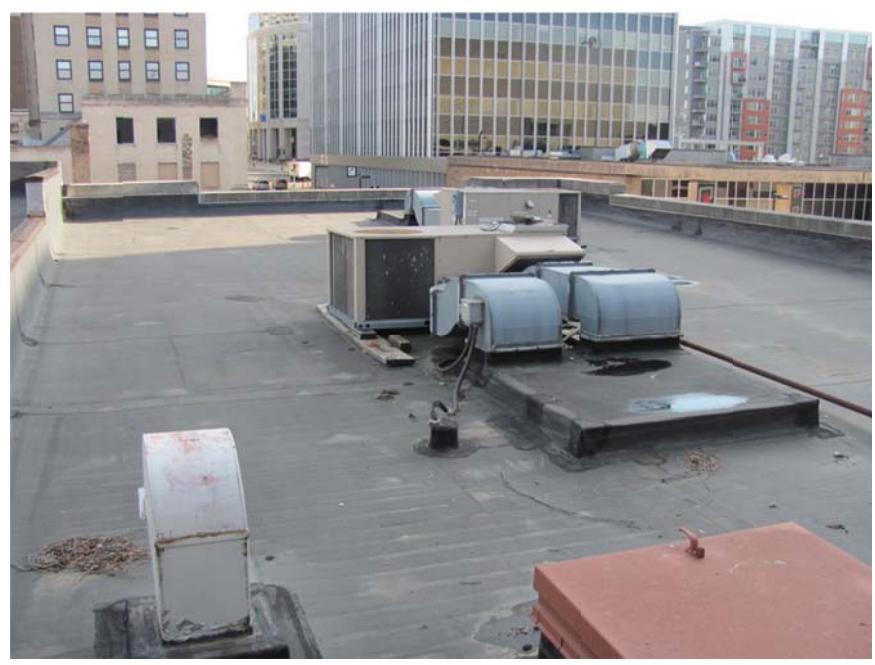
The roof is covered by a relatively new EPDM rubber membrane (Figure 7). The roof membrane extends up the back face of the parapet walls to a termination bar below the limestone coping of the street facades

Figure 7. Overview of the roof.

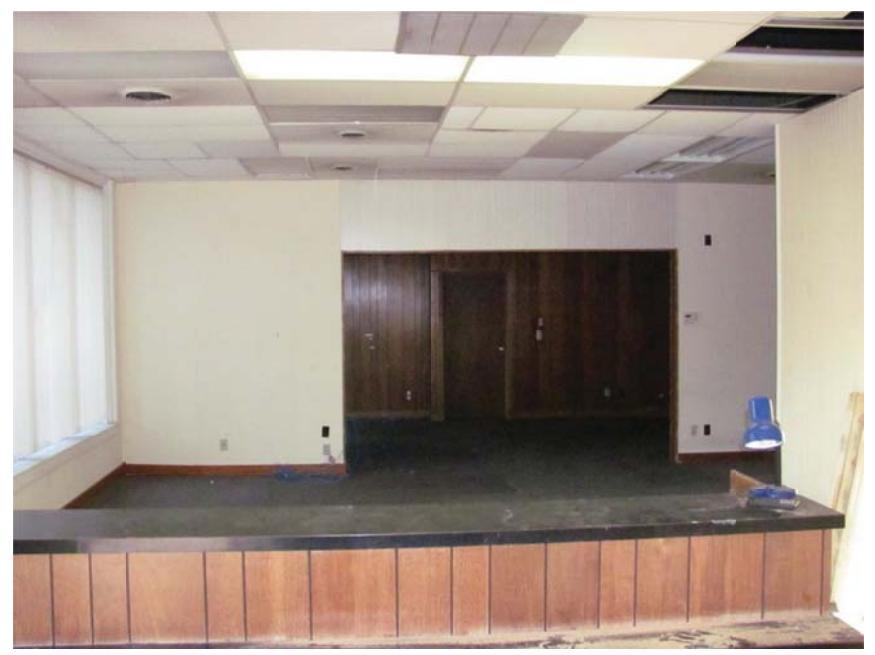
The interior of the basement, first, and second floors consists of office interiors, with carpeting or vinyl tile, wood-framed partition walls clad with gypsum board or wood paneling, suspended acoustic tile ceilings, flat panel hollow core wood doors, and simple wood trim (Figure 8). All of these materials apparently date to the circa 1969 renovation. The interior finishes are generally intact but worn.

Figure 8. View of the interior.

The existing interior finishes predominantly date to the late 1960s, although original ceilings and moldings are present at some locations. Repair or replacement of interior finishes would be necessary for continued use.

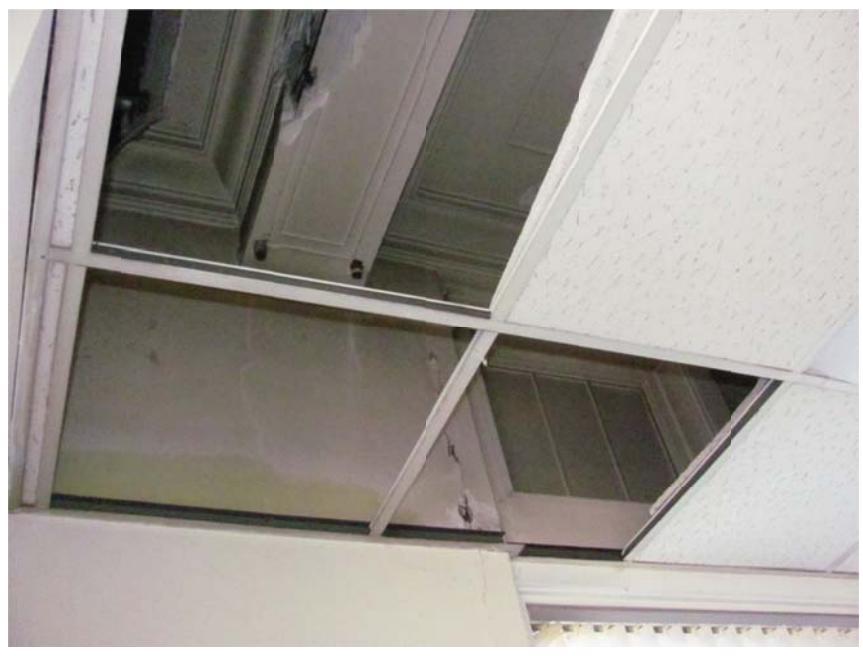
Where observed at a few locations at the first and second floors, portions of the original ceilings consisting of plaster on expanded metal lath are present above the suspended acoustic tile ceilings. The original ceilings include boxed-beams and molded cornices (Figure 9). The full extent and condition of the original ceiling finish is not known. Also visible above the suspended ceiling at the first floor were original wood-framed transom windows.

*Figure 9. The original plaster ceiling and cornice are present above the suspended acoustical ceiling system. Also note the original transoms at the first floor storefront.*

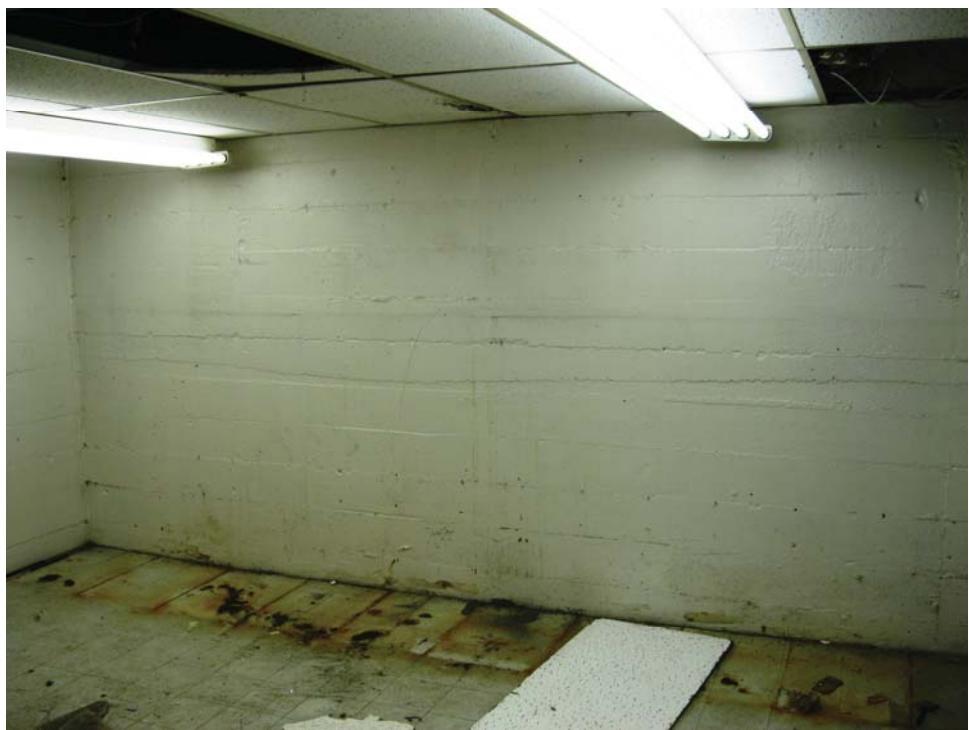
The basement walls are constructed of board formed concrete. Where exposed they appear in good condition and serviceable. No evidence of significant water infiltration is noted. The southwest grade level entry has a formed

Photo 1 - Concrete basement wall at Mifflin / Fairchild corner

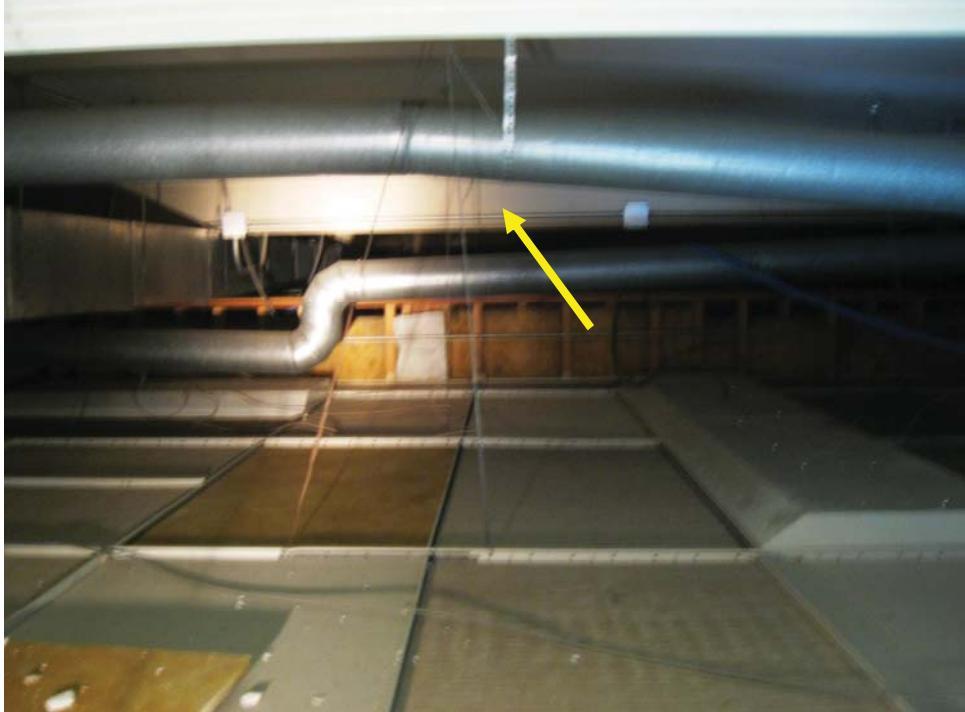
The second floor is also constructed of wood joists. They measure 2x12 @ 16" oc and span north/south. They are supported on interior steel beam lines taken as a W21x 44. The steel beams bear on the brick bearing wythe at the west wall. Along the east wall the beams are supported on steel columns adjacent and stabilized into the building to the east. The steel beams clear span the first floor space and are placed at roughly 13' oc. The span for calculation is taken at 37'. The floor joists bear atop the steel beams. A plaster ceiling is placed below the wood joists with a later acoustical tile ceiling placed below that. Floor capacity is calculated at 80 psf based on the joists and 45 psf based on the steel beam. Again present day code required live load is 50+15=65 psf for office occupancy.

Photo 2 – Typical steel girder (encased) supporting 2<sup>nd</sup> floor wood joists

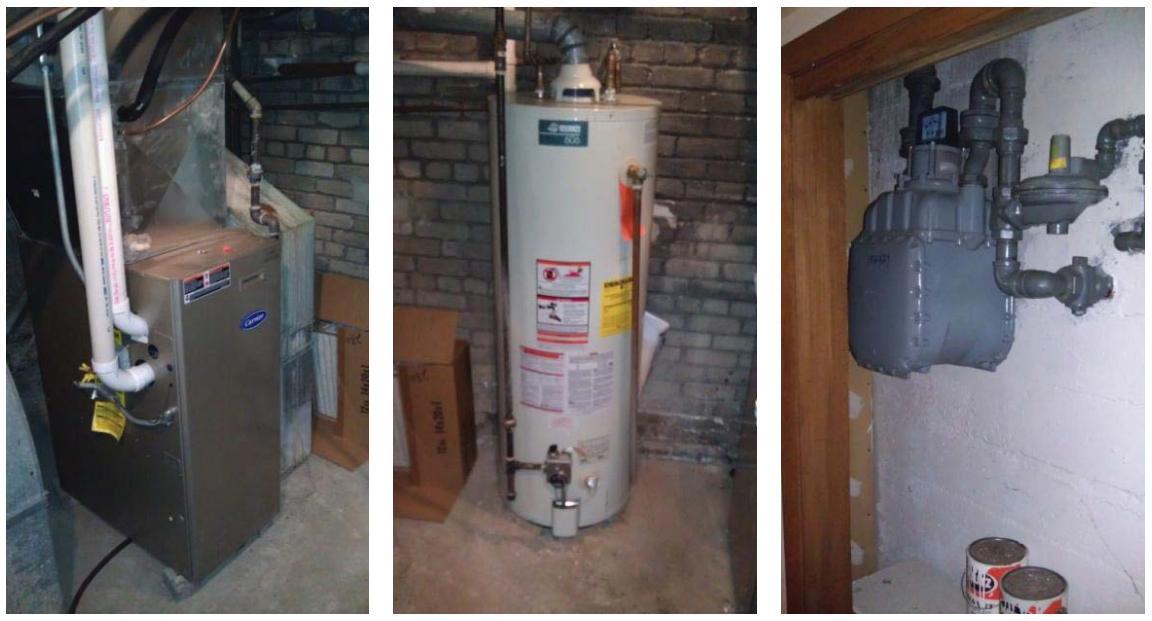
One of four identical furnaces, the water heater, and gas meter

The furnaces are new and are in very good condition. Roof mounted condensing units are of various types and sizes but all appear to be quite new. The packaged rooftop units are estimated to be about 10-15 years old which is about the normal life expectancy for that equipment. The domestic hot water heater is new and in very good condition. None of the hot water piping appears insulated. Sanitary piping is mostly cast iron and original.

While much of the HVAC equipment is new, there would be significant difficulty reusing any of it. This is due to the fact that temperature control zoning is likely less than ideal and modifications necessary to make the systems code compliant would be very difficult and costly, and likely impossible. The water heater could be used, assuming it would fit the new capacity requirements.

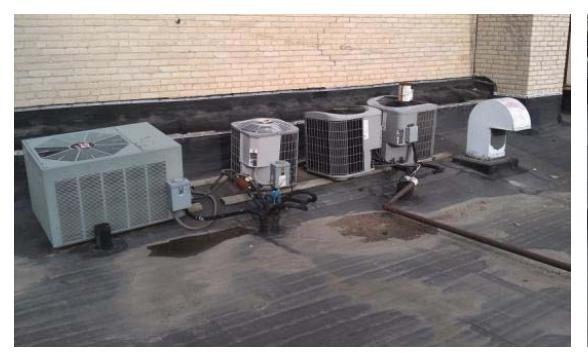
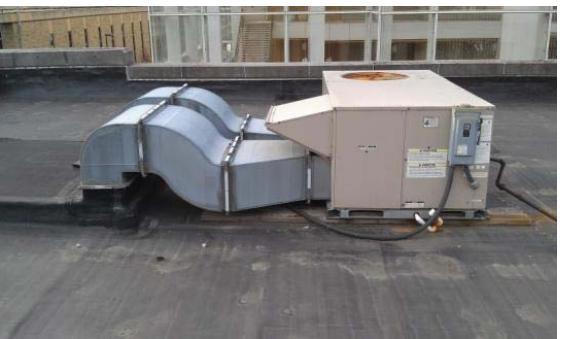
Condensing units serving the furnaces

One of two packaged rooftop units

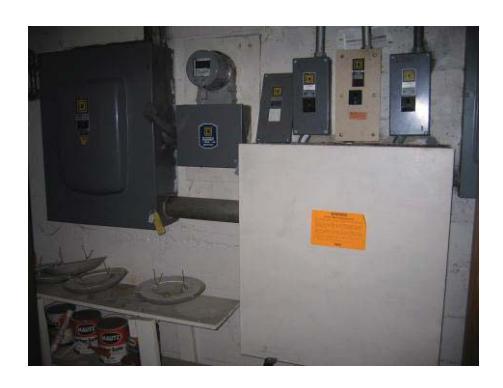
Electrical equipment age is from the 1980's. The telephone PBX appeared to be from the 1980's. There were no noted obvious failures of electrical equipment, such as evidenced by heat or smoke discoloration. The MG&E electrical service equipment appeared to be in good condition.

Electrical service in the basement.

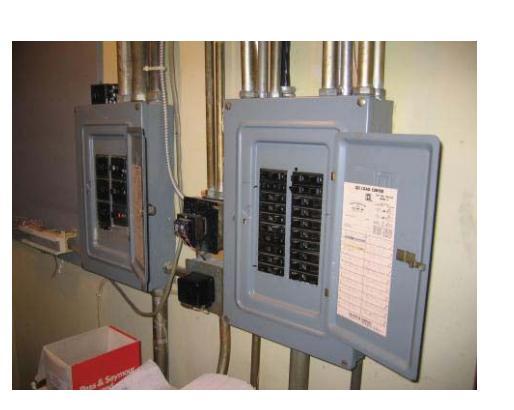
Electrical panels on 2<sup>nd</sup> floor.

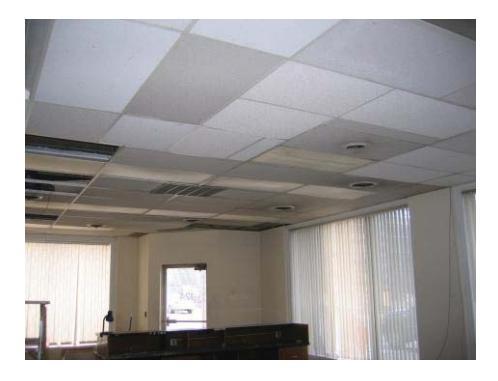
Light fixtures were primarily fluorescent (about 1980's). Some light fixtures were missing or removed. Wiring devices also appeared to be from the 1980's. Branch circuits ranged from flexible metal conduit to EMT conduit. Although the condition of the branch circuit wiring is not known, it appeared that the installation was from the 1980's.

First floor lights.

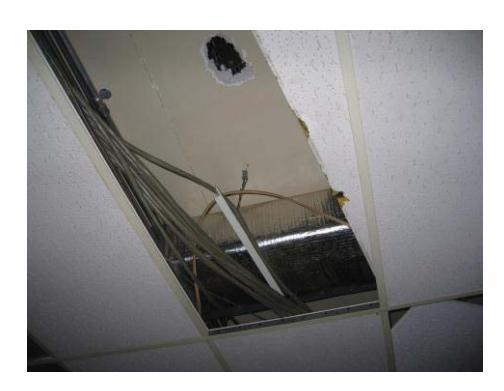
The telephone PBX cabling is supported by the suspended ceiling grid, which if constructed now would be a violation of the current code.

Electrical cables on 2<sup>nd</sup> floor.
