ANALYSIS OF WATER QUALITY MEMO

Madison Water Utility
Madison, Wisconsin
119 East Olin Avenue
Madison, WI 53713

To: Al Larson
From: Steve Gaffield (Montgomery Associates) and Ken Quinn (RMT)
Date: December 6, 2010
cc: Paul Boersma, Black & Veatch
Re: Analysis of water quality data for East Side Master Plan

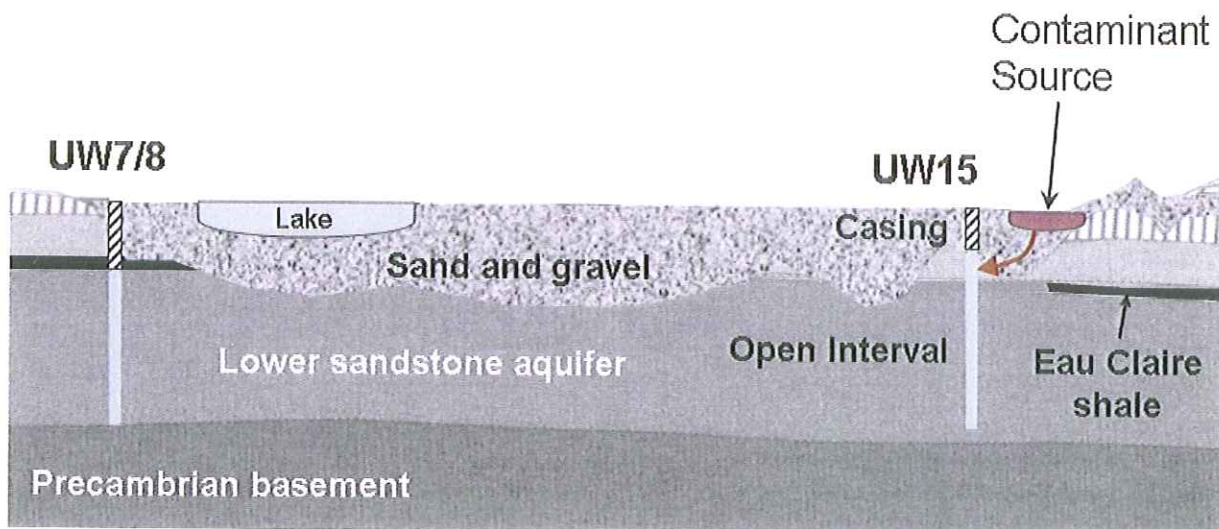
The elevations of the open well interval and of the Eau Claire Shale were compiled from available data from the WGNHS and WDNR (Table 1). This data indicates that UW7 and UW8 are open only to the lower aquifer, although the UW7 casing appears to only partially penetrate the Eau Claire Shale. Although the Eau Claire Shale is present at UW7 and UW8, it is believed to be missing nearby under Lakes Mendota and Monona, where the bedrock surface has been eroded below the level of the shale (Figure 1).

The presence and depth of the shale in UW15 are uncertain. The geologic log prepared by the WGNHS shows the Eau Claire Formation, but no shale. In addition, the depth listed for the Eau Claire Formation corresponds to an elevation several hundred feet lower than in the other wells, suggesting a possible inconsistency in how bedrock units were logged at the different wells. Thus, it is uncertain whether or not the Eau Claire Shale is present at UW15 and, if so, whether the well is open above the shale.

Figure 1. Conceptual geologic cross section showing construction of UW7, UW8 and UW15. Not to scale.

Based on the well construction, hydrostratigraphic and chloride data discussed above, UW15 does not appear to be protected by a confining unit between the shallow and deep sandstone aquifers. This creates a direct connection to shallow groundwater and susceptibility to contaminants that originate near the land surface (Figure 1).

- Extending either well's casing deeper would probably not significantly improve the Fe and Mn concentrations, because the wells are already cased through the Eau Claire Shale. If the Fe and Mn concentrations are related to induced flow from the lakes, however, there could be some benefit to extending the casing and creating a longer flow path from the lakes to the well.

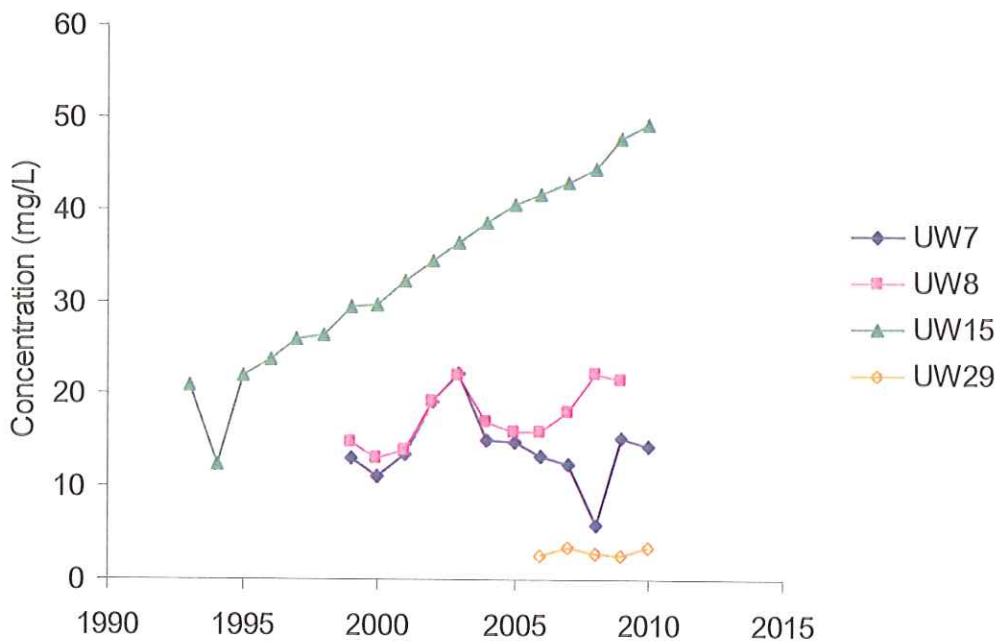
Chloride levels in UW7 and UW8 are slightly elevated, but lower than the current concentrations in the Madison lakes. Concentrations have fluctuated during the past decade with no clear trend. It appears likely that UW7 and UW8 are pumping some water from the shallow aquifer and/or lakes, with dilution by groundwater with lower chloride levels from the deep aquifer.

Figure 5. Chloride trends in UW7, 8, 15 and 29

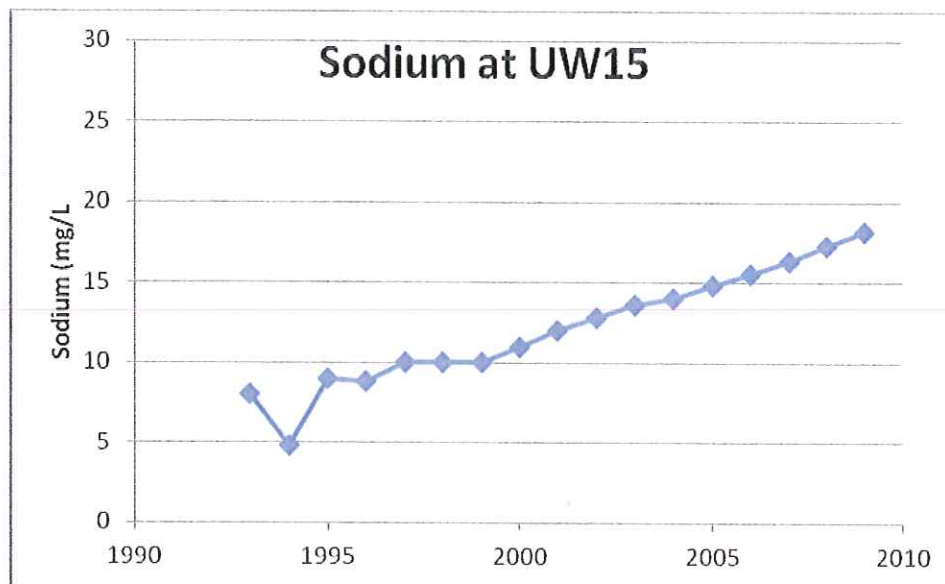
Changes in sodium in groundwater are also associated with road salt affects on Madison's aquifers. While there is no MCL for sodium, the United States Environmental Protection Agency has issued a health-based drinking water guideline of 20 mg/l or less for individuals with a restricted sodium diet, and a concentrations exceeding 30 to 60 mg/L can create a taste issue¹. The sodium concentration in UW15 is approaching this EPA guideline of 20 mg/L (Figure 6).

Figure 6. Sodium trend in UW15.

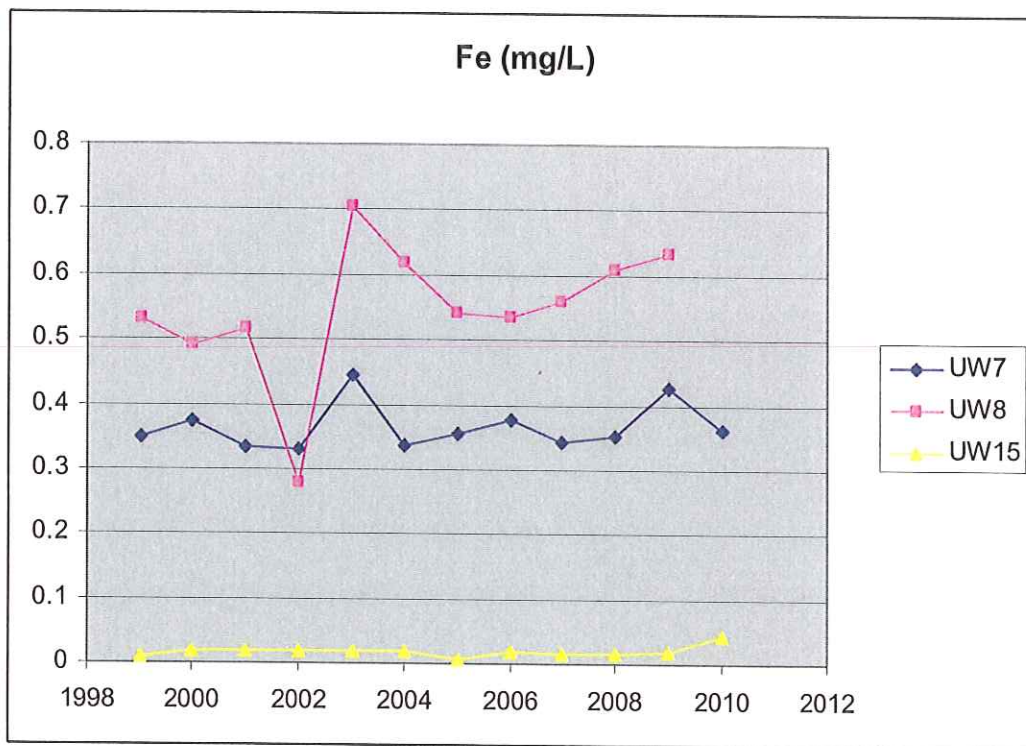
The Madison Water Utility collects water quality samples at least annually from each of its unit wells. Annual data for iron (Fe) and manganese (Mn) in Unit Wells 7, 8 and 15 are plotted in Figures 7 and 8. In addition, samples were collected each month for four years from 2006 – 2009; these results are plotted in Figures 9 and 10. Since 1999, a weak upward trend in Fe and Mn concentrations is apparent at UW8. No obvious trend is visible for UW7 or UW15. Unit Well 15 has much lower Fe and Mn than UW7 and UW8.

The probable cause of the difference in Fe and Mn between UW7/UW8 and UW15 is differences in the groundwater chemistry. Specifically, reducing conditions are present in the aquifer near UW7/UW8 and not at UW15. Under reducing conditions, Fe and Mn dissolve from the bedrock of the aquifer. The MWU does not routinely test for redox potential, however the MWU's sampling for nitrate, Mn, Fe, and SO_4 provides a very good indication of redox conditions. For example, nitrate has consistently not been detected in UW7 and UW8, where reducing conditions presumably have converted this aerobic species to a reduced species (e.g., ammonia or nitrogen gas). The nitrate concentrations at UW15 reflect surficial conditions, with a concentration of around 2 mg/L.

Figure 7. Annual iron concentrations in UW7, UW8 and UW15.

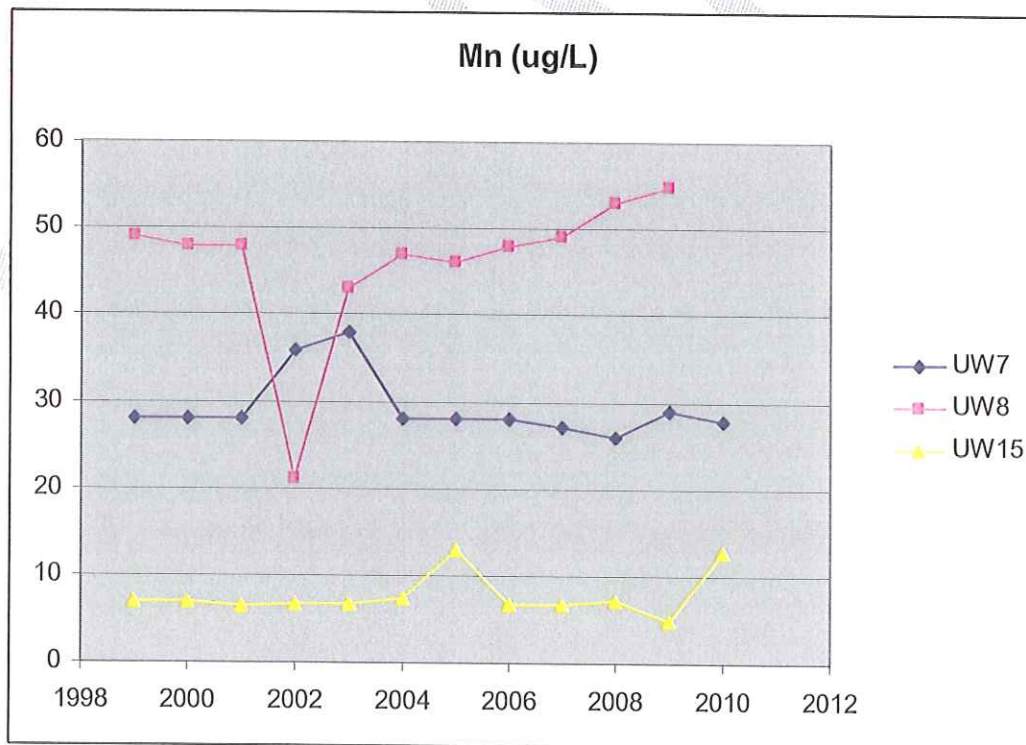
Figure 8. Annual manganese concentrations in UW7, UW8 and UW15.

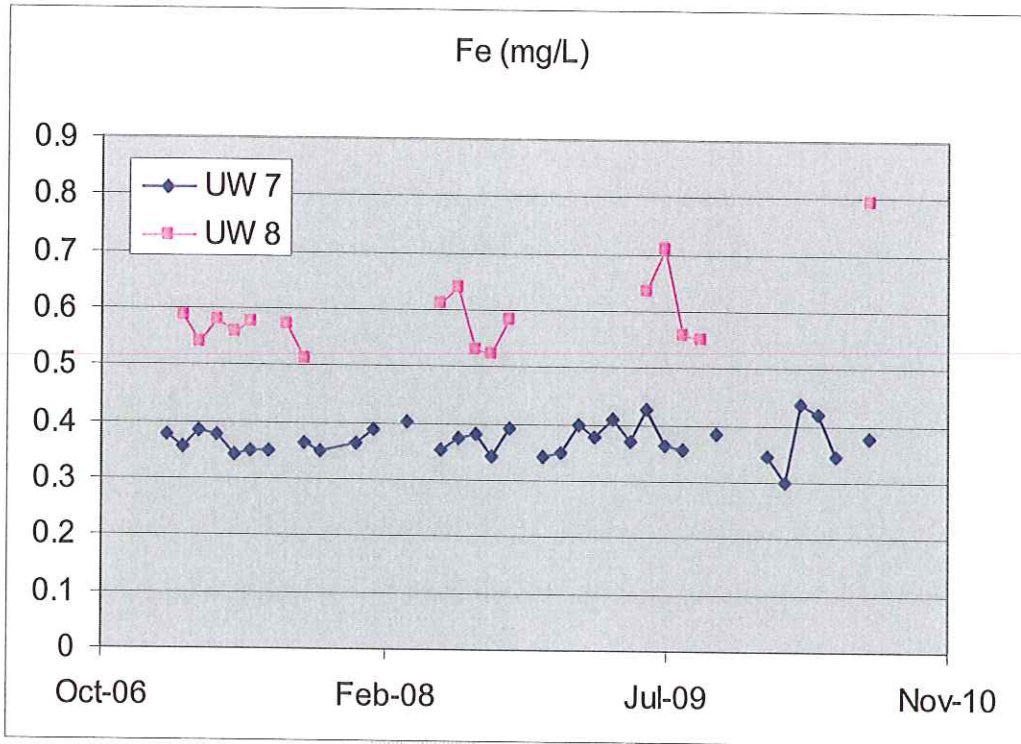
Figure 9. Monthly iron concentrations in UW7 and UW8.

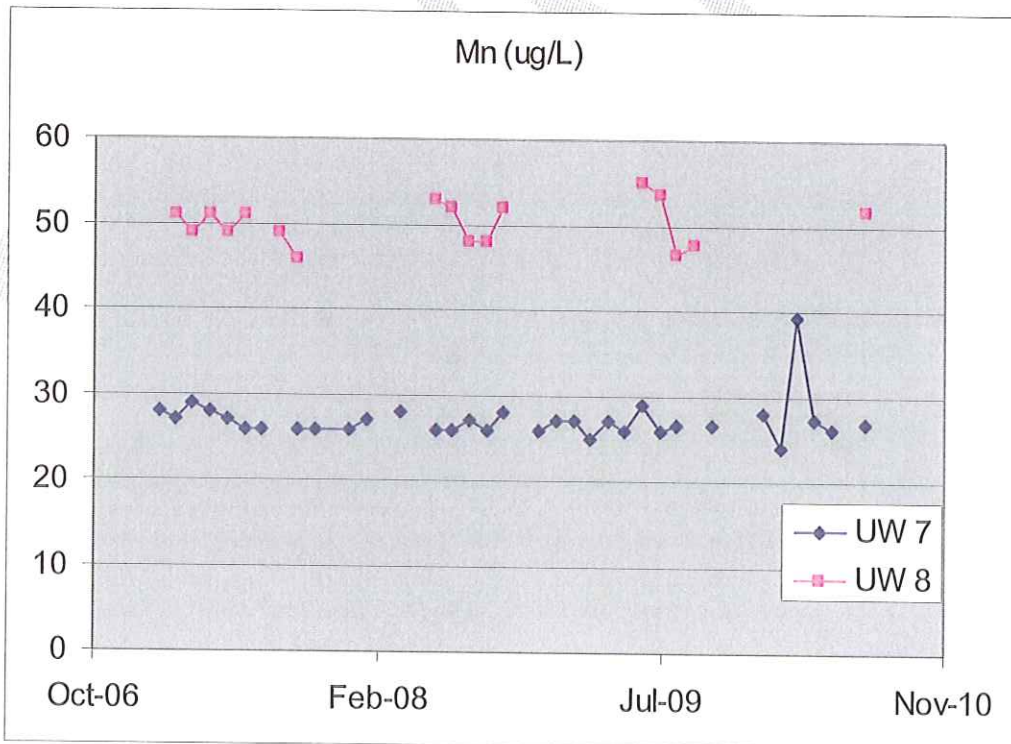
Figure 10. Monthly manganese concentrations in UW7 and UW8.

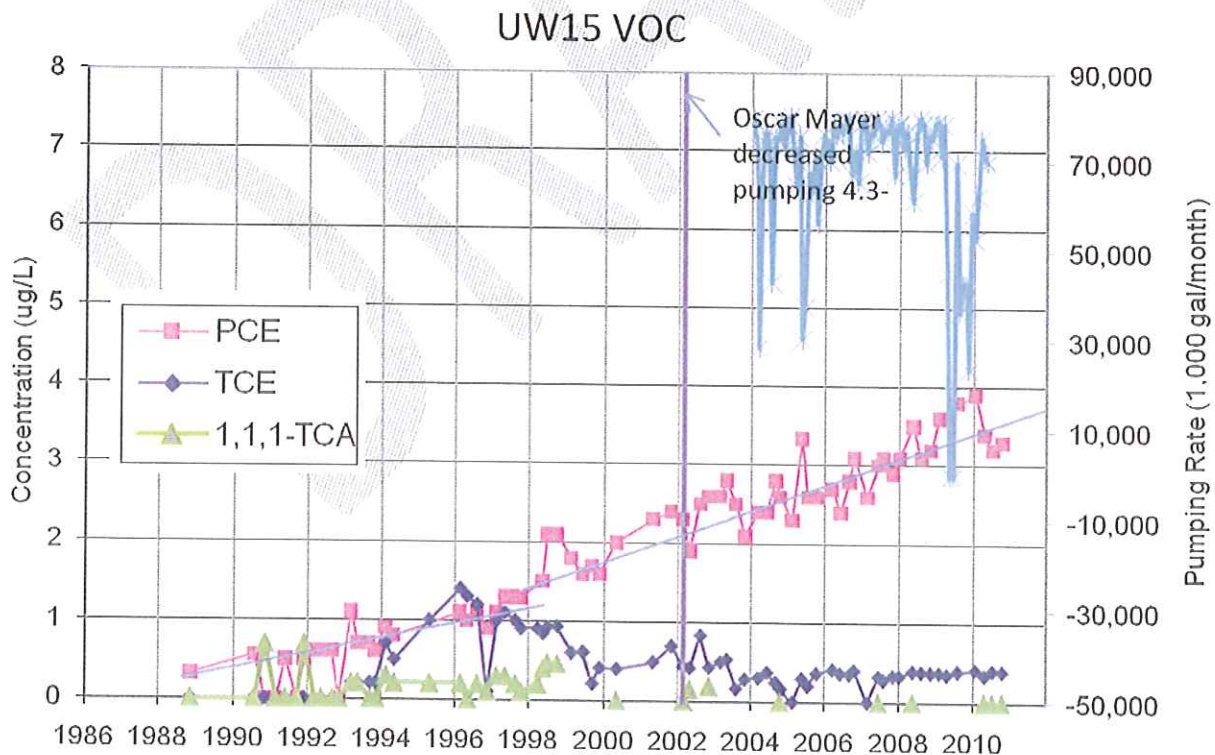
VOCs have been present since monitoring began in the late 1980s, as shown in Figure 11. Initial VOCs detected were PCE, TCE, and 1,1,1 TCA. In 1996, the TCE concentration started to decline and has leveled off at 0.33 ug/L in the last several years. This concentration is a small fraction of the 5 ug/l Maximum Contaminant Level (MCL), which is the concentration considered by the EPA acceptable for drinking water. The 1,1,1-TCA has always been low relative to its MCL (200 ug/L) and has very generally followed the TCE trend, in that it has decreased over the last decade.

Figure 11. Volatile Organic Compound concentrations in UW15. Pumping rate shown in light blue.

The PCE concentration has an upward trend since monitoring started in November 1988. The trend is shown as two separate trend lines on **Figure 11**. From November 1988 through about May 1996, the PCE trend was similar to that for TCE, increasing at a relatively slow rate. From about May 1996 through October 2010, the rate of concentration increase has been slightly higher. If the recent trend continues, PCE will exceed the 5 mg/L standard within the next year or two.

Between 2004 and 2010, UW15 has had two periods of time of decreased pumping rate³ of more than one month duration, in approximately May through June 2005 and April 2009 through February 2010. During both of these periods, it appears that the PCE concentration at UW15 increased above the trend line. These increases have been small (less than 1 ug/L), but they are significant with respect to the change that would exceed the MCL (i.e., from about 3 ug/L to 5 ug/L). These small increases appear to be temporary, potentially because of the short-term reduction in pumping rate. A correlation between lower pumping rate and increased PCE concentration at UW15 would suggest that the PCE:

- It may be possible to manage PCE concentrations by:
 - Maintaining a relatively high average monthly pumping rate to dilute the PCE; or
 - Extending the casing deeper to draw less shallow groundwater and more water from deeper parts of the aquifer.
