# 2023 Allied Drive - Carling Drive Blight Study

Madison, WI

Prepared by MSA Professional Services, Inc.  
May 2023

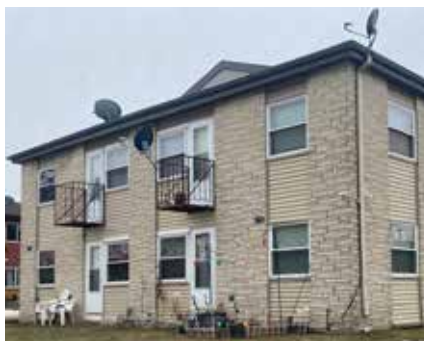
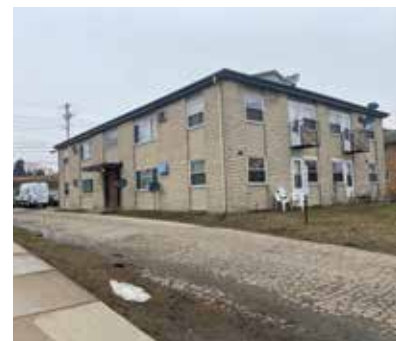
**Score: 42.0**

Building not Handicap Accessible; Chimneys & Vents: faded and peeling paint; Drives/Parking/Walks: major cracking on drive and parking; Erosion and Stormwater: evidence of water pooling; Exterior Doors & Entranceways: door: opening on frame, entranceway: cracked, chipping concrete; Porches & Overhangs: porch: major rust on first floor; Roof: discolored, minor uneven surface; Walls & Cladding: faded, missing mortar, unsightly opening cover on wall, stain at the bottom; Windows & Awnings: window: missing element and peeling paint on frame.

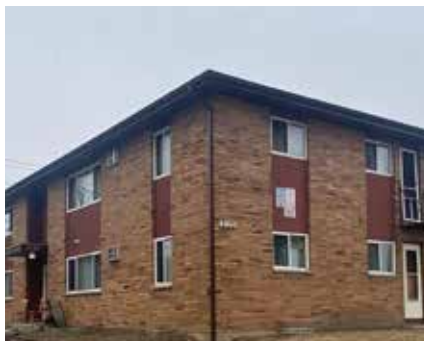
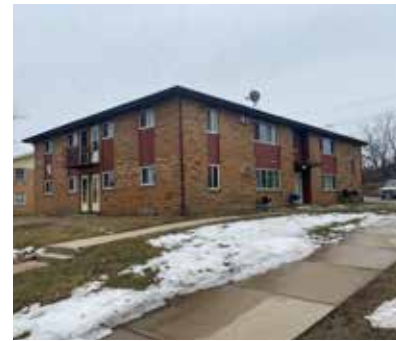
**PARCEL NO. 3 (2118 & 2122 Allied Drive)**

**Score: 52.5**

Building not Handicap Accessible; Chimneys & Vents: rust on vent; Drives/Parking/Walks: major cracking, deterioration of driveway; Erosion and Stormwater: evidence of water pooling; Porches & Overhangs: rust on balconies, Overhang: okay, Roof: discolored, rough and missing element on the edge at the side; Walls & Cladding: discolored, stain at the base.

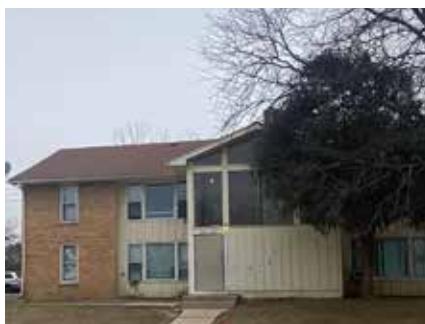
**PARCEL NO. 4 (2202 & 2206 Alleid Drive)**

**Score: 42.7**

Building not Handicap Accessible; Chimneys & Vents: discolored and rust on vent; Drives/Parking/Walks: major cracking and potholes; Erosion and Stormwater: evidence of water pooling; Exterior Doors & Entranceways: door: faded, deteriorating frame, peeling paint; Exterior Stairs/Stoops/Ramps: stairs: cracked and concrete chipping; Porches & Overhangs: discolored wooden porch; Roof: peeling paint on fascia; Storage & Screening: dumpster unscreened; Walls & Cladding: wood cladding: discolored, peeling paint, missing component; Windows & Awnings: window: chipping concrete sill and deteriorating wooden frame.

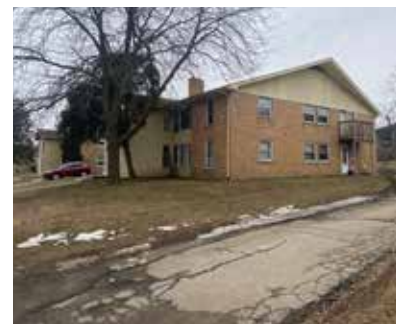
**PARCEL NO. 5 (2210 & 2214 Allied Drive)**

**Score: 45.8**

Building not Handicap Accessible; Chimneys & Vents: unmatched painting, discolored, rust on vent cap; Drives/Parking/Walks: cracking and potholes; Erosion and Stormwater: water pooling, Exterior Doors & Entranceways: deteriorating frame at the door bottom; Exterior Stairs/Stoops/Ramps: stairs: cracked, discolored, faded paint; Porches & Overhangs: discolored wooden porch; Roof: faded; Walls & Cladding: discolored mortar; Windows & Awnings: window: unsightly cover at the front, chipping concrete sill, peeling paint.

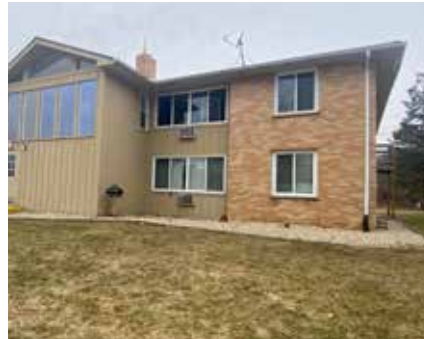
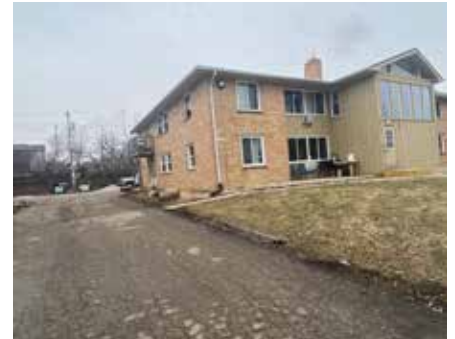
**PARCEL NO. 6 (2218 & 2222 Allied Drive)**

**Score: 52.2**

Building not Handicap Accessible; Chimneys & Vents: chipping brick, faded, rust on vent; Drives/Parking/Walks: cracking and potholes; Exterior Stairs/Stoops/Ramps: cracked, faded paint, chipping concrete; Porches & Overhangs: discolored wooden porch; Roof: faded; Storage & Screening: dumpster unscreened; Walls & Cladding: minor discoloration.

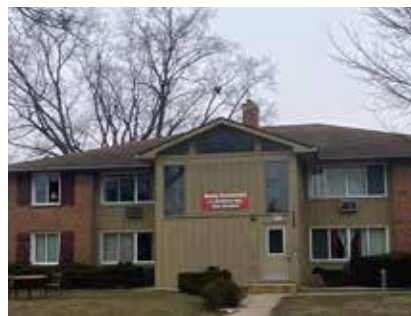
**PARCEL NO. 8 (2234 & 2238 Allied Drive)**

**Score: 57.4**

Building not Handicap Accessible; Drives/  
Parking/Walks: cracking; Exterior Doors &  
Entranceways: door: deteriorating frame  
at the base; Exterior Stairs/Stoops/Ramps:  
faded paint; discolored, concrete chipping;  
Porches & Overhangs: rust on balconies;  
Roof: discolored; Walls & Cladding: faded.

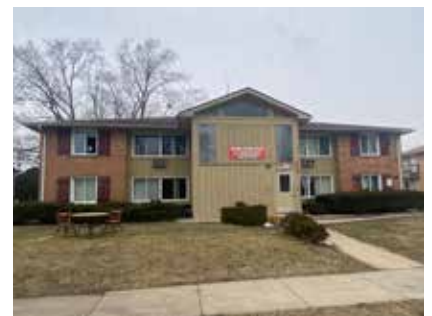
**PARCEL NO. 7 (2226 & 2230 Allied Drive)**

**Score: 45.9**

Building not Handicap Accessible; Chimneys & Vents: missing mortar and chipping brick; Drives/Parking/Walks: cracking, potholes; Erosion and Stormwater: water pooling; Exterior Doors & Entranceways: door: deteriorating frame at the bottom, faded, entranceway: faded paint, cracking, chipping concrete; Exterior Stairs/Stoops/Ramps: stair: discolored paint, chipping concrete, cracking; Minor Maintenance: interior chairs in yard; Porches & Overhangs: porch: discolored wooden; Roof: discolored; Walls & Cladding: faded and discolored; Windows & Awnings: chipping concrete sill.

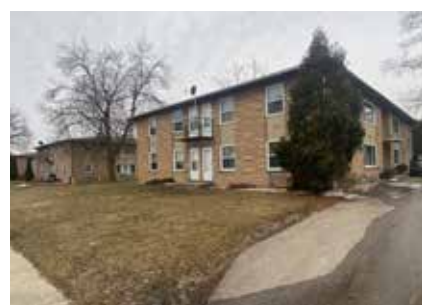
**PARCEL NO. 9 (2242 & 2302 Allied Drive)**

**Score: 49.5**

Building not Handicap Accessible; Drives/  
Parking/Walks: cracking, potholes; Erosion  
and Stormwater: water pooling; Exterior  
Doors & Entranceways: door: stain,  
deteriorating at the bottom frame; Exterior  
Stairs/Stoops/Ramps: discolored, chipping  
concrete; Porches & Overhangs: rust on  
balconies; Roof: discolored; Storage &  
Screening: dumpster unscreened; Walls  
& Cladding: faded; Windows & Awnings:  
peeling paint on sill.

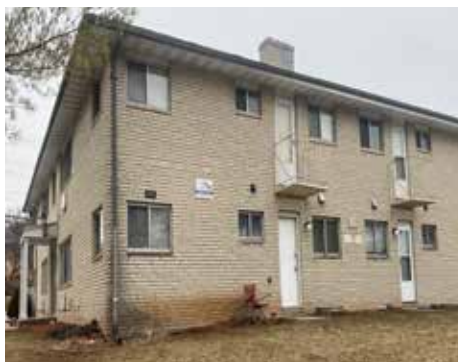
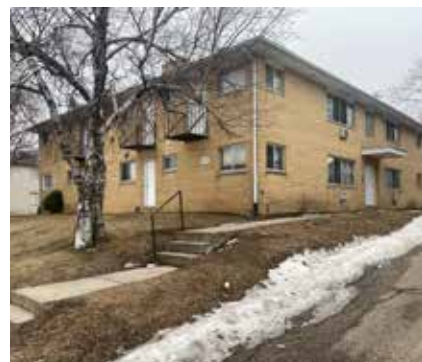
**PARCEL NO. 13 (2330-2358 Allied Drive)**

**Score: 41.6**

Building not Handicap Accessible; Chimneys  
& Vents: discolored, rust on vent; Drives/  
Parking/Walks: driveway: cracks, potholes;  
walks: cracked and sunken pavement;  
Erosion and Stormwater: evidence of water  
pooling; Exterior Doors & Entranceways:  
door: missing frame, dampness on frame  
bottom, paint peeling; Exterior Stairs/  
Stoops/Ramps: stairs: cracked; pitting on  
riser, uneven settling, chipping concrete,  
missing element on handrails; Porches  
& Overhangs: rust on balcony; Roof:  
discolored, missing element on fascia and  
soffit; Storage & Screening: dumpster  
unscreened; Walls & Cladding: stained and  
discolored; Windows & Awnings: paint  
peeling.

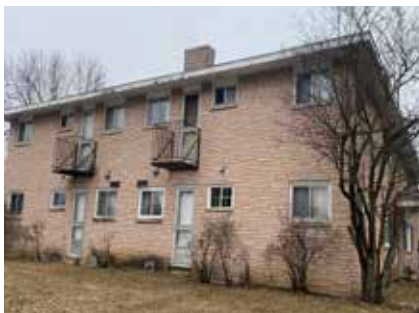
**PARCEL NO. 14 (2105 Allied Drive & 4713 Thurston Lane)**

**Score: 31.5**

Chimneys & Vents: discolored, chipping bricks; Drives/Parking/Walks: major cracking, potholes; Erosion and Stormwater: evidence of water pooling; Exterior Doors & Entranceways: door: discolored at the bottom; Porches & Overhangs: rust on balconies; Roof: discolored and missing shingles, deteriorating and paint peeling on fascia board, missing element on soffit; Storage & Screening: rust on pole and wired fence, dumpsters not screened; Walls & Cladding: faded, discolored and missing mortar, dirt/water staining in many places; Windows & Awnings: deteriorating and paint peeling on window frame.

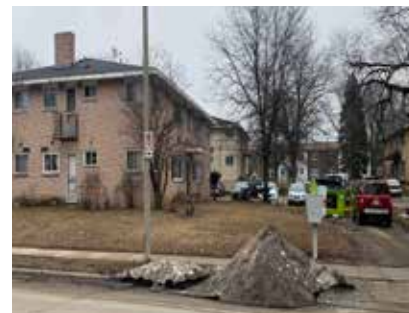
**PARCEL NO. 15 (2115 & 2121 Allied Drive)**

**Score: 38.0**

Building not Handicap Accessible; Chimneys & Vents: discolored, missing mortar, and rust on vent cap; Drives/Parking/Walks: major cracking, water pooling, and uneven surface; Erosion and Stormwater: water pooling on walkway; Exterior Doors & Entranceways: faded; deteriorating wooden frame, and rust on door nob; Minor Maintenance: vines on building, including wooden elements; Porches & Overhangs: faded and peeling paint on overhang; Roof: discolored, highly deteriorating soffit and fascia board, peeling paint; Signage & Lighting: discolored and faded house signage; Walls & Cladding: discolored, water staining.

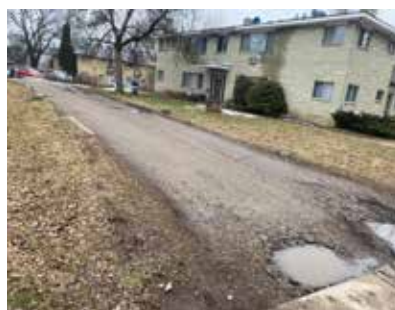
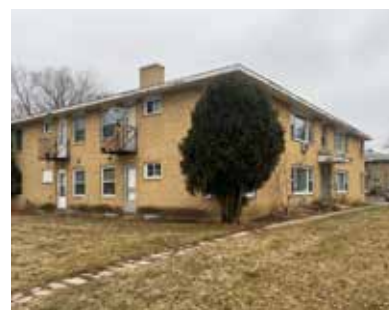
**PARCEL NO. 17 (2211 & 2217 Allied Drive)**

**Score: 36.9**

Chimneys & Vents: chimney: discolored, missing mortar; vent: rust; Drives/Parking/Walks: potholes, cracking; Erosion and Stormwater: water pooling; Exterior Doors & Entranceways: deteriorating door frame, faded; Gutters & Downspouts: missing element; Porches & Overhangs: rust on balconies; Roof: discolored, missing roof element, peeling paint on fascia, water staining on wall indicating roof leak; Storage & Screening: rust on pole and fence, dumpster unscreened; Walls & Cladding: discolored and faded; Windows & Awning: paint peeling on frame, discolored sill.

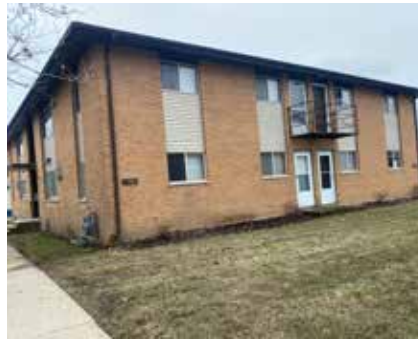
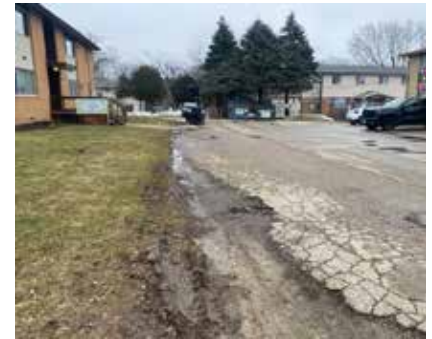
**PARCEL NO. 18 (2221 & 2225 Allied Drive)**

**Score: 38.0**

Building not Handicap Accessible; Chimneys & Vents: discolored and rust; Drives/Parking/Walks: crack, potholes and uneven surface; Erosion and Stormwater: evidence of water pooling; Exterior Doors & Entranceways: deteriorating door frame; Exterior Stairs/Stoops/Ramps: discolored stairs, chipping concrete on edges; Porches & Overhangs: rust on balconies; Roof: discolored, uneven surface; Signage & Lighting: faded signage; Walls & Cladding: discolored; Windows & Awning: deteriorating and missing elements on window frame.

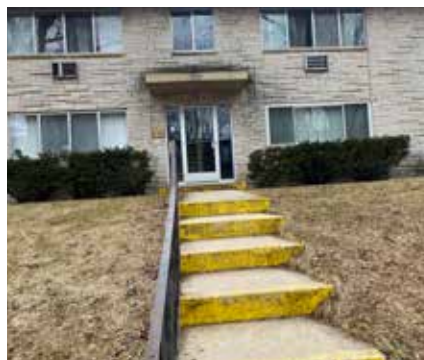
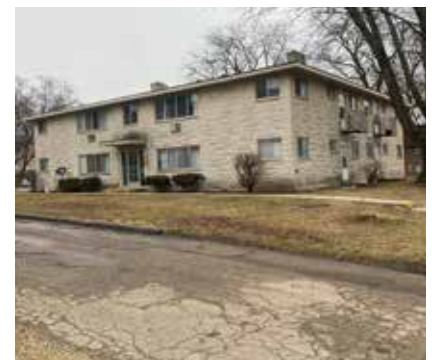
**PARCEL NO. 21 (2230 & 2234 Allied Drive)**

**Score: 54.7**

Building not Handicap Accessible; chimney: discolored; missing mortar; vent: rust on cap; wall vent: dented; Drives/Parking/Walks: minor cracking; Exterior Doors & Entranceways: storm door missing and door frame deteriorating; Exterior Stairs/Stoops/Ramps: peeling paint, concrete chipping, cracked, and rust on handrail; Porches & Overhangs: peeling paint, and rust on entrance porch roof; Roof: discolored and missing roofing element; Storage & Screening: unscreened dumpster; Walls & Cladding: water staining near ground; Windows & Awning: discolored sill.

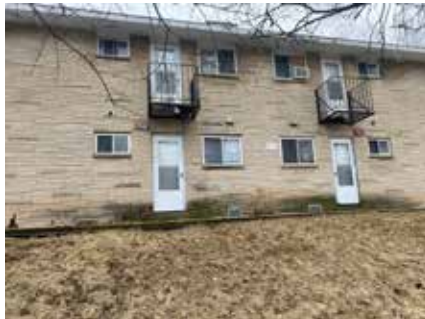
**PARCEL NO. 22 (2218 & 2222 Rosenberry Road)**

**Score: 46.3**

Building not Handicap Accessible; Chimneys & Vents: discolored, missing mortar, and rust on vent; Drives/Parking/Walks: cracked; Exterior Doors & Entranceways: door: deteriorating wooden frame; Exterior Stairs/Stoops/Ramps: cracked, sinking, uneven settling; Minor Maintenance: lawn rutted near driveway; Porches & Overhangs: deteriorating fascia on entrance porch; Roof: discolored; Walls & Cladding: water staining near ground; Windows & Awnings: faded, paint peeling.

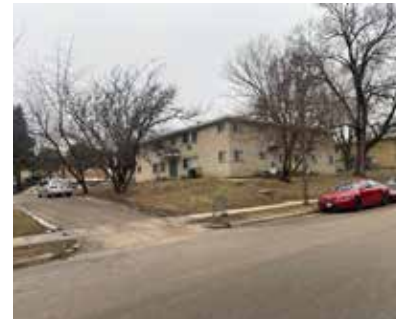
**PARCEL NO. 23 (2210 Rosenberry Rd)**

**Score: 53.8**

Building not Handicap Accessible; Chimneys & Vents: chimney faded, stain, and missing mortar; Drives/Parking/Walks: minor cracking; Exterior Doors & Entranceways: door: deteriorating wooden frame, discolored; Porches & Overhangs: discolored entrance porch roof; Roof: discolored; Walls & Cladding: severe water staining along base of walls; Windows & Awnings: stained concrete sill.

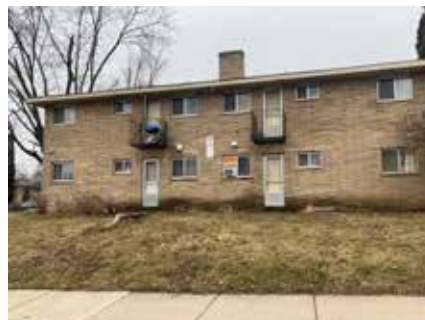
**PARCEL NO. 24 (2202 & 2206 Rosenberry Road)**

**Score: 49.0**

Chimney: faded, discolored mortar; vent: rust on cap; Drives/Parking/Walks: minor cracking; Exterior Doors & Entranceways: door: deteriorating frame at the base; Porches & Overhangs: deteriorating entrance porch cover; Roof: stained; rust on fascia cover, unmatched eaves ceiling; Walls & Cladding: water staining near ground on all visible walls; Windows & Awnings: staining on window sill.

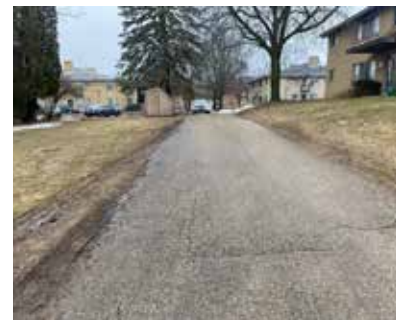
**PARCEL NO. 25 (2110 & 2114 Rosenberry Road)**

**Score: 53.5**

Building not Handicap Accessible; Chimneys & Vents: stained and rust on vent; Drives/Parking/Walks: cracking; Exterior Doors & Entranceways: door: faded, deteriorating frame; Porches & Overhangs: rust on balconies; Roof: stained, missing element, deteriorating fascia and soffit; Walls & Cladding: water staining along bottom of walls; Windows & Awnings: stained and chipping concrete sill; missing element on frame.

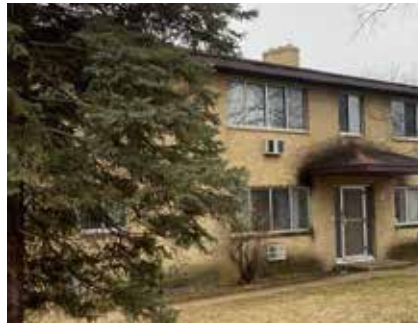
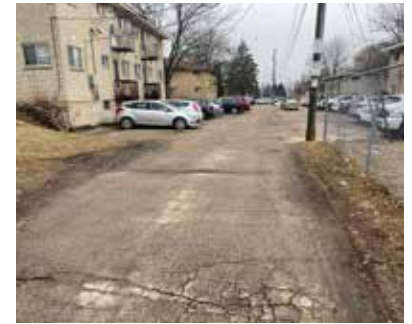
**PARCEL NO. 26 (2102 & 2106 Rosenberry Road)**

**Score: 43.3**

Building not Handicap Accessible; Chimneys & Vents: chimney: discolored mortar, chipping bricks; vent: rust on cap; Drives/Parking/Walks: cracking, potholes; Exterior Doors & Entranceways: door: faded; deteriorated door and frame; Foundation: faded; Porches & Overhangs: deteriorating entrance porch cover, rust on balconies, Roof: highly discolored, missing element, deteriorated fascia and soffit; Storage & Screening: deteriorated and missing element on wooden fence; Walls & Cladding: highly discolored, faded, missing mortar; Windows & Awnings: peeling paint; stained sill; missing element on frame.

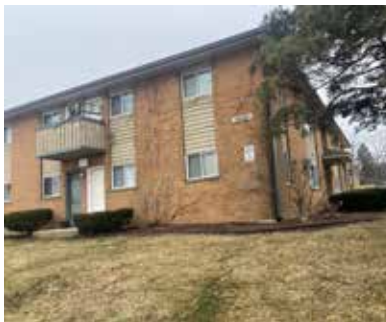
**PARCEL NO. 29 (2418 & 2422 Allied Drive)**

**Score: 59.7**

Drives/Parking/Walks: minor cracking;  
Exterior Doors & Entranceways: door: faded,  
deteriorating wooden frame; Exterior  
Stairs/Stoops/Ramps: chipping concrete;  
Porches & Overhangs: faded and deteriorating  
wooden porch; Roof: discolored; Walls  
& Cladding: faded, stained; Windows &  
Awnings: chipping and stained concrete sill,  
unsightly damaged blind behind glass.

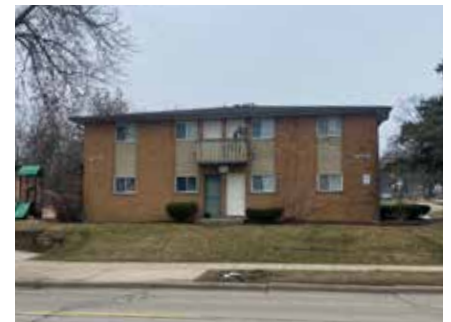
**PARCEL NO. 27 (2402 & 2406 Allied Drive)**

**Score: 57.9**

Building not Handicap Accessible; Drives/Parking/Walks: cracking; Exterior Doors & Entranceways: door: faded, peeling paint and deteriorating frame; Major Maintenance: minor graffiti on wall; Minor Maintenance: bed frame on balcony, vines on wall; Roof: discolored; Walls & Cladding: faded, stained cladding, minor graffiti on wall; Windows & Awnings: stained sills.

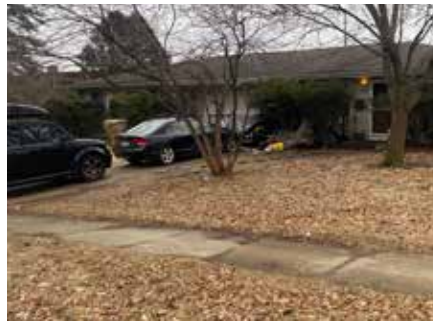
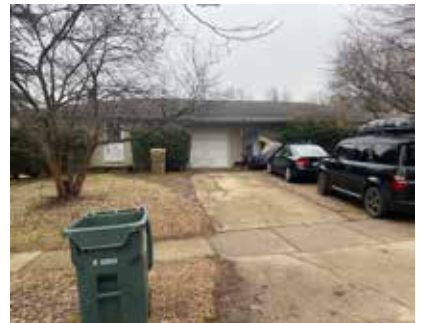
**PARCEL NO. 37 (4701 & 4705 Crescent Road)**

**Score: 38.3**

Building not Handicap Accessible; Drives/  
Parking/Walks: driveway: cracked, uneven  
surface, sinking pavement; walk: not  
available; Exterior Doors & Entranceways:  
faded, stained, deteriorated wooden  
frame; Exterior Stairs/Stoops/Ramps: stair:  
dilapidated, cracked, discolored, concrete  
chipping; Major Maintenance: stacked  
materials and equipment on driveway; Roof:  
discolored; Storage & Screening: stacked  
materials and equipment on driveway; Walls  
& Cladding: faded, stained.

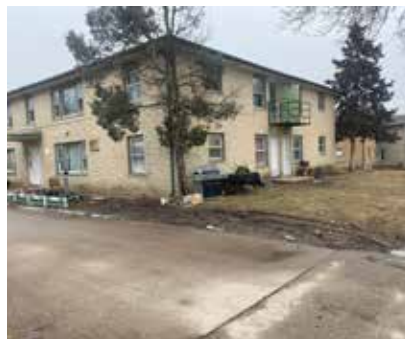
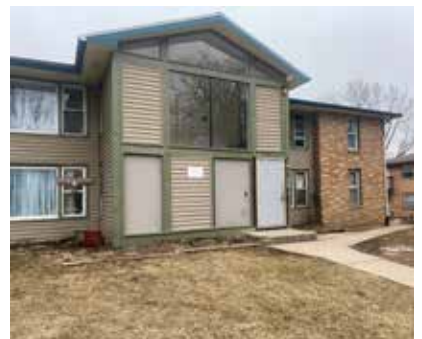
**PARCEL NO. 40 (2221, 2305, 2301, 2225  
Carling Drive)**

**Score: 51.0**

Building not Handicap Accessible; Chimneys &  
Vents: discolored, rust; Drives/Parking/Walks:  
cracking; Exterior Doors & Entranceways:  
faded, deteriorated frames, storm doors  
missing; Exterior Stairs/Stoops/Ramps: stairs:  
stained, concrete chipping, cracked; Major  
Maintenance: trash and indoor furniture in  
yard; Porches & Overhangs: faded and rust  
on porch cover; Roof: discolored; Walls &  
Cladding: brick water stained along ground;  
Windows & Awnings: stained sills.

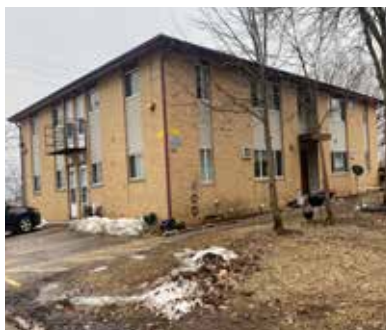
**PARCEL NO. 80 (4702, 4706 Thurston Lane)**

**Score: 50.2**

Building not Handicap Accessible; Chimneys & Vents: stained; rust; Drives/Parking/Walks: cracking; potholes; Exterior Doors & Entranceways: door: peeling paint, deteriorating wooden door and frame; Exterior Stairs/Stoops/Ramps: chipping concrete, stained; Foundation: cracked, concrete chipping; Porches & Overhangs: paint peeling on the entrance porch cover; Roof: discolored, paint peeling on fascia; Storage & Screening: discolored wooden fence, dumpster unscreened; Walls & Cladding: discolored; Windows & Awnings: stained sill.

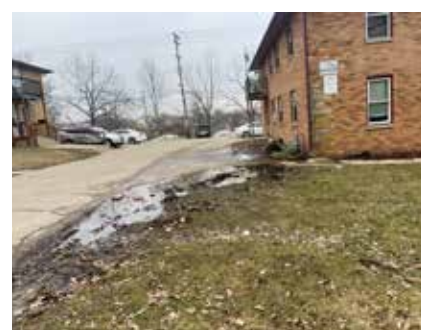
**PARCEL NO. 41 (2309-2345 Carling Drive)**

**Score: 53.5**

Building not Handicap Accessible; Chimneys & Vents: chimney: discolored, chipping brick, missing mortar; vent: rust; Drives/Parking/Walks: cracking; Exterior Doors & Entranceways: door: faded, peeling paint, dent on frame and door; Exterior Stairs/Stoops/Ramps: cracked; chipping concrete, pitting on stairs and stoop; Foundation: chipping concrete, discolored; Porches & Overhangs: rust on overhang porch, peeling paint and faded entrance porch cover; Roof: discolored; Walls & Cladding: discolored; faded, chipping brick, missing mortar; Windows & Awnings: stained sill, sagging frame element.

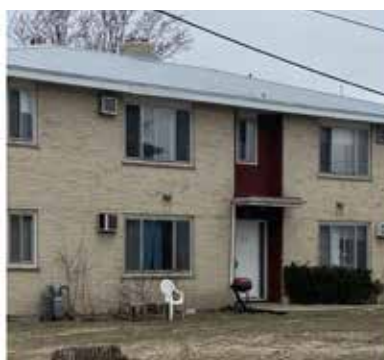
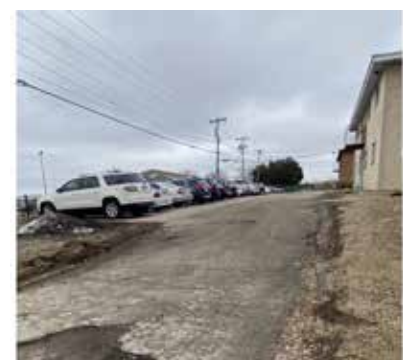
**PARCEL NO. 81 (2013 Allied Drive & 4710 Thurston Lane)**

**Score: 47.5**

Building not Handicap Accessible; Drives/Parking/Walks: cracking, potholes; Exterior Doors & Entranceways: door: deteriorating frame, missing element, paint peeling; Exterior Stairs/Stoops/Ramps: rust on handrail, discolored; Porches & Overhangs: peeling paint and rust on entrance porch covers; Signage & Lighting: deteriorating wooden signage frame; Storage & Screening: discolored and deteriorating wooden fence; Walls & Cladding: faded, discolored, Windows & Awnings: deteriorating wooden framed; stained sills.

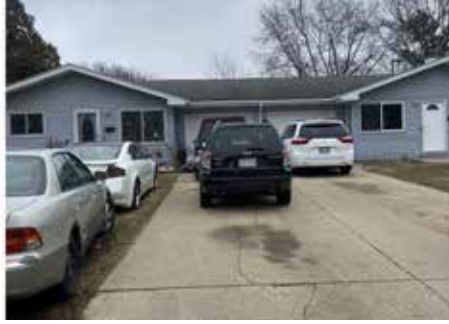
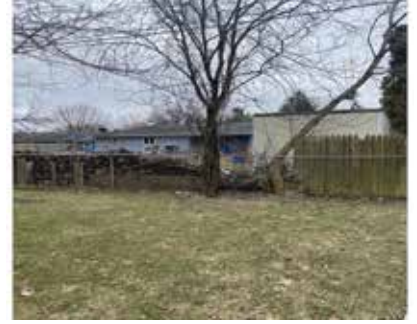
**PARCEL NO. 82 (4730 & 4734 Crescent Road)**

**Score: 59.4**

Building not Handicap Accessible;  
Chimneys & Vents: rust on vent; Drives/  
Parking/Walks: cracking, stains; Major  
Maintenance: piled up trash, cars parked on  
lawn; Roof: discolored; Storage & Screening:  
discolored; deteriorating wooden fence; Walls  
& Cladding: faded; Windows & Awnings:  
stained; paint peeling.

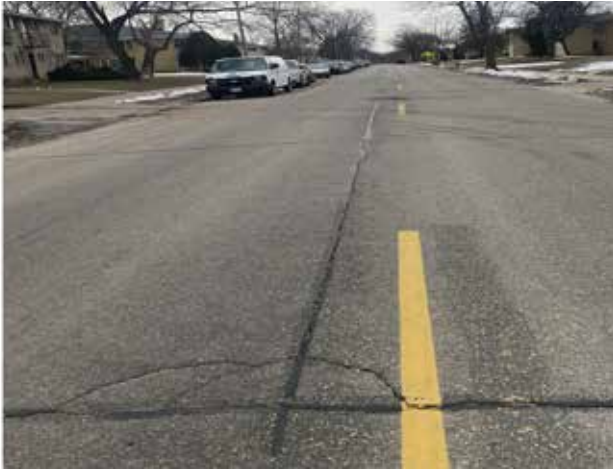
Allied Dr (cracking, some minor potholes toward the end)

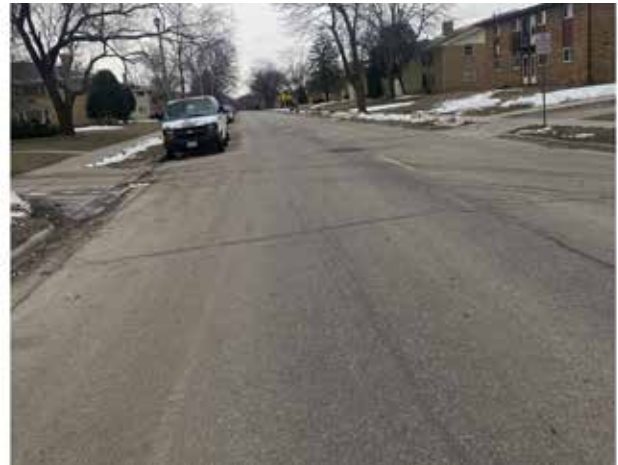
Allied Dr (cracking, some minor potholes toward the end)

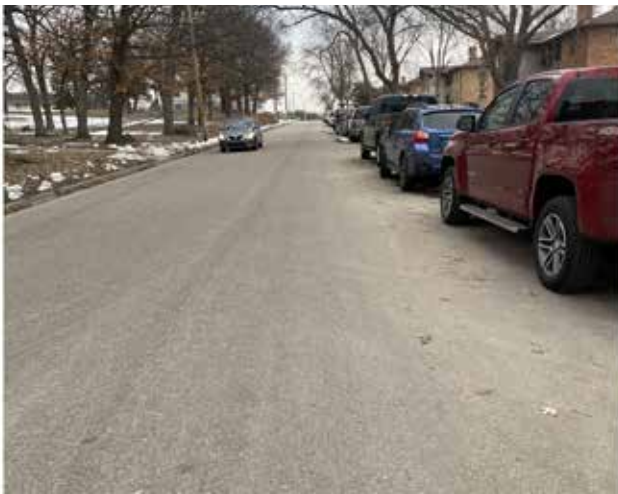
Carling Drive (relatively good)

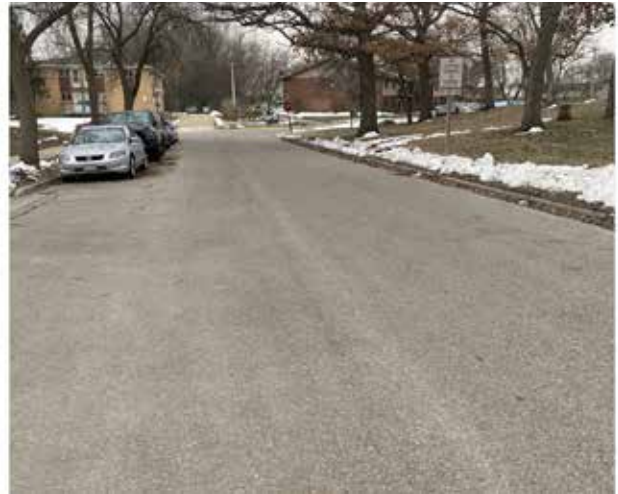
Carling Drive (good)

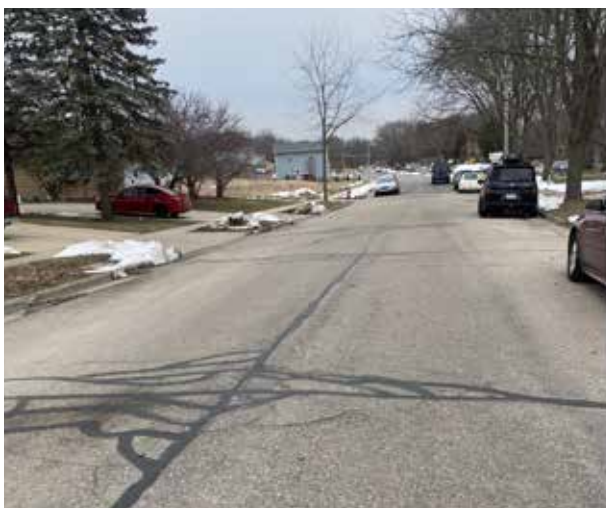
Crescent Road (cracking and uneven surface)

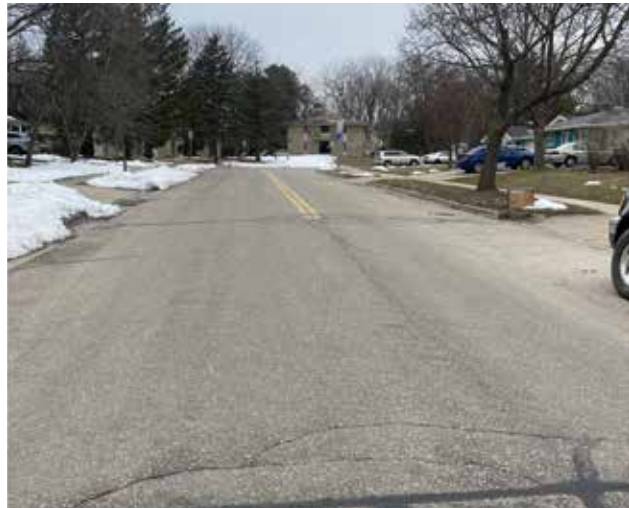
Crescent Road (cracking, and generally fair)

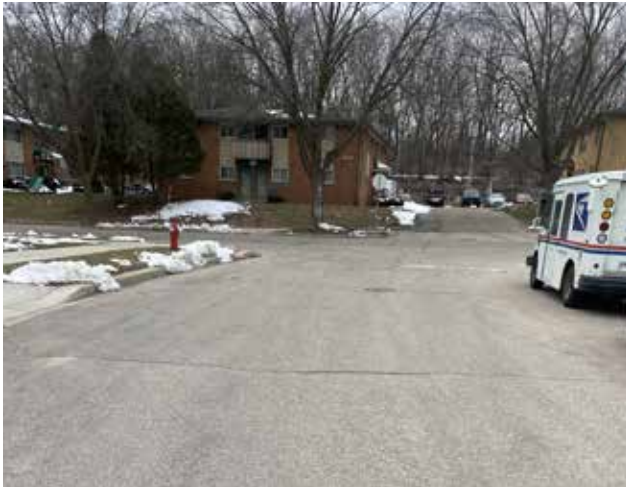
Dunns Marsh Terrace (minor cracking, fading road marking, fair condition )

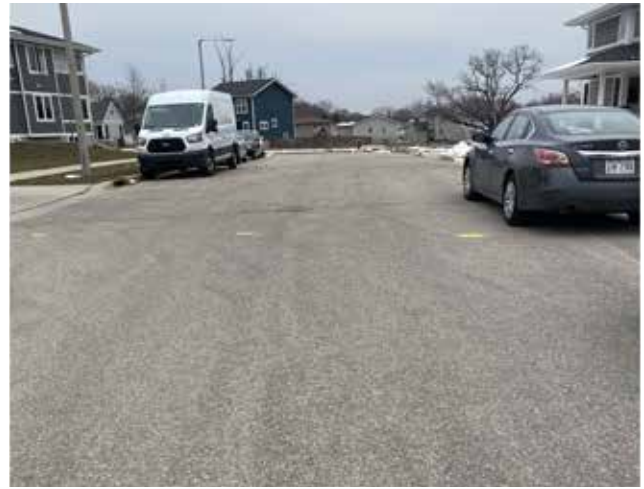
Dunns Marsh Terrace (minor cracking, fading marking)

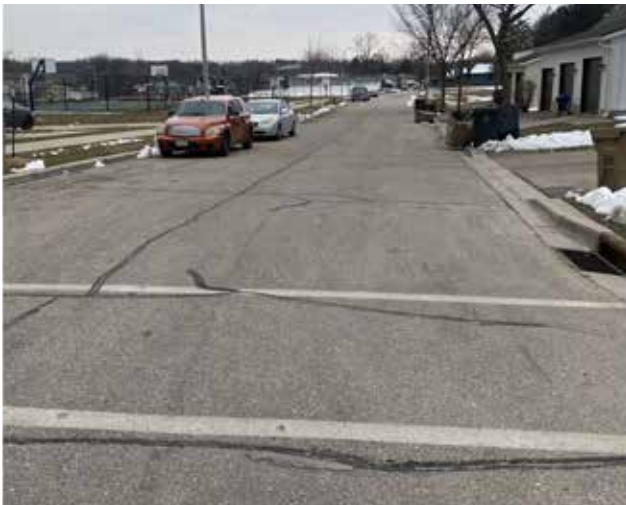
Gene Parks Place (cracking, uneven surface and settling)

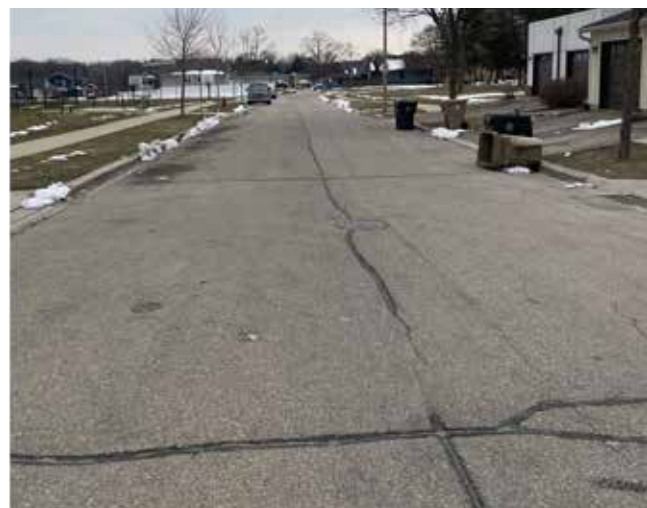
Gene Parks Place (cracking, uneven surface)

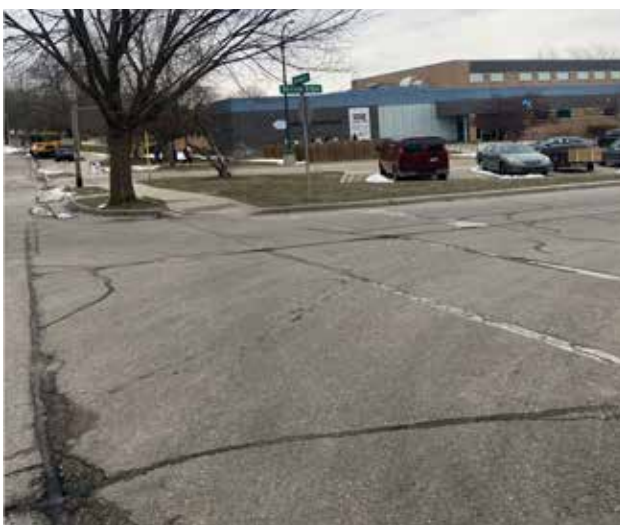
Jenewein Road (tarred cracks, crumbling along gutters, fading line paint)

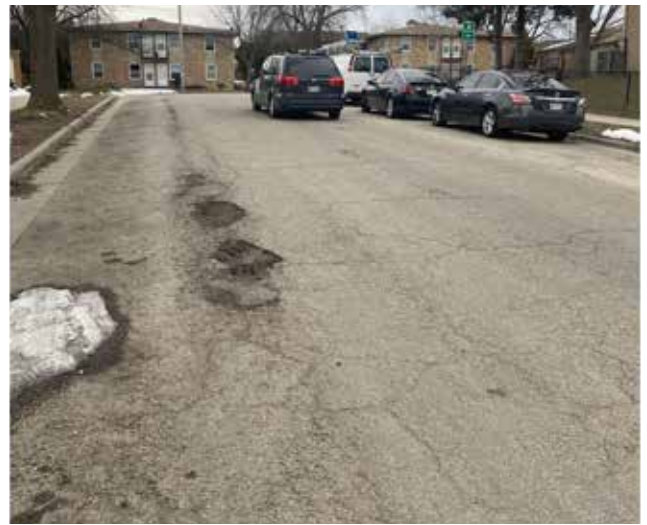
Jenewein Road (cracking, potholes, aggregate showing)

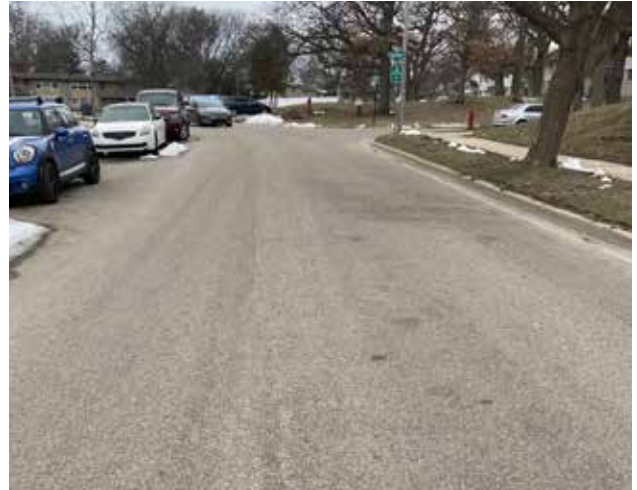
Lovell Lane (relatively good)

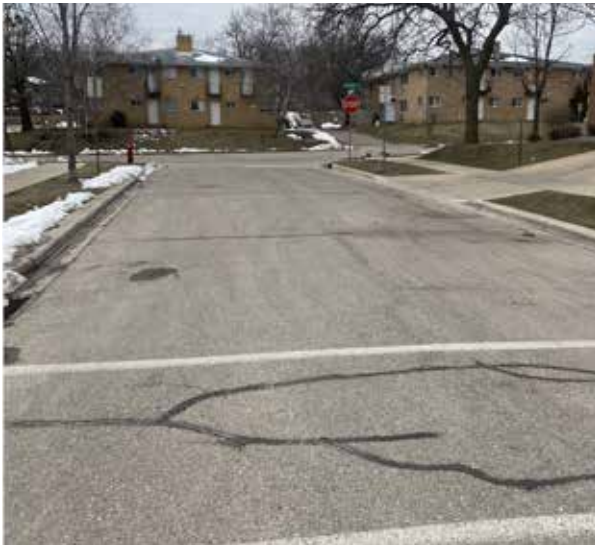
Mike McKinney Ct (tarred cracking, fading cross line paint)

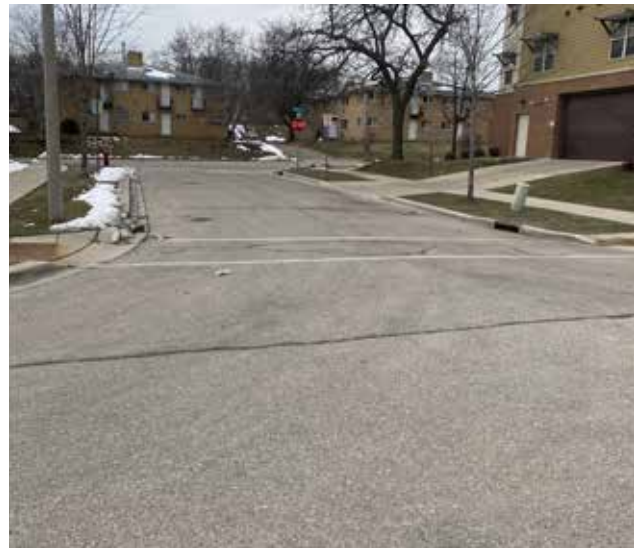
Mike McKinney Ct (tarred cracking, fading cross line paint)

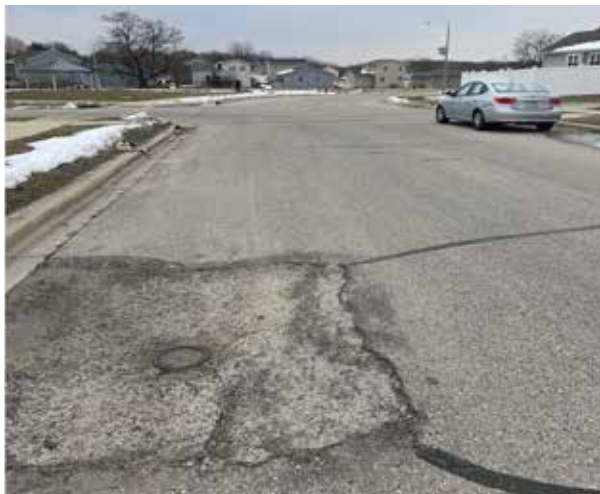
Percy Julian Way (cracking, poor tarred finishes in a section, fading cross line paint)

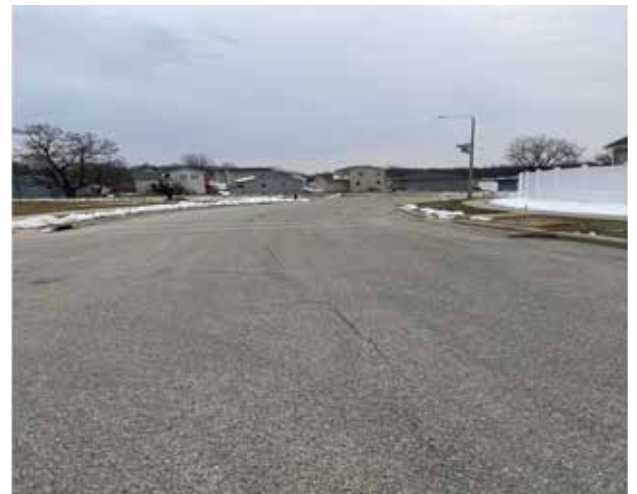
Percy Julian Way (minor cracking, relatively fair)

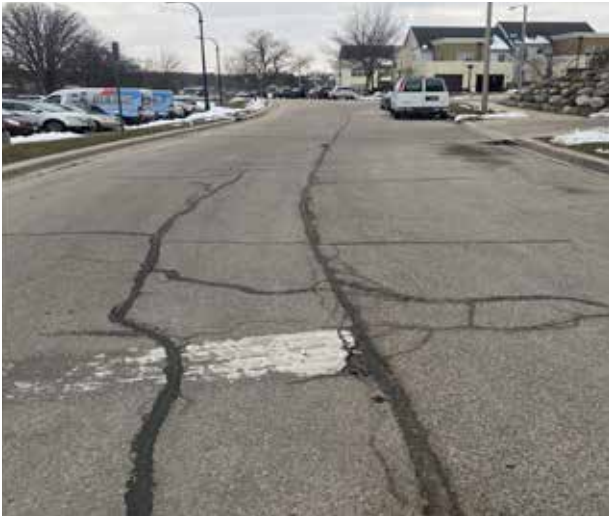
Revival Ridge (cracking, crumbling along center, fading marking paint)

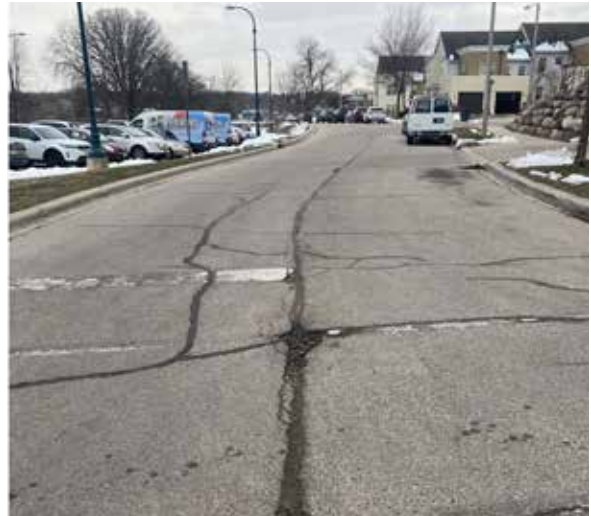
Revival Ridge (cracking, crumbling along center, fading marking paint)

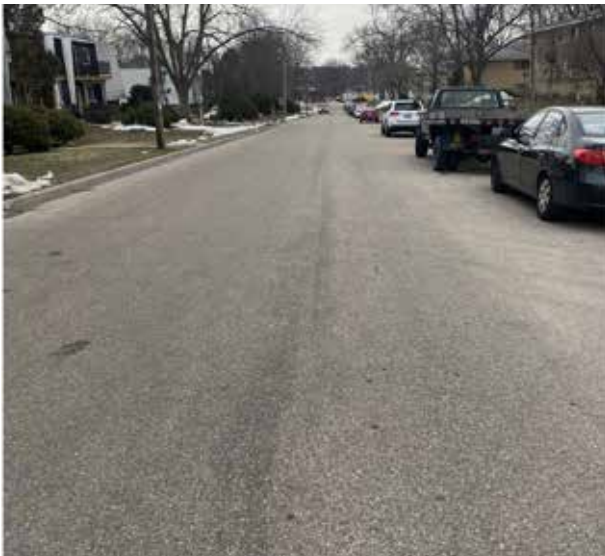
Rosenberry Road (good)

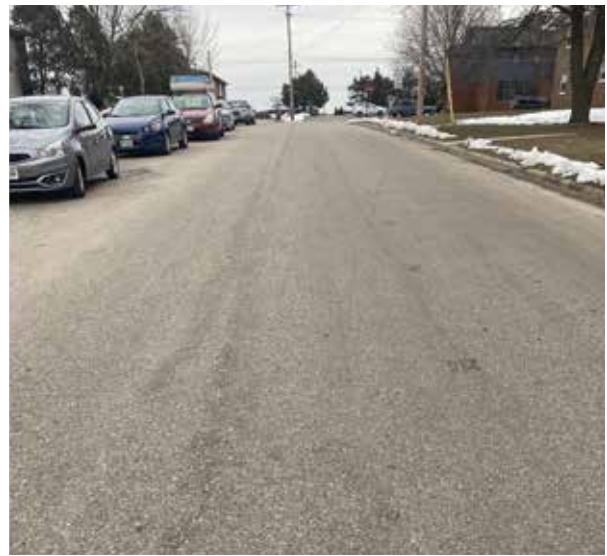
Rosenberry Road (good)

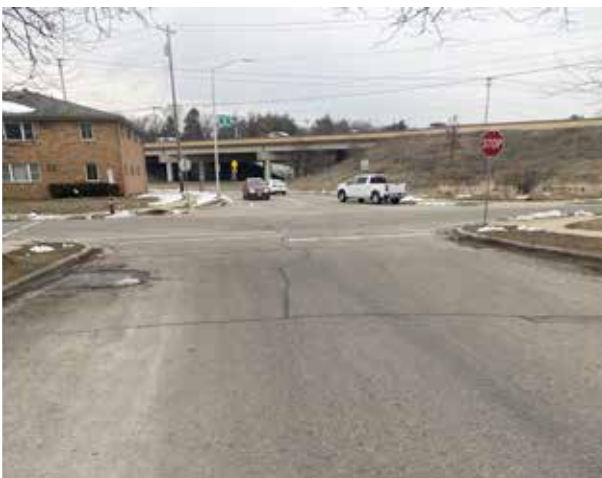
Thurston Lane (tarred cracks, fading marking paint, fair condition)

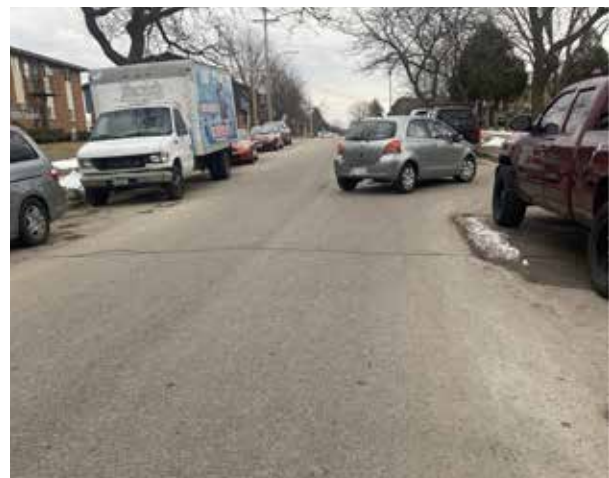
Thurston Lane (tarred cracks, fading marking paint, fair condition)

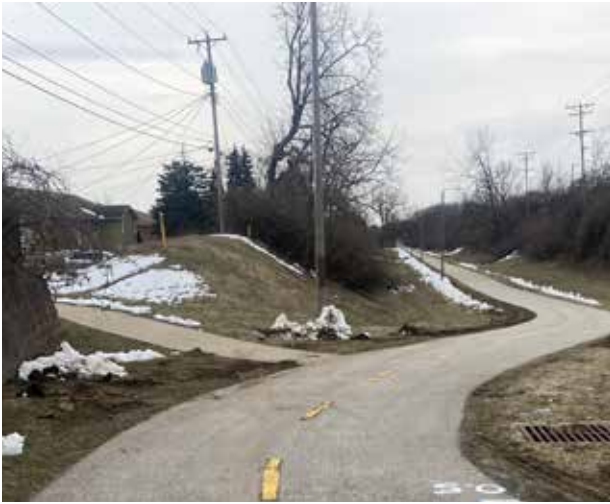
Bike Path (good)

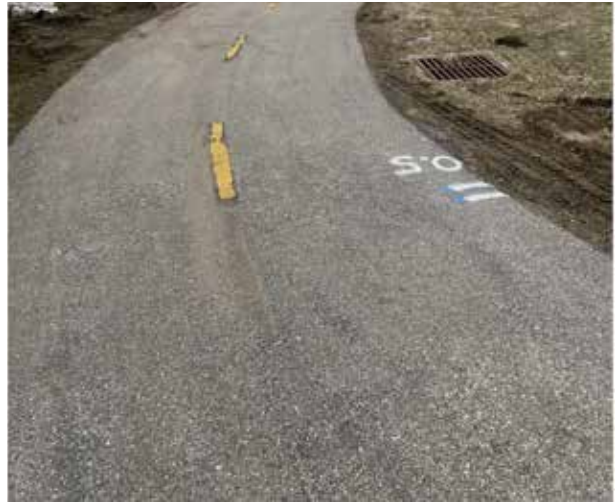
Bike Path (good)
