# **Annie C. Stewart Memorial Fountain**

# **BASIC INFORMATION**

Title of Work: Annie C. Stewart Memorial

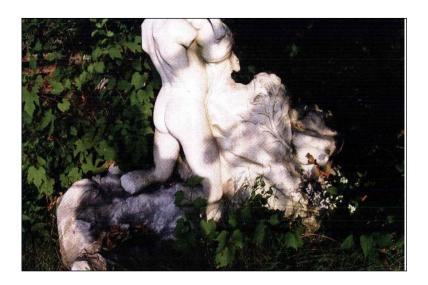
Annie Stewart Triton Figure

BASE OF (FORMER) EAST "TRITON" -ANNIE C. STEWART / MEMORIAL / FREDERICH J. CLASGENS SCULPTURE 1924 (This is one of 2"Tritons" no longer at Erin St. site. Sections of the sculpture are missing. The Boy should be brought inside and cleaned and preserved.

The Triton has been in storage since 1988. There appears to be a lack of funding, just for the sculpture. The last estimate for total restoration of the fountain was \$160,000.00. Some repair was done around 1996, but has since failed.

In addition, the statue of the mermaid, the young boy, and the dolphin is in good condition. There are some areas of discoloration from moss and dirt, but the marble itself is in pretty good shape except for the sugaring of the surface. The mermaid's nose, by the way, was broken off many years ago and is still missing. One of the two trident figures that were on the base of the basin is in storage and my recommendation is that they **not** be placed here at the fountain again because they will simply be vandalized and stolen. Some moss and lichen growth which is green is noted on the statue in the crevices where it has an ambient temperature and environment to grow. The remaining trident boy should be put indoors.

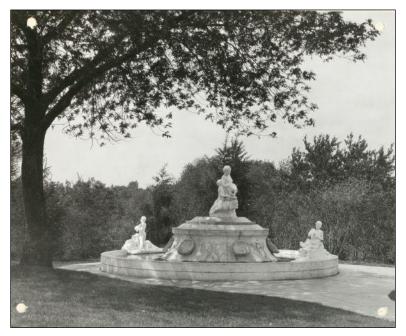
Memorial Fountain at Vilas Park

Original memorial's central figure was a mermaid who supplied water from a cornucopia. She and a little boy "Triton" who sits beside her ride a stylized dolphin (intact). The fountain sculpture included two more "tritons" (east and west) who were drinking fountains. Goldfish swam in pool and water ran from cornucopia to primary pool (base) and out four spouts on base's exterior. A cavity underneath pool base regulated the flow, which also carried the water underground to the zoo lagoon. The fountain was Madison's first outdoor sculpture (save the Capitol ones), and is in an extreme state of disrepair. The fountain has been nonfunctional for many years. The condition of the primary marble sculptures (mermaid and triton) is poor. The west "triton" was vandalized and destroyed. The east triton is missing an arm, foot and head. This sculpture is at a monument company with restoration incomplete.
