# Mendota-Grassman Greenway

**Public Information Meeting #2**  
**by City of Madison Engineering Division**  
**October 3 , 2022**

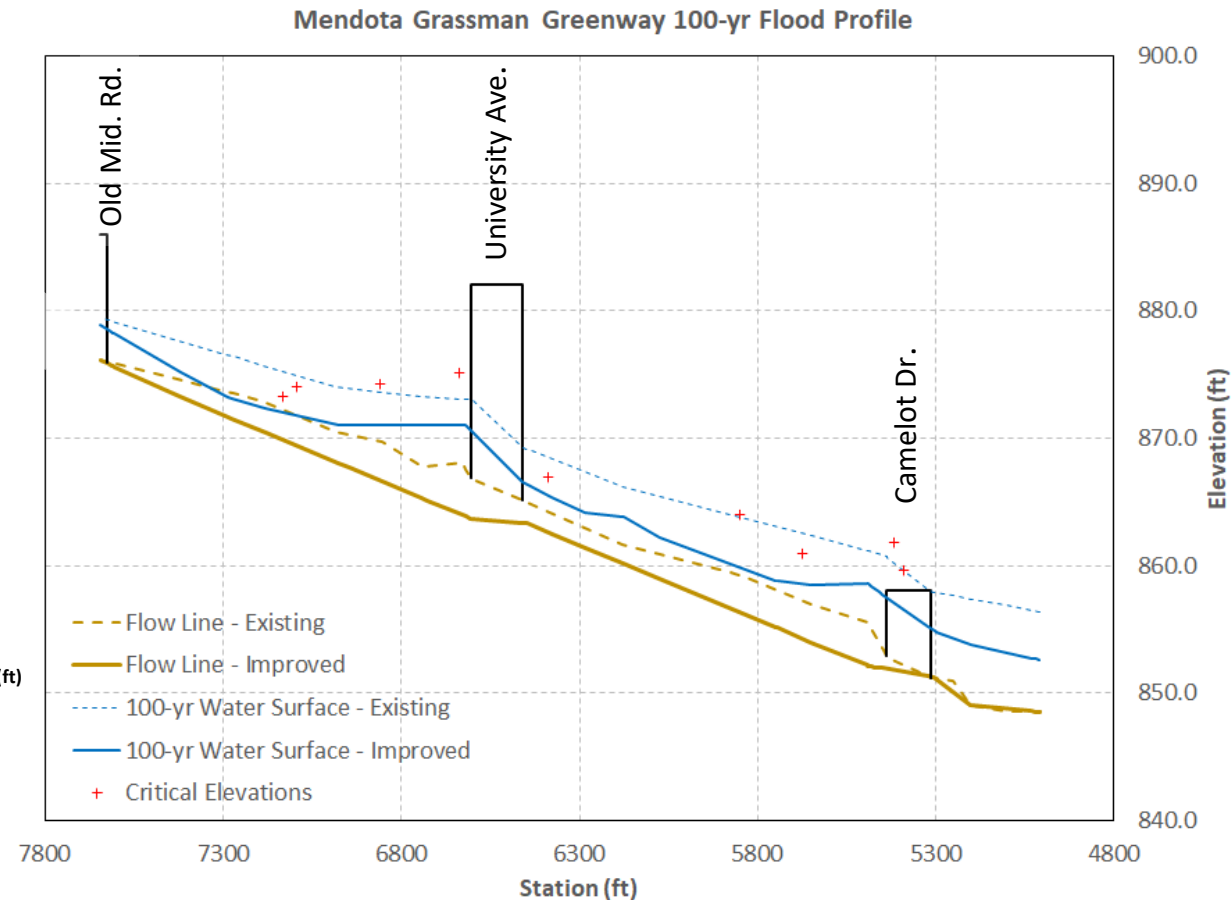
# 30% Design

# - 1% Annual Chance Inundation

Average Inundation Elevation Reduction = 2.8 feet

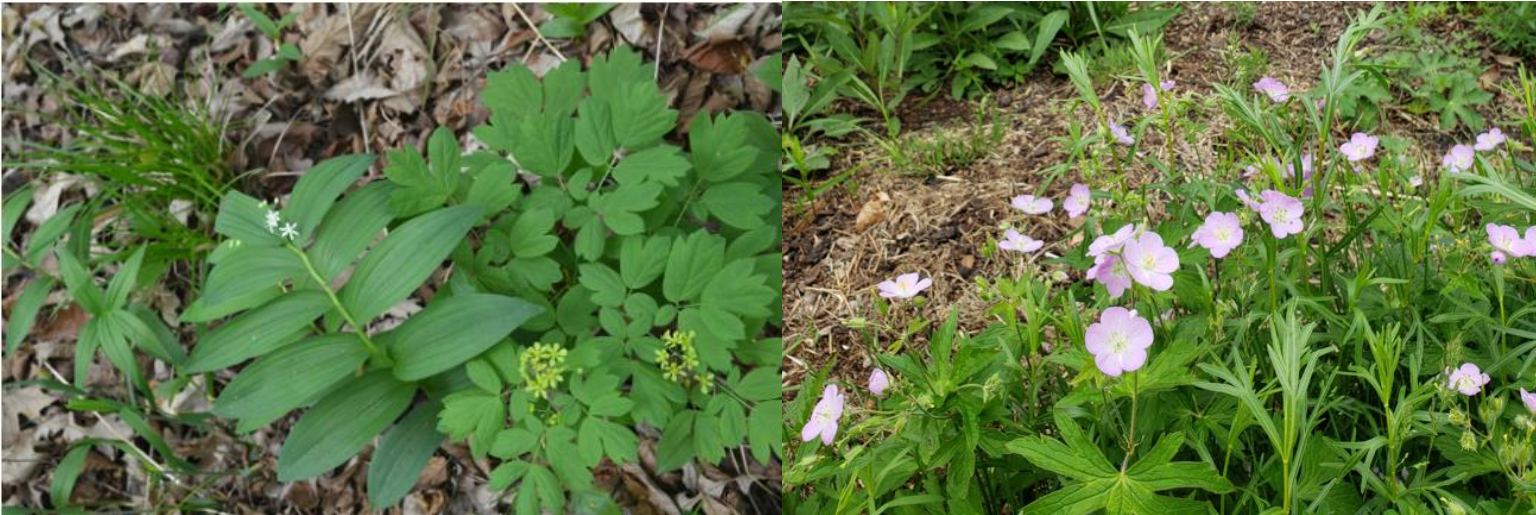
### WOODLAND SEED MIX

Blue cohosh	Caulophyllum thalictroides
Wild geranium	Geranium maculatum
Elm-leaved goldenrod	Solidago ulmifolia
Virginia wild rye	Elymus virginicus
Bottlebrush grass	Hystrix patula
Common wood sedge	Carex blanda

Blue cohosh and Solomon's plume (L); Wild geranium (R)

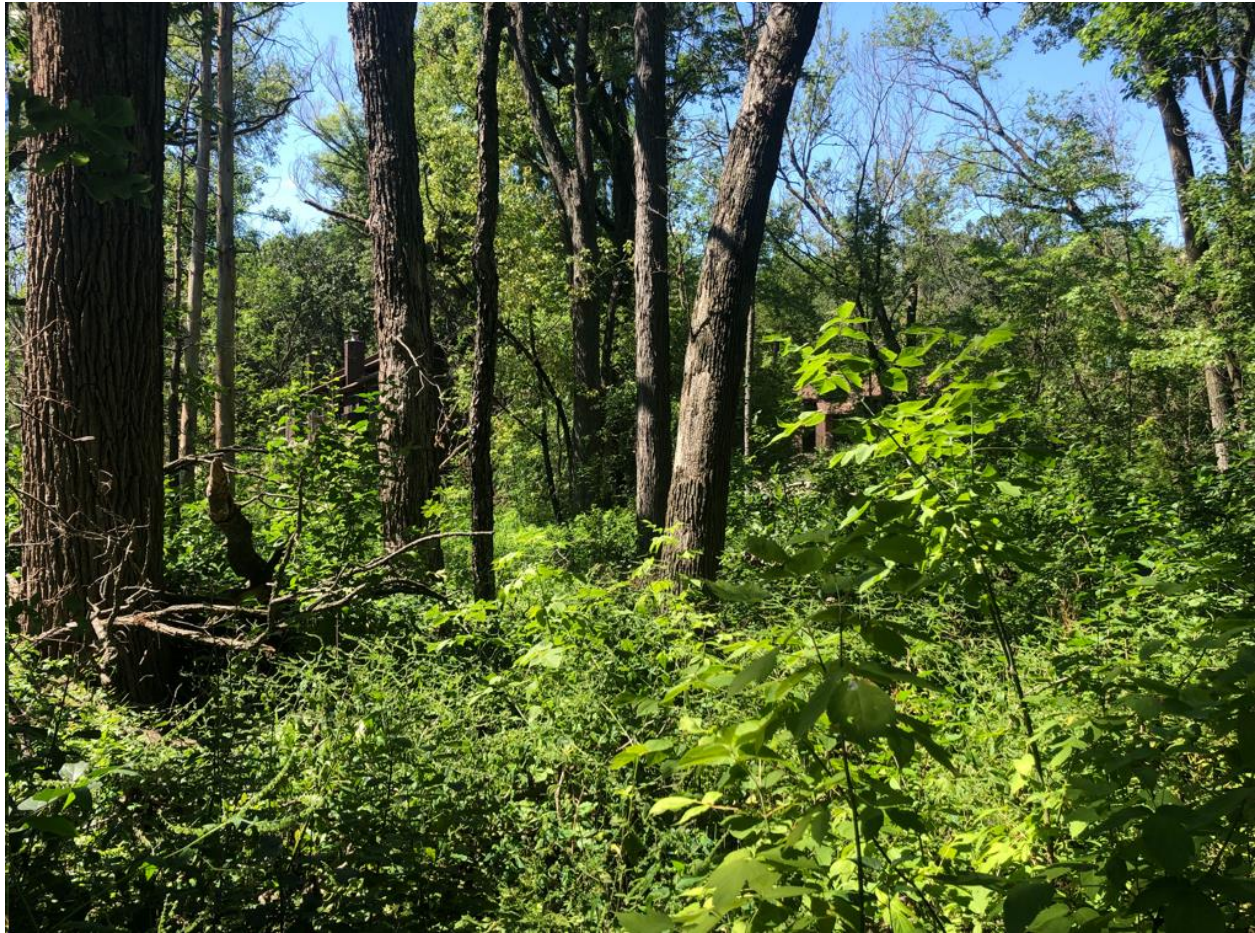
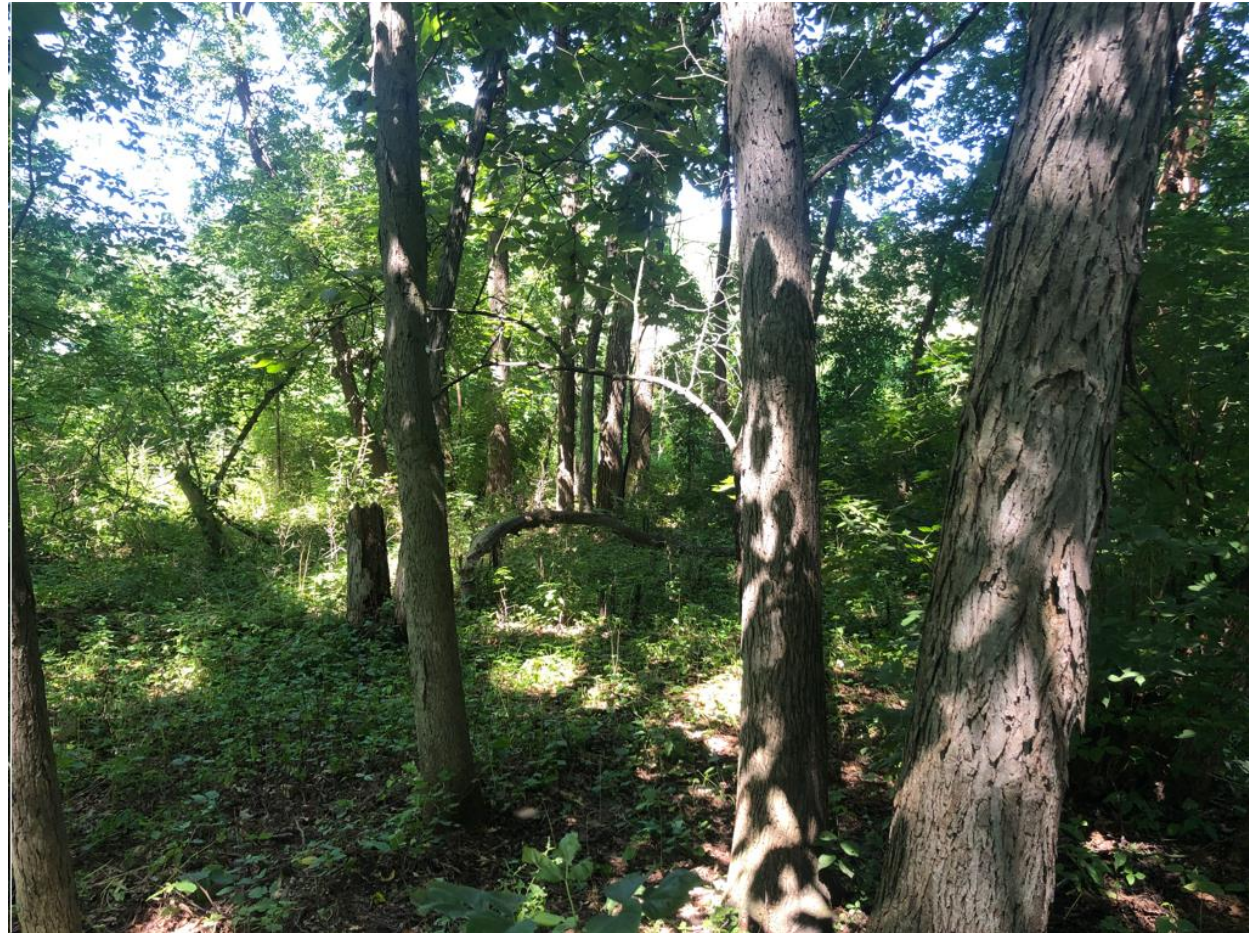
# Current Vegetation

Woody volunteers: ash, buckthorn, box elder, honeysuckle. Little to no oak regeneration. Low herbaceous veg. diversity: Virginia stickseed, Virginia creeper, burdock, curly dock, jewelweed, garlic mustard.

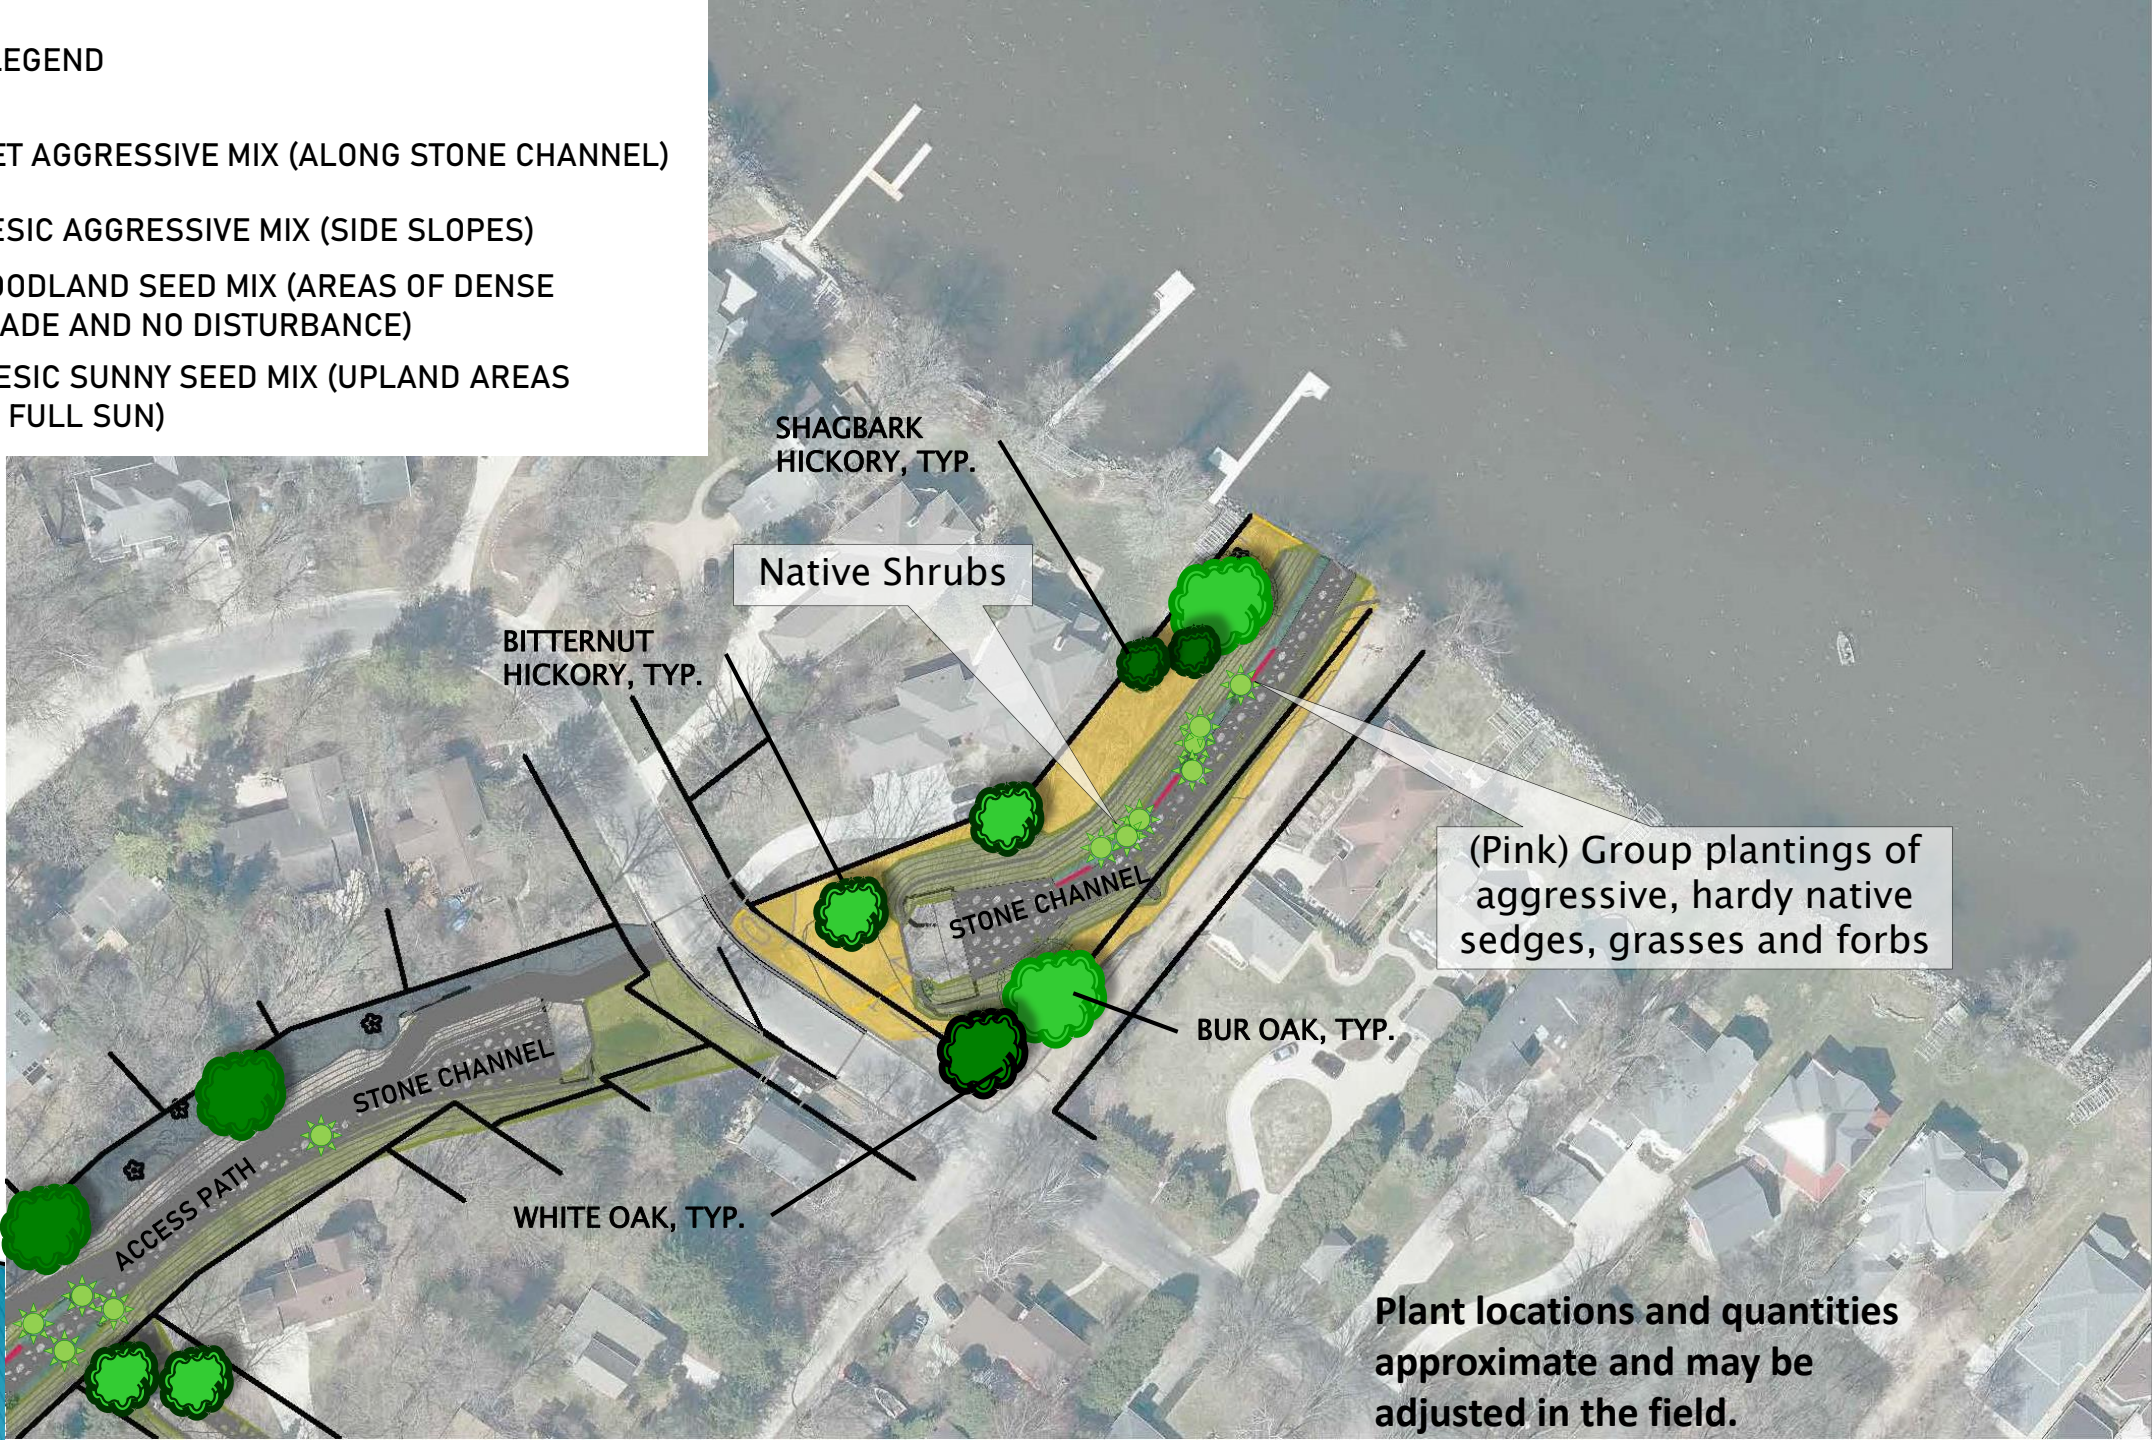
SEED MIX LEGEND

- WET AGGRESSIVE MIX (ALONG STONE CHANNEL)
- MESIC AGGRESSIVE MIX (SIDE SLOPES)
- WOODLAND SEED MIX (AREAS OF DENSE SHADE AND NO DISTURBANCE)
- MESIC SUNNY SEED MIX (UPLAND AREAS IN FULL SUN)

Plant locations and quantities approximate and may be adjusted in the field.

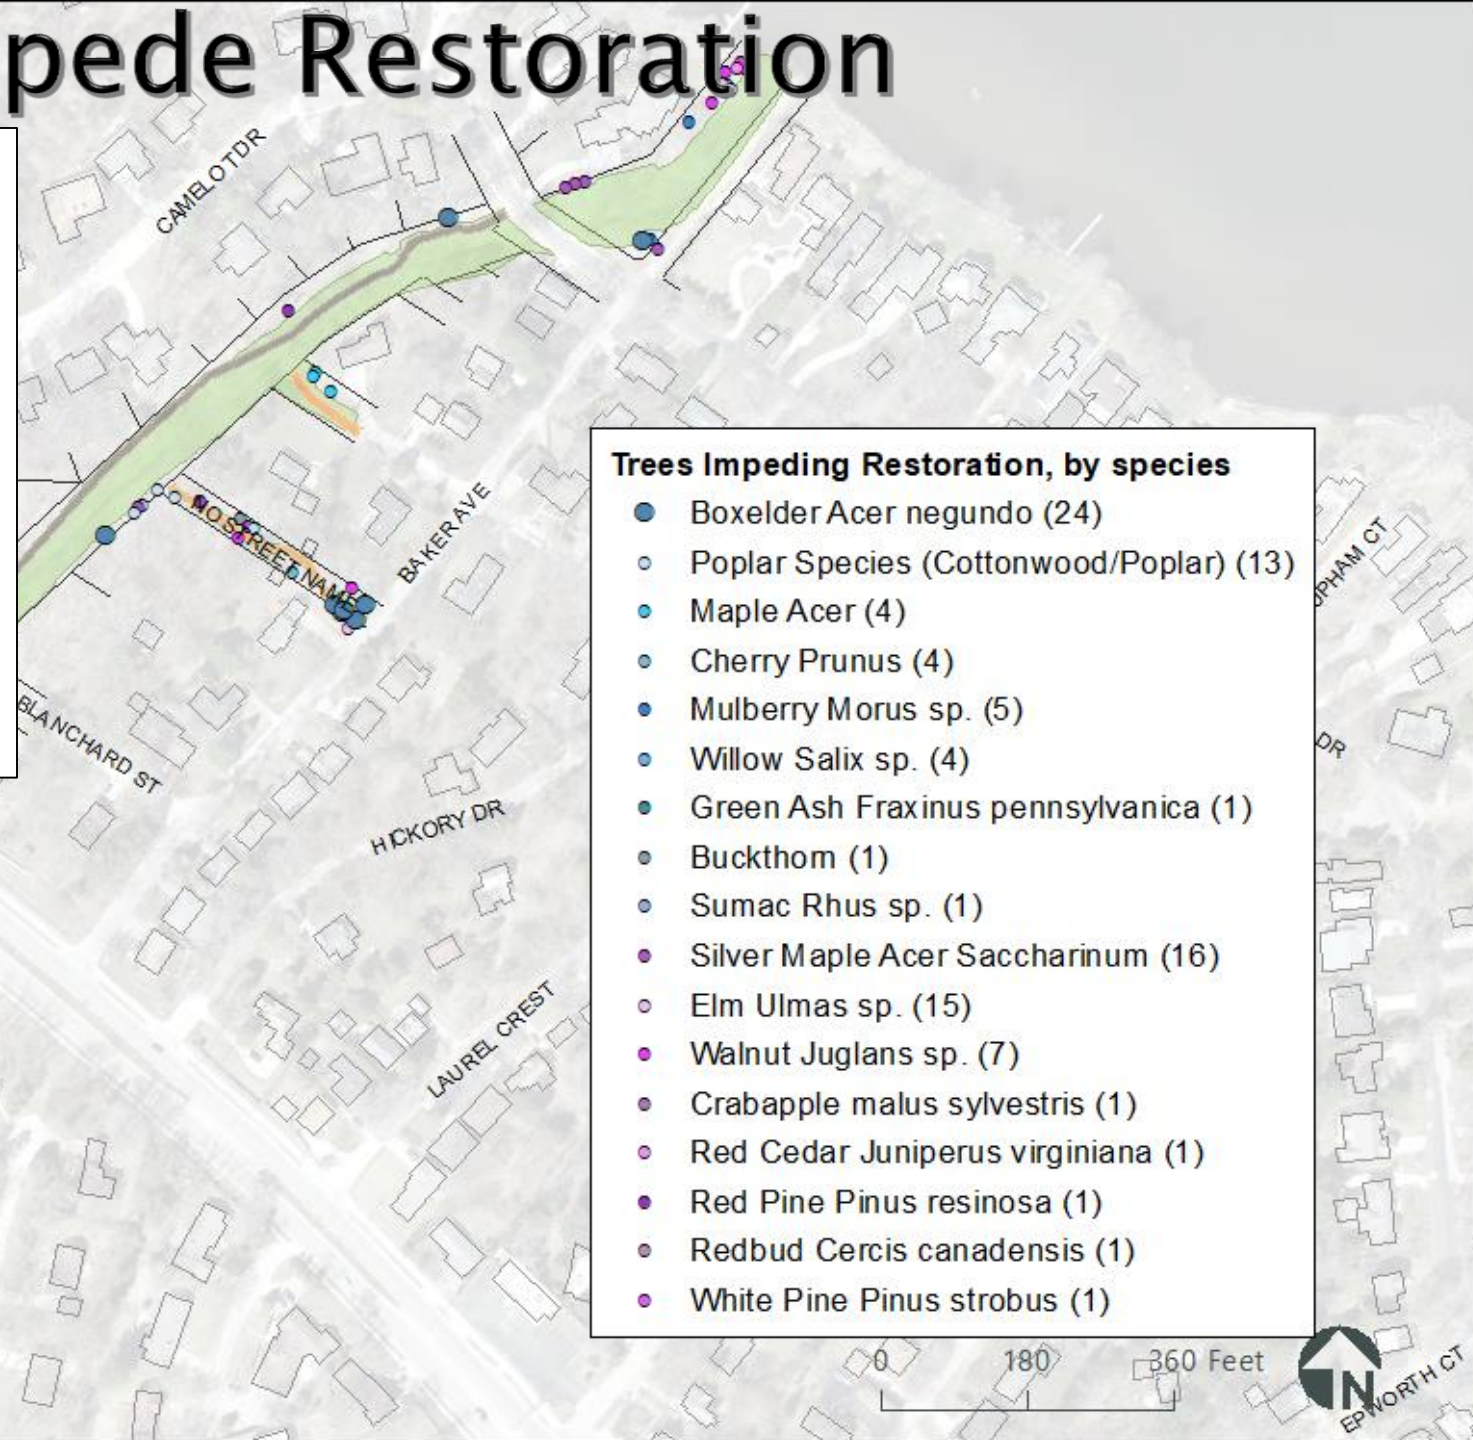
SEED MIX LEGEND

- WET AGGRESSIVE MIX (ALONG STONE CHANNEL)
- MESIC AGGRESSIVE MIX (SIDE SLOPES)
- WOODLAND SEED MIX (AREAS OF DENSE SHADE AND NO DISTURBANCE)
- MESIC SUNNY SEED MIX (UPLAND AREAS IN FULL SUN)
