Sauk Creek Corridor Plan

DRAFT PRELIMINARY CORRIDOR PLAN - MEETING #3

CITY OF MADISON

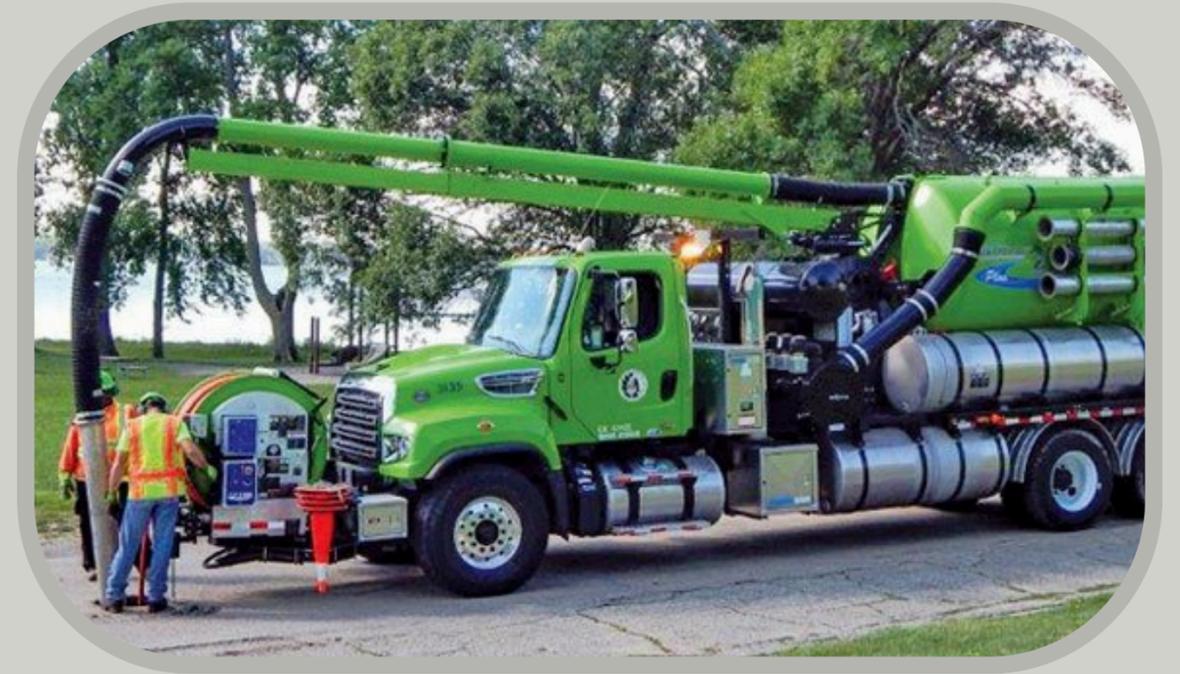
City will be using standard vactor moving forward

Vactor truck has scheduled maintenance **THIS FALL** to clean the sanitary sewer, and will be followed with a truck that can televise the pipes to assess their condition

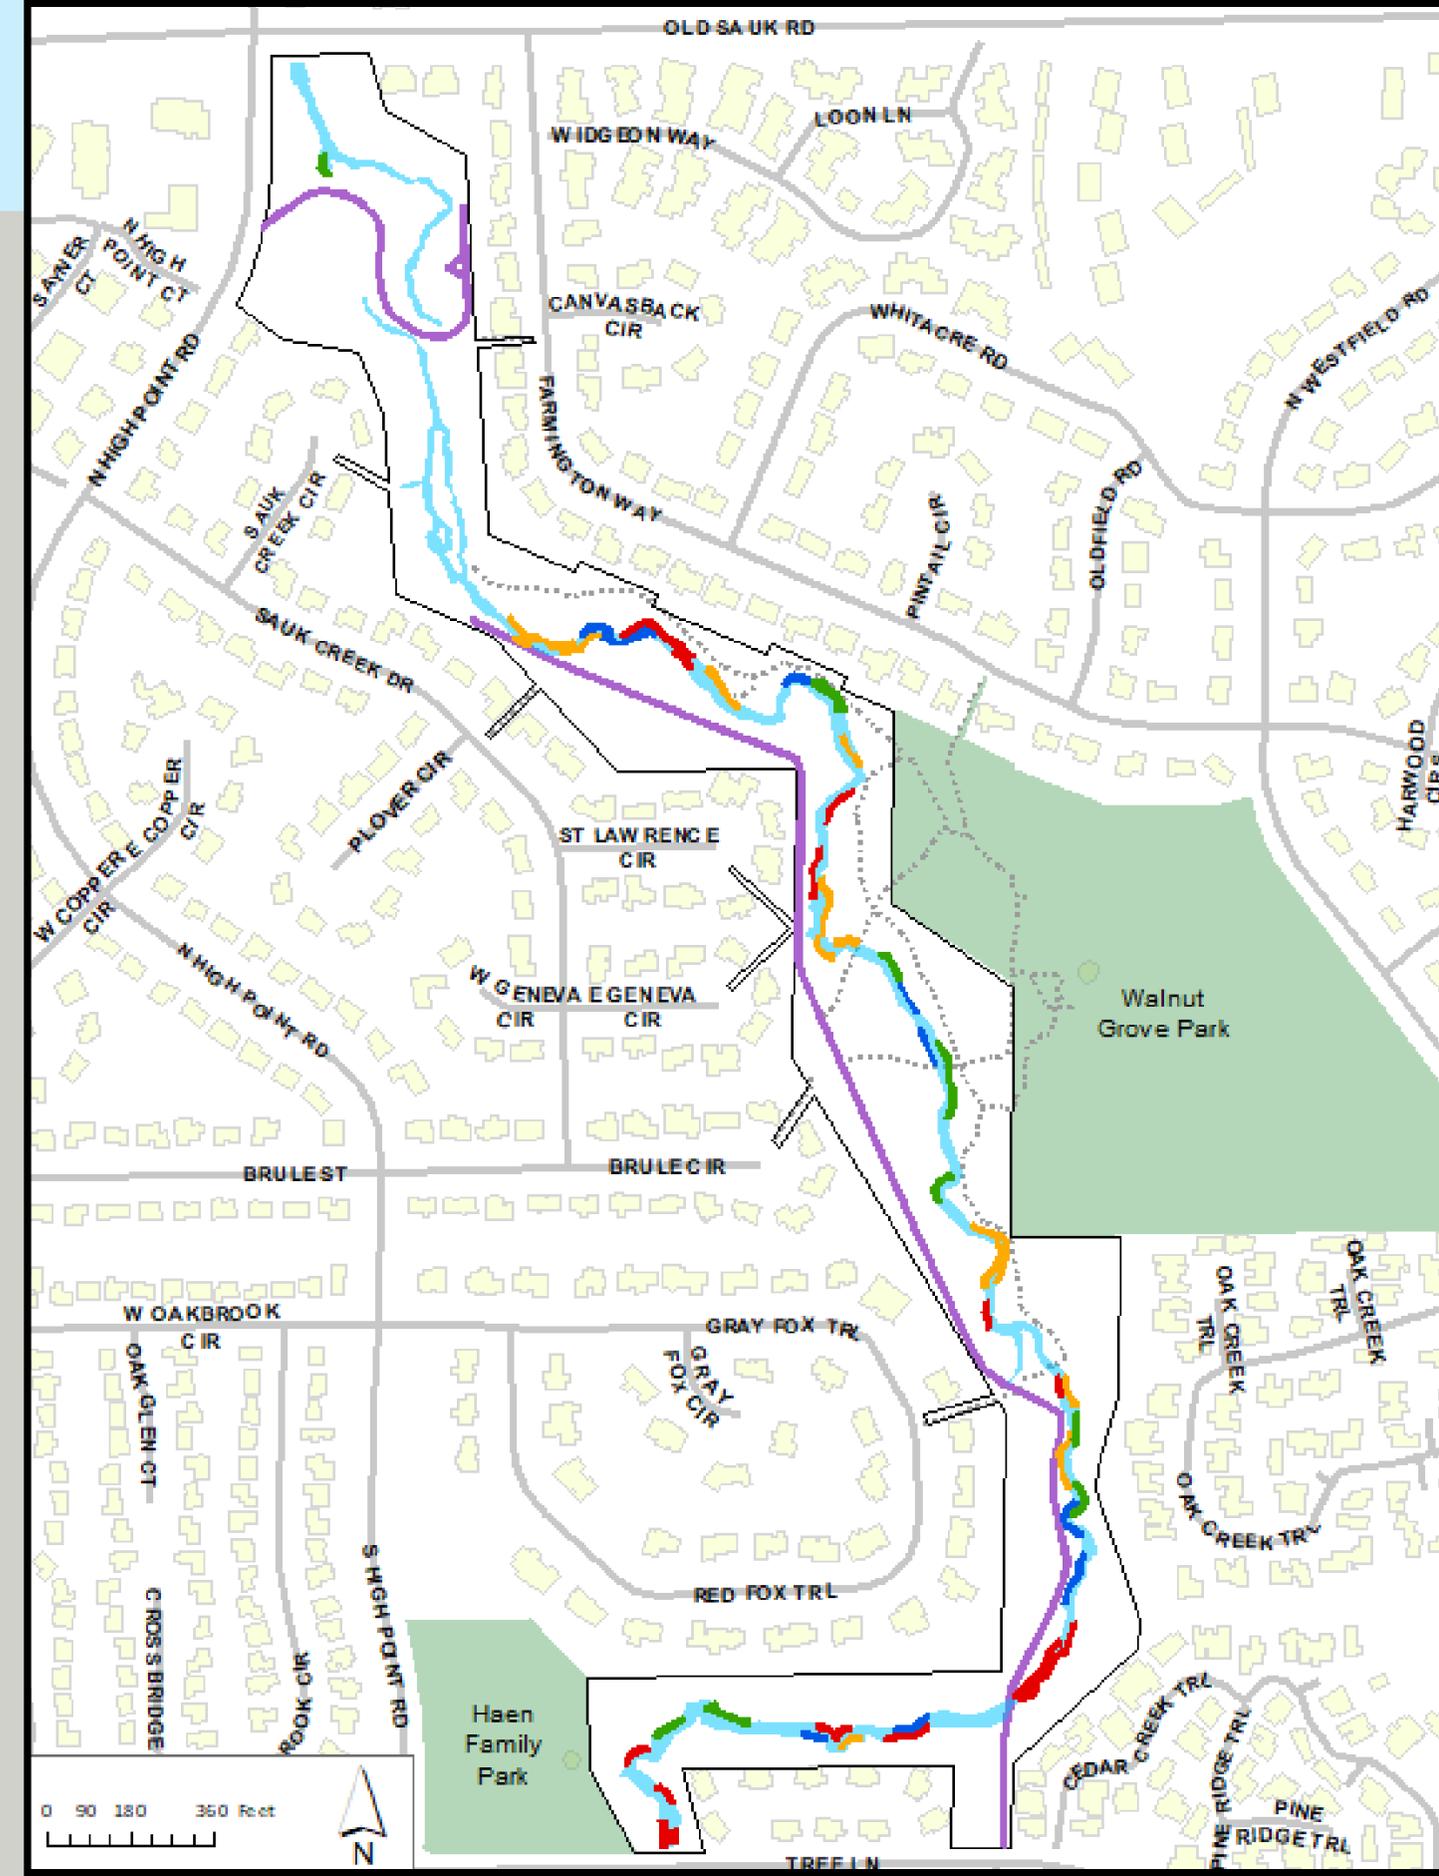
Review of existing bank condition

Bank Condition Analysis is

>4' Tall vertical and undercut banks

3-4' tall vertical and undercut banks

>4' tall banks, 2:1 or steeper

3-4' banks, 2:1 or steeper

Generally, more susceptible to erosion

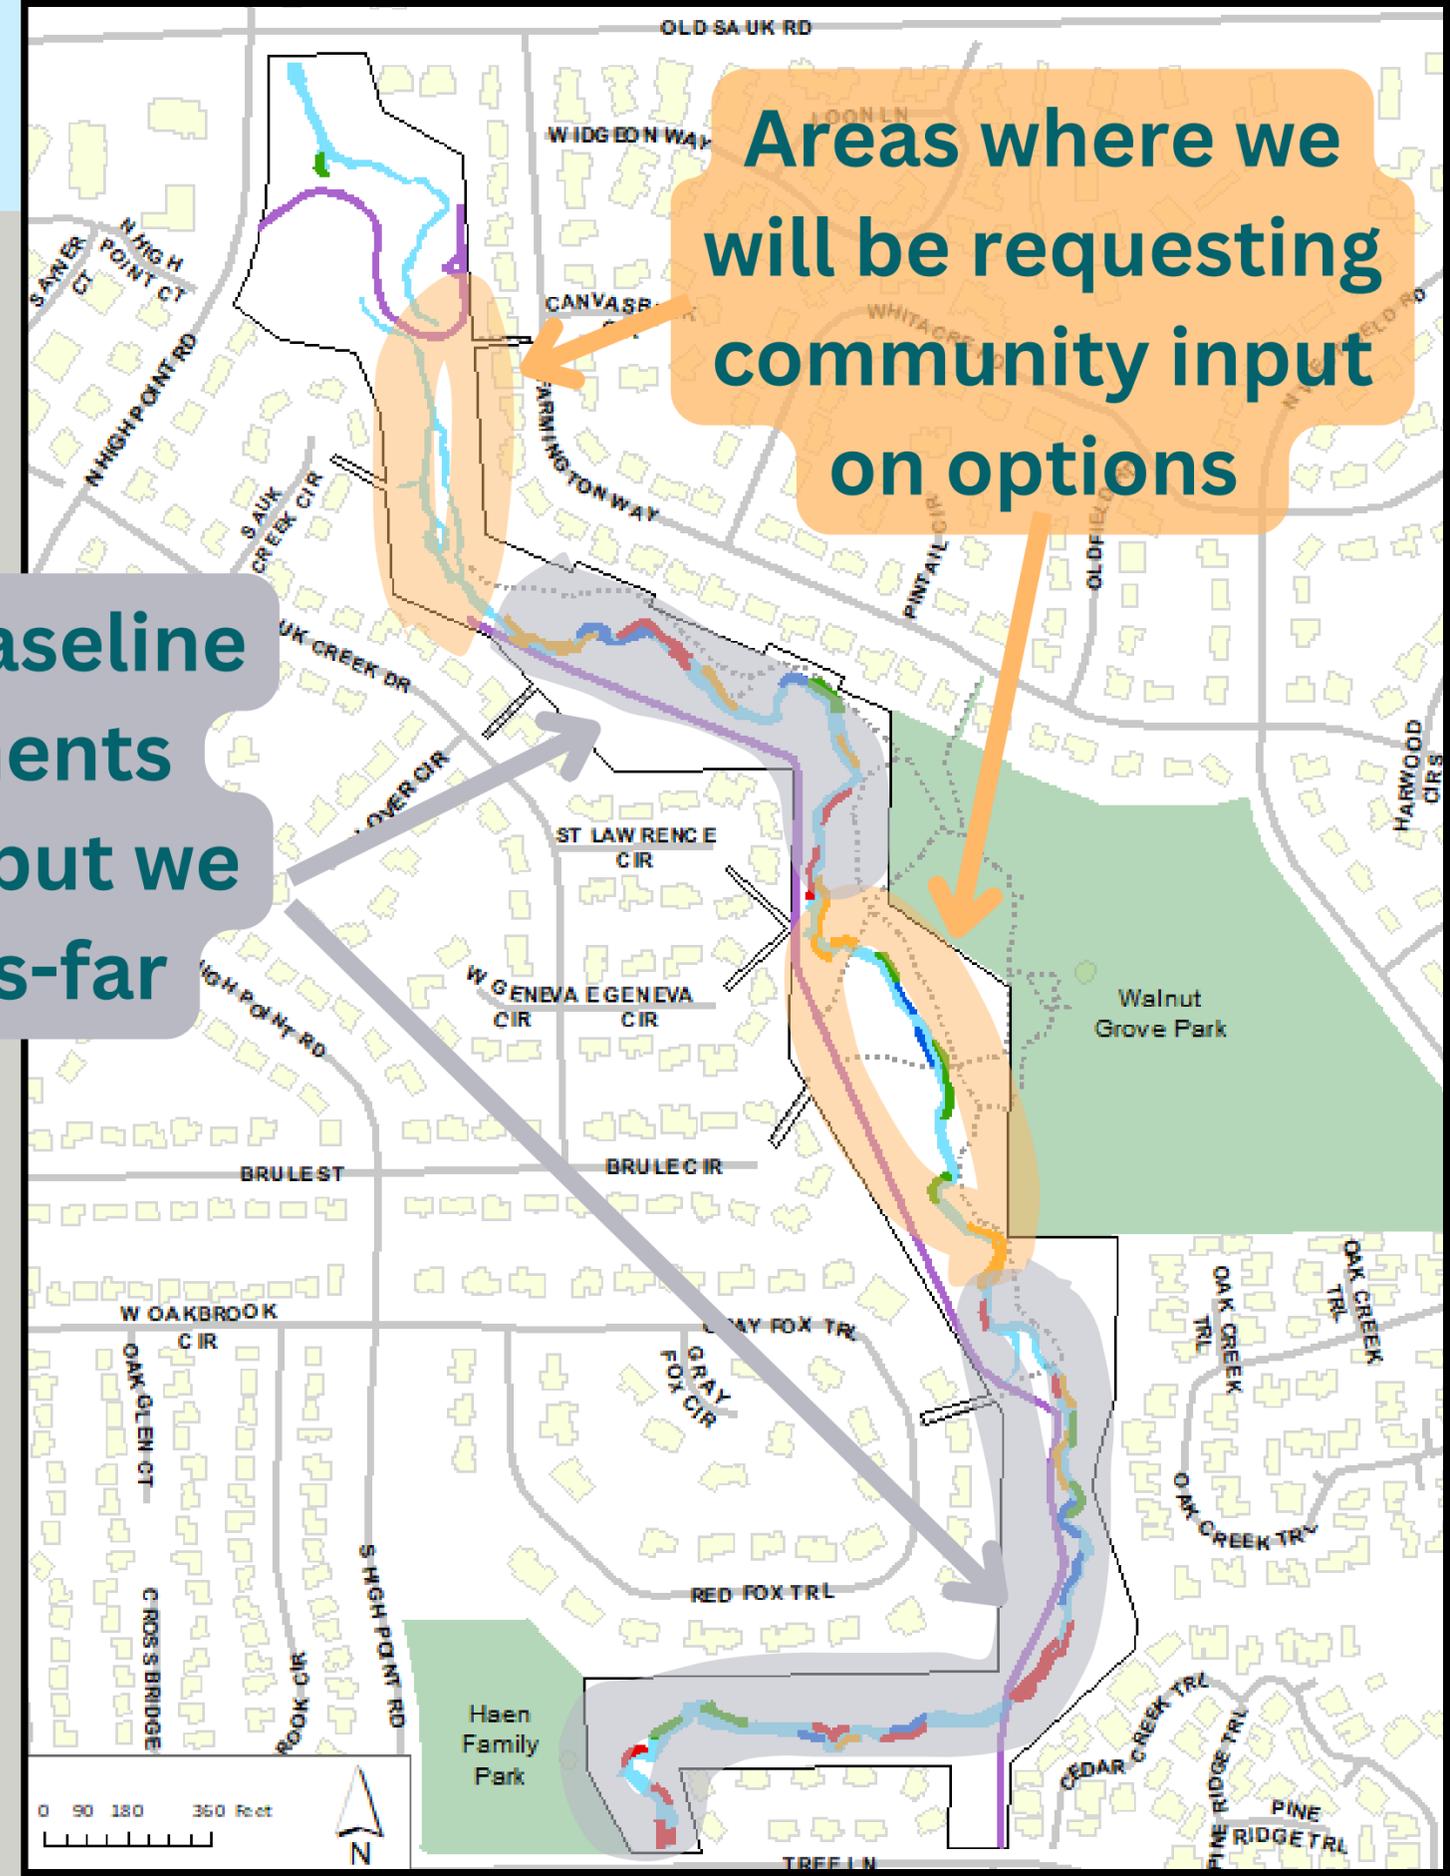
Stormwater Improvements Proposal

Over the next few slides the City will share parts of the stormwater improvements we are recommending as baseline improvements, and asking for input on specific areas

Areas where we will be requesting community input on options

Proposed baseline improvements based on input we heard thus-far

Minimum riprap bank protection recommended by City shown in black

Includes highest risk banks (red/orange category) as well as:

- Banks next to critical infrastructure
- Banks at risk of eroding (green/blue) that are adjacent to the above banks
- Connections between banks to limit the riprap/bare bank interface

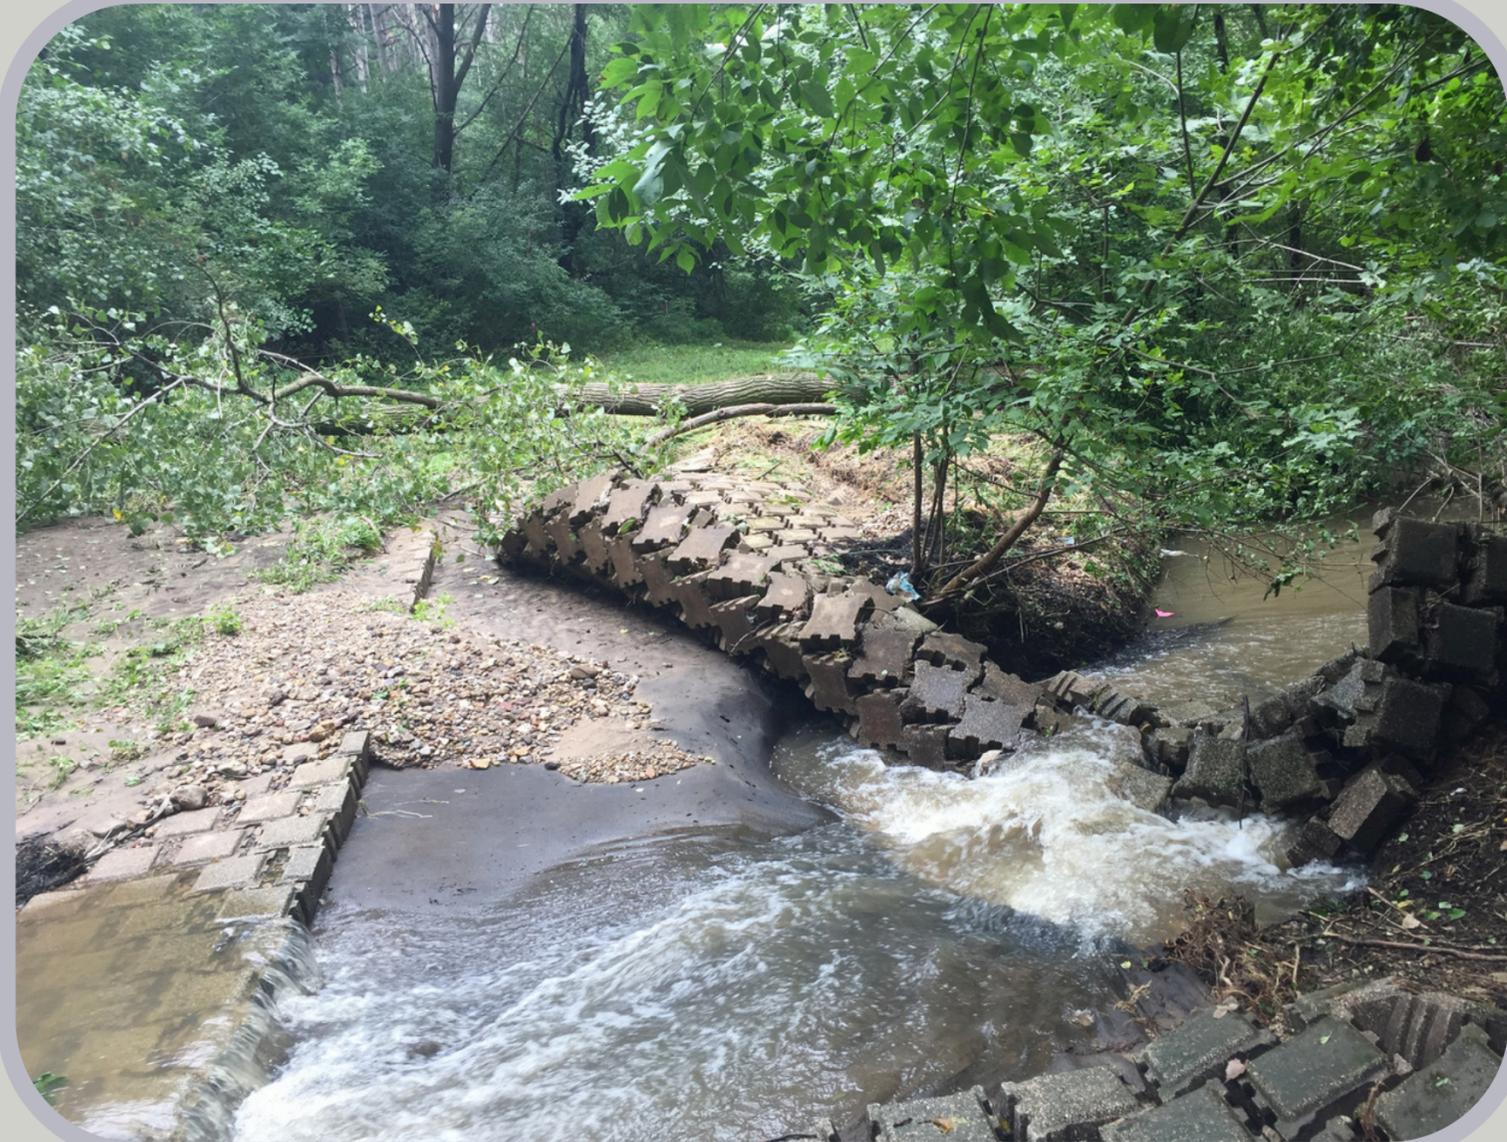
At Sanitary Access Path near Tree Lane and Randolph. Re-damaged in 2018.

- Existing crossing at Tree Lane and Randolph -
- Broken crossing does not allow for quick-response during emergencies
 - City wants to improve this crossing with a culvert so it is accessible in wet or dry conditions

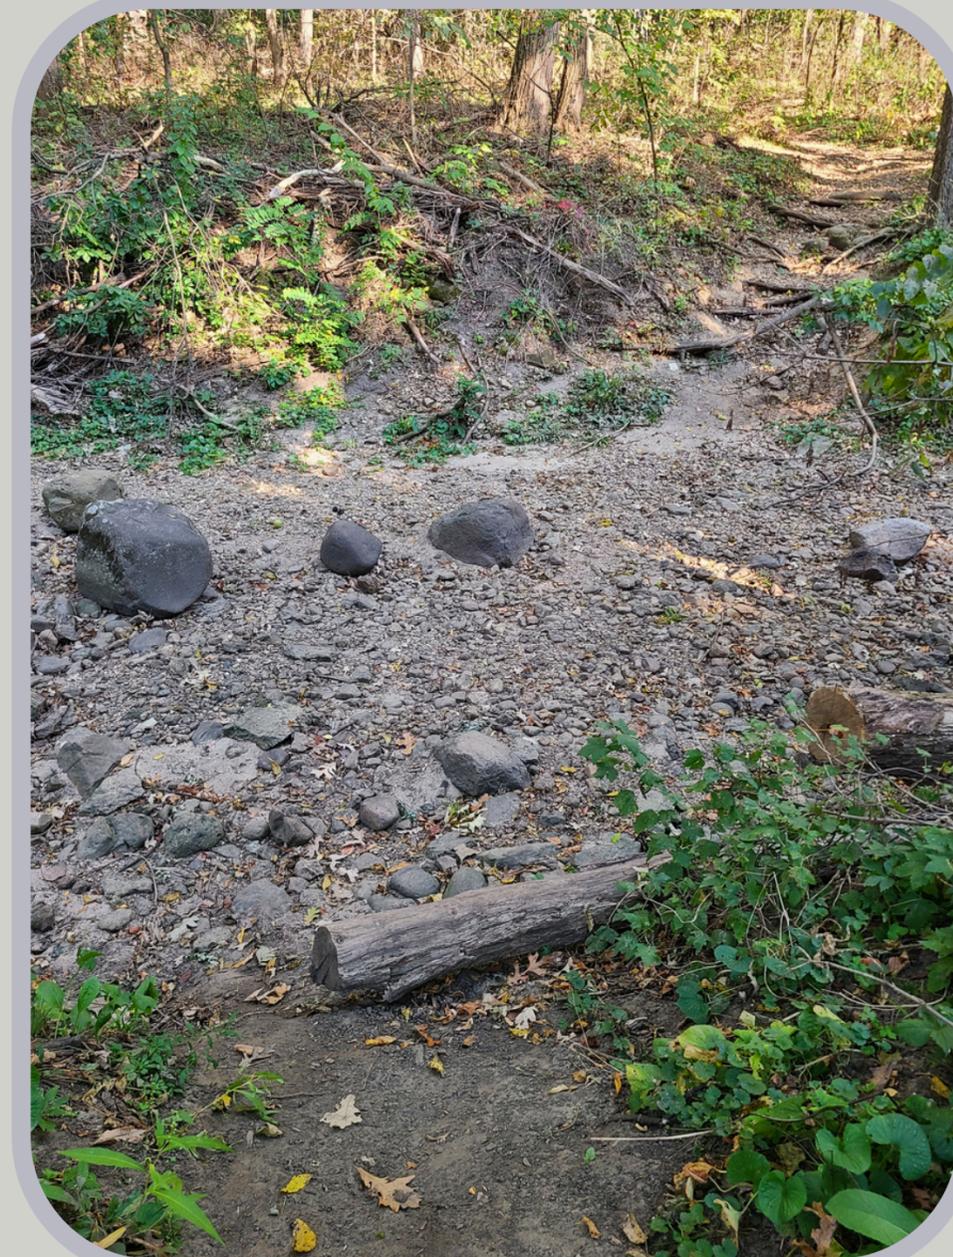
Unofficial walking path crossing channel

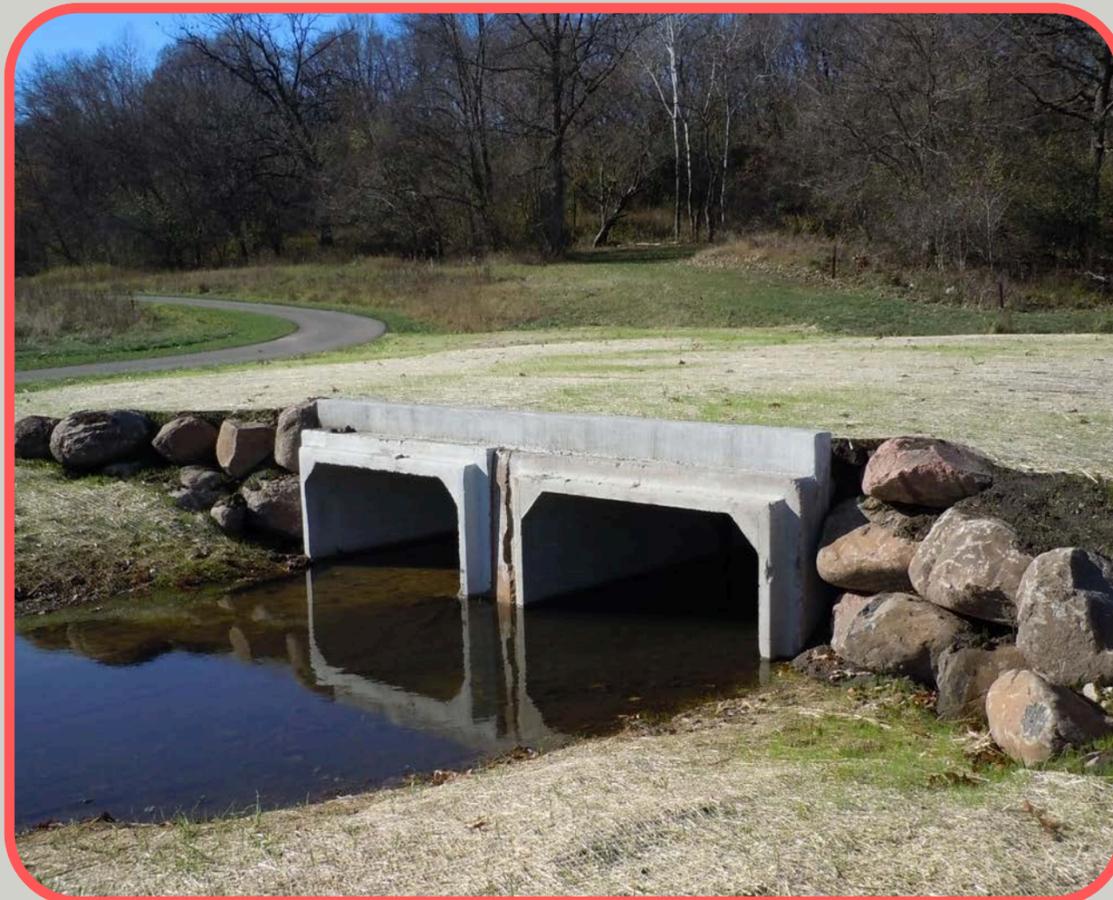
Sanitary access path improved crossing Culverts will help tractor more safely cross the channel

note: material over top of culvert will be concrete for stability

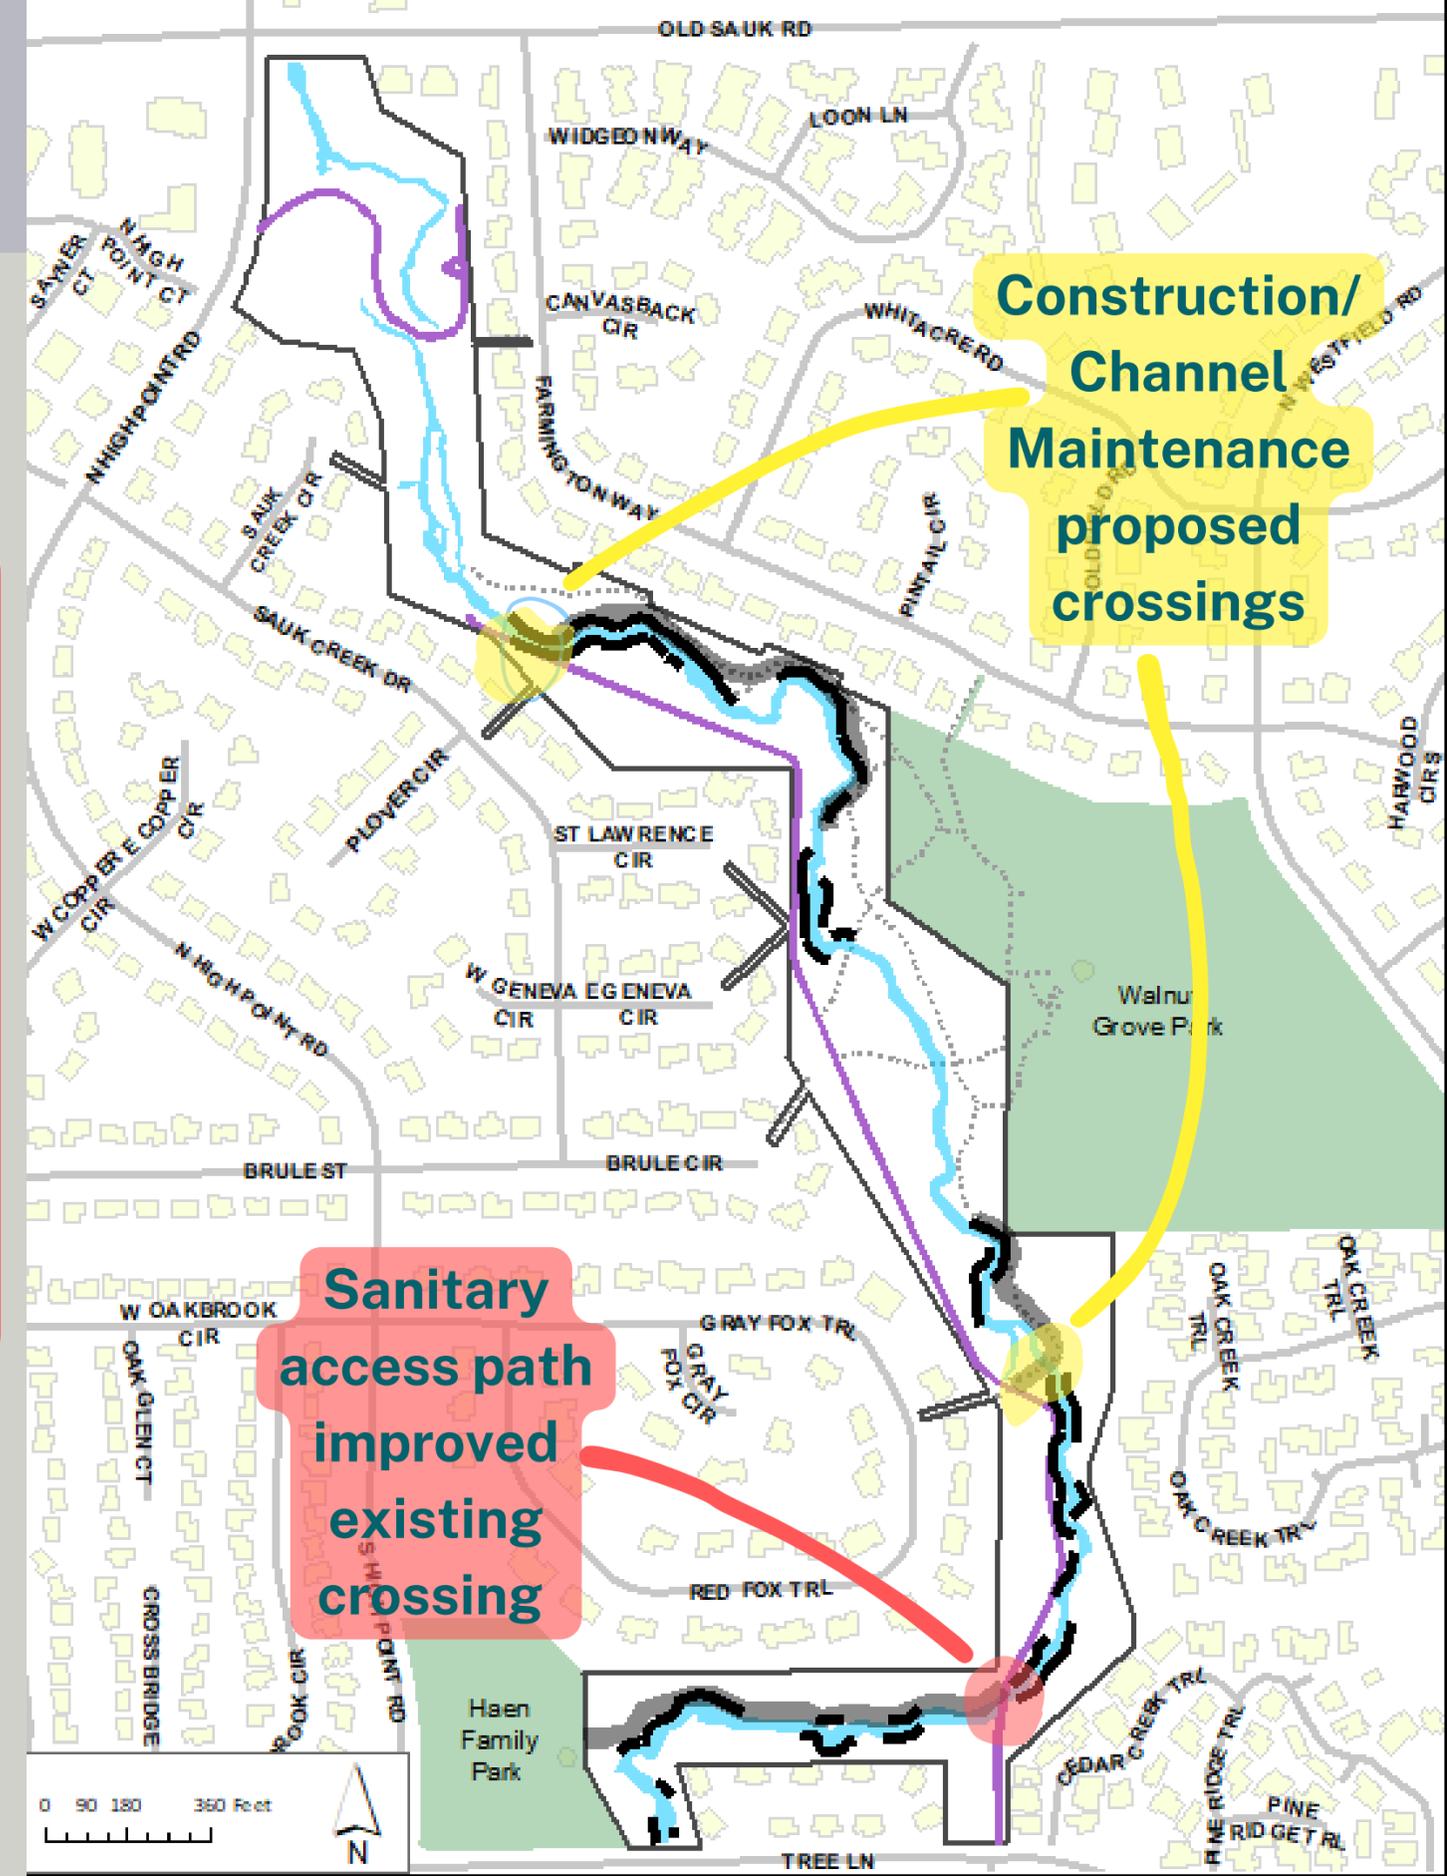
Construction Access

- To minimize tree impacts, existing sanitary access from Tree Lane to Plover Circle will be main spine for future construction access when channel repairs are completed
- Moving forward, repairs of sanitary access path will be completed with gravel

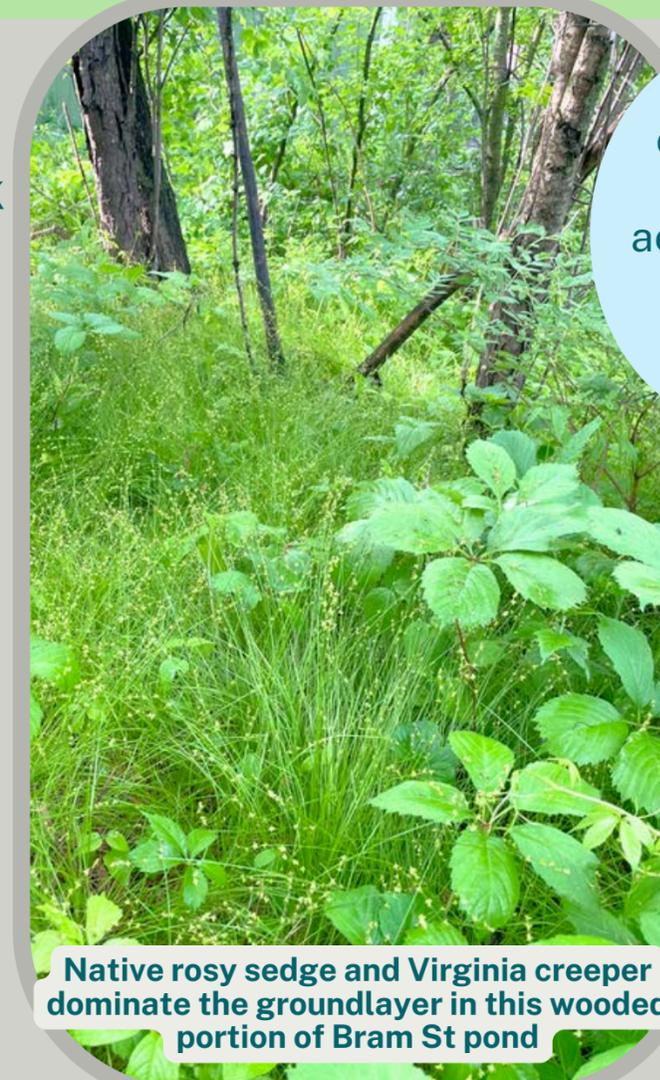
Native rosy sedge and Virginia creeper dominate the groundlayer in this wooded portion of Bram St pond

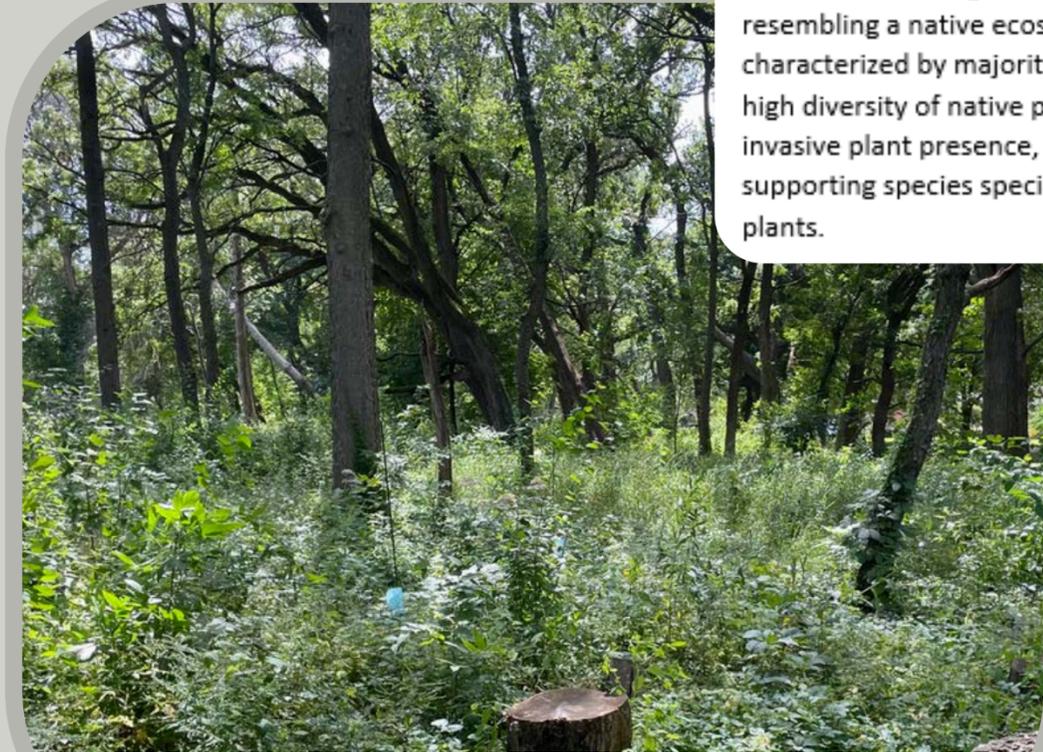
Tier 1 sites are dominated by native species including the canopy layer (for wooded sites), and a diverse assemblage of herbaceous species. Blue tree tube shelters a planted hickory sapling.

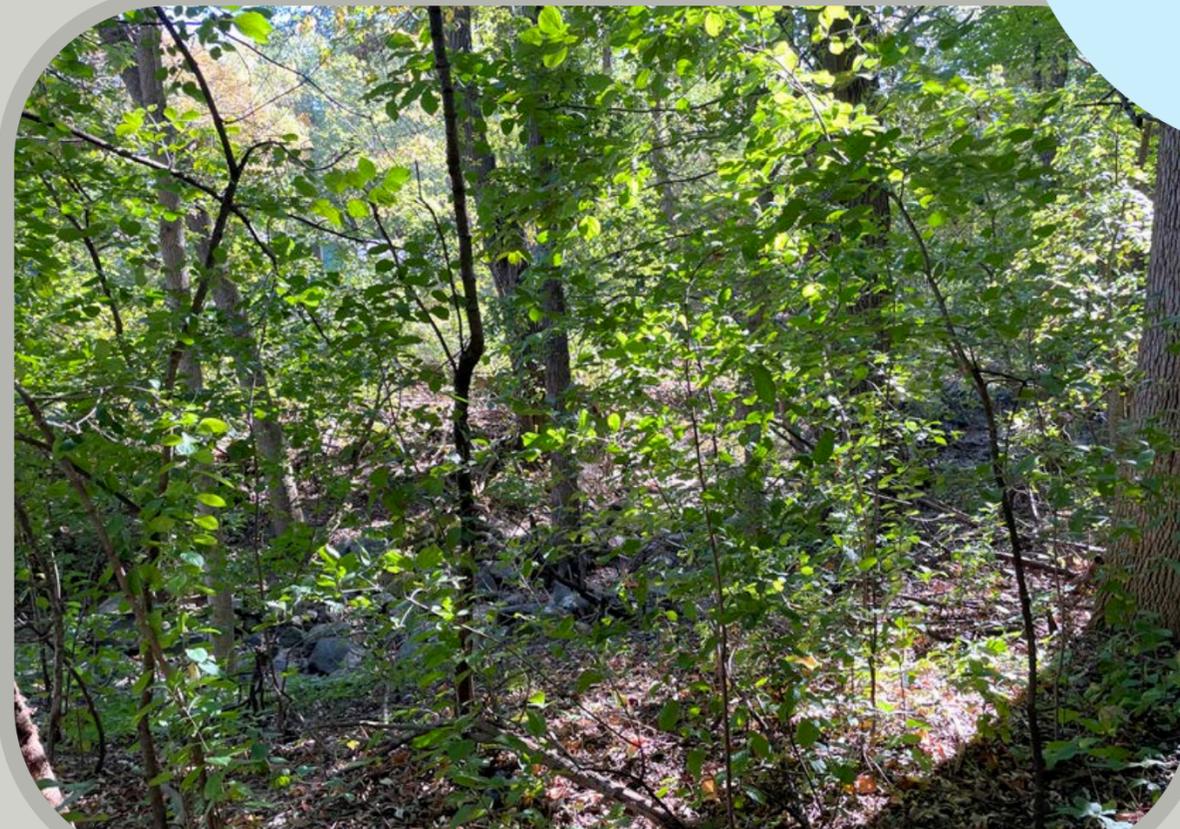
Common buckthorn in a wooded greenway. The Ecological Assessment makes a connection between invasive trees/shrubs and a lack of biodiversity.

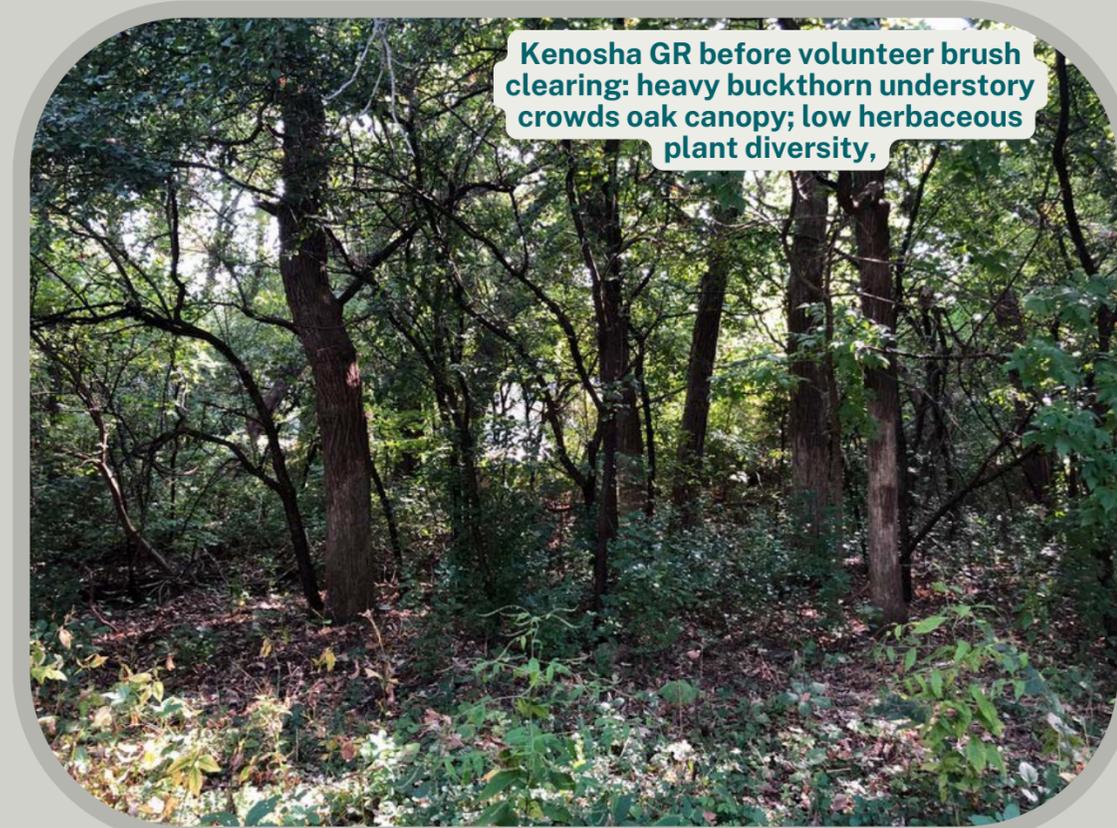
Kenosha GR before volunteer brush clearing: heavy buckthorn understory crowds oak canopy; low herbaceous plant diversity,

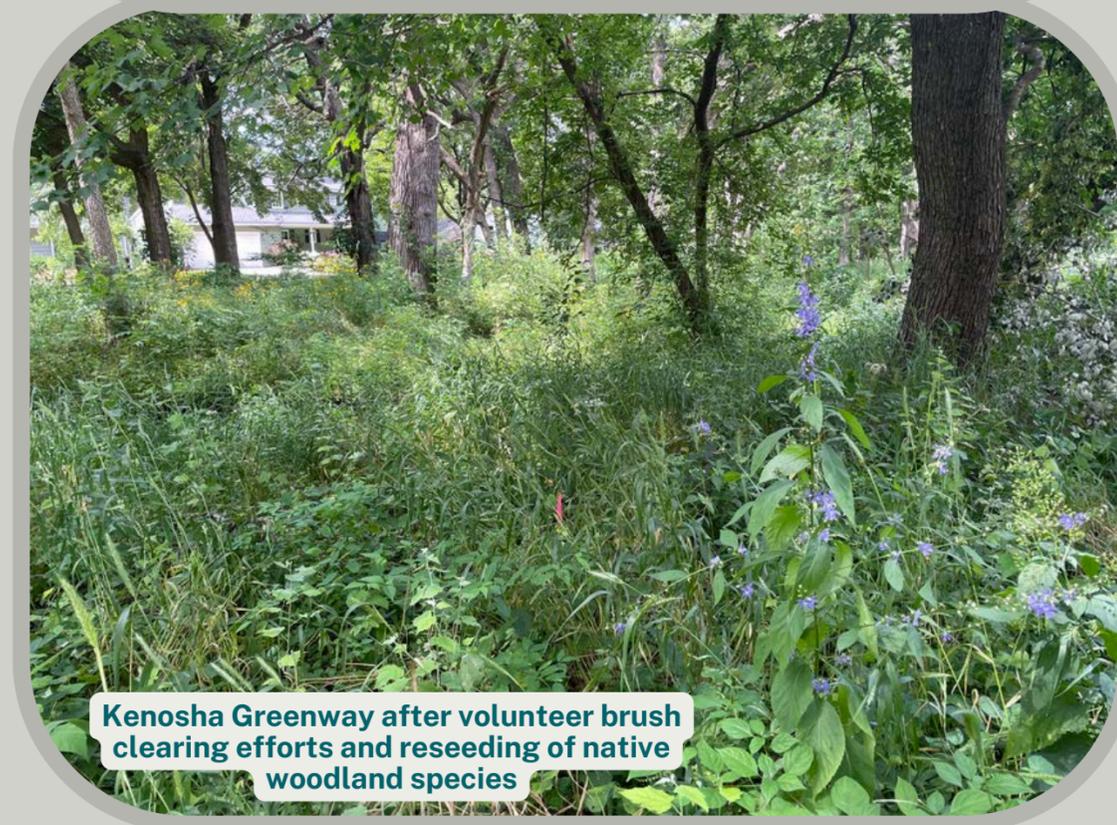
Kenosha Greenway after volunteer brush clearing efforts and reseeding of native woodland species

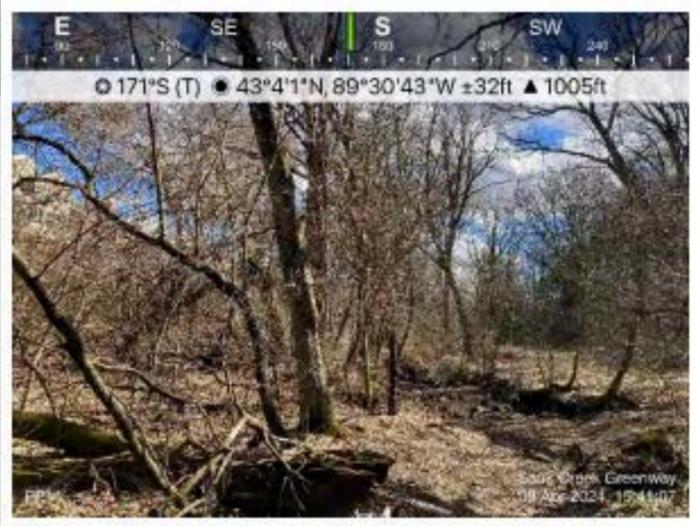
Photo #19 Photo point 11, view south of degraded woodland and Sauk Creek

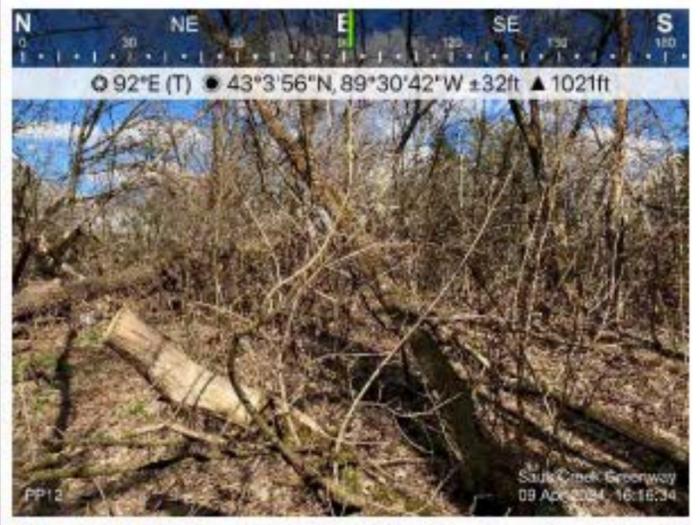
Photo #21 Photo point 12, view east in Area 5 of degraded understory and channel erosion

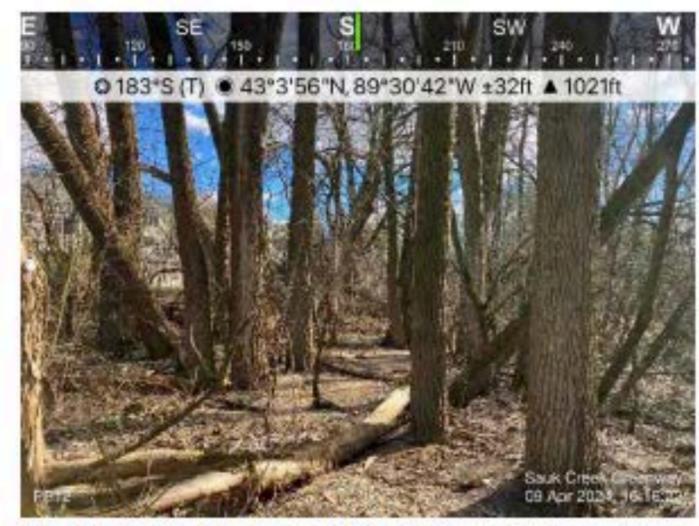
Photo #20 Photo point 12, view south in Area 5 dominated by cottonwood with sediment on ground surface

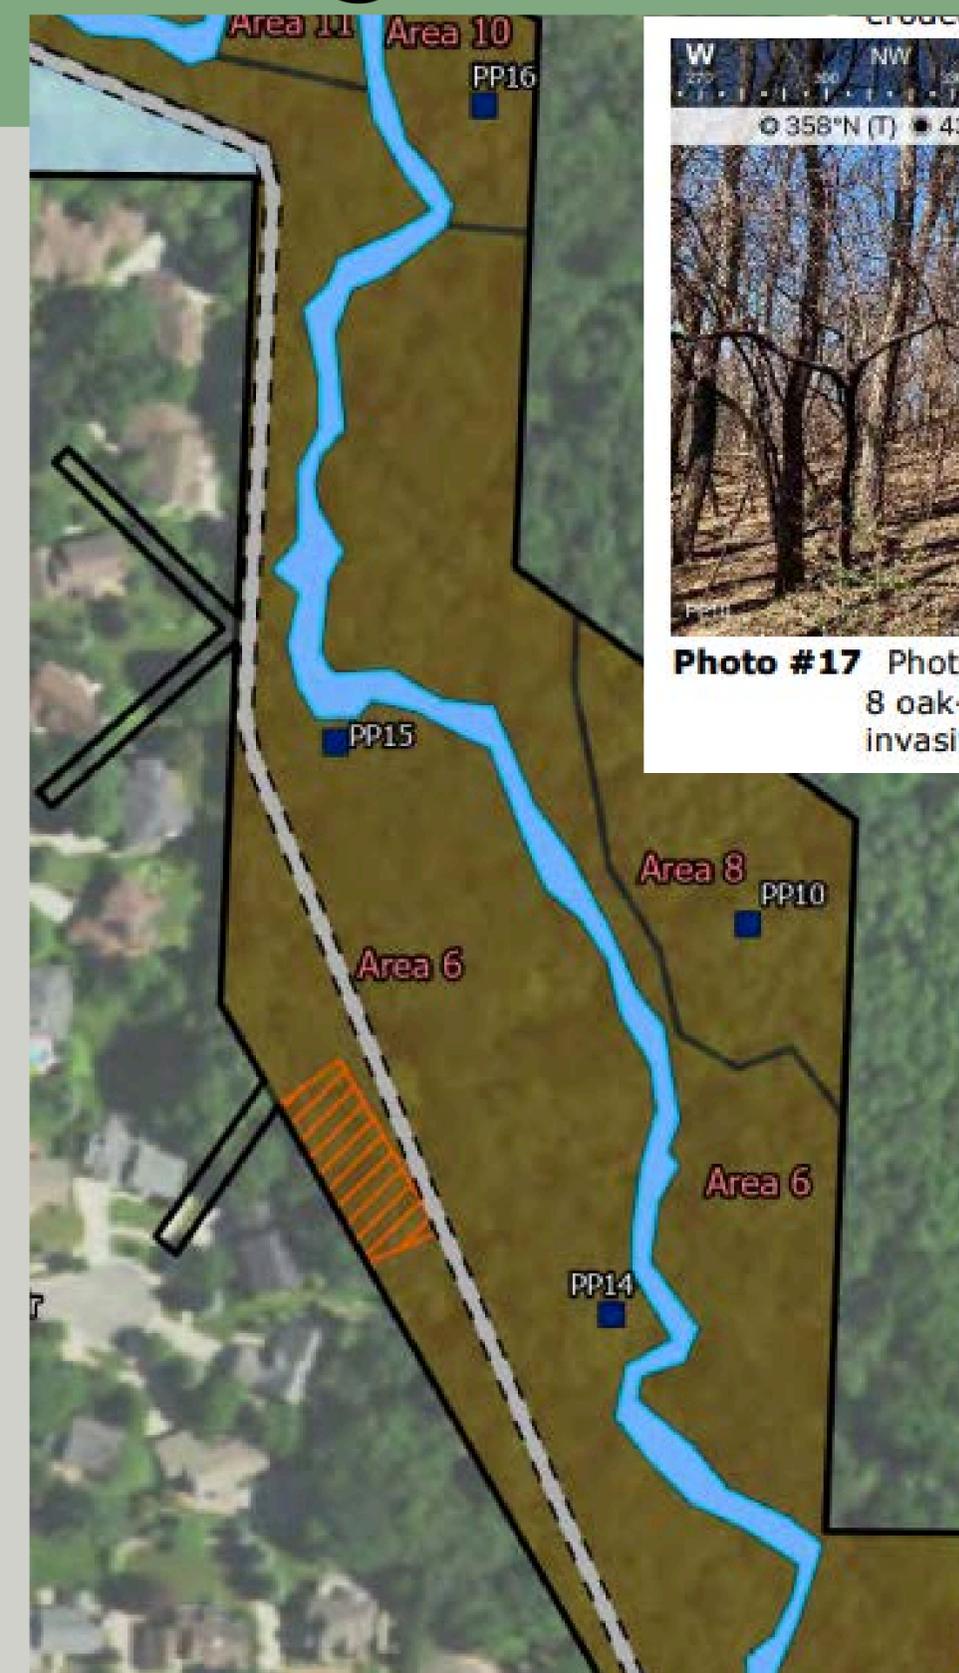
Photo #17 Photo point 10, view north in Area 8 oak-hickory forest dominated by invasive

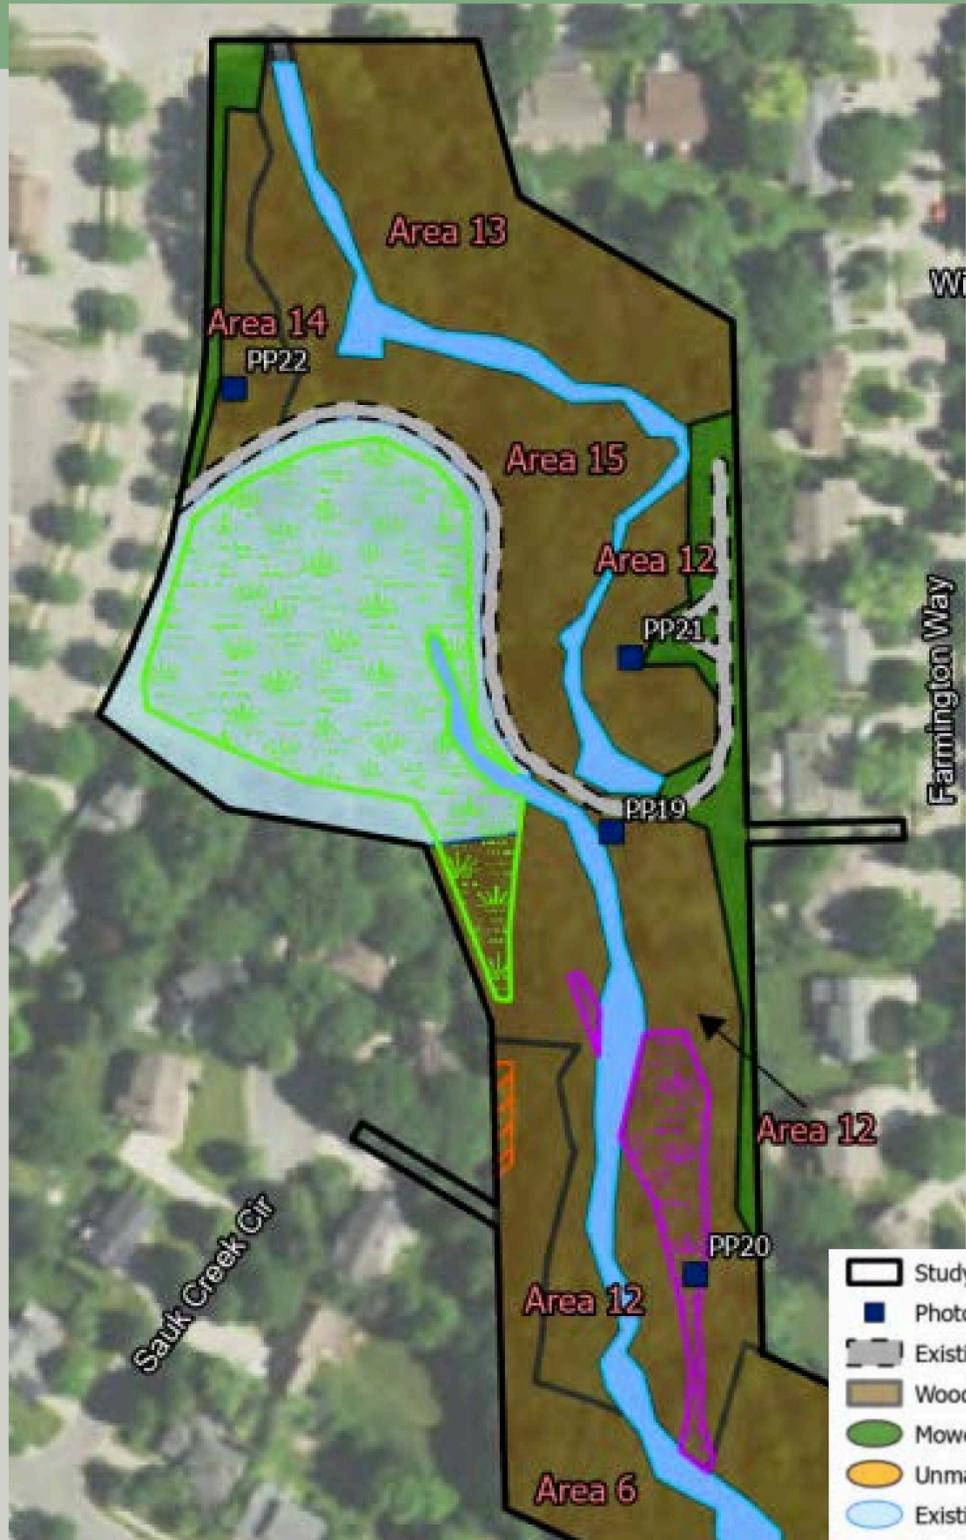
Photo #33 Photo point 20, view west in Area 12 of sediment on ground surface

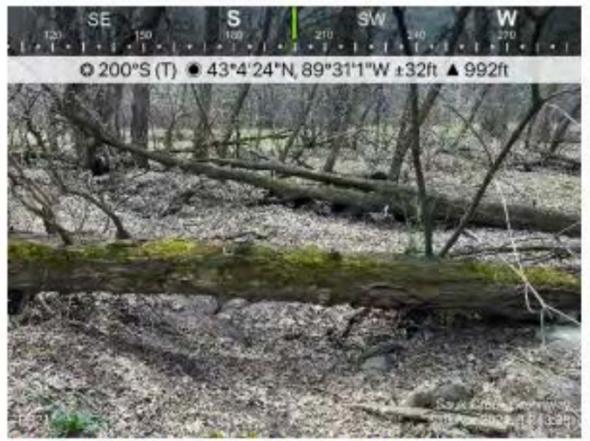
Photo #36 Photo point 21, view south in Area 12 with soil erosion and tree damage

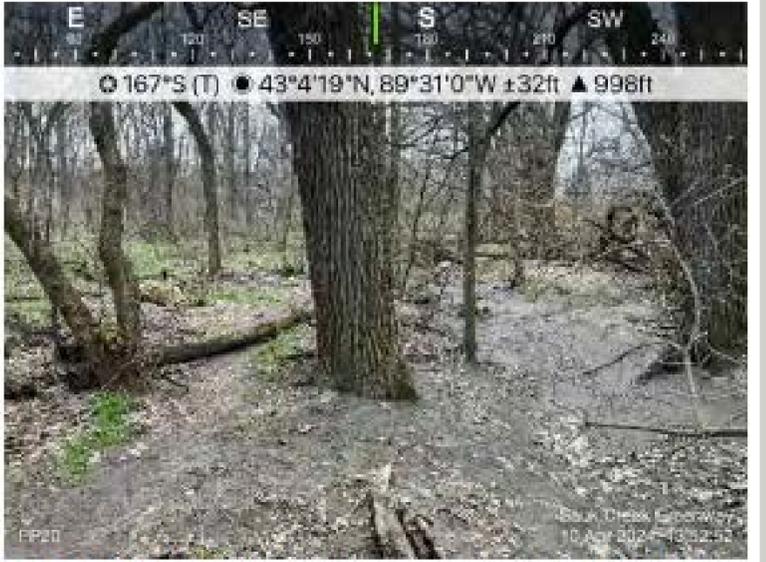
Photo #32 Photo point 20, view south in Area 12 of secondary channel and sediment around oak trees

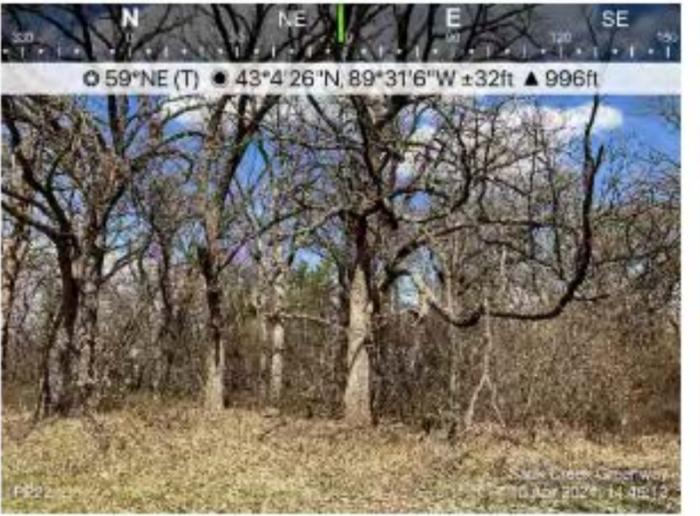
Photo #38 Photo point 22, view northeast of Area 14 with Area 15 degraded oak woodland in background
