## ANNIE C. STEWART MEMORIAL FOUNTAIN ASSESSMENT REPORT AND RECOMMENDATIONS

<b>Date of Work:</b>	May 2022	<b>Project Name and Location:</b>	Annie C. Stewart Memorial Fountain Madison, WI
<b>Date of Report:</b>	June 22, 2023 (draft) Jamie Morris	<b>Owner/Client:</b>	City of Madison
<b>Reported by:</b>	Andrzej Dajnowski		
<b>Artist/Date:</b>	Frederick J. Clasgens, installed 1925		
<b>Dimensions:</b>	21' in diameter at perimeter wall		
<b>Project Goal:</b>	To perform conservation assessment and develop treatment options with estimated pricing.		
<b>Work Performed by:</b>	<b>Contact:</b> Karin Wolf, City of Madison William Fruhling, City of Madison		
	CSOS Neomek Incorporated Wiss, Janney, Elstner Associates

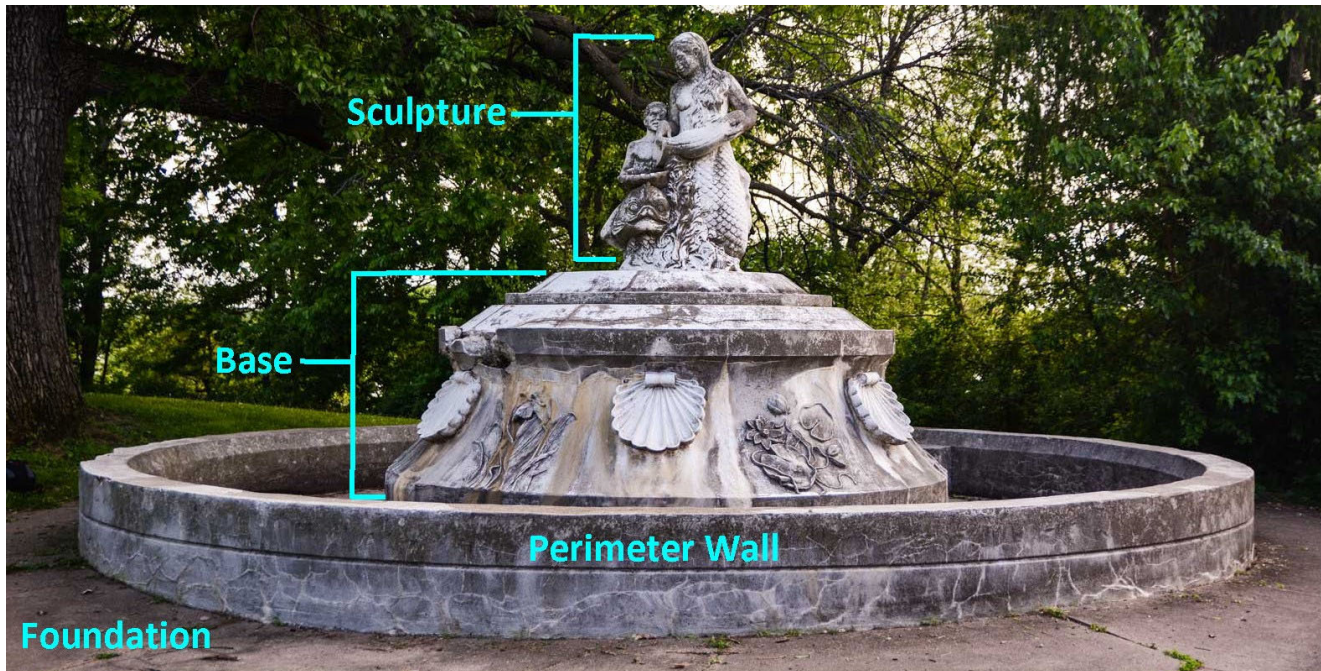
This image identifies the sections of the fountain as discussed in the matrix above

<b>Annie Stewart Memorial Fountain - Repair Matrix</b>			
	<b>Repair In Place</b>	<b>Relocate Indoors</b>	<b>Relocate Outdoors</b>
<b>Minimal Repairs</b>	Not, feasible, safety hazard	Remove marble, clean, simple base, install indoors  \$90k dismantle, transport marble \$10-15k cleaning \$25-35k new simple base No foundation if floor supports load \$50-70k reinstallation	Remove marble, clean, simple base, install outdoors  \$90k dismantle, transport marble \$10-15k cleaning \$25-35k new simple base \$15k new foundation \$50-70k reinstallation
		<b>Total: \$175-210k</b>	<b>Total: \$190-225k</b>
<b>Moderate Repairs</b>	Not, feasible, safety hazard	Remove marble, clean, <u>minimal recreations</u> , simple base, install indoors  \$90k dismantle, transport marble \$10-15k cleaning \$25-35k recreate marble loss \$25-35k new simple base No foundation if floor supports load \$50-70k reinstallation	Remove marble, clean, <u>minimal recreations</u> , <u>replicate stone base</u> , install outdoors  \$90k dismantle, transport marble \$10-15k cleaning \$25-35k recreate marble loss up to \$100k limestone base \$15-20k new foundation \$50-70k reinstallation

<b>Total: \$200-245k</b>	<b>Total: \$290-330k</b>
<b>Thorough Repairs*</b>	“Repair” not feasible, would require rebuilding - see two cells to the right for cost.	Remove marble, clean, <u>all recreations</u> , <u>replicate stone base</u> , install indoors  \$90k dismantle, transport marble \$10-15k cleaning \$25-30k recreate marble loss up to \$100k limestone base no perimeter No foundation if floor supports load \$50-70k reinstallation	Remove marble, clean, <u>all recreations</u> , <u>replicate stone base &amp; perimeter wall</u> , install outdoors  \$90k dismantle, transport marble \$10-15k cleaning \$25-30k recreate marble loss up to \$100k limestone base \$50-70k concrete perimeter \$25-30k new foundation \$50-70k reinstallation
		<b>Total: \$275-305k</b>	<b>Total: \$350-405k</b>
*Recreate missing tritons if desired for thorough repair: \$60-80k each if concrete, \$90-130k each if limestone. If inside with no outer ring, tritons could be placed approximate to center on simple bases.
