ANNIE C. STEWART MEMORIAL FOUNTAIN ASSESSMENT REPORT AND RECOMMENDATIONS

Date of Work:	May 2022	Project Name and Location:	Annie C. Stewart Memorial Fountain Madison, WI
Date of Report:	June 22, 2023 (draft) Jamie Morris	Owner/Client:	City of Madison
Reported by:	Andrzej Dajnowski		
Artist/Date:	Frederick J. Clasgens, installed 1925		
Dimensions:	21' in diameter at perimeter wall		
Project Goal:	To perform conservation assessment and develop treatment options with estimated pricing.		
Work Performed by:	CSOS Neomek Incorporated Wiss, Janney, Elstner Associates	Contact:	Karin Wolf, City of Madison William Fruhling, City of Madison

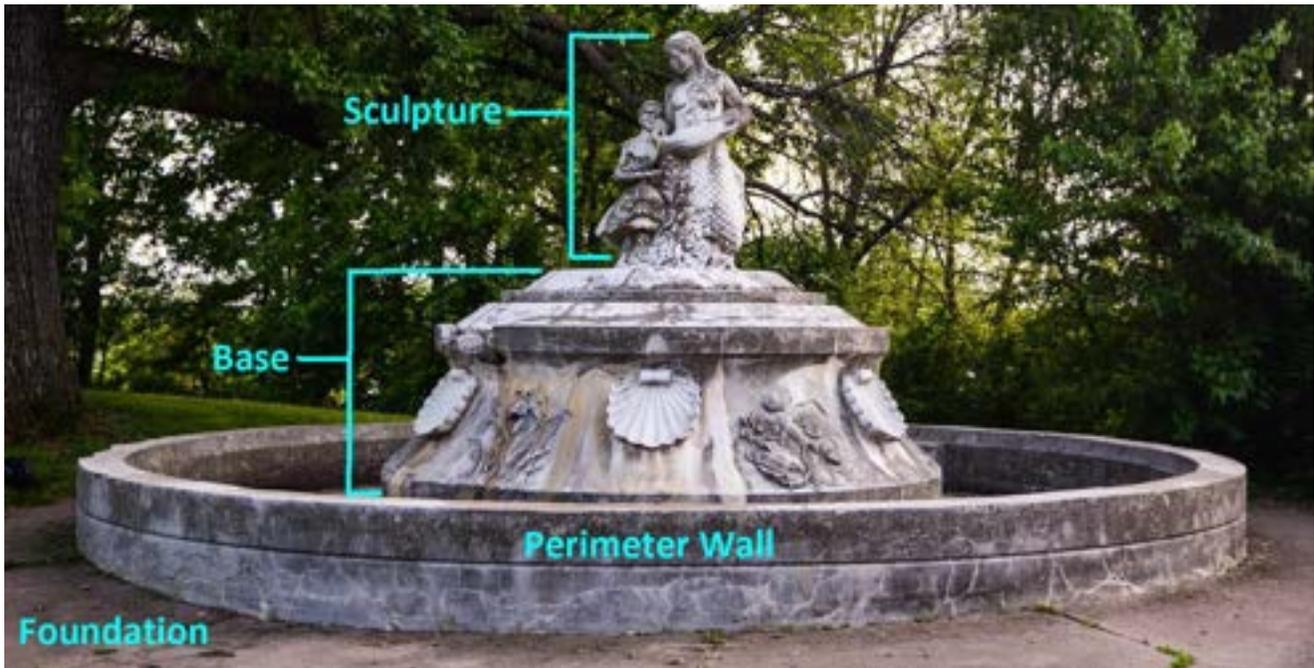
This image identifies the sections of the fountain as discussed in the matrix above

Annie Stewart Memorial Fountain - Repair Matrix			
	Repair In Place	Relocate Indoors	Relocate Outdoors
Minimal Repairs	Not, feasible, safety hazard	Remove marble, clean, simple base, install indoors \$90k dismantle, transport marble \$10-15k cleaning \$25-35k new simple base No foundation if floor supports load \$50-70k reinstallation	Remove marble, clean, simple base, install outdoors \$90k dismantle, transport marble \$10-15k cleaning \$25-35k new simple base \$15k new foundation \$50-70k reinstallation
		Total: \$175-210k	Total: \$190-225k
Moderate Repairs	Not, feasible, safety hazard	Remove marble, clean, <u>minimal recreations</u> , simple base, install indoors \$90k dismantle, transport marble \$10-15k cleaning \$25-35k recreate marble loss \$25-35k new simple base No foundation if floor supports load \$50-70k reinstallation	Remove marble, clean, <u>minimal recreations, replicate stone base</u> , install outdoors \$90k dismantle, transport marble \$10-15k cleaning \$25-35k recreate marble loss up to \$100k limestone base \$15-20k new foundation \$50-70k reinstallation

Total: \$200-245k	Total: \$290-330k
Thorough Repairs*	“Repair” not feasible, would require rebuilding - see two cells to the right for cost.	Remove marble, clean, <u>all recreations, replicate stone base</u> , install indoors \$90k dismantle, transport marble \$10-15k cleaning \$25-30k recreate marble loss up to \$100k limestone base no perimeter No foundation if floor supports load \$50-70k reinstallation	Remove marble, clean, <u>all recreations, replicate stone base & perimeter wall</u> , install outdoors \$90k dismantle, transport marble \$10-15k cleaning \$25-30k recreate marble loss up to \$100k limestone base \$50-70k concrete perimeter \$25-30k new foundation \$50-70k reinstallation
		Total: \$275-305k	Total: \$350-405k
<p>*Recreate missing tritons if desired for thorough repair: \$60-80k each if concrete, \$90-130k each if limestone. If inside with no outer ring, tritons could be placed approximate to center on simple bases.</p>
