**ANNIE C. STEWART MEMORIAL FOUNTAIN
CONSERVATION/PRESERVATION PLAN
MADISON, WISCONSIN**

Annie C. Stewart Fountain Conservation/Preservation Plan

Prepared for the City of Madison
By InSite Consulting Architects

August 15, 2017

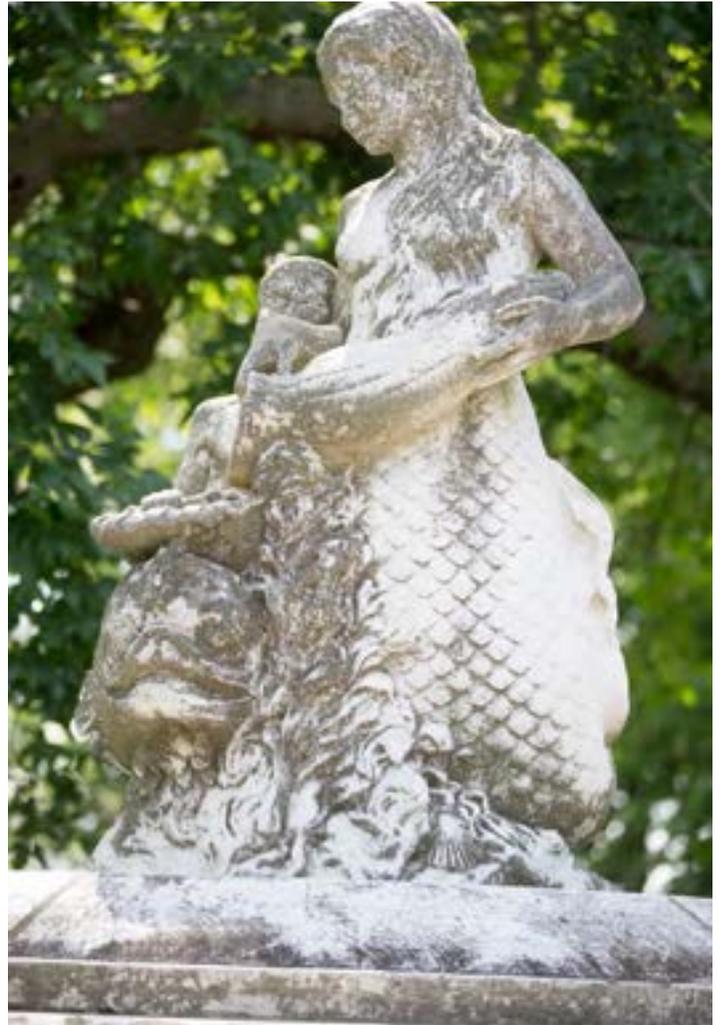
Figure 1: Overall view of condition of marble figures

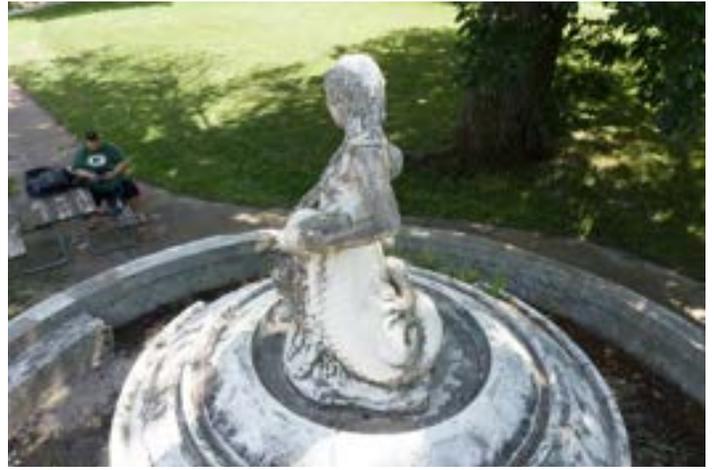
Figure 11: View of marble figures

It is recommended that, once the piece has been restored to its best possible condition that it be laser-scanned to memorialize its condition digitally. From this scan a replica could be made and missing elements may be restored.

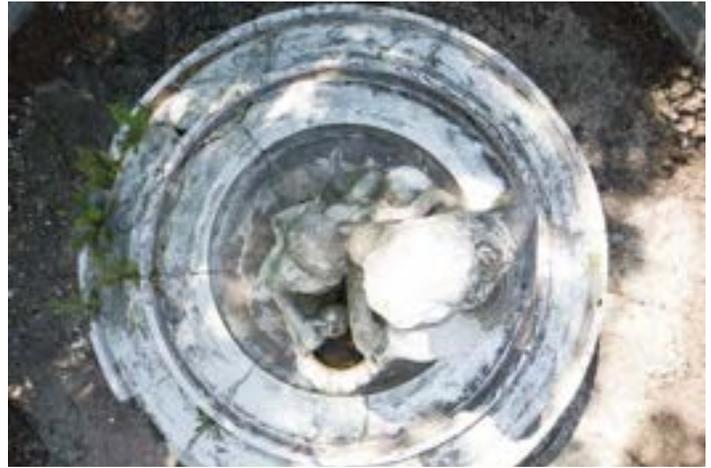
Figure 14: View of intricate spatial arrangement of marble figures from above

The support of the removal will likely require the restraint and/or confinement of certain details within the sculpture, such as the negative space between the Triton and Mermaid. This must be executed with precision to avoid breakage.

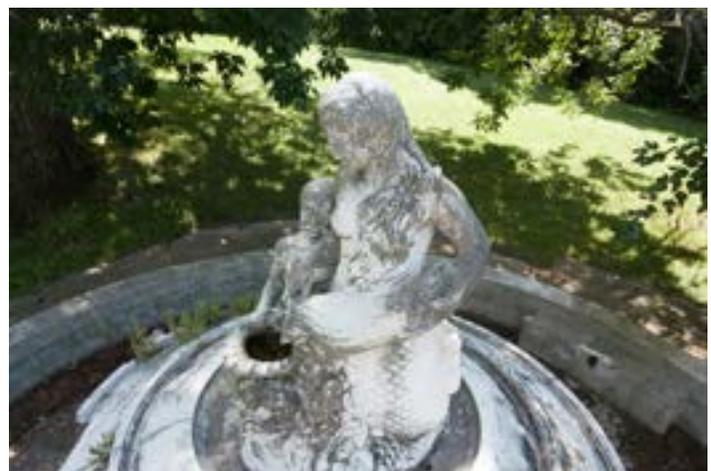
Figure 16: View of mermaid and cornucopia

The opening of the cornucopia must not be altered to allow for water to shed on the surface. Instead we recommend that the openings for the fountain be used to allow for internal drainage. This will keep the “bowl” of the cornucopia to remain empty. This will, of course, need to be cleaned on a regular basis.

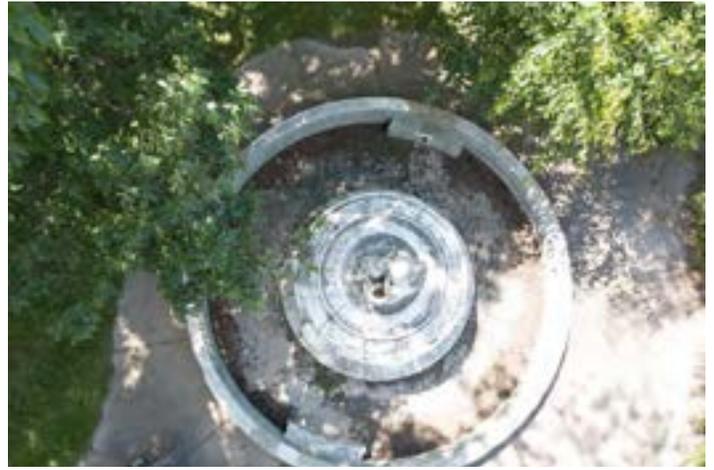
Figure 17: Overhead view of entire fountain

The outer ring of concrete and the “stools” that supported the outer Tritons must be recreated verbatim. They must be installed in the same configuration and locations.

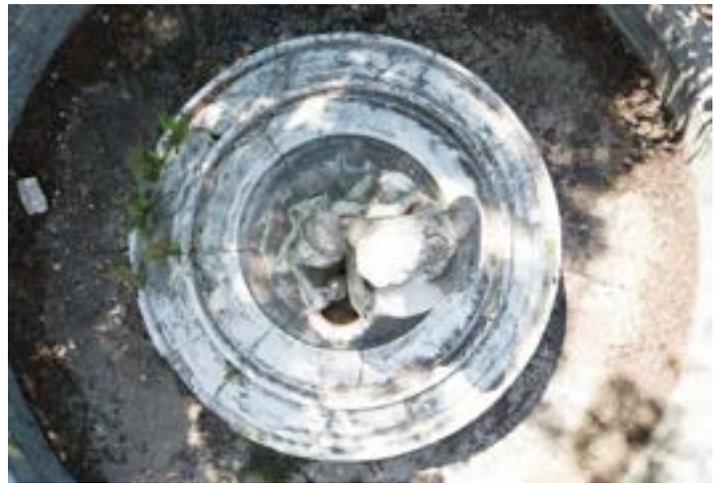
Figure 18: Close up overhead view of marble figures

The sculpture and pedestal must also be reinstalled in precisely using the same configuration and orientation. This is a critical aspect of the overall composition and must be replicated.

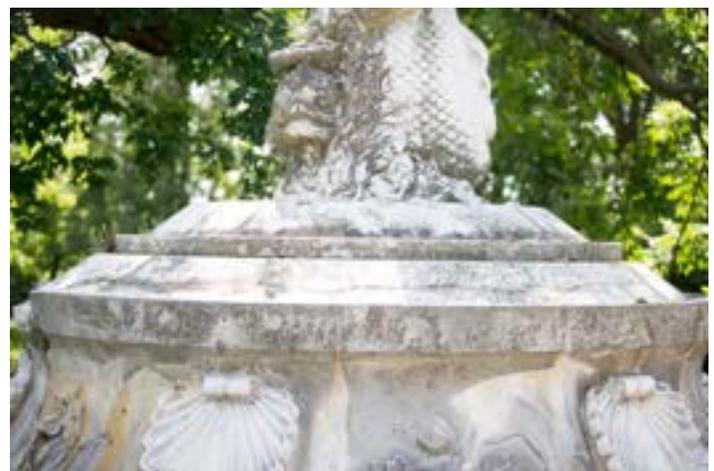
Figure 19: Relatively intact base/pedestal transition

The sculpture must be separated from the base with a minimum of damage to all of the original materials. Minimal wrecking may be required, but the pieces were set using some sort of mechanism/plan. We were unable to ascertain the method, further study is required.

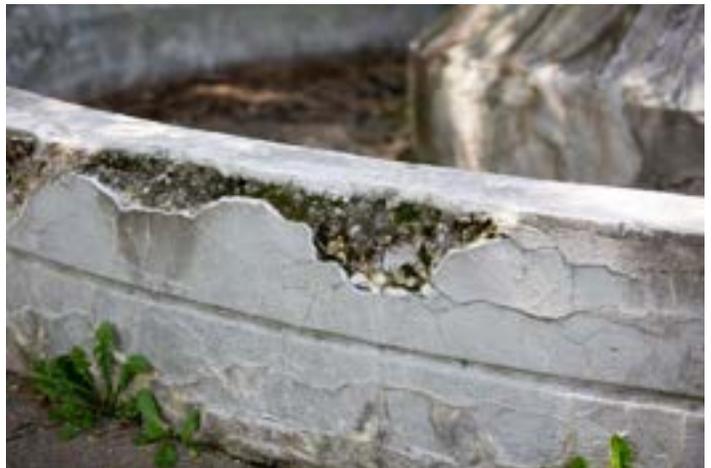
The outer ring was constructed using a coarse-aggregate concrete. Either at the time of construction or in the intervening years, a thin coat of cement stucco was applied to the outer ring to give it its finished appearance.

Figure 24: Coarse ring aggregate concrete at lower perimeter

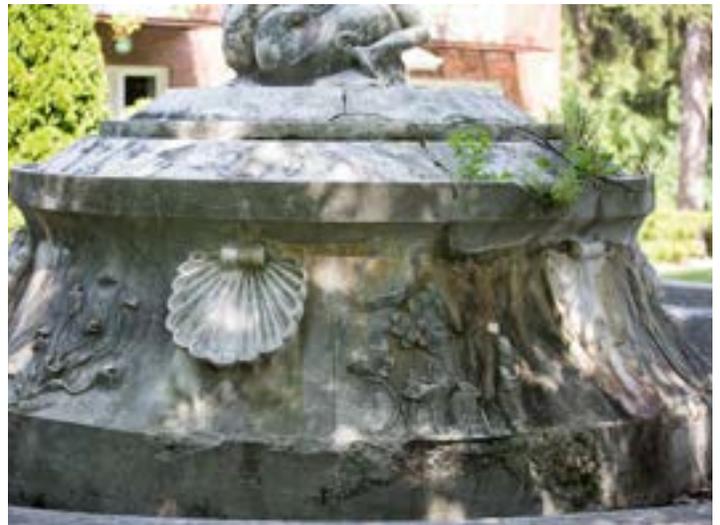
Figure 27: Primary area that should be used when recreating the stone base

The reconstruction can be based on the pieces that remain.

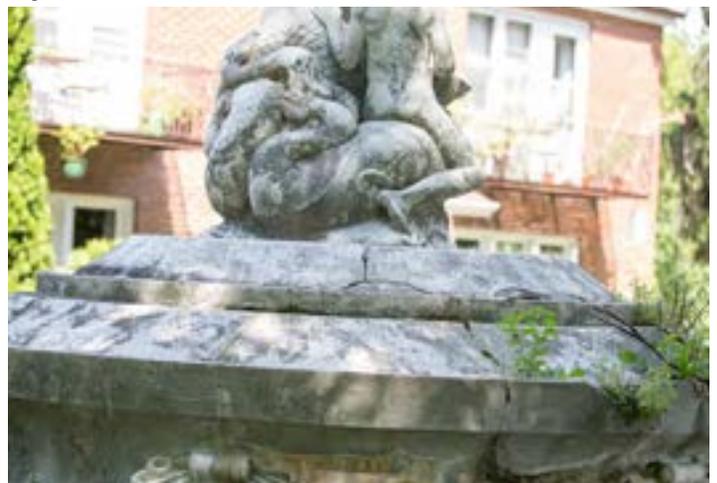
Figure 28: Close up of primary area that should be used when recreating the stone base

The entire fountain must first be fully documented using laser scanning techniques.

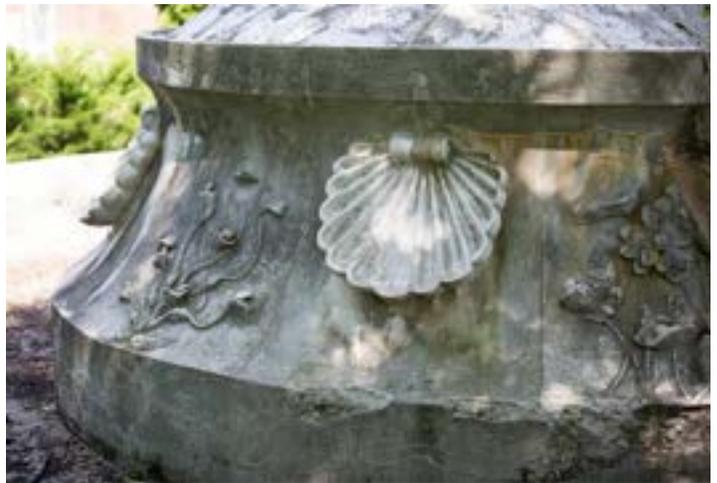
Figure 30: View of intact botanical motifs

Preservation of the pieces that make up the entire installation is critical to the overall success of the process.

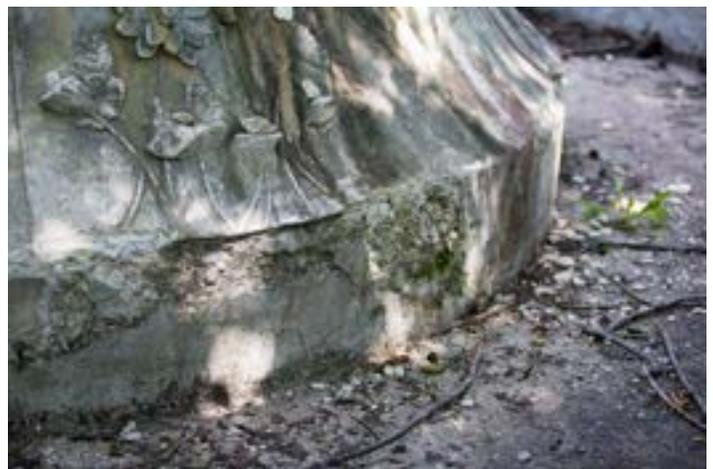
Figure 31: Stone to concrete transition

Careful documentation of the construction, particularly at the junctures of dissimilar materials must be executed with care in order to guide the reconstruction process.

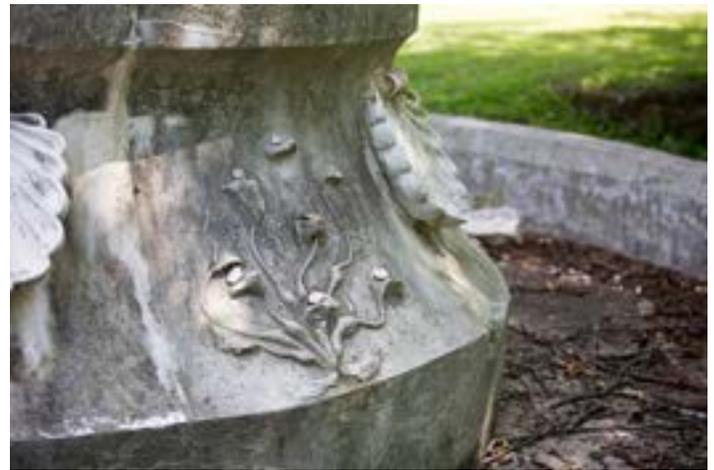
Figure 33: View of relief at fountain base

Concrete from the Mid-1920s was very different from concrete today. The concrete used on site must be analyzed to ensure that the correct aggregate size, shape, density as well as the correct cement chemistry, color and strength are considered during the reconstruction process.

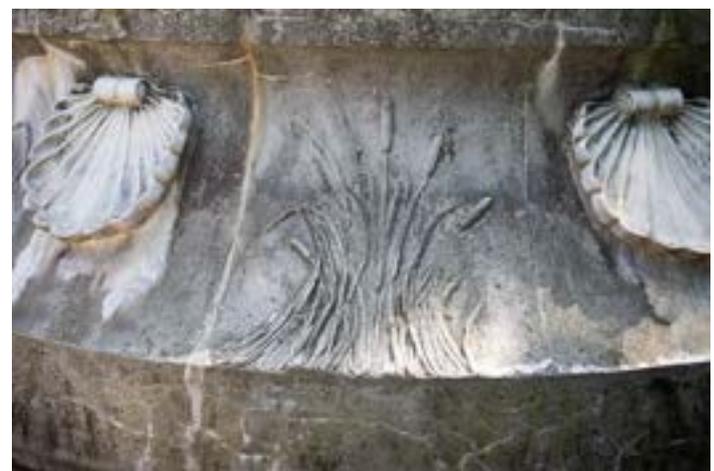
Figure 34: Relatively intact stone to concrete transition

Intact areas of material transition may be studied to develop a plan for the best reconfiguration of the work. Based on the effect still visible nearly 100 years after installation, the precision in designing and installing the base is exceptional.

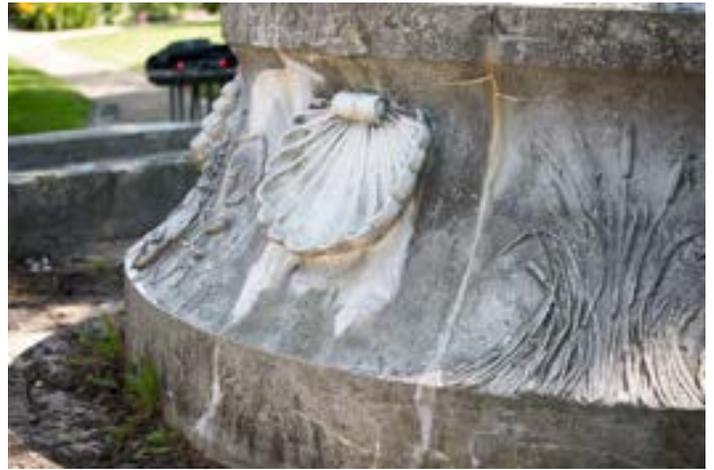
Figure 35: View of relief at foundation base

The botanical motifs employed in the base must be preserved and recreated or restored. The final decision regarding the disposition of the materials of the base should be considered carefully.

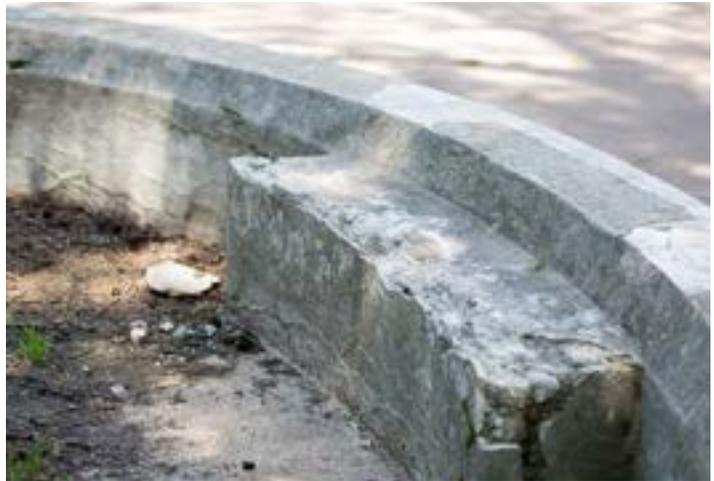
This is the location of one of the missing Tritons.

Figure 39: View of base of "dry" Triton

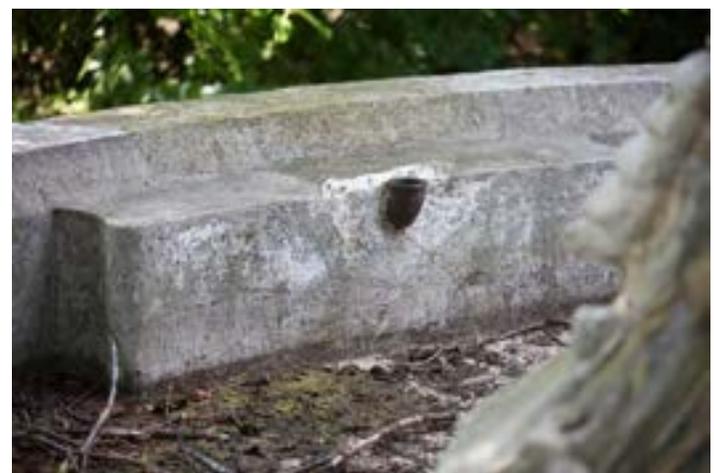
The location of the second missing Triton that was plumbed for the drinking fountain.

Figure 40: View of base of "wet" Triton

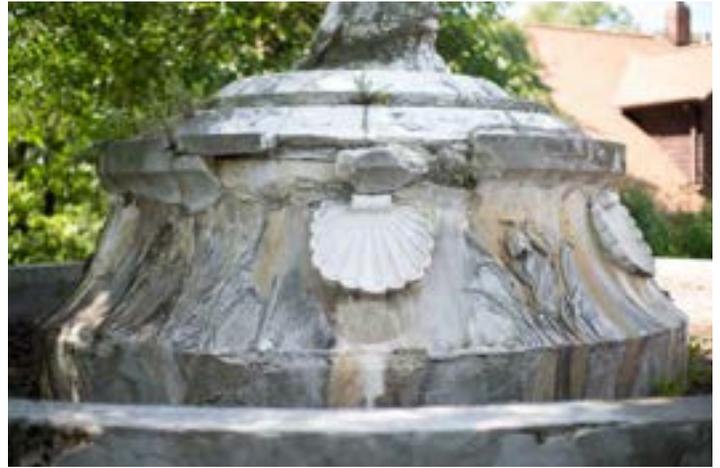
The damage to the fountain's base of limestone and concrete is not reversible. Complete restoration is required.

Figure 44: Overall view of base

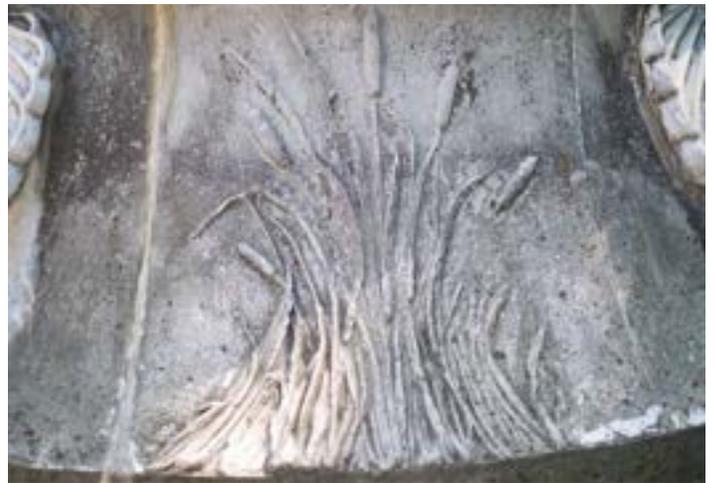
The damage to the fountain's base of limestone and concrete is not reversible. Complete restoration is required.

Figure 48: View of cattail motif

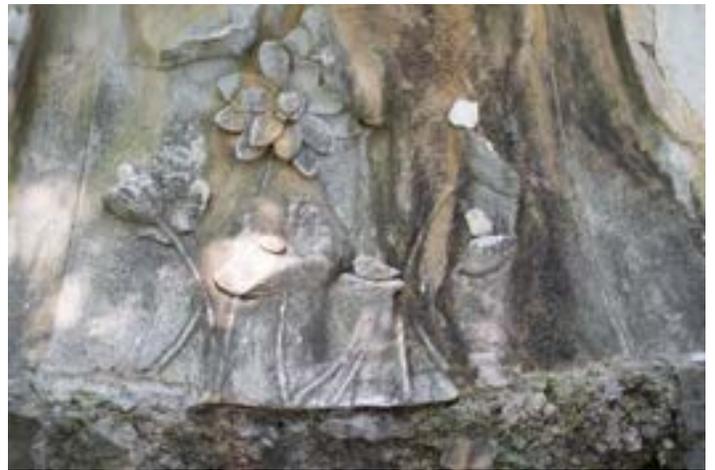
The damage to the fountain's base of limestone and concrete is not reversible. Complete restoration is required.

Figure 51: View of floral motif

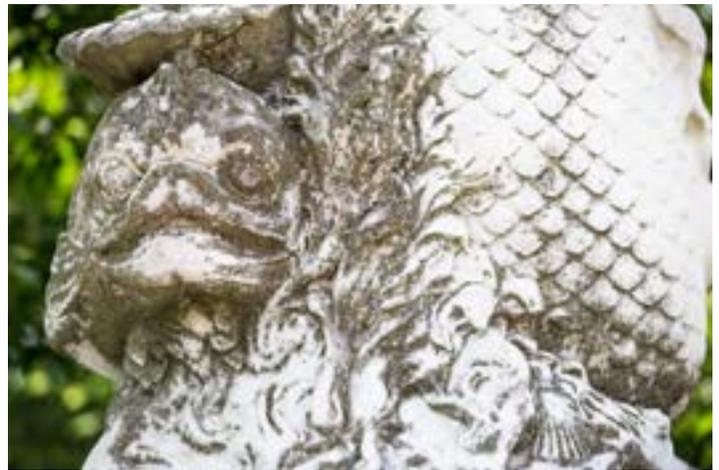
Dolphin in 2017- Much of the fine detail is obscured by organic growth. Cleaning using a benign biocide and appropriate (field tested/verified) techniques will reveal the true condition of the marble subjects. The nature of the piece's subjects, their delineation in stone, their orientation, neighboring vegetation and exposure to the elements will come to light after a proper conservation-based cleaning.

The damage to the fountain's marble elements appears to be both treatable and reversible. Conservation is required.

Figure 54: View of dolphin in 2017

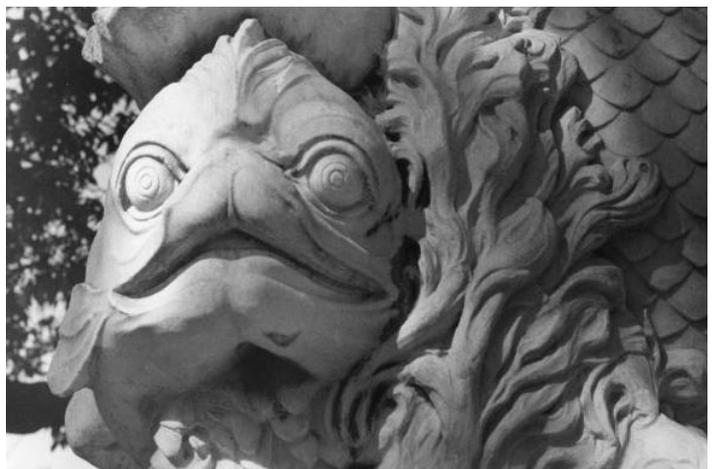
Dolphin in 1973 - The detail evident in this image is exceptional. While unconfirmed, it is apparent that the sculpture was either recently cleaned prior to this photograph or was benefited by a more proactive cleaning and maintenance program. When compared to a contemporary image of the same details it is evident that a significant amount of organic material obscures the detail. A proper conservation cleaning will help to ascertain what, if any, additional damage the piece has suffered.

This is the best example we could find of the condition of the marble sculpture in a preserved state. We believe that the marble should be restored to a condition as close to this as possible.

Figure 55: View of dolphin in 1973
