City of Madison

**Madison Municipal
Building
Conceptual
Schematic
Design Study**

November 2013

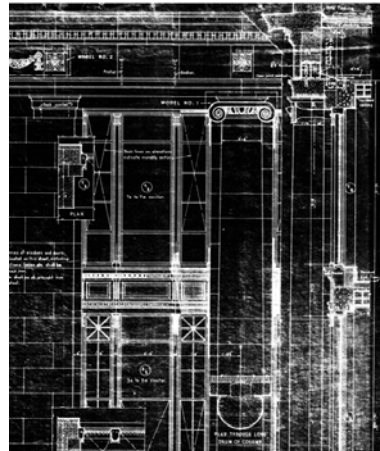
Figure 6 – Original Drawing of Front Window and Wall Section

“The integrity of the building has been affected by the 1979-1982 remodeling. On the exterior, the dark, fixed replacement windows are incompatible with the building as shown in Figure 6. The first floor and basement have been gutted, losing all integrity. However, the second and third floors are intact. While the alterations detract from the building’s architectural character, enough of the original appearance has been retained to lend the building as a fine local example of Neo-Classical Revival design applied to a civic building.”¹

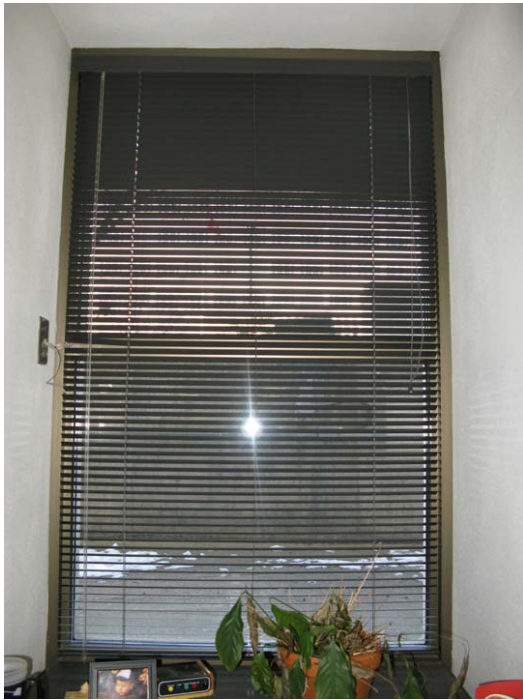
Figure 15 – Aluminum Framed Replacement Windows are Located on the Lower and First Floor Levels

Standard two inch, commercial grade, bronze colored, aluminum framed, fixed, storefront windows with tinted insulated glass were installed as replacements to the original steel windows located on the lower level and first floor within the stone openings. The replacement units attempt to resemble the original design intent however they fall very short because the frame, glass and muntin inserts vary in color, reflectance and size.

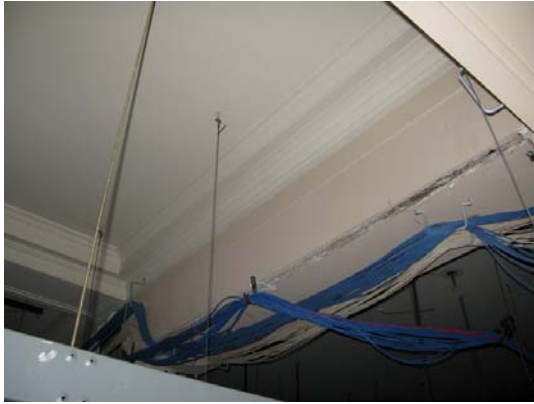
Figure 25 – Original Plaster Ceilings and Decorative Crown Moldings remain above the Suspended Ceilings on the First Floor

side of the first floor; the location of the original post office lobby. In the same area, above the suspended acoustical ceiling tile grid system are remnants of the original lobby's decorative plaster coffers. It appears as if every decorative coffer has been damaged from the installation of mechanical and electrical upgrades.

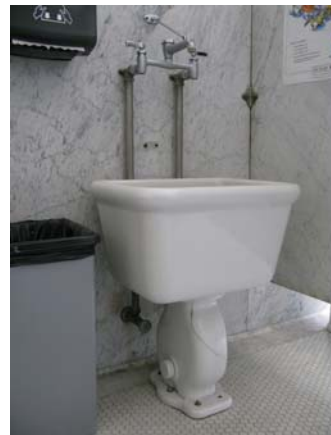
Figure 27 – Slop Sink in Women's Restroom

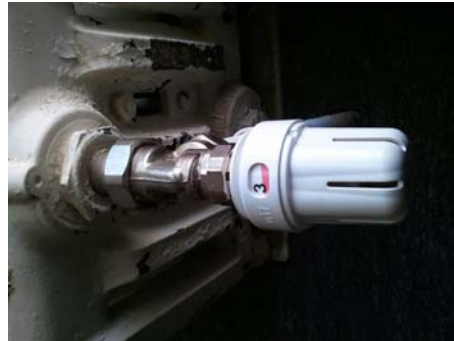
Figure 36 – Steam Radiator Control Valve

The only temperature controls on second and third floor during heating season is through manually opening or closing the control valve located at each radiator. These radiators and associated steam and condensate piping are approximately eighty-seven years old and are at the end of their expected life. Moisture damage was noted in multiple locations due to radiator leaks, and the radiators have been painted multiple times with paint peeling on all radiators.

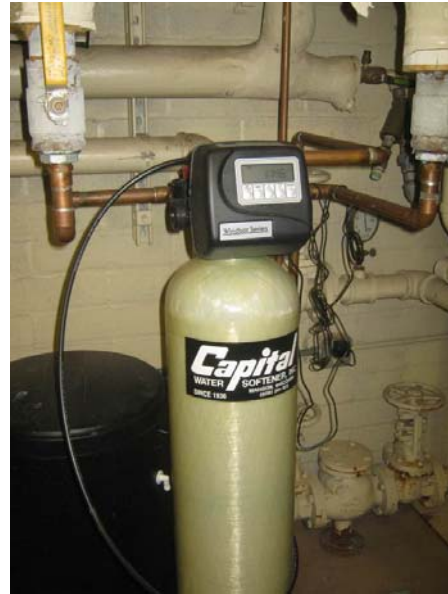
One gas fired water heater, located in the lower level mechanical room, provides hot water to the building. All hot water is softened by a water softener located in the same mechanical room. The domestic hot water system is currently stored and circulated at approximately 115°F. Both the water heater and softener appear to be a newer vintage and are said to be in good working condition.

Figure 41 – Water Softener

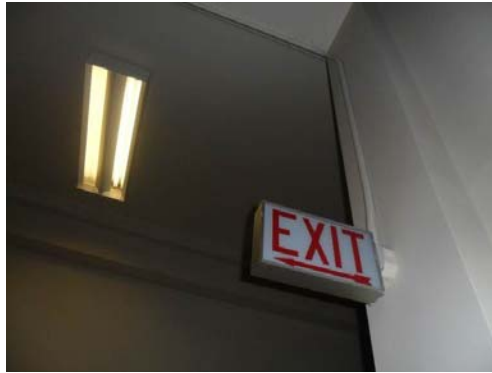
The existing electrical system is a 4000 Amp, 120/208V 3-phase, 4-wire service, which is adequate for the facilities current functions and use. This electrical system is most likely more than capable of handling modifications and minor expansions to the existing building, as the majority of new systems are very efficient compared to what is currently installed. The existing lighting is largely outdated, and very inefficient to modern fluorescent and LED fixtures. Fire alarm is dated and may require updates in the near future. All three electrical systems have a fair amount of exposed conduit and junction boxes, especially on second and third floor due to the original block walls and additional system items being added over the years.

Figure 47 – Exit Sign

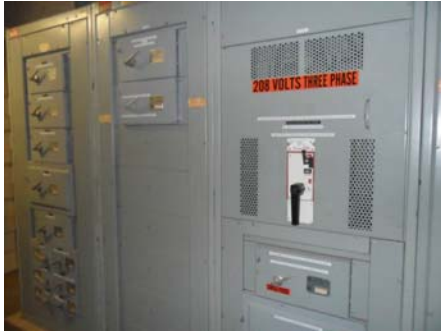
As mentioned before, the existing service is 4000 Amp, 120/208V 3-phase, 4-wire service, GE Service Entrance switchgear, in good condition. The incoming utility service is served from exterior transformers on the northwest side of the building. The existing main electrical service equipment is in good condition, and large portions of the branch panels are undergoing an upgrade. Most of the second and third floor panels are being completely overhauled with new branch panels and splice boxes replacing the original 1920s panels in the corridors. In addition, the distribution has been upgraded to include an individual feeder for each panel located on the upper floors, greatly expanding the available capacity.

Figure 48 – Current Electrical Service

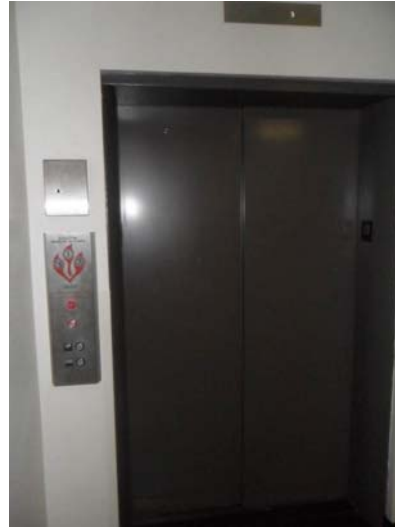
The building also has an elevator, which has undergone some changes since the original building. It appears to still be served from the original exposed motor located in the penthouse equipment room. The inspection dates looked current and the elevator appears to be in good working condition. The elevator cab itself has had at least one recent upgrade, and so have the button interfaces on each floor.

Figure 53 – Elevator Button Interfaces

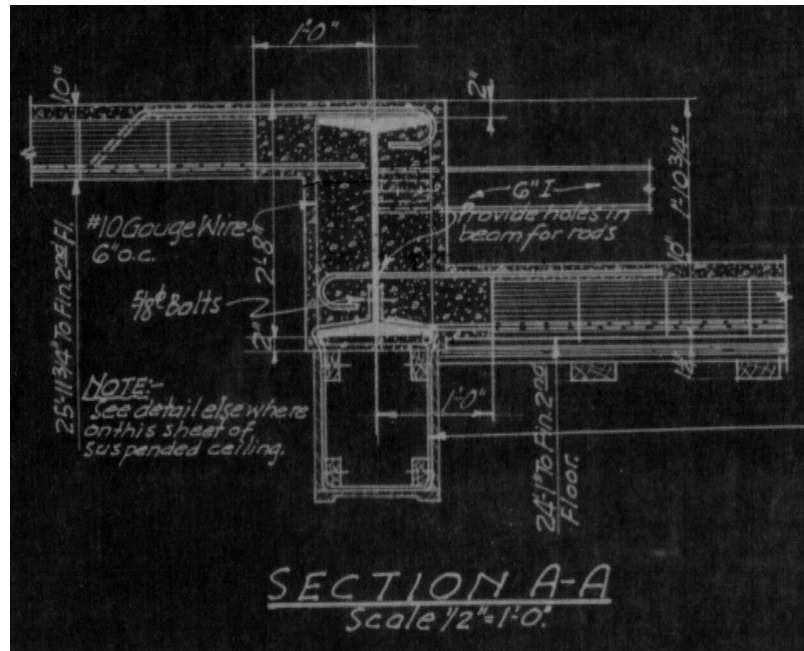
The old court room on second floor is a two story space. There is an opening in the third floor slab for this space and the existing drawings indicate the roof slab is recessed 1'-10 3/4".

Figure 56 – Recessed Roof Slab at Court Room from Existing Drawings
