## Building Inspection Division

**DATE:** February 23, 2015  
**TO:** Plan Commission  
**FROM:** Matt Tucker, Zoning Administrator

**SUBJECT:** Request for PD Alteration, 520-524 E. Johnson Street

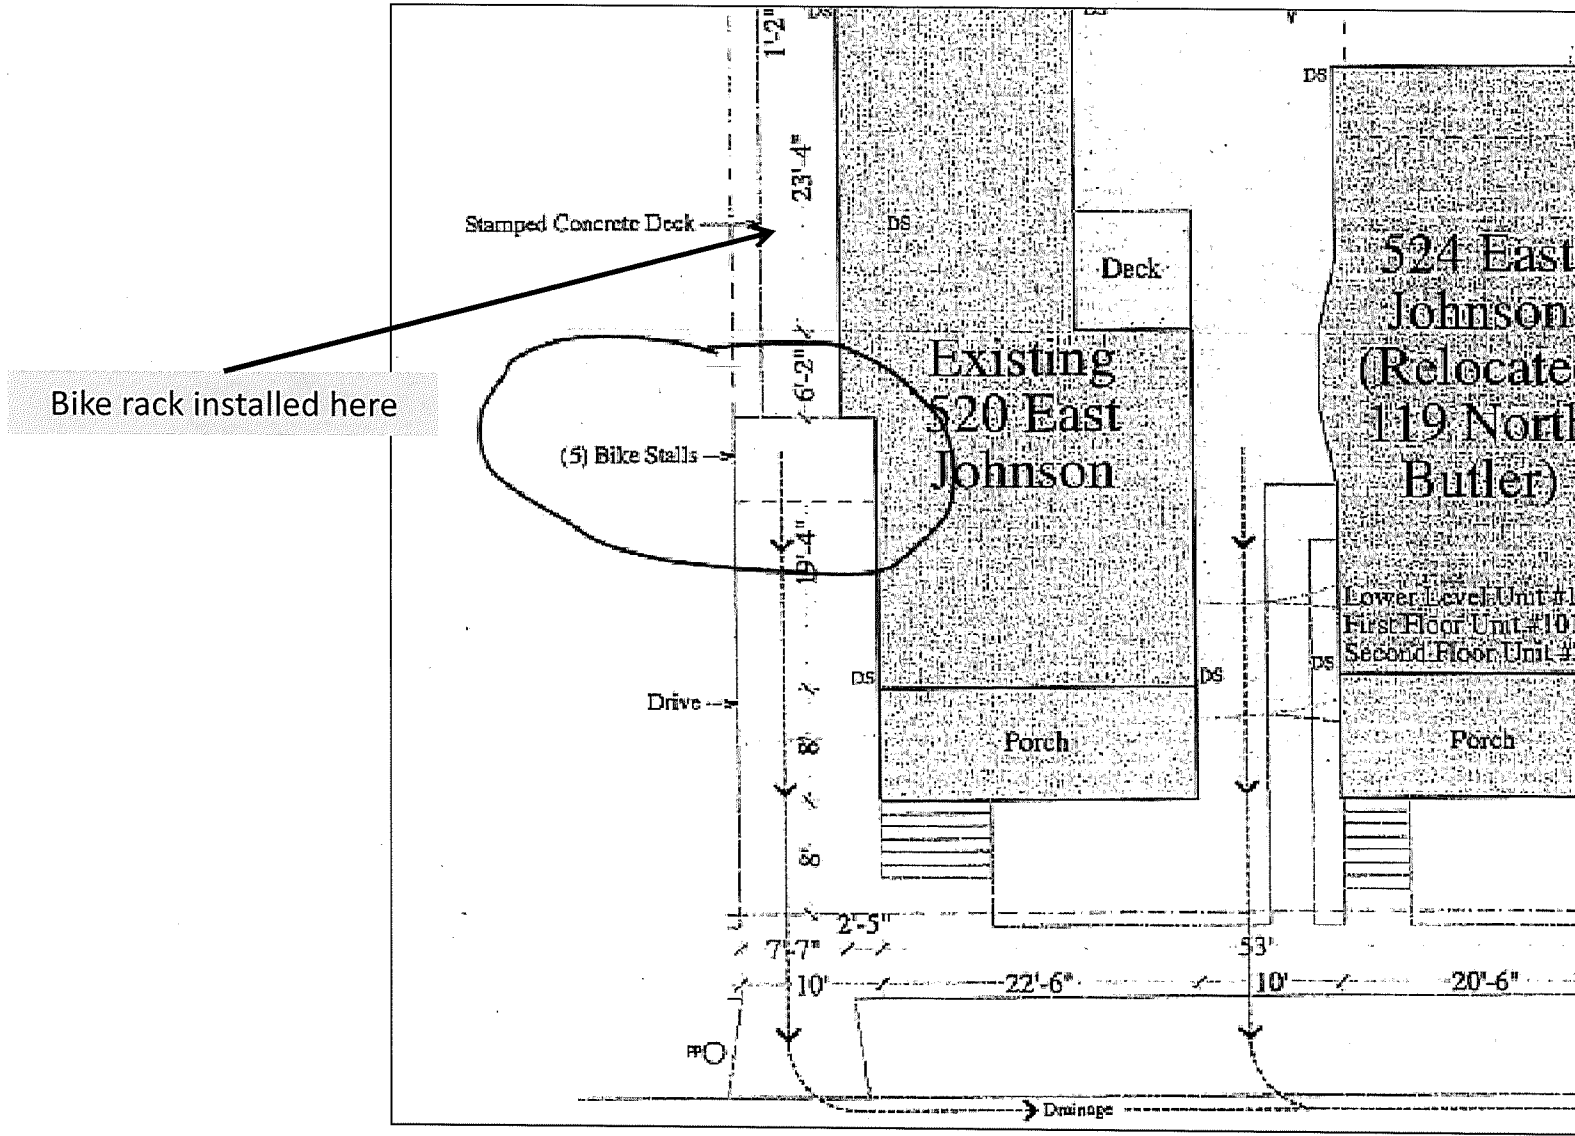
# Bike parking approval next to 520 E. Johnson

The bike parking access issue could be fixed if one added a step/steps in the retaining wall, so a person need not climb such a rise with a bike to get to the path leading to Blair Street.

Inadequate depth for parking and access, need 11', provide about 6'-7'

As noted above, the bike parking problem can easily be remedied by correct configuration and an approved rack, and by placing a single row of block at the base of the existing retaining wall, to create a step that would be acceptable.
