EXISTING BUILDING REVIEW

125 State Street

Name: Madison Fire Engine House No. 2/ Castle & Doyle Building

125 State Street – Architectural Review

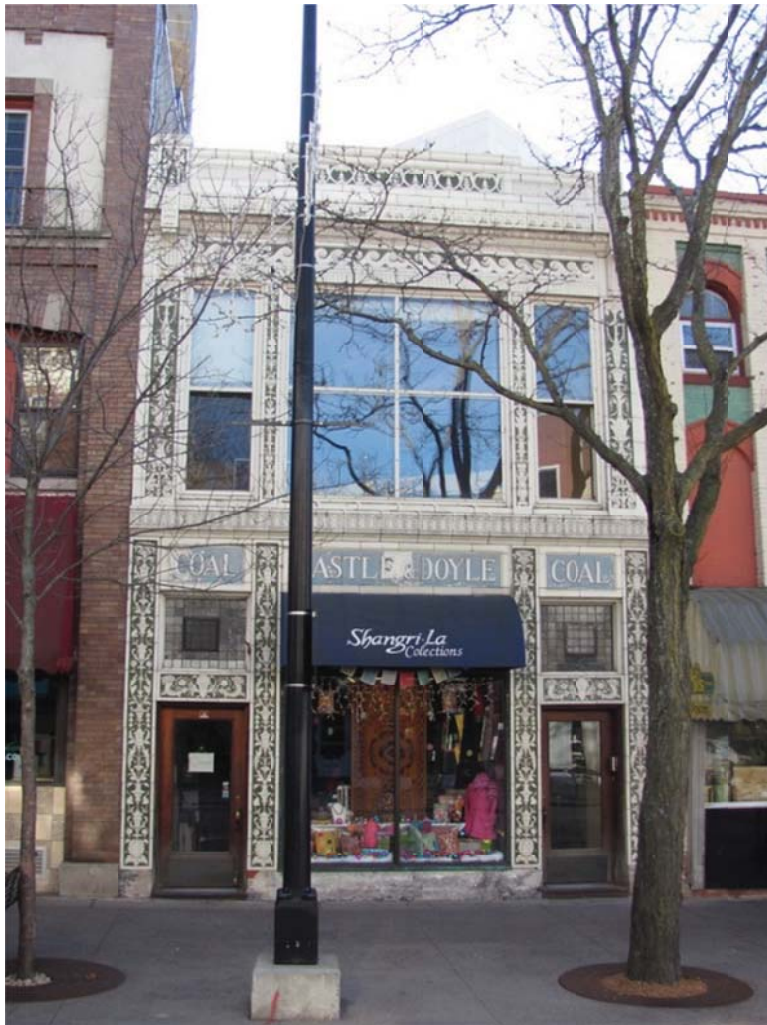
The State Street facade is clad with white and green glazed terra cotta masonry (Figure 1). At the base of the facade, the masonry veneer appears to have been altered after 1921; this area includes marbleized cast stone panels as well as exposed common brick masonry (Figure 2). The terra cotta masonry is generally in very good condition, with a few individual damaged units, including one cracked window sill, one unit with a hole, one spalled unit, and one displaced unit above the first floor storefront (Figure 3 through Figure 5). At two locations, terra cotta coping units have been removed and set on the roof surface. Mortar joints in the terra cotta masonry are generally eroded. One inspection opening through the interior finishes at the second floor had been created by others prior to the site visit. At this opening, the back side of two terra cotta units are visible, as well as two wythes of brick backup masonry. One steel tie wire connecting the terra cotta to the brick backup was observed at this opening.

Figure 1. Overall view of the State Street facade.

Appropriate repairs to the terra cotta State Street facade may include repair of individual damaged units; re-setting of coping units, perhaps to include a through-wall flashing integrated with the roof membrane and counterflashing; and repointing of mortar joints. At grade, a new masonry veneer may be desirable to

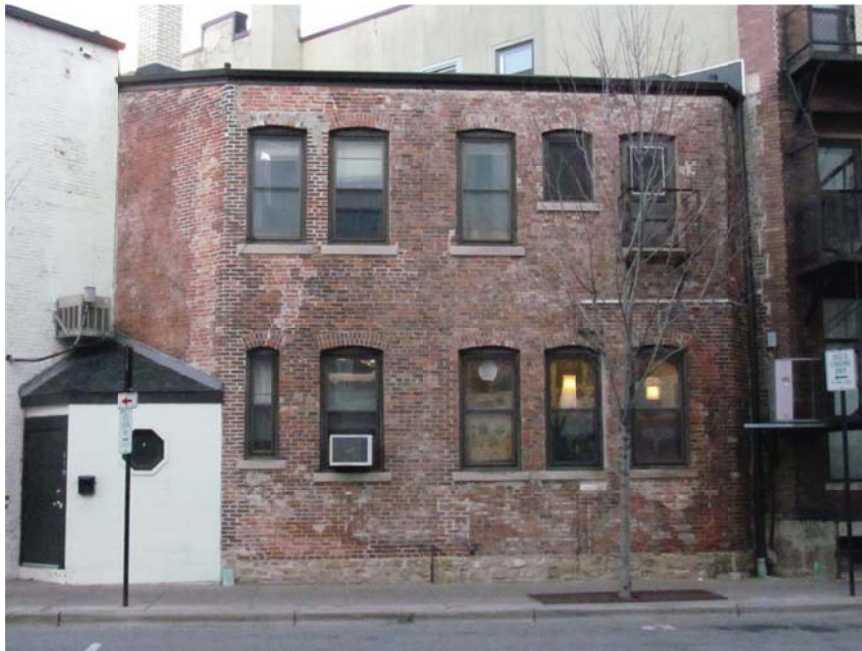
The Fairchild Street facade, which apparently dates to the original construction of the building circa 1856, has a stone foundation at grade (Figure 9). Above the foundation, the walls are load-bearing red brick masonry in a common bond with headers every seventh course. Limestone is used for window sills. Window openings are formed with two-course rowlock brick arches.

Figure 9. The Fairchild Street facade.

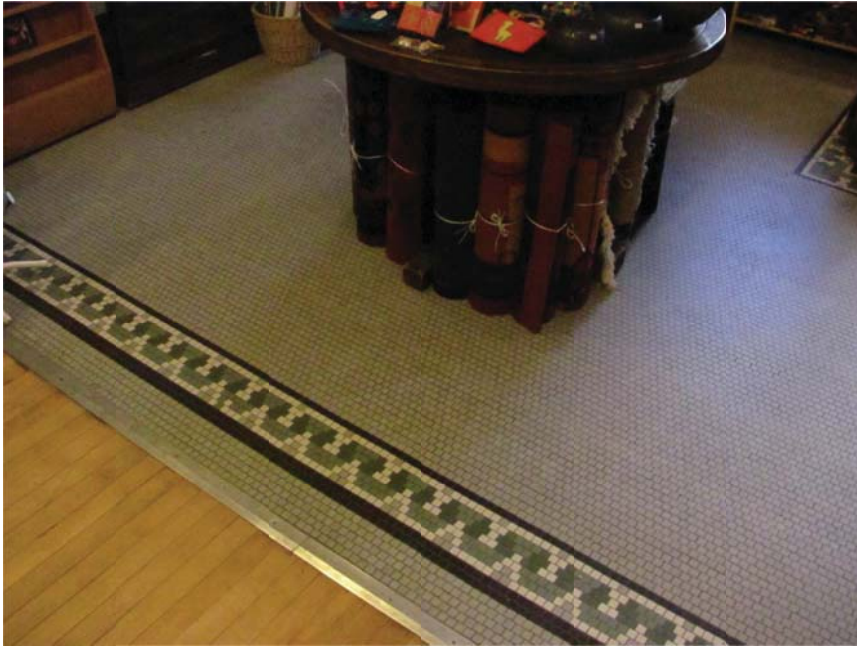
The first floor interior is now used for retail purposes. The finishes installed in the 1921 renovation are largely intact, including hardwood and mosaic ceramic tile flooring, marble wainscot, stained and varnished wood trim, interior doors and hardware, plaster walls and ceiling, and plaster crown molding (Figure 15 and Figure 16).

Figure 15. Hardwood and mosaic ceramic tile flooring in the first floor retail space.

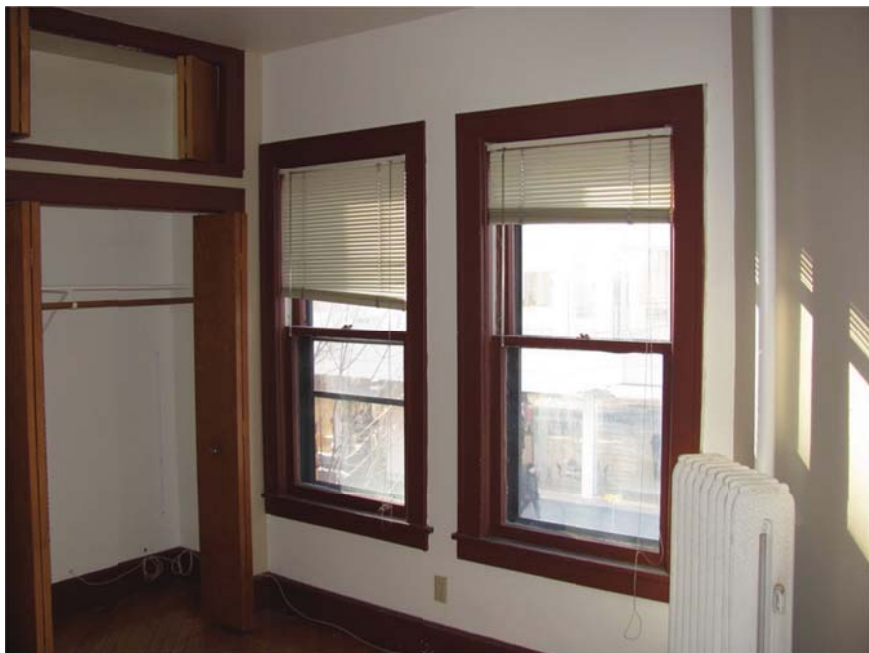
The second floor interior has been adapted as a two-bedroom apartment. The kitchen and bathroom are several decades old. The two bedrooms and main living room have painted wood baseboard and window and door trim, hardwood floors, painted plaster walls, and several historic wall sconce light fixtures (Figure 17 and Figure 18). These finishes apparently date to the 1921 renovation of the building. Throughout the second floor, the plaster ceiling has been covered with rigid insulation and painted gypsum board. Second floor interior doors are newer flat panel wood veneer doors.

Figure 17. The second floor interior.

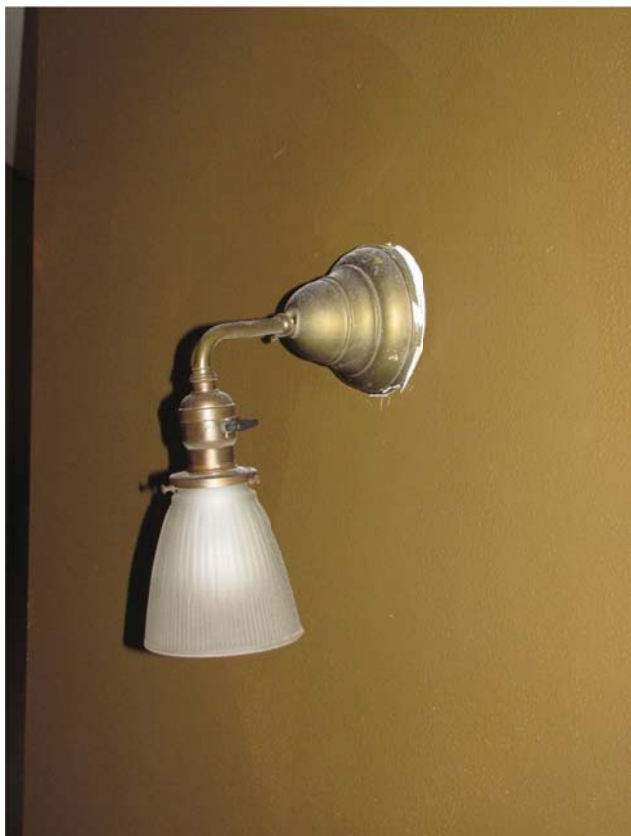
Figure 18. Circa 1921-era wall sconce light fixture at the second floor.
