## Memorandum

July 16, 2008

Re: Structural/Architectural Assessment of Homes for Proposed Demolition  
Findorff Yards Office Lofts  
Urban Land Interests  
Engberg Anderson Project No. 081780.00

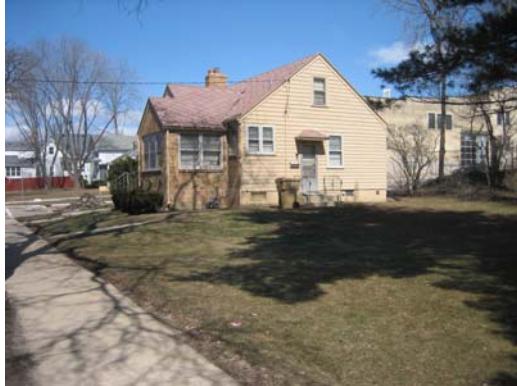
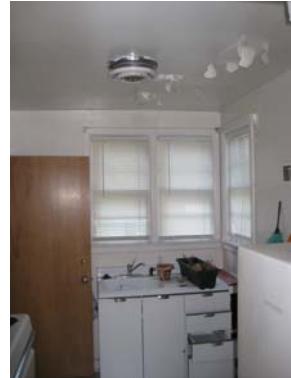
### 159 Proudfit Street

The home is approximately 821 sq.ft. and clad with masonry and wood siding on the walls and asphalt shingles on the roof. Single pane windows with a mixture of aluminum and wood framed storm windows cover the openings.

There is noticeable damage to the asphalt shingles as well as flashing or lack of flashing at the chimney and front porch/entry. The deterioration of flashing, or lack of flashing, has led to water infiltration and staining at the chimney in the attic, wall of the back porch and within the ceiling of the back bedroom. A complete removal and replacement of the roofing system would be required to eliminate water infiltration issues. See the following photos that highlight the issues discussed related the water infiltration:

The issues discussed above and the size of the home make it economically unfeasible to relocate this home to another site. A home of identical size and layout would be less expensive to build new than to move this existing home to a new lot and construct a new foundation and make all of the necessary updates. It is our recommendation to demolish and recycle the existing home at 159 Proudfit.

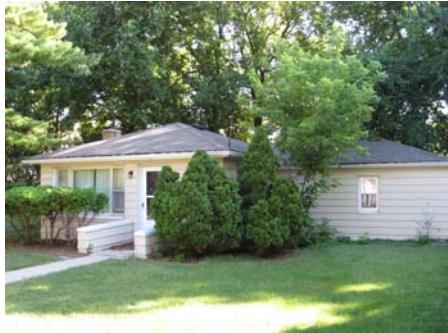
**167 Proudfit Street**

The home is approximately 896 sq.ft. and clad with mainly metal siding on the walls and asphalt shingles on the roof. Single pane windows with aluminum framed storm windows cover the openings.

The aluminum cladding of the home extend below grade level; this is not a typical condition for aluminum siding due to the fact that moisture has no place to escape if it moves behind the siding itself. There is noticeable damage to the siding as well as some of the openings on the home. The interface of the masonry chimney and the metal siding has deteriorated over time. It is noticeable that attempts have been made to fix water issues by the numerous sealant joints at the interface.

With the problems listed above and the size of the home, it is our recommendation that the home at 167 Proudfit Street be demolished and any items not destroyed, or affected, by the mold be recycled if possible.

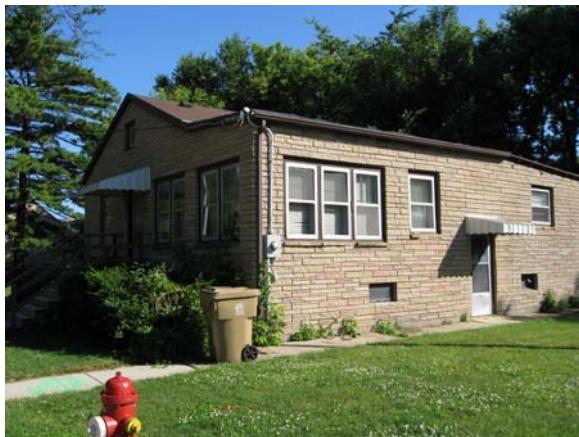
The home is approximately 1,273 sq.ft. and clad with an architectural concrete masonry system on the walls and asphalt shingles on the roof. Single pane windows with aluminum framed storm windows cover the openings. The exterior concrete masonry appears in good condition with the exception of some tuck pointing to the mortar with caulking. The main issues with the exterior are found at the eaves of the roof and the wood trim. In both cases there are numerous areas of rot and noticeable holes within the two areas mentioned. Animal infestation was confirmed when we opened the attic to the smell of animal /bat feces.

Photo of existing home at 171 Proudfit Street

With the extensive water damage to the home on the first floor, it is our recommendation to demolish and recycle the existing home at 171 Proudfit Street.
