Pacific Cycle – Existing Residence 4908 Hammersley Rd

Iconica Project Number: 20120410

Date of Inspection: November 6, 2012
Report: Capital Needs Assessment
Report By: Robert G. Feller, AIA

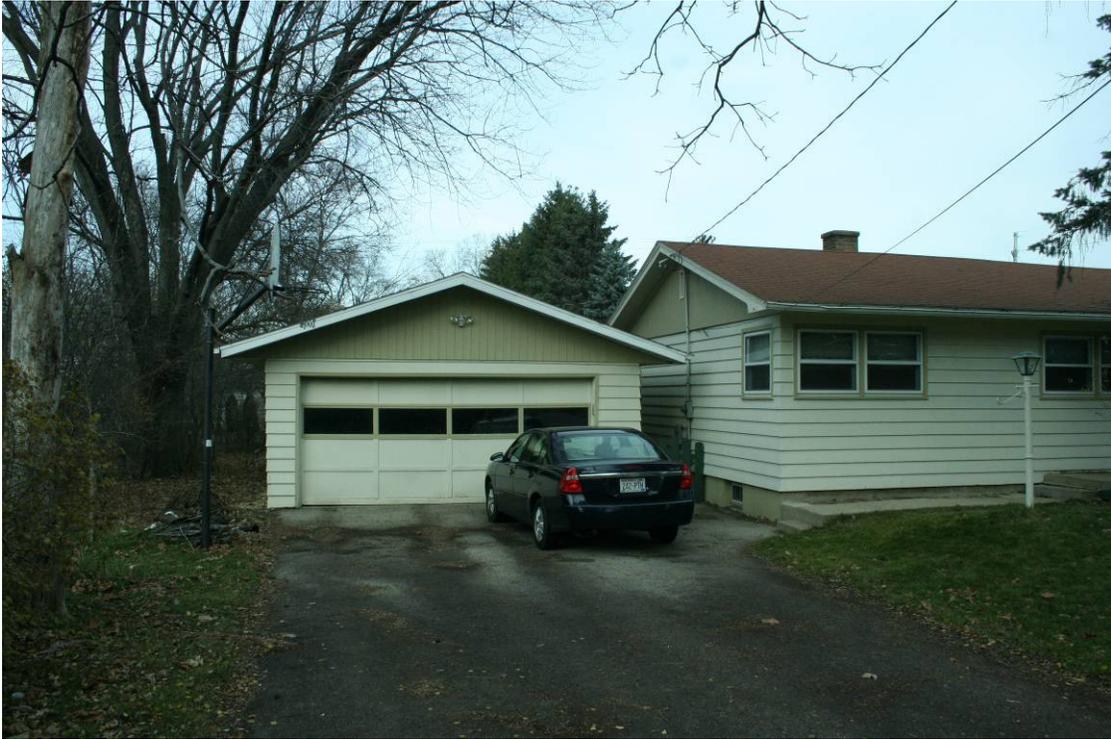
4908 Garage Elevation

The existing semi-attached garage is located on the west side of the house. The garage is in need of maintenance and repair required for the overhead door.

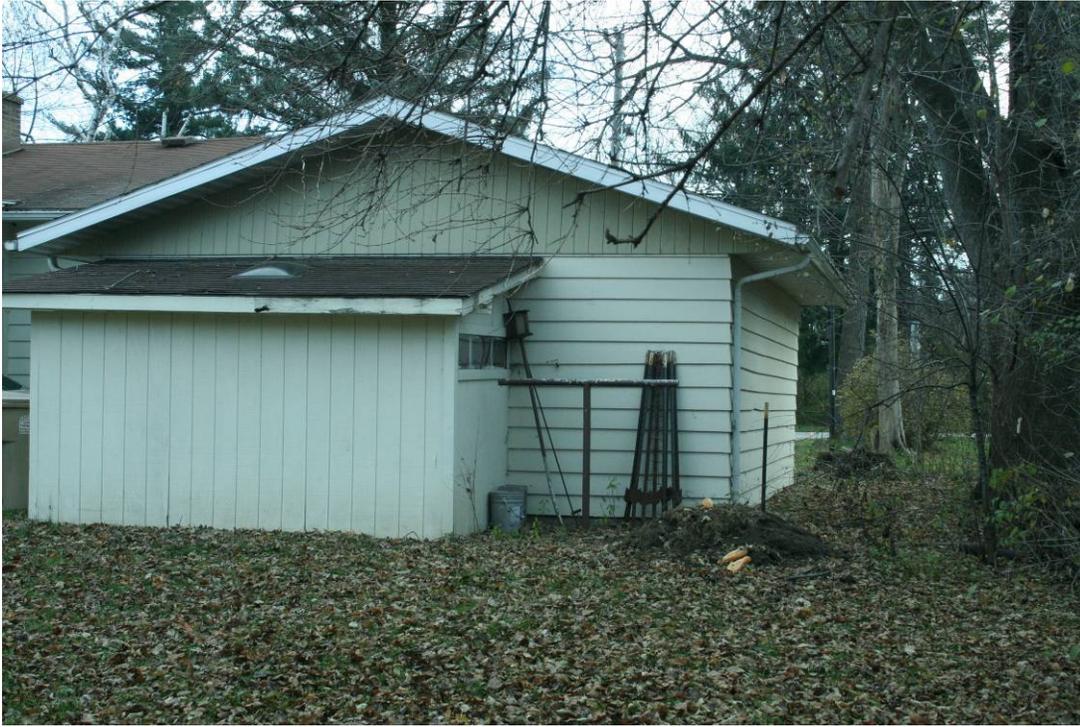
4908 Back of garage

The building exterior siding appears to be original and is in fair condition. The exterior soffits appear to be in good shape. The garage requires repair work and the existing lean-to shed should be removed or completely rebuilt.

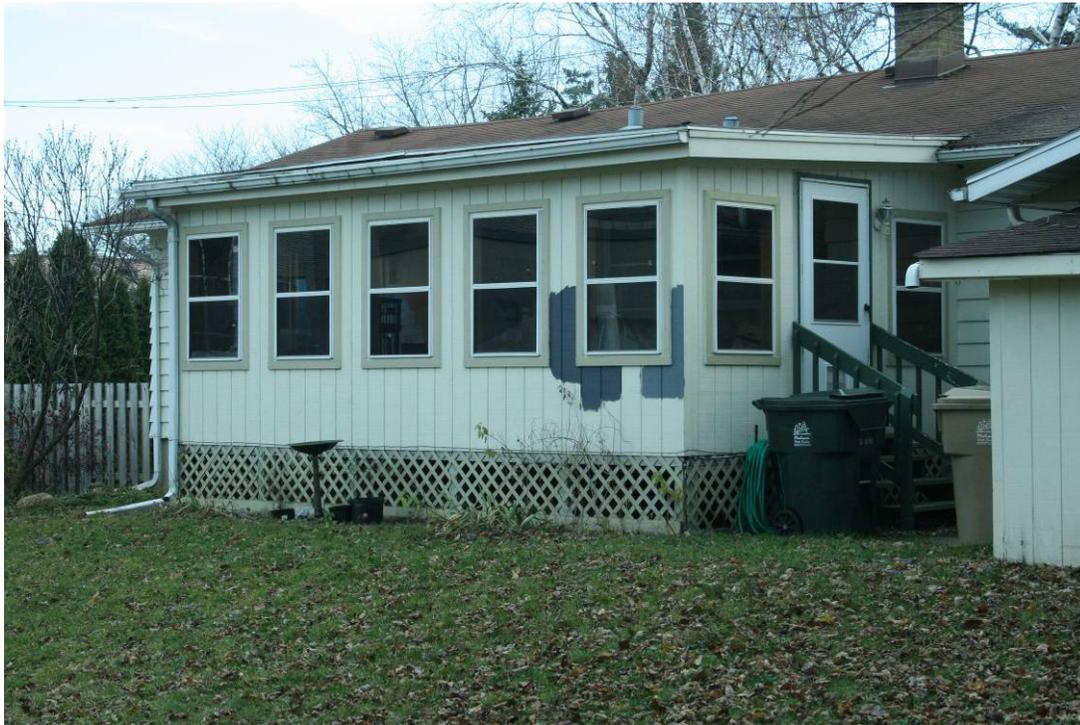
4908 Three season's porch

Onsite amenities include semi-attached garage, three season porch and deck. All amenities are in need of repair to keep safe and in good working condition.

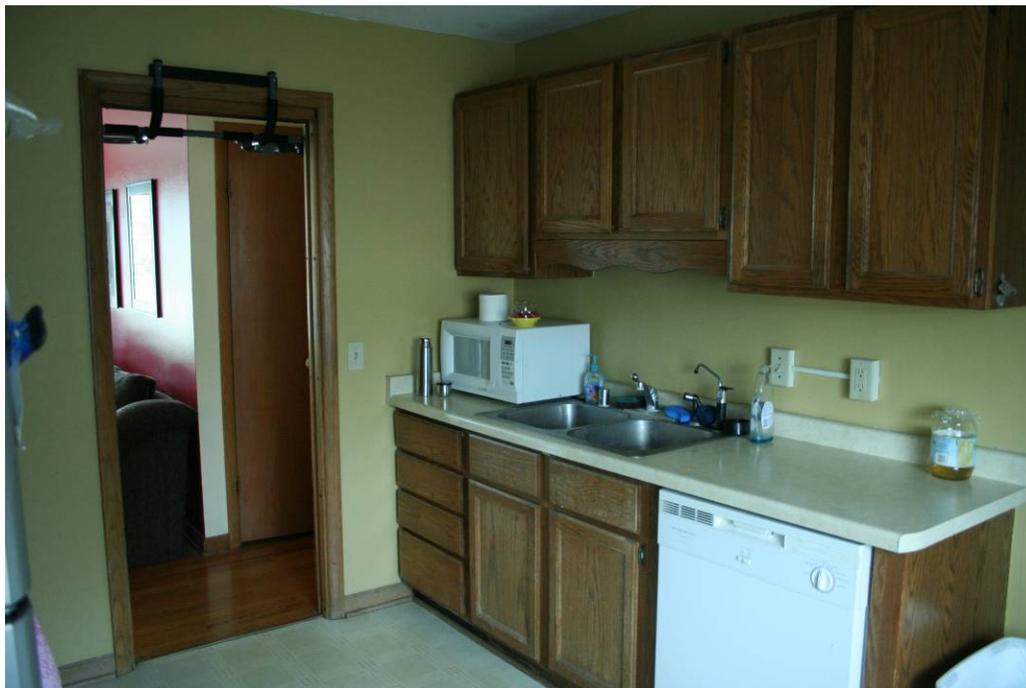
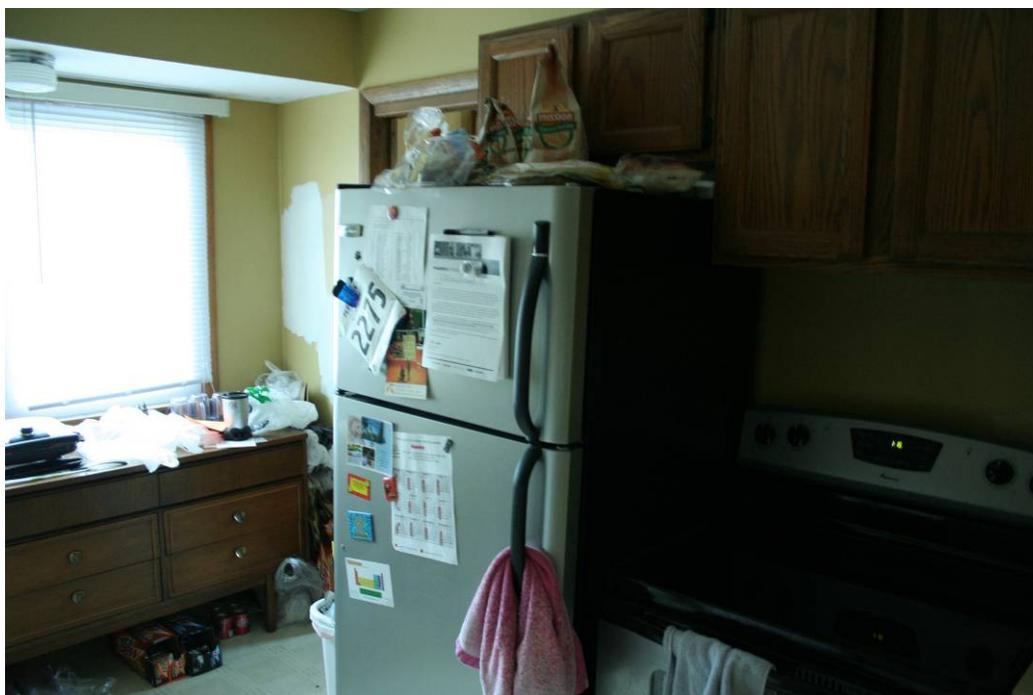
4908 Interior of kitchen

The house is heated by forced air furnace heat. Cooling is provided by way of on grade condenser. The bathroom is not exhausted to the exterior which will eventually lead to moisture issues. The kitchen also is not exhausted to the exterior. Exhaust should be provided to the exterior to prevent moisture build and interior damage including mold build-up.

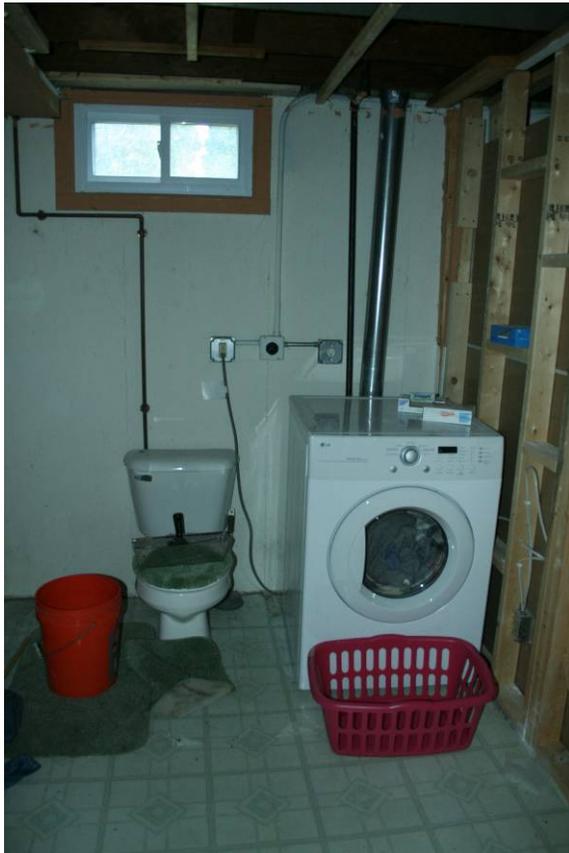
4908 Basement bath and Laundry

Almost all fixtures are in fair condition. Toilets are primarily 3 gpf fixtures and should be replaced with 1.6gpf units to conserve water resources.

Lavatory faucets and shower head should be replaced with low flow type to conserve water.
