**ANNIE C. STEWART MEMORIAL FOUNTAIN
CONSERVATION/PRESERVATION PLAN
MADISON, WISCONSIN**

Annie C. Stewart Fountain Conservation/Preservation Plan

Prepared for the City of Madison
By InSite Consulting Architects

PHOTO REPORT

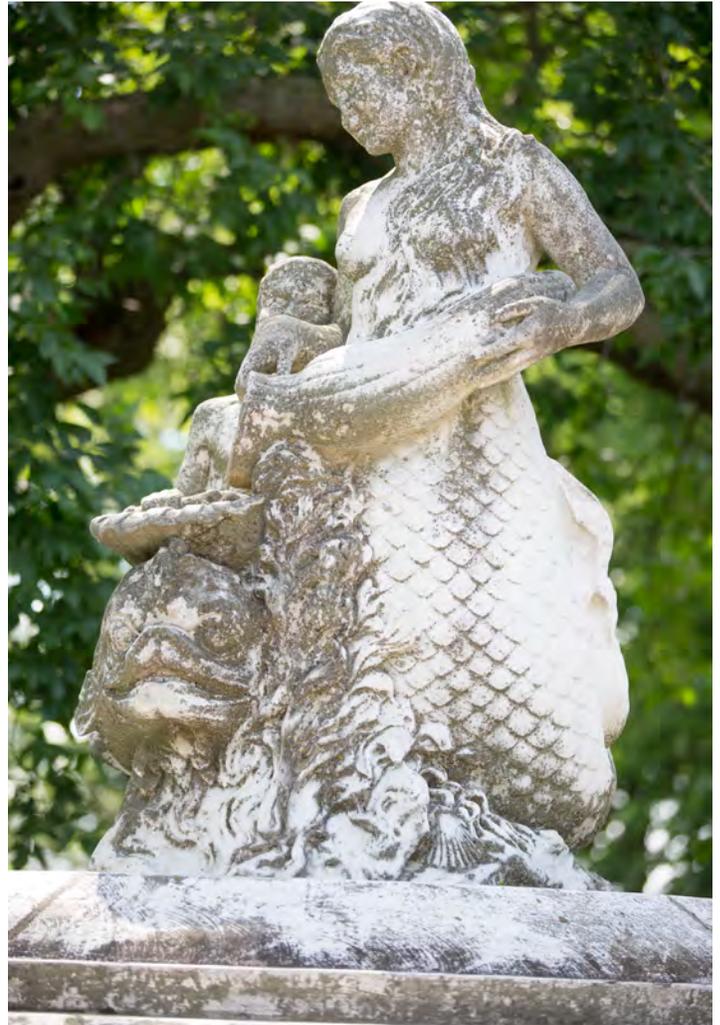
Figure 1: Overall view of condition of marble figures

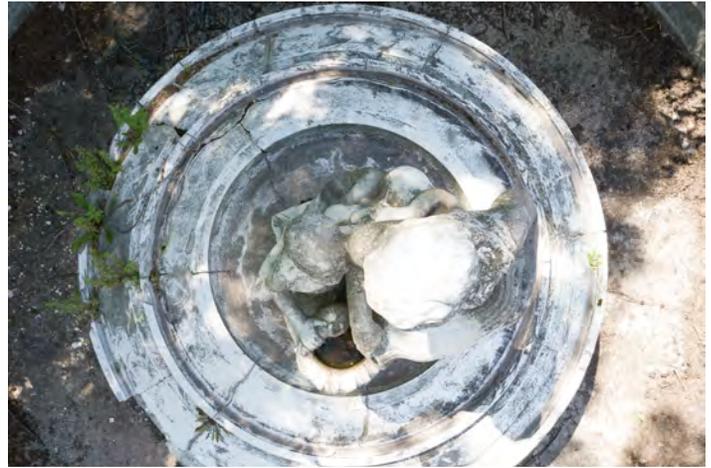
Figure 14: View of intricate spatial arrangement of marble figures from above

The support of the removal will likely require the restraint and/or confinement of certain details within the sculpture, such as the negative space between the Triton and Mermaid. This must be executed with precision to avoid breakage.

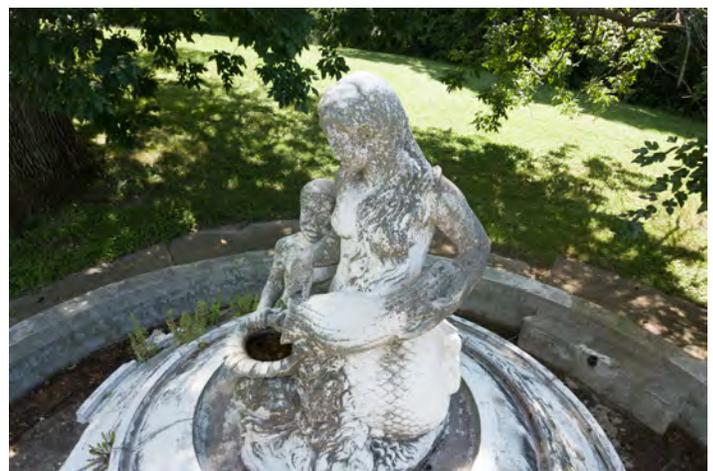
Figure 16: View of mermaid and cornucopia

The outer ring of concrete and the “stools” that supported the outer Tritons must be recreated verbatim. They must be installed in the same configuration and locations.

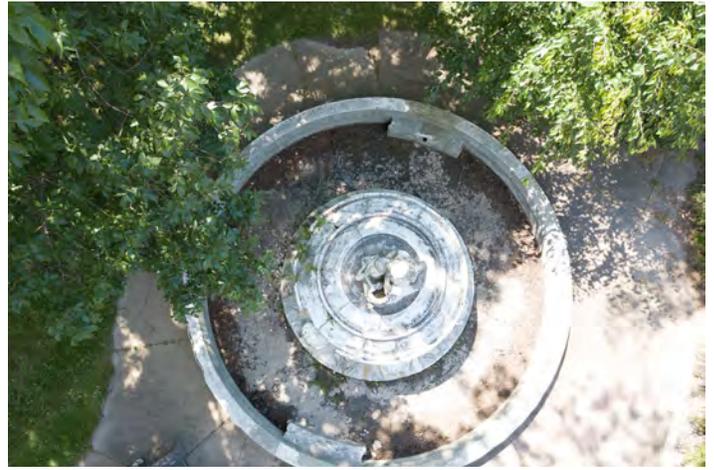
Figure 17: Overhead view of entire fountain

The sculpture and pedestal must also be reinstalled in precisely using the same configuration and orientation. This is a critical aspect of the overall composition and must be replicated.

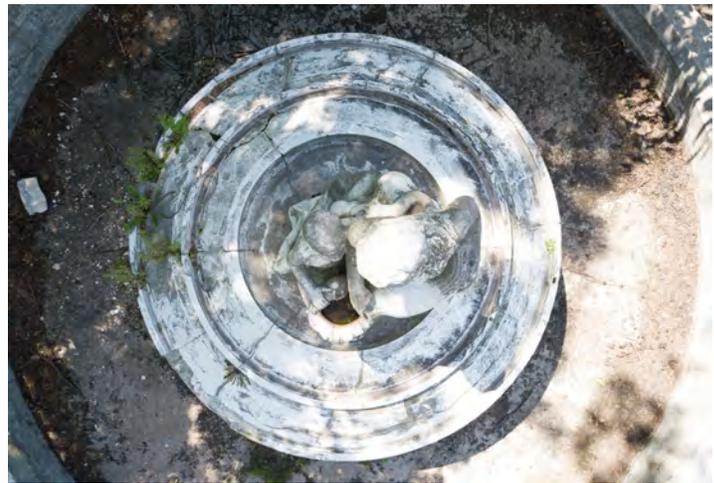
Figure 18: Close up overhead view of marble figures

The sculpture must be separated from the base with a minimum of damage to all of the original materials. Minimal wrecking may be required, but the pieces were set using some sort of mechanism/plan. We were unable to ascertain the method, further study is required.

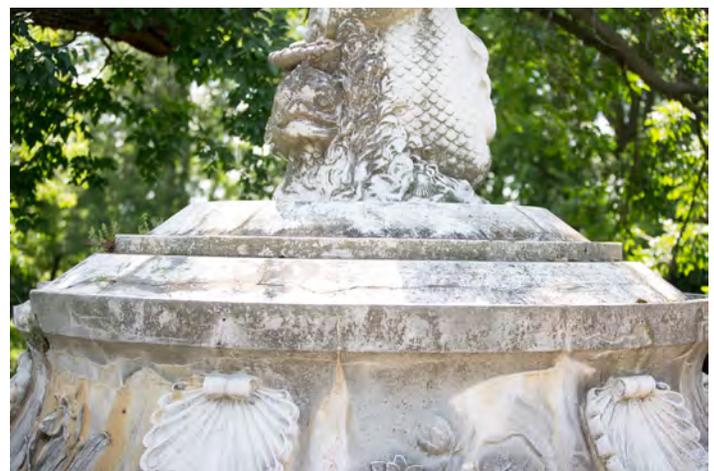
Figure 19: Relatively intact base/pedestal transition

The limestone base was beautiful in its own right. The details of the shells and finely detailed bas-relief botanical motifs are unique and locally relevant through its depiction of plants indigenous to the area.

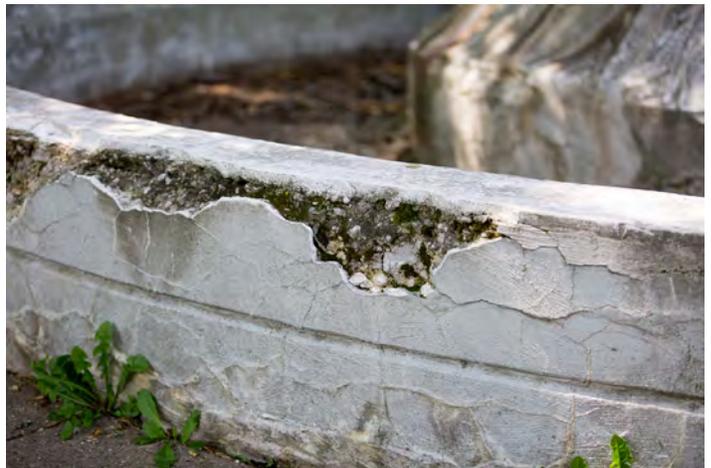
Figure 24: Coarse ring aggregate concrete at lower perimeter

The term “emerging damage” could be used throughout this report. This is one of many examples of the deterioration at the fountain that will continue to worsen. In our experience, these issues manifest themselves at an increasing rate as time progresses and neglect continues.

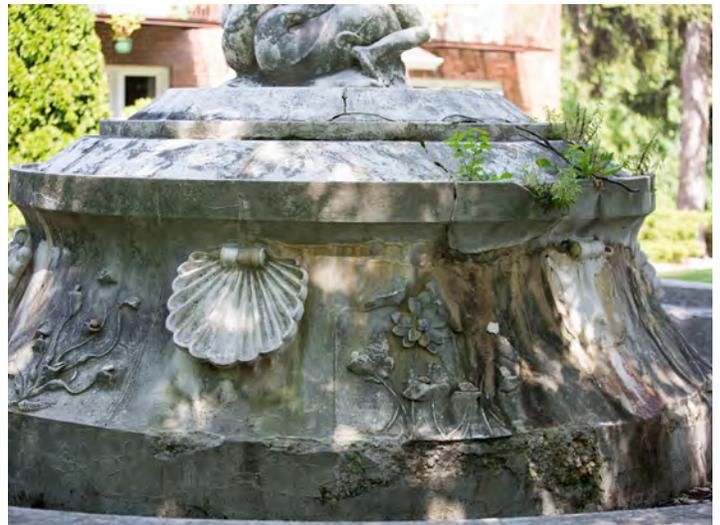
Figure 27: Primary area that should be used when recreating the stone base

The reconstruction can be based on the pieces that remain.

The entire fountain must first be fully documented using laser scanning techniques.

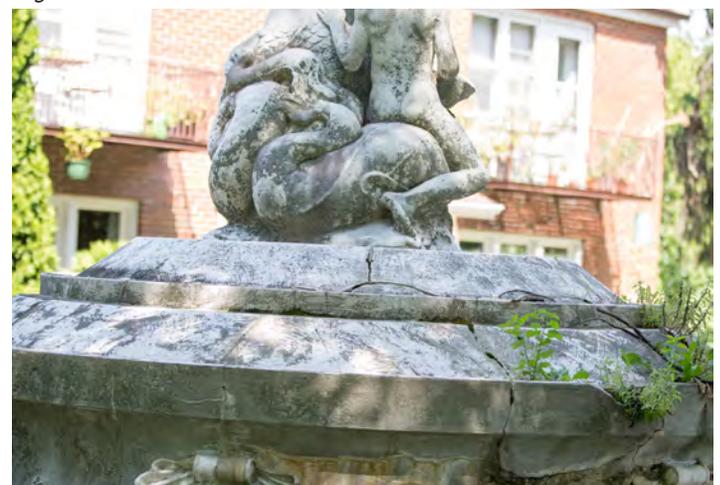
Figure 28: Close up of primary area that should be used when recreating the stone base

Then the fountain should be carefully deconstructed with as little loss to the original material as possible. Using an art conservator and a stone mason with experience in such work.

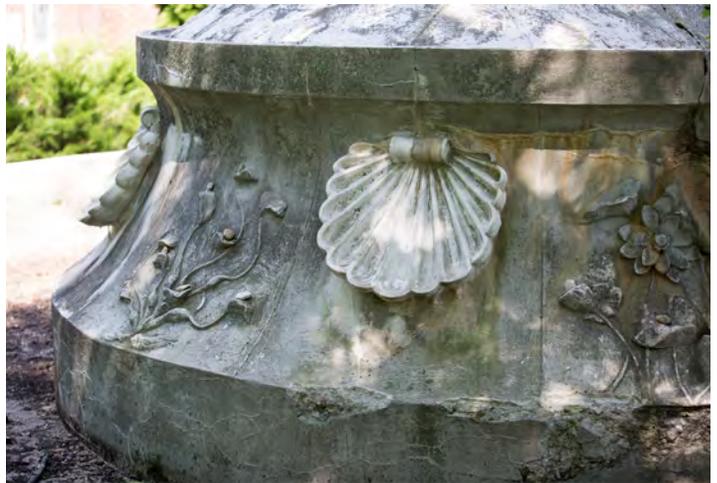
Figure 30: View of intact botanical motifs

Careful documentation of the construction, particularly at the junctures of dissimilar materials must be executed with care in order to guide the reconstruction process.

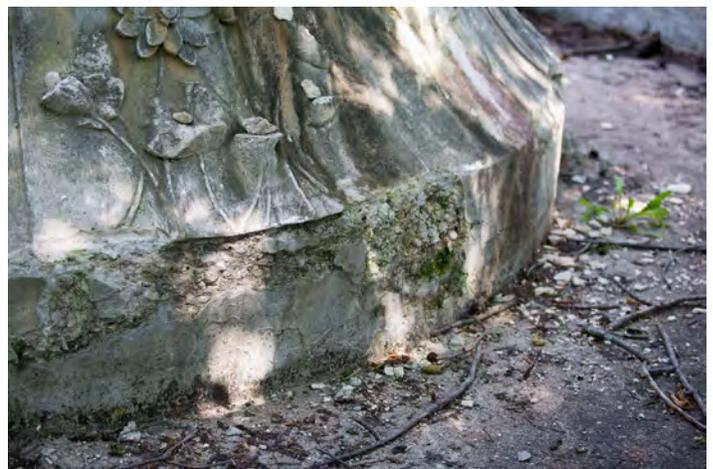
Figure 31: Stone to concrete transition

The concrete sub-base/foundation may actually be a cap over a cistern that was likely part of the original installation. Again, great care must be given when deconstructing the fountain.

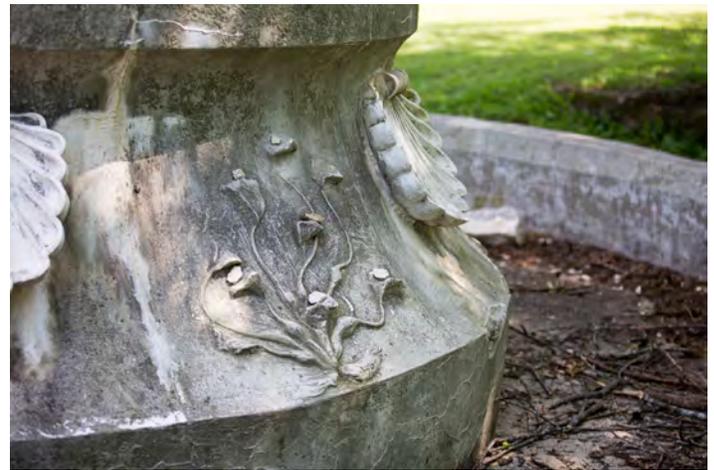
Figure 33: View of relief at fountain base

Intact areas of material transition may be studied to develop a plan for the best reconfiguration of the work. Based on the effect still visible nearly 100 years after installation, the precision in designing and installing the base is exceptional.

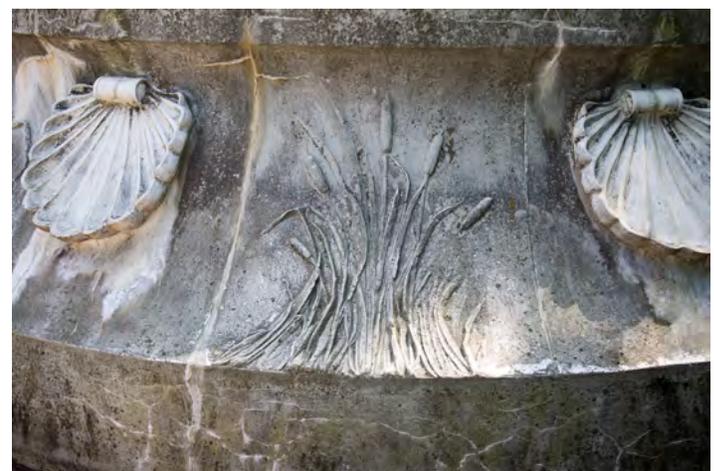
Figure 34: Relatively intact stone to concrete transition

The botanical motifs employed in the base must be preserved and recreated or restored. The final decision regarding the disposition of the materials of the base should be considered carefully.

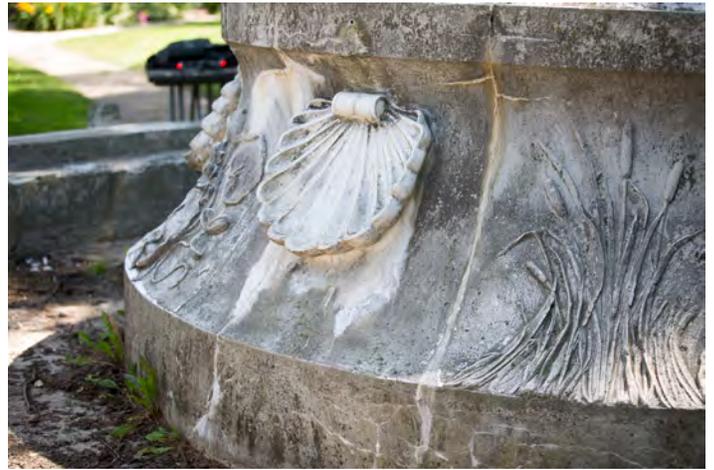
Figure 35: View of relief at foundation base

It is possible that the base was conceived by the artist and executed by others (as had been the case with the marble pieces). We believe that it is possible that this work was done by local artisans, although, we have not been able to confirm this.

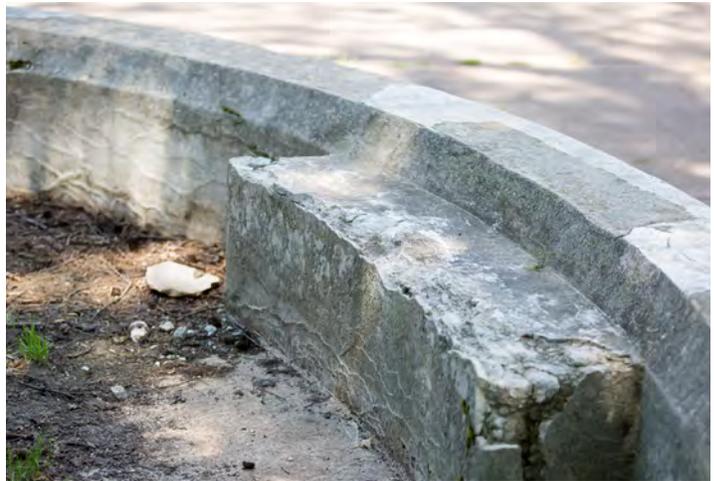
This is the location of one of the missing Tritons.

Figure 39: View of base of "dry" Triton

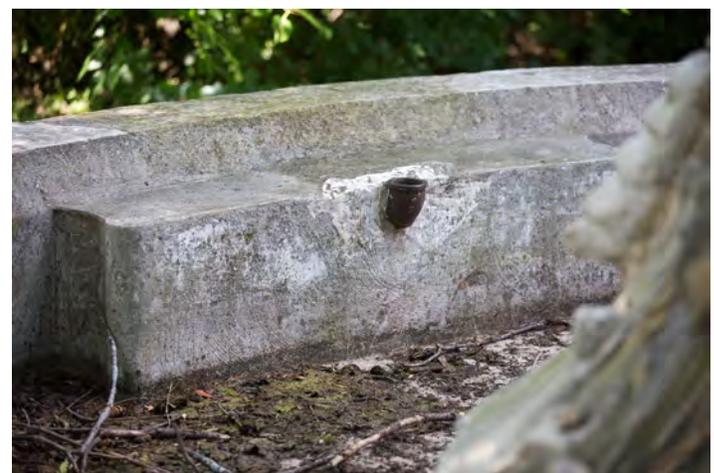
The location of the second missing Triton that was plumbed for the drinking fountain.

Figure 40: View of base of "wet" Triton

The damage to the fountain's base of limestone and concrete is not reversible. Complete restoration is required.

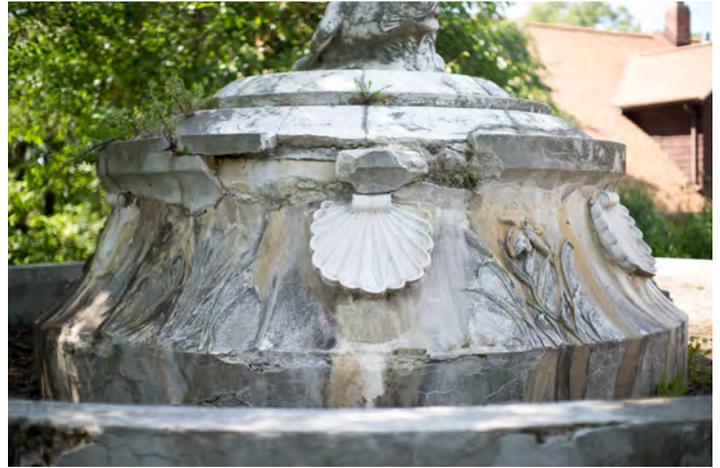
Figure 44: Overall view of base

The damage to the fountain's base of limestone and concrete is not reversible. Complete restoration is required.

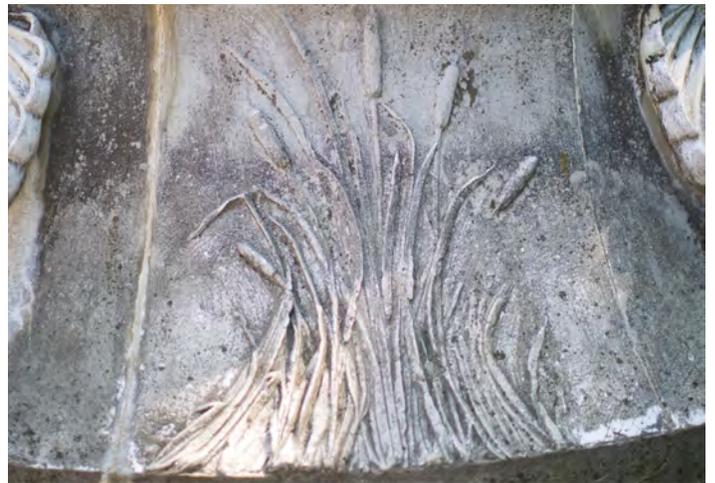
Figure 48: View of cattail motif

The damage to the fountain's base of limestone and concrete is not reversible. Complete restoration is required.

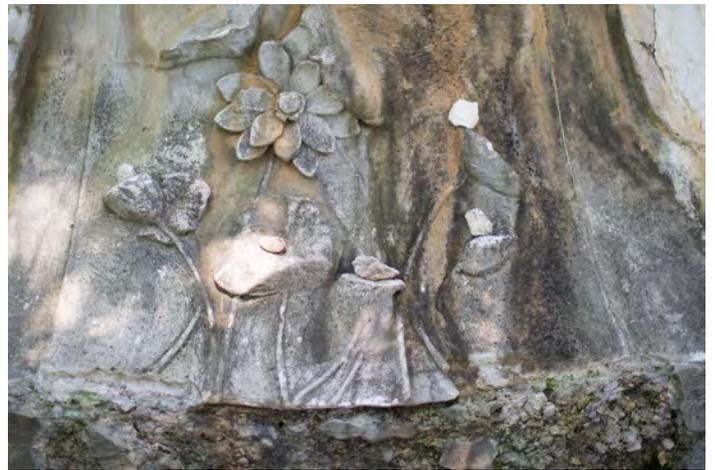
Figure 51: View of floral motif

The damage to the fountain's base of limestone and concrete is not reversible. Complete restoration is required.

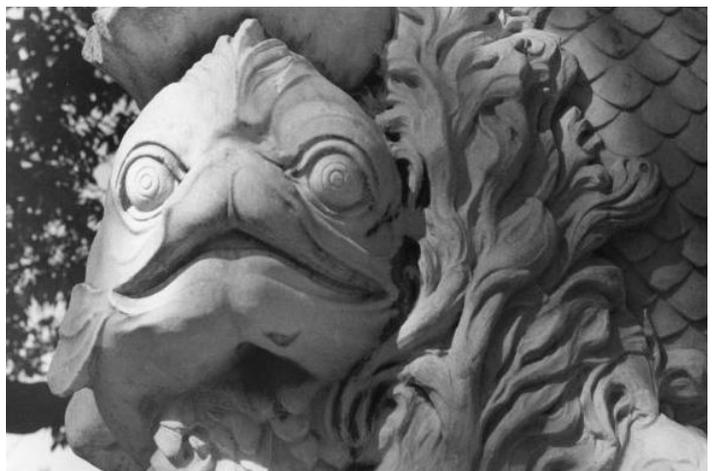
Dolphin in 1973 - The detail evident in this image is exceptional. While unconfirmed, it is apparent that the sculpture was either recently cleaned prior to this photograph or was benefited by a more proactive cleaning and maintenance program. When compared to a contemporary image of the same details it is evident that a significant amount of organic material obscures the detail. A proper conservation cleaning will help to ascertain what, if any, additional damage the piece has suffered.

This is the best example we could find of the condition of the marble sculpture in a preserved state. We believe that the marble should be restored to a condition as close to this as possible.

Figure 55: View of dolphin in 1973
