Mendota-Grassman Greenway

**Habitat Stewardship Subcommittee
by City of Madison Engineering Division
November 7, 2022**

Goal of project- Reduce 1% Annual Chance Flooding

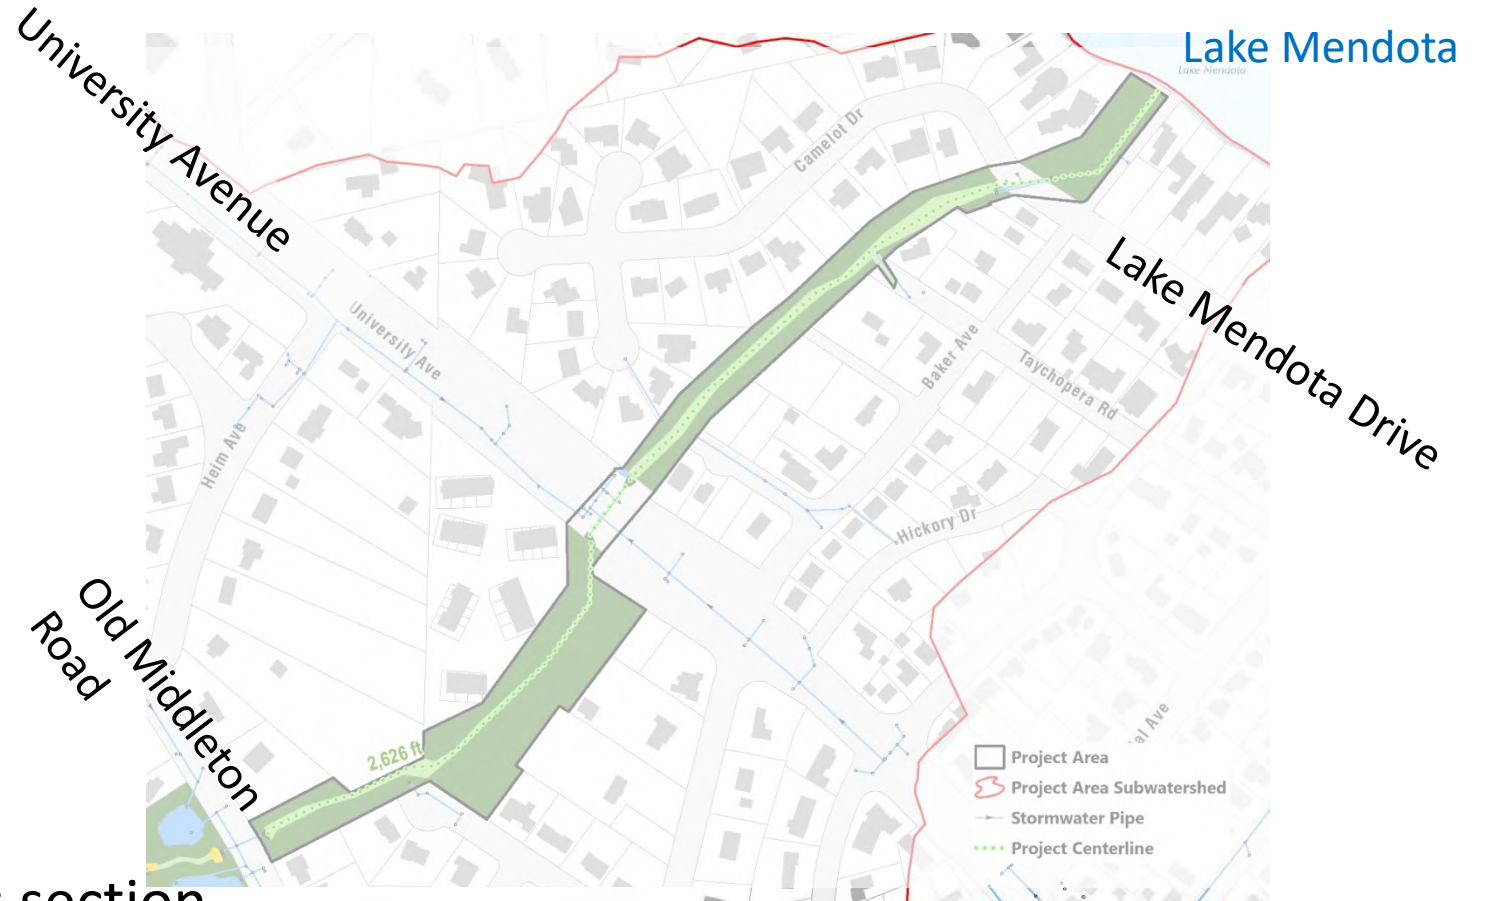
Channel Work

Existing Width ~ 20 feet

Evaluated three alternatives consisting of different widths and side-slopes with intent to minimize impacts to desirable trees

Recommendation ~ 39-foot average width

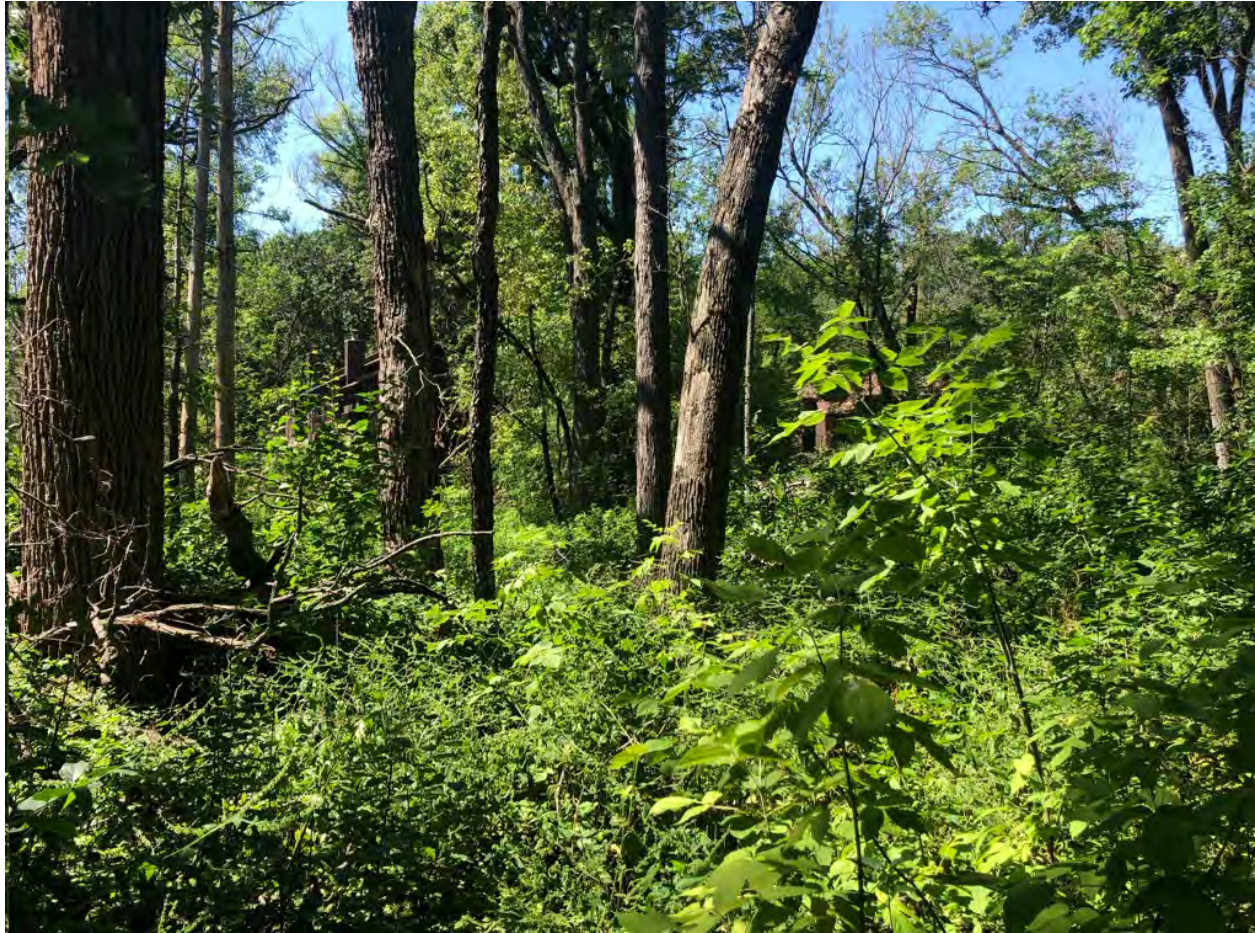
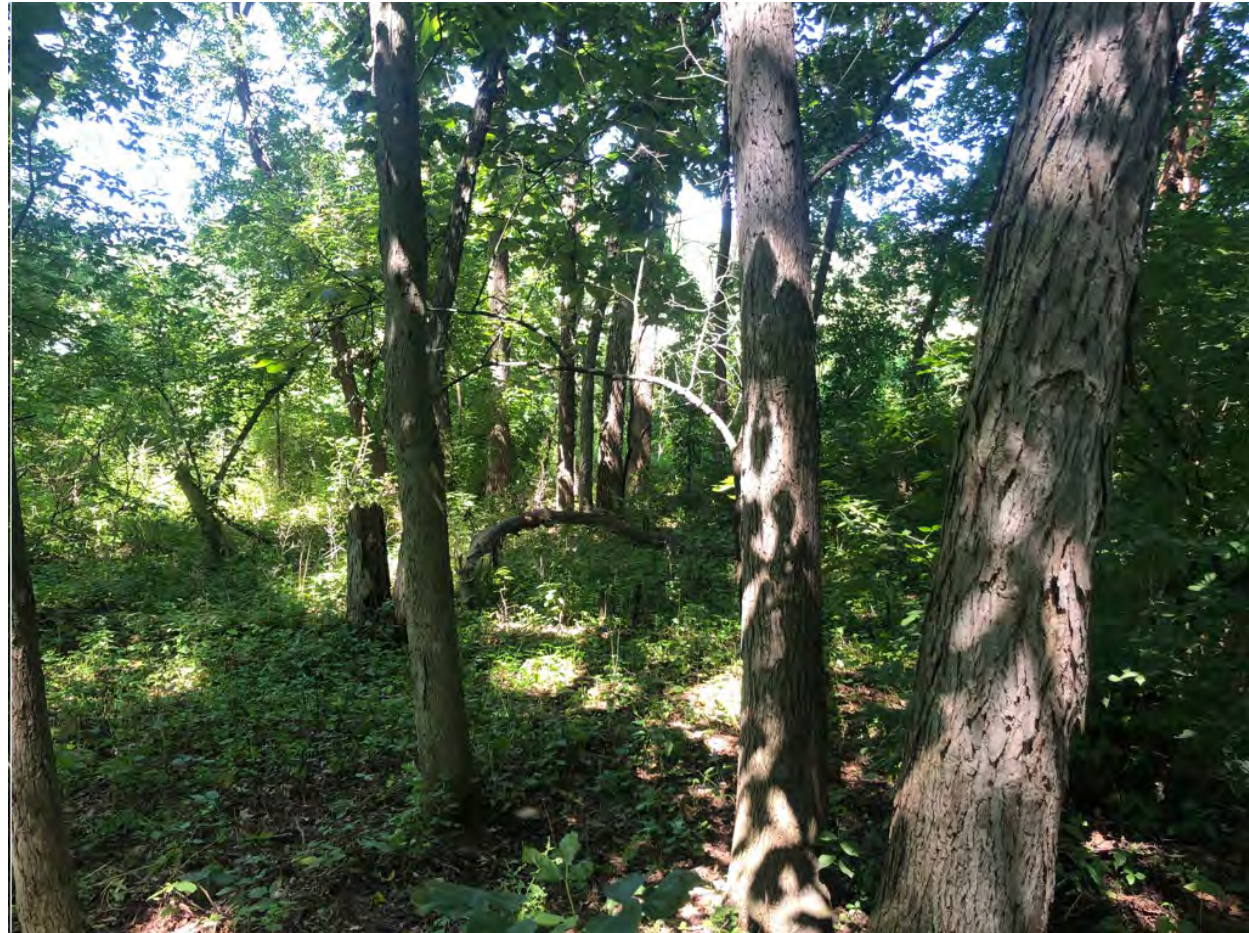
Current Vegetation

Woody volunteers: ash, buckthorn, box elder, honeysuckle. Little to no oak regeneration. Low herbaceous veg. diversity: Virginia stickseed, Virginia creeper, burdock, curly dock, jewelweed, garlic mustard.

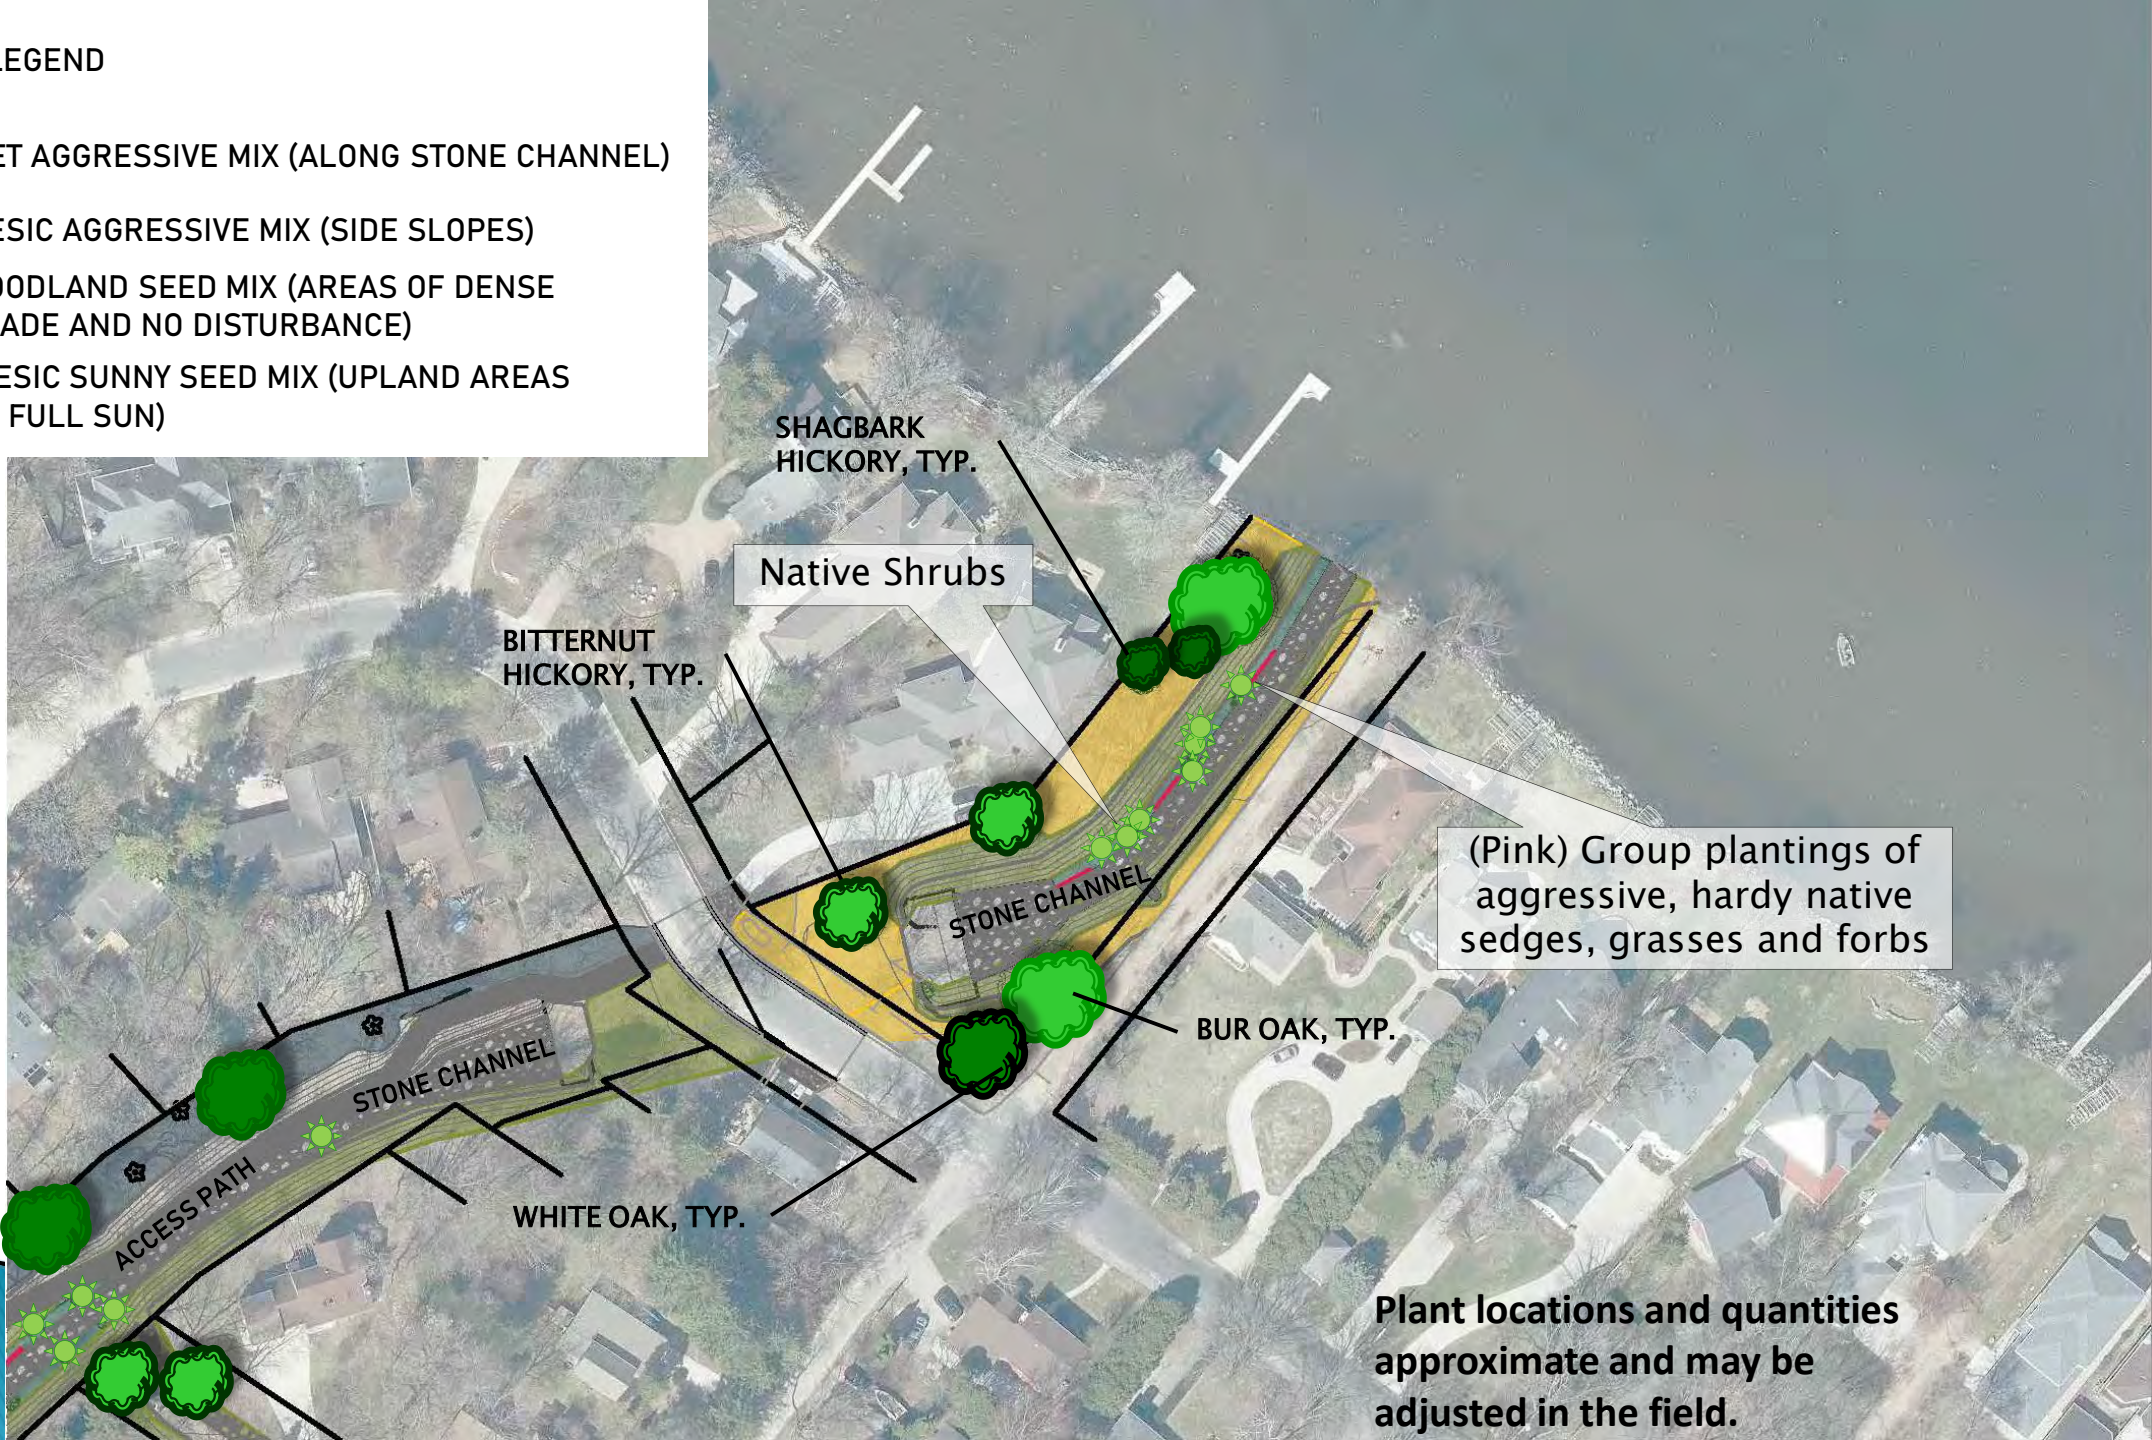
SEED MIX LEGEND

- WET AGGRESSIVE MIX (ALONG STONE CHANNEL)
- MESIC AGGRESSIVE MIX (SIDE SLOPES)
- WOODLAND SEED MIX (AREAS OF DENSE SHADE AND NO DISTURBANCE)
- MESIC SUNNY SEED MIX (UPLAND AREAS IN FULL SUN)

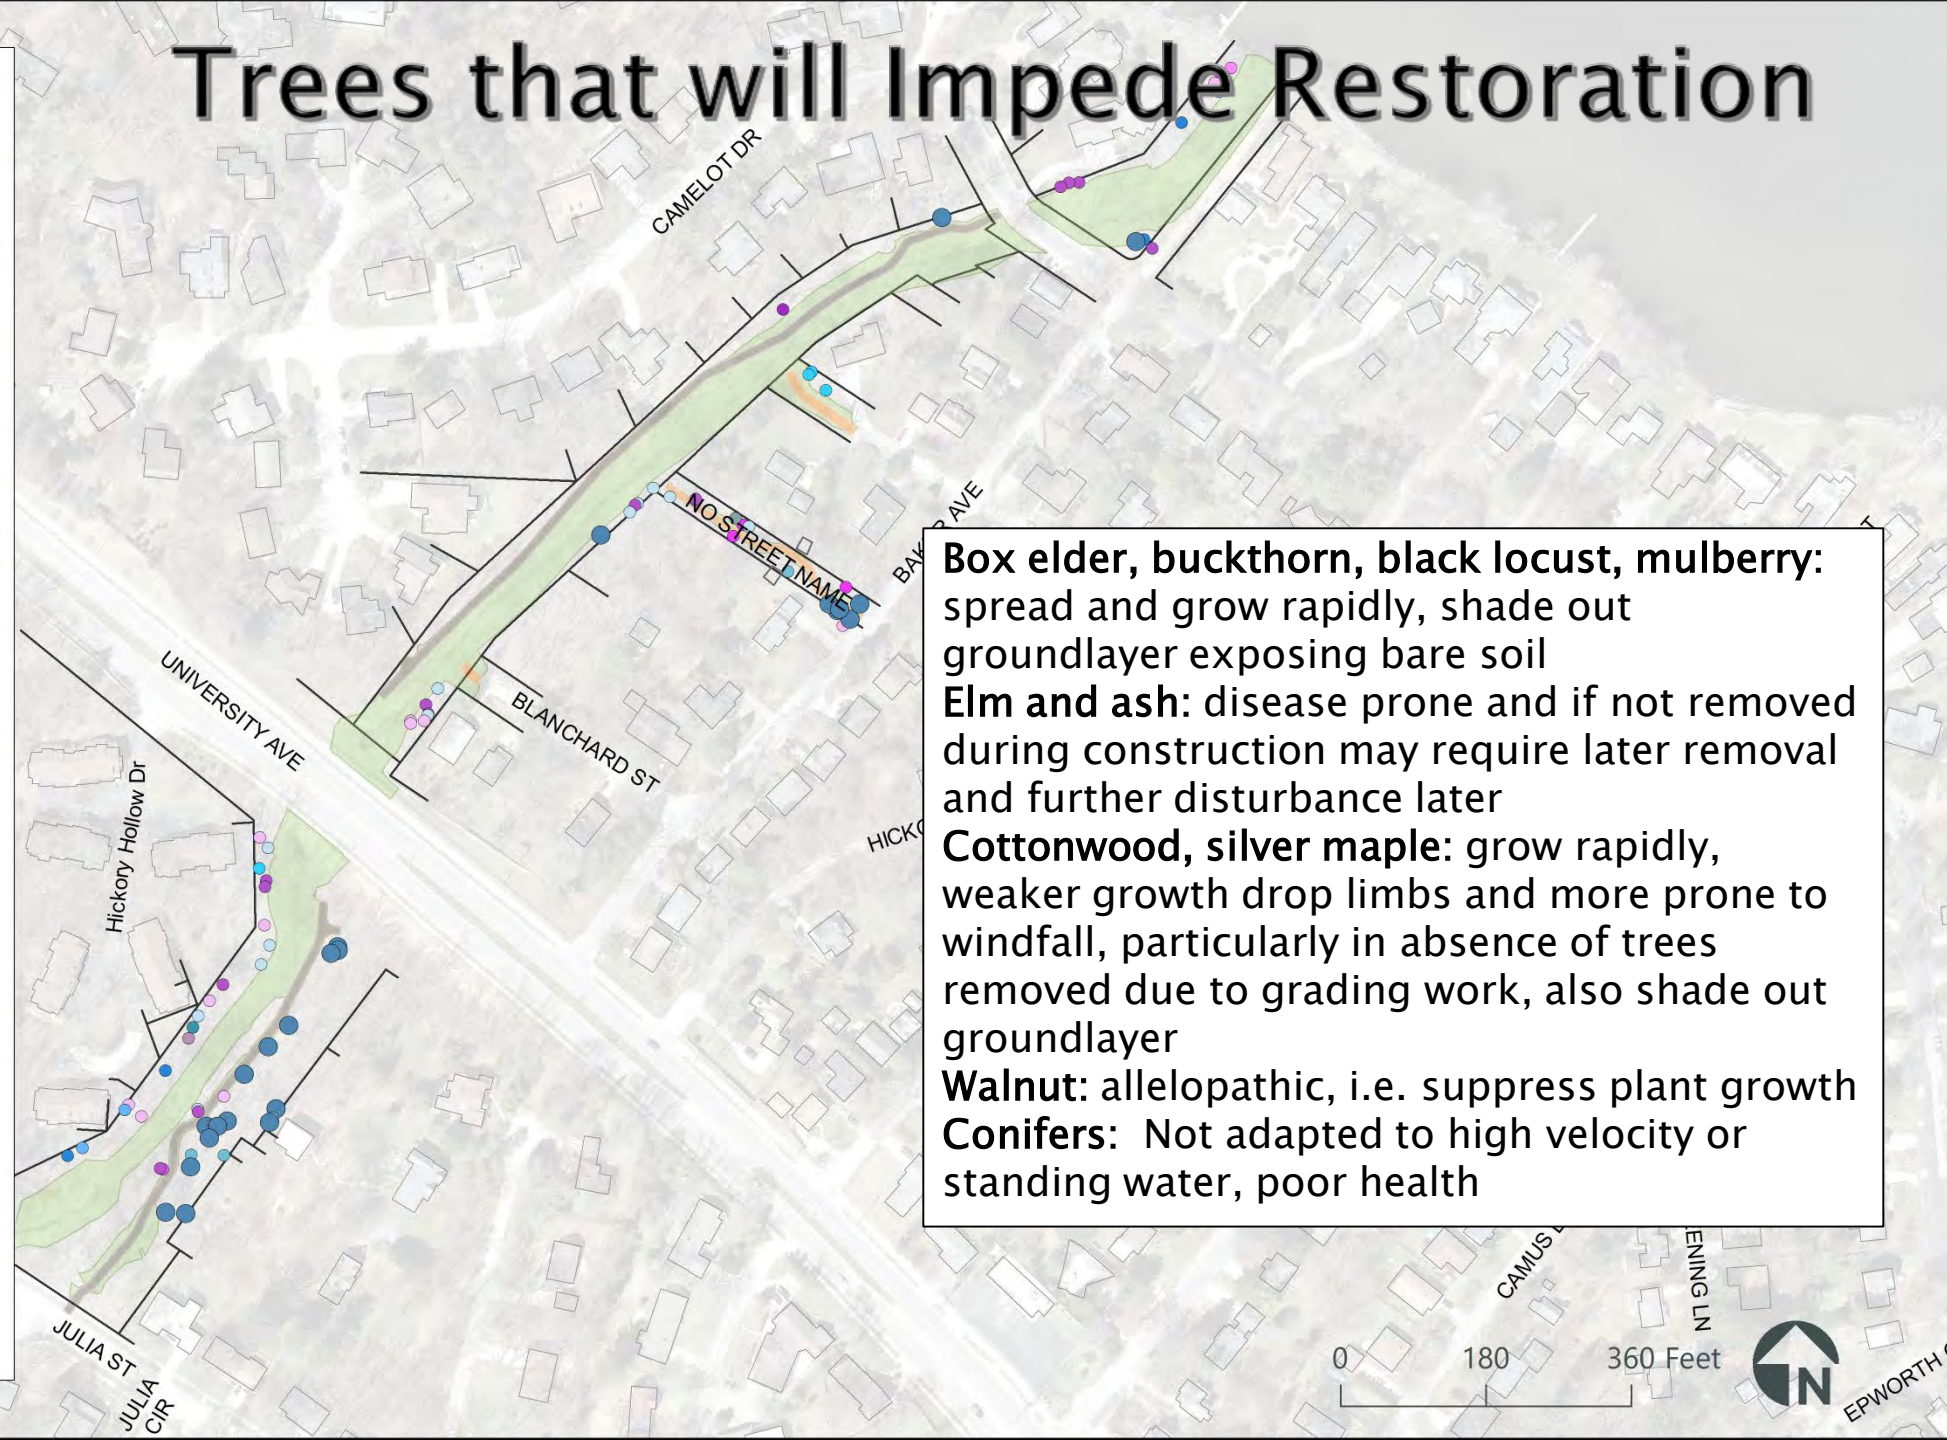
Trees that will Impede Restoration

Box elder, buckthorn, black locust, mulberry: spread and grow rapidly, shade out groundlayer exposing bare soil

Elm and ash: disease prone and if not removed during construction may require later removal and further disturbance later

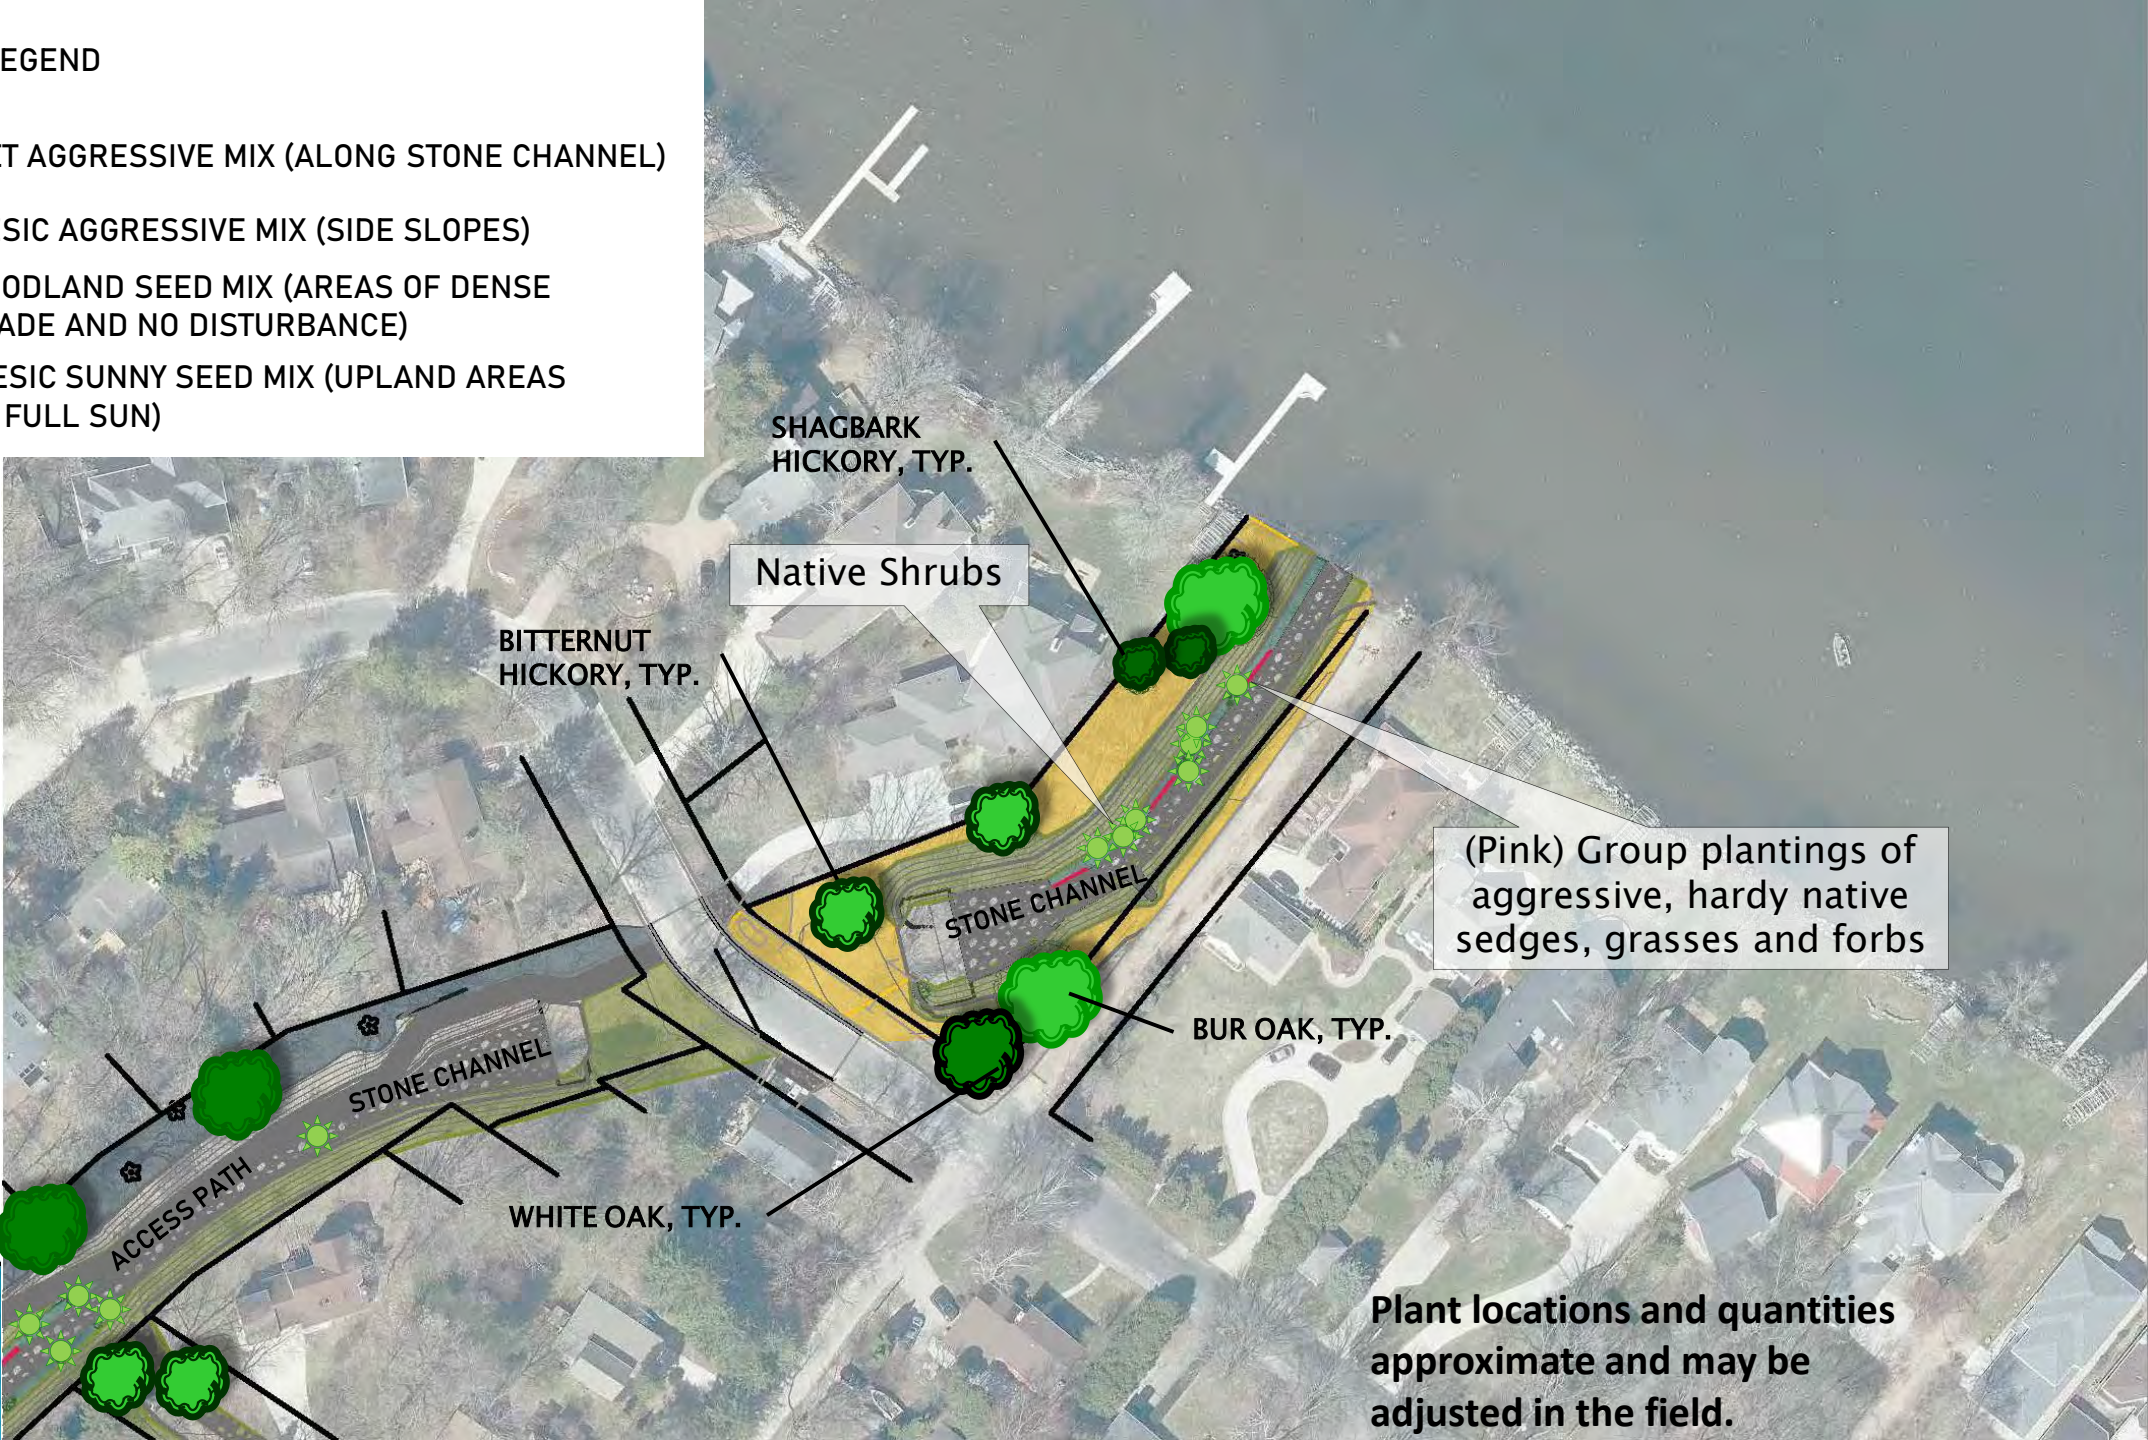
SEED MIX LEGEND

- WET AGGRESSIVE MIX (ALONG STONE CHANNEL)
- MESIC AGGRESSIVE MIX (SIDE SLOPES)
- WOODLAND SEED MIX (AREAS OF DENSE SHADE AND NO DISTURBANCE)
- MESIC SUNNY SEED MIX (UPLAND AREAS IN FULL SUN)
