Summary of Potential Well Sites March 24, 2011

Madison Water Utility Pressure Zone 4 Well Siting Factors

Dairy Center Summary March 24, 2011

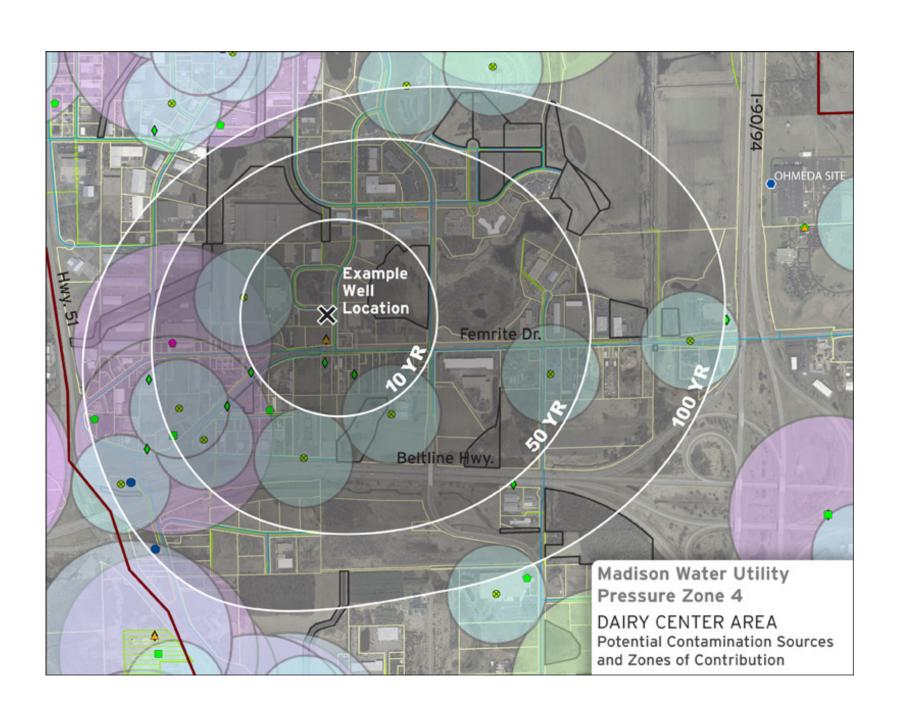
Contours on contamination maps labeled "10 YR", "50 YR", and "100 YR" show the estimated areas of the bedrock aquifer ("zones of contribution") that contribute groundwater to a well at the "example well location" over period of 10, 50 and 100 years at an average pumping rate for Madison water supply wells. These zones of contribution were estimated using the Dane County Regional Aquifer Flow Model developed cooperatively by the Wisconsin Geological and Natural History Survey and the United States Geological Survey.

Status	In consideration
Background	This site was originally identified for evaluation because there are several undeveloped parcels in this area not immediately adjacent to identified known or potential sources of contamination.
Primary Reason for Exclusion	NA
Advantages	Relatively centrally located in southern portion of pressure zone.
311	Within 1,600 feet of a 16-inch water main through a partly-developed area.
	Properties in the area are for sale.
	The only documented groundwater contamination sites within 10 to 50 year zones of contribution (ZOCs) are limited to two properties with minor petroleum contamination plumes, from leaking underground tanks, that do not extend beyond the respective source properties. The 100 year ZOC intersects a 1,200 foot radius two additional sites with residual petroleum contamination.
Disadvantages	Hydrogeologically down-gradient from the Ohmeda groundwater contamination plume

Somewhat close to two sites closed with residual groundwater contamination
Site Buildability	None of the available sites are within the mapped 100-year floodplain.
Site Dulidability	Portions of the properties on the lots on the east side of Dairy Drive abut or extend into mapped wetlands.
	A high pressure gas pipe in this area will likely require a minimum100-foot setback.
	Soils in the area have low to moderate bearing capacity and high water table.
Contaminated Sites Summary	Four sites with groundwater contamination exceeding groundwater quality enforcement standards are shown on the Wisconsin Department of Natural Resources GIS system within the 100-year zone of contribution (ZOC) identified using the Dane County groundwater flow model. The contaminants of concern at all of these sites are petroleum related and do not appear to have migrated much beyond the boundaries of the source properties.

Two additional sites with the 100-year ZOC are currently being investigated for petroleum contamination in groundwater.
	The Datex-Ohmeda site is currently under investigation for dissolved chlorinated solvents (primarily trichloroethylene and related contaminants) in groundwater. The plume extends at least as far as the existing Madison Water Utility property on Femrite Drive west of the interstate.

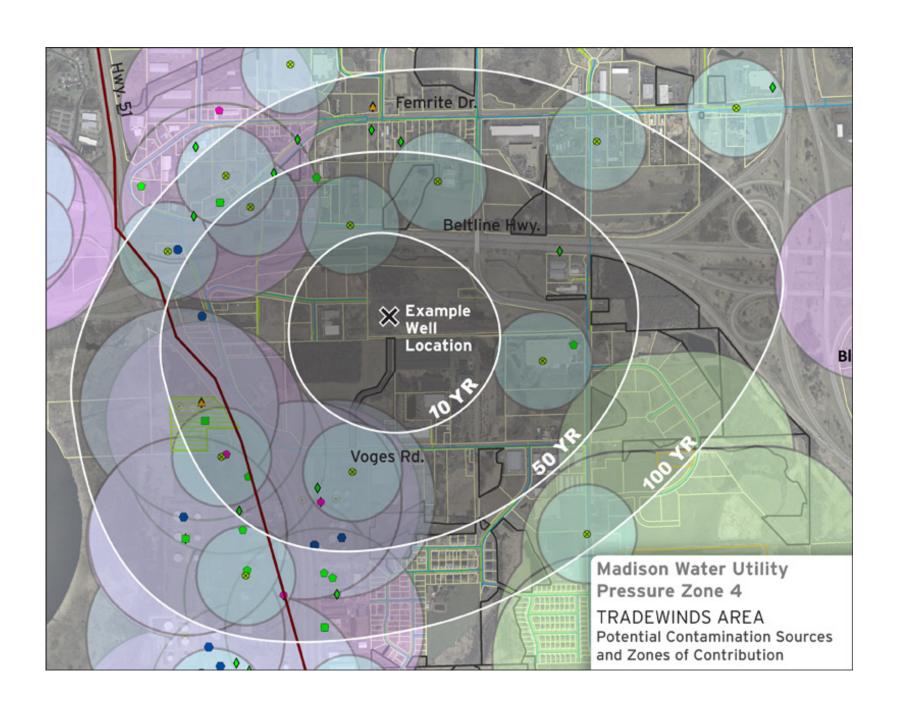
Tradewinds Area Summary March 24, 2011

0	In a consideration
Status	In consideration
Background	This site was originally identified for evaluation because it is in a relatively large tract of undeveloped land not immediately adjacent to identified known or potential sources of contamination.
	IN LA
Primary Reason for Exclusion	NA .
Advantages	Relatively centrally located in southern portion of pressure zone
	Within 3,000 feet of a 16-inch water main through largely un-developed area
	Properties in the area are for sale
Disadvantages	Hydrogeologically down-gradient from the Ohmeda groundwater contamination plume
	Proposed lots 1 through 5 in the Tradewinds Business Center may be within 600 feet of a 500 gallon gasoline aboveground storage tank at Franklin Fueling Systems on Marsh Road, a NR 811 variance would be required for these lots.
	The 50 and 100 year zones of contribution (ZOCs) include the northern portion of the Terminal Drive/Triangle Street tank farms.

Site Buildability	Several of the available proposed lots (3 through 7, 14, 15, and 16) in the Tradewinds Business Center area are currently with the mapped 100-year floodplain.
	Most of the proposed lots on the north side of Tradewinds Parkway are mapped as filled wetlands.
	Soils in the area have low to moderate bearing capacity and high water table.
Contaminated Sites Summary	Nine sites with groundwater contamination exceeding groundwater quality enforcement standards are shown on the Wisconsin Department of Natural Resources GIS system within the 100-year zone of contribution (ZOC) identified using the Dane County groundwater flow model. The contaminants of concern at all of these sites are petroleum related and do not appear to have migrated much beyond the boundaries of the source properties.
	Eight additional sites with the 100-year ZOC are currently being investigated for petroleum contamination in groundwater.

The Datex-Ohmeda site is currently under investigation for dissolved chlorinated solvents (primarily trichloroethylene and related contaminants) in groundwater. The plume extends at least as far as the existing Madison Water Utility property on Femrite Drive west of the interstate.
Notes	The quality of the fill soils in portions of the Tradewinds area will need to be evaluated for geotechnical properties and potential contamination on an individual site basis.

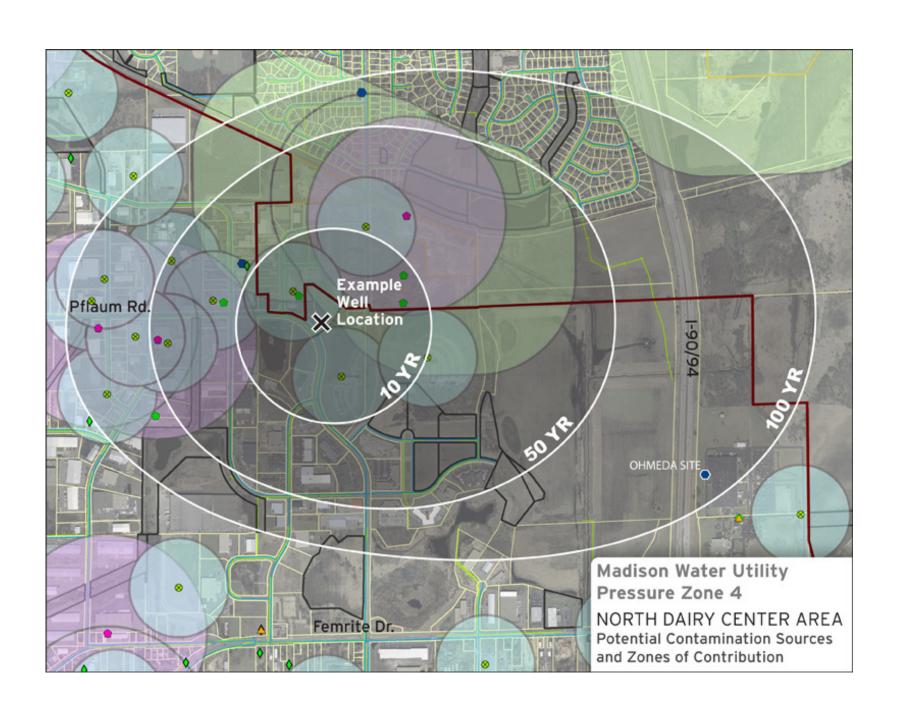
North Dairy Center Summary March 24, 2011

Status	In consideration as an alternate to Dairy Center or Tradewinds
Background	This site was identified as an alternate for evaluation because there is at least one available undeveloped parcel in this area that may be suitable as a well location. This area was added for consideration after potential limitations were identified on sites in the Dairy Center (south) and Tradewinds areas.
Primary Reason for	NA NA
Exclusion	I WA
LACIUSIOII	
Advantages	Relatively centrally located in southern portion of pressure zone.
	Within 100 to 500 feet of a 16-inch water main.
	At least one property in the area is for sale.
Disadvantages	Relatively close to three sites closed with residual groundwater contamination and one active site with petroleum and solvent contamination in groundwater.
	Variance would be required for proximity to active underground storage tank systems.
Site Buildability	The area is not within the mapped 100-year floodplain.

Soils in the area have low to moderate bearing capacity and high water table.
Contaminated Sites	Three sites with groundwater contamination exceeding groundwater quality enforcement standards are shown on the
Summary	Wisconsin Department of Natural Resources GIS system within the 100-year zone of contribution (ZOC) identified using
Cummar y	the Dane County groundwater flow model. The contaminants of concern at all of these sites are petroleum related and
	do not appear to have migrated much beyond the boundaries of the source properties.
	Two inactive landfills are located within the 50-year ZOC.
	The former Safety-Kleen facility on Daniels Street is currently under investigation for petroleum contamination and
	solvents in soil and groundwater.
	The Datex-Ohmeda site is currently under investigation for dissolved chlorinated solvents (primarily trichloroethylene
	and related contaminants) in groundwater. The plume extends at least as far as the existing Madison Water Utility

property on Femrite Drive.
