RE: ADDENDUM 1 10005-0-2021-AM Architectural Design Services for a Men's Homeless

## **ROOF INSPECTION**

Site: 2002 Zeier Road Madison, WI

Inspection Date: October 29, 2020

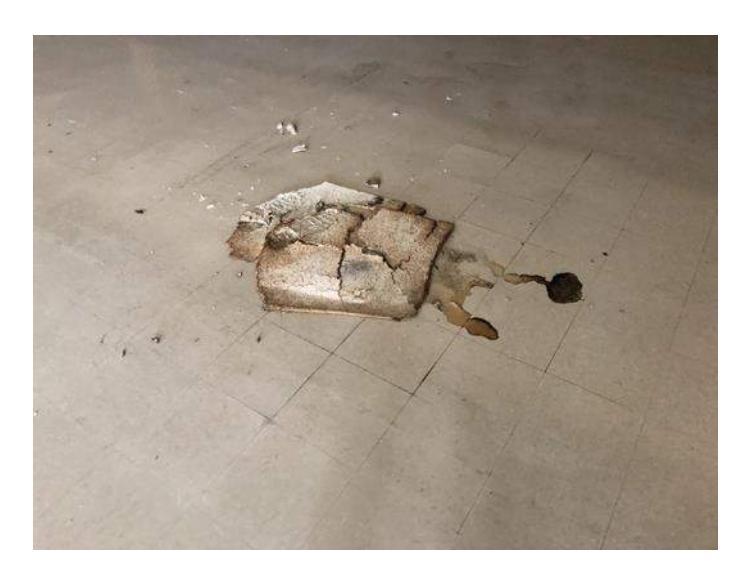
The building is vacant. We walked the floor and found one dropped tile underneath the east rooftop unit. We did not find any areas of moisture inside the building.

We noted approximately seven openings in flashings. We did not however find any openings in the flashings on rooftop unit #2 which is the unit above the dropped tile. It is possible there is a tear in the membrane beneath the ballast or the unit itself may be leaking. Additional investigation will be required including removing ballast from the around the vicinity of the unit.

Dropped ceiling tile underneath rooftop unit #2.

We would recommend repairing seven openings in flashings and remove ballast from around rooftop unit #2 to further investigate the leak. Cost to repair: \$1,045.00

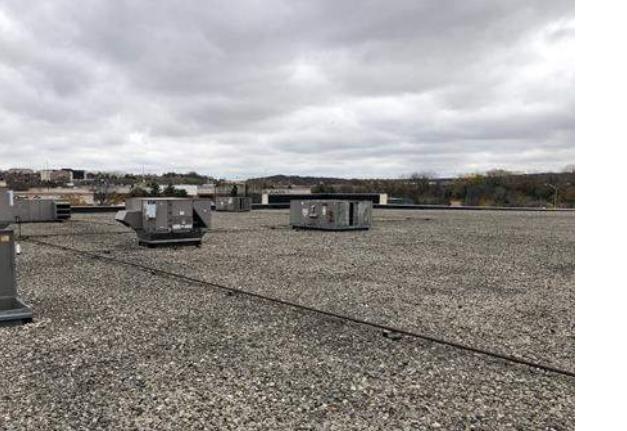
We found date stamps on the main ballasted EPDM roof from 1989 making this roof system approximately 31 years old. A typical service life expectancy for a ballasted EPDM roof is 25 years. The perimeter wall flashings have been reworked approximately six years ago though it appears a reinforced perimeter fastening strip was not used because the flashings are beginning to tent again in some areas and other areas with very low flashings were not reflashed and are showing significant tenting that is at risk of tearing.

Roof overview.

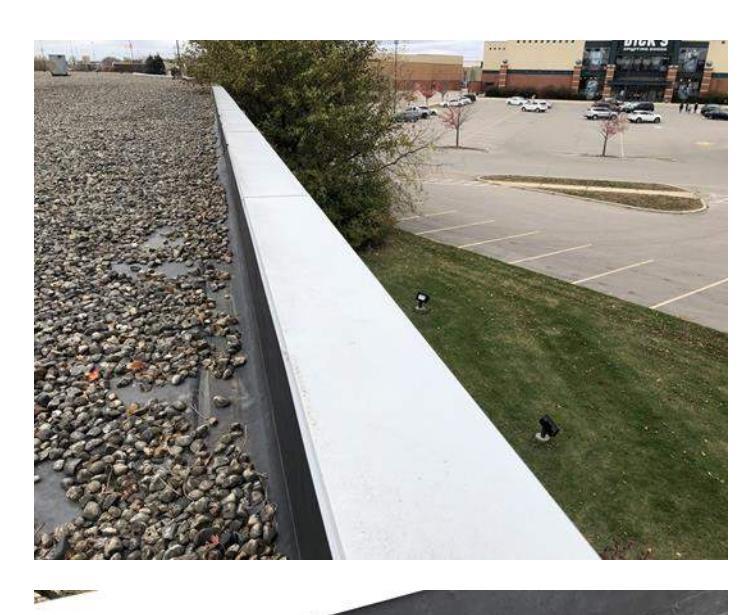
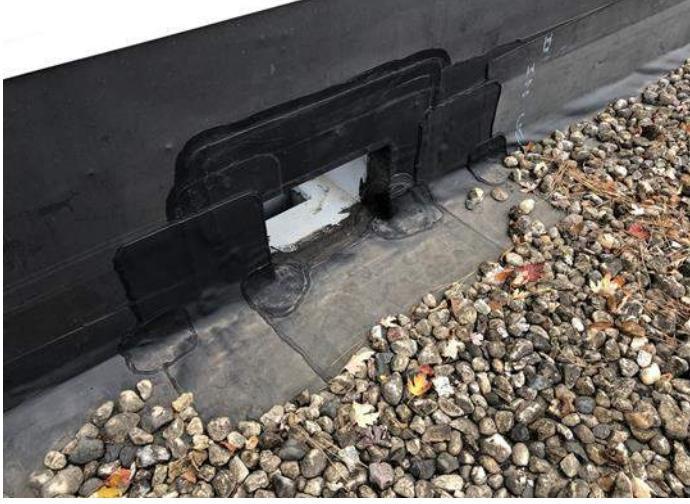
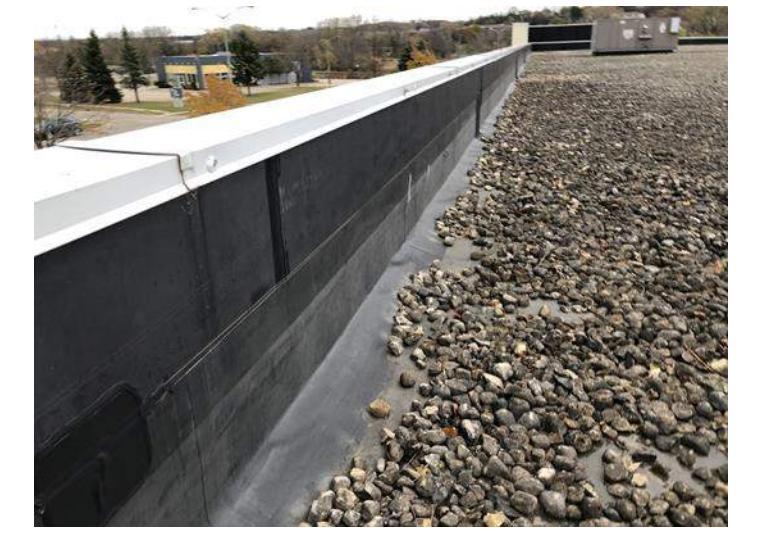
Metal coping is in good condition.

Scuppers are clear of debris.

Area of reflashed wall.

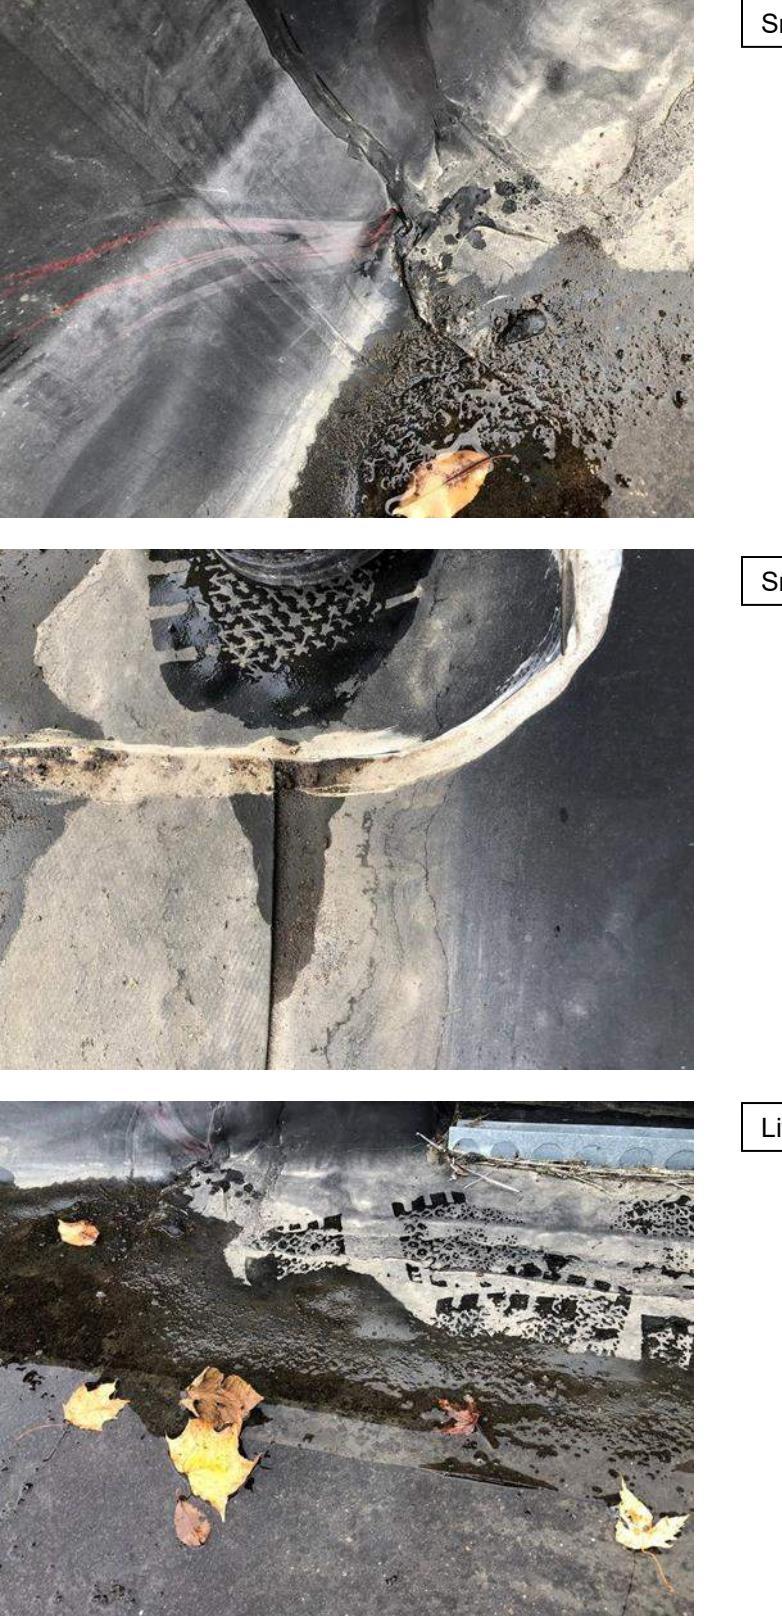
Small opening.

Lifting flashing in submerged area.

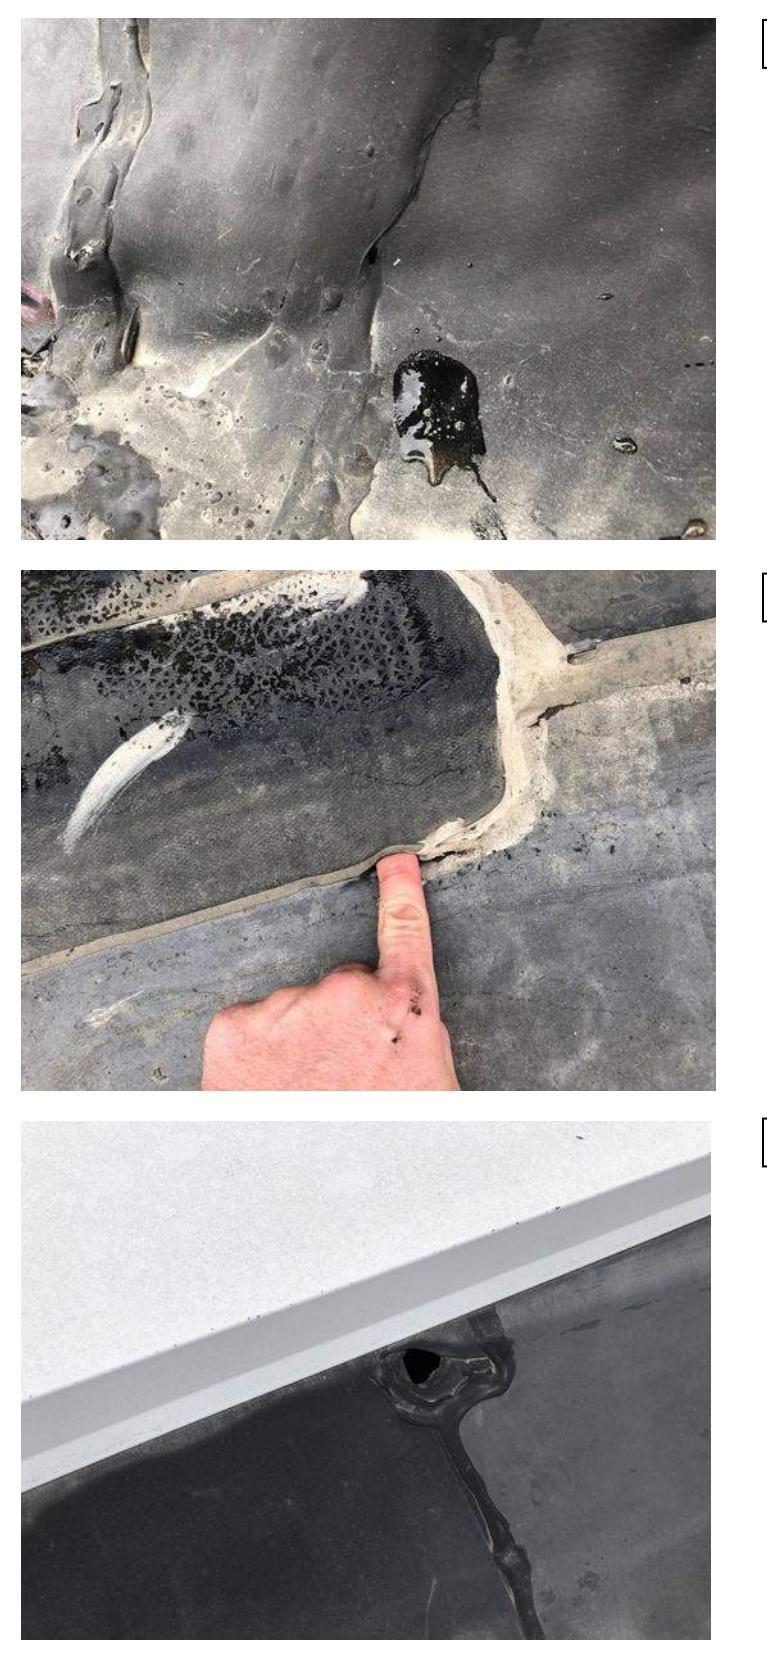
Small opening.

Hole in wall flashing.

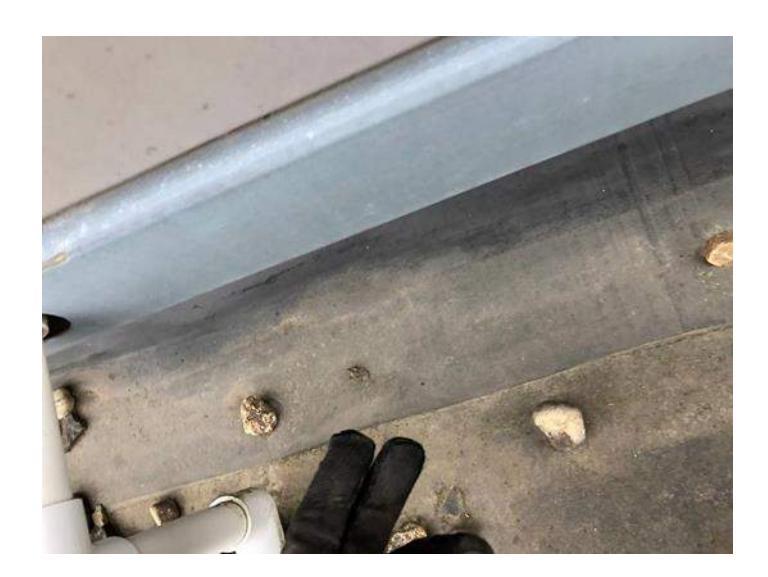
Area of lifting flashing where seam tape is missing.

Red marks areas of walls to be reflashed.

We would recommend reflashing two lengths of tenting flashing. Cost to repair: \$2,961.00

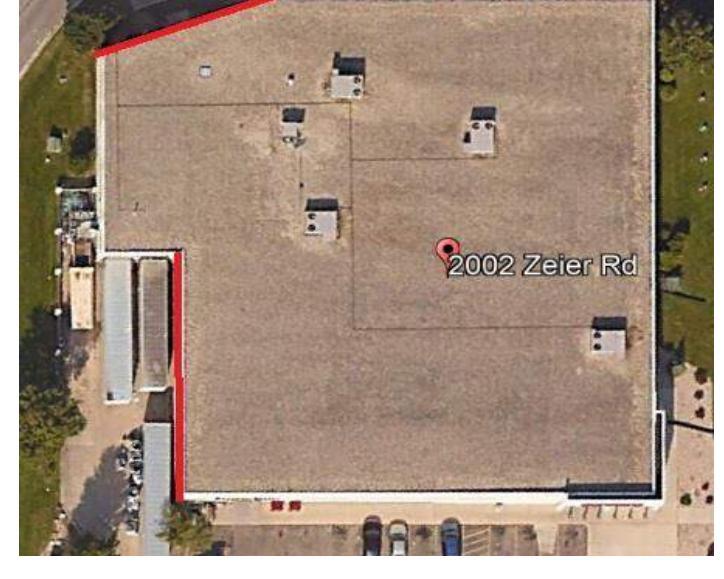
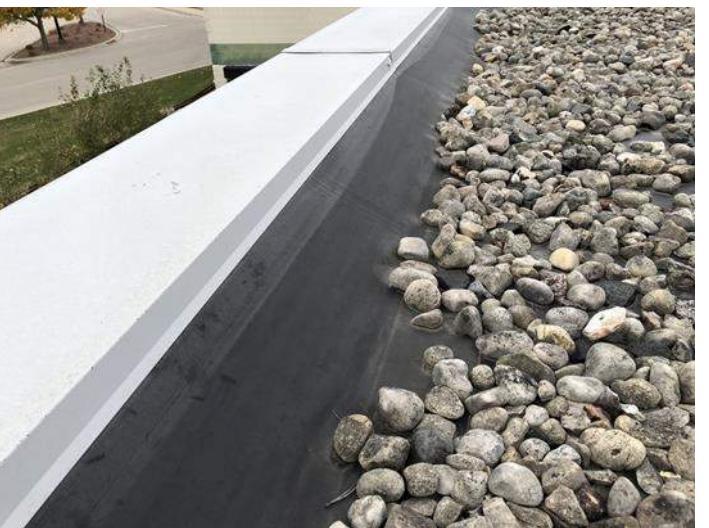
Tenting wall flashing. Area of lighter membrane indicates amount of tenting membrane. If the membrane continues to shrink, it will eventually tear open.

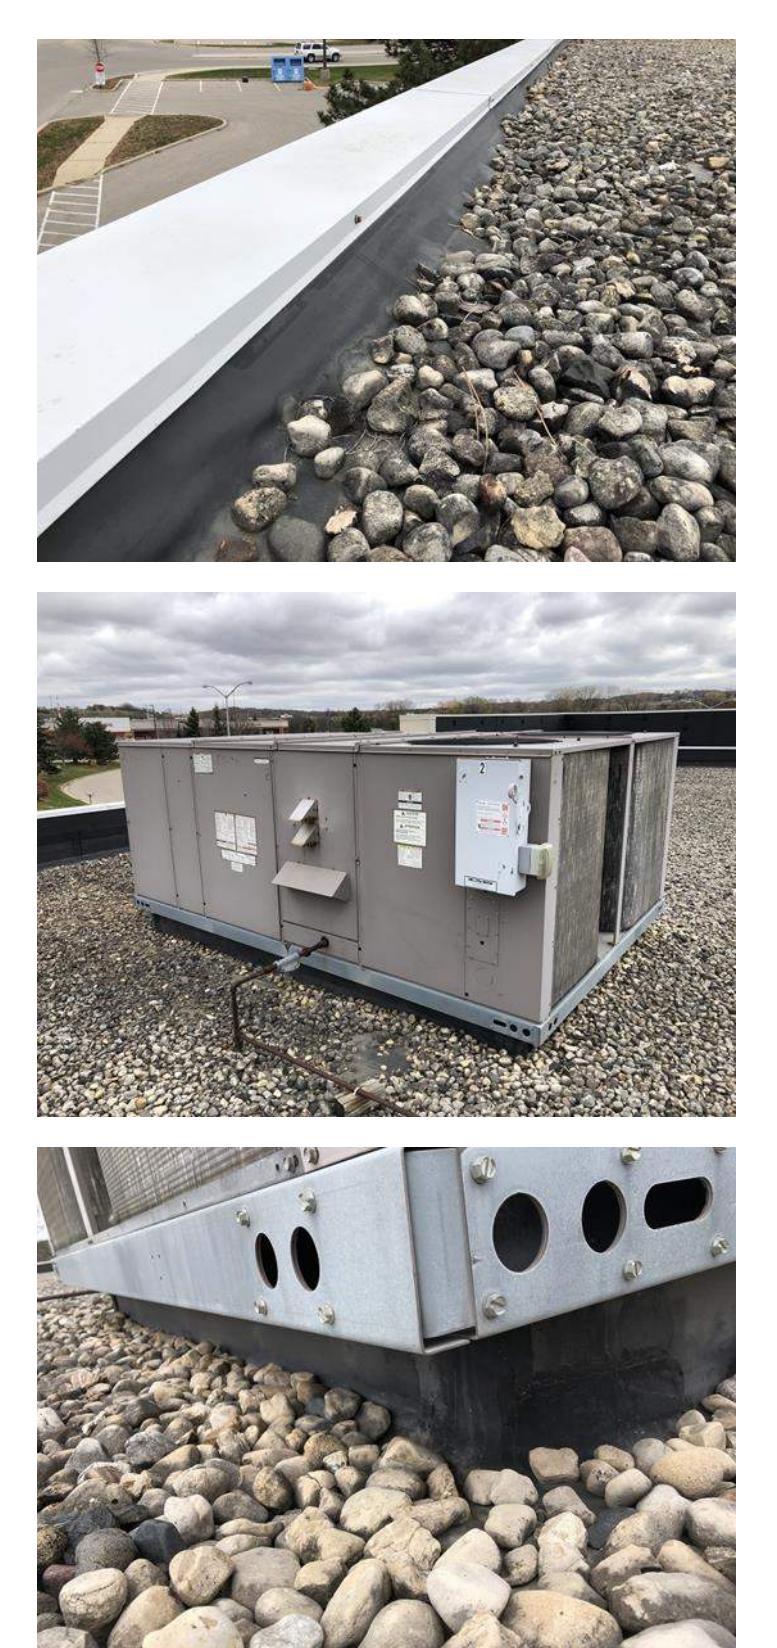
Area of tenting membrane.

Rooftop unit #2 in vicinity of dropped ceiling tile.

Flashings are rooftop unit #2 appear intact.

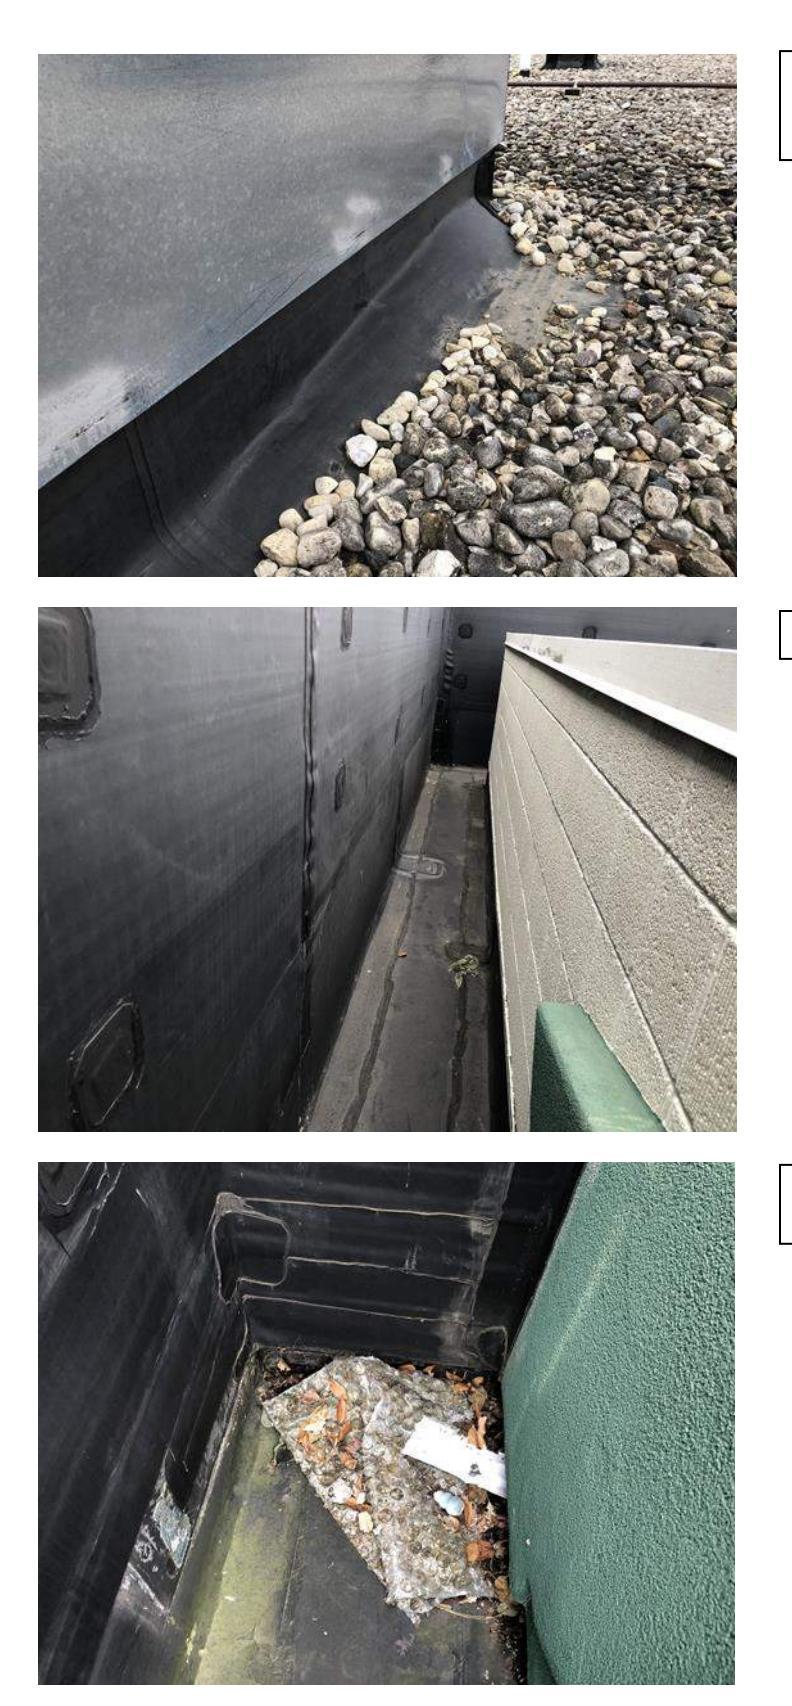
Other units show some minor tenting of membrane. This should be monitored in future inspections.

Entrance roof overview.

Debris should be cleared from the roof system.
