InSite Consulting Architects
 115 East Main Street Suite 200
 Madison, Wisconsin 53703
 (800) 453-8086

Madison Municipal Building - Renovation Exhibit G

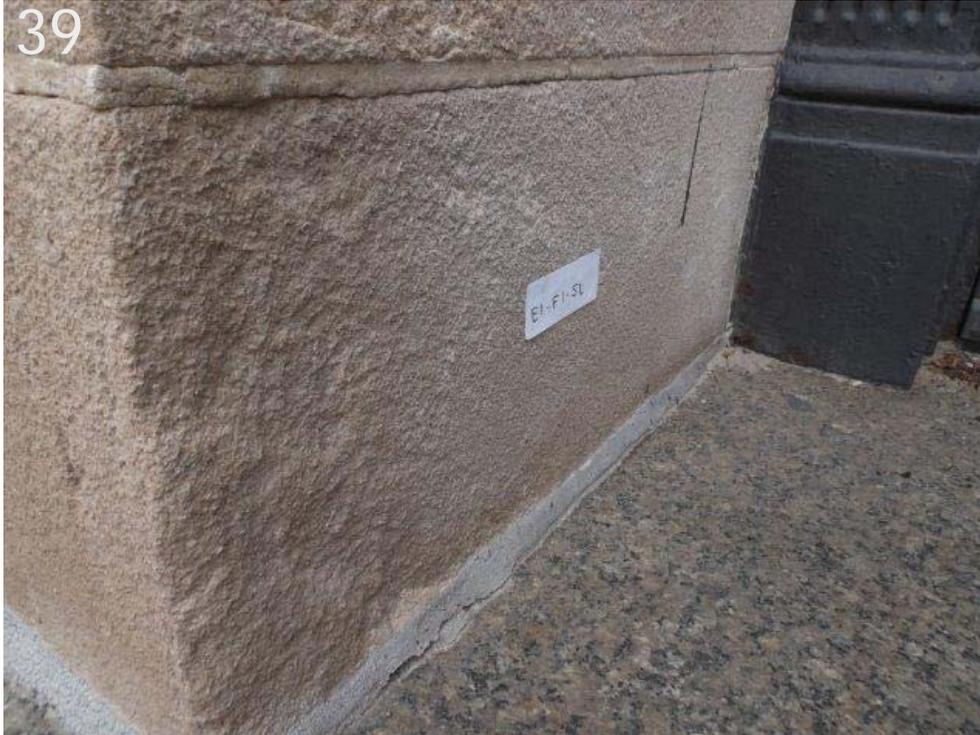
E1 F1 5L

8. CONSOLIDATION REPAIR - REFER TO SPECIFICATION SECTION 04 01 40, SECTION 3.13; INSTALL CONSOLIDATION MATERIAL AS SPECIFIED IN STRICT ACCORDANCE WITH THE MANUFACTURER'S REQUIREMENTS. ESTIMATES FOR SCOPE OF THIS TREATMENT ARE INCLUDED IN THE NOTES. NO WORK IS TO COMMENCE ON A SACRED STONE WITHOUT FIRST RECEIVING APPROVAL FOR THE FINAL SCOPE FROM THE ARCHITECT

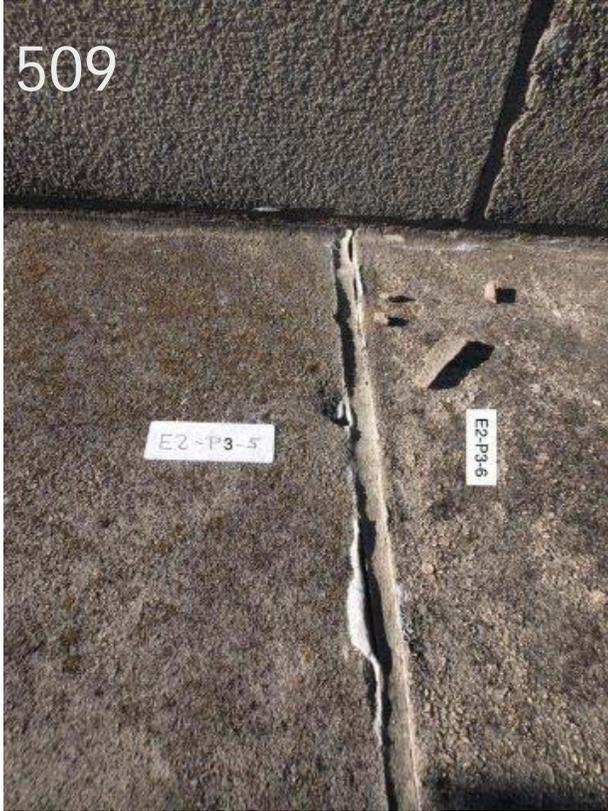
E2 P3 5

3. SUBSTITUTE STONE PATCH (SSP) - REFER TO SPECIFICATION SECTION 04 01 40, SECTION 3.2; REPAIR SPALLS AND OTHER ANOMALIES IN STONE USING CEMENTITIOUS PATCHING MATERIAL USING THE MATERIALS SPECIFIED, TRAINED METHODS AND CERTIFIED WORKERS. ESTIMATES FOR THE VOLUME OF MATERIAL REMOVED AND NEEDED FOR THIS REPAIR ARE PROVIDED BELOW - FINAL SCOPE MAY VARY DEPENDING ON CONDITIONS ENCOUNTERED IN THE FIELD

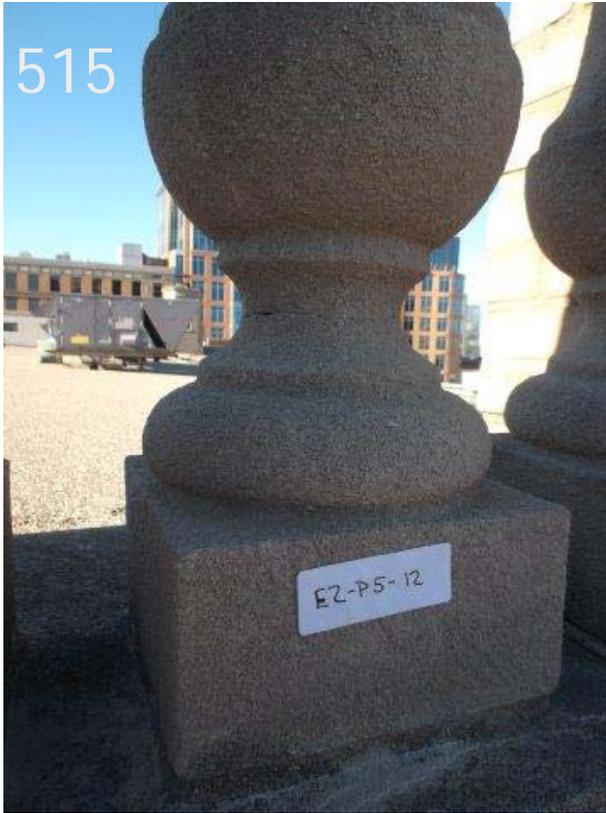
E2 P5 11

19. BALUSTER REPAIR - REFER TO SPECIFICATION SECTION 04 01 40, SECTION 3.11; IT IS THE INTENT OF THIS PROJECT TO PRESERVE ALL BALUSTERS FOR REINSTALLATION. THE WORK INCLUDES THE BINDING AND CAREFUL REMOVAL OF THE BALUSTERS FOR SHOP-EXECUTED PRESERVATION PROCEDURES. THIS NOTE APPLIES TO ALL BALUSTERS

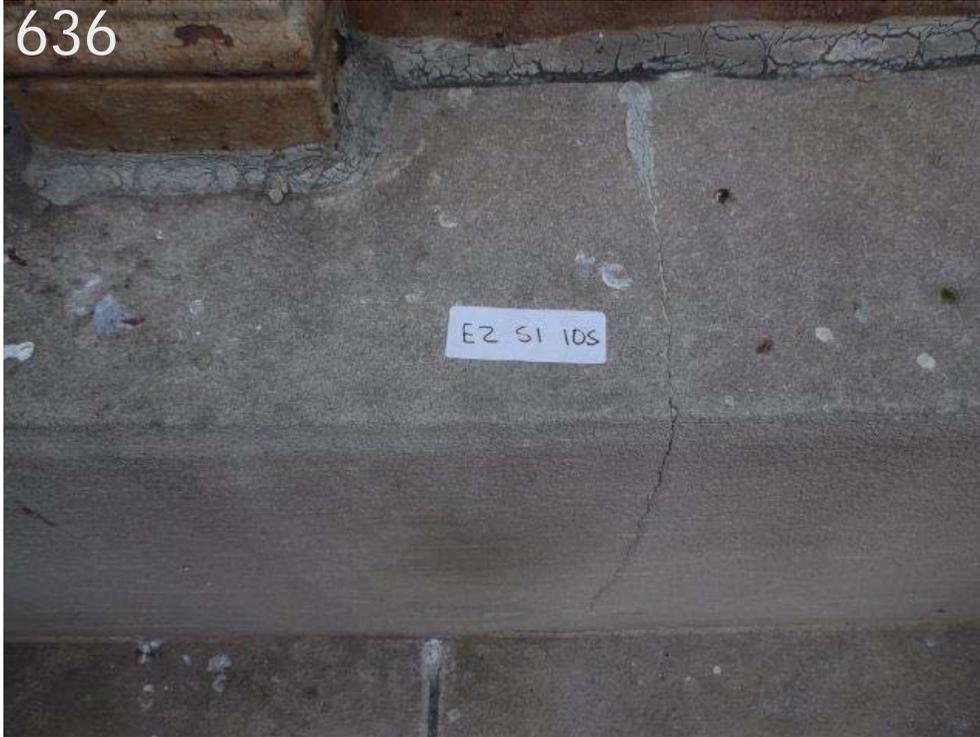
E2 S1 10SL

2. CRACK INJECTION AND STAIN - REFER TO SPECIFICATION SECTION 04 01 40, SECTION 3.8: DRILL INJECTION HOLES AS DIRECTED BY THE MANUFACTURER, INJECT DISPERSED HYDRATED LIME, USING THE MATERIALS SPECIFIED, TRAINED METHODS AND CERTIFIED WORKERS; STAIN AS REQUIRED USING TRAINED METHODS AND CERTIFIED WORKERS. ESTIMATES FOR THE AMOUNT OF CRACK INJECTION NEEDED FOR THIS REPAIR ARE PROVIDED BELOW - ALTERNATIVE METHODS MAY BE PROPOSED TO REDUCE IMPACT ON EXISTING MATERIAL. FINAL SCOPE MAY VARY DEPENDING ON CONDITIONS ENCOUNTERED IN THE FIELD

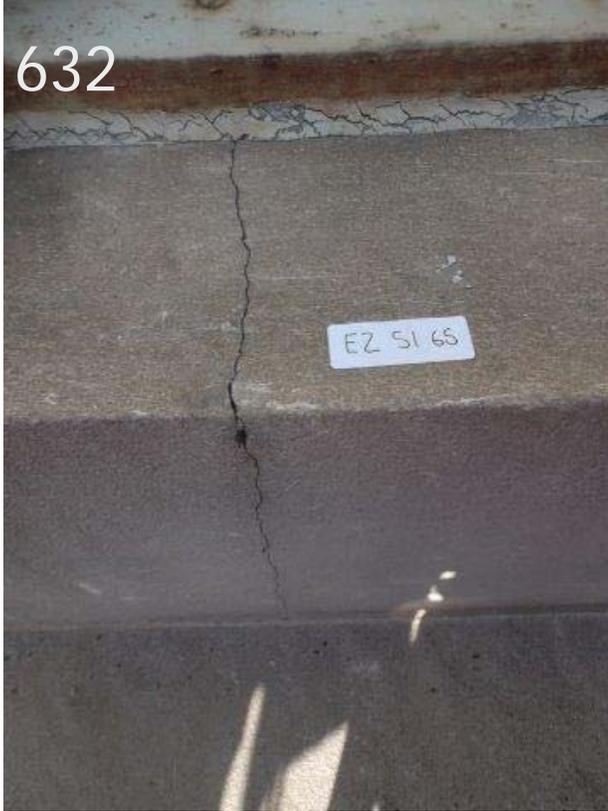
E2 S1 6SL

2. CRACK INJECTION AND STAIN - REFER TO SPECIFICATION SECTION 04 01 40, SECTION 3.8: DRILL INJECTION HOLES AS DIRECTED BY THE MANUFACTURER, INJECT DISPERSED HYDRATED LIME, USING THE MATERIALS SPECIFIED, TRAINED METHODS AND CERTIFIED WORKERS; STAIN AS REQUIRED USING TRAINED METHODS AND CERTIFIED WORKERS. ESTIMATES FOR THE AMOUNT OF CRACK INJECTION NEEDED FOR THIS REPAIR ARE PROVIDED BELOW - ALTERNATIVE METHODS MAY BE PROPOSED TO REDUCE IMPACT ON EXISTING MATERIAL. FINAL SCOPE MAY VARY DEPENDING ON CONDITIONS ENCOUNTERED IN THE FIELD

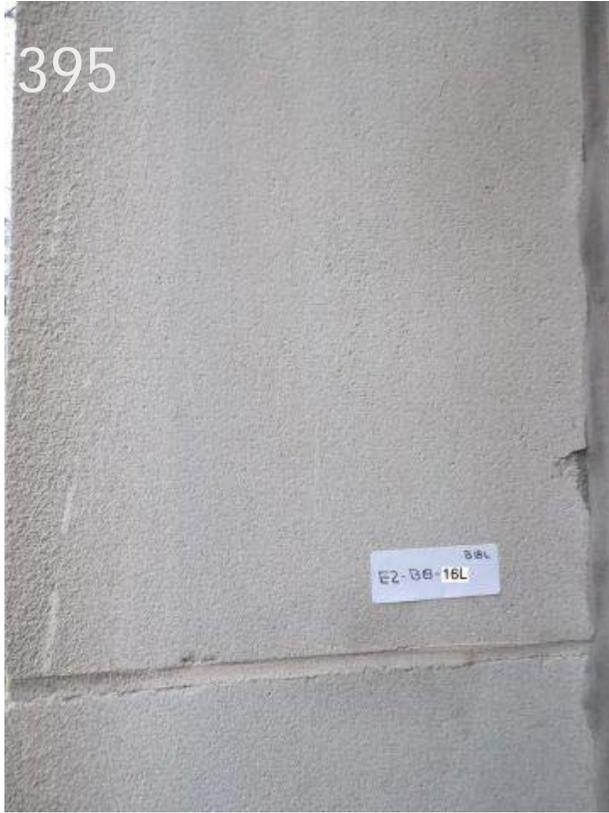
E2 B6 16L

2. CRACK INJECTION AND STAIN - REFER TO SPECIFICATION SECTION 04 01 40, SECTION 3.8: DRILL INJECTION HOLES AS DIRECTED BY THE MANUFACTURER, INJECT DISPERSED HYDRATED LIME, USING THE MATERIALS SPECIFIED, TRAINED METHODS AND CERTIFIED WORKERS; STAIN AS REQUIRED USING TRAINED METHODS AND CERTIFIED WORKERS. ESTIMATES FOR THE AMOUNT OF CRACK INJECTION NEEDED FOR THIS REPAIR ARE PROVIDED BELOW - ALTERNATIVE METHODS MAY BE PROPOSED TO REDUCE IMPACT ON EXISTING MATERIAL. FINAL SCOPE MAY VARY DEPENDING ON CONDITIONS ENCOUNTERED IN THE FIELD

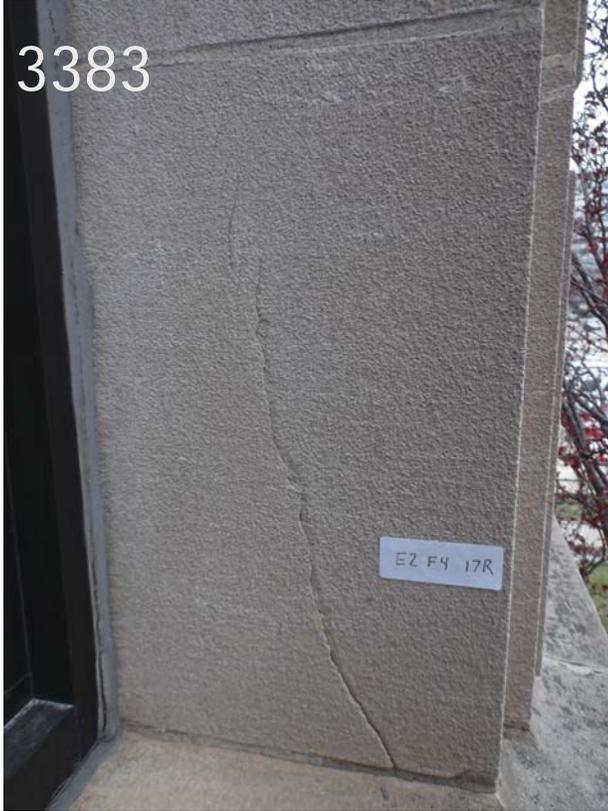
E2 F4 17R

12. ROUT, LIME INJECTION, SSP - REFER TO SPECIFICATION SECTION 04 01 40, SECTION 3.2 AND 3.8; THIS IS A MULTIPLE TECHNIQUE SCOPE ITEM. FOR ALL SCOPES/TECHNIQUES USE THE MATERIALS SPECIFIED, TRAINED METHODS AND CERTIFIED WORKERS. ESTIMATES FOR THE AMOUNT OF EACH TECHNIQUE/SCOPE NEEDED FOR THIS REPAIR ARE PROVIDED BELOW - FINAL SCOPE MAY VARY DEPENDING ON CONDITIONS ENCOUNTERED IN THE FIELD

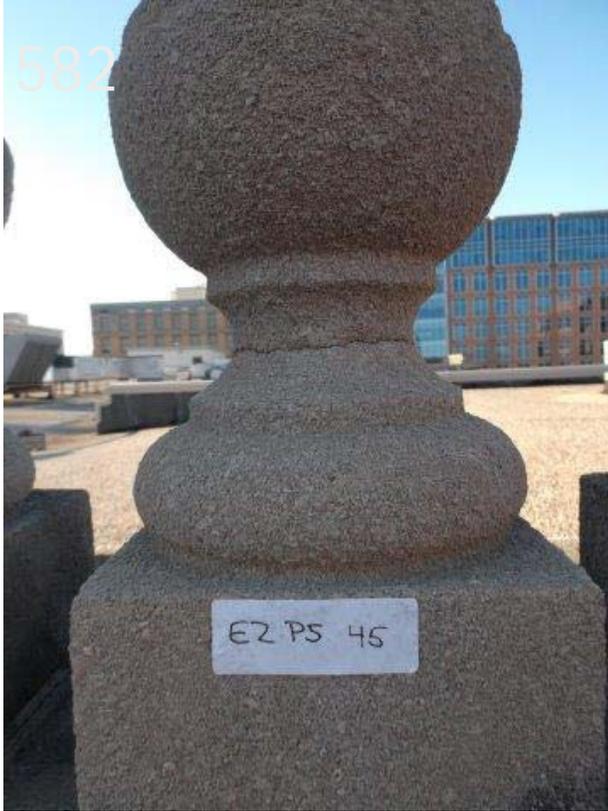
E2 P5 45

19. BALUSTER REPAIR - REFER TO SPECIFICATION SECTION 04 01 40, SECTION 3.11; IT IS THE INTENT OF THIS PROJECT TO PRESERVE ALL BALUSTERS FOR REINSTALLATION. THE WORK INCLUDES THE BINDING AND CAREFUL REMOVAL OF THE BALUSTERS FOR SHOP-EXECUTED PRESERVATION PROCEDURES. THIS NOTE APPLIES TO ALL BALUSTERS

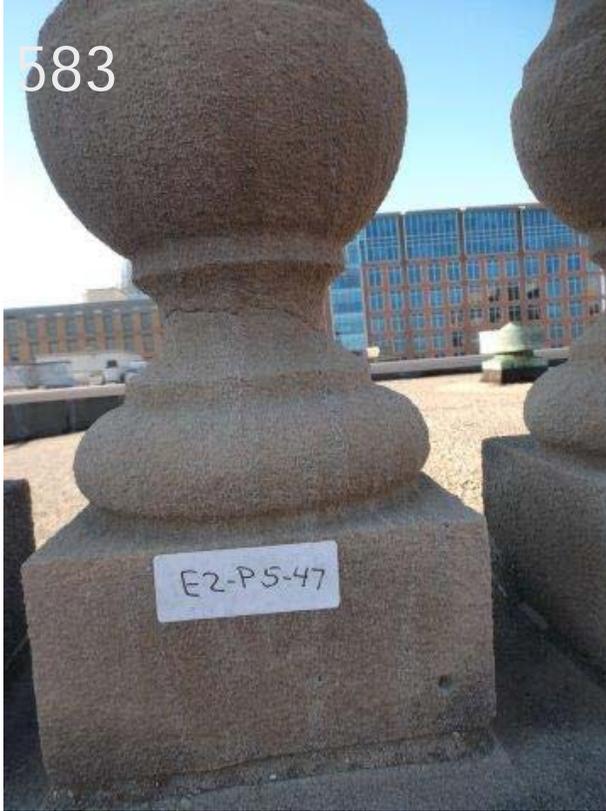
E2 P5 47

19. BALUSTER REPAIR - REFER TO SPECIFICATION SECTION 04 01 40, SECTION 3.11; IT IS THE INTENT OF THIS PROJECT TO PRESERVE ALL BALUSTERS FOR REINSTALLATION. THE WORK INCLUDES THE BINDING AND CAREFUL REMOVAL OF THE BALUSTERS FOR SHOP-EXECUTED PRESERVATION PROCEDURES. THIS NOTE APPLIES TO ALL BALUSTERS

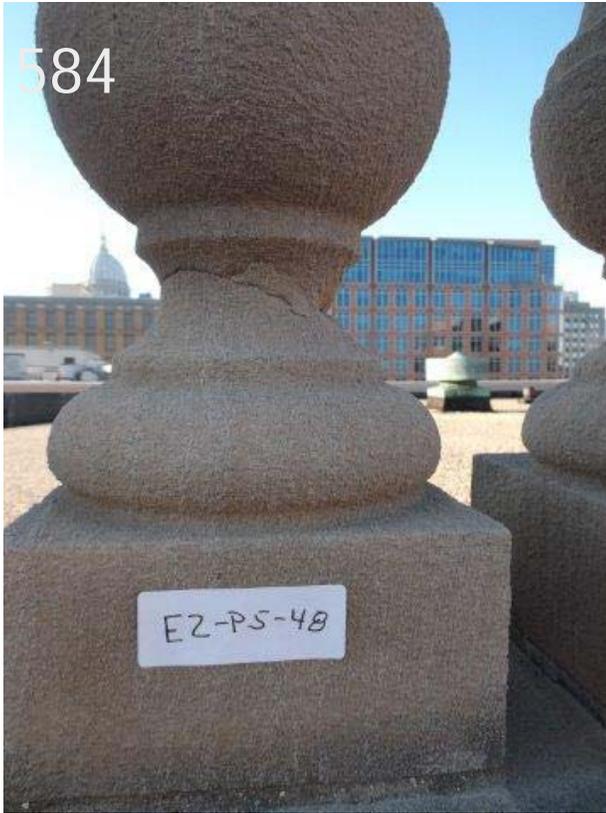
E2 P5 48

19. BALUSTER REPAIR - REFER TO SPECIFICATION SECTION 04 01 40, SECTION 3.11; IT IS THE INTENT OF THIS PROJECT TO PRESERVE ALL BALUSTERS FOR REINSTALLATION. THE WORK INCLUDES THE BINDING AND CAREFUL REMOVAL OF THE BALUSTERS FOR SHOP-EXECUTED PRESERVATION PROCEDURES. THIS NOTE APPLIES TO ALL BALUSTERS

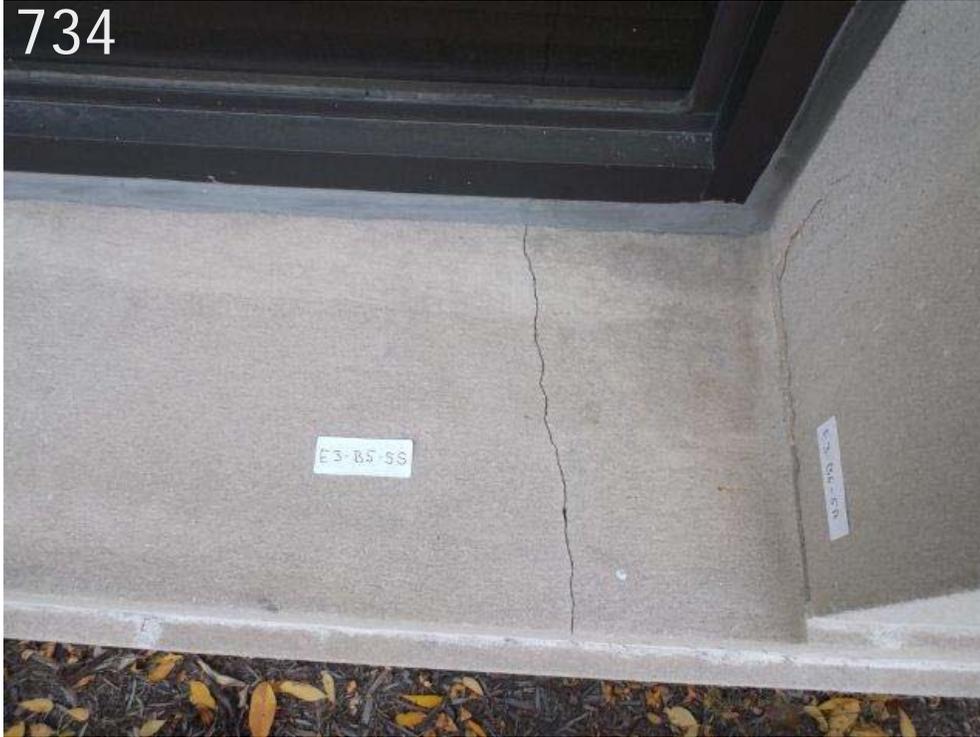
E3 B5 5S

2. CRACK INJECTION AND STAIN - REFER TO SPECIFICATION SECTION 04 01 40, SECTION 3.8: DRILL INJECTION HOLES AS DIRECTED BY THE MANUFACTURER, INJECT DISPERSED HYDRATED LIME, USING THE MATERIALS SPECIFIED, TRAINED METHODS AND CERTIFIED WORKERS; STAIN AS REQUIRED USING TRAINED METHODS AND CERTIFIED WORKERS. ESTIMATES FOR THE AMOUNT OF CRACK INJECTION NEEDED FOR THIS REPAIR ARE PROVIDED BELOW - ALTERNATIVE METHODS MAY BE PROPOSED TO REDUCE IMPACT ON EXISTING MATERIAL. FINAL SCOPE MAY VARY DEPENDING ON CONDITIONS ENCOUNTERED IN THE FIELD

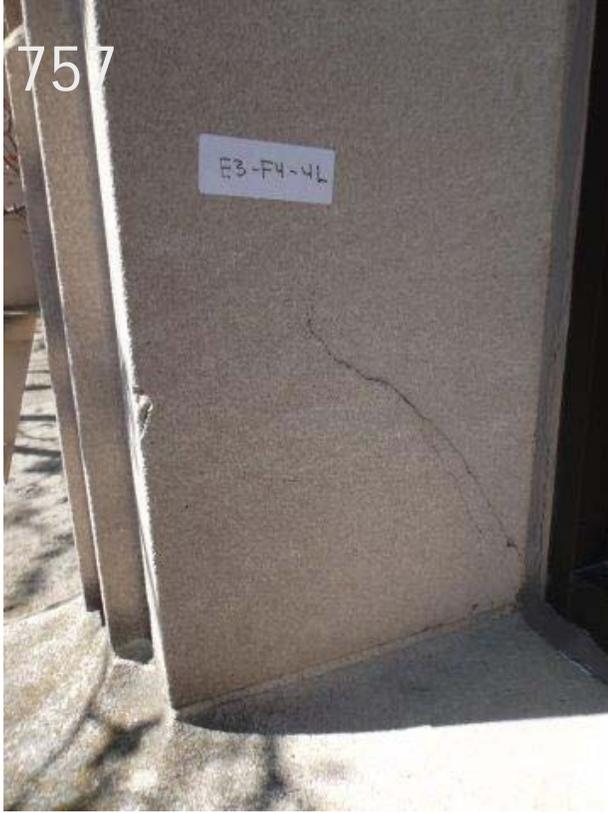
E3 F4 4SL

9. DUTCHMAN - REFER TO SPECIFICATION SECTION 04 01 40, SECTION 3.7; REMOVE DAMAGED STONE TO A SPECIFIED DEPTH AND INSERT A NEW PIECE OF STONE TO FIT IN THE OPENING TO CREATE THE APPEARANCE OF A SEAMLESS PATCH, USE THE MATERIALS SPECIFIED, TRAINED METHODS AND CERTIFIED WORKERS. ESTIMATES FOR THE VOLUME OF EACH TECHNIQUE/SCOPE NEEDED FOR THIS REPAIR ARE PROVIDED BELOW - FINAL SCOPE MAY VARY DEPENDING ON CONDITIONS ENCOUNTERED IN THE FIELD

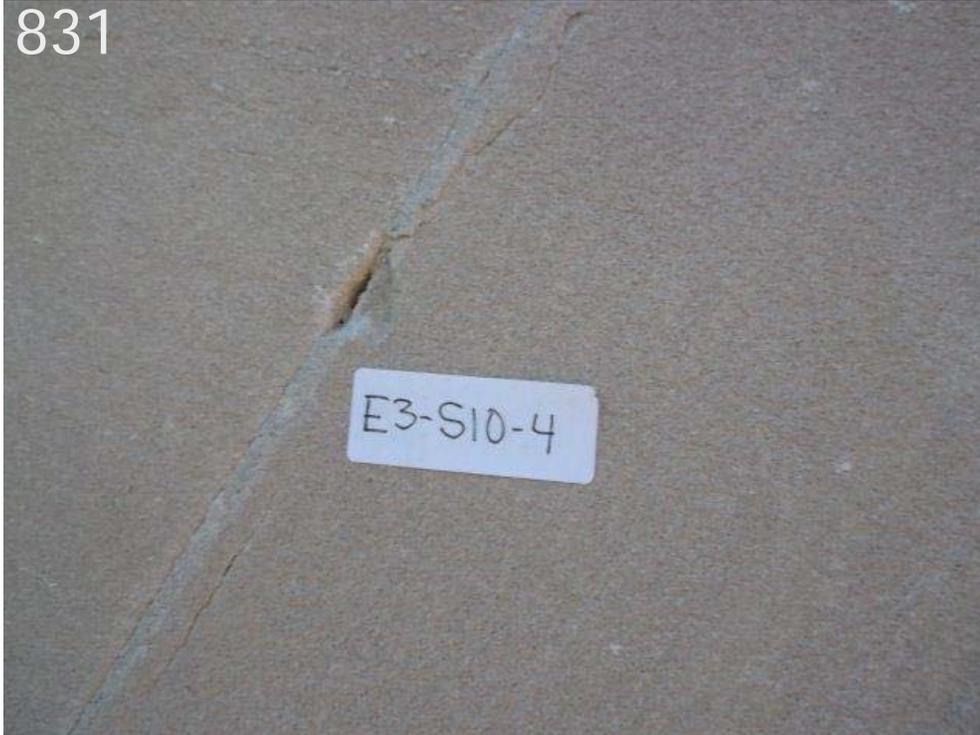
E3 S10 4

5. SACRED STONE - THIS IS A STONE THAT HAS SPECIAL INSTRUCTIONS OR MULTIPLE PRESERVATION TECHNIQUES. ESTIMATES FOR SCOPE OF EACH TREATMENT ARE INCLUDED IN THE NOTES. NO WORK IS TO COMMENCE ON A SACRED STONE WITHOUT FIRST RECEIVING APPROVAL FOR THE FINAL SCOPE FROM THE ARCHITECT

The stone arch at window S-23 will require some measure of deconstruction and temporary support. Final scope will require inspection in the field by Architect. Assume for the purposes of this bid all of the stones identified as sacred will require replace

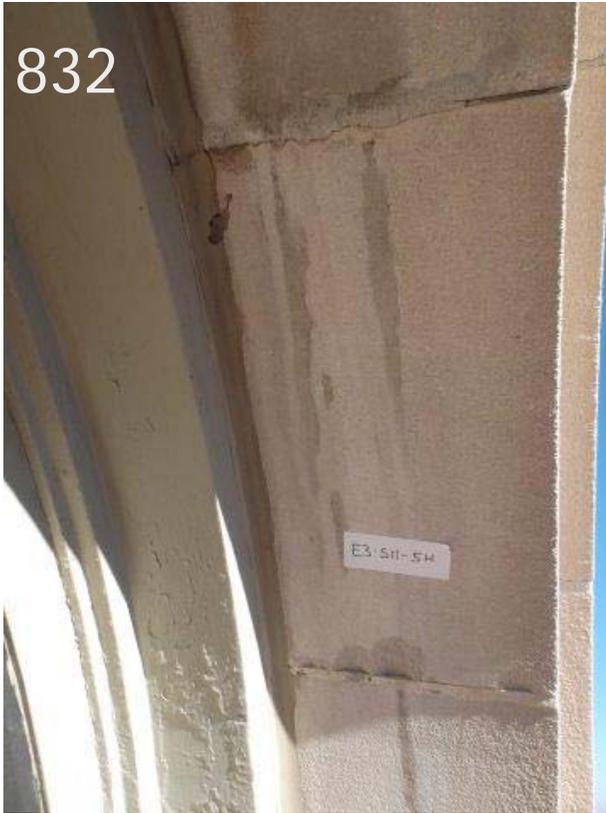
E3 S11 5H

4. MORTAR PATCH - REFER TO SPECIFICATION SECTION 04 01 40, SECTION 3.12; THIS IS A PASSIVE REPAIR, NO EXCESSIVE PATCHING OF STONE IS REQUIRED. CAREFULLY REMOVE ANY DETERIORATED STONE AND ADJACENT STONE THAT HAS BEEN DAMAGED. PLACE WITH NEW MORTAR, AS PART OF THE REQUIRED 100% REPOINTING WORK AT ALL MASONRY AREAS. THIS WORK SHOULD BE INCLUDED IN THE OVERALL COST FOR REPOINTING - FINAL SCOPE MAY VARY DEPENDING ON CONDITIONS ENCOUNTERED IN THE FIELD

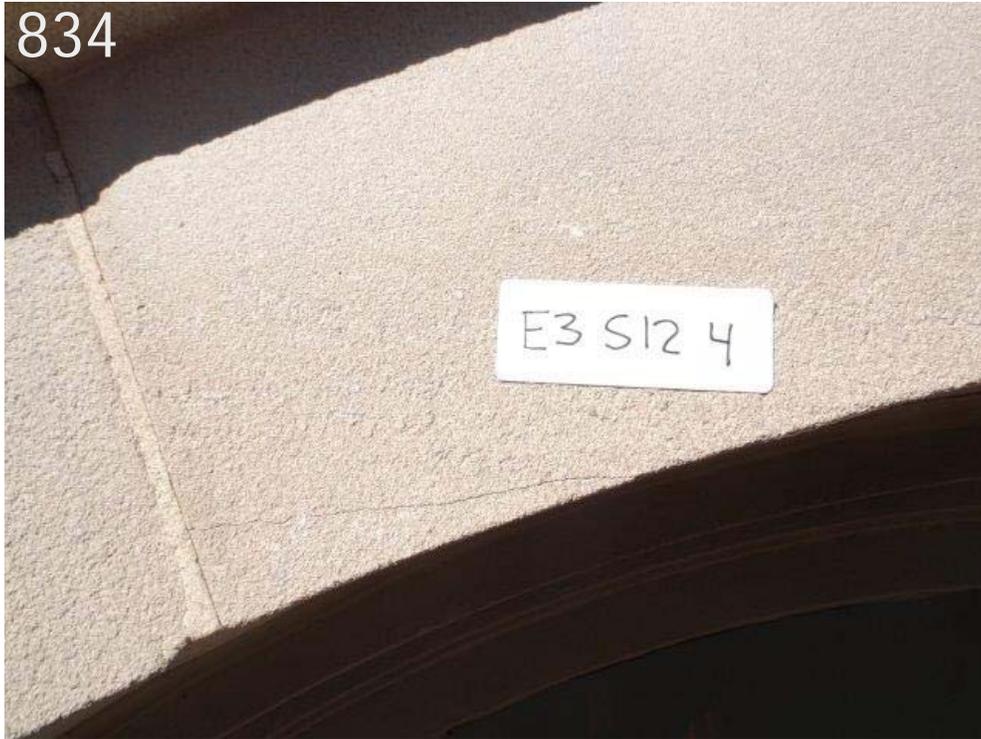
E3 S12 4

5. SACRED STONE - THIS IS A STONE THAT HAS SPECIAL INSTRUCTIONS OR MULTIPLE PRESERVATION TECHNIQUES. ESTIMATES FOR SCOPE OF EACH TREATMENT ARE INCLUDED IN THE NOTES. NO WORK IS TO COMMENCE ON A SACRED STONE WITHOUT FIRST RECEIVING APPROVAL FOR THE FINAL SCOPE FROM THE ARCHITECT

The stone arch at window S-23 will require some measure of deconstruction and temporary support. Final scope will require inspection in the field by Architect. Assume for the purposes of this bid all of the stones identified as sacred will require replace

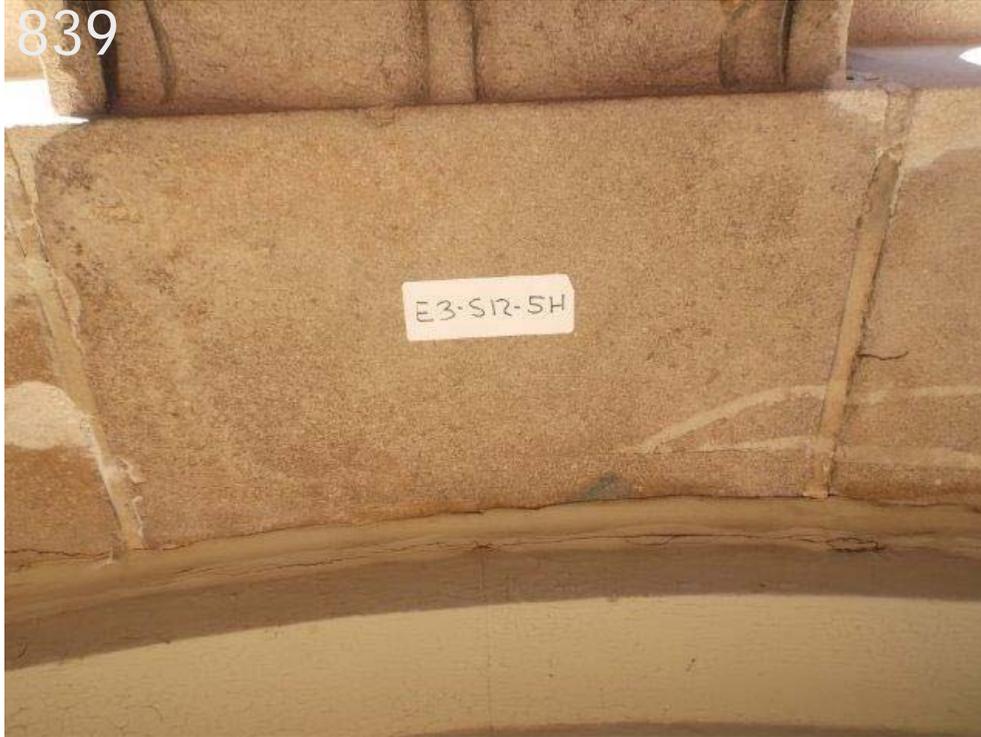
E3 S12 5H

5. SACRED STONE - THIS IS A STONE THAT HAS SPECIAL INSTRUCTIONS OR MULTIPLE PRESERVATION TECHNIQUES. ESTIMATES FOR SCOPE OF EACH TREATMENT ARE INCLUDED IN THE NOTES. NO WORK IS TO COMMENCE ON A SACRED STONE WITHOUT FIRST RECEIVING APPROVAL FOR THE FINAL SCOPE FROM THE ARCHITECT

The stone arch at window S-23 will require some measure of deconstruction and temporary support. Final scope will require inspection in the field by Architect. Assume for the purposes of this bid all of the stones identified as sacred will require replace

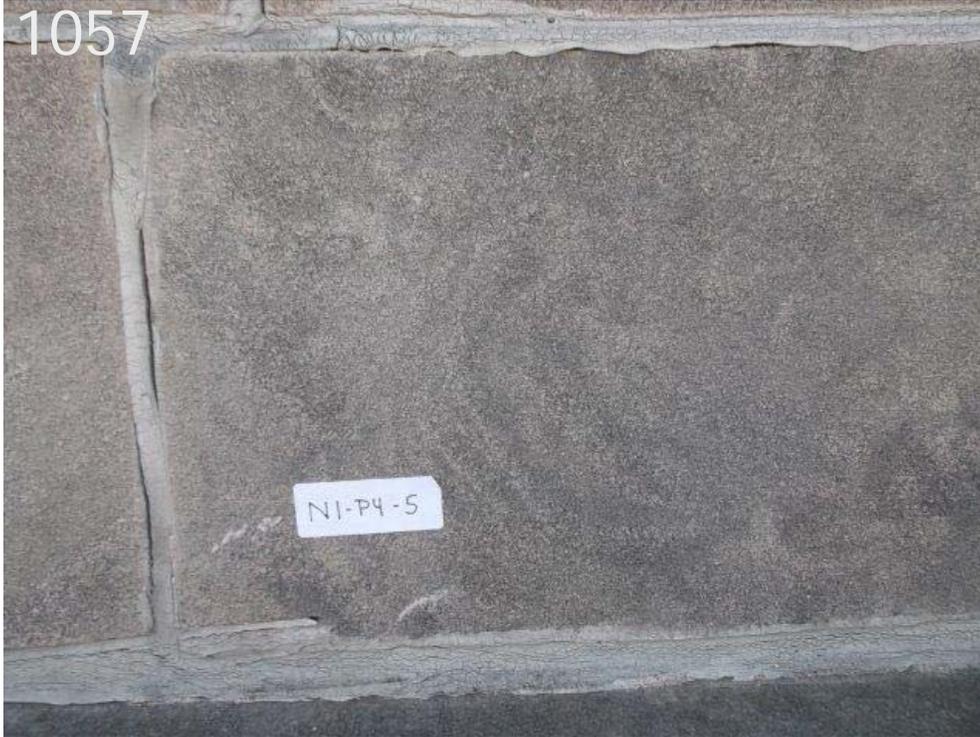
N1 P4 5

7. REMOVE, REVERSE, REDRESS, RESET - REFER TO SPECIFICATION SECTION 04 01 40, SECTION 3.5; THIS IS A MULTIPLE TECHNIQUE SCOPE ITEM. FOR ALL SCOPES/TECHNIQUES USE THE MATERIALS SPECIFIED, TRAINED METHODS AND CERTIFIED WORKERS. ESTIMATES FOR THE AMOUNT OF EACH TECHNIQUE/SCOPE NEEDED FOR THIS REPAIR ARE PROVIDED BELOW - FINAL SCOPE MAY VARY DEPENDING ON CONDITIONS ENCOUNTERED IN THE FIELD

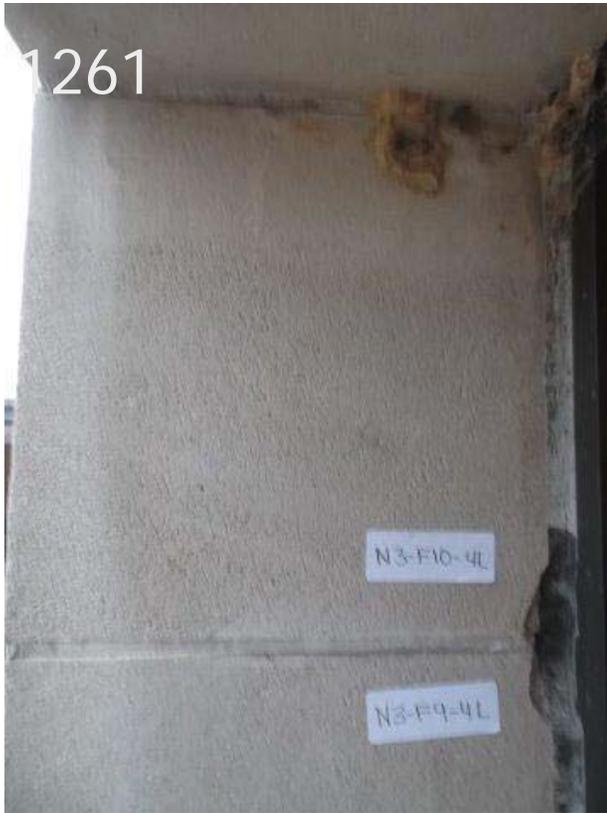
N3 F10 4L

15. REDRESS IN-SITU - REFER TO SPECIFICATION SECTION 04 01 40, SECTION 3.10; CAREFULLY REMOVE LOOSE STONE FRAGMENTS FROM FACE OF STONE AND FINISH FACE OF STONE TO MATCH EXISTING TEXTURE USING THE MATERIALS SPECIFIED, TRAINED METHODS AND CERTIFIED WORKERS; STAIN AS REQUIRED USING TRAINED METHODS AND CERTIFIED WORKERS. ESTIMATES FOR THE AREA OF REDRESS IN-SITU NEEDED FOR THIS REPAIR ARE PROVIDED BELOW - FINAL SCOPE MAY VARY DEPENDING ON CONDITIONS ENCOUNTERED IN THE FIELD

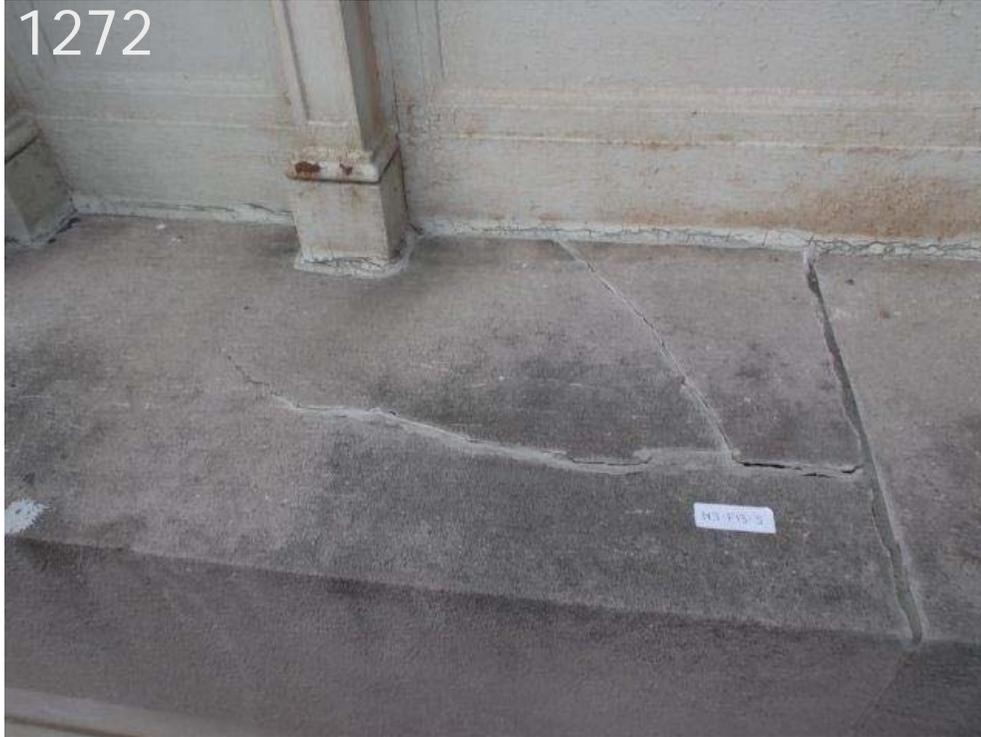
N3 F13 5

5. SACRED STONE - THIS IS A STONE THAT HAS SPECIAL INSTRUCTIONS OR MULTIPLE PRESERVATION TECHNIQUES. ESTIMATES FOR SCOPE OF EACH TREATMENT ARE INCLUDED IN THE NOTES. NO WORK IS TO COMMENCE ON A SACRED STONE WITHOUT FIRST RECEIVING APPROVAL FOR THE FINAL SCOPE FROM THE ARCHITECT

Route all cracks at this stone to a uniform depth of 1.5" and width of 1". Install helical anchors as required to stabilize within the routed areas install new substitute stone patch material to the affected areas.

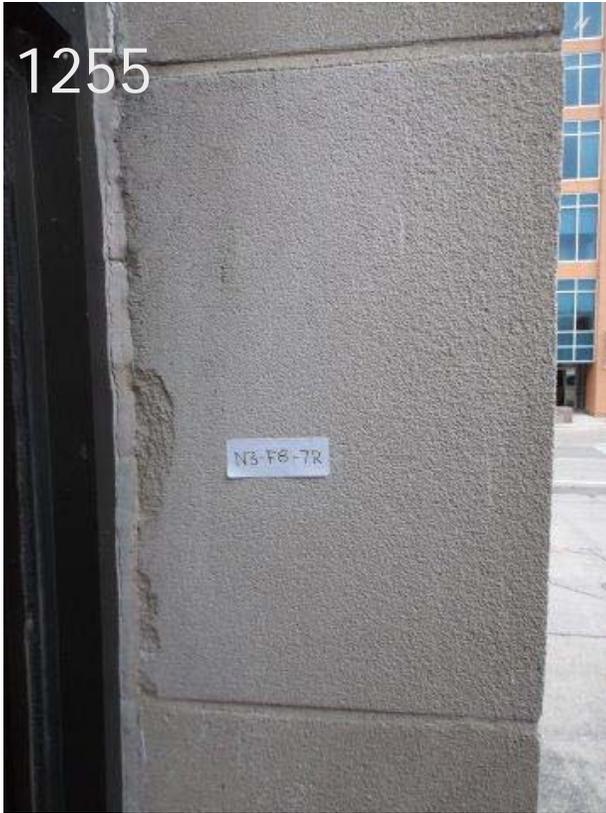
N3 F8 7R

15. REDRESS IN-SITU - REFER TO SPECIFICATION SECTION 04 01 40, SECTION 3.10; CAREFULLY REMOVE LOOSE STONE FRAGMENTS FROM FACE OF STONE AND FINISH FACE OF STONE TO MATCH EXISTING TEXTURE USING THE MATERIALS SPECIFIED, TRAINED METHODS AND CERTIFIED WORKERS; STAIN AS REQUIRED USING TRAINED METHODS AND CERTIFIED WORKERS. ESTIMATES FOR THE AREA OF REDRESS IN-SITU NEEDED FOR THIS REPAIR ARE PROVIDED BELOW - FINAL SCOPE MAY VARY DEPENDING ON CONDITIONS ENCOUNTERED IN THE FIELD

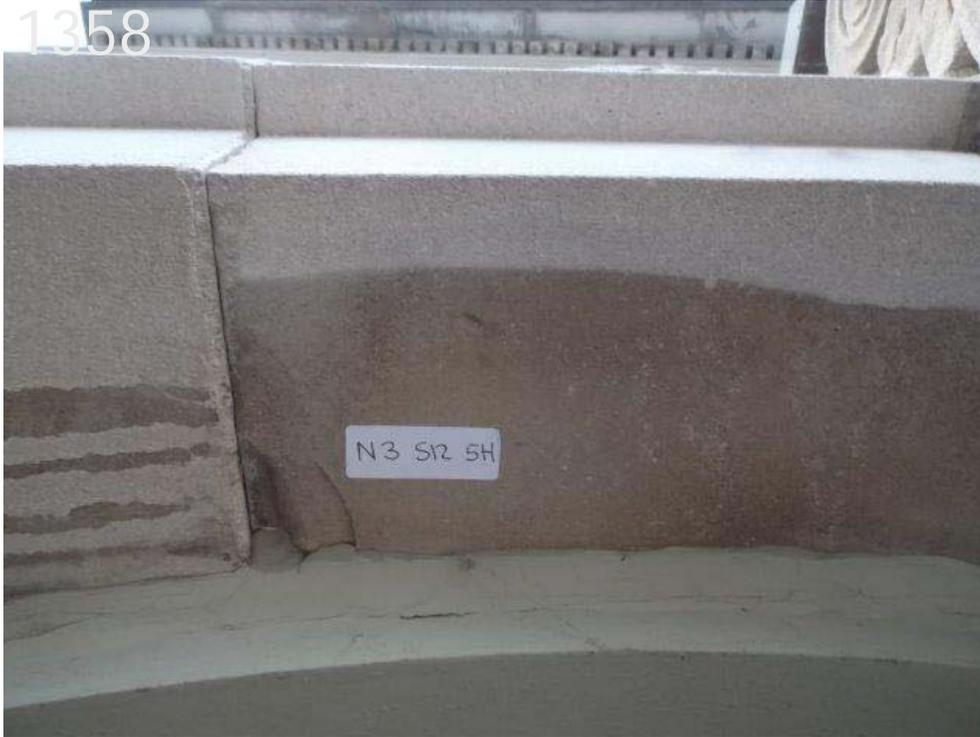
N3 S12 5H

9. DUTCHMAN - REFER TO SPECIFICATION SECTION 04 01 40, SECTION 3.7; REMOVE DAMAGED STONE TO A SPECIFIED DEPTH AND INSERT A NEW PIECE OF STONE TO FIT IN THE OPENING TO CREATE THE APPEARANCE OF A SEAMLESS PATCH, USE THE MATERIALS SPECIFIED, TRAINED METHODS AND CERTIFIED WORKERS. ESTIMATES FOR THE VOLUME OF EACH TECHNIQUE/SCOPE NEEDED FOR THIS REPAIR ARE PROVIDED BELOW - FINAL SCOPE MAY VARY DEPENDING ON CONDITIONS ENCOUNTERED IN THE FIELD

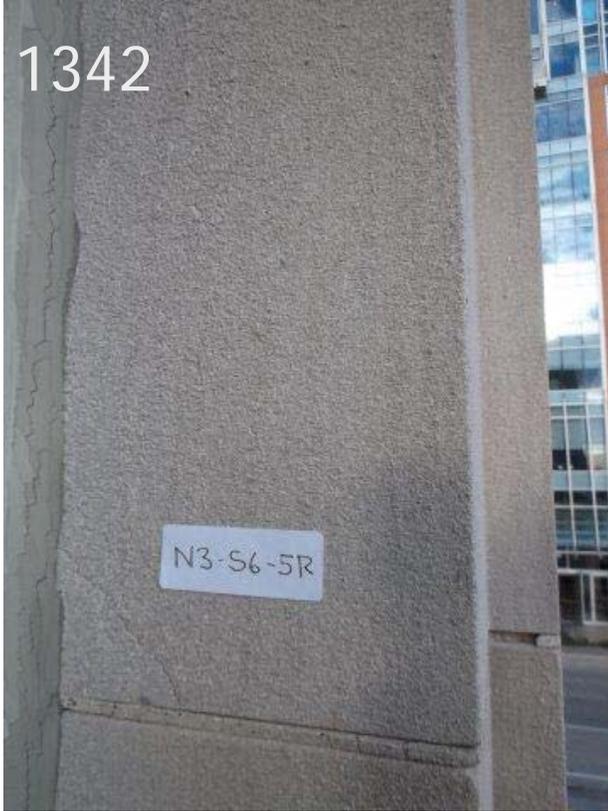
N3 S6 5R

2. CRACK INJECTION AND STAIN - REFER TO SPECIFICATION SECTION 04 01 40, SECTION 3.8: DRILL INJECTION HOLES AS DIRECTED BY THE MANUFACTURER, INJECT DISPERSED HYDRATED LIME, USING THE MATERIALS SPECIFIED, TRAINED METHODS AND CERTIFIED WORKERS; STAIN AS REQUIRED USING TRAINED METHODS AND CERTIFIED WORKERS. ESTIMATES FOR THE AMOUNT OF CRACK INJECTION NEEDED FOR THIS REPAIR ARE PROVIDED BELOW - ALTERNATIVE METHODS MAY BE PROPOSED TO REDUCE IMPACT ON EXISTING MATERIAL. FINAL SCOPE MAY VARY DEPENDING ON CONDITIONS ENCOUNTERED IN THE FIELD

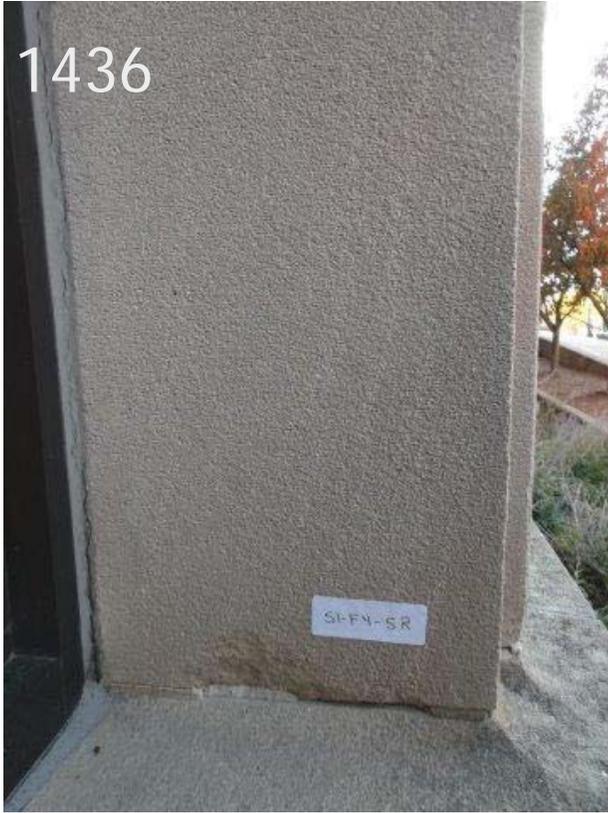
S1 F4 5R

3. SUBSTITUTE STONE PATCH (SSP) - REFER TO SPECIFICATION SECTION 04 01 40, SECTION 3.2; REPAIR SPALLS AND OTHER ANOMALIES IN STONE USING CEMENTITIOUS PATCHING MATERIAL USING THE MATERIALS SPECIFIED, TRAINED METHODS AND CERTIFIED WORKERS. ESTIMATES FOR THE VOLUME OF MATERIAL REMOVED AND NEEDED FOR THIS REPAIR ARE PROVIDED BELOW - FINAL SCOPE MAY VARY DEPENDING ON CONDITIONS ENCOUNTERED IN THE FIELD

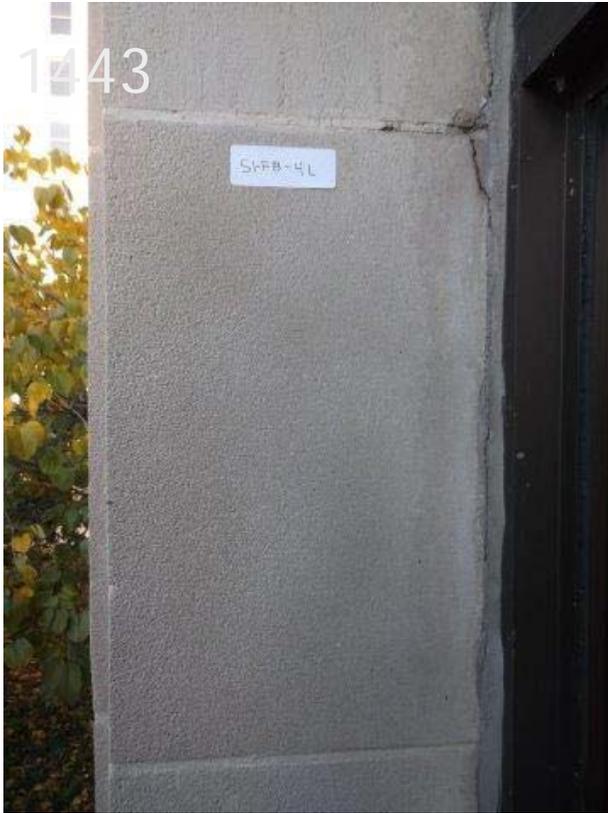
S1 F8 4L

3. SUBSTITUTE STONE PATCH (SSP) - REFER TO SPECIFICATION SECTION 04 01 40, SECTION 3.2; REPAIR SPALLS AND OTHER ANOMALIES IN STONE USING CEMENTITIOUS PATCHING MATERIAL USING THE MATERIALS SPECIFIED, TRAINED METHODS AND CERTIFIED WORKERS. ESTIMATES FOR THE VOLUME OF MATERIAL REMOVED AND NEEDED FOR THIS REPAIR ARE PROVIDED BELOW - FINAL SCOPE MAY VARY DEPENDING ON CONDITIONS ENCOUNTERED IN THE FIELD

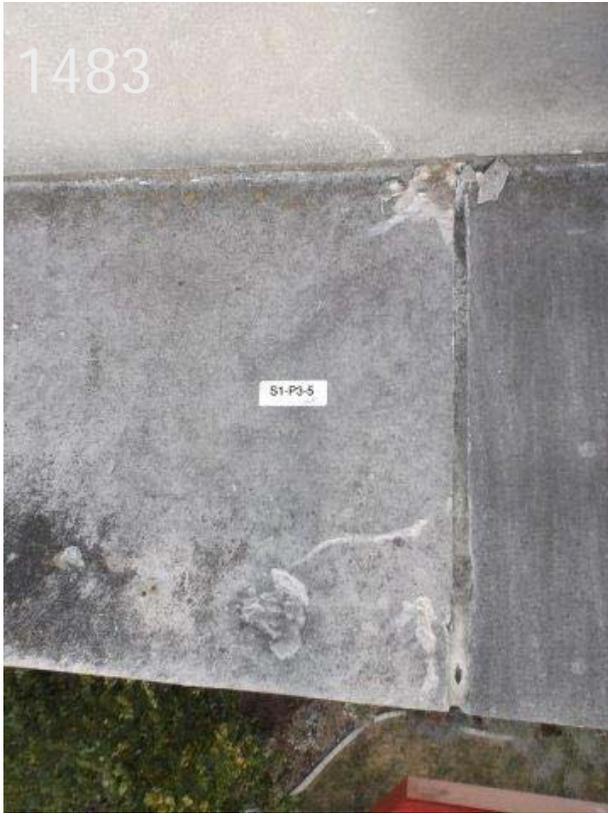
S1 P3 5

3. SUBSTITUTE STONE PATCH (SSP) - REFER TO SPECIFICATION SECTION 04 01 40, SECTION 3.2; REPAIR SPALLS AND OTHER ANOMALIES IN STONE USING CEMENTITIOUS PATCHING MATERIAL USING THE MATERIALS SPECIFIED, TRAINED METHODS AND CERTIFIED WORKERS. ESTIMATES FOR THE VOLUME OF MATERIAL REMOVED AND NEEDED FOR THIS REPAIR ARE PROVIDED BELOW - FINAL SCOPE MAY VARY DEPENDING ON CONDITIONS ENCOUNTERED IN THE FIELD

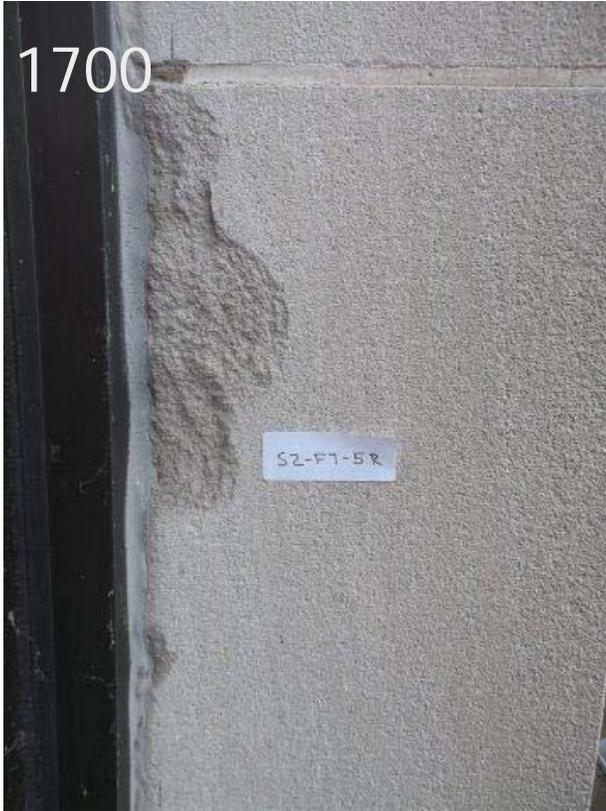
S2 F7 5R

3. SUBSTITUTE STONE PATCH (SSP) - REFER TO SPECIFICATION SECTION 04 01 40, SECTION 3.2; REPAIR SPALLS AND OTHER ANOMALIES IN STONE USING CEMENTITIOUS PATCHING MATERIAL USING THE MATERIALS SPECIFIED, TRAINED METHODS AND CERTIFIED WORKERS. ESTIMATES FOR THE VOLUME OF MATERIAL REMOVED AND NEEDED FOR THIS REPAIR ARE PROVIDED BELOW - FINAL SCOPE MAY VARY DEPENDING ON CONDITIONS ENCOUNTERED IN THE FIELD

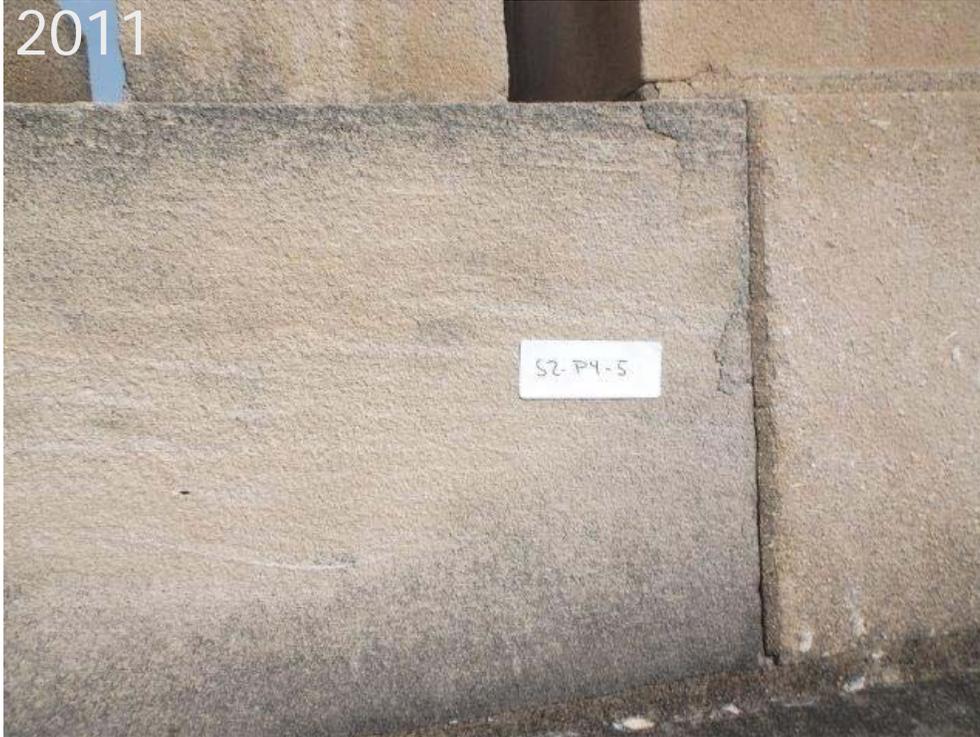
S2 P4 5

2. CRACK INJECTION AND STAIN - REFER TO SPECIFICATION SECTION 04 01 40, SECTION 3.8: DRILL INJECTION HOLES AS DIRECTED BY THE MANUFACTURER, INJECT DISPERSED HYDRATED LIME, USING THE MATERIALS SPECIFIED, TRAINED METHODS AND CERTIFIED WORKERS; STAIN AS REQUIRED USING TRAINED METHODS AND CERTIFIED WORKERS. ESTIMATES FOR THE AMOUNT OF CRACK INJECTION NEEDED FOR THIS REPAIR ARE PROVIDED BELOW - ALTERNATIVE METHODS MAY BE PROPOSED TO REDUCE IMPACT ON EXISTING MATERIAL. FINAL SCOPE MAY VARY DEPENDING ON CONDITIONS ENCOUNTERED IN THE FIELD

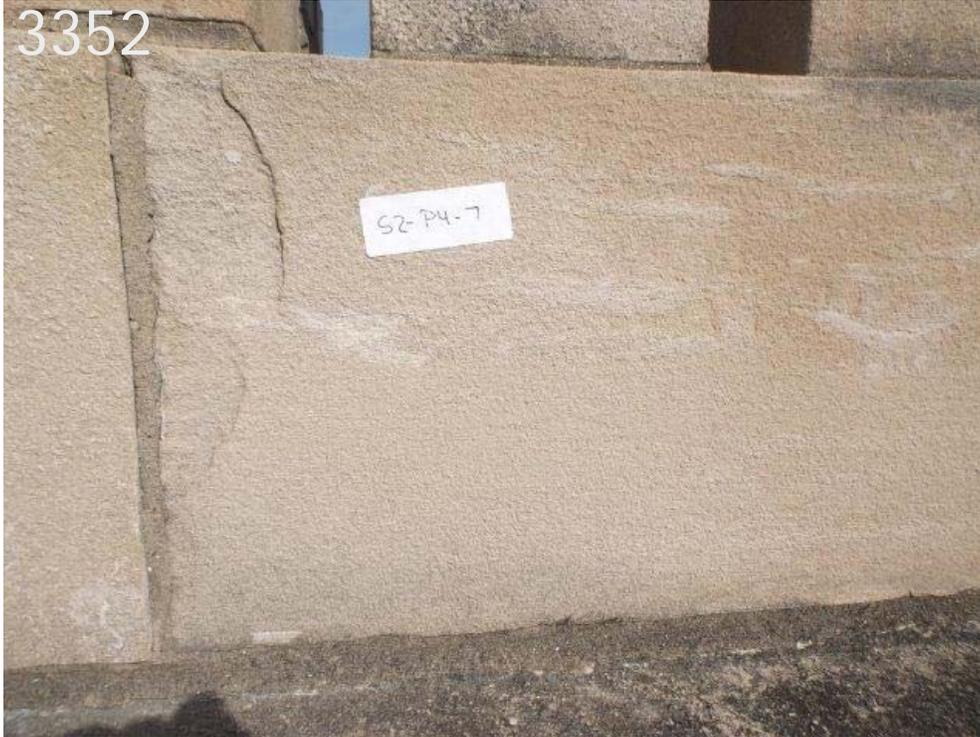
S2 P4 7

15. REDRESS IN-SITU - REFER TO SPECIFICATION SECTION 04 01 40, SECTION 3.10; CAREFULLY REMOVE LOOSE STONE FRAGMENTS FROM FACE OF STONE AND FINISH FACE OF STONE TO MATCH EXISTING TEXTURE USING THE MATERIALS SPECIFIED, TRAINED METHODS AND CERTIFIED WORKERS; STAIN AS REQUIRED USING TRAINED METHODS AND CERTIFIED WORKERS. ESTIMATES FOR THE AREA OF REDRESS IN-SITU NEEDED FOR THIS REPAIR ARE PROVIDED BELOW - FINAL SCOPE MAY VARY DEPENDING ON CONDITIONS ENCOUNTERED IN THE FIELD

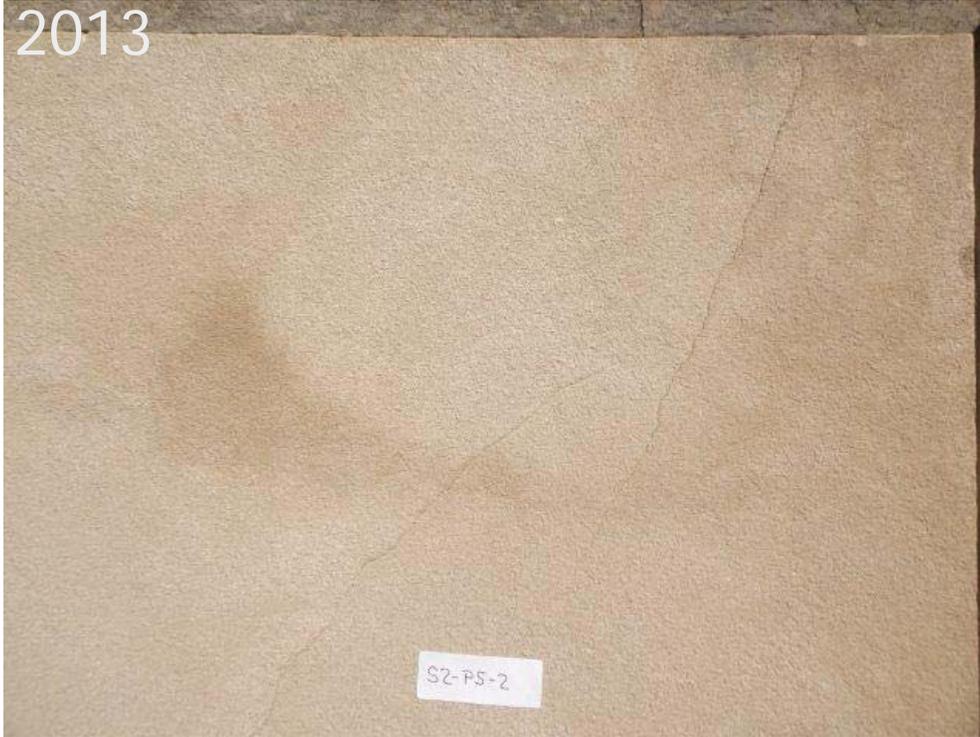
S2 P5 2

6. ADHESIVE WITH HELICAL ANCHOR AND SSP - REFER TO SPECIFICATION SECTION 04 01 40, SECTIONS 3.9 AND 3.2; THIS IS A MULTIPLE TECHNIQUE SCOPE ITEM. FOR ALL SCOPES/TECHNIQUES USE THE MATERIALS SPECIFIED, TRAINED METHODS AND CERTIFIED WORKERS. ESTIMATES FOR THE AMOUNT OF EACH TECHNIQUE/SCOPE NEEDED FOR THIS REPAIR ARE PROVIDED BELOW - FINAL SCOPE MAY VARY DEPENDING ON CONDITIONS ENCOUNTERED IN THE FIELD

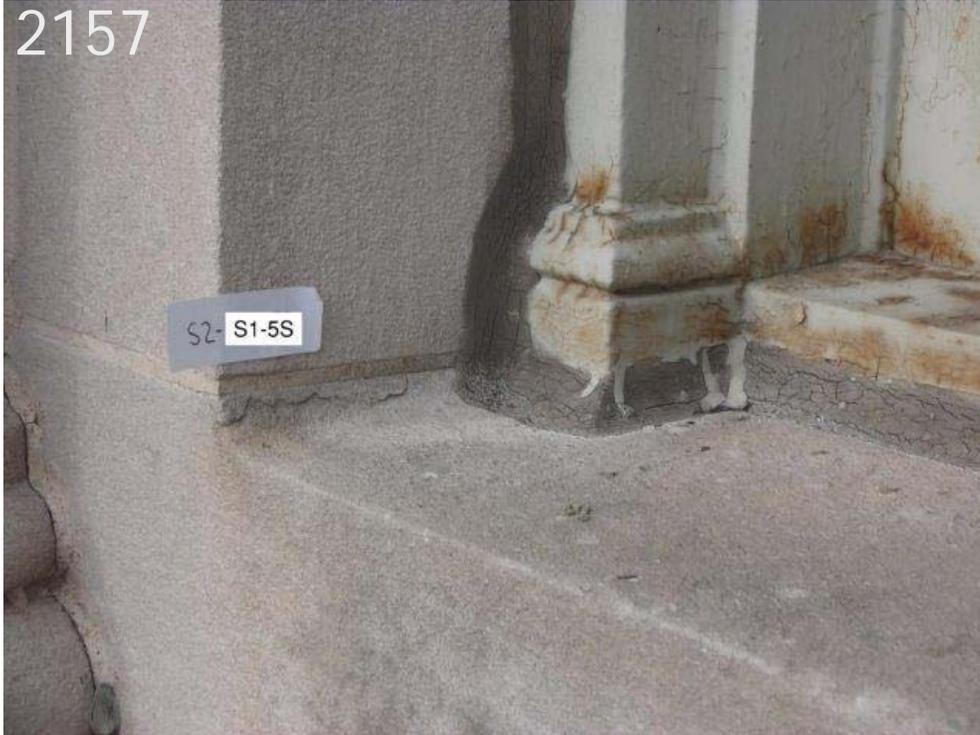
S2 S1 5S

3. SUBSTITUTE STONE PATCH (SSP) - REFER TO SPECIFICATION SECTION 04 01 40, SECTION 3.2; REPAIR SPALLS AND OTHER ANOMALIES IN STONE USING CEMENTITIOUS PATCHING MATERIAL USING THE MATERIALS SPECIFIED, TRAINED METHODS AND CERTIFIED WORKERS. ESTIMATES FOR THE VOLUME OF MATERIAL REMOVED AND NEEDED FOR THIS REPAIR ARE PROVIDED BELOW - FINAL SCOPE MAY VARY DEPENDING ON CONDITIONS ENCOUNTERED IN THE FIELD
